BREAKSPEARS

THE 19th – 20th CENTURY HOUSE

**BREAKSPEAR ROAD NORTH, HAREFIELD, UB9 6NA
LONDON BOROUGH OF HILLINGDON**

AN INVESTIGATION OF THE HISTORIC BUILDING

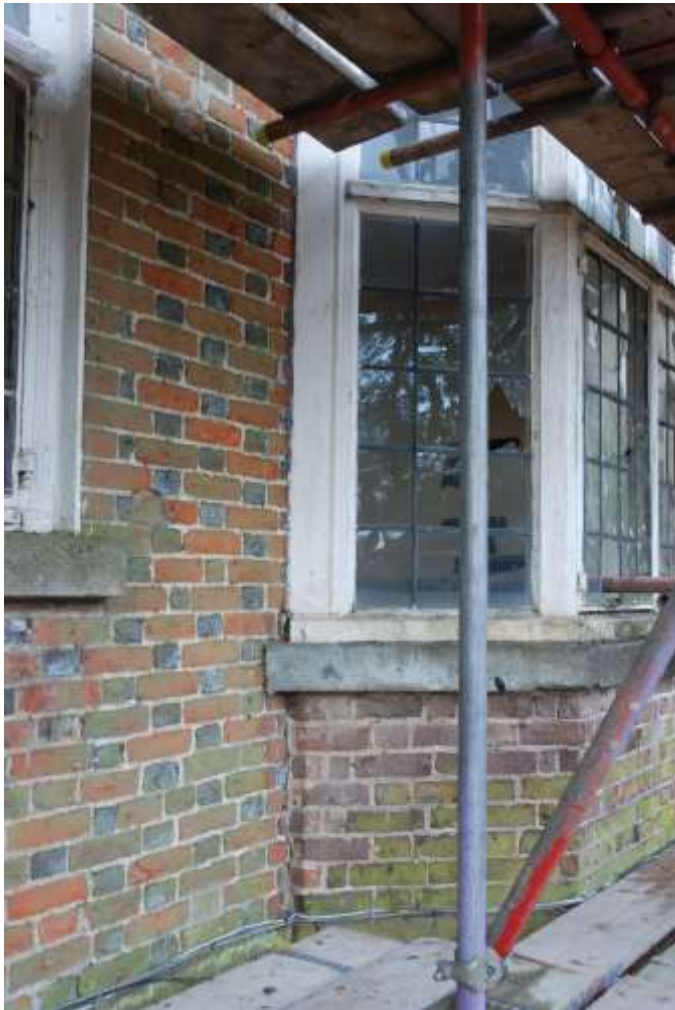
It was clear, from the exterior, that the northern bay windows was later in date than the 'early' house, in that the window was built abutting the earlier brickwork (fig. 39). Furthermore, the brickwork surrounding this window is the purple-red / brown-yellow bricks, set in Flemish bond, in contrast to the red brickwork of the earlier house.

Fig. 39: The bay-window on the northern frontage, outside room F22. The brickwork of the bay window is built clearly abutting the earlier façade brickwork.

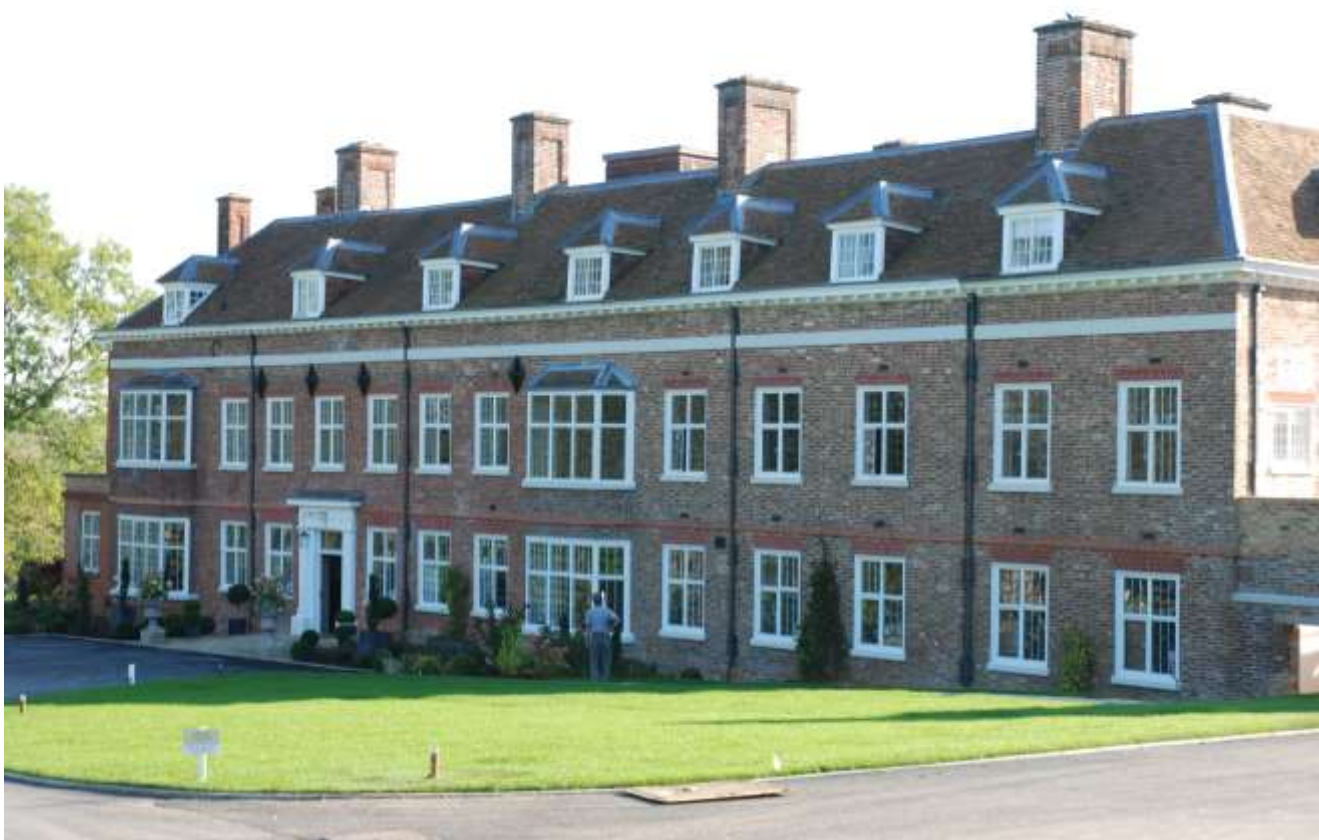
Alongside the extension of the house to the west was the rebuilding of the whole of the upper part of the house, from directly above the top of the first-floor windows. This is reflected in the brickwork in the upper part of the house – clearly the later greyer bricks set in regular Flemish bond, and also including the red brick gauged work directly over the windows. Such brickwork is found from directly above the first floor windows, the whole way along both the northern and southern frontages (i.e. both in the earlier and later parts of the house). This therefore acts as evidence that the upper part of the house was totally rebuilt, in both the earlier and later parts of the house. This clearly took place at the same date as the western extension, as the brickwork in the lower part of the area of the later house fits with that in the upper part of the house, and is consistent with this.

Fig. 42: Northern frontage of Breakspears. The later (greyer) brickwork of Partridge's rebuild can be seen the whole way along, above the top of the first-floor windows.

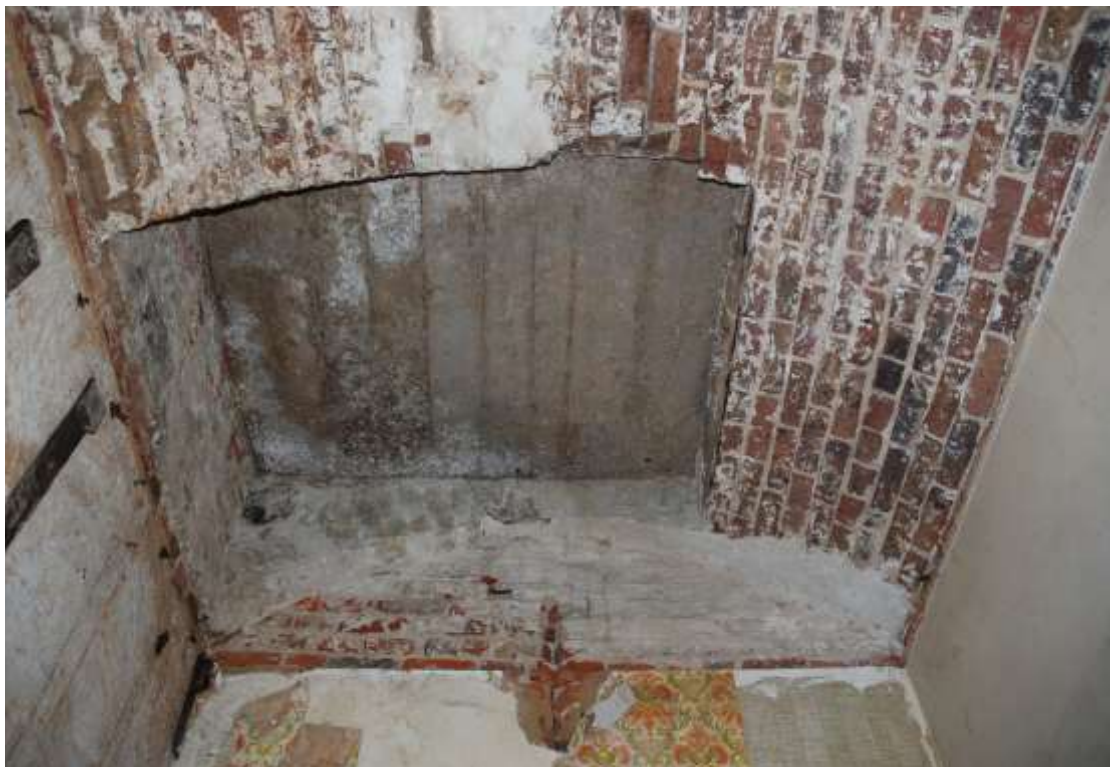
There was an access hatch through from the rooms above into the beer-cellar. This is now blocked, however was observed in the north-west corner of the room, above the entrance, and measured approximately 1.14m (north-south) by 1.62m (east-west). It seems likely that this was used to pass drink, etc, into the room, from the entrance for tradesmen at the western end of the house, on the floor above and, due to the natural rise in the land, would have been accessed from ground level.

Fig. 89: Photograph of the access hatch (now blocked).

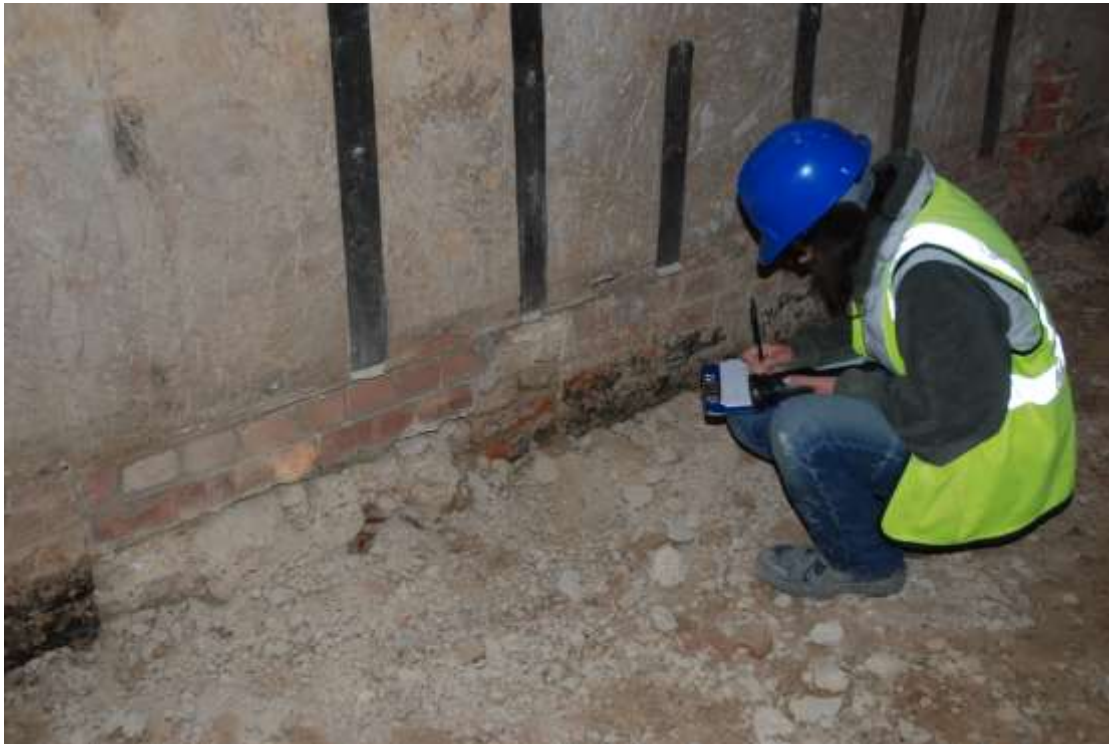
It would appear that there was once a further door on the western wall, centrally located along this wall and again approximately 1.08m in width. This is not recorded on any historic plan, however *c.* 0.4m (in height) of modern blocking was observed just above and below the modern floor.

Fig. 90: Photograph of the blocked door on the western wall.

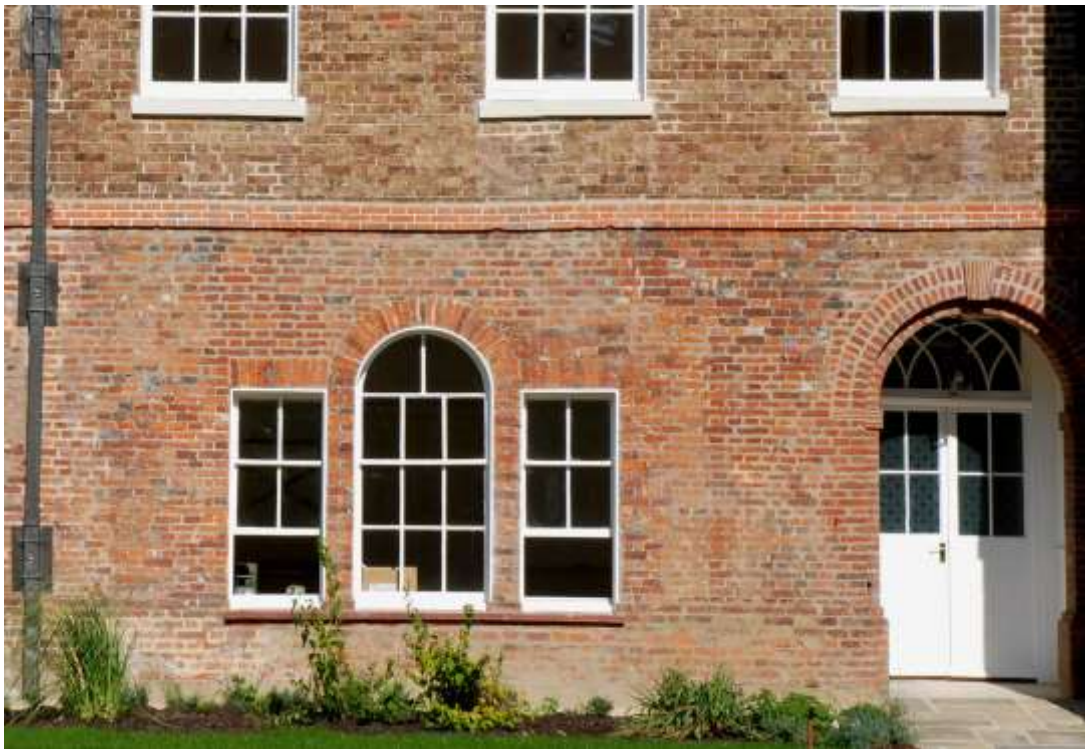
Furthermore, the brickwork surrounding both the Venetian window and rear doorway arch appears to have been 'patched up'. This acts as further evidence that they were inserted at a later date, although it is possible that some of this dates from the 1920s repairs (see section 10).

Fig. 145: Venetian window and southern door-arch – they both consist of poor-quality brickwork and the brickwork surrounding them is patchy.

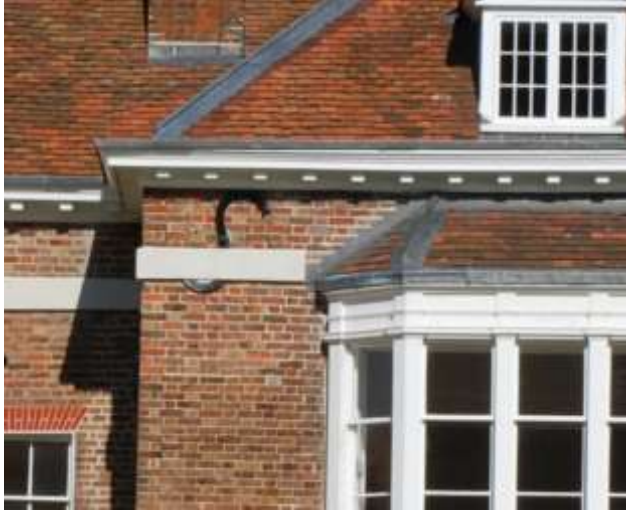
Alongside Captain Tarleton's eastern extension was the insertion of the S-shaped tie rod, which ran north-south through the house at the level of the second floor. This must be associated with Captain Tarleton's works, as its height fits with the height of the extension after Tarleton raised the floors / ceilings. It is also depicted on the c. 1900 photograph (fig. 171), so cannot have been inserted alongside the other tie-rods with the 1924 repair works.

Fig. 170: The S-shaped tie rod, inserted at the same time as Captain Tarleton's eastern extension.

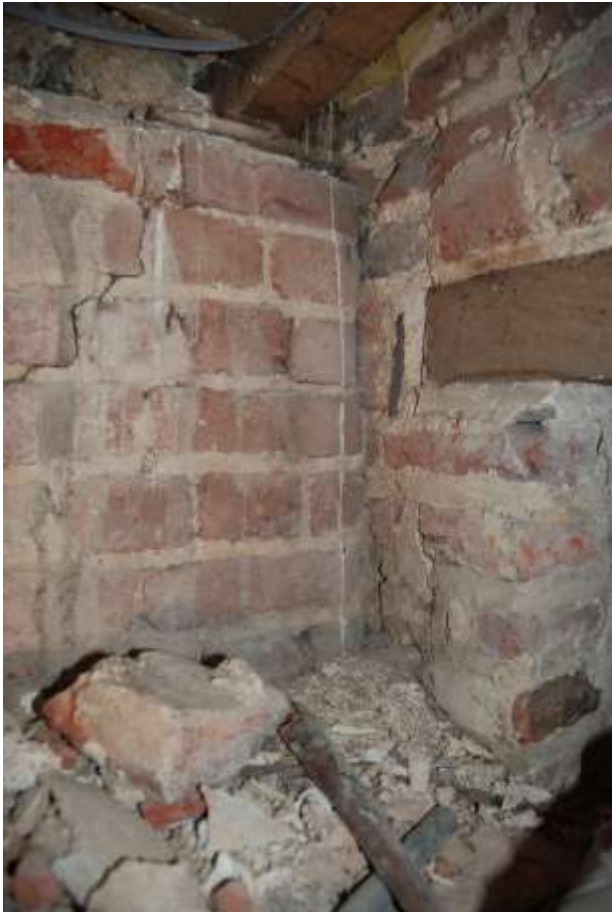
The infilling of the cellars, presumably undertaken by Captain Tarleton, consisted of a rubble fill, with a space of c.600mm below the suspended floor. The supporting and surrounding brickwork all appears quite modern, and appears to have covered up any original wall lines. This infilling also probably includes the addition of the small timber-lined hatch (0.5 X 0.42m) observed in the south-west corner of the existing cellar, overlying the secondary brickwork.

Fig. 173: Photograph of rubble infill and fairly modern secondary brickwork in area of earlier cellars (under the Drawing Room).

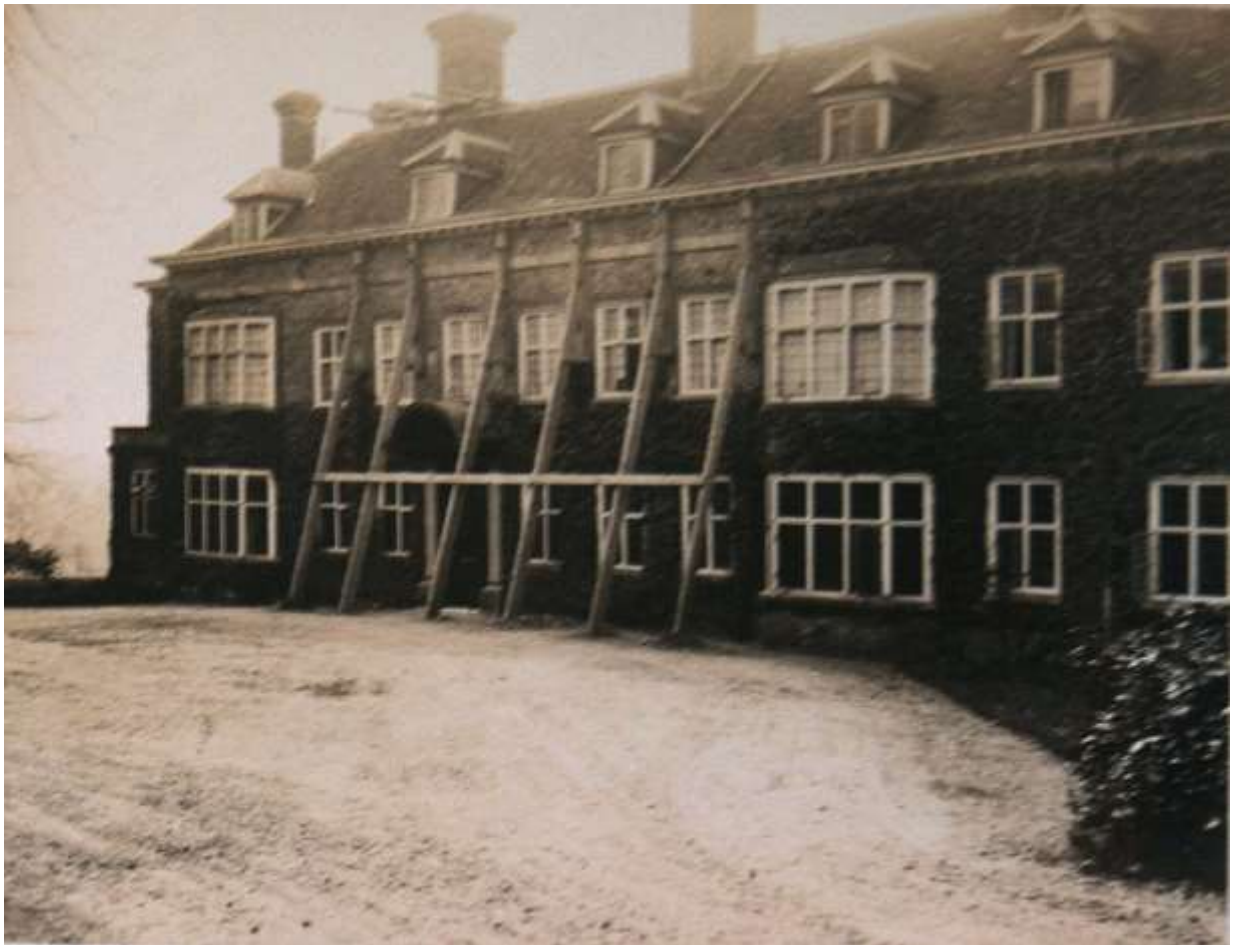
Fig. 250: Photograph of the repair works undertaken in 1924-25, northern frontage. © Christopher Fagan.

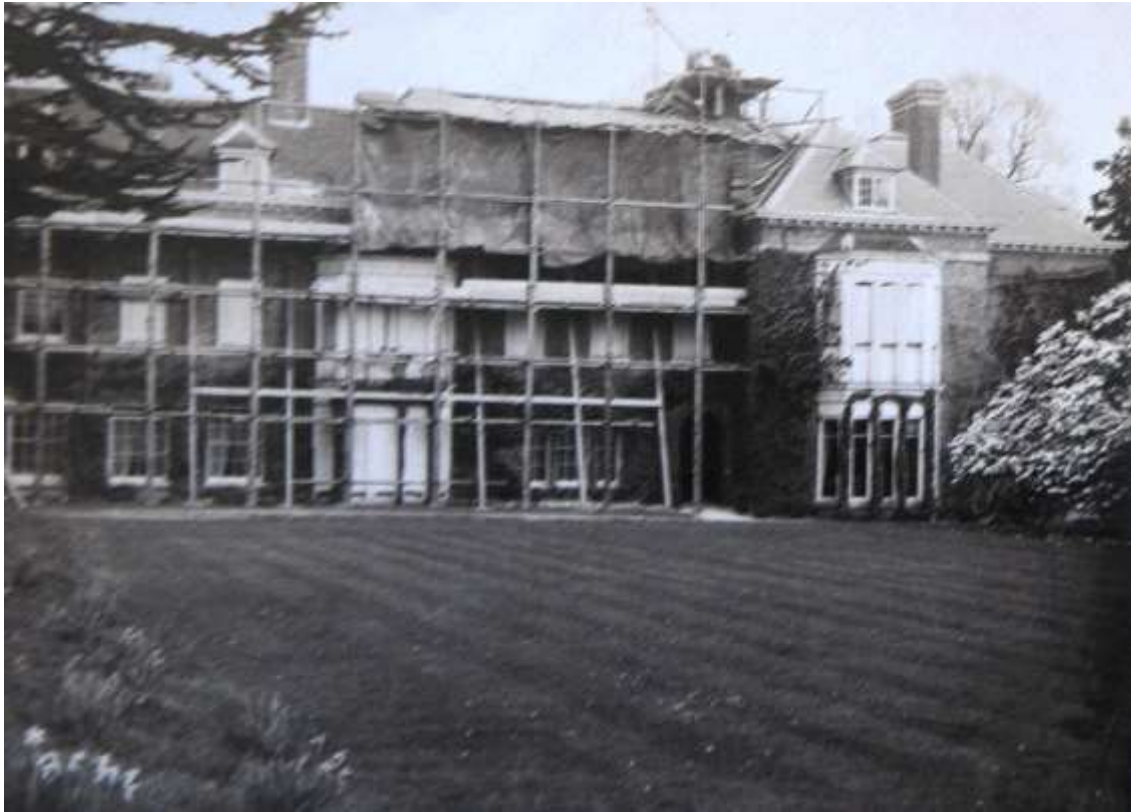
Fig. 251: Photograph of the repair works undertaken in 1924-25, southern frontage. © Christopher Fagan.

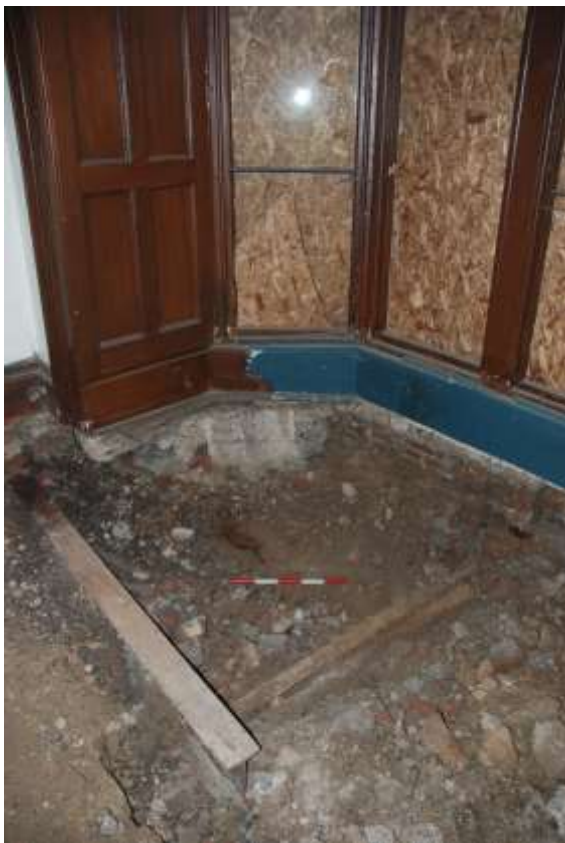
Fig. 252: Photograph of the RSJs and concrete under the library floor, to support the structure.

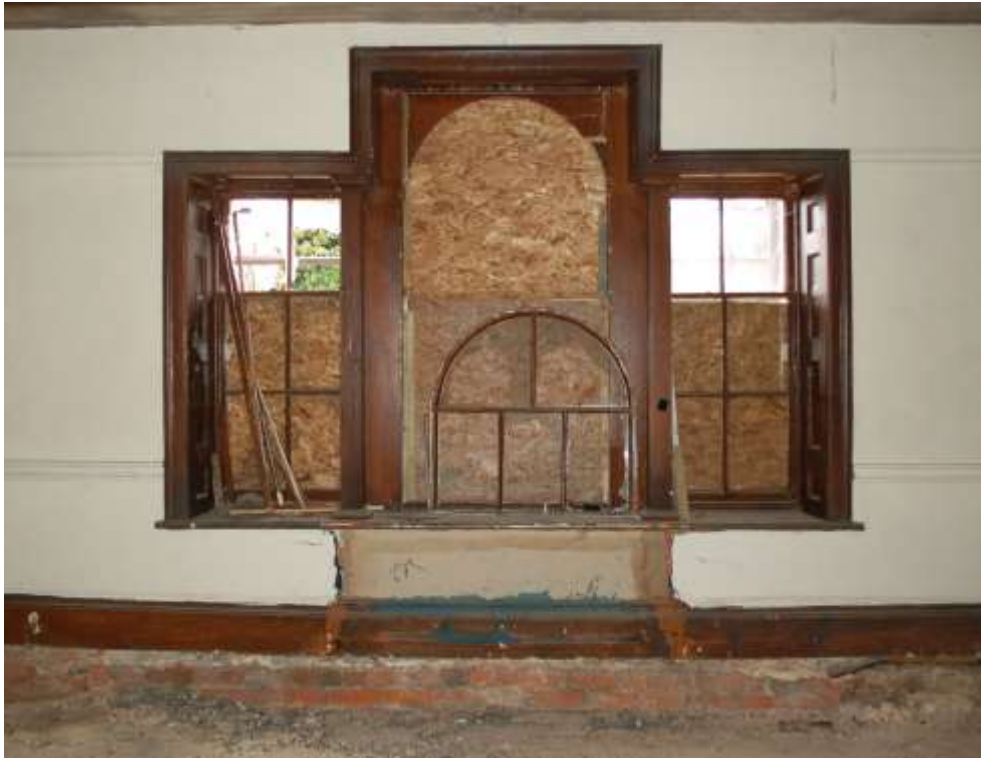
Fig. 253: Photograph of the brickwork underpinning the Venetian window – part of the 1924-25 repair works.

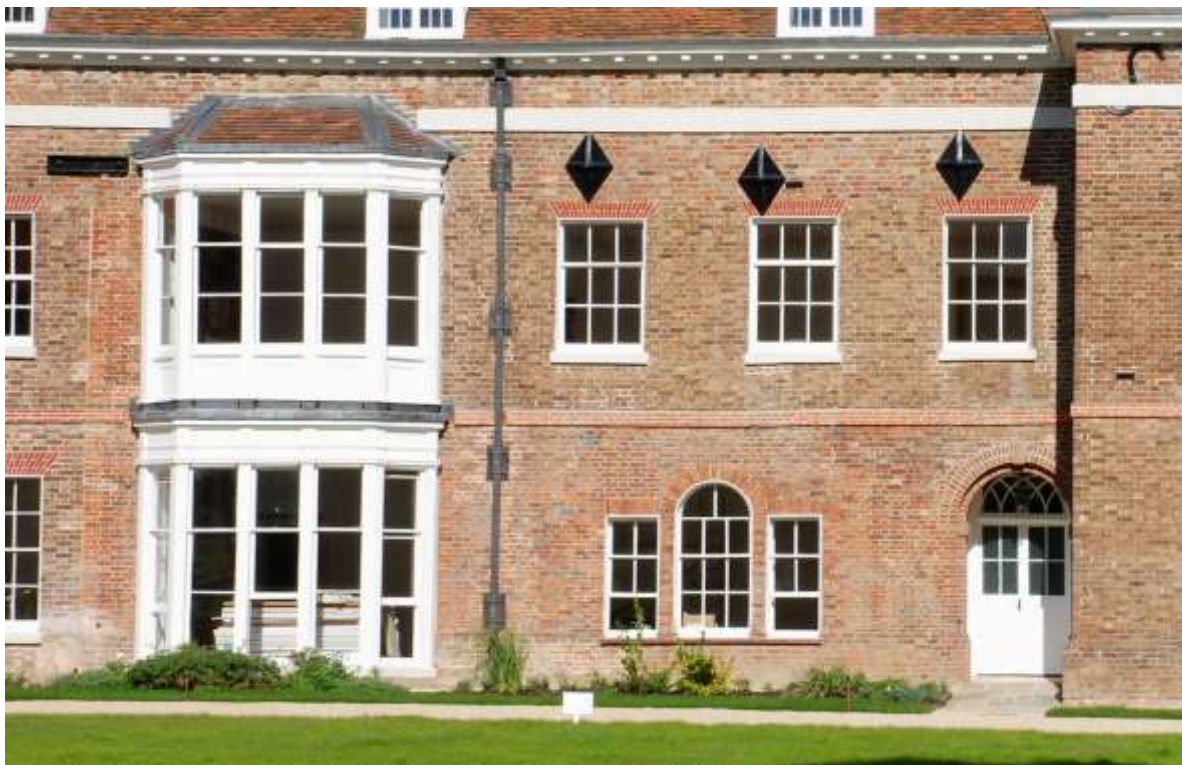
Fig. 254: Photograph of the four tie-rods (southern frontage).

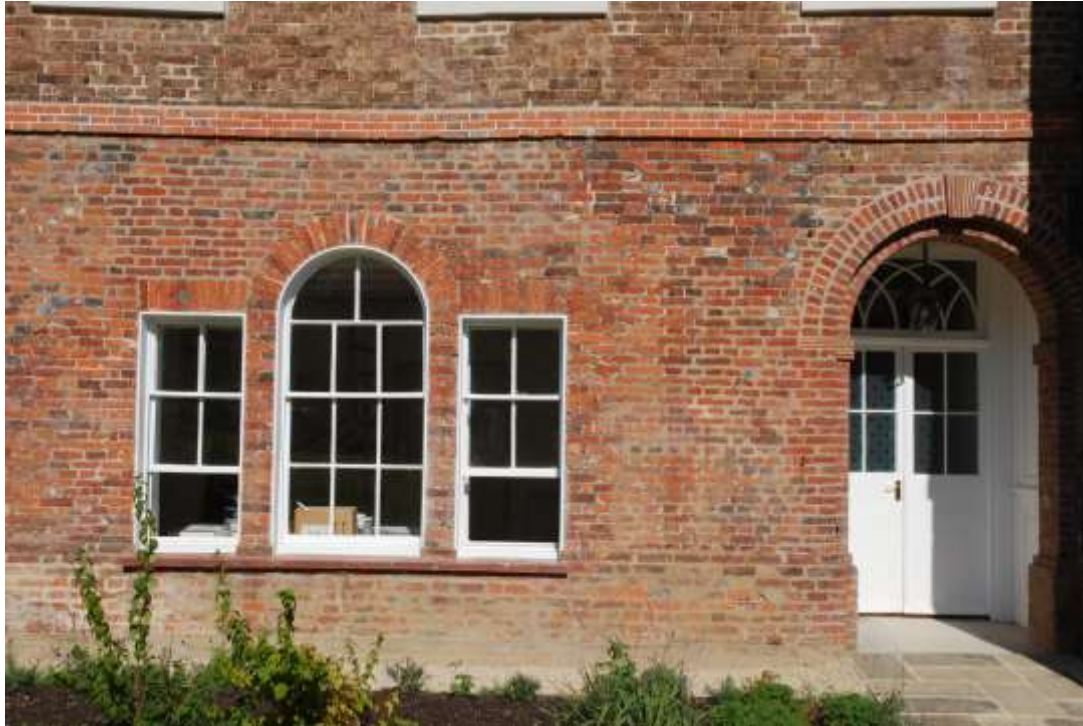
Fig. 255: Patching of the southern wall, around the Venetian window and door.

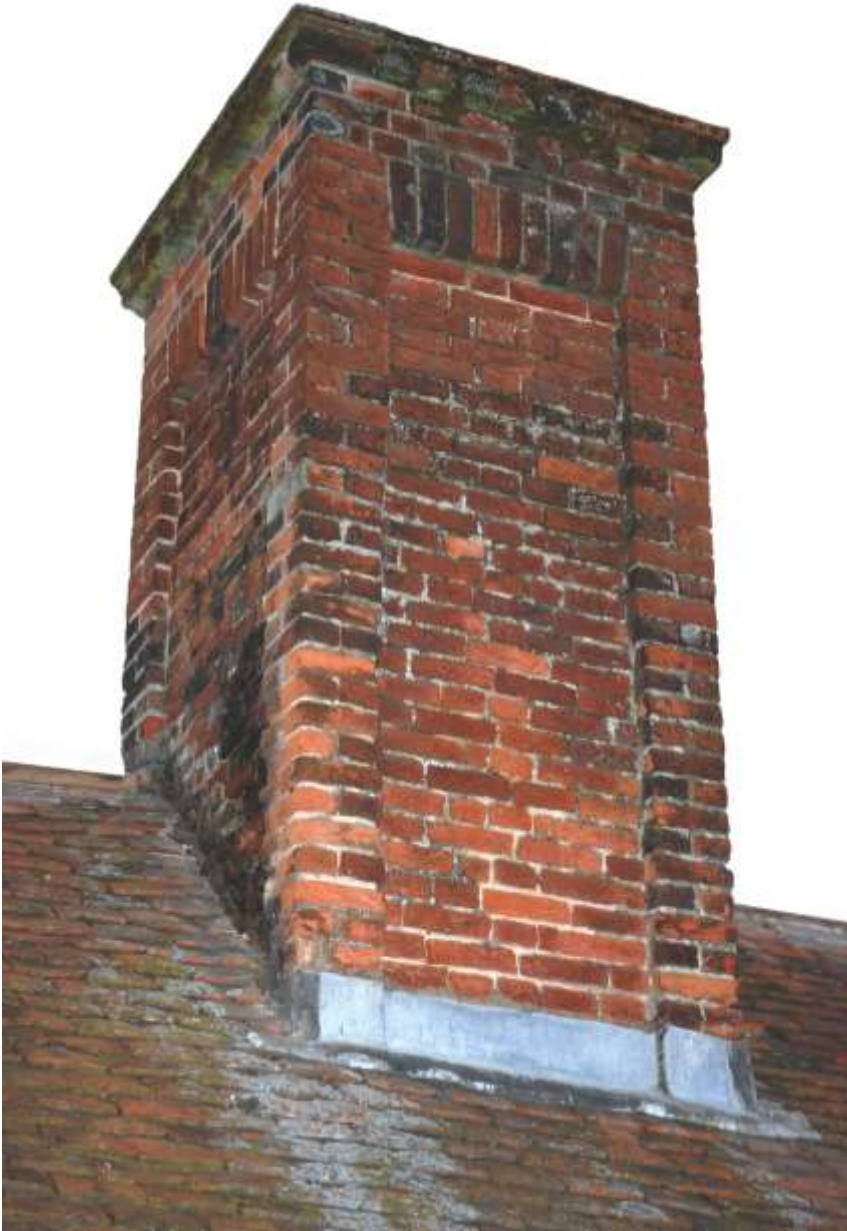
Fig. 259: Photograph of the chimney above the entrance hall and billiard room, with the upper courses clearly having been rebuilt during the 1924-25 repair works.
