# 4 - 6 LOWER STONE STREET, MAIDSTONE, KENT, ME15 6JN

# HERITAGE STATEMENT

February 2013

SITE CODE: LSS13 NQ: TQ 76193 55598

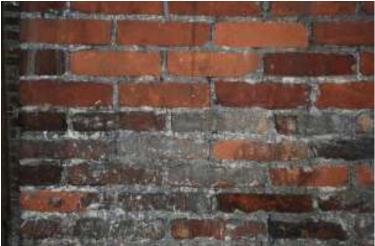
Fig.18: Photo showing the small section of limewashed brickwork in the northern chimney, possibly on the line of the original exterior wall (taken within the roofspace of the later western extension)

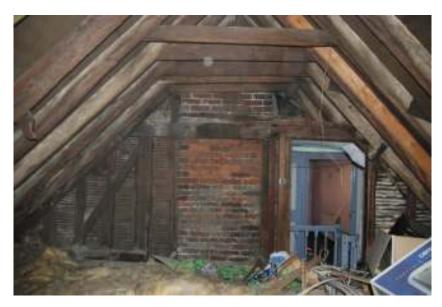
Fig.23: Photo showing the northern chimney, looking east

- **5.1.8** The upper parts of both of these chimneys appear to have been replaced at some later date this is obvious in the brickwork on the upper parts of both chimneys (see fig.23). Furthermore, the southern chimney has been 'kinked back', at its upper levels, to the west (see discussion in section 5.5) it is believed that this must have taken place at a later date as it would have been illogical to have constructed it like this originally.

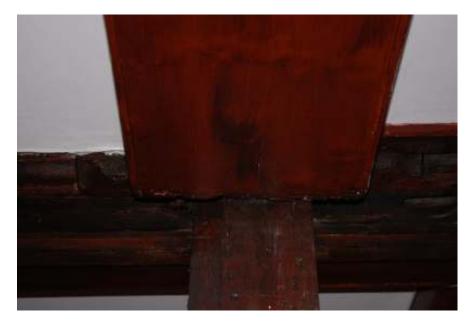
- **5.1.9** There was an indication, on the first-floor, of where the original east-west division between the two rooms (1 and 2) was. This took the form of a moulded ceiling beam, visible running east-west across the room to the north of the central window, and in the same position as the wall separating rooms 13 and 14 on the second-floor (it is therefore possible that this wall is the original one separating the two rooms on the second-floor). The underside of this beam had a series of mortices for closely-spaced vertical studs, although the present division across the room is clearly a later, possibly modern, reconstruction. It should also be noted that the moulding is very similar to one illustrated in Brown, 1986 (see fig.25), which is dated to the late 16<sup>th</sup> early 17<sup>th</sup> century.

Fig.24: Photo of the moulded ceiling beam running east-west between rooms 1 and 2 (running left to right across the image)

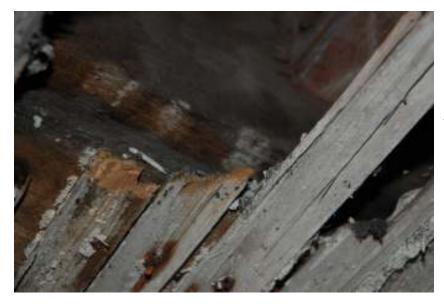
- **5.1.11** The ceilings in this area are all made of lath-and-plaster. This does not, however, appear to have been original, as it overlies older timbers with the imprint of lath-and-plaster on them.

Fig.26: Photo of lathand-plaster ceiling in room 1, with imprint of possible earlier latheand-plaster on timber underneath

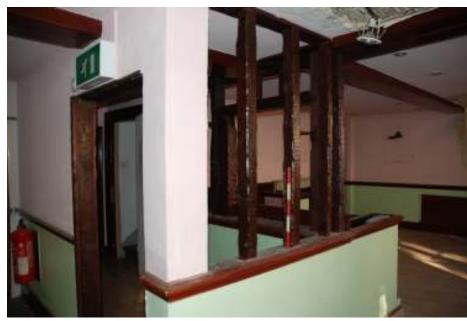
Fig.28: Photo of pieces of reused timber in the entrance to rooms 1 and 2

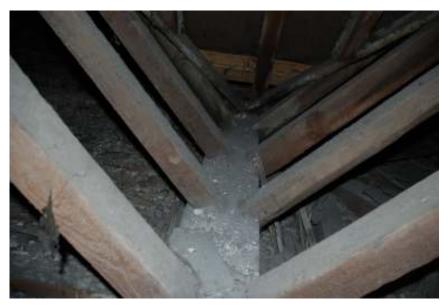
Fig.31: Photo of the roof timbers over the original part of the building, showing how the rafters in the rear (western) part are attached to the central beam differently from those in the front (eastern) part

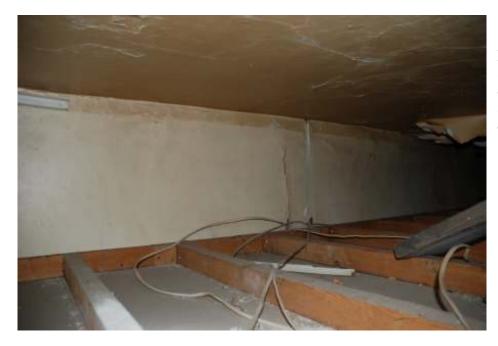
Fig.32: Photo through the ceiling of room 7, showing the original higher ceiling

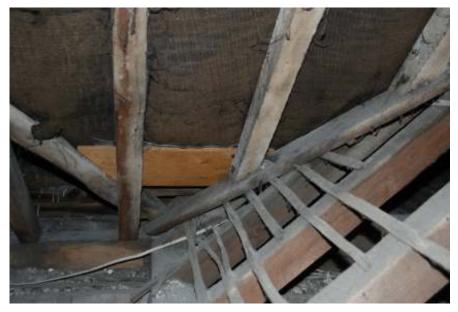
Fig.43: Photo of the roof of the junction between the rooms over the passageway and the original part of the building. The roof of the rooms over the passageway (left of frame) overlies the laths of the roof over the original building (right of frame)

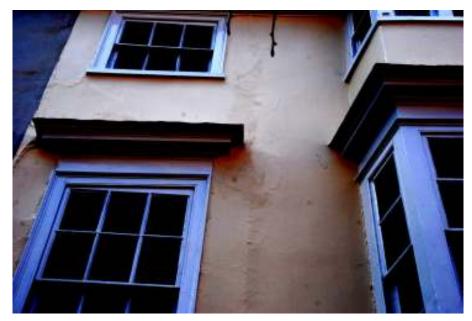
Fig.44: Photo (with enhanced contrast) showing the line on the exterior front wall between the original part of the building and the rooms above the passageway

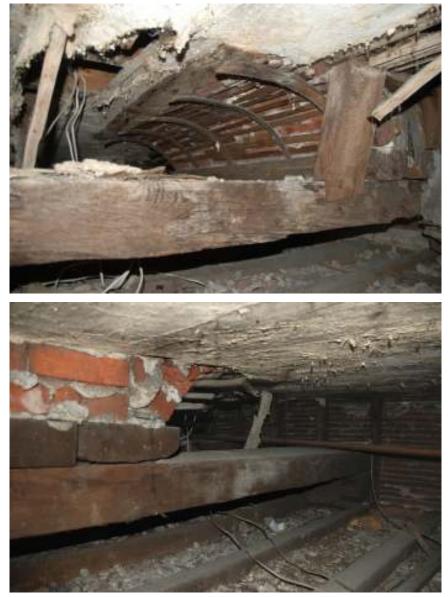
Fig.53: Photo showing the southern chimney 'kinking back', looking north-east. This shows one of the large supporting timbers in the foreground with brickwork supported on laths and rising up to a second northsouth timber at the top of the frame

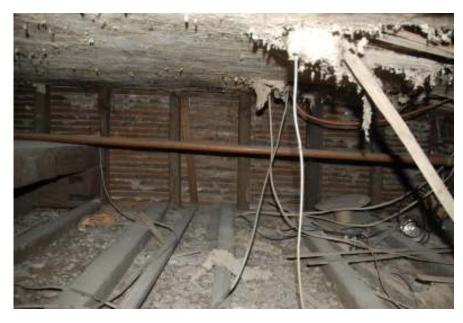
- **5.5.4** There was also evidence that this western wall was a relatively substantial one, suggesting that it was, at some point, an external wall. In particular, a large horizontal timber was observed in this wall at the ceiling level of room 11. The substantial nature of this wall was also clearly observed in the gap between the floor and ceiling of rooms 11 and 17/18.

Fig.55: Photo of wall between rooms 11 and 12, looking west, and showing its substantial nature. The gap between the floor of rooms 17 and 18, and the ceiling of room 11, is also visible here

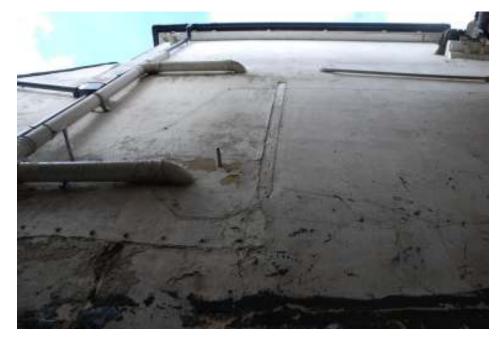
Fig.57: Photo of the piece of timber in the exterior southern wall, on the line of the first southwestern extension

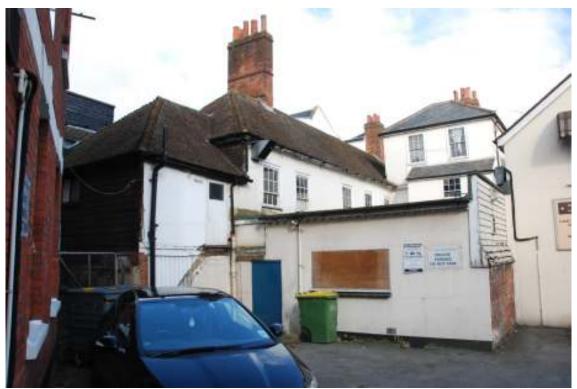
**5.6.4** The roof of this south-western extension is clearly of a different construction from that over the original part of the building. There is also a small lean-to roof extension at the western end of the first-floor part - there is no evidence to suggest that this is not original to this extension.

Fig.65: Photo showing the different roof construction in the south-western extension (right of frame)
