**THE SPRINGFIELD ICE HOUSE, BURNTWOOD SCHOOL,  
BURNTWOOD LANE, EARLSFIELD, LONDON BOROUGH OF  
WANDSWORTH  
SW17 0AQ**

**AN ON-SITE ARCHAEOLOGICAL INVESTIGATION**

Grade II listed building  
Historic England List Entry Number: 1065554

Site code: ICE 15  
NGR: TQ26717 72466

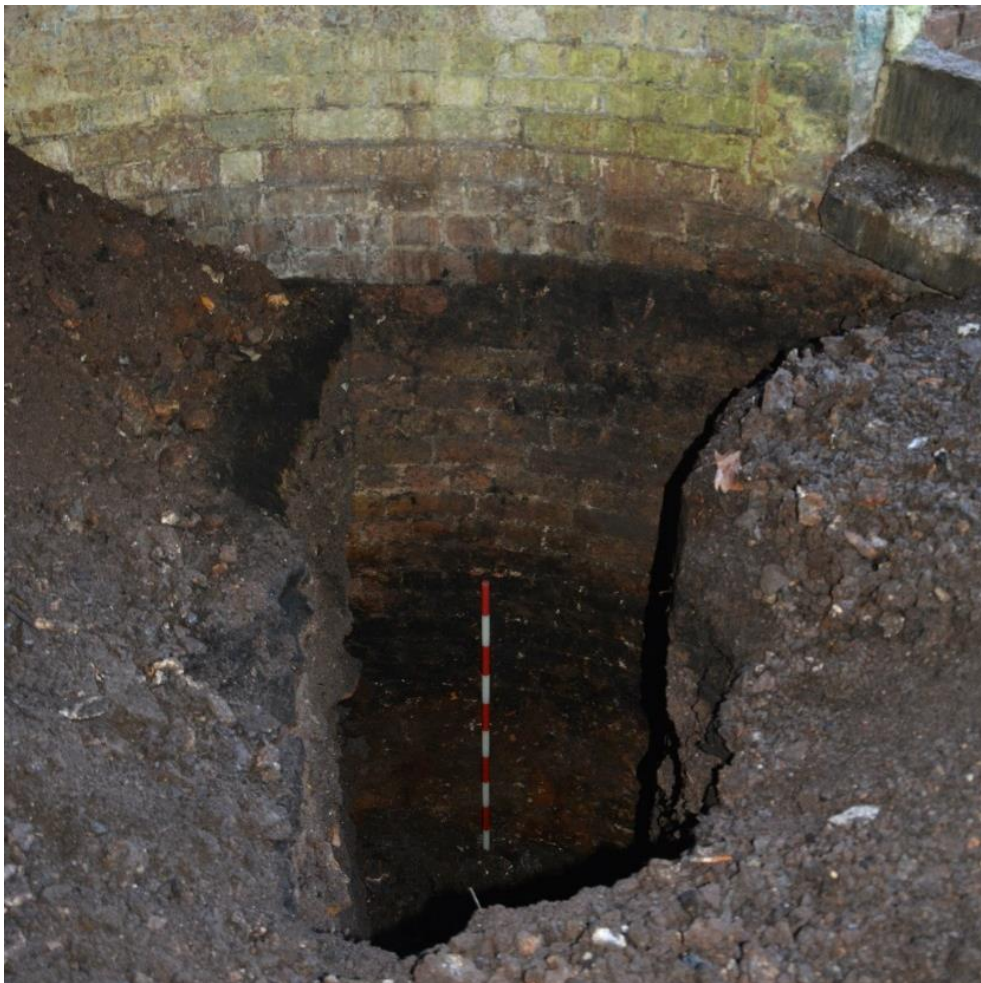
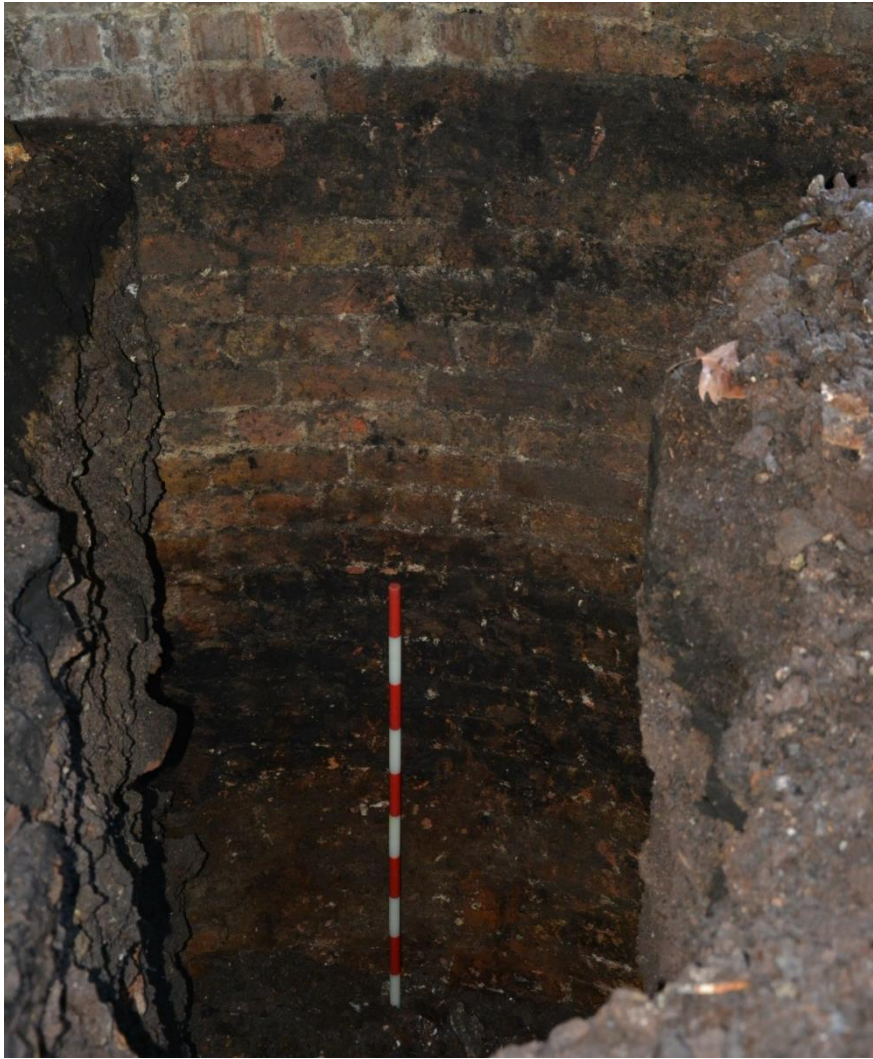
6.2 The single room constituting the main part of the ice house is domed and brick lined. Inside the ice house domed interior the trial pit was dug against the inside face of perimeter wall and abutted the existing vaulted-arch entrance to the building. The pit was of a roughly rectangular shape and extended towards the centre of the building (figs.9-11). The pit measured 1.43m in length and approximately 1m in width. Its depth from the original threshold was 2.08m. The diameter of the ice house's domed interior measured 3.01m (at the widest level). The interior turned out to be a regular circle.

*Fig.10: Test pit inside the icehouse (1m scale)*

*Fig.11: Test pit inside the ice house- detail (1m scale)*

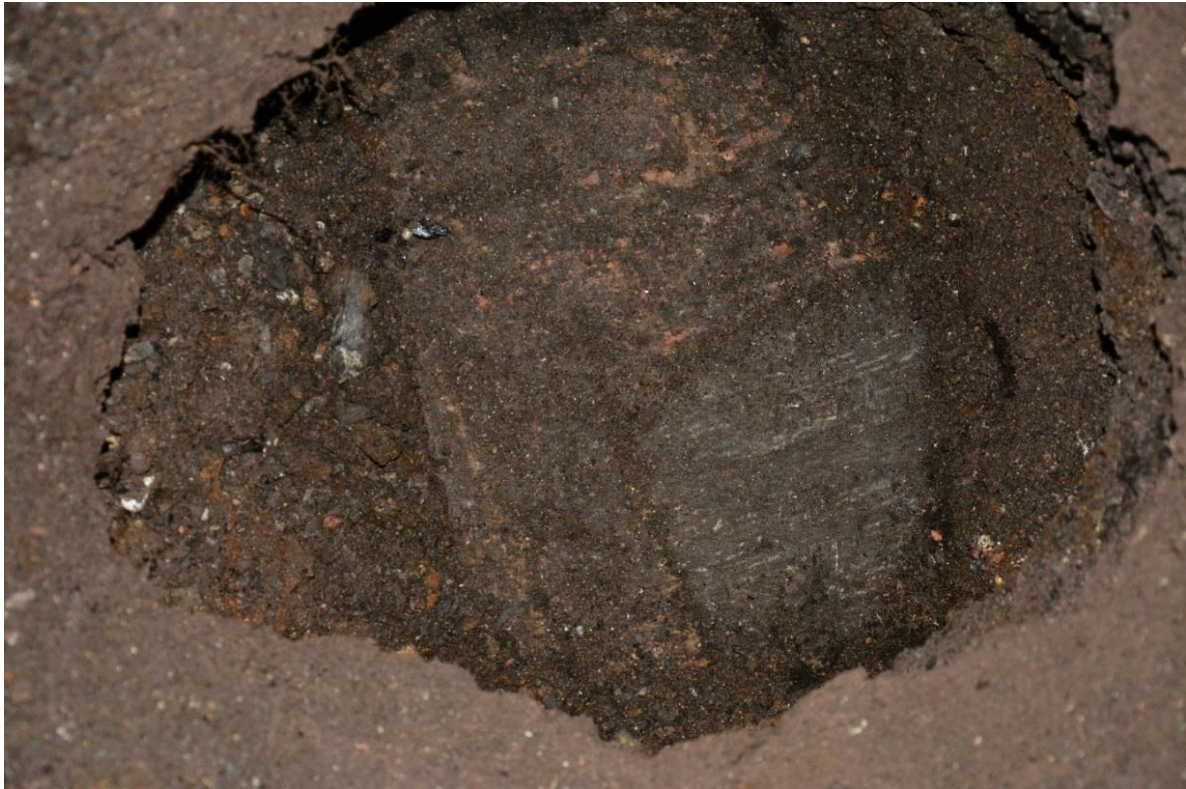
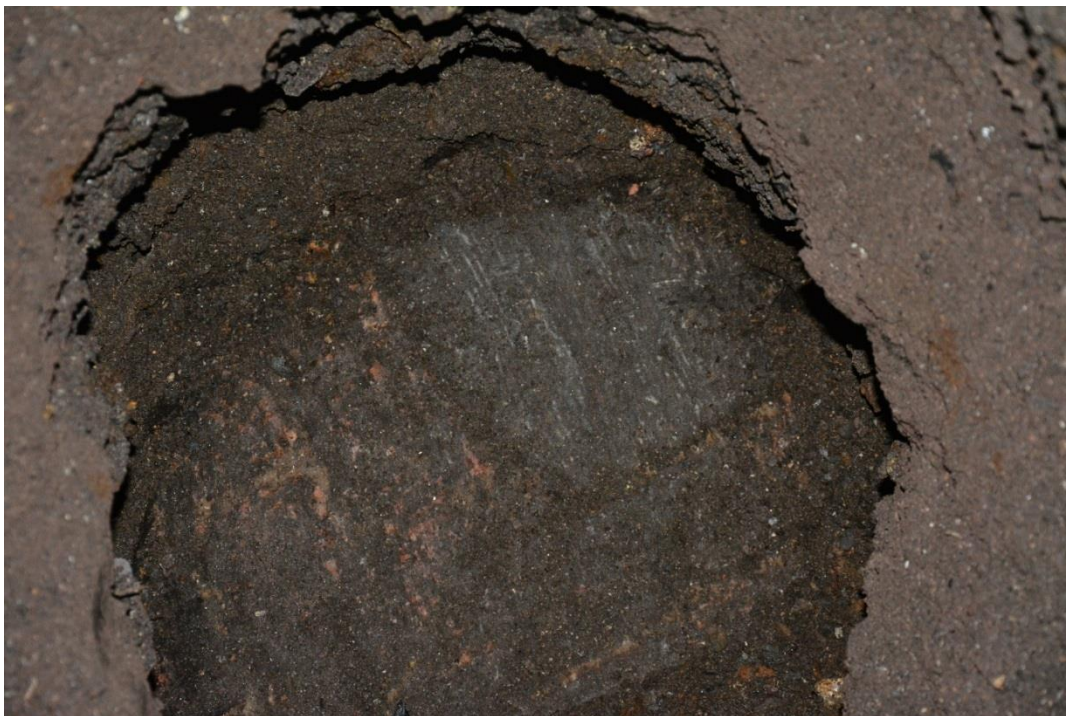
A part of the trial pit that was closer to the centre was dug 0.62m deeper, to the depth of 2.70m from the original threshold. At this depth the original brick floor of the building was reached (*figs.12-13*). The level of the brick floor was recorded at 11.71mOD, though it may be sloping down slightly towards the centre. The measured distance from the floor to the centre of the dome was 4.28m. The perimeter wall turned out to slope very slightly inwards, a normal feature of ice house construction, and reducing the diameter of the base.

*Fig.12: A test pit exposing the brick floor inside the ice house*

*Fig.13: A test pit exposing the brick floor inside the ice house*

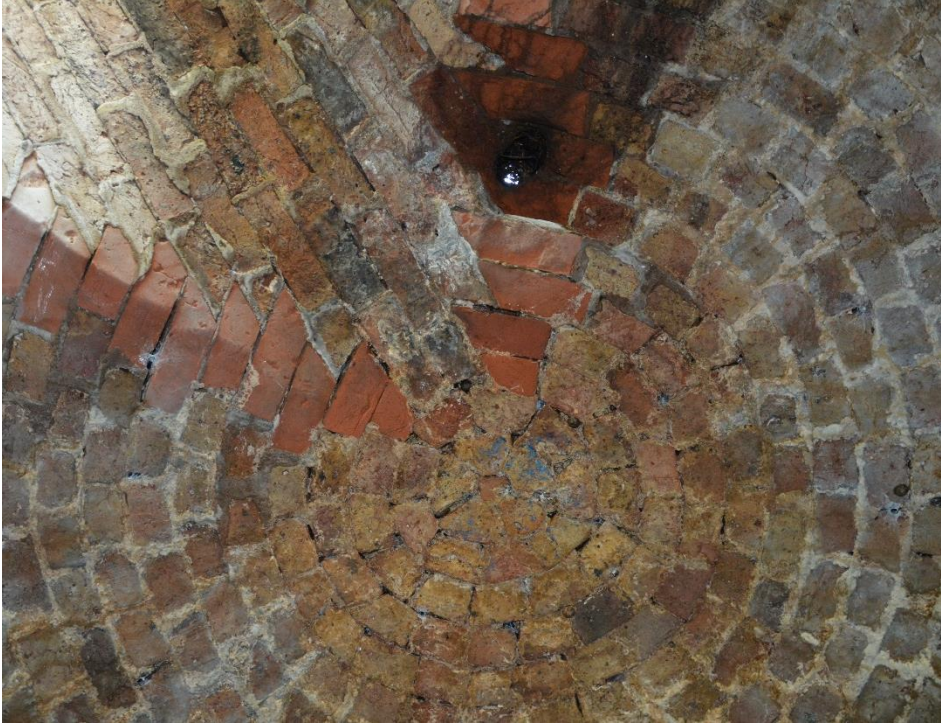
**6.3** There is no sign of a ventilation hole in the dome. The feature near the entrance which, based on architect's exterior plans, was initially suspected to be a ventilation hole turned

out to be most likely just a result of a damage to the dome structure. It is indicated by the fact that the hole is of a very irregular shape and by its unusual location through the line of finer red rubbed bricks at the junction between the dome and vaulted entrance (see fig.14).

*Fig.14: The centre of the dome visible from below (a hole in the structure at the top of the frame representing later damage)*

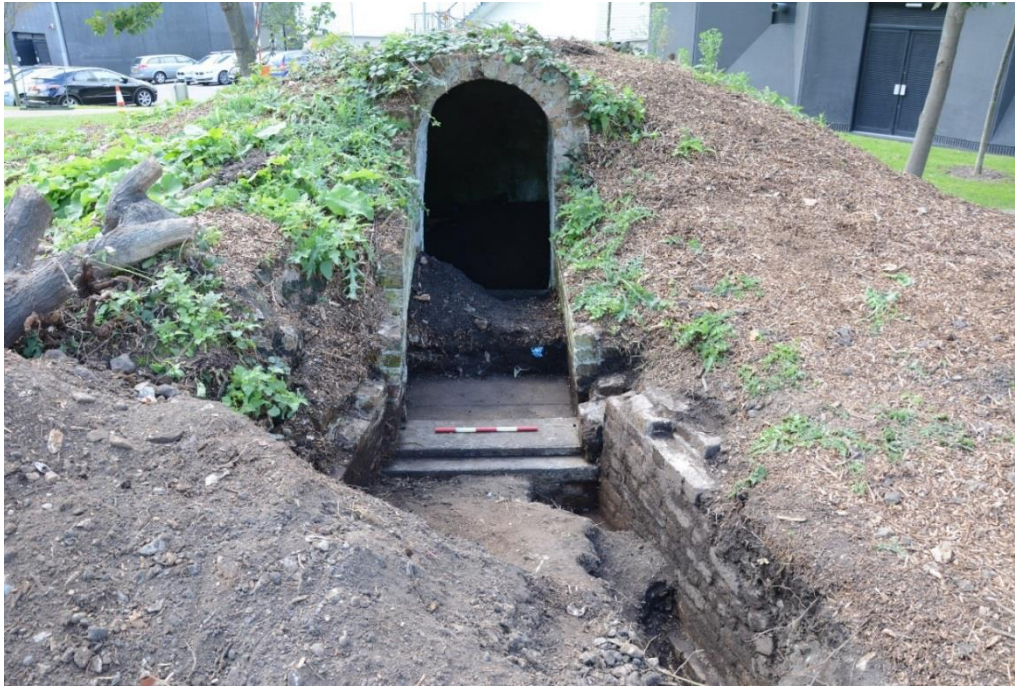
*Fig.15: Exterior walls and pathway (0.5m scale)*

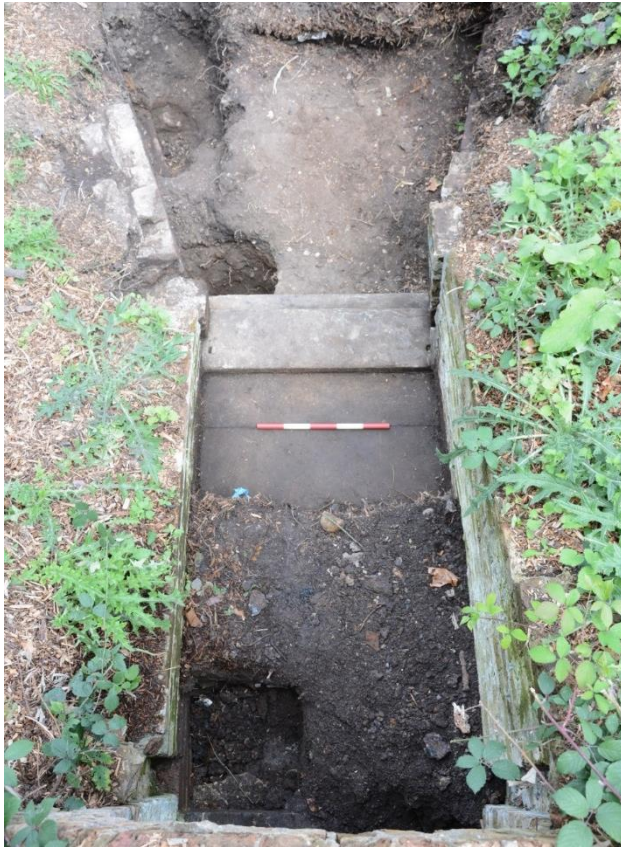
- 6.4** Outside the ice house a small test pit was dug on the northwestern corner of the pathway, just at the entrance to the domed space (fig. 16). It measured approximately 0.50m x 0.40m. The pit exposed stone paving in this area of the pathway.
- 6.5** The existing remains of walls and a pathway were cleared of accumulated debris and exposed (see figs.15-16). The wall on the northern side was investigated in greater detail, with two trial holes dug up to its base (figs.19-21). The trial holes measured approximately 0.30m x 0.40m (next to the stone threshold), and 0.90m x 0.45m (at the end of the wall). The depth of the pit next to the stone threshold was approximately 0.50m and the depth of the pit at the end of the wall was approximately 0.35m. At the depth of 0.35m the base of the northern wall was reached (level 14.11mOD).

*Fig.16: External walls, pathway, and a part of a breeze block wall and concrete foundations at base of frame (view from a top of the mound)*

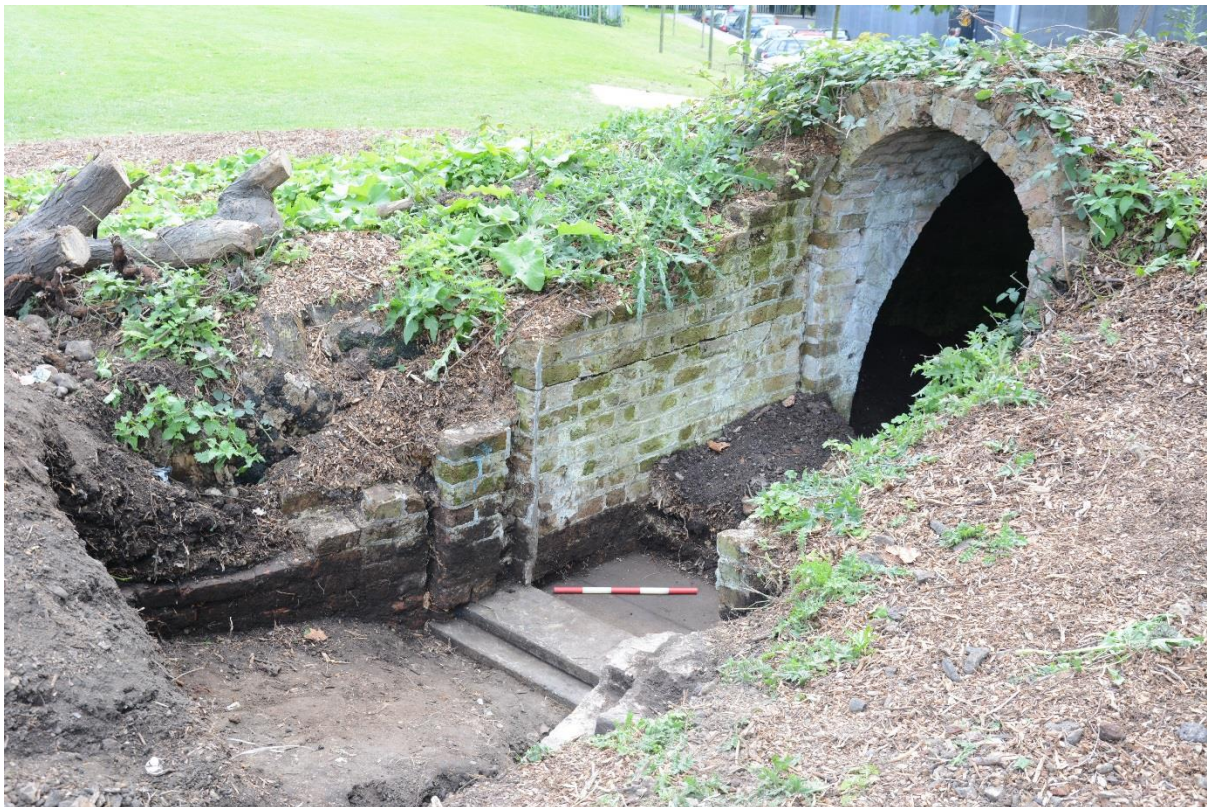
*Fig.17: Southern wall (0.5m scale)*

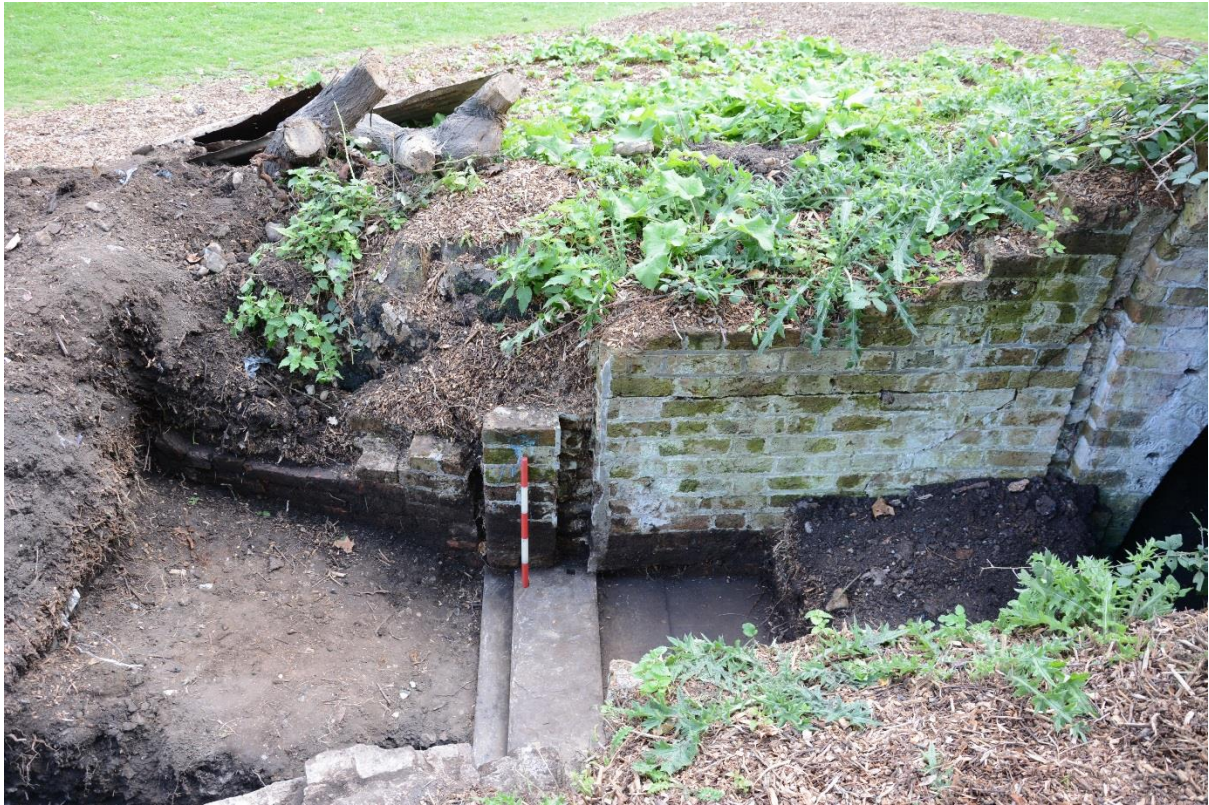
*Fig.18:Southern wall (0.5m scale)*

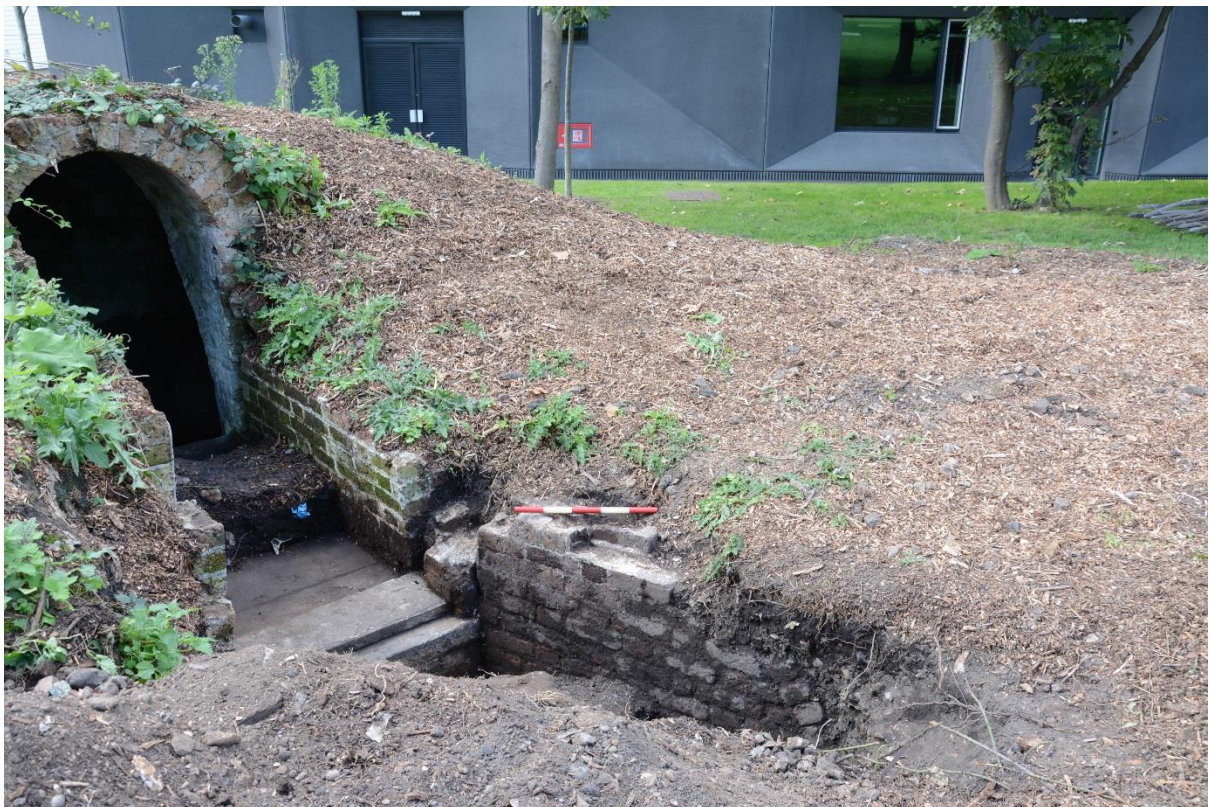
*Fig.19: Northern wall (0.5m scale)*

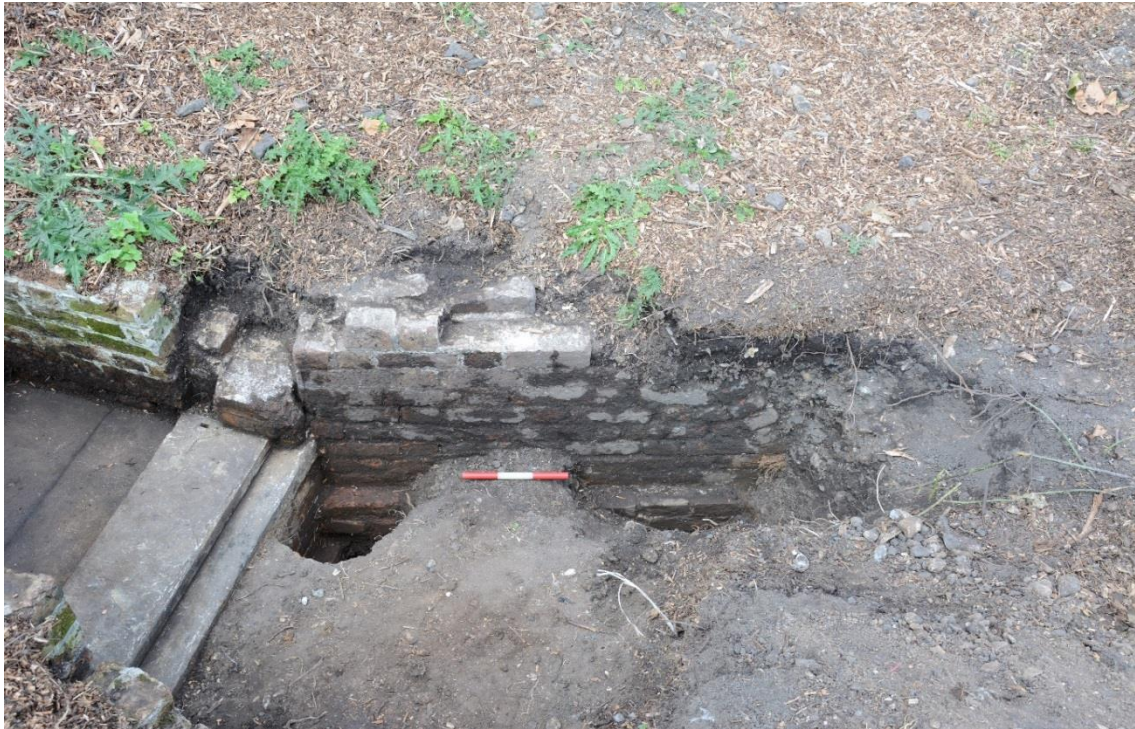
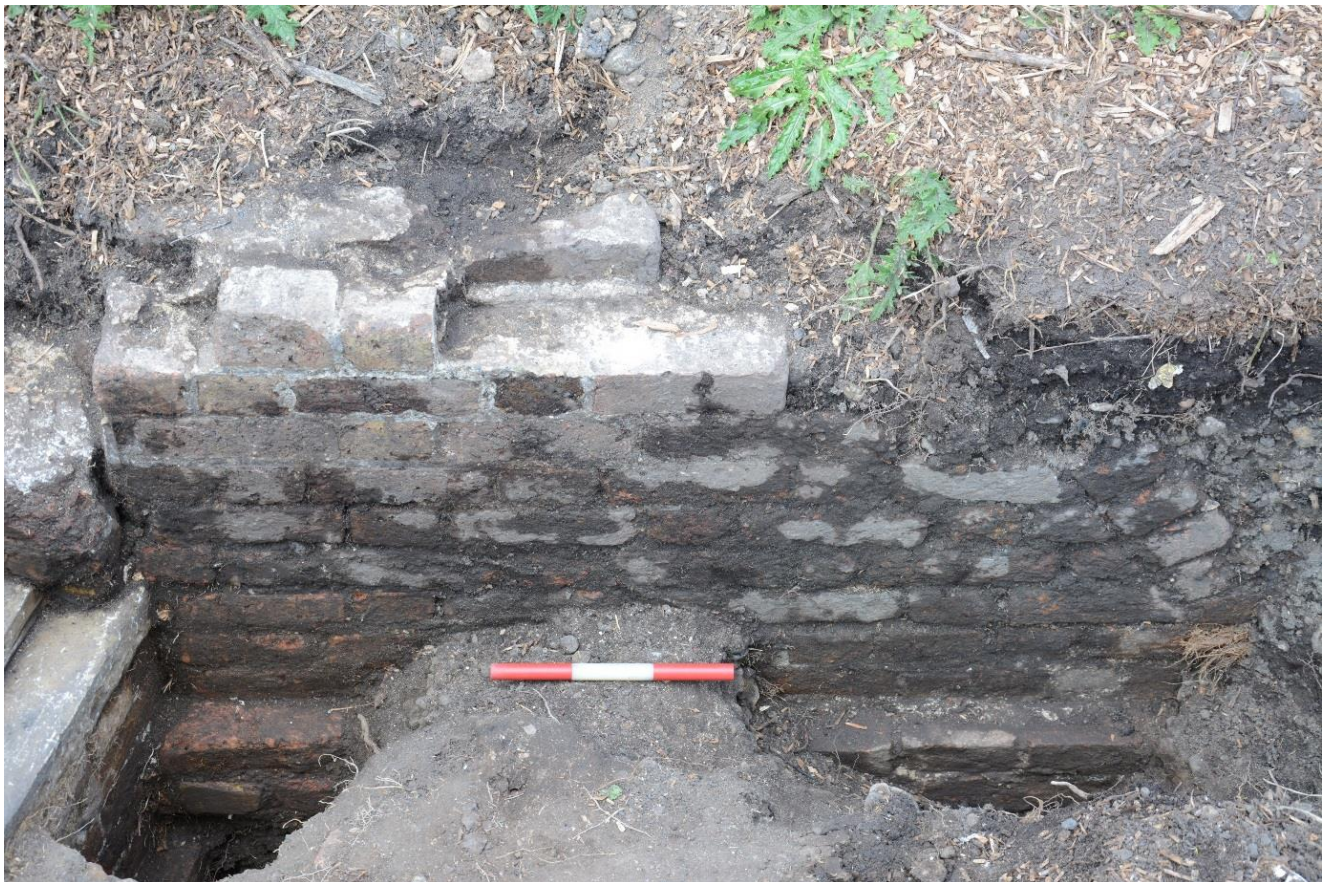
*Fig.20: Test holes at the northern wall, outer part (0.3m scale)*

*Fig.21: Test holes at the northern wall- detail (0.3m scale)*

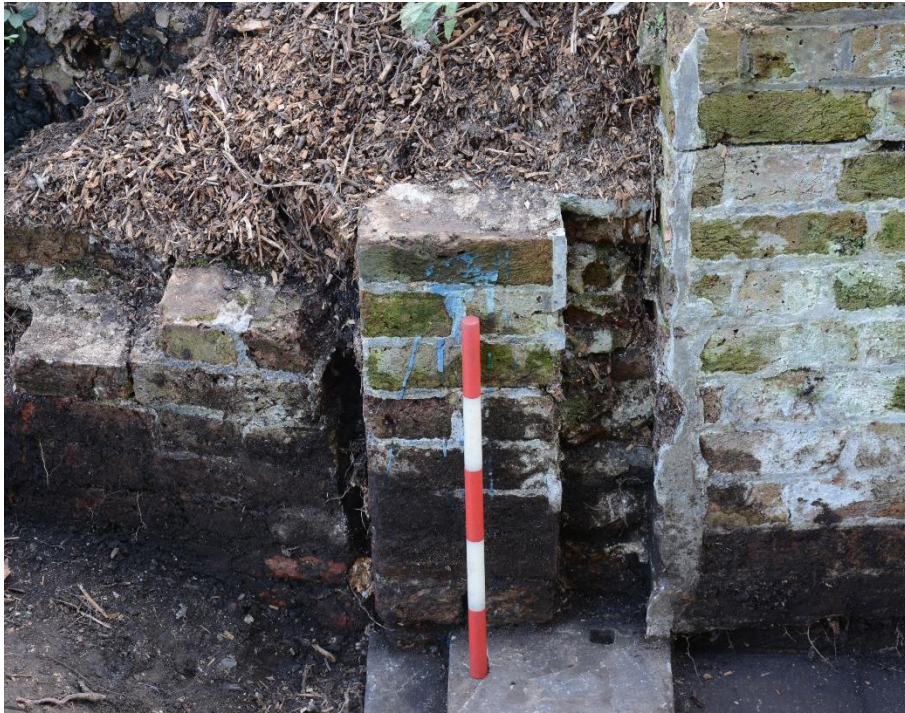
*Fig.22: Rebate for a door jamb in the southern wall- close up (0.5m scale)*

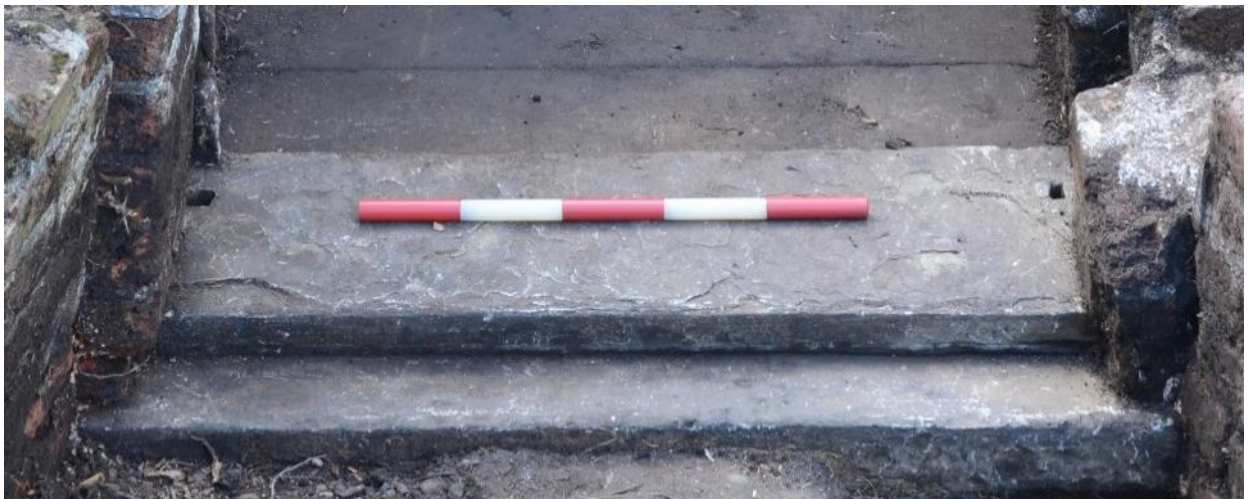
*Fig.23: Stone threshold with mortises on either side, for door jambs (0.5m scale)*

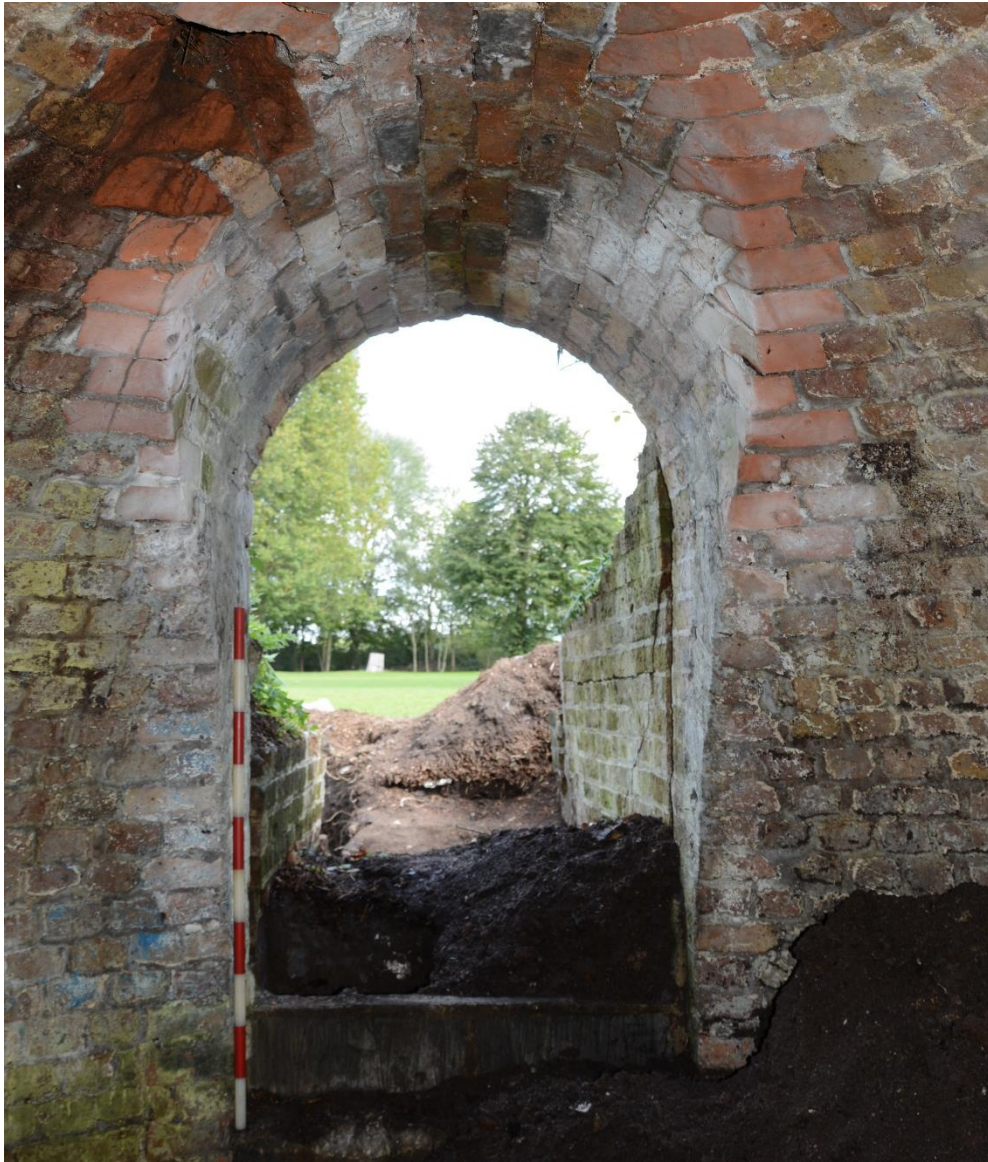
*Fig.24: Base of a modern blocking wall and concrete foundation within the doorway (view from the ice house's interior, 1m scale).*

- 7.2 The arched doorway, at present, includes at its base the remains of a modern blocking wall and concrete foundation. However, the level of original threshold can be still identified. In the northern wall at the entrance there is an iron hinge, which suggests the presence of a door in this place. The hinge was at some point crudely hammered back into the wall after the original door went out of use. Immediately behind the external face of the arched entrance there are rebates for door jambs in both walls, which confirm the presence of a door in this place in the past.

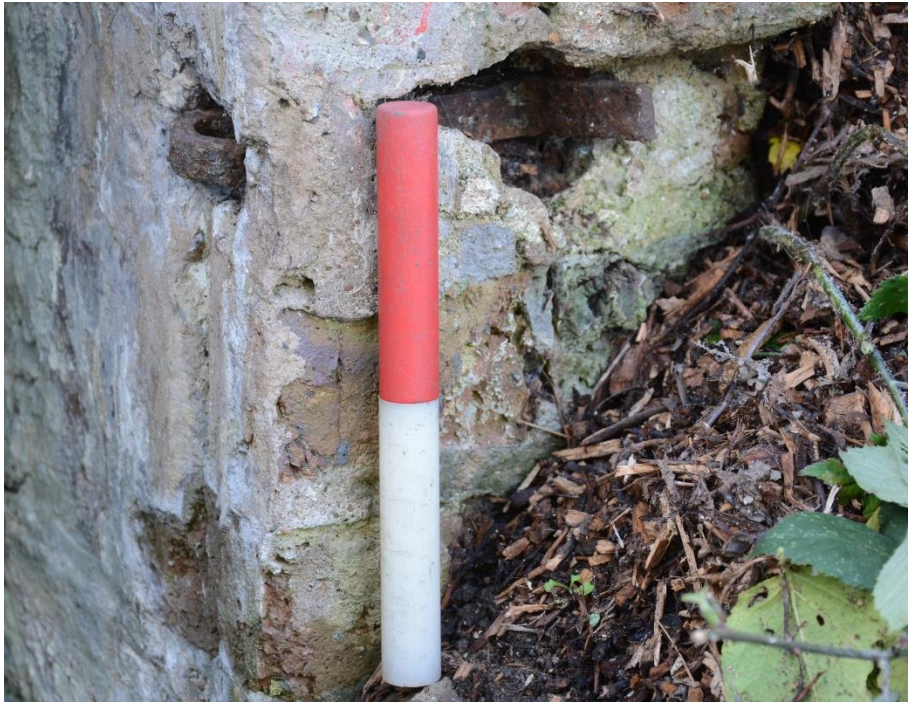
*Fig.25: An iron hinge on upper right hand side of the entrance (0.2m scale)*

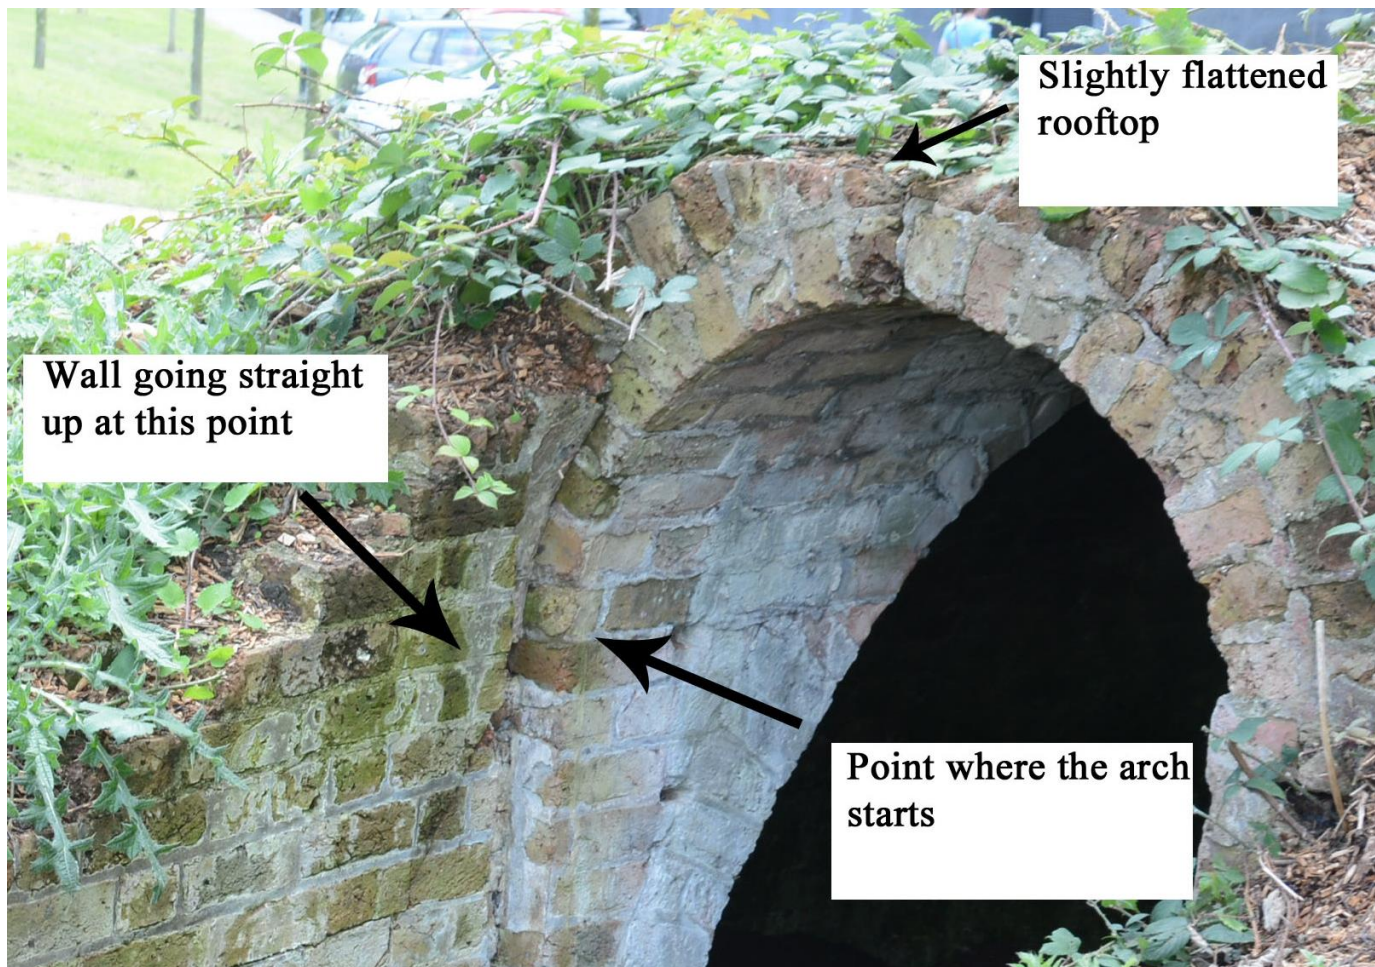
*Fig.26: Curving arch and vertical coursing of outer wall*

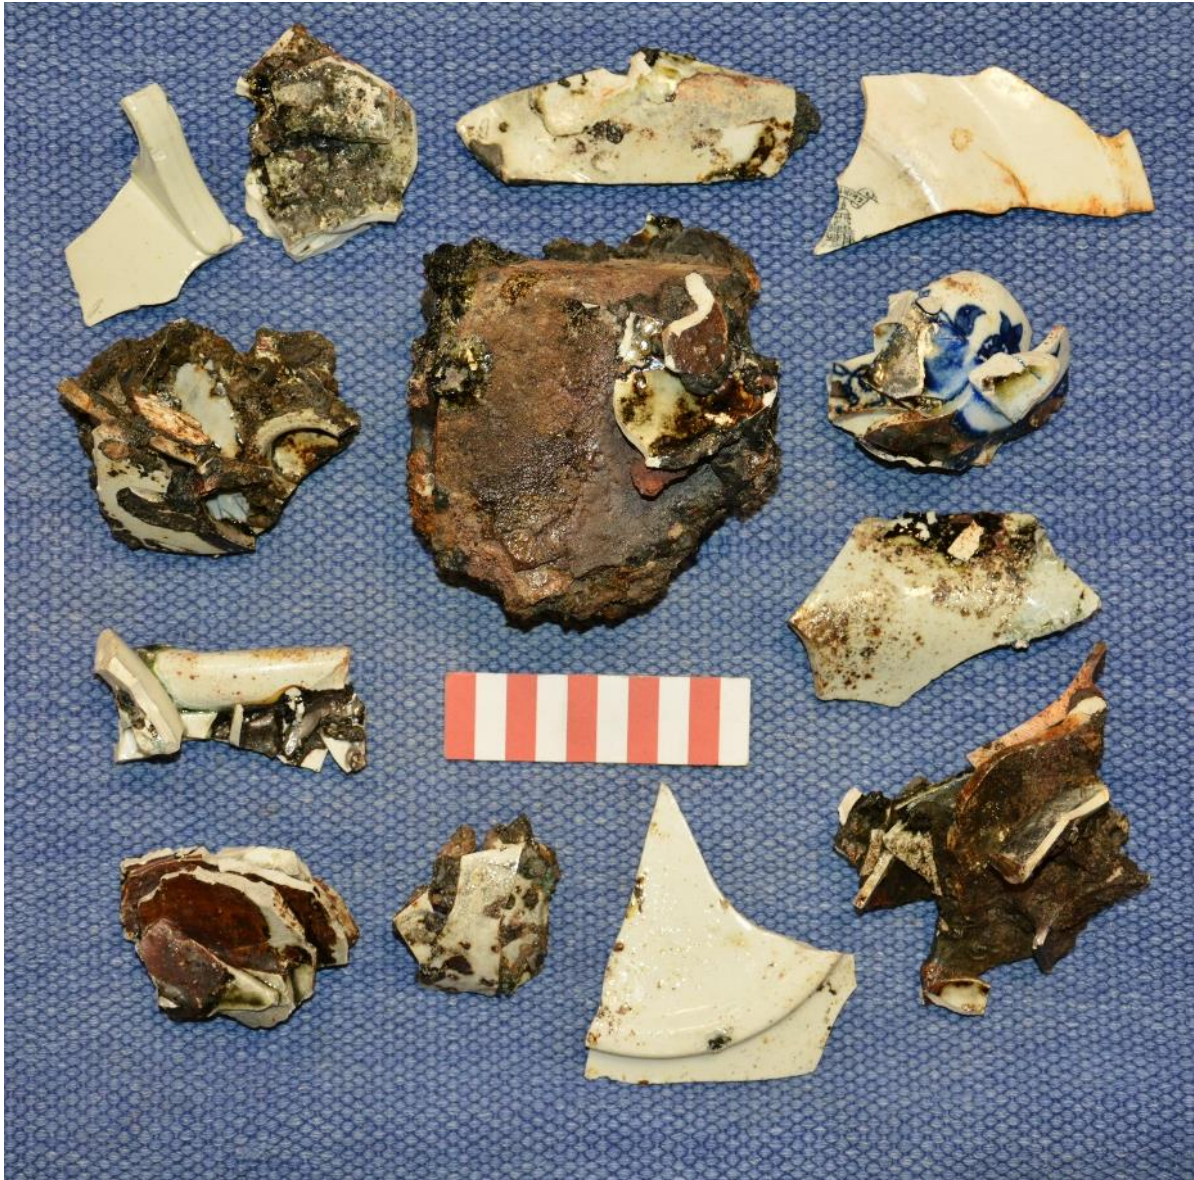
The dump of pottery largely comprises undecorated but glazed refined white earthenware of 19<sup>th</sup> century date (MoLAS fabric code REFW), other than a single "Flow Blue" decorated cup or bowl, dateable to 1830 – 1900 (MoLAS fabric code TPW FLOW). The pottery is all shattered, melted, burnt and fused together, having clearly been exposed to extremely fierce heat. It consists of a mixture of standard domestic forms, such as cups, plates and bowls (see fig.29).

The initial suggestion for an explanation for burnt fused pieces was a kiln failure. A broken/collapsing kiln would smash the pots, which then would burn and get fused together. The pottery glaze would liquidize, forming the shiny bubble-like structure on a surface of pot fragments, which can be observed on the surface of the pieces retrieved from the pit. However, the lack of kiln furniture (which would be necessary in case of firing glazed pottery) among the masses of fused and shattered pottery seems to contradict the above idea. The lack of kiln furniture rather indicates strongly that this is not kiln waste, but most likely material which was destroyed in a catastrophic fire, probably while stacked in a cupboard or similar.

*Fig.29: Shattered fused pieces of pottery from the interior trial pit (0.1m scale)*
