**CHARLTON HOUSE, HORNFAIR ROAD, CHARLTON SE7**

**ARCHAEOLOGICAL OBSRVATION OF CONTRACTOR'S GROUNDWORKS**

**NORTH TERRACE DISABLED ACCESS RAMP**

February 2007

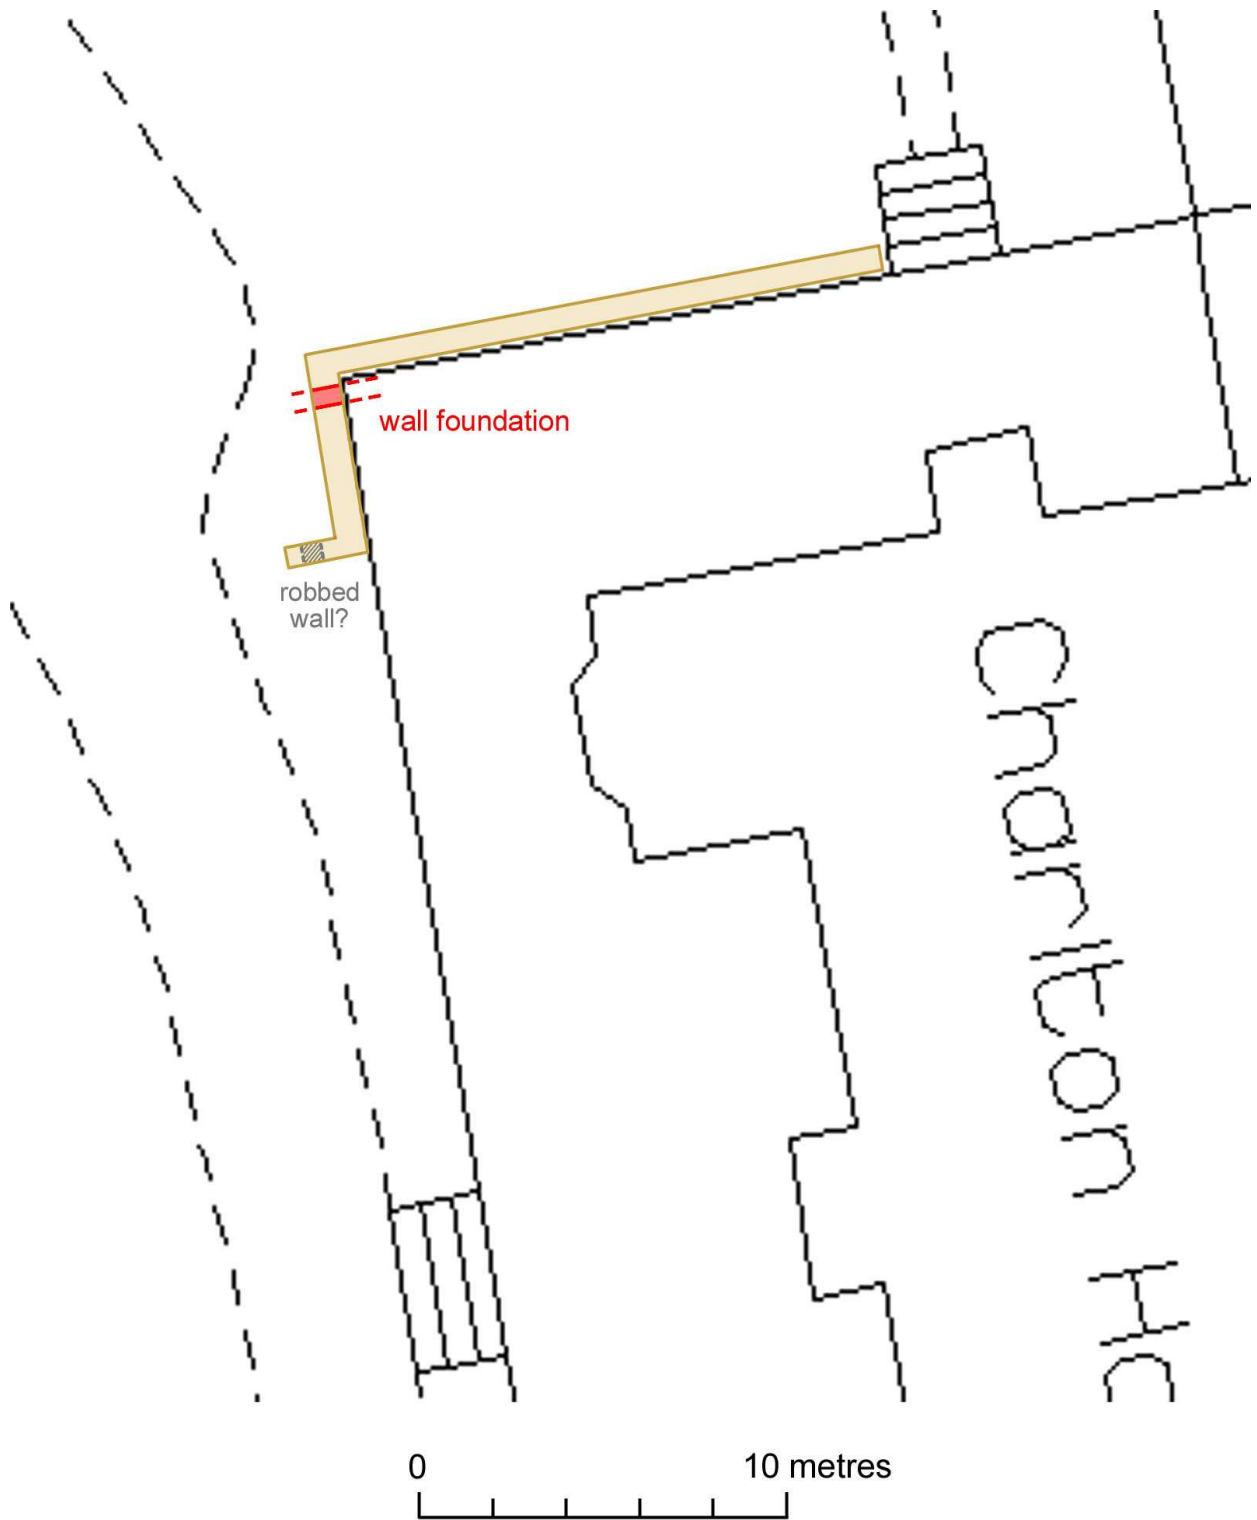
The contractor's groundworks had cut back into the sloping grassed bank at the northwest corner of the House, continuing along the line of the terrace some 15m to the east and for a shorter distance to the south (see Fig 2). The visible base of excavation was just below the surrounding ground level.

Fig 2 1:200 plan based on an enlargement of the OS map (Fig 1), showing the approximate area of open groundworks plus the locations of the east-west brick wall base and the possible north-south wall trench

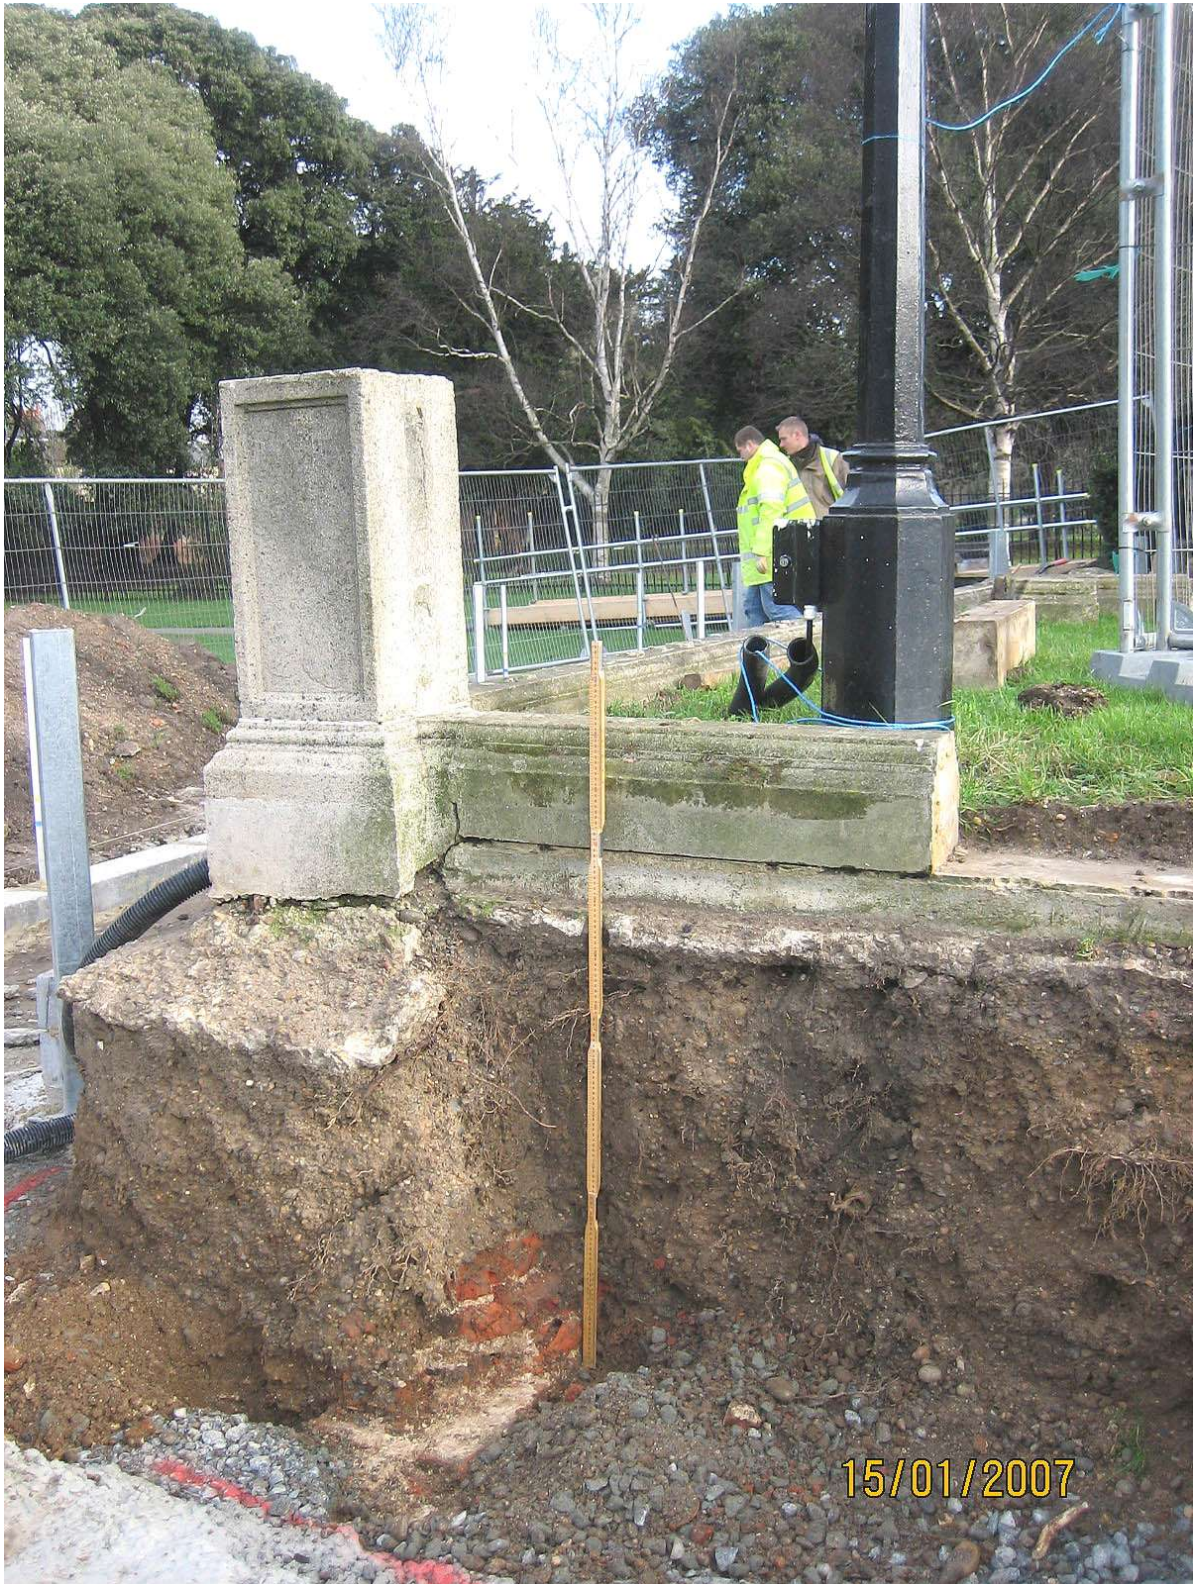
- 3.2** At the northwest corner of the groundworks the remains of an east-west brick wall were exposed in plan and section. A total length of 0.8m was recorded, comprising at least six courses of brickwork although the base was not determined. The upper four courses formed a wall some 340mm thick, and below this level the brickwork was stepped out to the north by up to 110mm. The bricks were red, bonded with lime mortar and once again similar to those used in the construction of the early 17<sup>th</sup> century House.

Fig 3 General view of the site area looking northeast, with the exposed brick wall base in the foreground

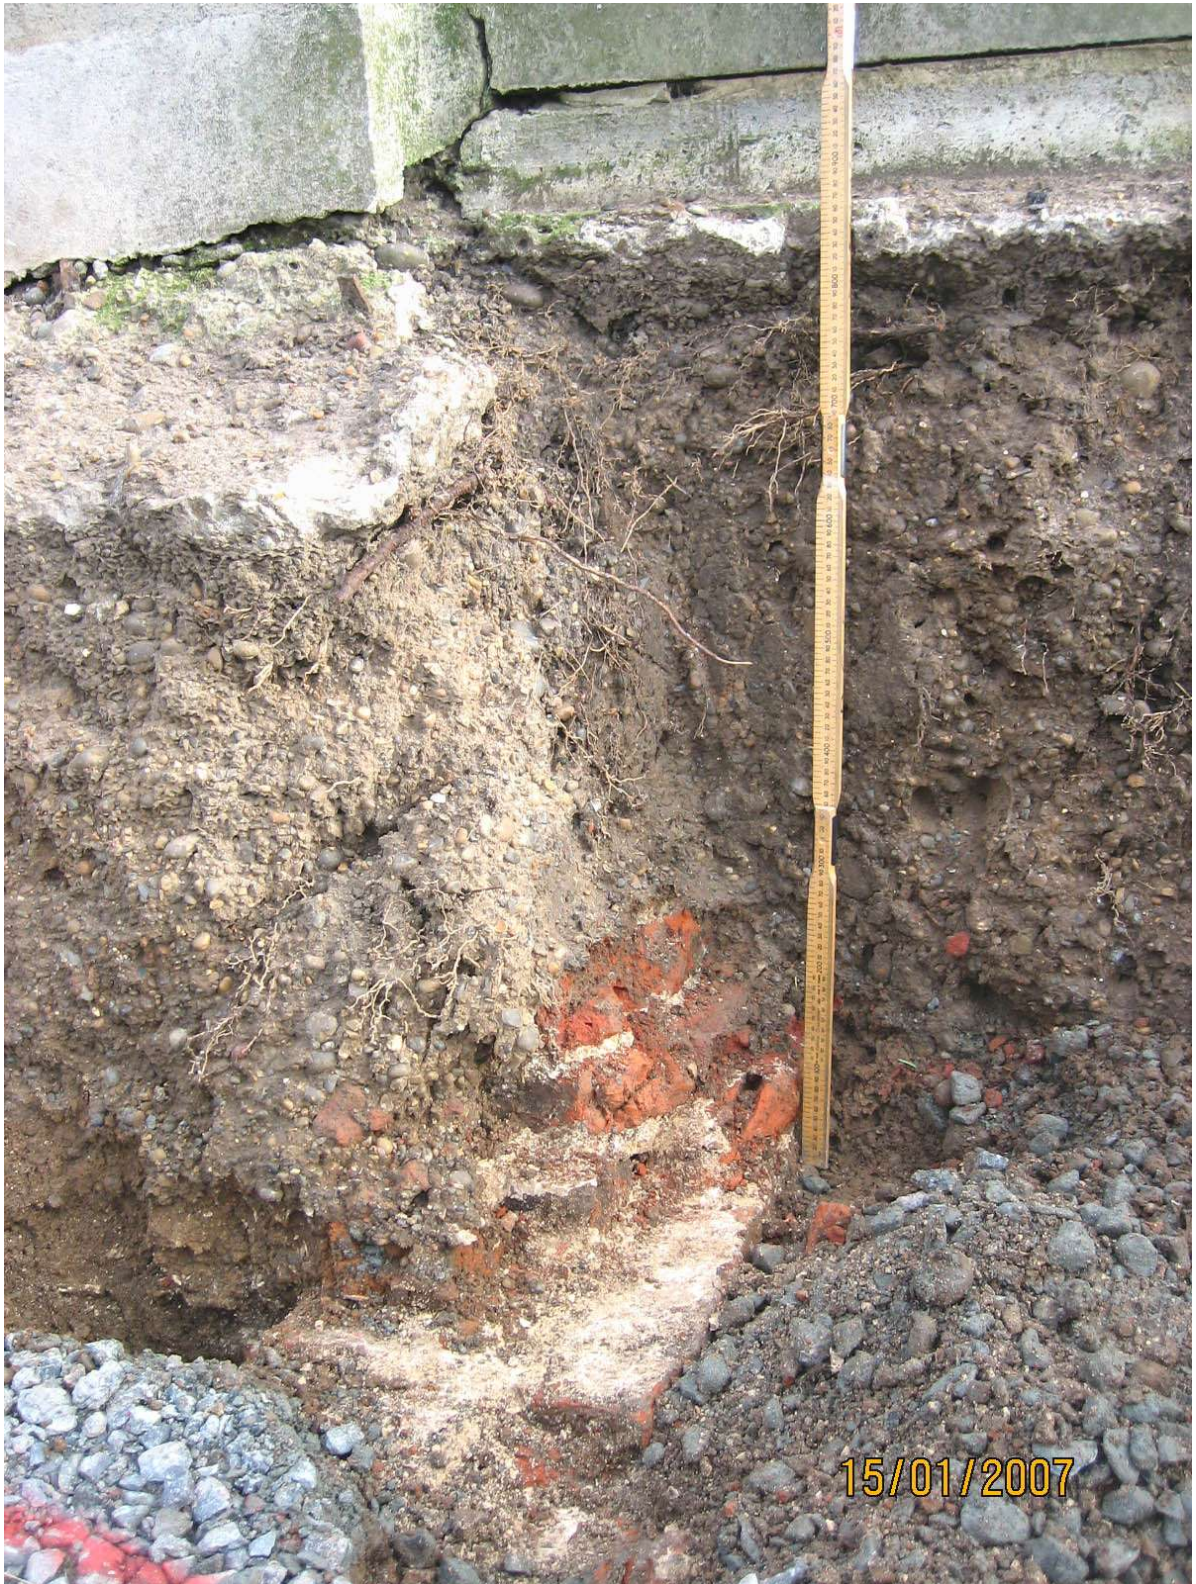
The deposits visible in section on either side of the wall were quite different. To the north was the mixed sandy silt with frequent brick and mortar rubble that is described above (3.1). However, to the south was a clean mid brown sand/silt with frequent pebbles but almost no other inclusions that probably represents redeposited natural.

Fig 4 Detailed view of the brick wall base and adjacent deposits
