WHITEHALL, 1 MALDEN ROAD, CHEAM

LONDON BOROUGH OF SUTTON, SM3 8QD

**AN ARCHAEOLOGICAL WATCHING BRIEF AND
HISTORIC BUILDING RECORDING**

September 2018

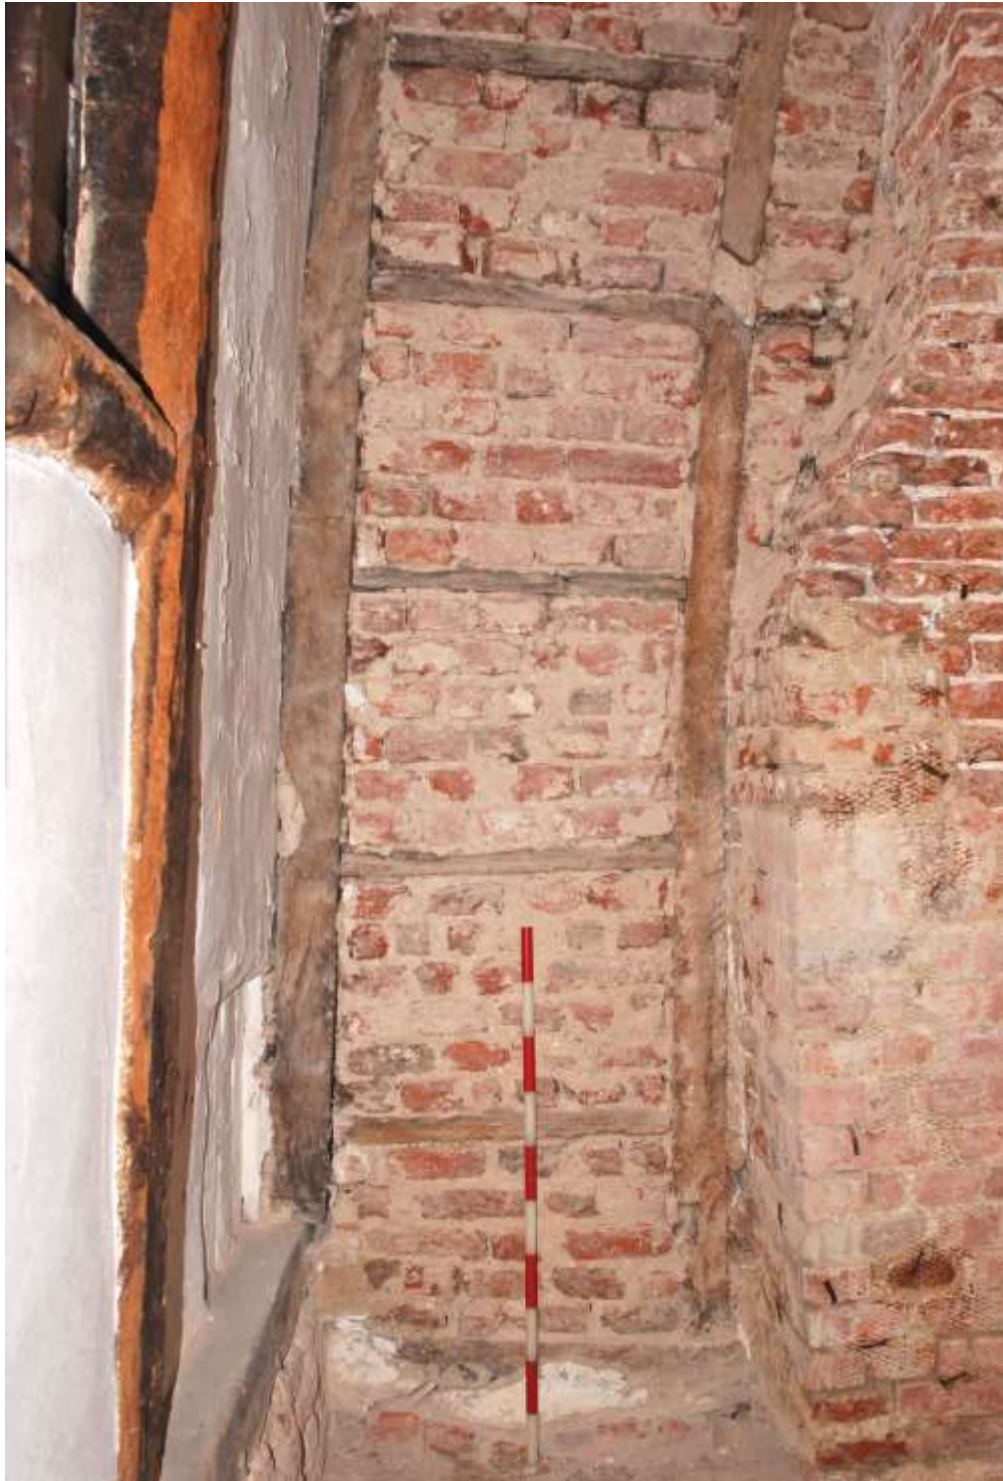
Fig.27: *The blocking wall between the external east wall and chimney (1.0m scale)*

The short section of wall between the chimneystack and main east wall of the building comprised brickwork with horizontal bond timbers every five to six courses (Fig.27 above). This wall seems to have been an alteration, blocking off a previously open area: thus the plaster that was removed was observed to abut existing finished surfaces on both adjacent walls. Moreover, whilst to the east the brickwork adjoined

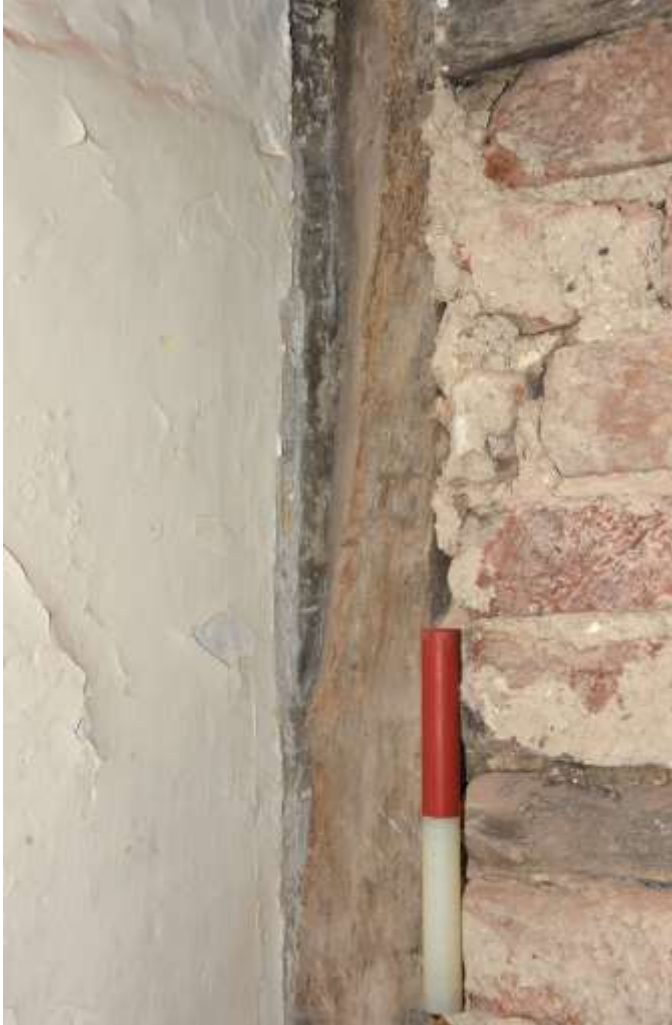
Fig.28: The junction between the blocking wall and main eastern wall of the building. Plasterwork on the first of these abutted an existing surface on the main wall, seen here as the darker grey strip to the right of the timber stud (0.2m scale)

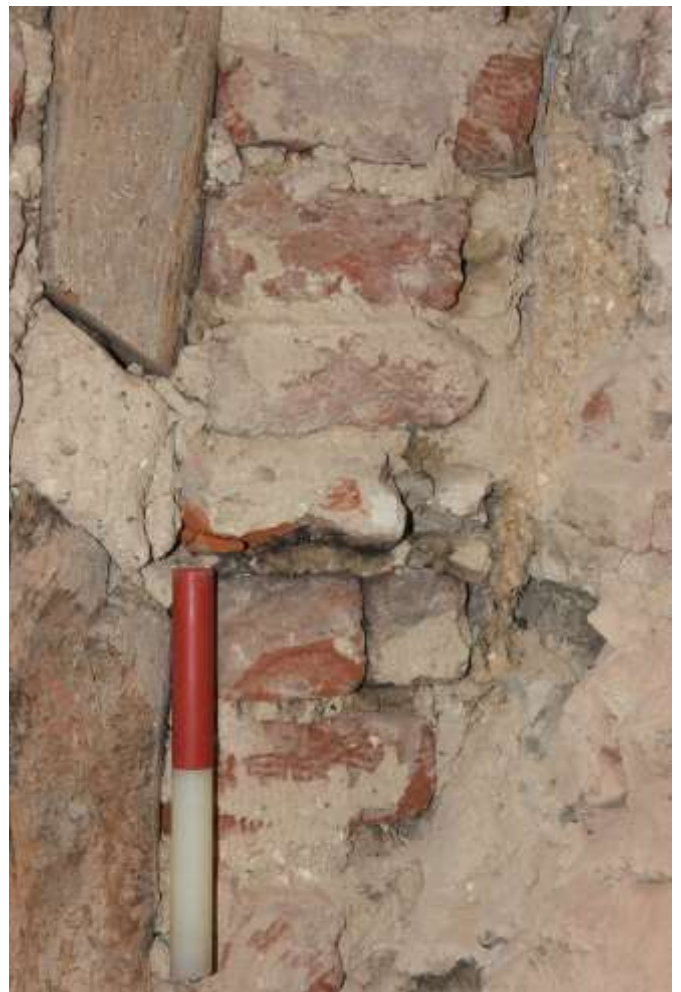
Fig.29: The junction between the blocking wall and – on the right – the chimneystack. The plastered surface of the latter continues behind the later brickwork (most clearly seen towards the top right hand corner)

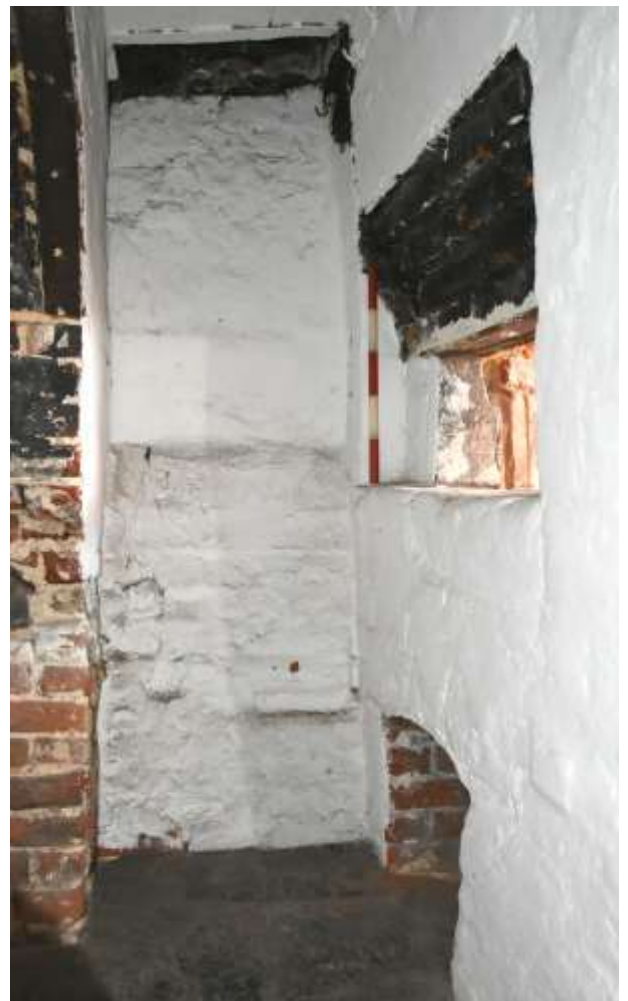
Fig.42: Opening to the lower (storage?) chamber, here with a slightly concave iron lintel over. Note also the contrast in brickwork, with a modern reconstruction to the rear (0.2m scale)

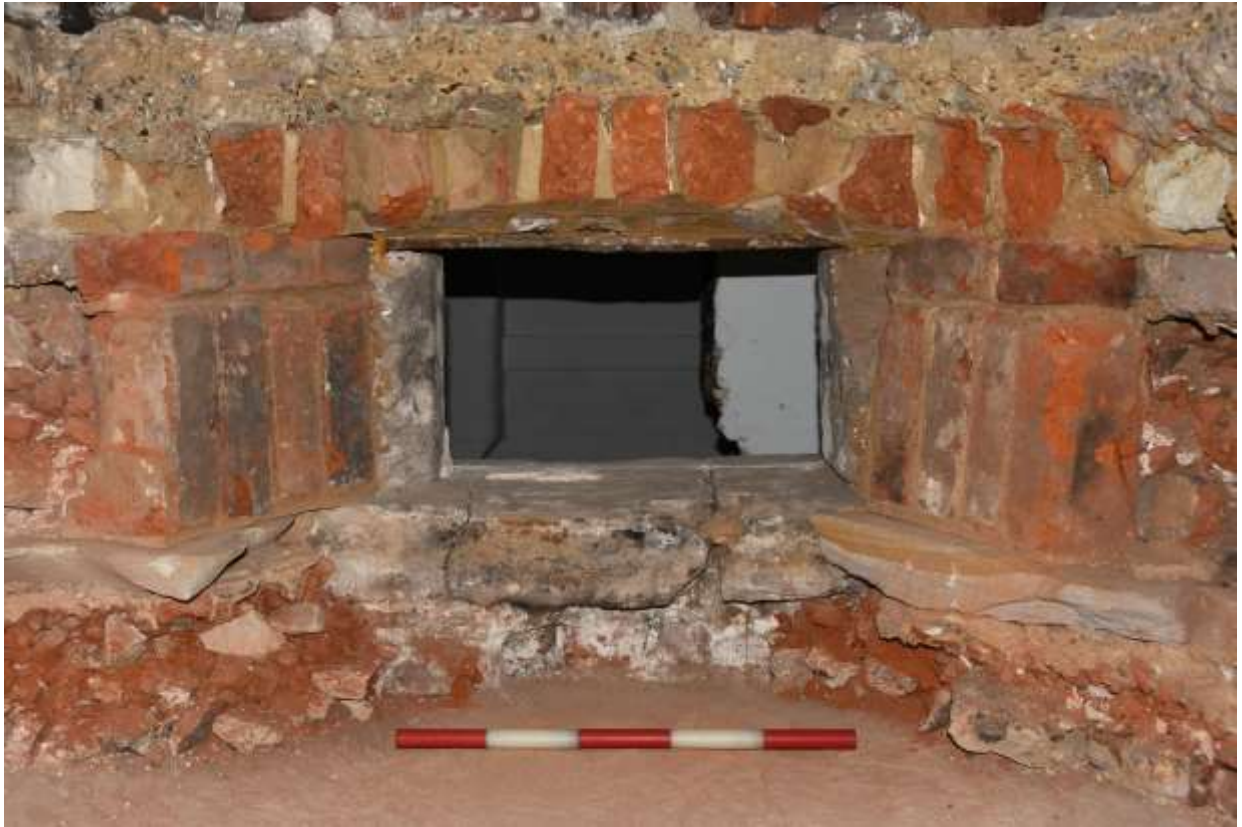
Fig.44: View from the rear of the oven mouth, with original stone lining to sides and base plus iron lintel over, but everything else quite modern (0.5m scale.)

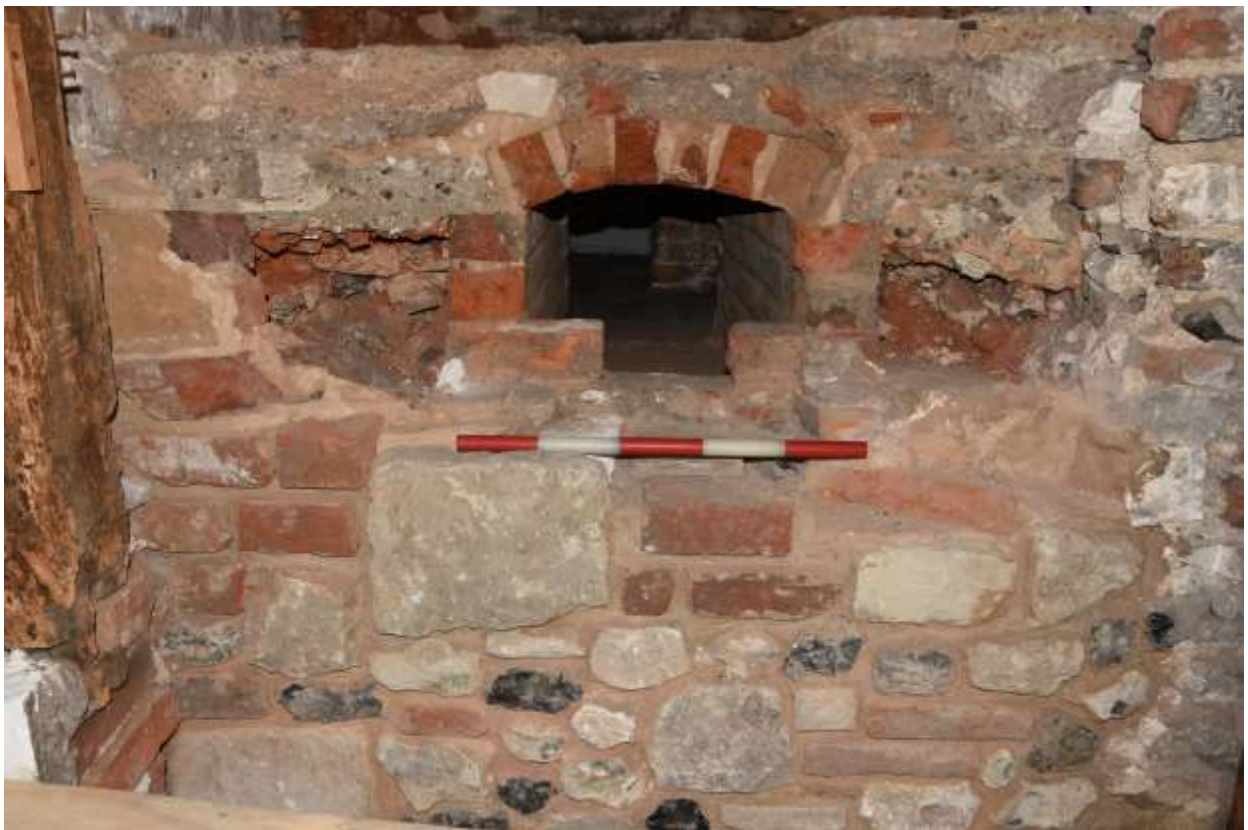
Fig.45: View from the rear of the lower chamber, all of recent construction

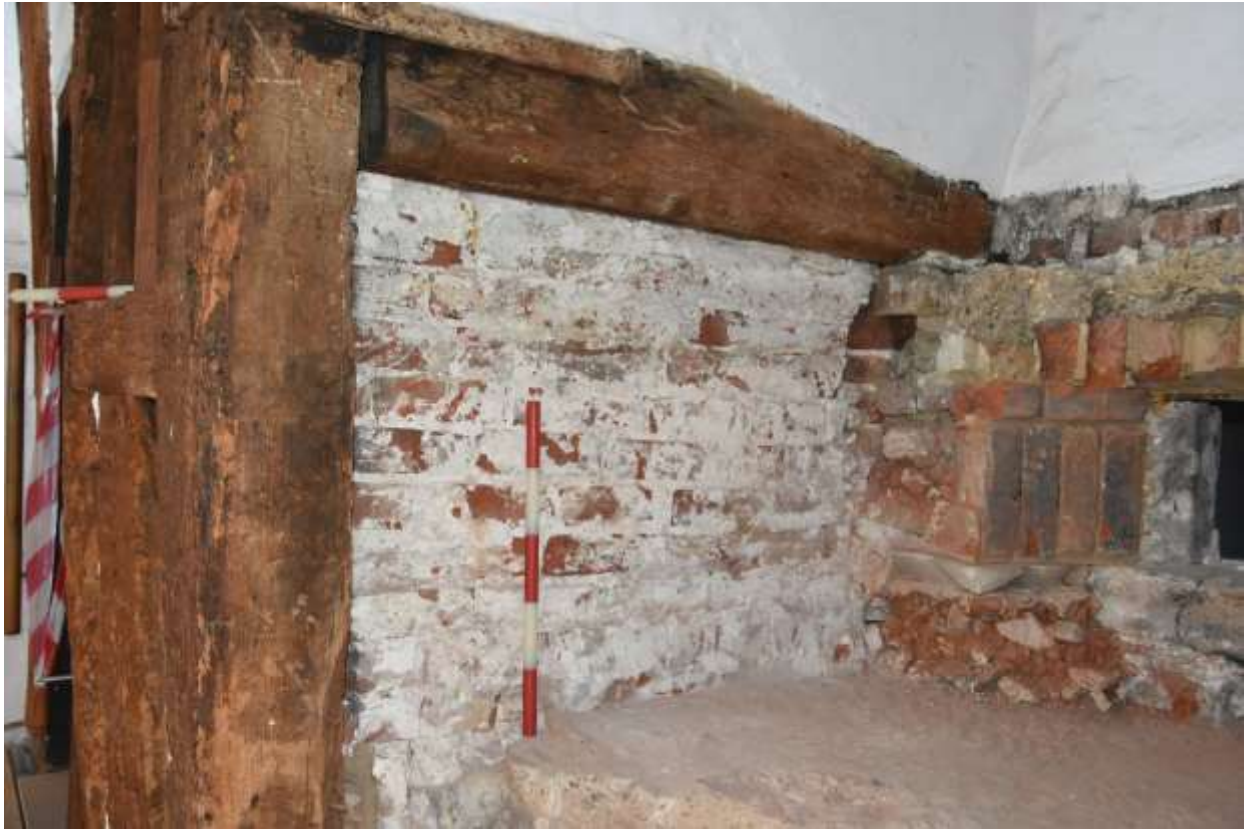
Fig.46: *On its northern side the reconstructed oven abuts an earlier limewashed brick wall – indicating that the area was previously open, the original oven having already been removed*

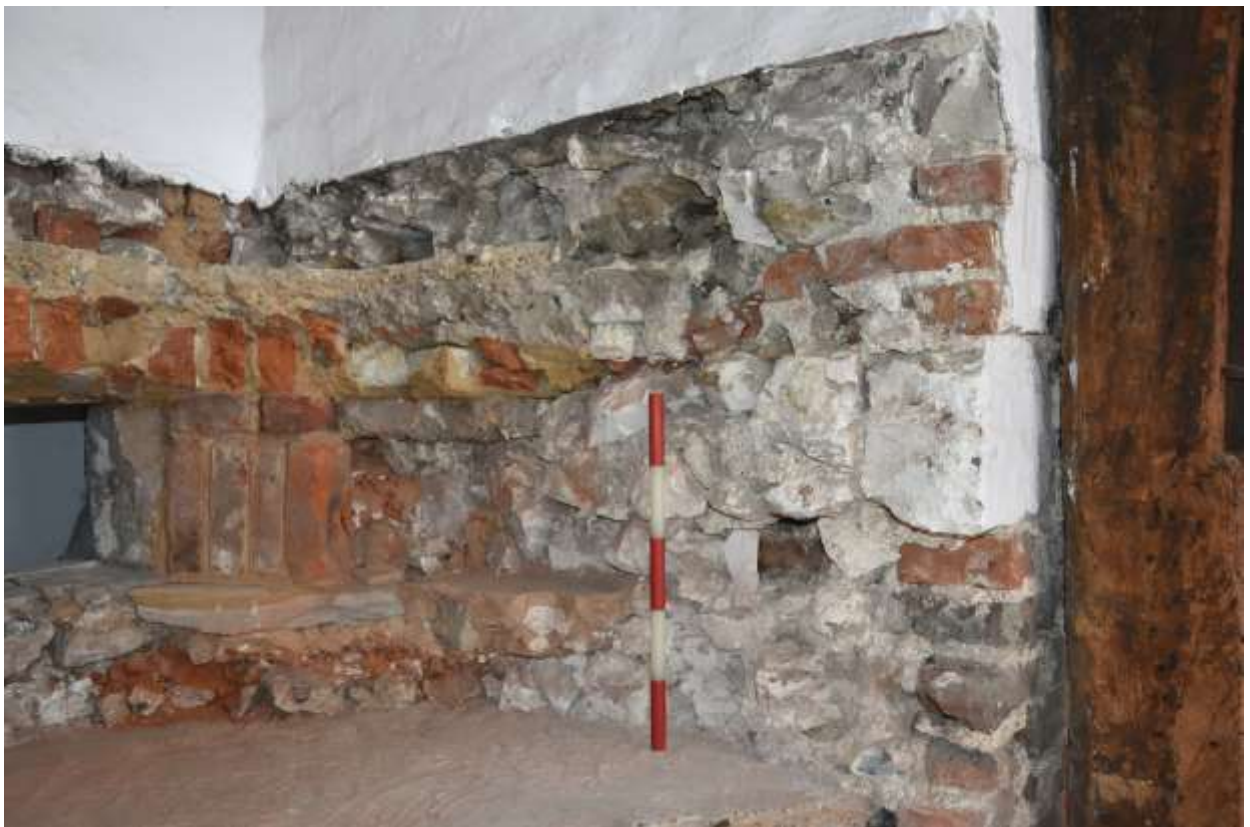
Fig.47: *Detail of the earlier wall on the south side of the oven – in this instance the face has been broken away, perhaps during the modern reconstruction (0.5m scale)*

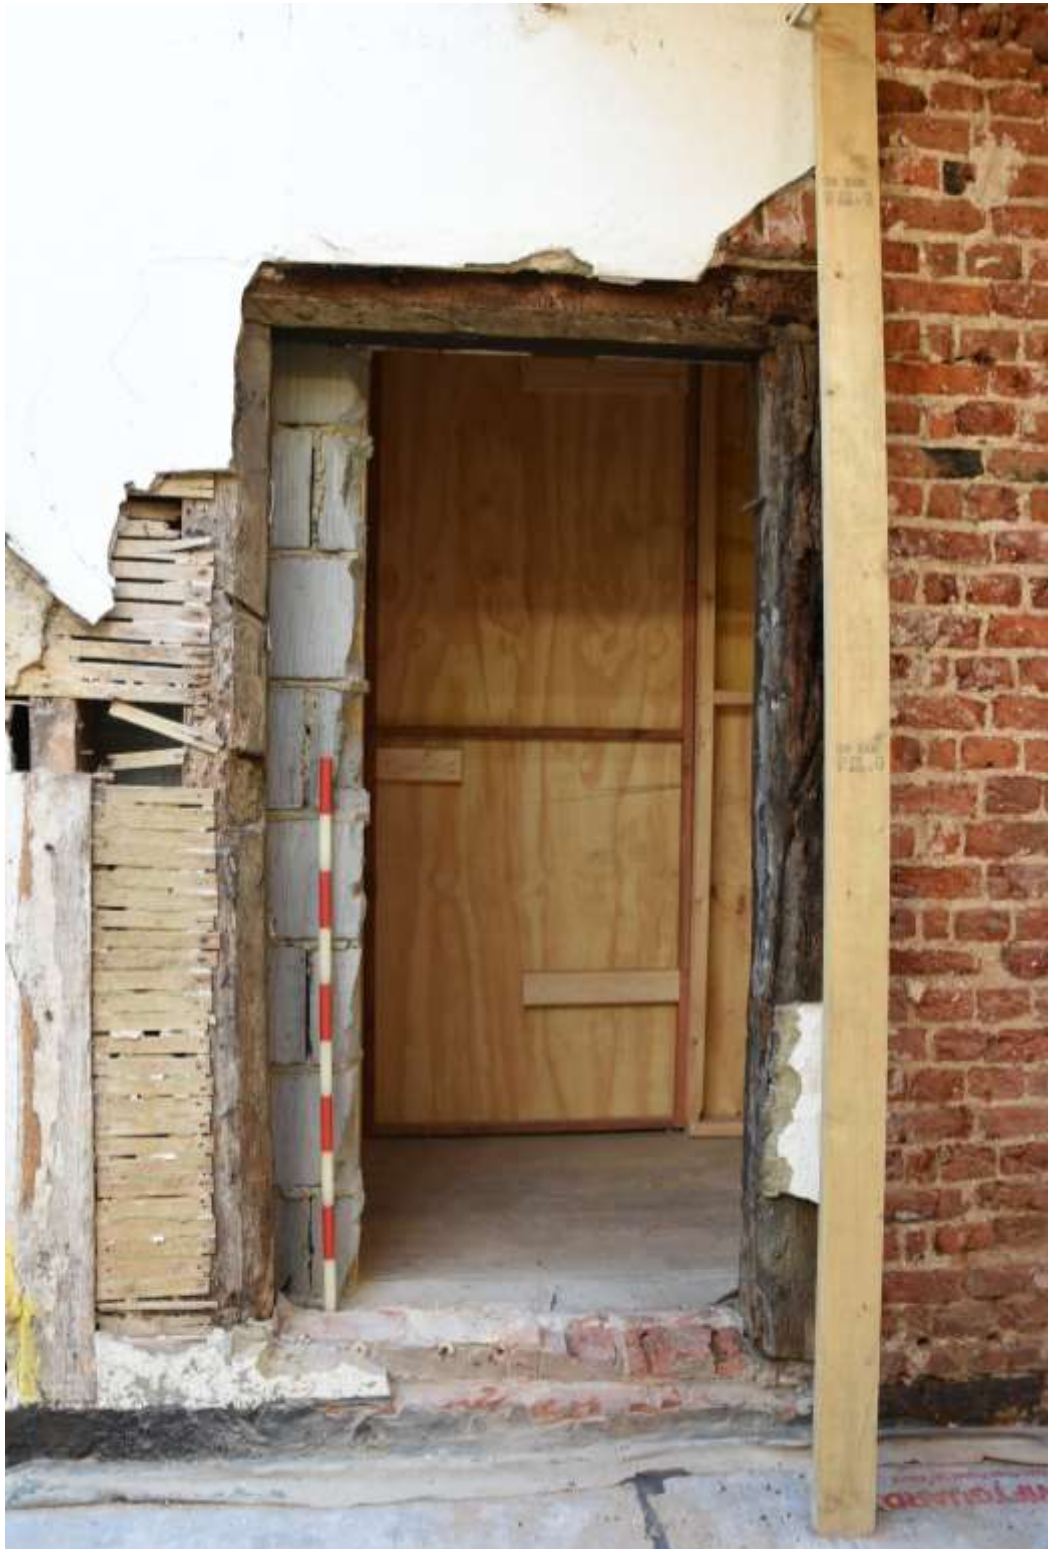
Fig.59: The blocked doorway in the northern wall of Room G-12 exposed (1m scale)

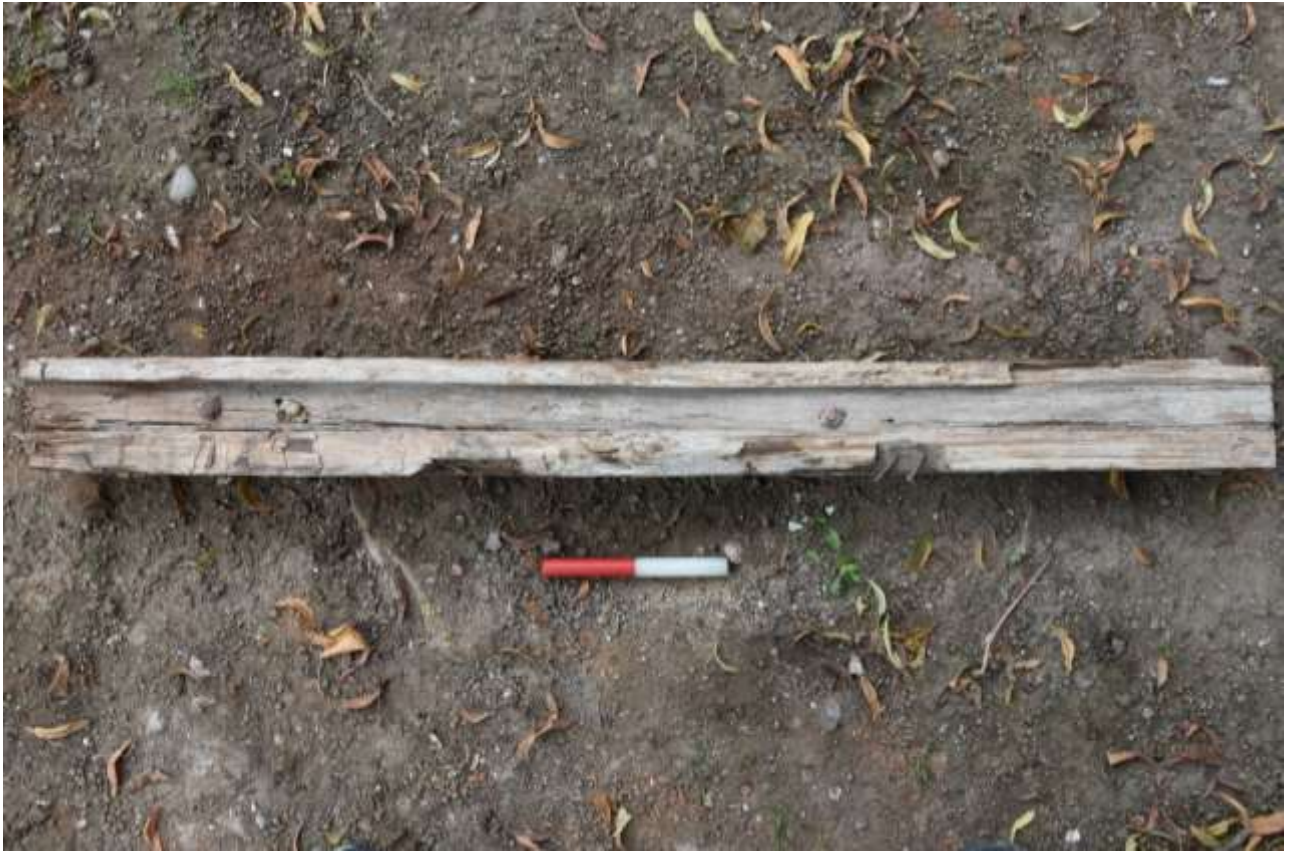
Fig.78: *Reused timber located behind the doorhead and forming a lintel to support part of the overlying brickwork, this face as seen in situ – cf. Fig.68 (0.2m scale)*

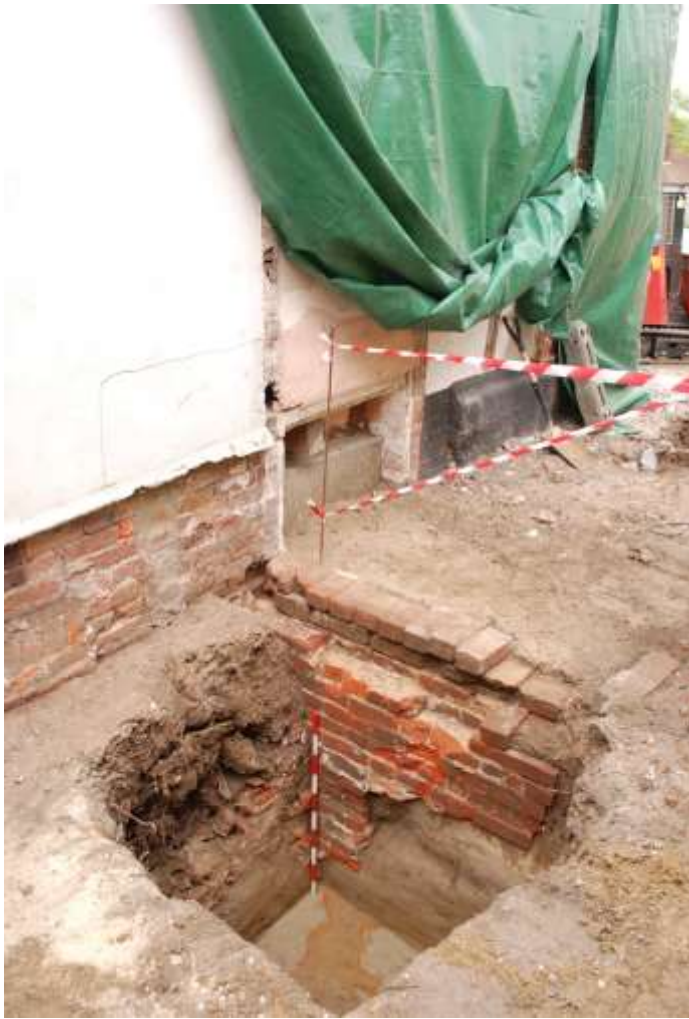
Fig.125: *The external face of the eastern flank wall to the cellar steps, exposed by a later foundation pit after blocking & infilling of the entrance itself (1m scale)*

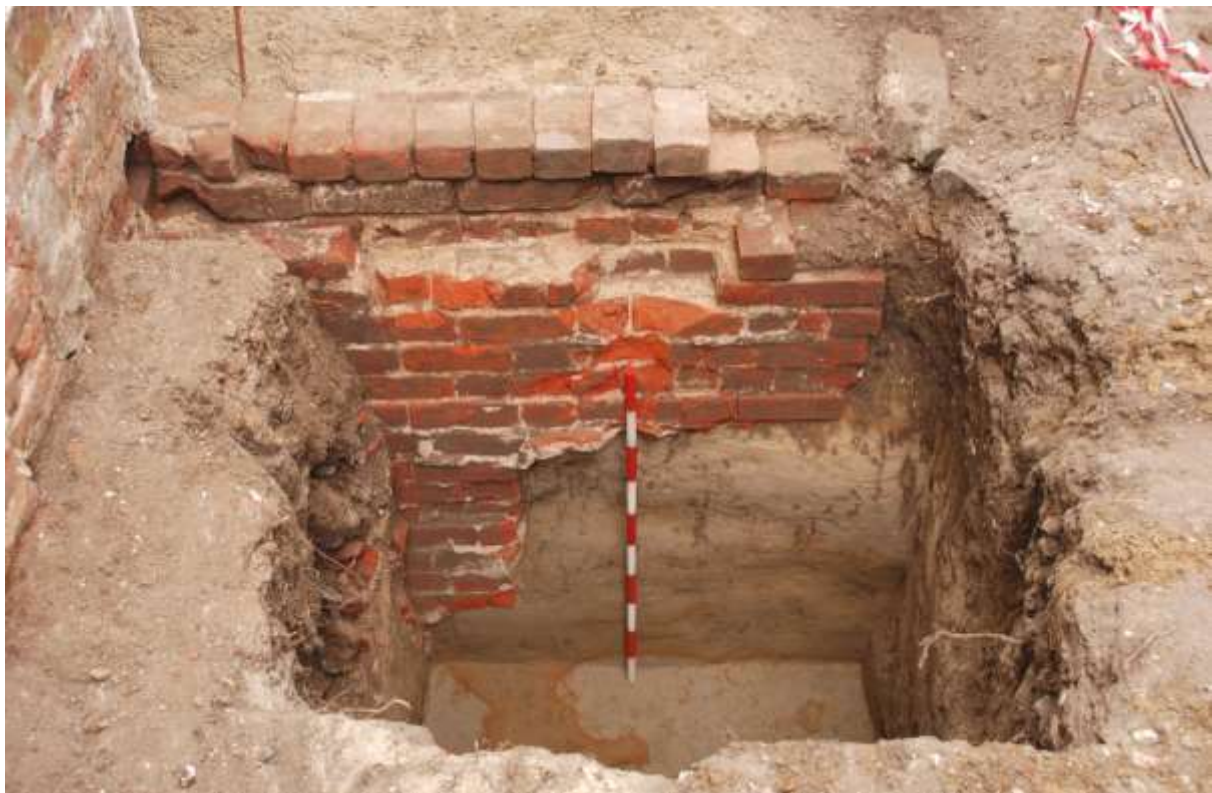
Fig.126: *Detail of the above looking SW. The upper two courses form a rebuild over the main body of the wall, context (18) (1.0m scale)*
