9. THE FIRST FLOOR

The impact of works on the first floor was variable, with significant evidence being recorded in the central corridor (F-02) and the Porch Chamber (F-03), both internally and on the external wall of Room F-04, and most extensively within the rear extension Room F-07.

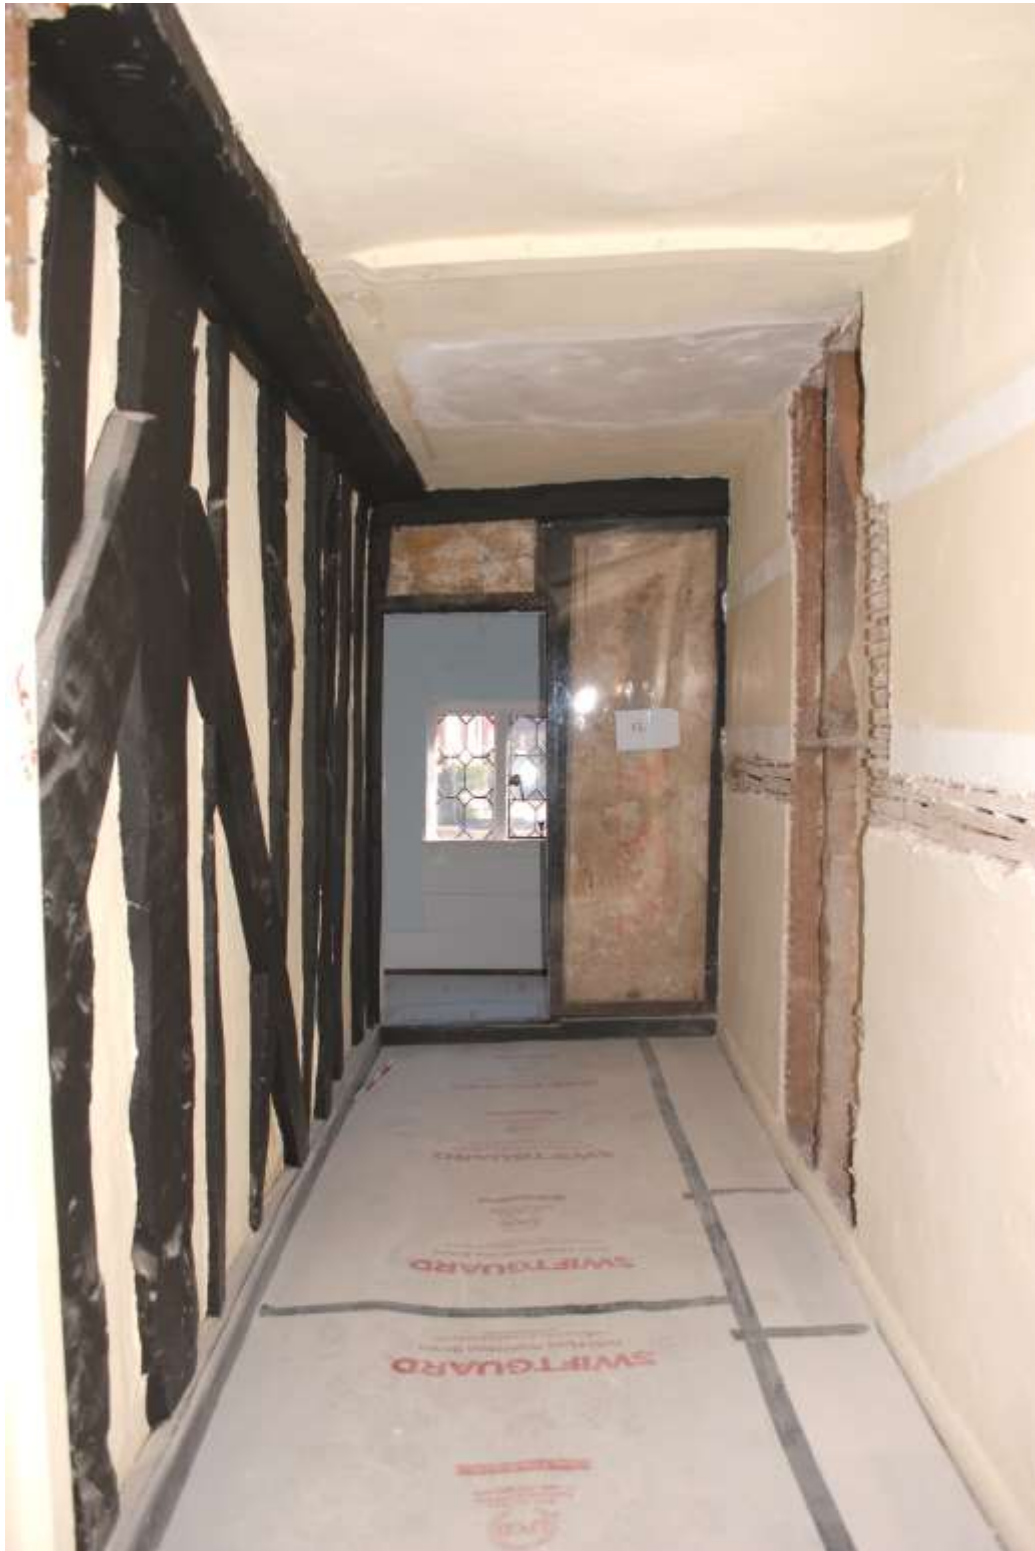
The principal work in the first floor corridor comprised the cutting of a new doorway through to the southern room F-04. This necessitated the removal of one stud and adjacent mid rail, plus lathe and plaster wall covering on either side.

Fig.130: Looking along the corridor towards the front of the building: on the right hand (southern) side lath & plaster removed in the area of the new doorway

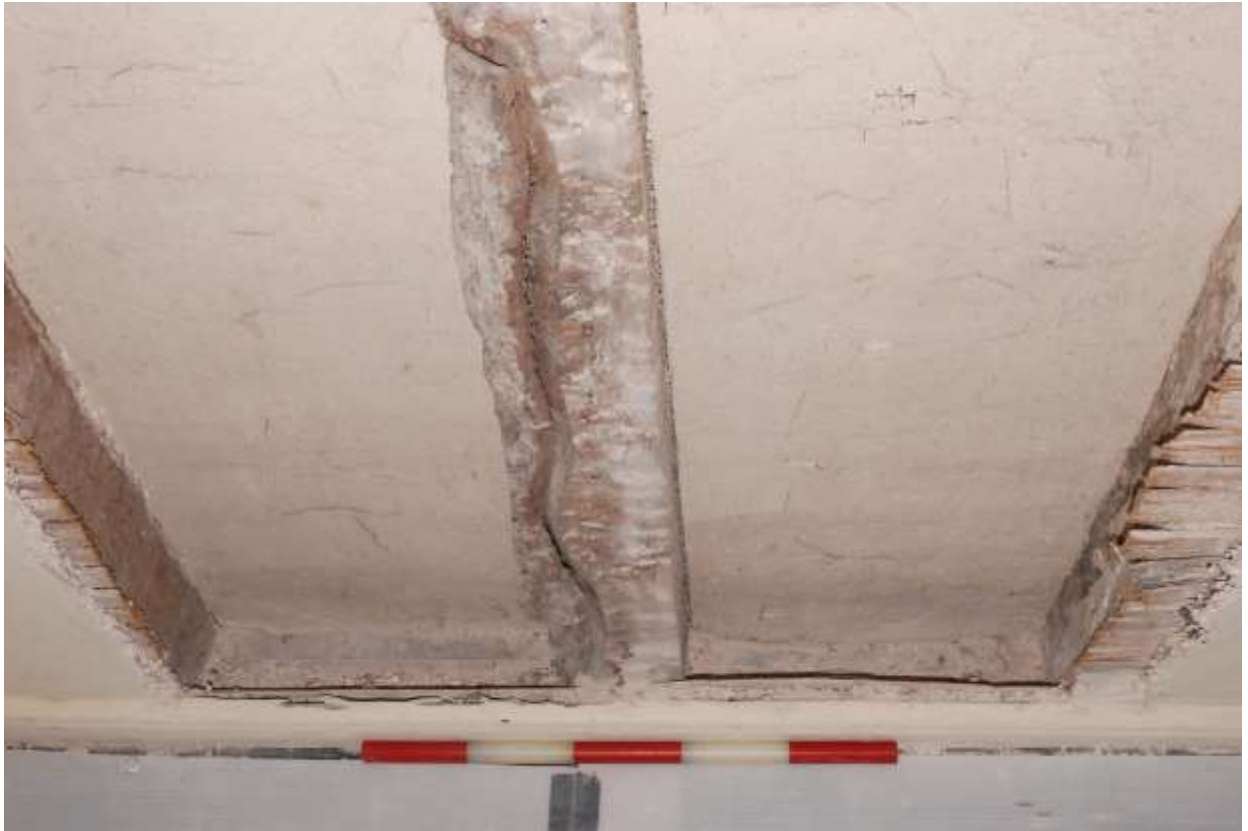
However, removal of the lath and plaster wall covering on the corridor side of the new doorway (and also a strip of plastering on either side of this) revealed that there was an earlier finished surface between the studs – essentially matching that on the other side of the corridor (Figs.132-33). Thus it is assumed that originally this was intended to be seen, and only subsequently covered over. Why one side of the corridor should have been treated in this way but not the other is unknown.

Fig.134: *Detail looking towards the base of the new doorway and showing the earlier wall face (0.5m scale)*

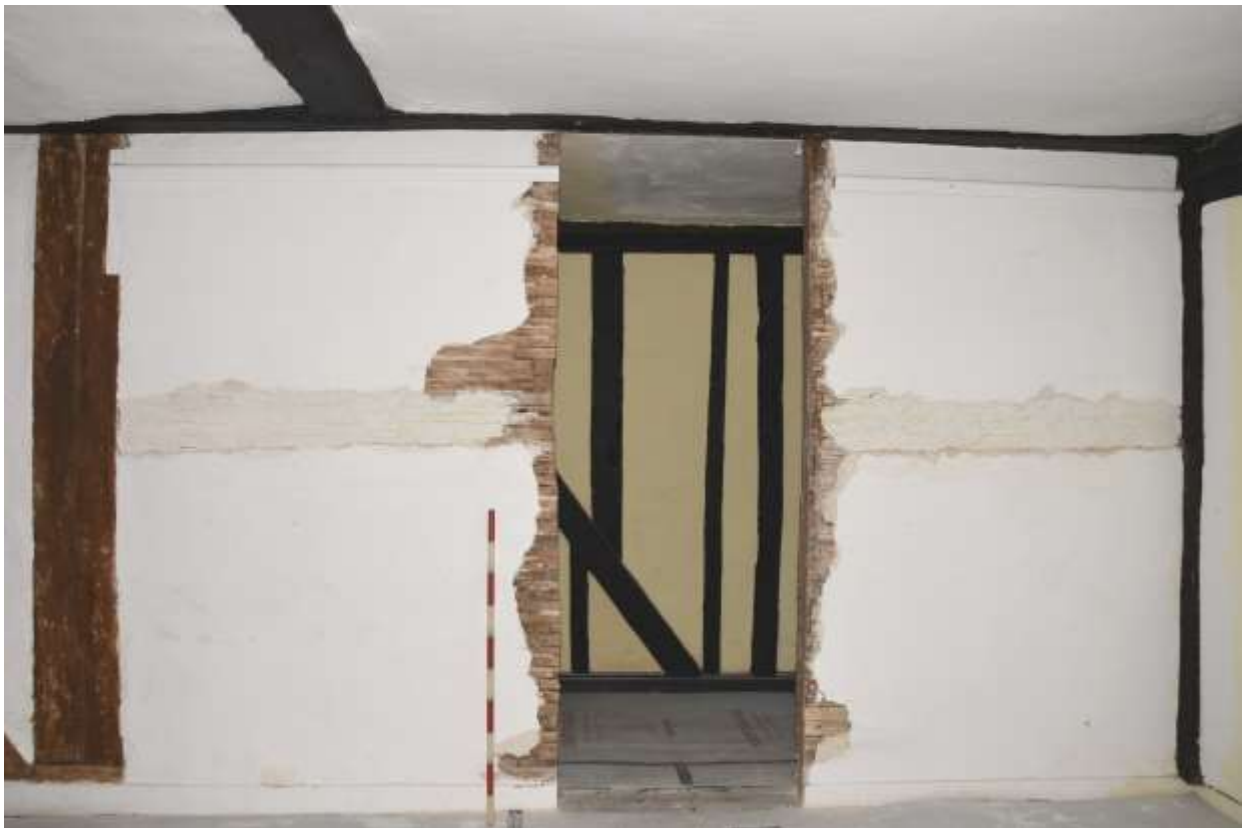
Fig.135: *View from Room F-04 after cutting through the new doorway*

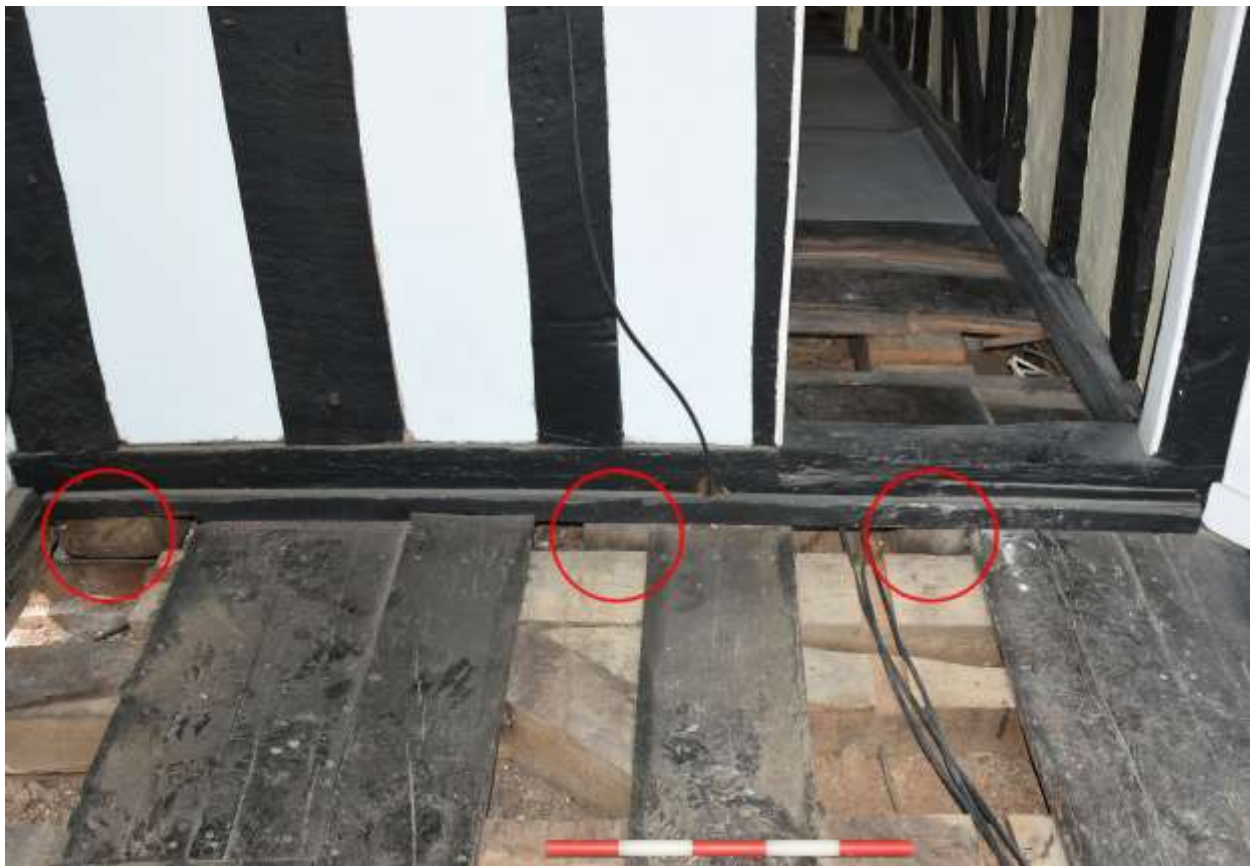
It seems clear that the porch forms an extension to an originally unbroken and jettied building frontage. This design is also closely reiterated in that of the porch itself as originally constructed, with its' projecting and rounded-off joists to create a jettied upper storey. Clearly the intention was to match the extension with the existing and adjacent frontages, as they would then have appeared.

Fig.144: View looking from the outer side of the porch chamber back to the main building frontage, with the finished ends of three joists visible and circled. It seems clear that these originally formed part of an uninterrupted jetty along the frontage, with part of the overlying bressumer now forming the door threshold (0.5m scale)

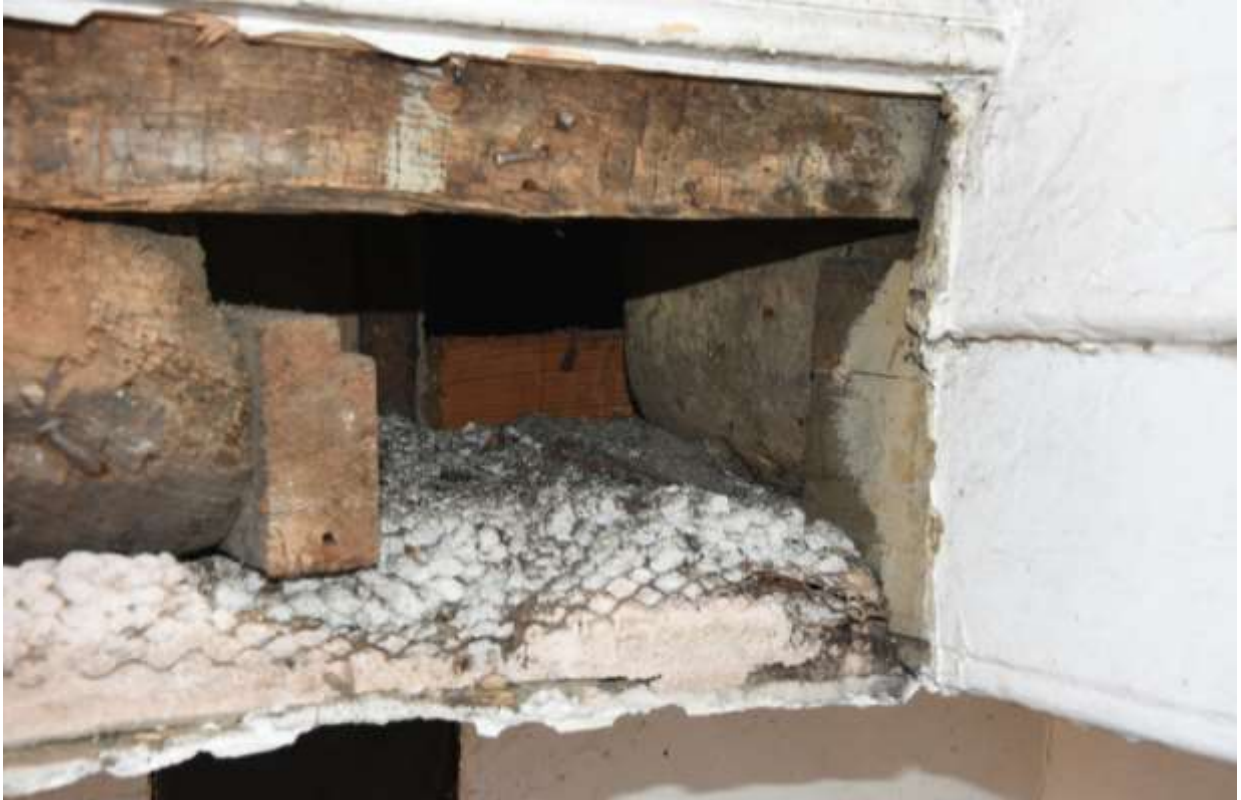
Fig.145: Exterior view on the north side of the junction between the porch and main wall. On the left is a joist with a rounded lower edge carrying the porch jetty: just right of centre (& now hidden within the porch structure) the similarly finished end of one of the main joists

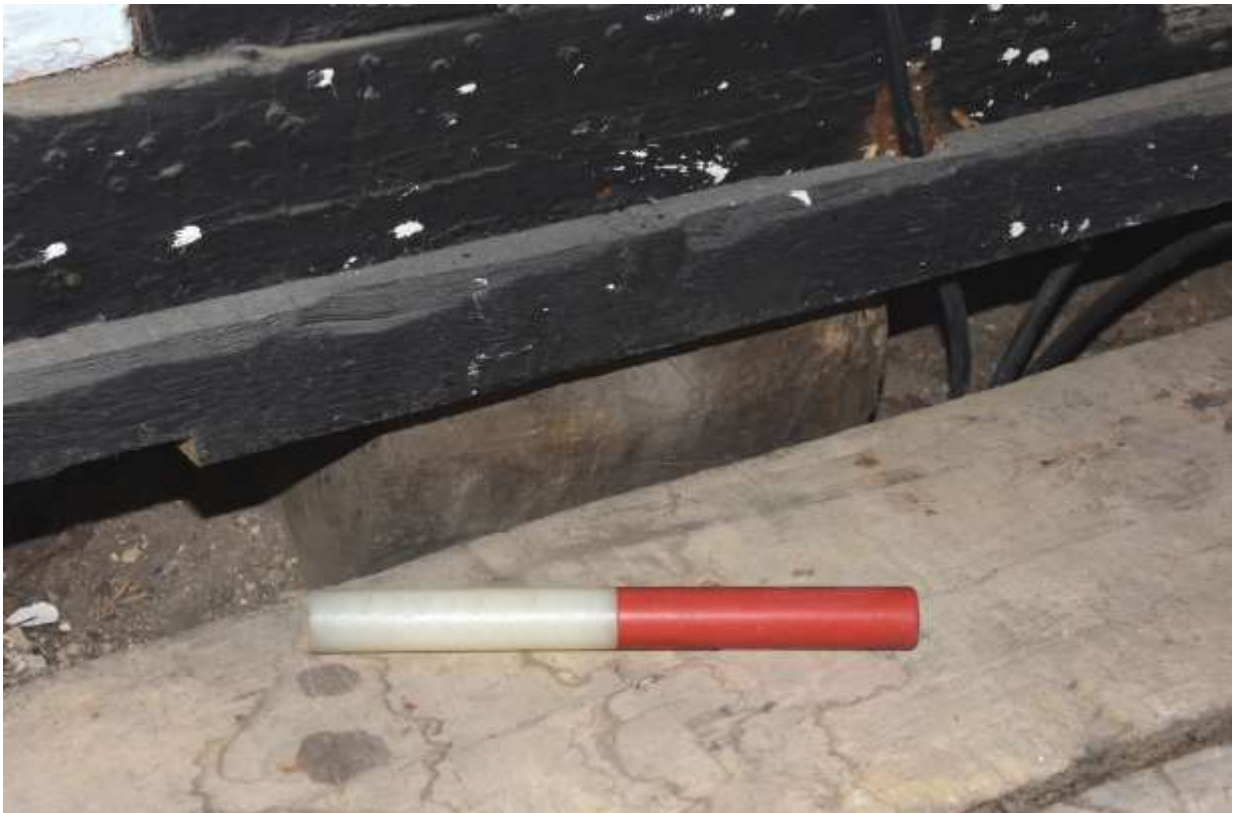
Fig.146: Detail of the central joist in Fig.144, on the line of the original jettied frontage and with the porch extension in the foreground (0.2m scale)

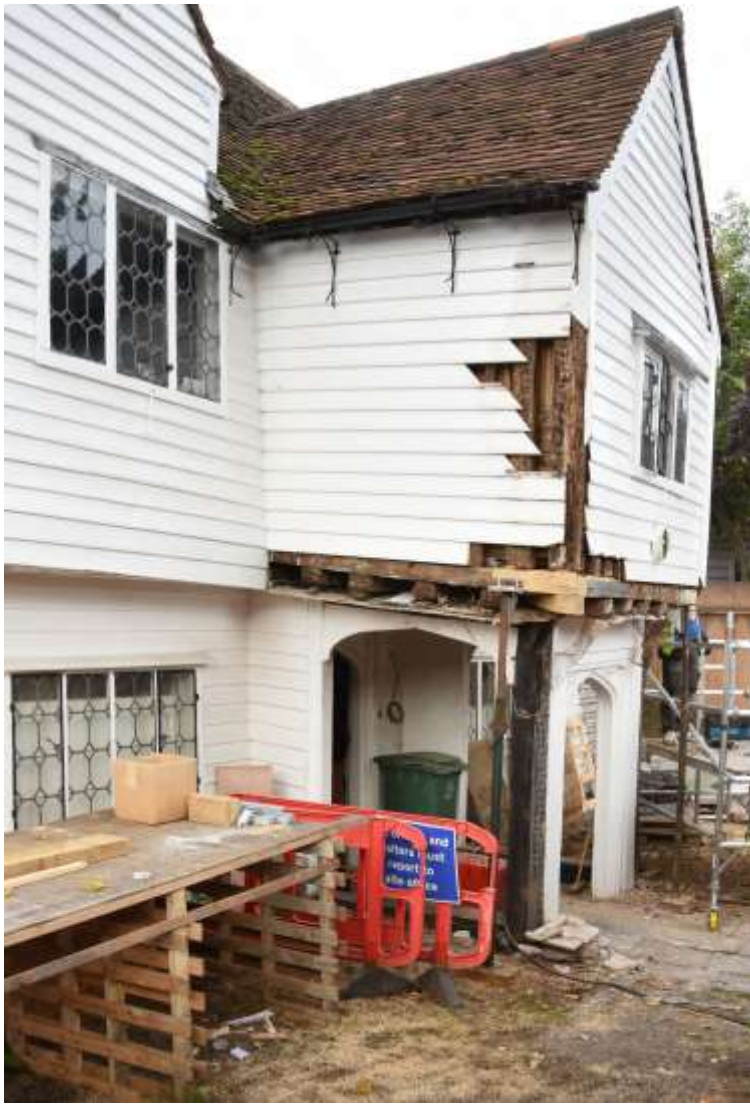
In the course of works several timbers (or at least parts at the outer corners of the porch) found to be decayed and in need of replacement. This process was also recorded, and sections of removed timber salvaged for further off-site examination and potential dendrochronological dating.

Fig.151: A view during repair works, the new lighter-coloured timberwork clearly visible at the southeast corner of the porch

The timbers removed included parts of the diagonal oak beams, which – as well as the arrangements illustrated here – were also morticed into the underlying jetty brackets at the corners of the porch. Sections of the overlying jetty bressumer at each corner were also replaced (*cf.* Figs.151 & 153).

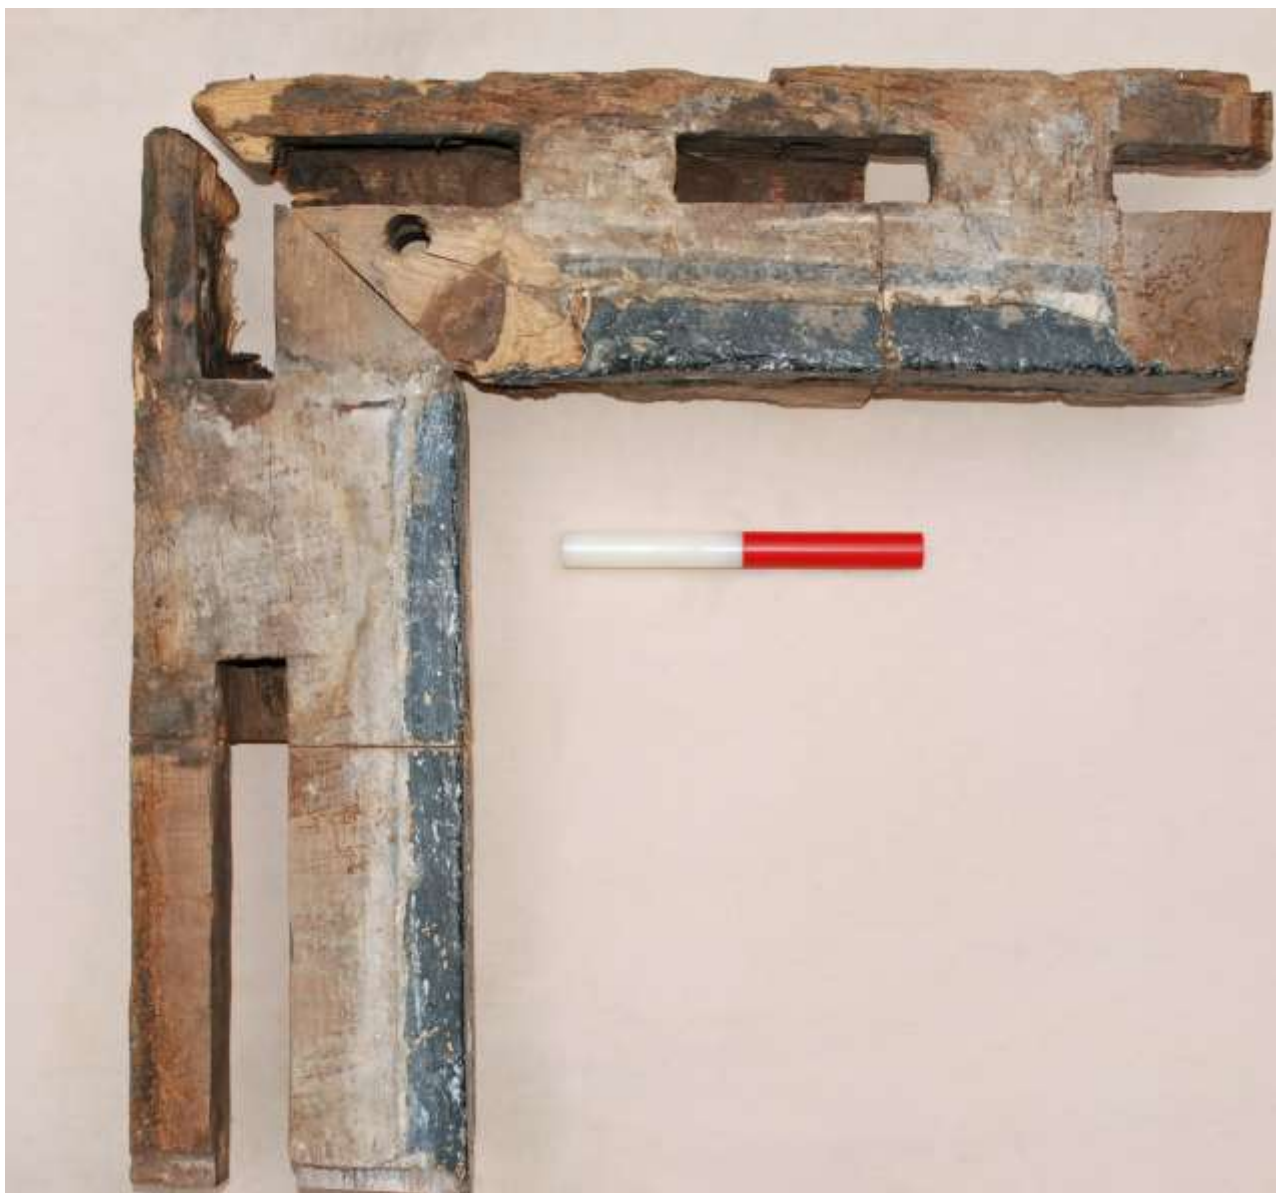
Fig.153: Removed sections of the jetty bressumer from the northeast corner of the porch, with a series of mortices for the studding. The two sections were originally held together at the corner by a pegged mortice (0.2m scale)

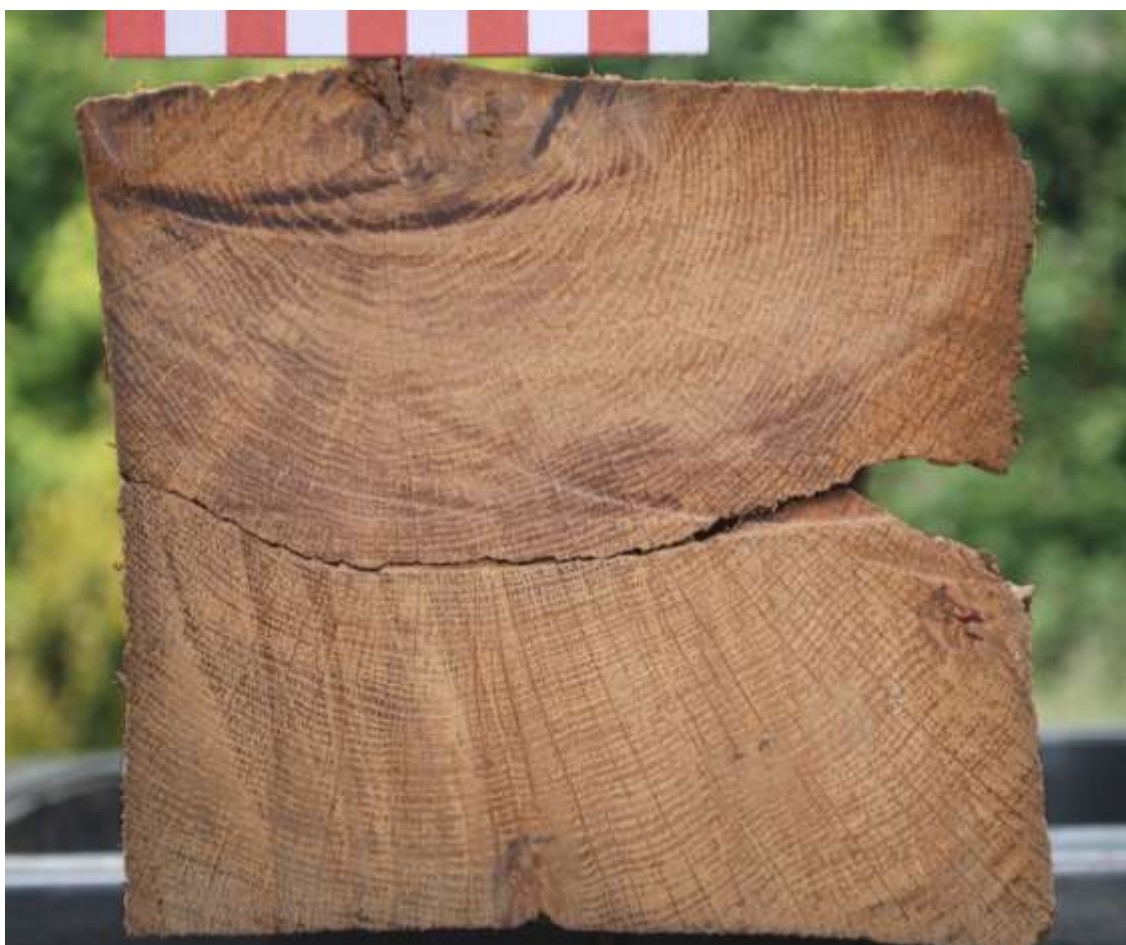
Fig.157: Cross-section of the diagonal beam from the northeast corner of the porch, showing c 100+ growth rings with sapwood at lower right

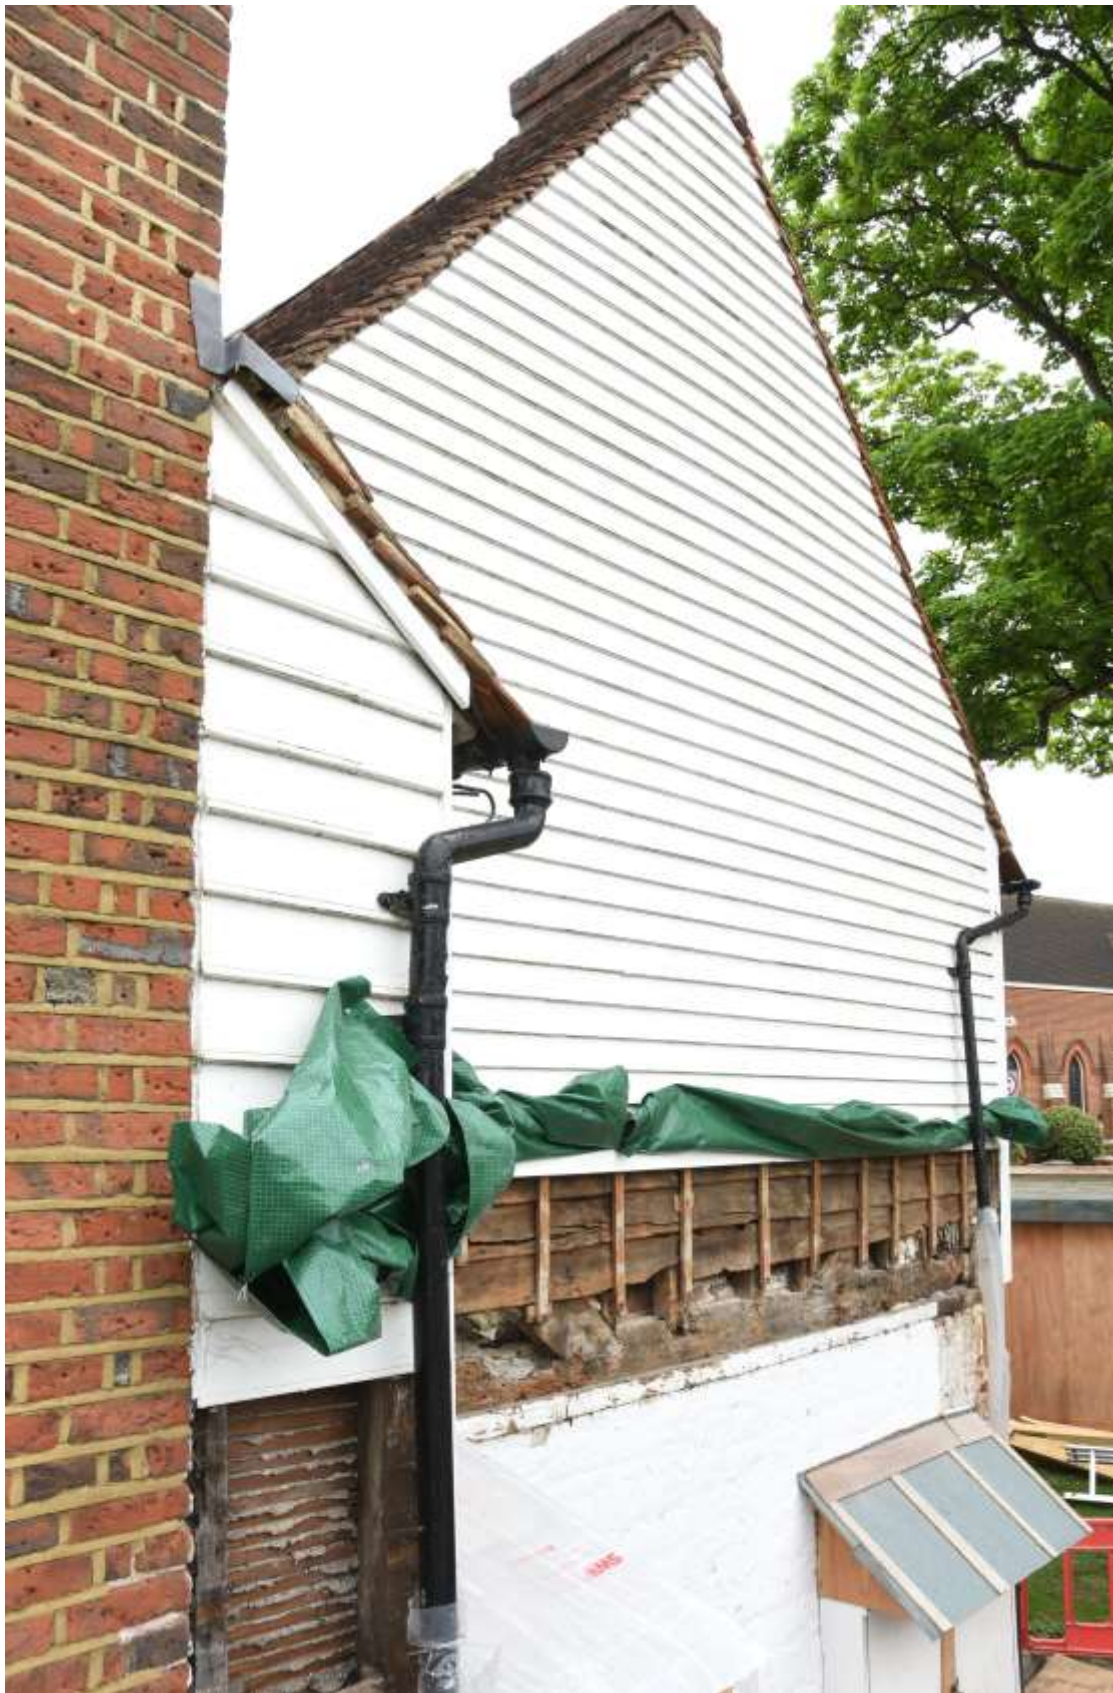
Removal of modern weatherboarding on the external wall of Room F-04 (at the southern gable end of the building) exposed an earlier phase of boarding, plus some of the underlying timber framing (*cf.* Fig.159).

Fig.159: General view of the southern end of the building looking towards Malden Road and showing earlier weatherboarding and the underlying beams. NB. The exposed lath & plaster in the foreground is a much more recent part of the extension Room F-05

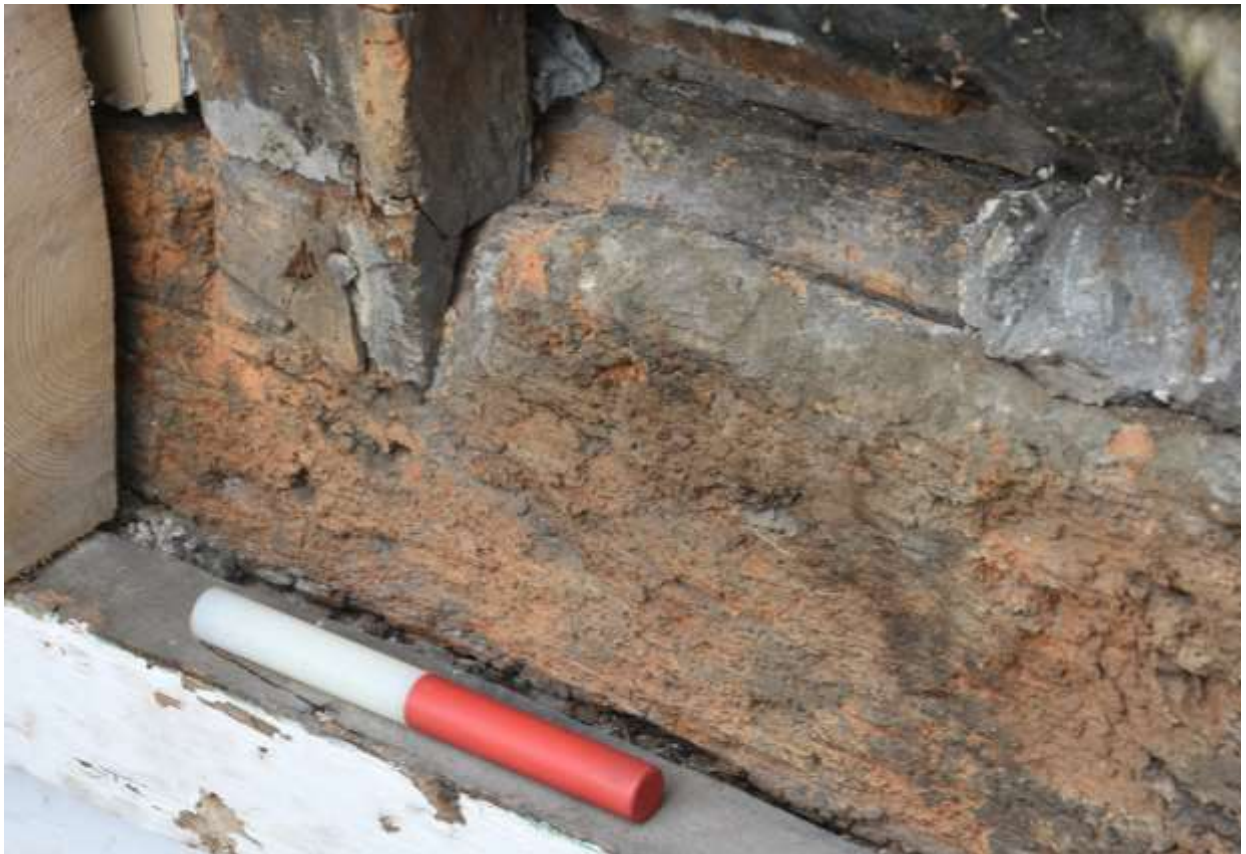
All the timberwork above this level was secondary, although some of the individual timbers may be reused. The construction itself was not of a comparable standard to the original, with the down braces quite roughly set near the top of the beam and nailed rather than pegged into substantial lap joints (Fig.166). Similarly the studs were variously placed on or stepped over the front beam, or utilised existing mortices or slots (*eg.* Figs.165, 169 & 174).

Fig.165: *The junction between a stud and the girding beam at the west end of the exposed section. The slotted front of the beam has been cut away and the stud roughly stepped & nailed over this*

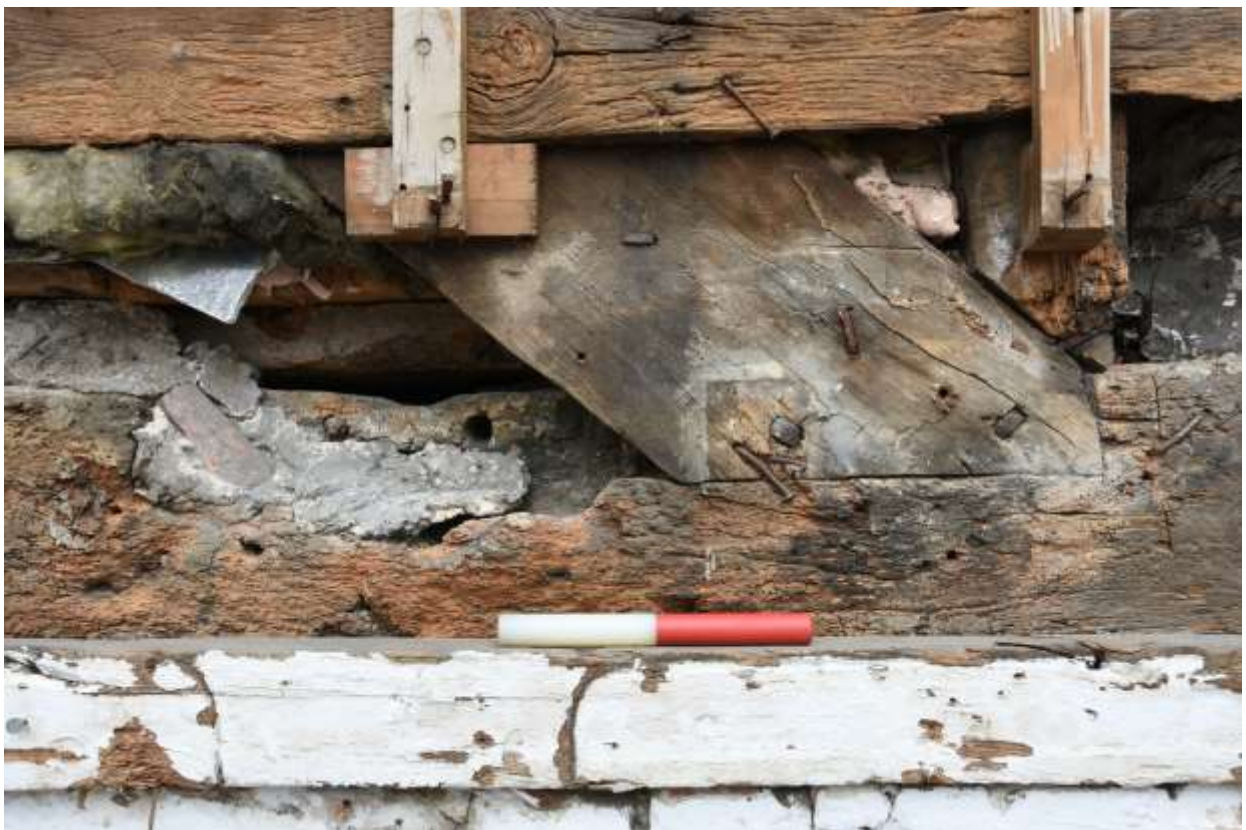
The down braces had also been slightly repositioned towards the centre of the wall, so presumably were a bit longer than their predecessors. However, to judge by the associated lap joint in the girding beam the eastern brace at least (at *c* 200mm by 80mm) may not have been quite as large as the original. The western brace was slightly larger, *c* 230mm by 80mm. The angle of the original braces also appears to have been slightly steeper, again taking the outline of original eastern joint as a guide.

Fig.166: *The base of the western down brace, fixed with two large nails, and just to the left an earlier lap joint and pegholes, presumably for a similar but slightly shorter brace (0.2m scale)*

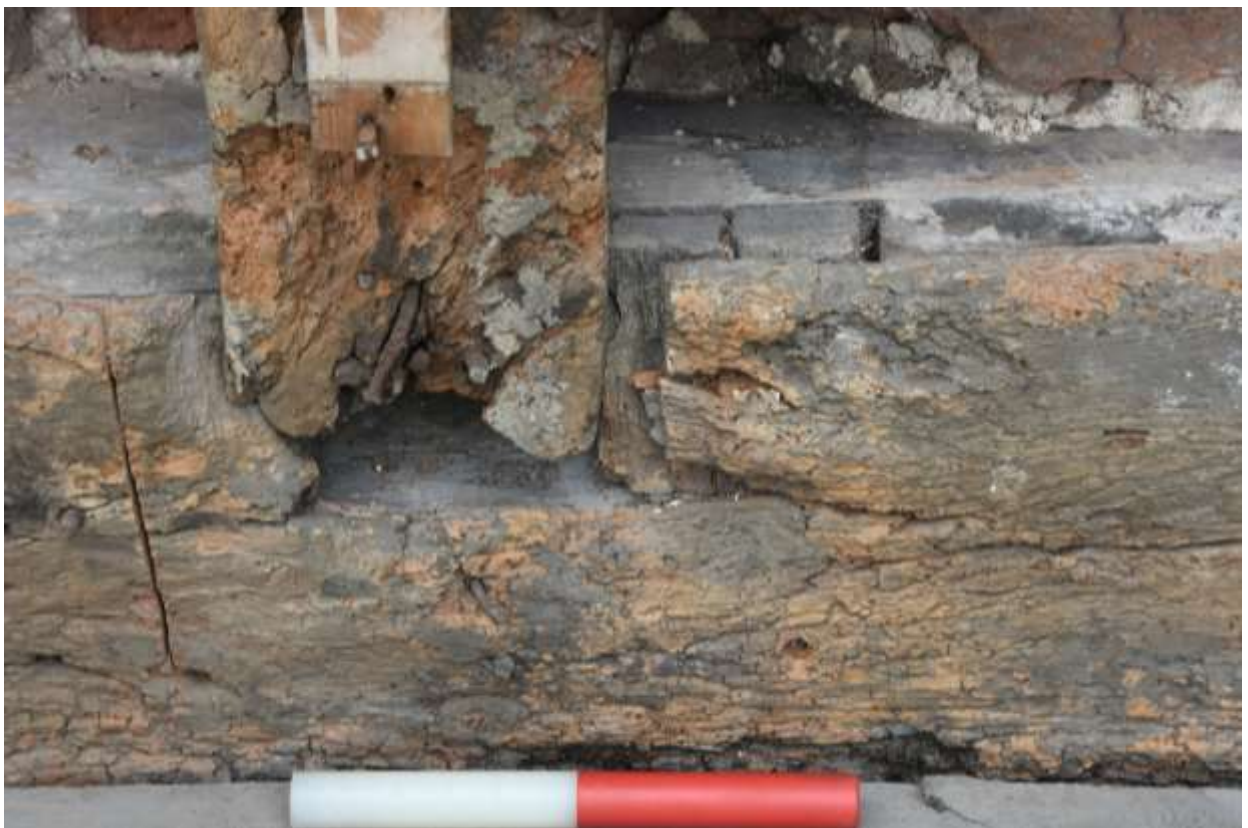
Fig.170: Detail of the base of one the above studs. This is set into one side of an earlier and wider (200mm) mortice within the girding beam. Part of the earlier tenon & dowel are visible immediately to the right, sawn off flush with the surface of the beam (see also elevation Fig.163)

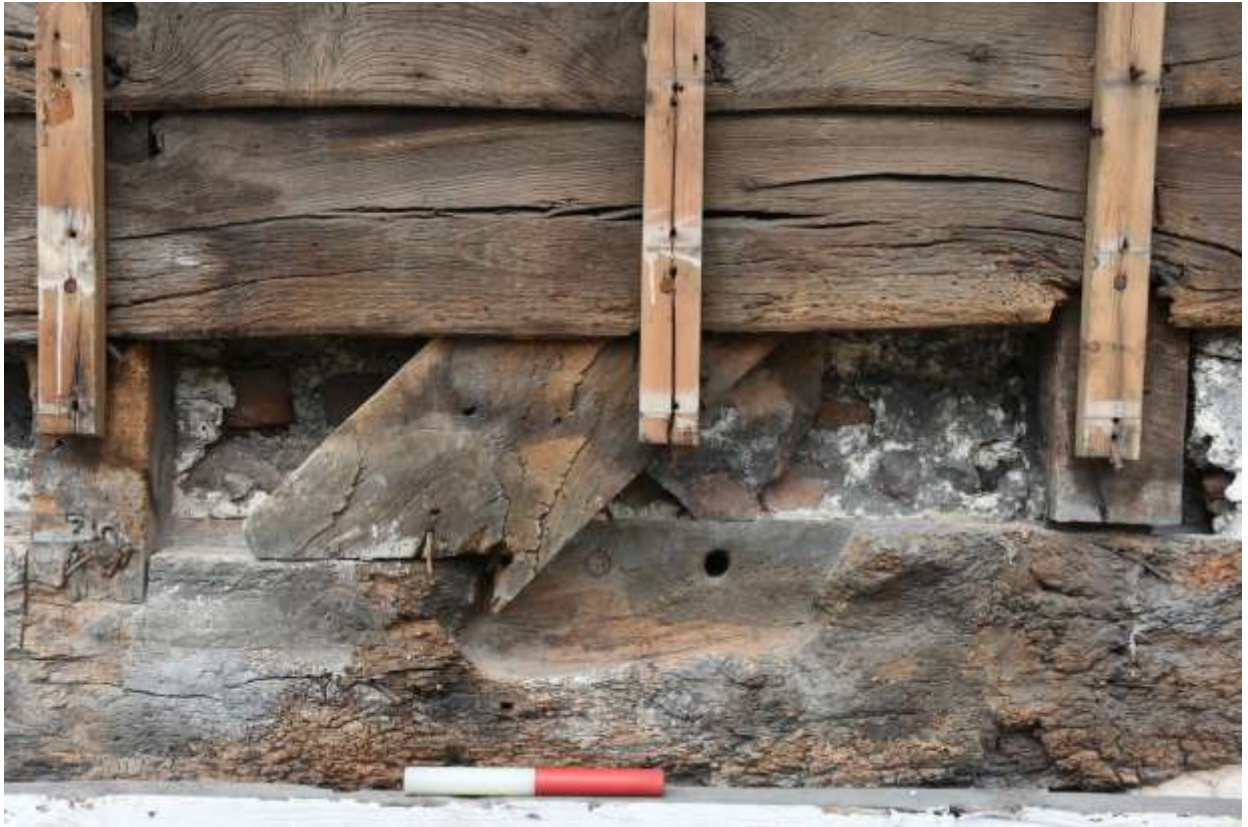
Fig.171: Detail of the base of the eastern down brace, slightly overlapping one side of an earlier lap joint and pegholes. The construction is quite rough, the brace apparently nailed into a shallow cut on the top of the beam rather than the previous deeper and pegged joint

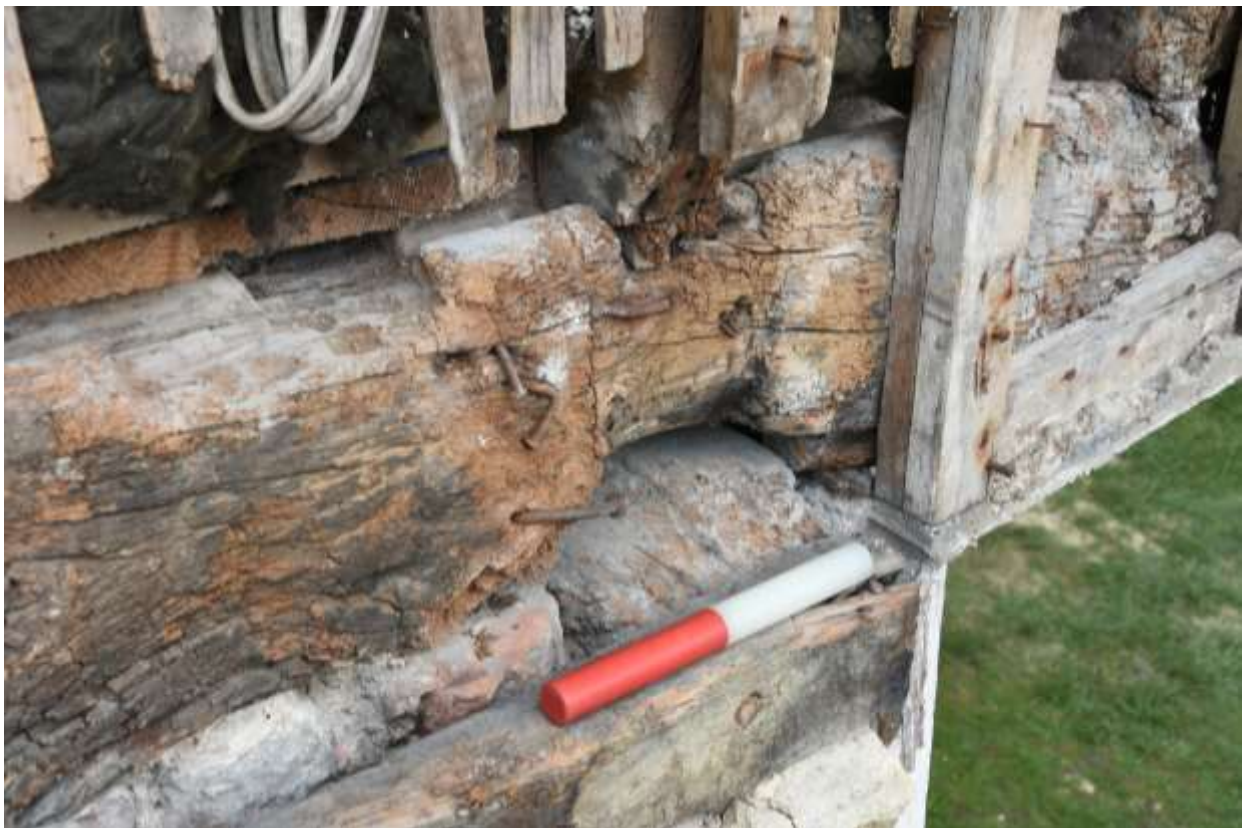
Fig.174: Detail of the heavily eroded joint between the two principal beams. The top of the E-W beam also has two smaller cut-outs: that immediately above the 0.2m scale containing a piece of timber below the later stud, and that to the left empty

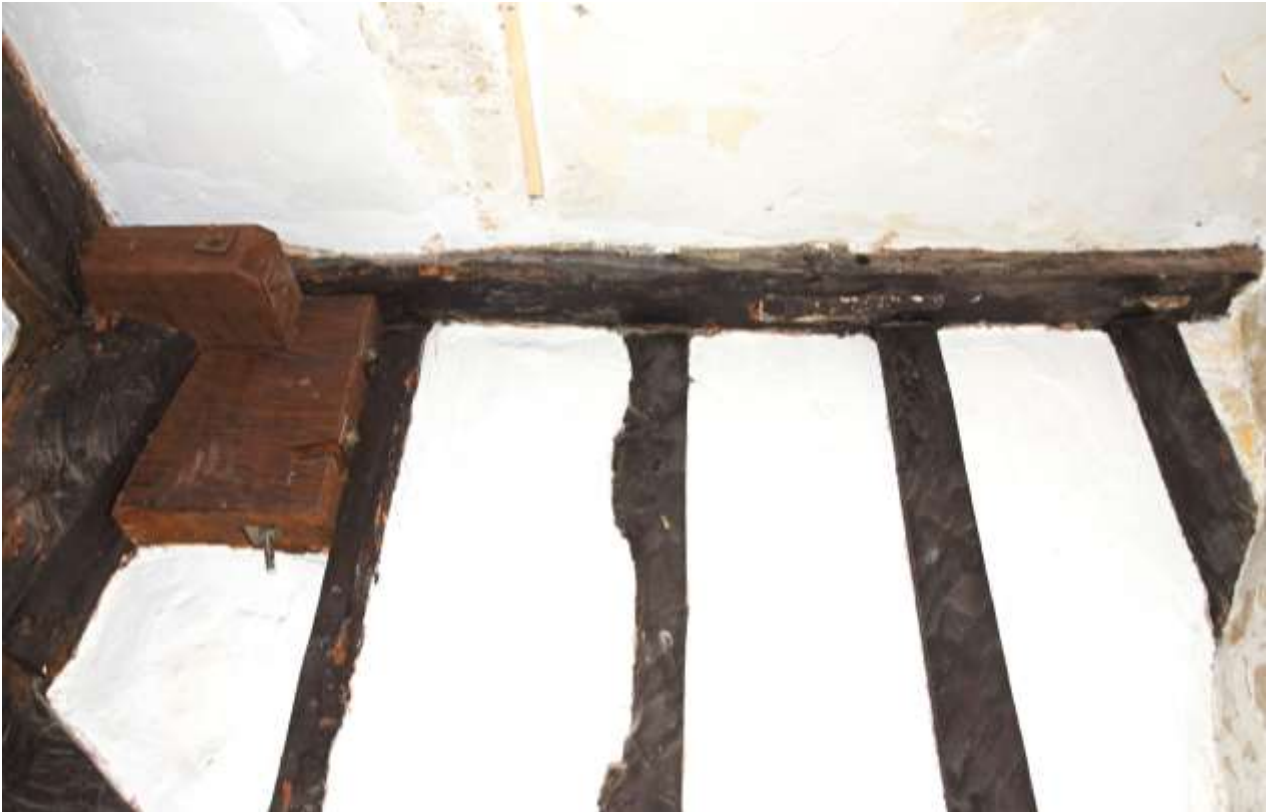
Fig.176 (above): *Studs & tie beam to the east of the chimneystack. The underside of the beam has four empty or blocked mortices, c100mm x 30mm up to 290mm x 45mm in size, though given that the wall has been rebuilt this may simply be reused (cf. Section 9.3.1)*

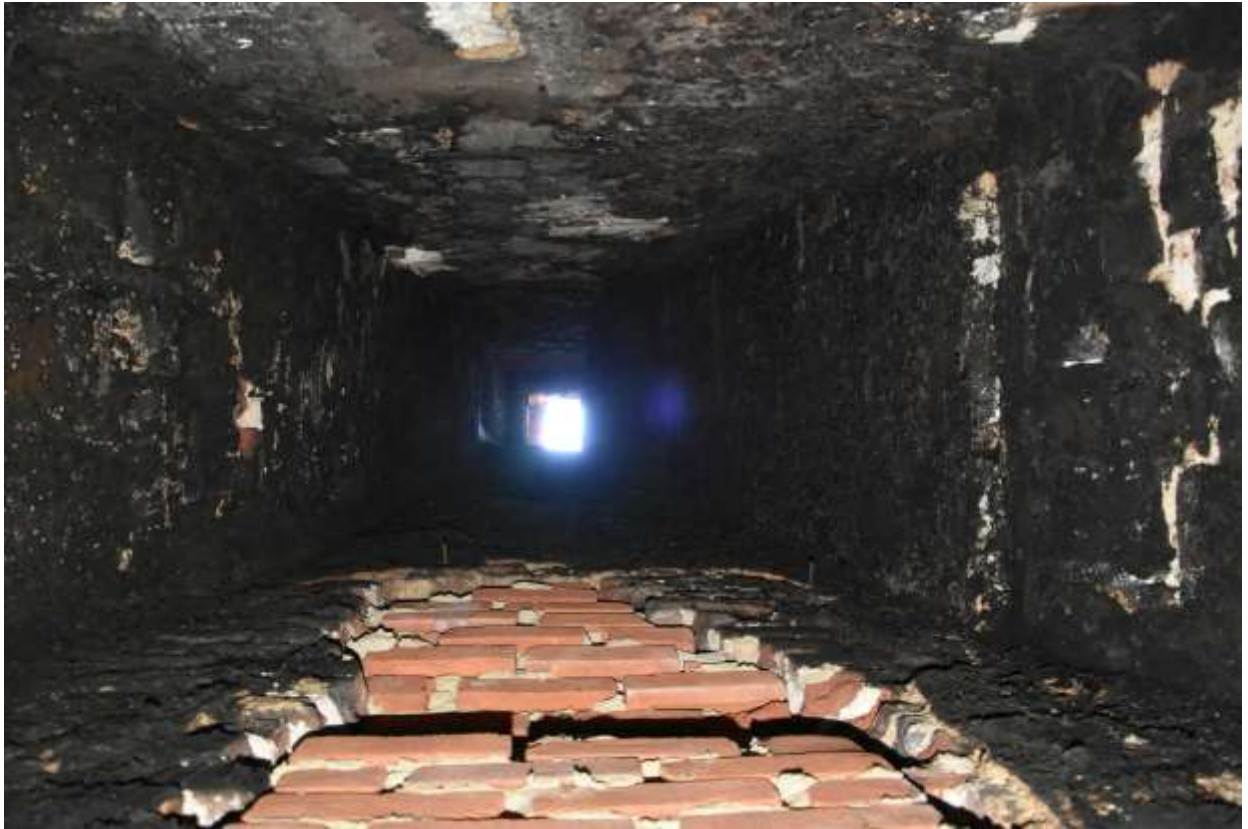
There was some indication on the internal face of the southern wall for the rebuild observed outside and described in the preceding Section. Evidence was also obtained for fairly recent (probably mid 1970s) blocking within the chimneystack, to the rear of the fireplace (*cf.* Figs.178-79).

Fig.178: Views looking straight up the southern chimney, at the base of the frame showing the recent brick blocking to the rear of the fireplace in Room F-04
