9. THE FIRST FLOOR

The impact of works on the first floor was variable, with significant evidence being recorded in the central corridor (F-02) and the Porch Chamber (F-03), both internally and on the external wall of Room F-04, and most extensively within the rear extension Room F-07.

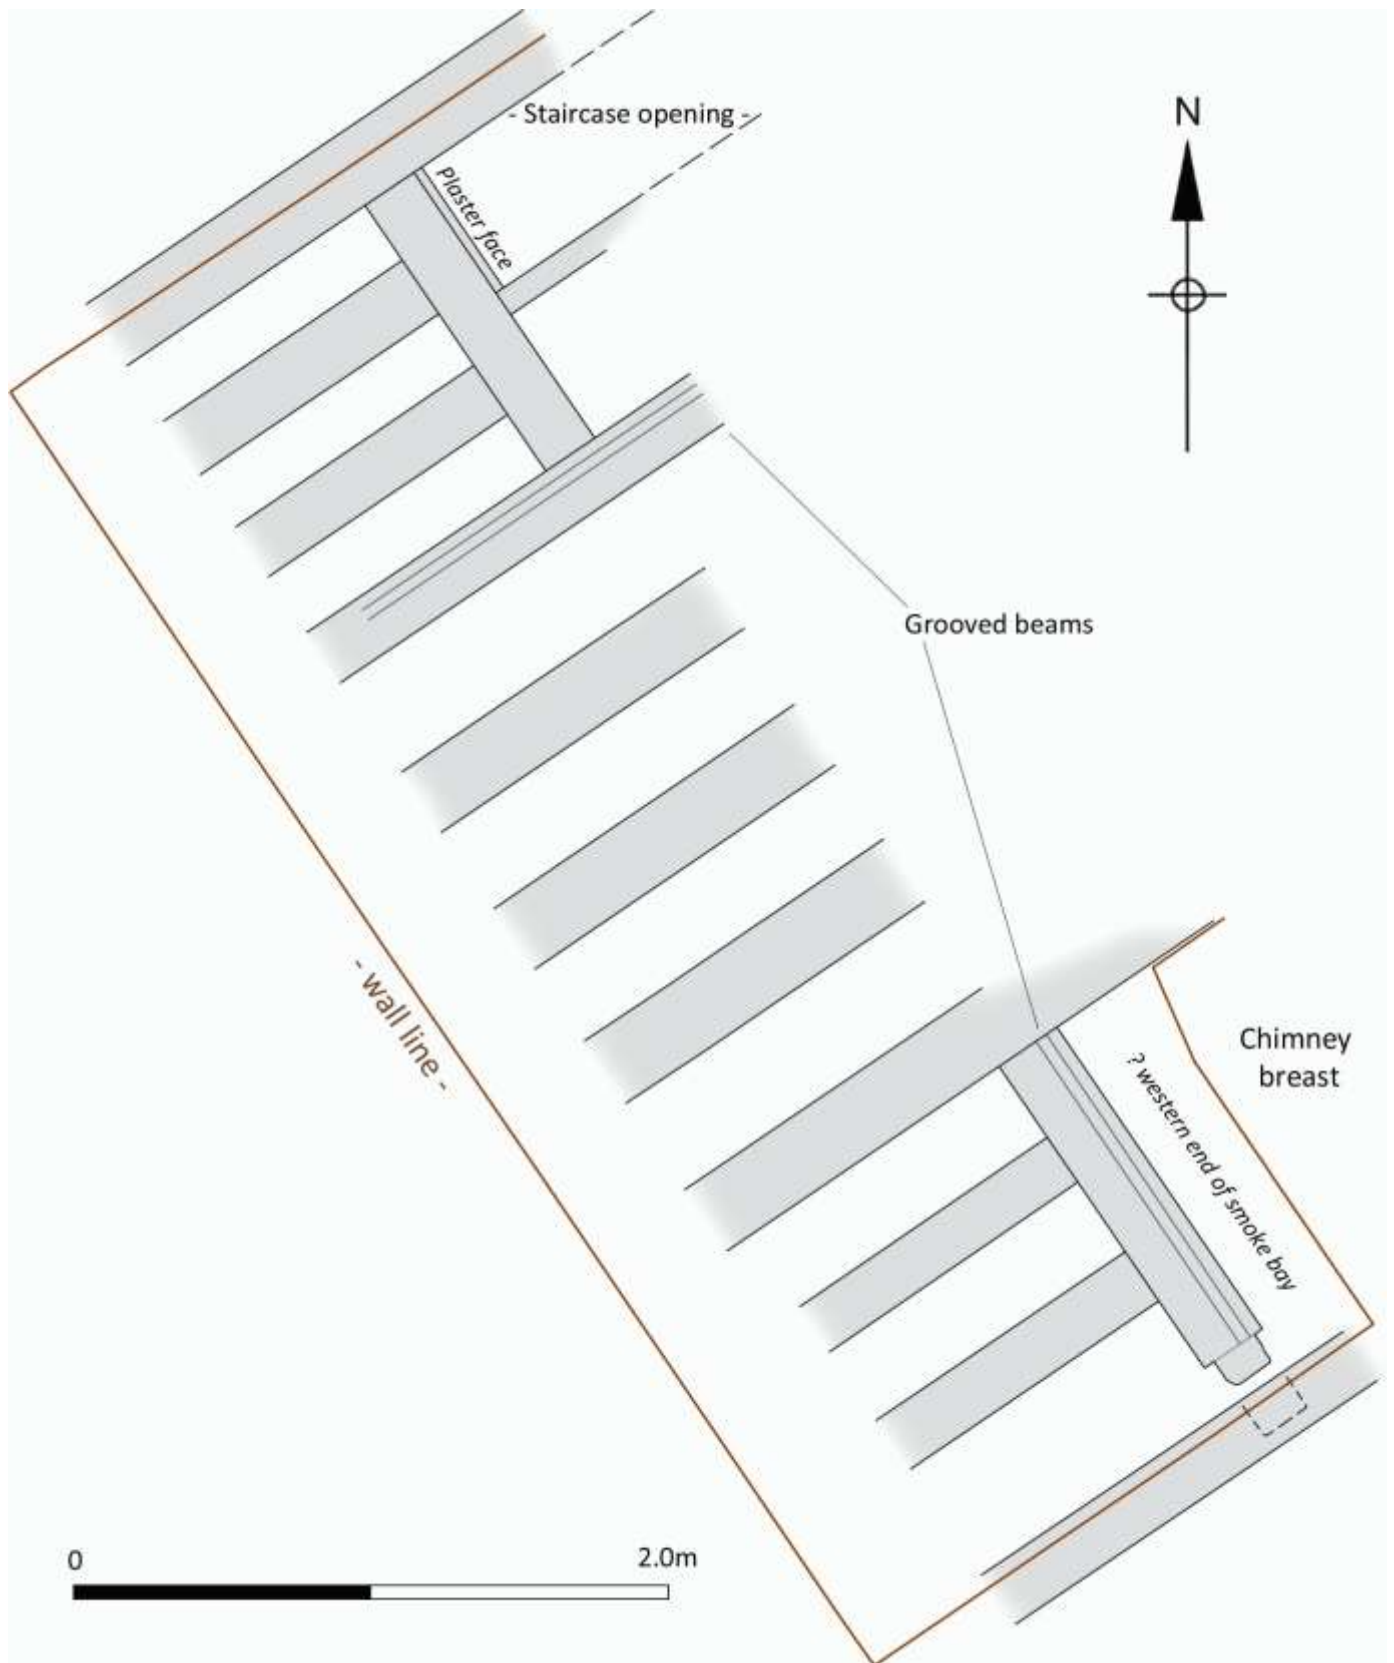
Fig.184: Room F-04 – Plan of the exposed area of the original joists, staircase opening and possible southern smoke-bay

It is assumed that this arrangement of timbers adjacent to the south wall of the building relates to an original smoke-bay, which is thought to have preceded the present chimneystack. This interpretation is given further credence by the gap – some 0.3m or more – that now exists between the trimming piece and the eastern side of the chimney stack.

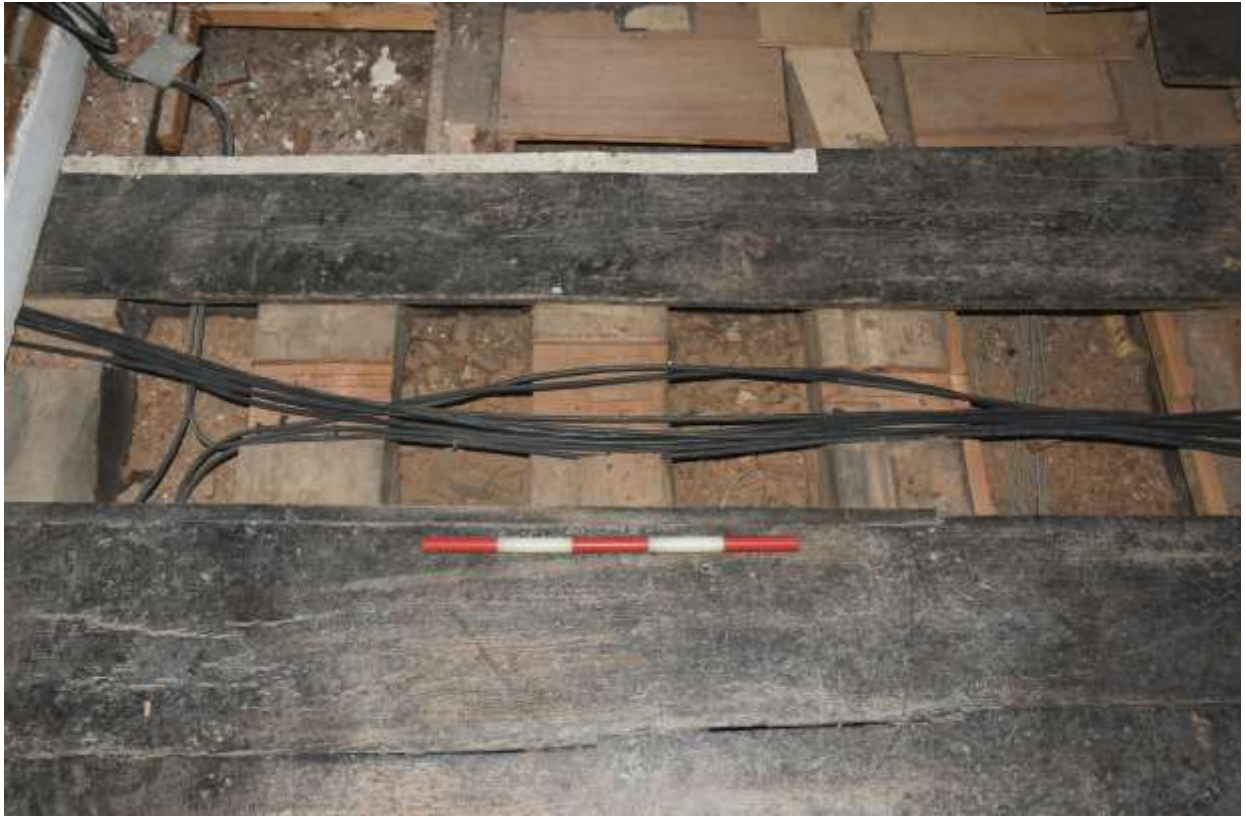
Fig.185: View from the northwestern corner of the room, with a series of joists in the foreground and the staircase opening beyond – the trimming piece at its western end below the in situ floorboard but represented by the white line (0.5m scale)

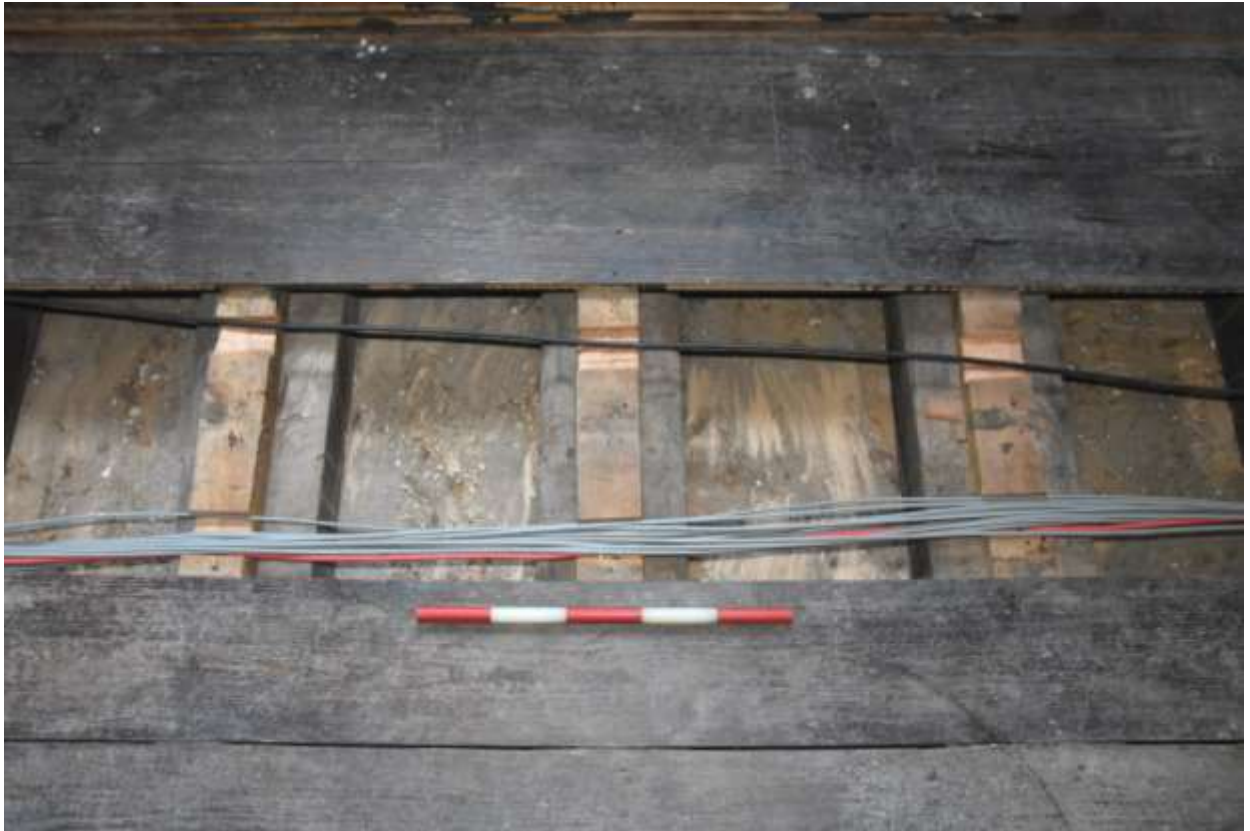
Below the window several floorboards were lifted in order to locate new services (Figs.194-95). As elsewhere this revealed that the present floor was a fairly recent reconstruction: the previous floor had been removed and narrow secondary timbers laid over the original joists.

Fig.194: *Detail of the floor construction, with floorboards supported on narrow and quite recent secondary timbers (0.5m scale)*

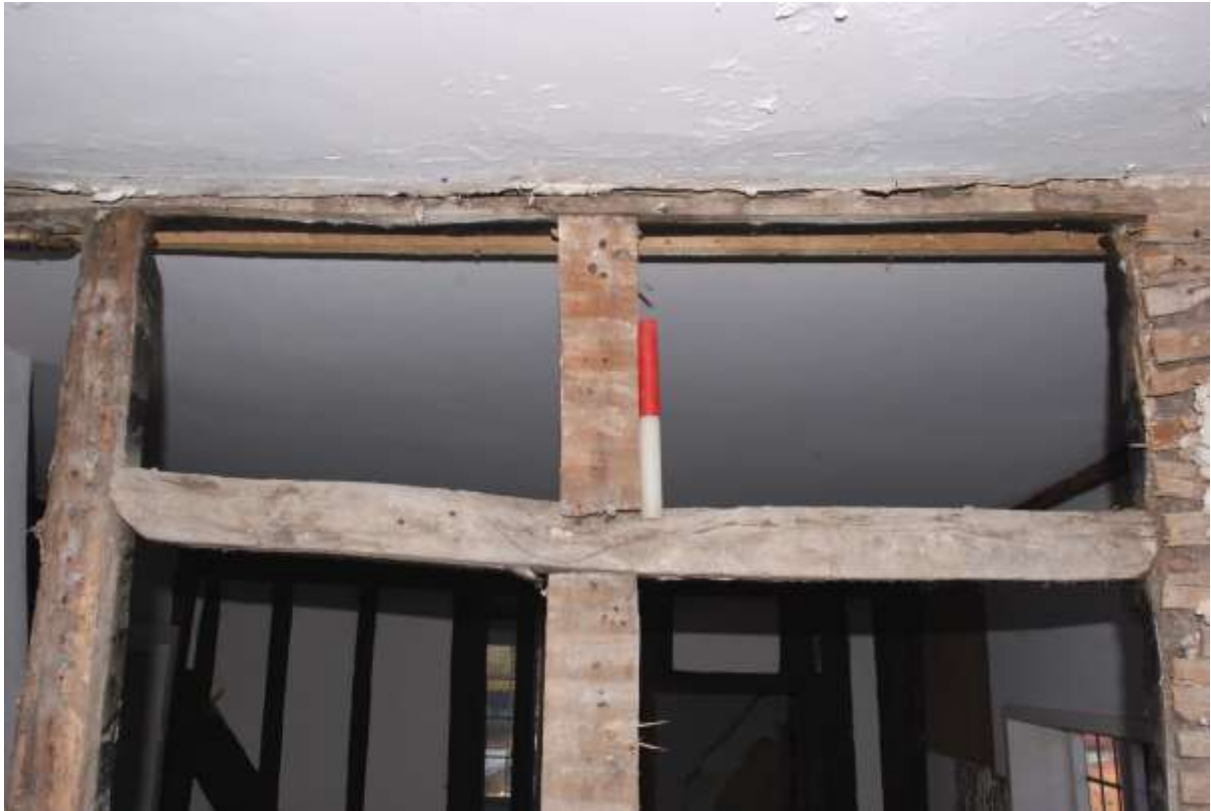
The wall is evidently later than the adjacent building, and probably formed the subdivision of an originally single room. The construction was quite rough, with several specific observations to support this conclusion:

Fig.200: *Detail of the upper part of the frame, looking approximately west from Room F-12. The structure is roughly constructed, with minimally worked or reused timber (0.2m scale)*

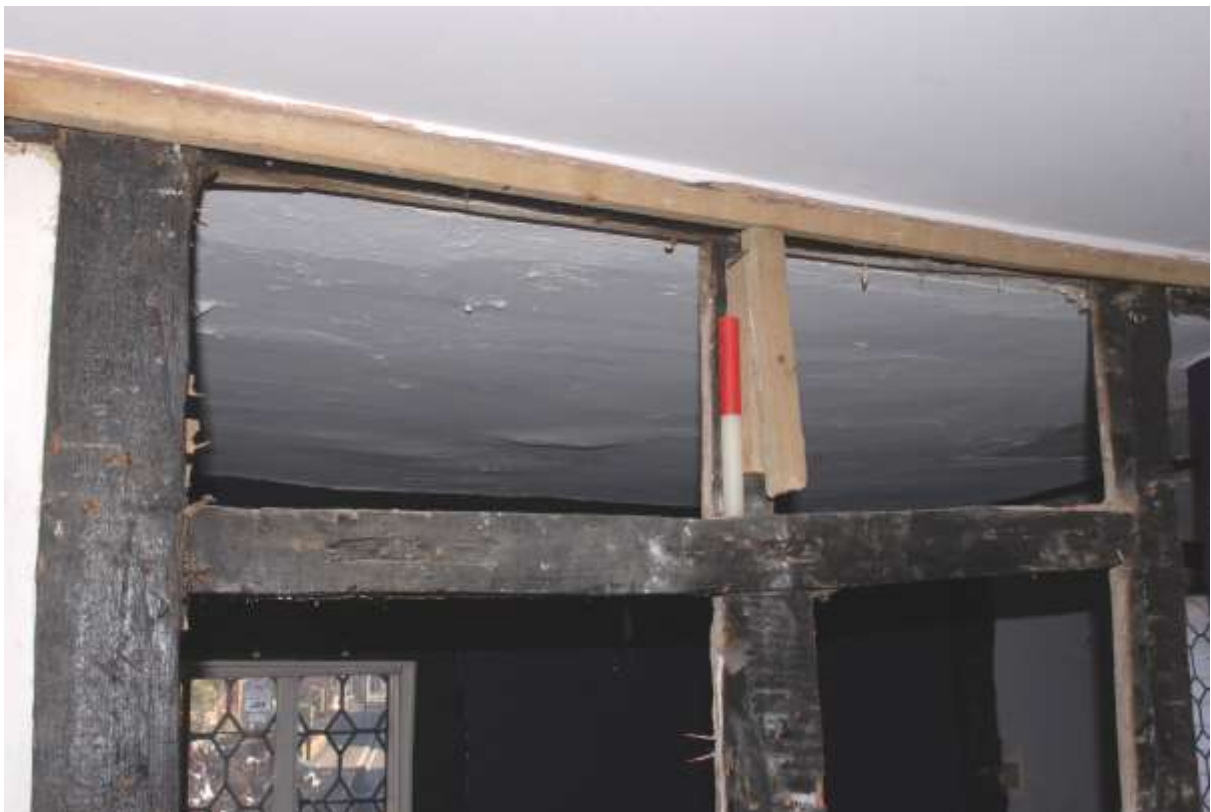
Fig.201: *As above but looking east from Room F-11. On this side the horizontal beam includes three mortices along its length, the tenons cut off flush with the surface*
