9.5 Room F-07

Room F-07 forms part of the northwestern extension otherwise represented by Rooms G-12, S-05 and the cellar (Sections 7.3, 10.4, *etc.*), and is of probable mid to later 17th century date. The principal development here comprised the creation of a new access doorway from the northern staircase/ lift extension, located towards the western end of the north wall (*cf.* Figs.207-209).

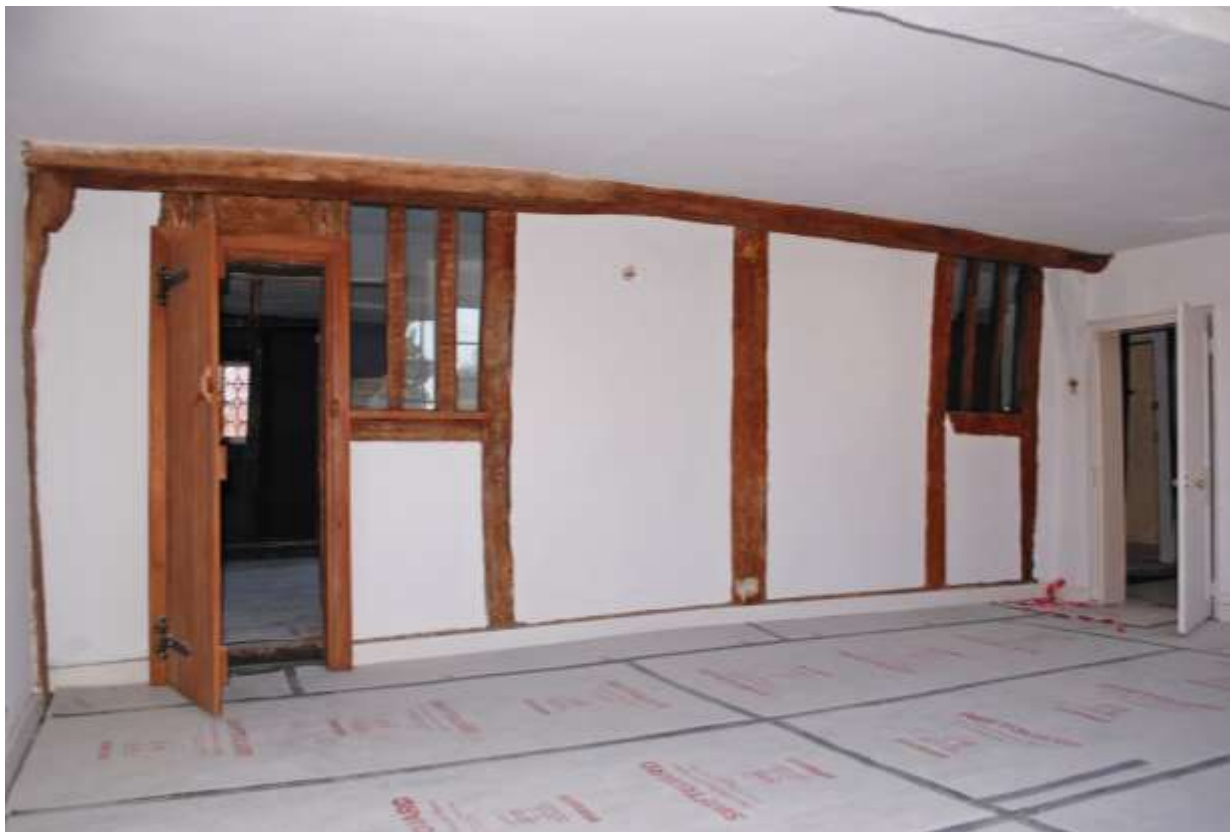
Fig.206: View towards the rear (eastern) part of Room F-07, showing timbers and windows of the original western building elevation. The doorway on the left is quite recent, and does not appear on Gravett's plan – merely the adjacent window, then blocked (Gravett 1966, Fig. 1)

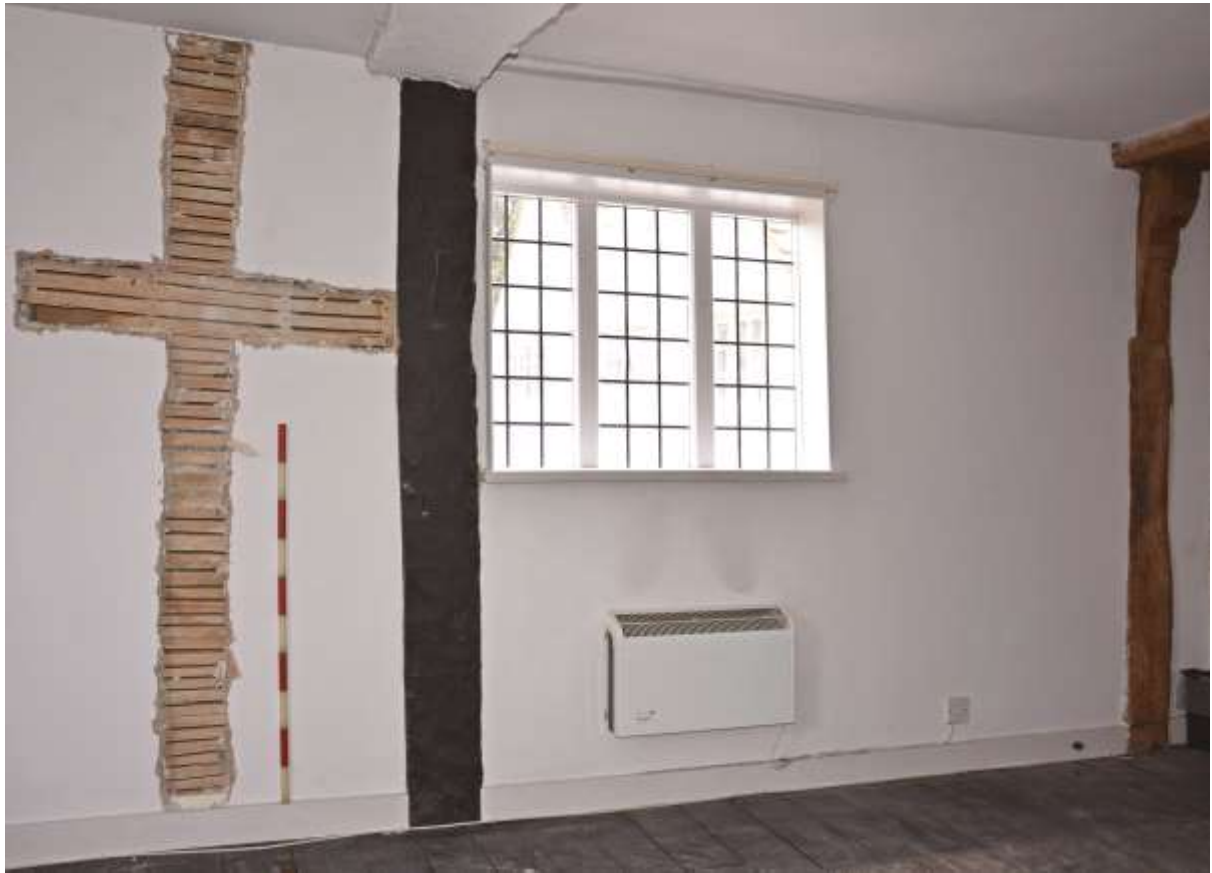
Fig.208: Preliminary investigation in March 2016 of the proposed new access through the northern wall, showing exposed laths (1m scale)

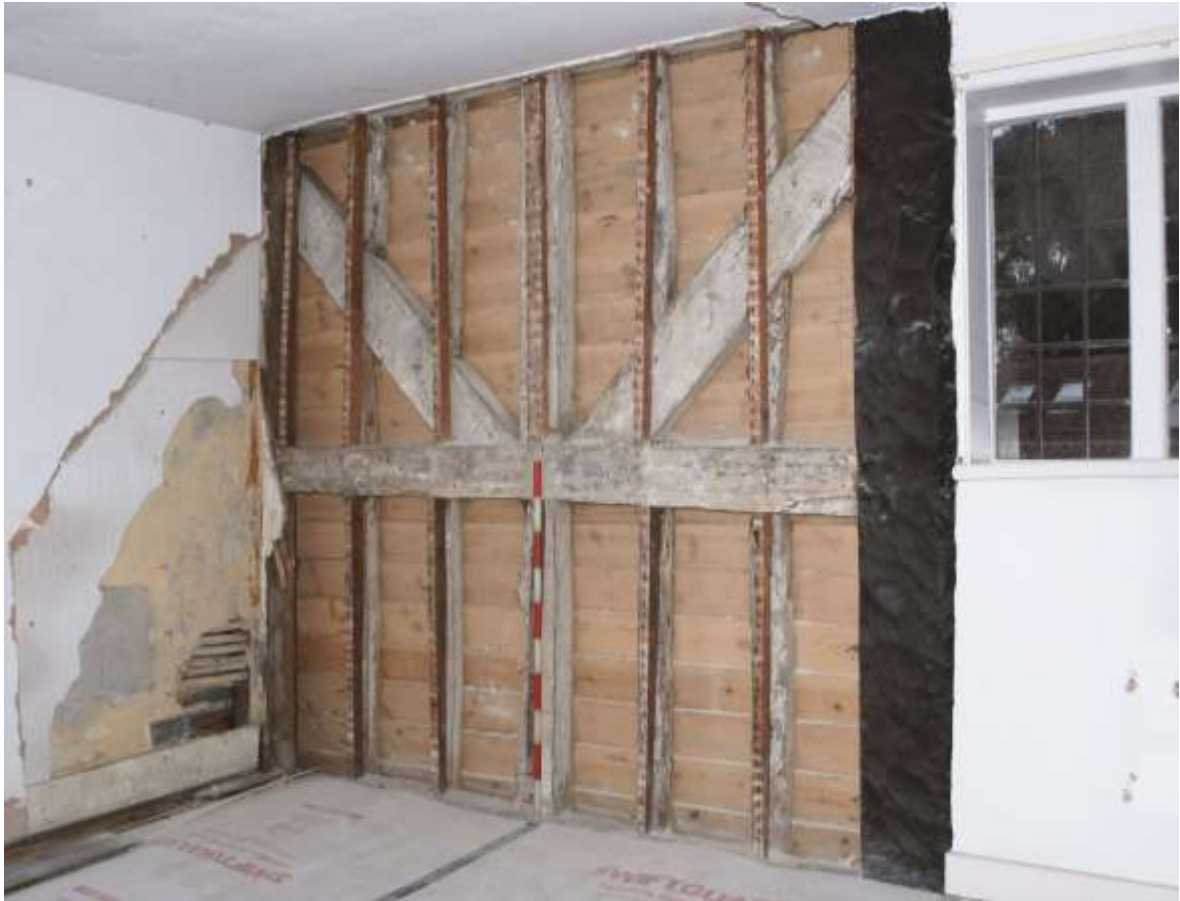
Fig.210: *Closer view of the exposed timber framing at the west end of the northern wall*

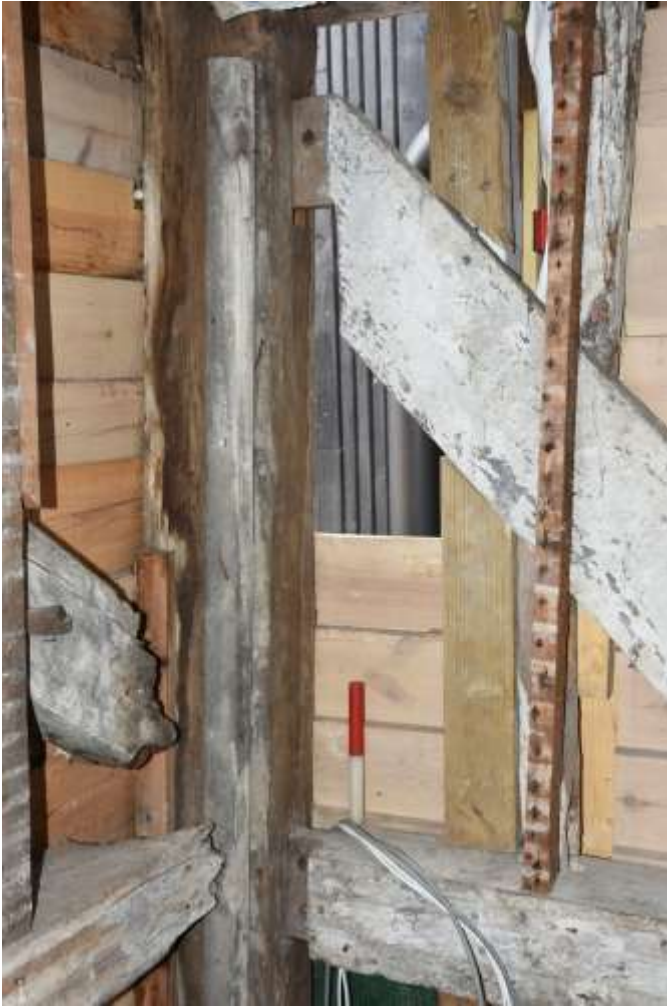
Fig.214: *The northwest corner post and adjacent timbers. The post is a replacement, without the limewash of the originals and apparently lacking mortices to correspond with the decayed beams of the west wall (lower right). See also Fig.255 (0.2m scale)*

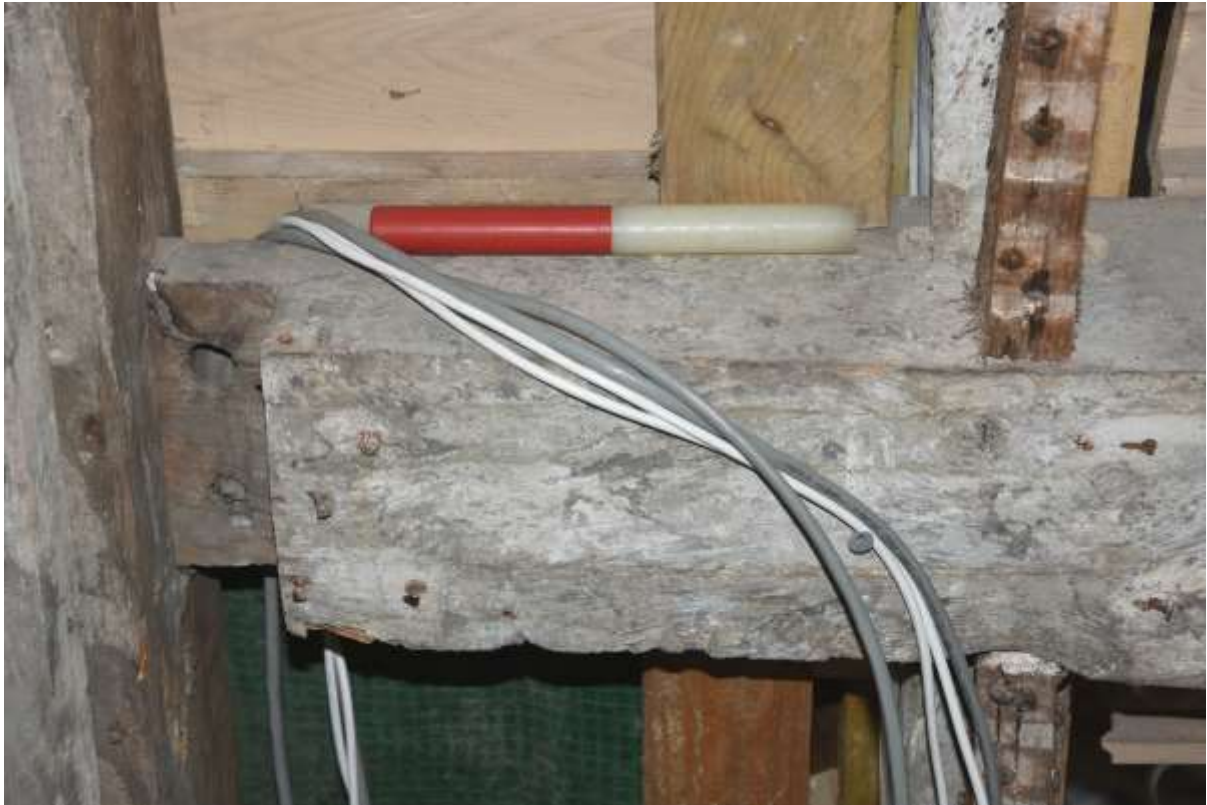
Fig.218 (above): *Mortice & tenon joint between the corner post and midrail at the western end of the north wall. Outward movement of the post has exposed about 50mm of the mortice, which (as elsewhere) was apparently not pegged into the replacement timber*

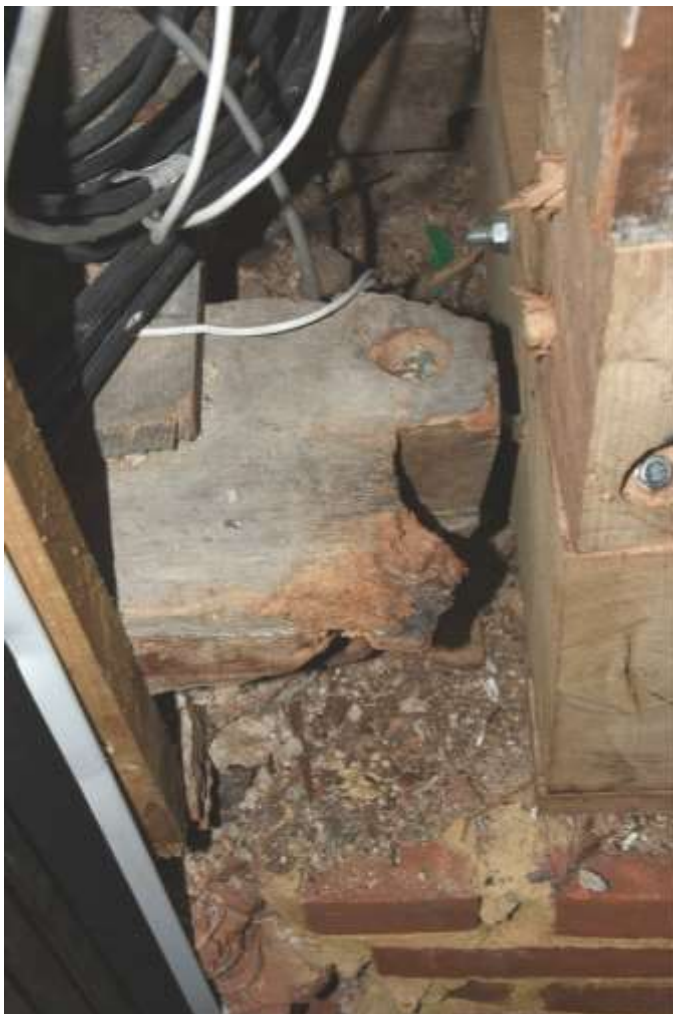
Fig.219: *Remnant of a mortice on the basal or girding beam at the western end of the north wall. The adjacent timber has already been replaced*

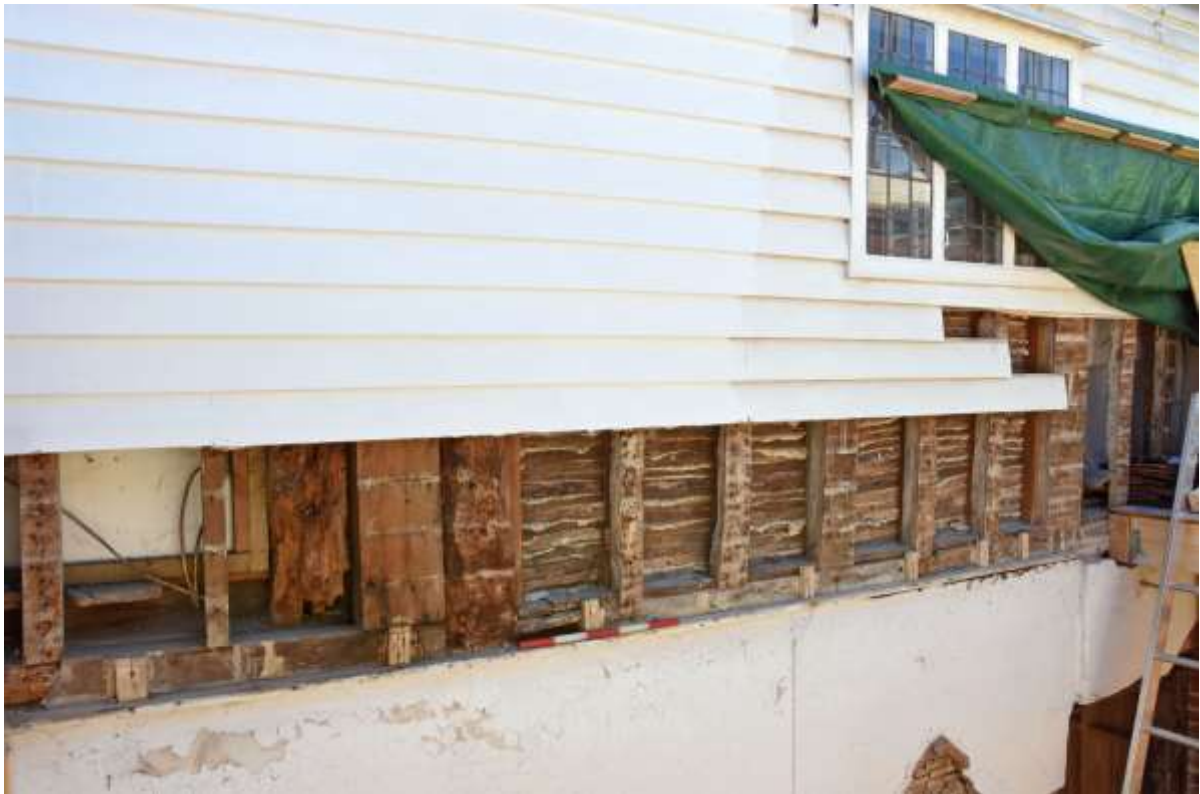
Fig.220: View of northern wall construction at first floor level after partial removal of weatherboarding. The new doorway is to the far right of the frame

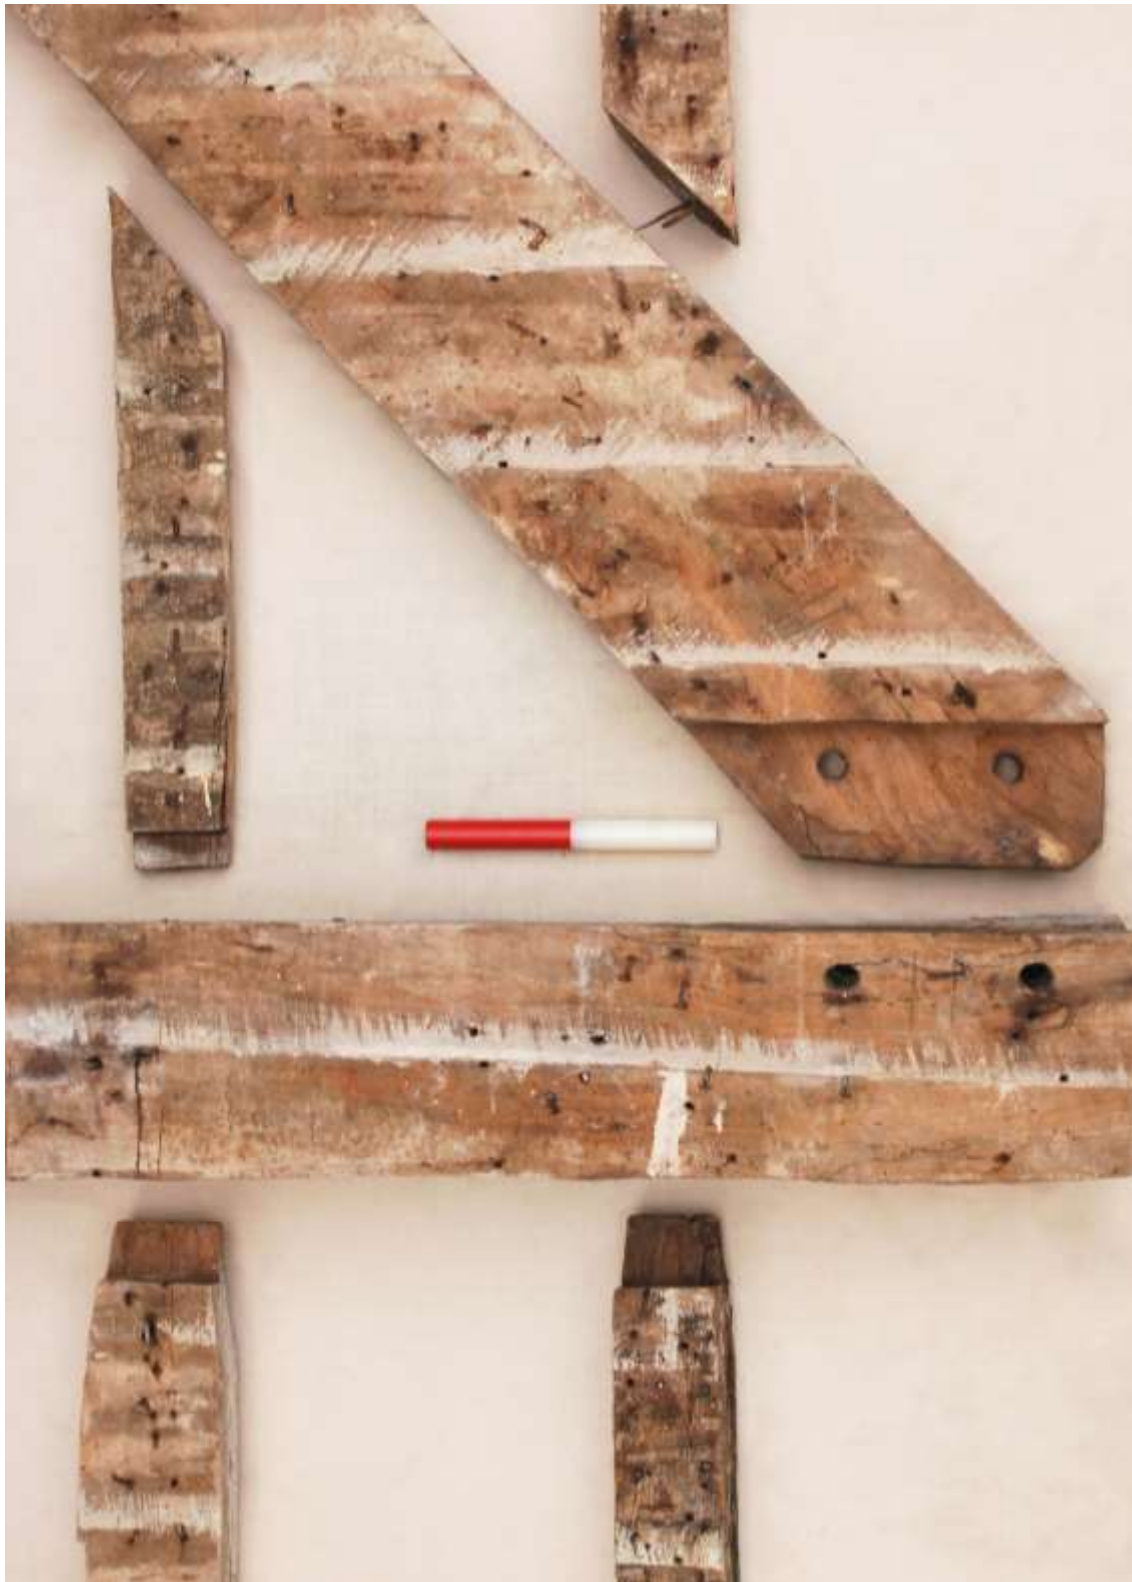
Fig.222: Exploded view of the external (north-facing) side of the removed timbers (0.2m scale)

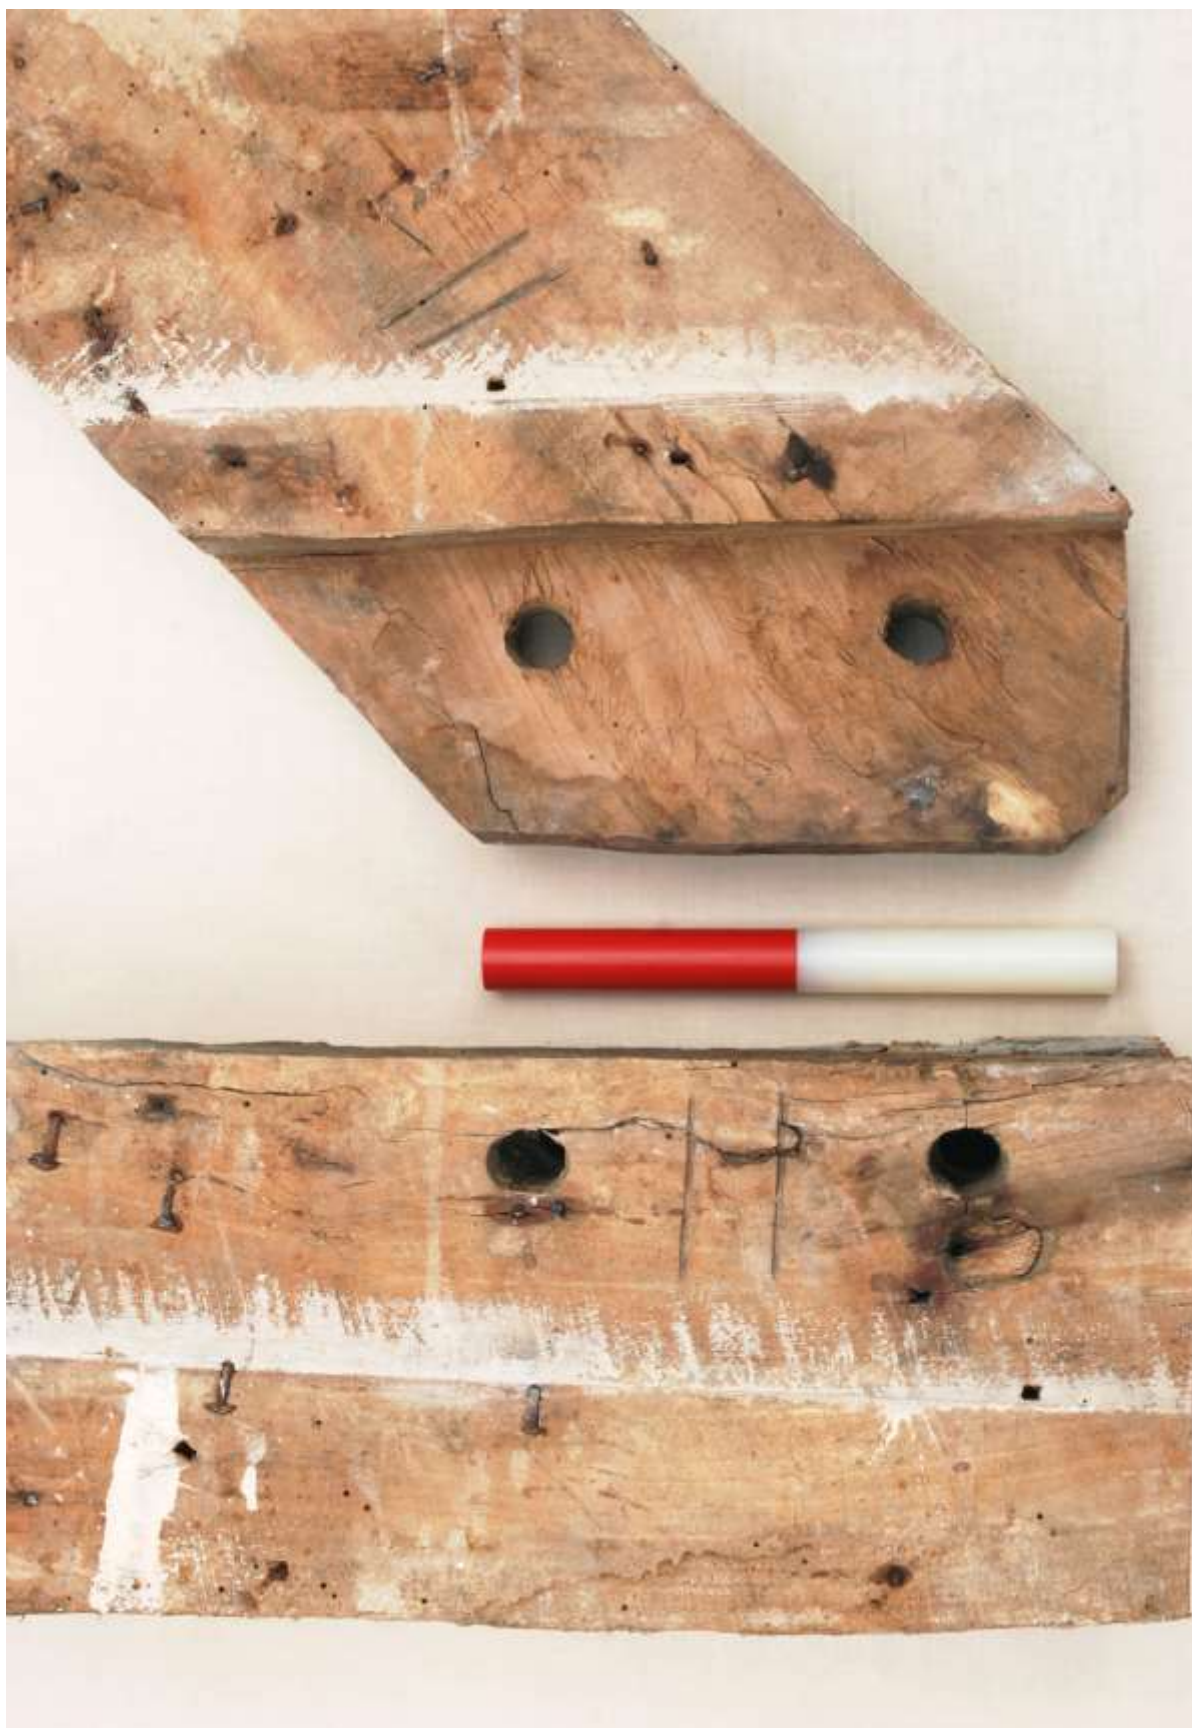
Fig.223: Detail of the mortice & tenon joint between the midrail and base of the down brace, also showing carpenters' marks (0.2m scale). The thickness of the down brace (front to back) is 67mm to 90mm – greatest in the centre – and that of the midrail 122mm to 135mm

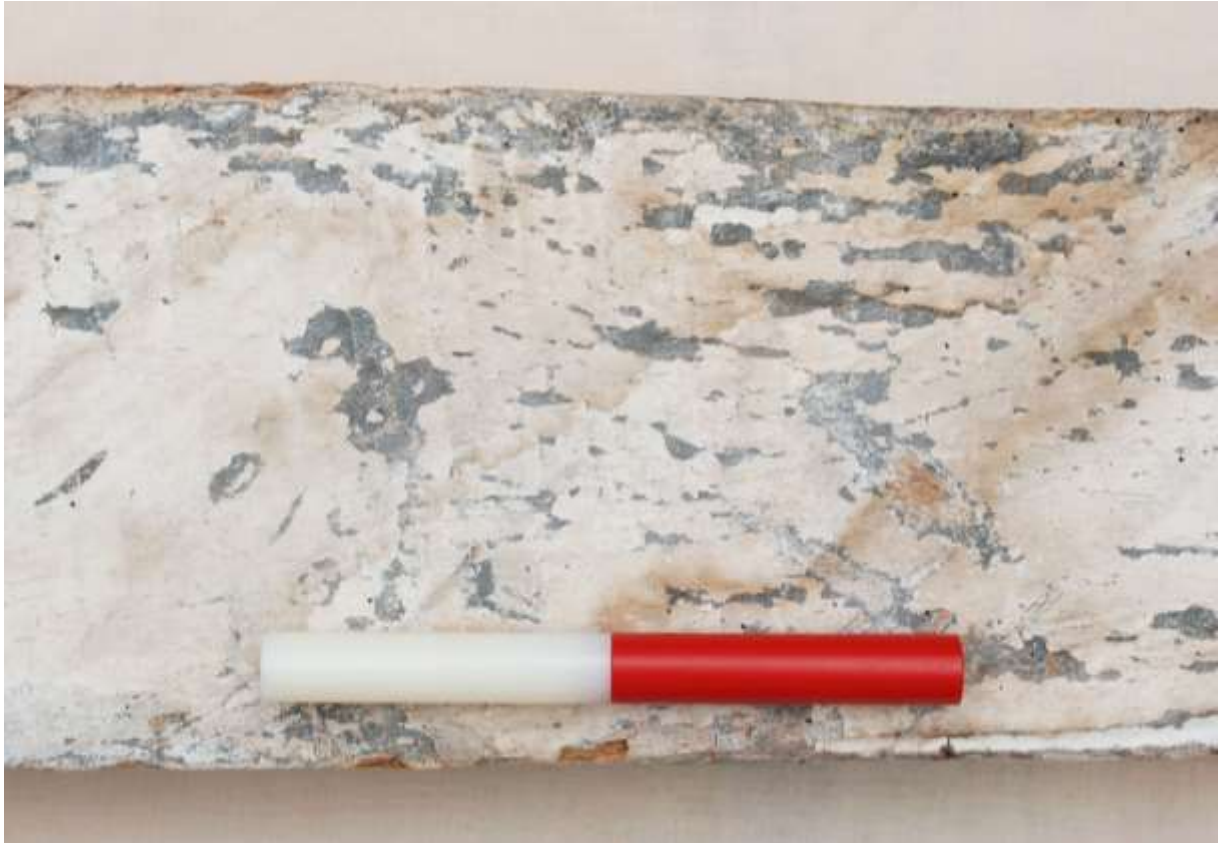
Fig.225: Detail of the internal face of the down brace. There appear to be three coats of paint /limewash on the original timbers – white, mid greenish-grey, and finally another white coat

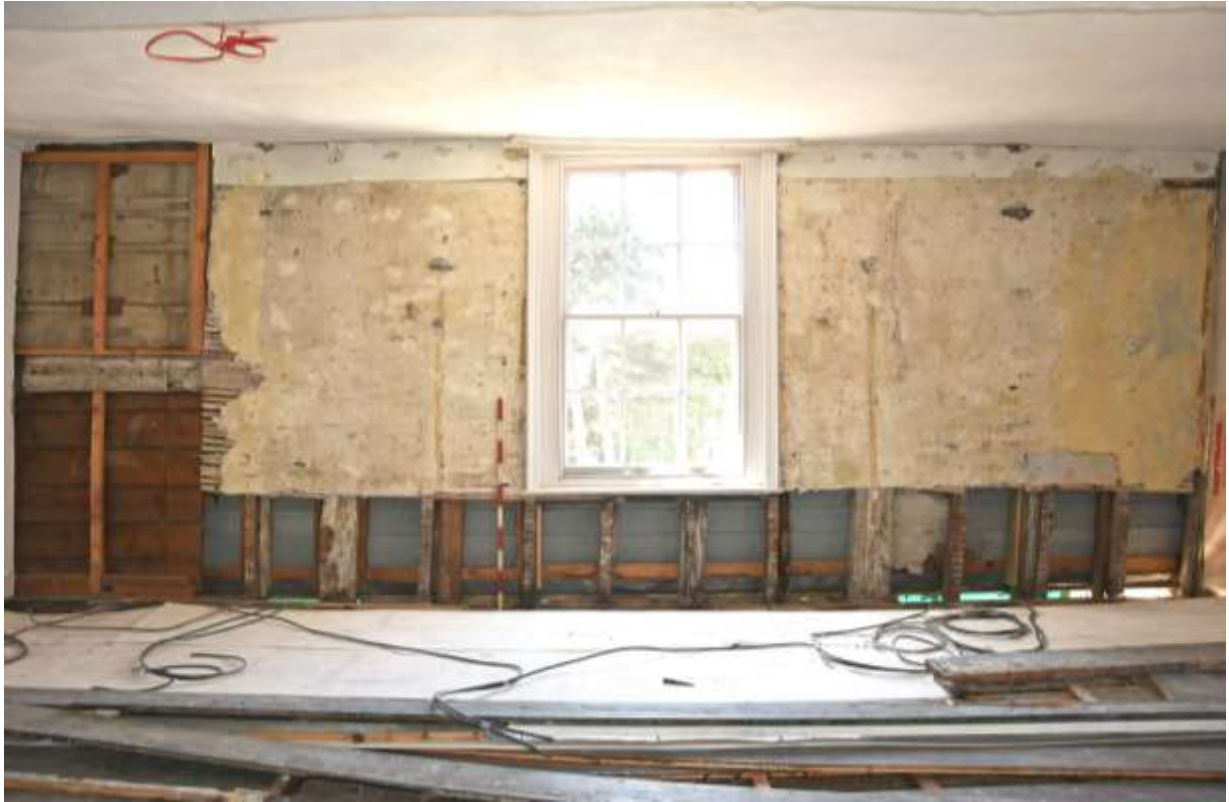
Fig.226: View of the western wall after removal of the lower section of lath and plaster (1.0m scale)

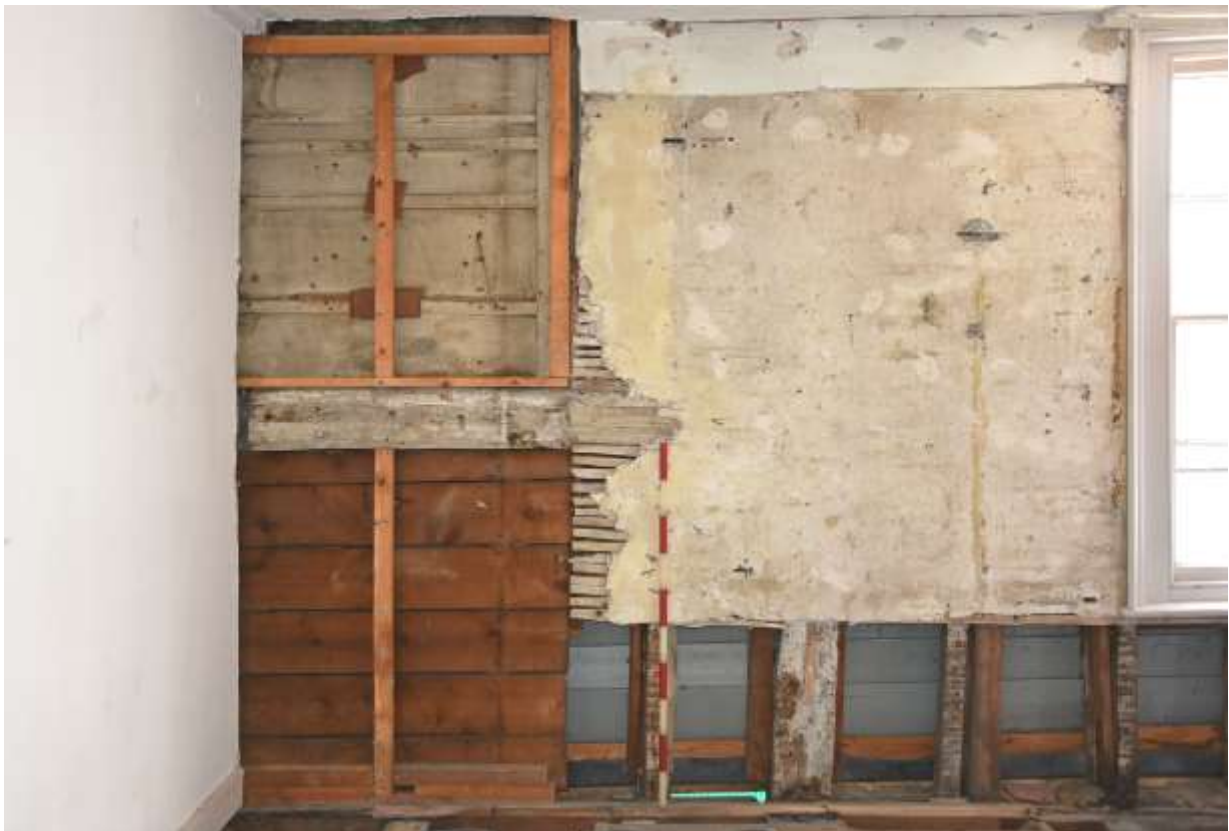
Fig.227: The southern part of the wall. The boarded section in the corner derives from a 19th century corner cupboard that has removed all the lath & plaster (Gravett 1966, Fig.1)

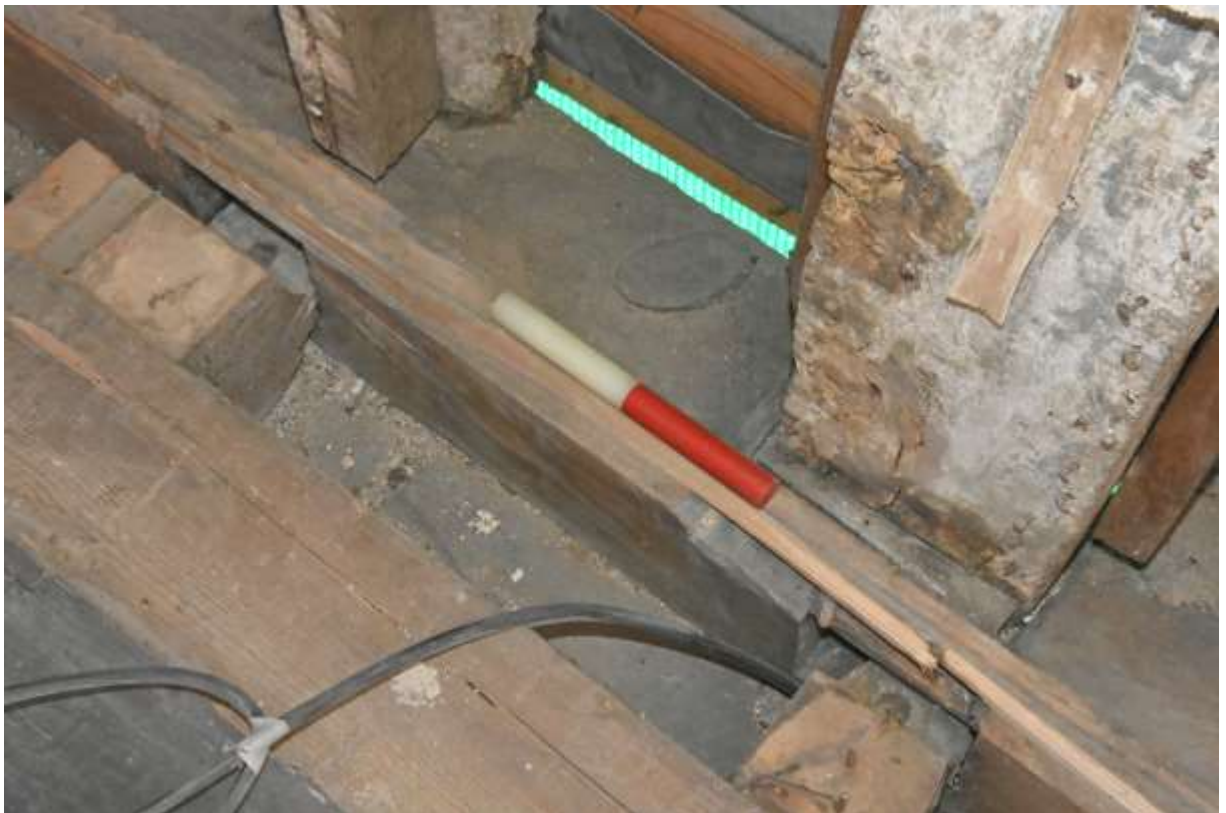
- Between the studs of the western wall and underlying girding beam there were a series of small wedges and fillets *c* 5mm to 25mm in thickness (see Figs.231, 239, 260, 263, *etc.*). None of the timbers had been properly secured into the beam.

Fig.231: An oblique view of the above joints. The southern principal stud (foreground) sits in a shallow cut-out in the replacement girding beam, whilst the stud to the rear has a small (<10mm) wedge below

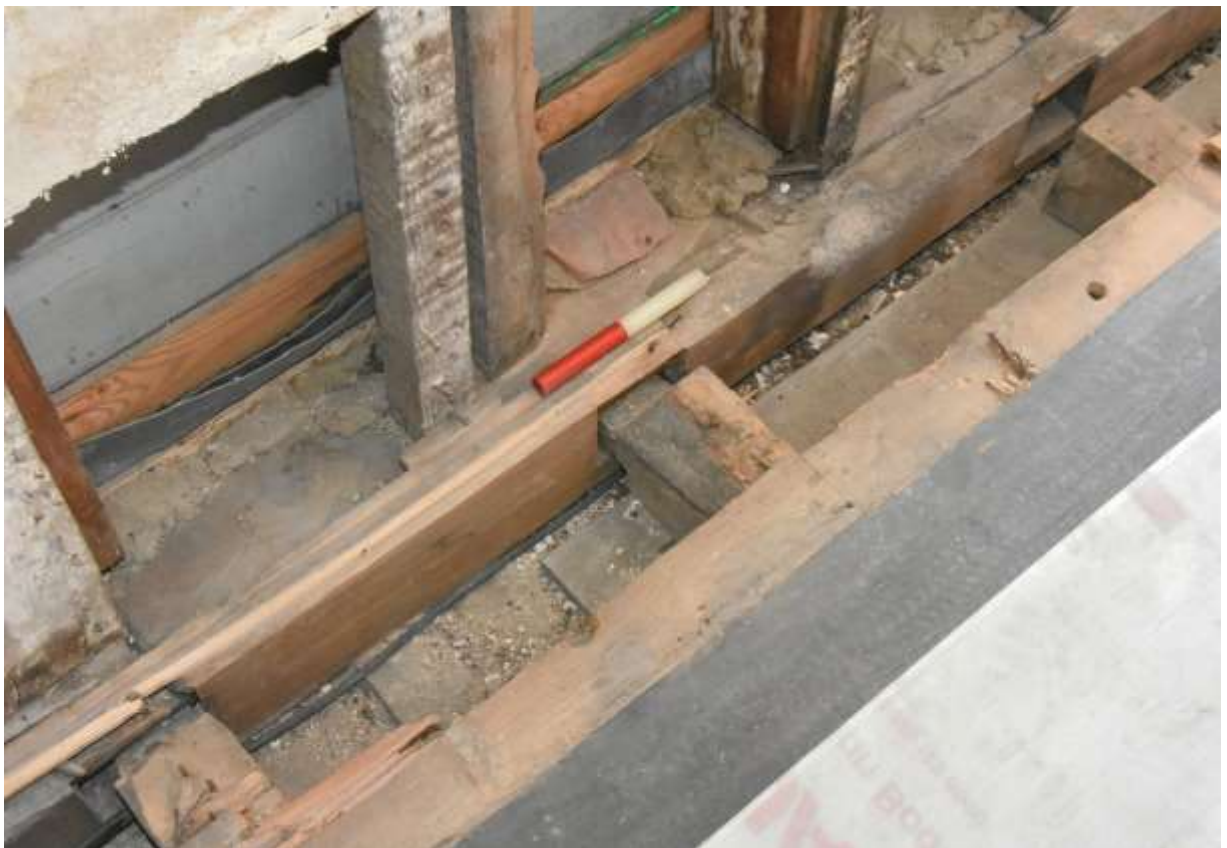
Fig.233: *An oblique view of the above. The end of the joist at top right has apparently been sawn off, leaving a c 50mm gap between it and the girder beam, whilst the tenon of the central joist is the only one definitely lacking a peghole (0.2m scale)*

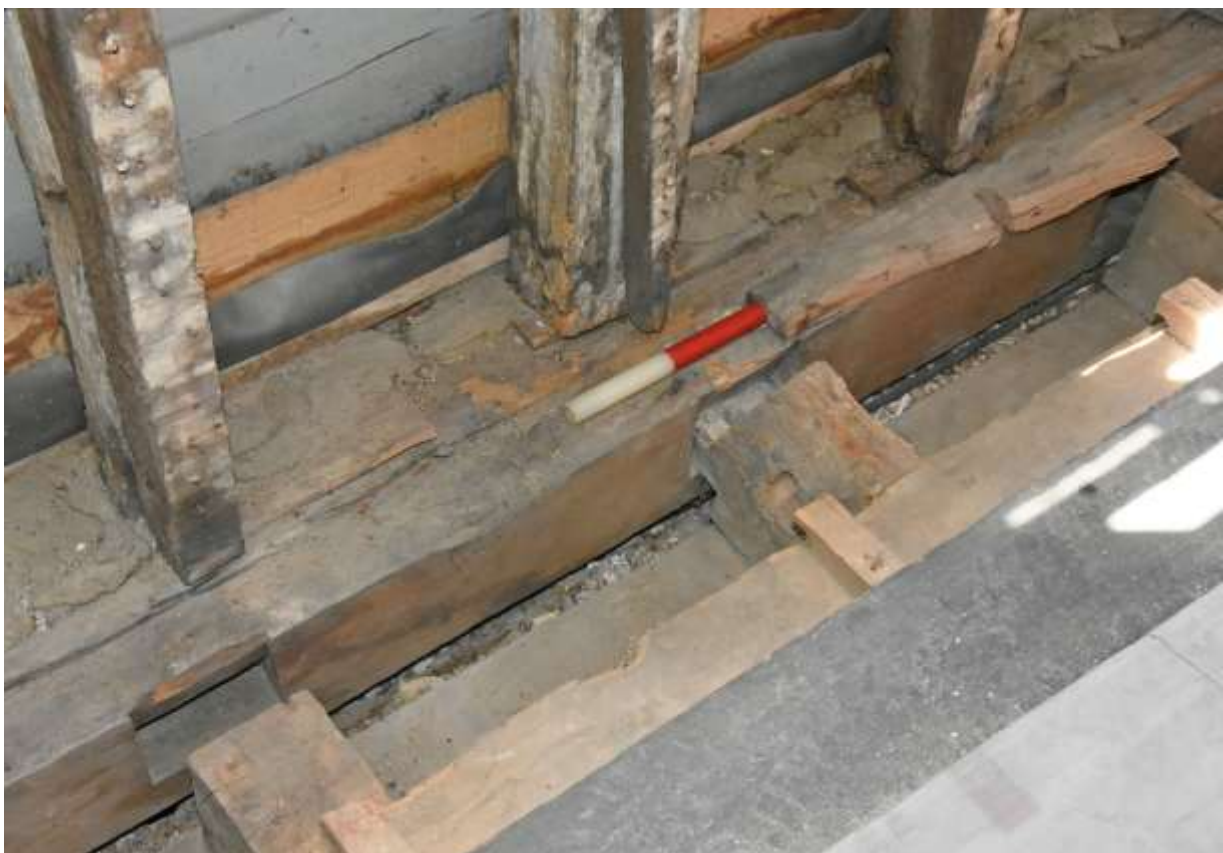
Fig.235: *Oblique view of the above, with the truncated joist shown in Fig.233 in the bottom left foreground. The central and left-hand studs are limewashed and may be original; all three studs also sit on fillets or wedges (c 15 to 25mm) securing their junction with the girder beam*

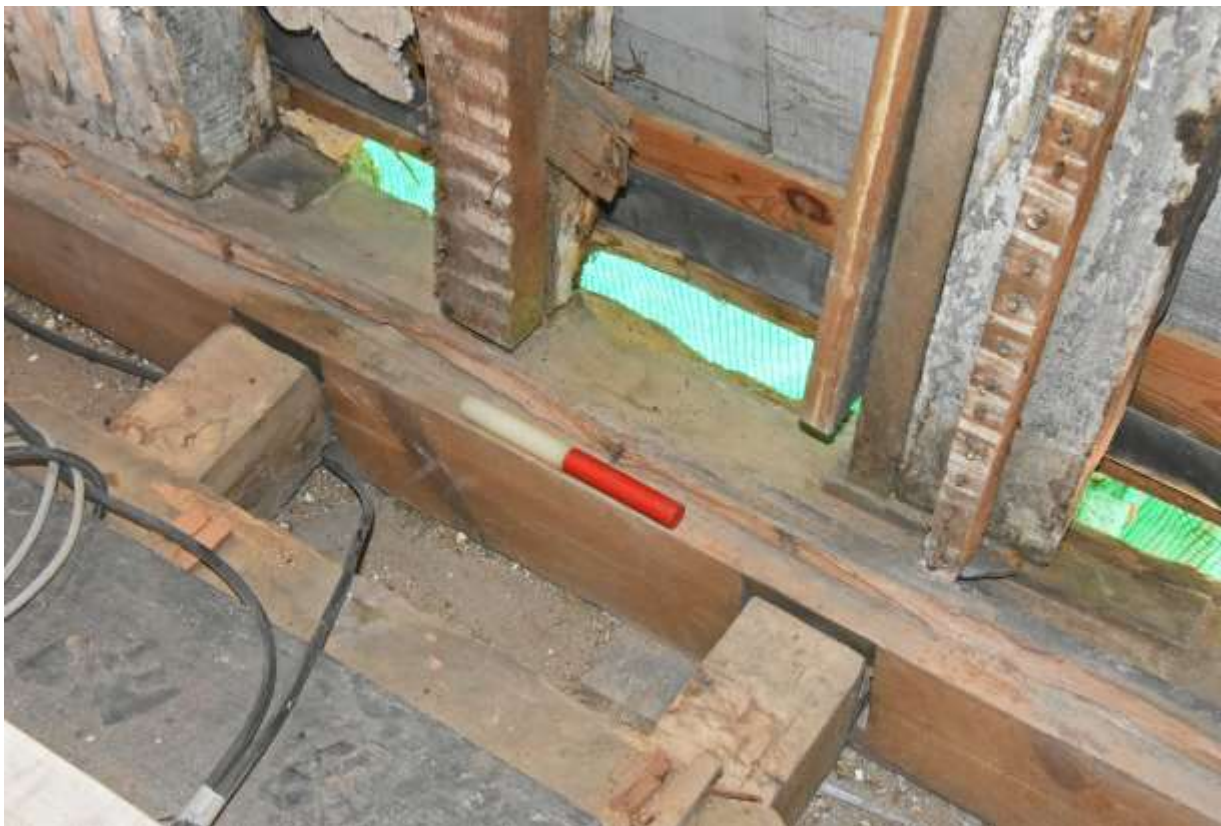
Fig.239: An oblique view of the centre and right-hand joists in Fig.238. All three studs in the upper part of the photo have thin (c 5 to 10mm) wooden fillets or wedges at the base to secure their junction with the girding beam

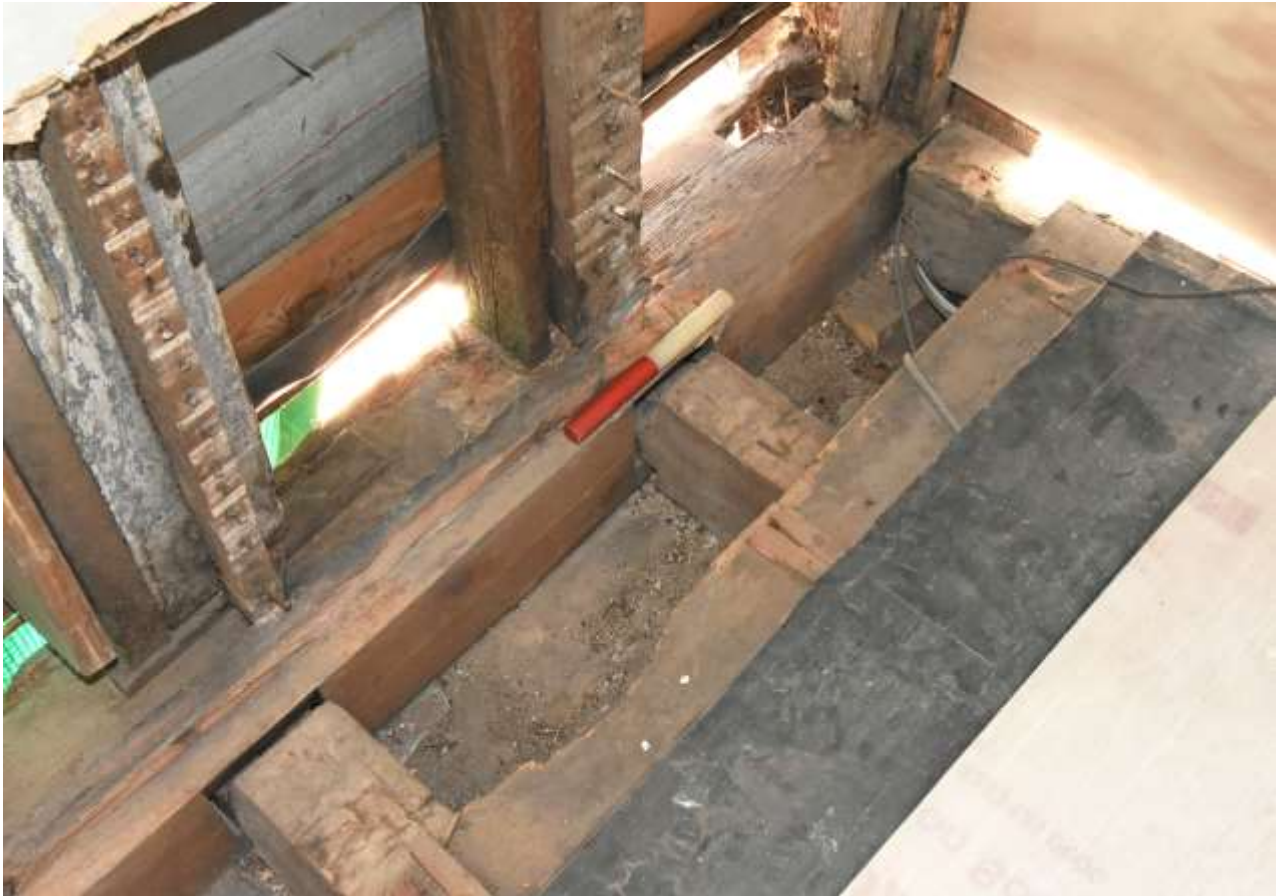
The framing of the western wall was less complete or original than that to the north, and had been subject to considerable decay and consequent repair – much of it of a rather *ad hoc* nature. This had also led to some structural movement, in particular a marked outward lean towards the western end of the north wall. The western wall as a whole had also moved slightly outwards, by *c* 20mm to 30mm along the base and by about 55mm at the upper level of the north end, exposing the adjacent joints.

Fig.240: *The northern end of the girding beam plus the corner post at top right. The outward movement of the beam here is about 20mm, once again exposing tenons and pegholes at the ends of the joists (0.2m scale)*

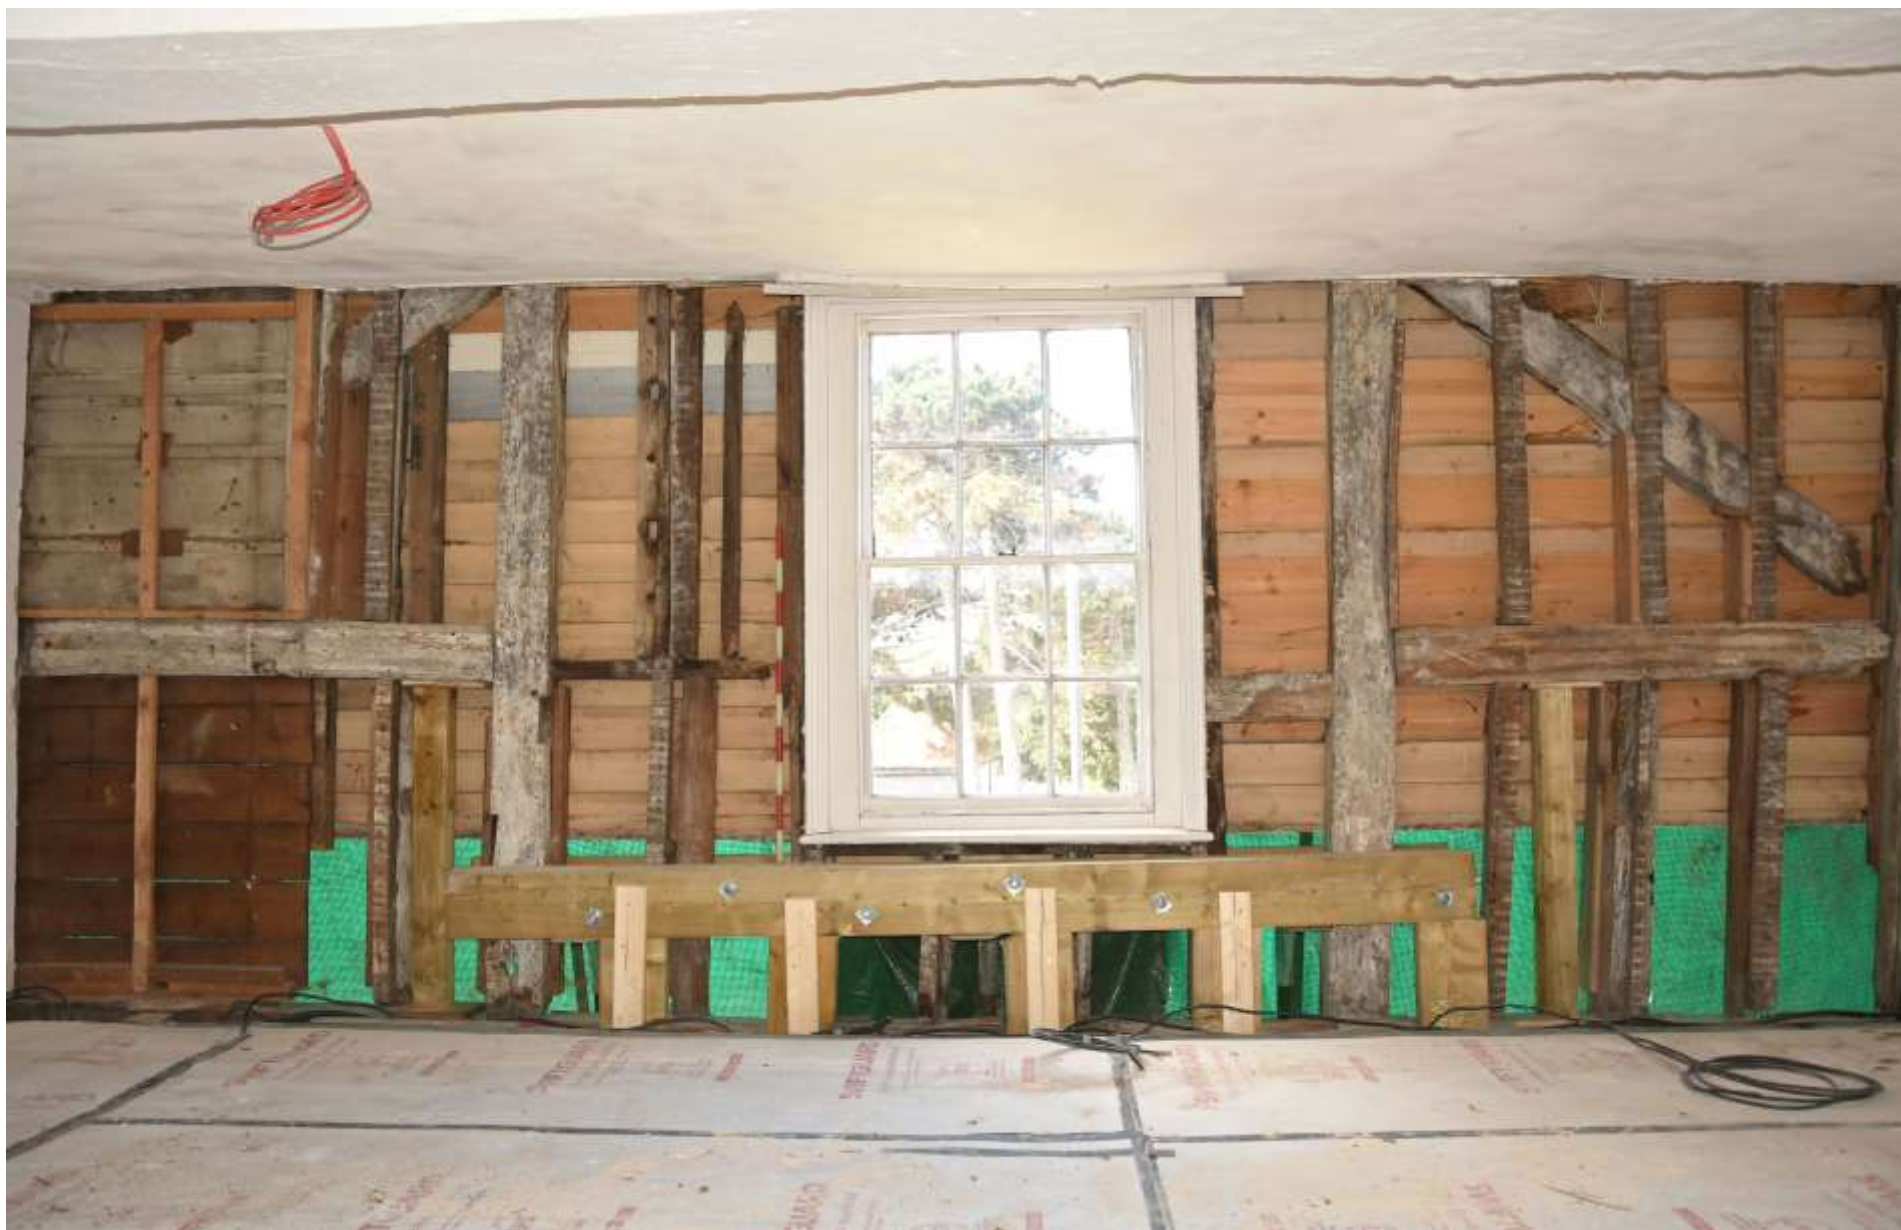
Fig.241: The timber frame of the western wall after stripping of the secondary lath & plaster, with temporary stabilising timbers below the window
