9.5 Room F-07

Room F-07 forms part of the northwestern extension otherwise represented by Rooms G-12, S-05 and the cellar (Sections 7.3, 10.4, *etc.*), and is of probable mid to later 17th century date. The principal development here comprised the creation of a new access doorway from the northern staircase/ lift extension, located towards the western end of the north wall (*cf.* Figs.207-209).

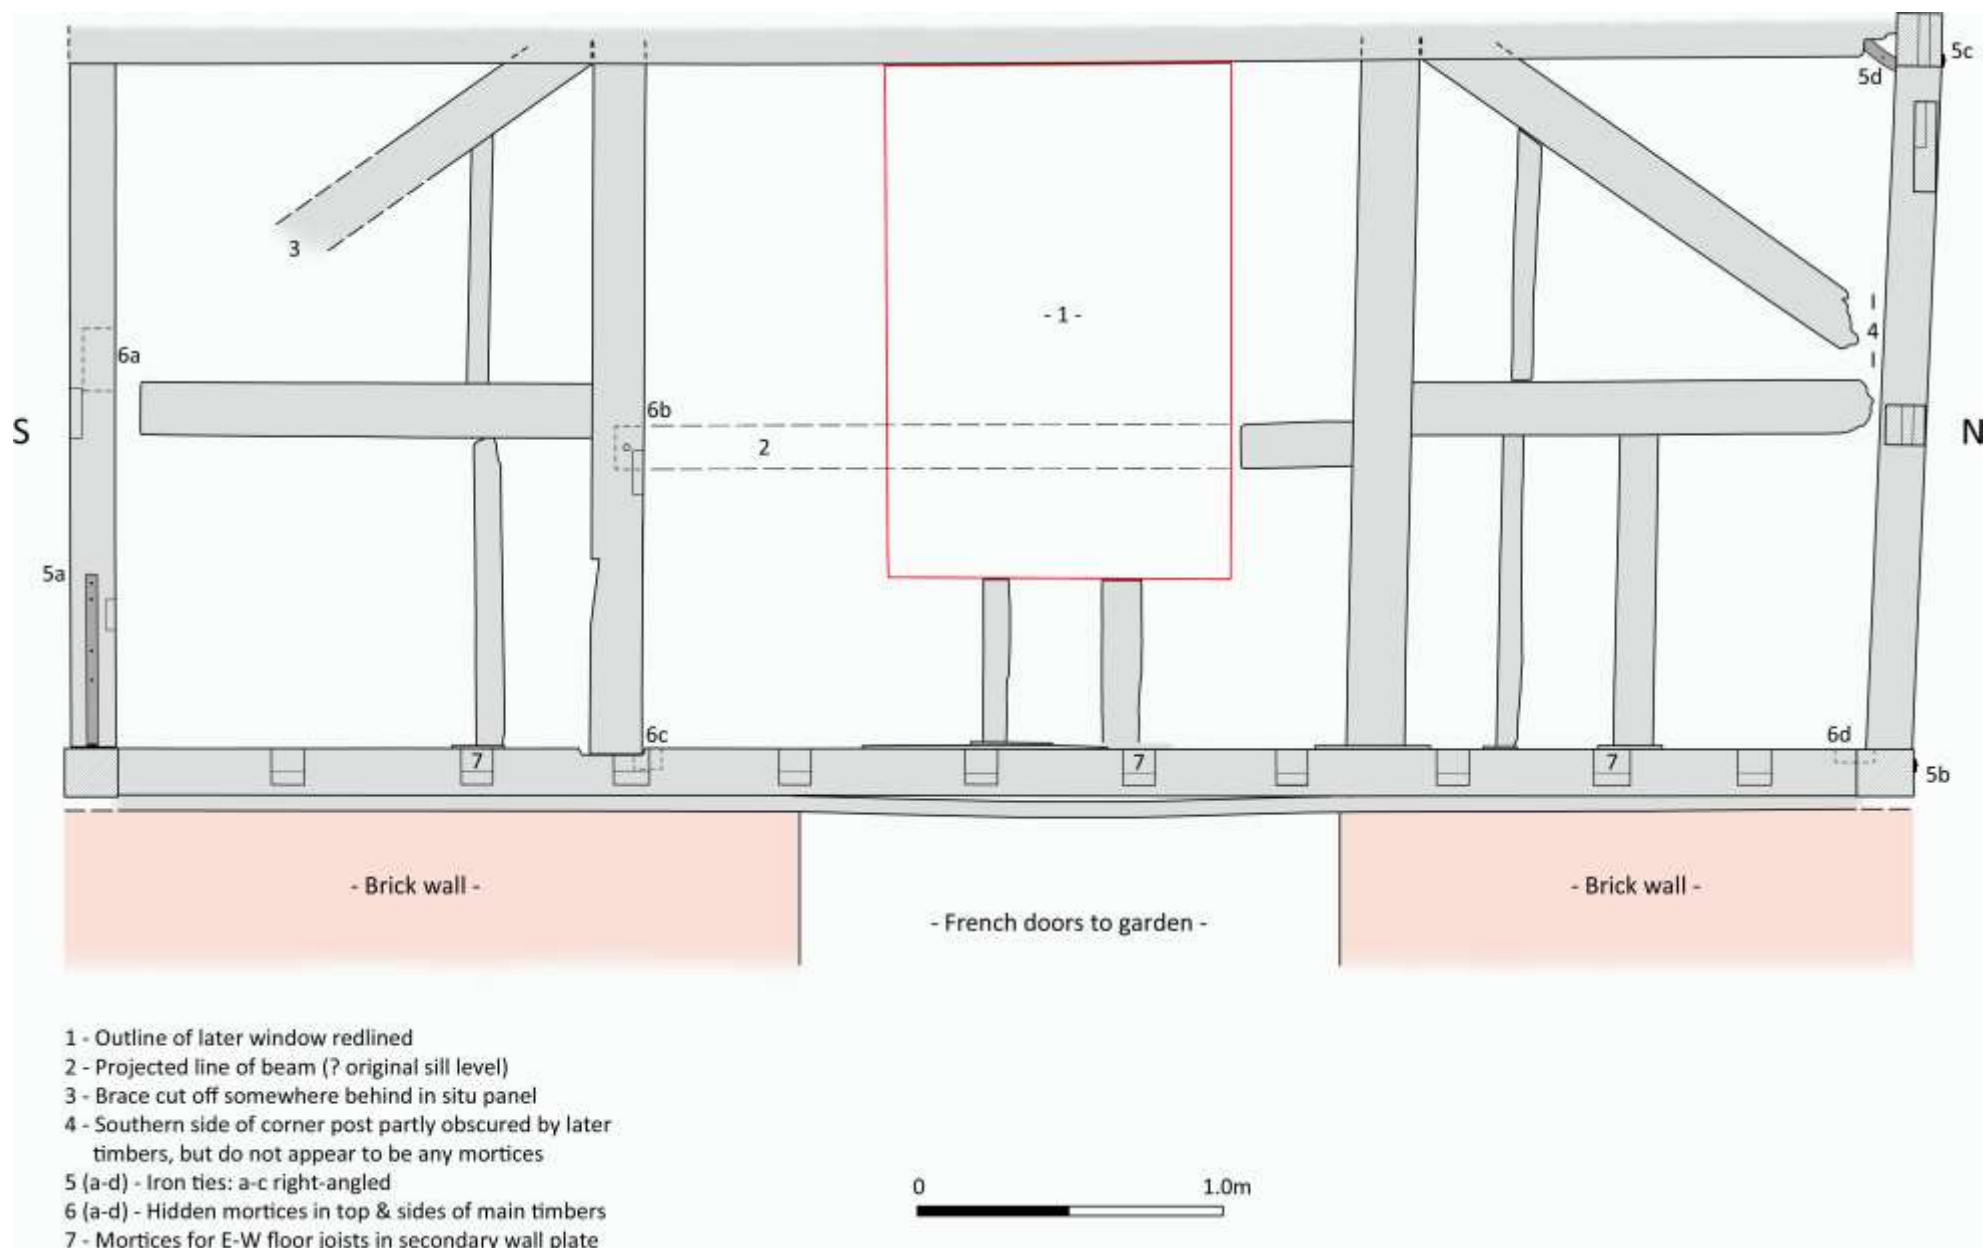
The most obvious evidence for repair was the replacement of the girding beam that ran across the full width of the room – some 6m – although this too was now in poor condition and required replacement. The lower sections of the corner posts at both ends also had to be replaced – the southern post an original element of the framing, the northern post already replaced once.

Fig.242: A simplified elevation of the western wall, showing the surviving original timbers (with limewash covering) and principal elements of repair – the basal or girding beam and the northern corner post

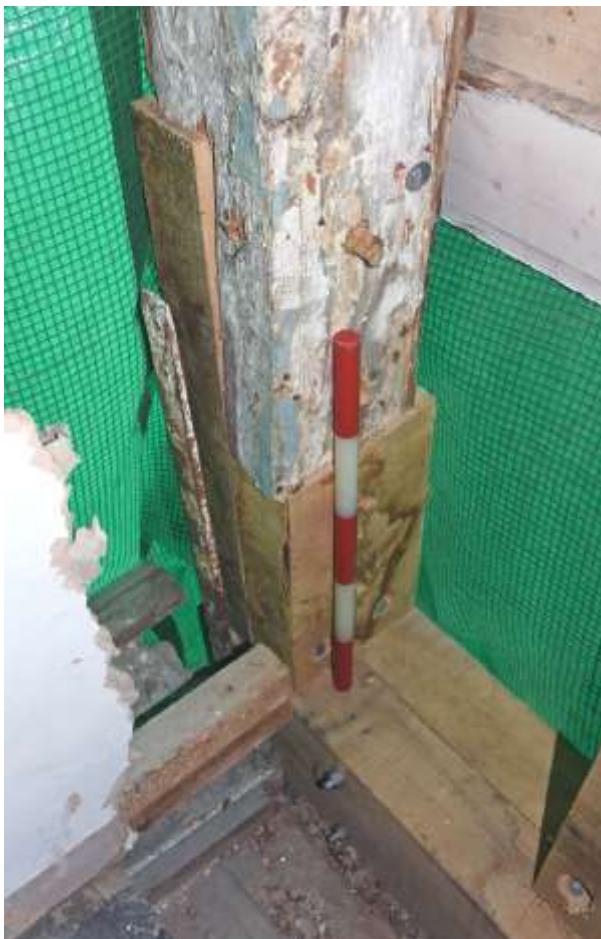
Fig.246: *Detail of the original southwestern corner post, after replacement of the lower section and adjacent beam. The vertical iron strap previously used to secure this to the south wall is visible to the left*

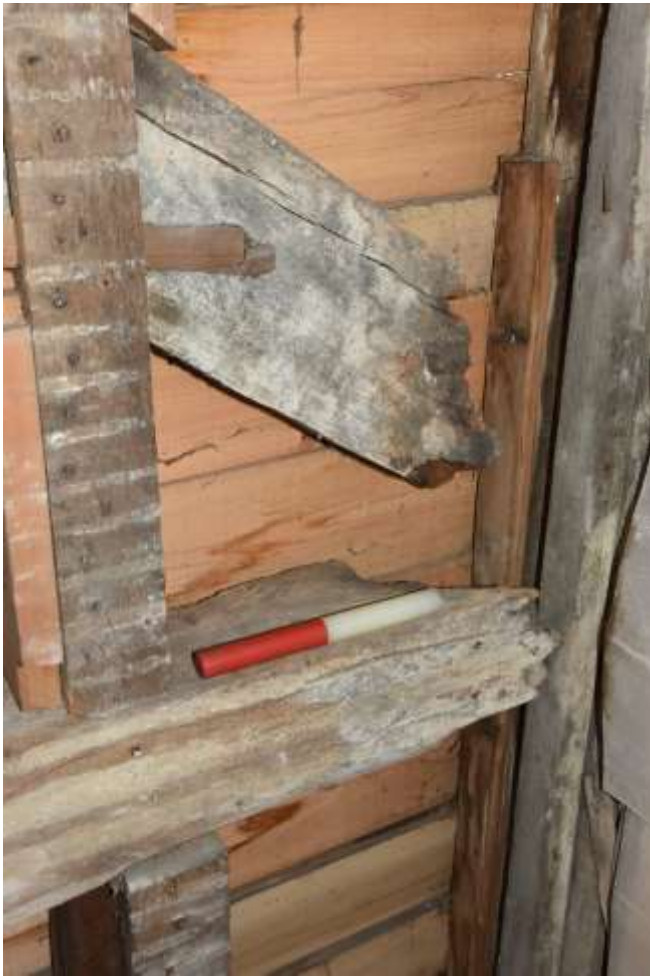
- Some failed timbers had been clearly been replaced, but others such as the midrail and headbrace at the northern end of the western wall were simply left as rotted stumps no longer attached to the corner post (Fig.255). Instead the two sides of the structure were secured top and bottom by iron straps.

Fig.255: *The totally decayed ends of the northern midrail and headbrace: there has been no attempt to repair these when the corner post was replaced, the two sides of the structure being secured rather by iron straps at top and bottom*

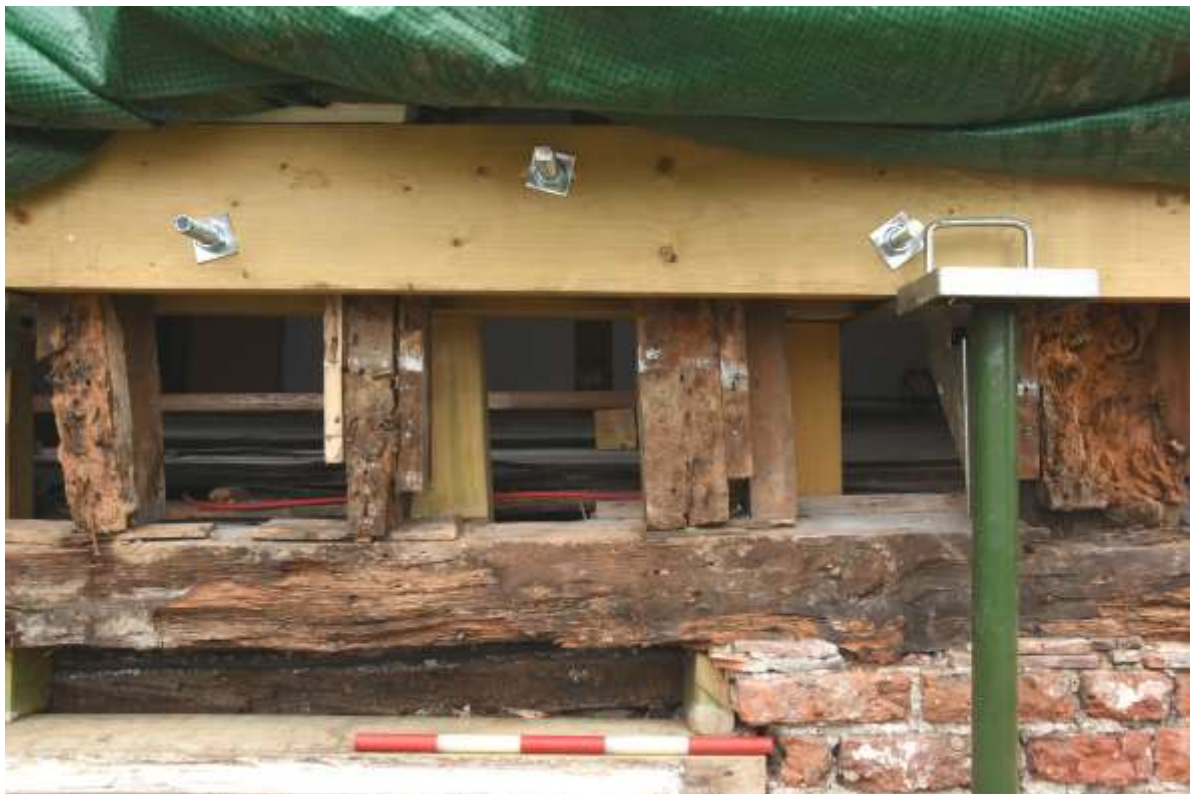
Fig.260: *Continuing the above view above the south side of the French doors. Note the use of thin wooden fillets or wedges between three of the studs and the replacement girding beam. Also visible is the smaller secondary timber below the beam (see elevation Fig.242)*

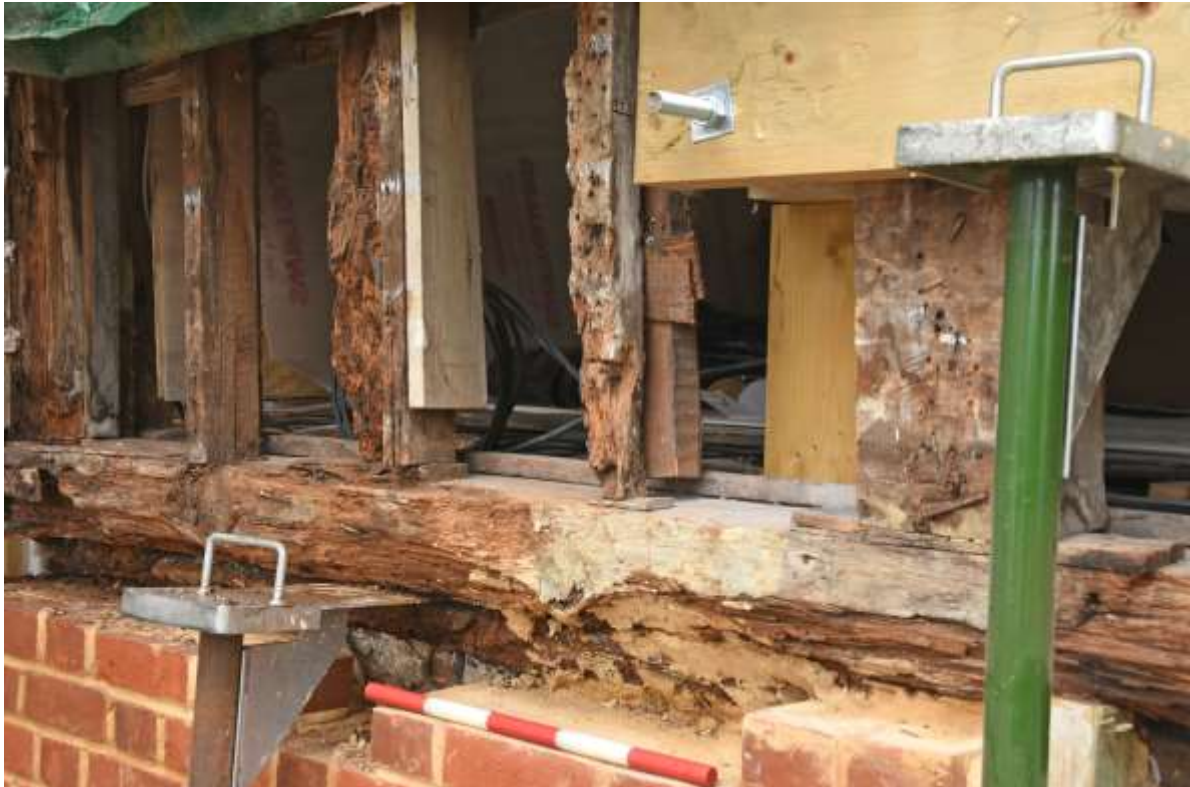
Fig.265: View of studs along the northern part of the wall, the three in the foreground all with timber packing (<15mm) at their bases, plus the northwest corner post at the extreme left. NB. Brickwork at base replaced (0.5m scale)

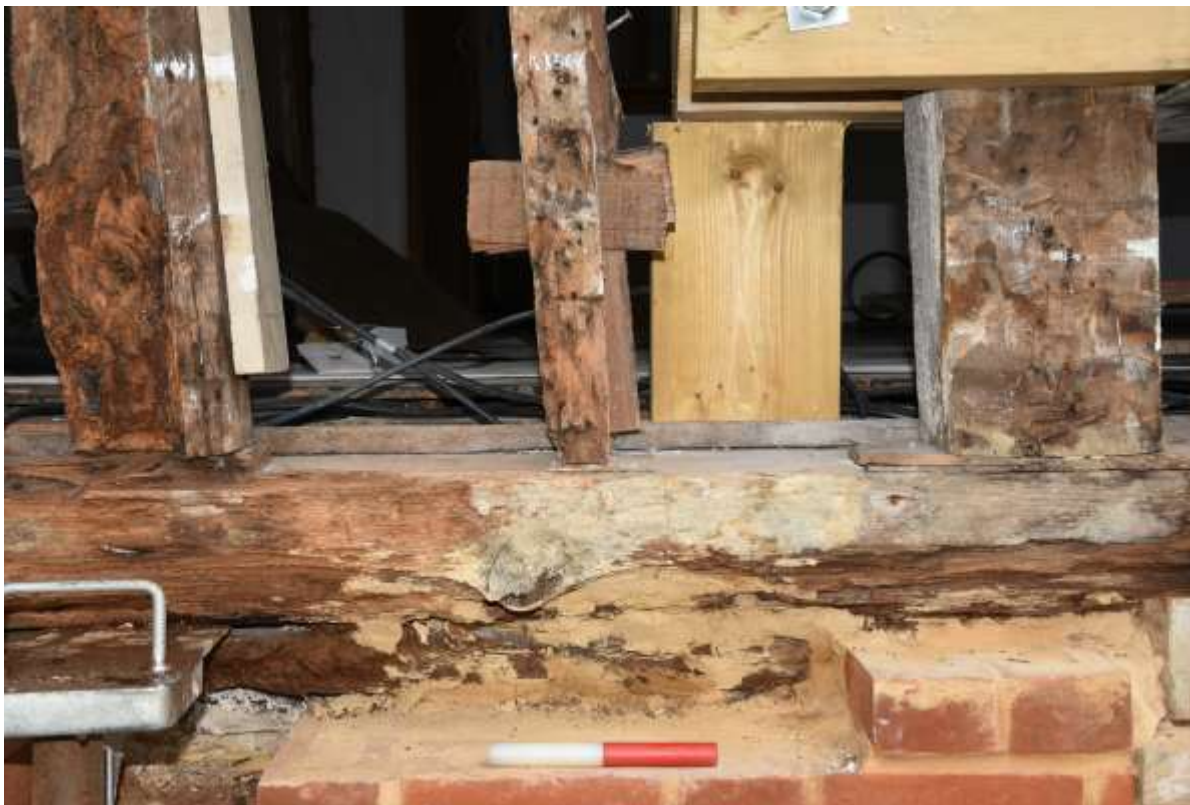
Fig.266: Detail of the above; the original principal northern stud is on the right, with a thin (5mm to 10mm) fillet of wood between it and the underlying replacement girding beam

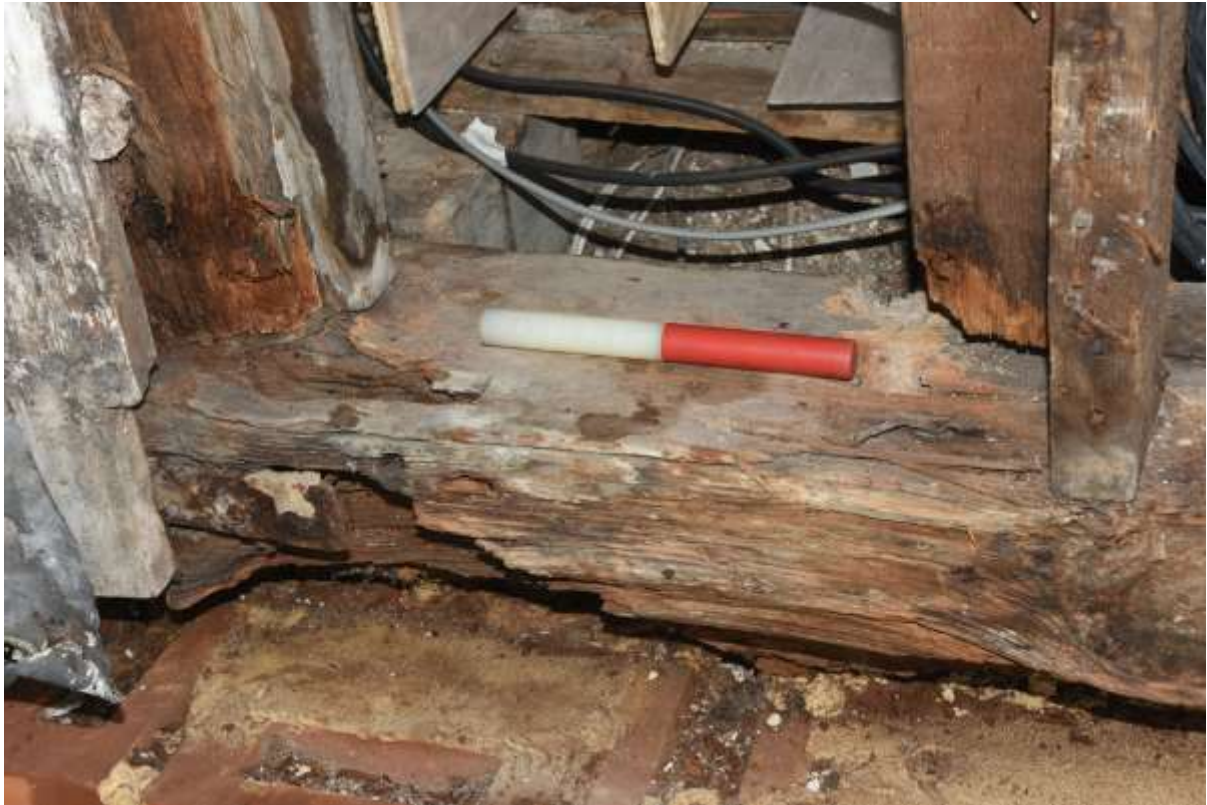
Fig.267: The northern end of the girding beam with corner post to the left, and just visible below this an iron strap that wraps round the corner to the equivalent beam on the north wall

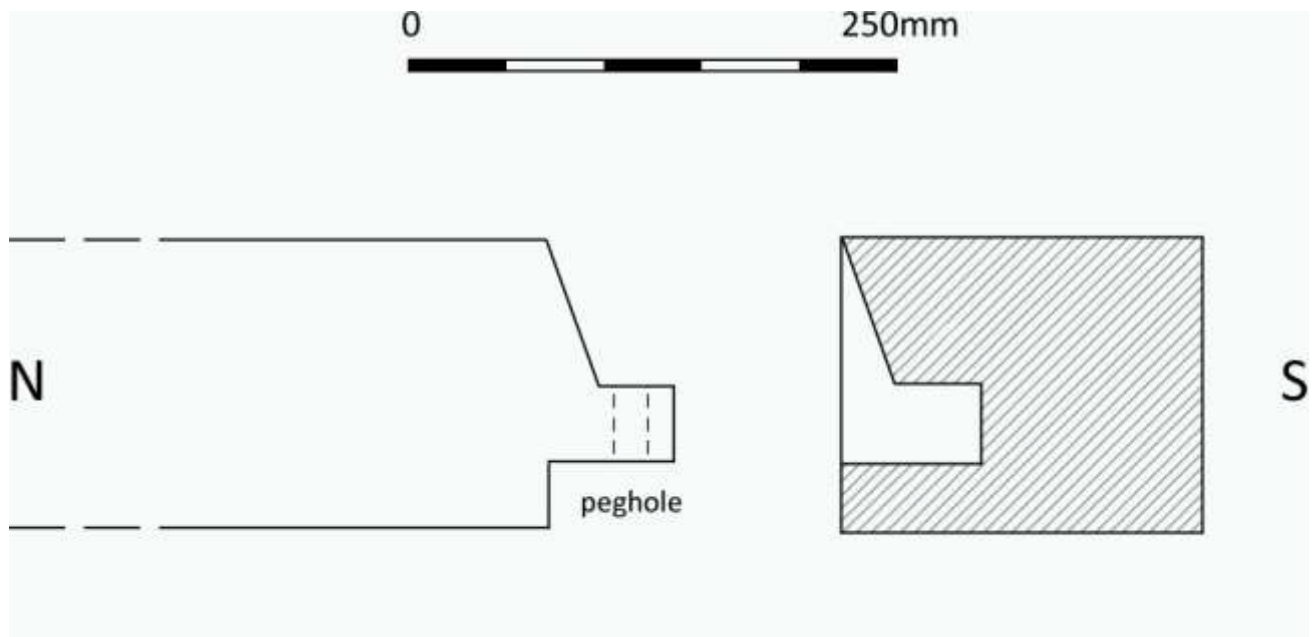
- Mortices had been cut in the replacement girding beam to receive the existing joists with their tusk tenons (Figs.230-31; 271-72, *etc.*), and on the east side of the northern corner post to fit the tenons of the northern wall down brace and midrail (Figs.216-17.). Almost all of these tenons had pegholes – and were presumably thus secured in the original construction. However, there was no evidence for any corresponding holes in the replacement timber – and consequently the whole structure had moved apart by several centimetres, as noted above.

Fig.272: Cross-section through the mortice and tusk tenon. Although dowel or pegholes were visible on almost all of the extant tenons (with only one definitely absent) there were no corresponding holes on the replacement girding beam

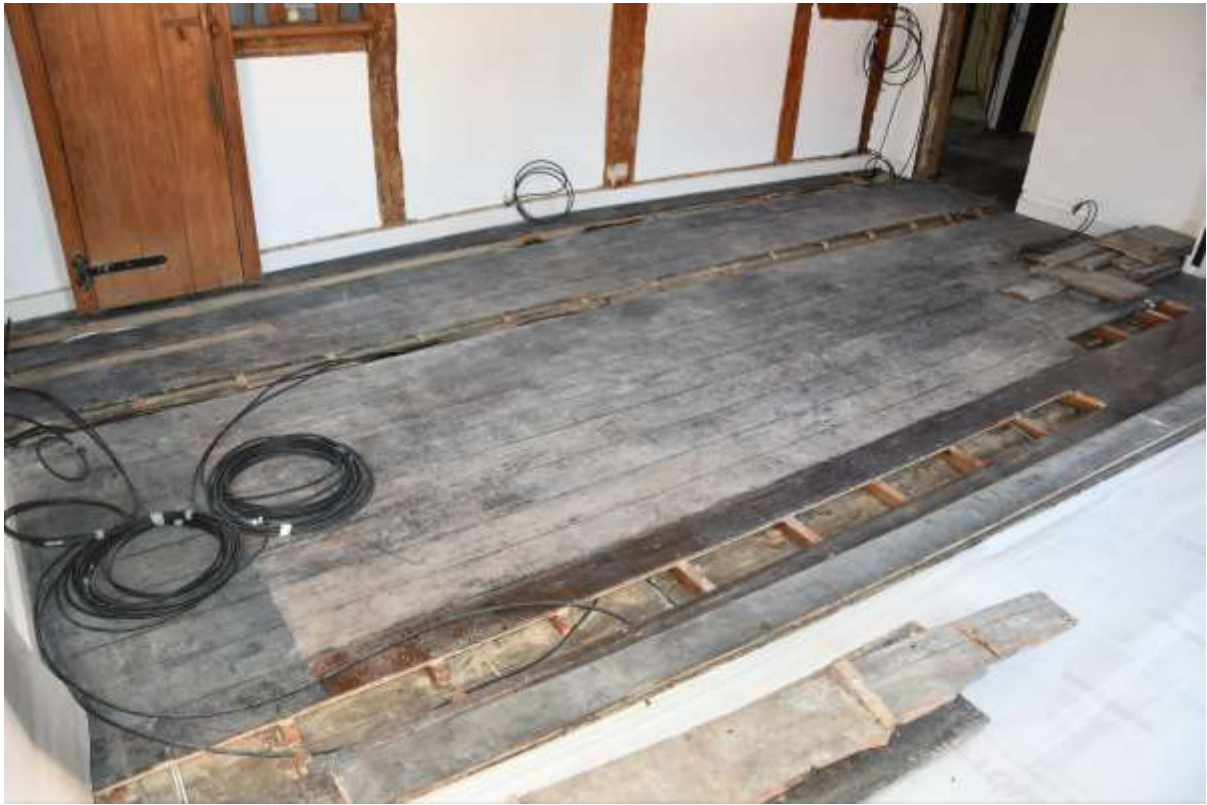
Fig.275: General view of the floor area looking approximately southeast, and showing the series of blocks put over the earlier floor to level its replacement. In general the thickness of these increased from north to south, from c 20mm up to about 100mmn

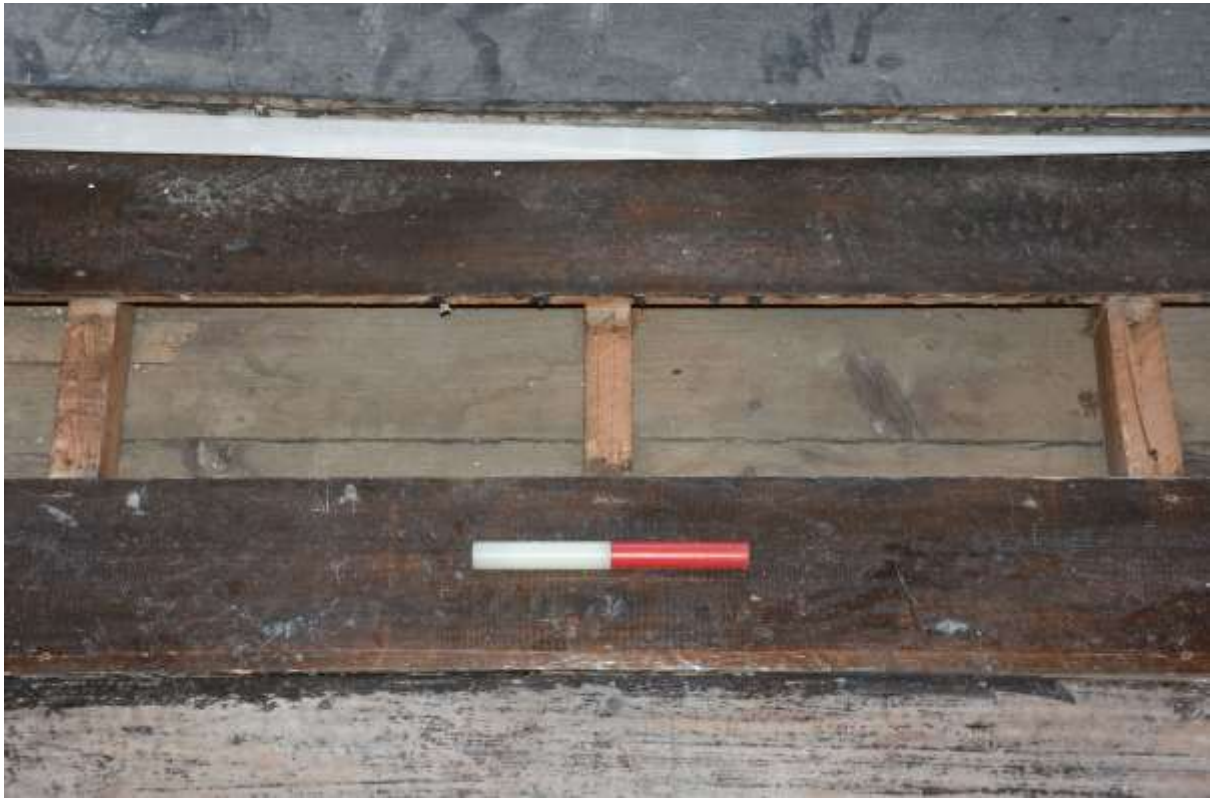
Fig.277: *Detail of the area in the foreground of the preceding figures, showing the previous floor surface and blocks used to level its replacement (0.2m scale)*
