# Moat Bank Barns, Moat Bank, Lichfield, Staffordshire,

Archaeological Building Recording (Level 2)

Report No. 1959

March 2021

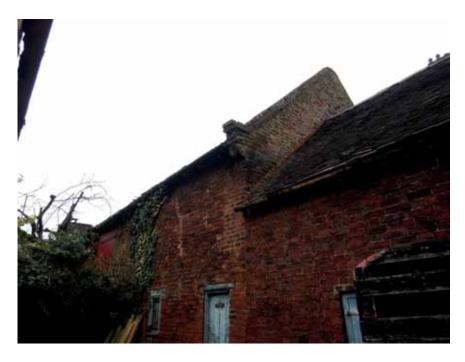
Plate 11: East facing elevation of the main barn (south side) showing sandstone corbel springer to verge parapet, looking NW.

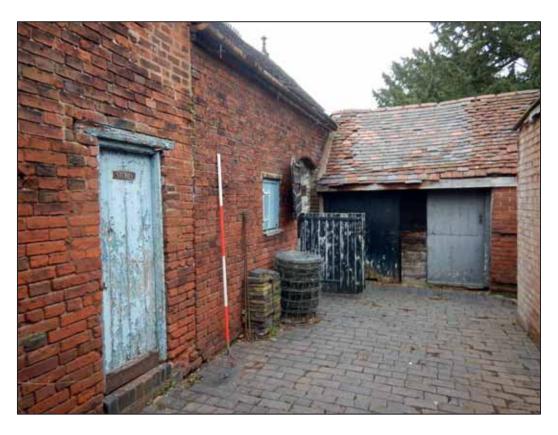
4.2.14 The south facing elevation of the main barn lies to the west of the dog kennels and is flush with it, although the dog kennels are not keyed into the main barn and are clearly a later addition (plate 23). The wall is partially obscured by an extensive rabbit run, vegetation, parked cars, the west wing (Moat Bank Cottages) and later yard walls (plate 21). Nevertheless, it is constructed in red brick with plain ceramic roof tiles. The lowest course of bricks can be seen to rest upon a foundation of rubble sandstone at the east end of the wall (plate 26). The east gable end has a brick parapet whereas the west gable has a partial parapet (plate 24). The bricks are laid in an irregular English garden bond with a regular series of slit openings measuring one headers width by three brick courses high. These openings are largely blocked with later blue brick. There has clearly been a great deal of alteration and re-pointing/renovation leading to variations in the above. In particular the construction of the west range, now in private ownership (Moat Bank Cottage) appears to have caused some damage to the west end of the south wall when it was inserted. Furthermore, the north wall of the west wing blocks the slit openings in the south elevation of the main barn. Also, the main central barn doors appear to be a later insertion with blue brick jambs crudely keyed into the older fabric of the wall (plate 25).

Plate 23: South Facing Elevation of the east end of the main barn and Dog Kennels, Looking ENE. 2m scale.

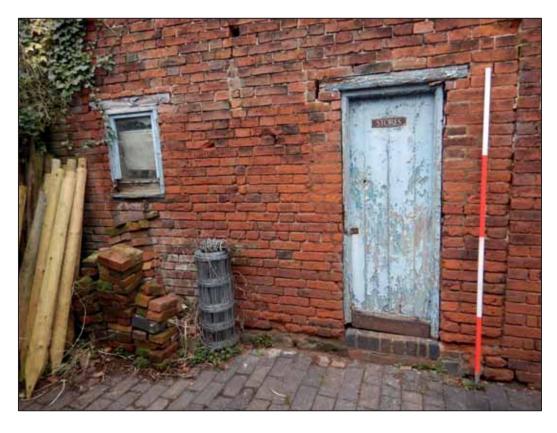
Plate 26: South Facing Elevation of the Main Barn (east end), showing partial sandstone base to wall and unkeyed junction with dog kennels. looking NNW. 2m scale.

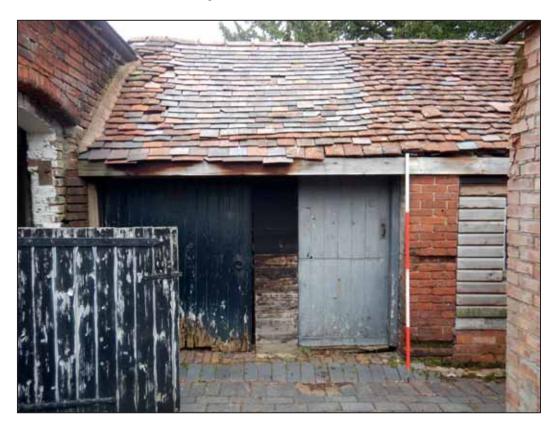
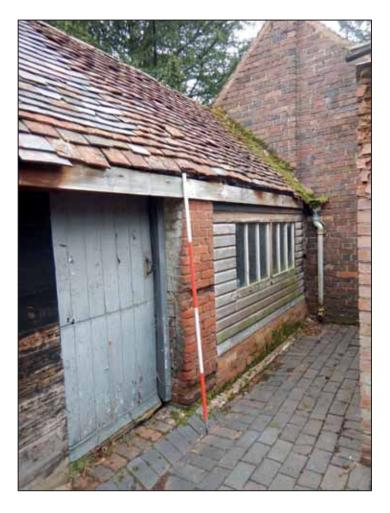
4.2.16 The west-facing elevation of the east range fronts on to the central yard but views towards it are now partially obscured by a modern brick garage (plates 28-29). The frontage appears to have been originally open to the southern enclosed courtyard but with a central brick pillar bearing rounded corners. The formerly open spaces either side of the pillar have since been closed by a combination of shiplap, tongue and groove boarding and modern low plinth brick walling. The roof is covered in plain tile showing evidence for a recent repair and replacement with more modern plain tiles to the northern bay of the wing (plate 28). The northern opening now contains two large wooden doors each 1.78m high, the southern door measuring 0.9m wide and the northern 1.48m wide. The panelling to the south of the brick pillar contains a single six light wooden mullion window (plate 29).

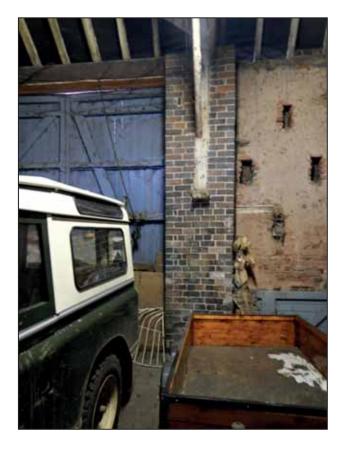
Plate 35: Main Barn, south wall showing principal post bricked in to later brick door jamb. looking S.

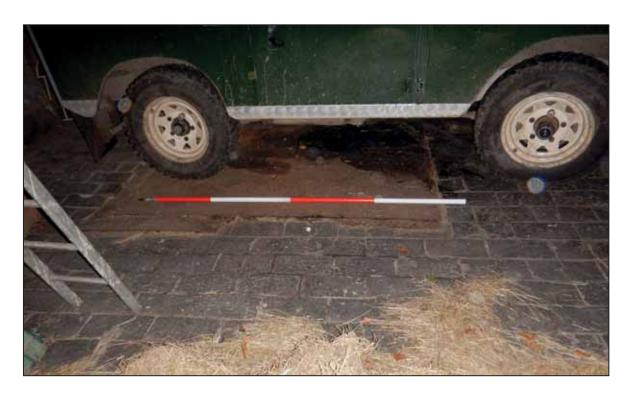
Plate 39: Main Barn, central bay, possible inspection pit, looking W. 2m scale.

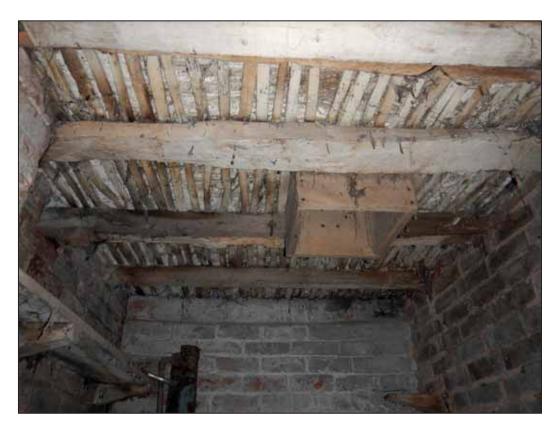
Plate 41: Main Barn, small store, showing original joists, lathes and former grain chute. looking E.

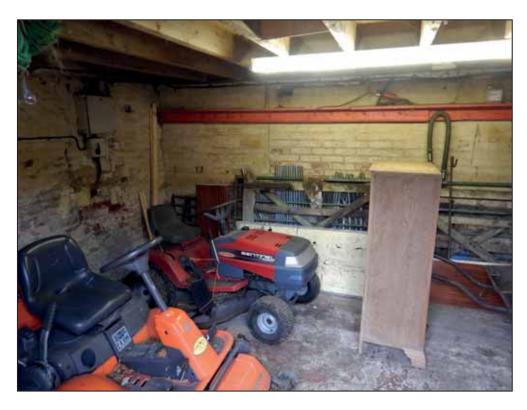
Plate 43: Main Barn, partitioned room under hayloft showing blocked former opening at east end of S wall. looking SSE.

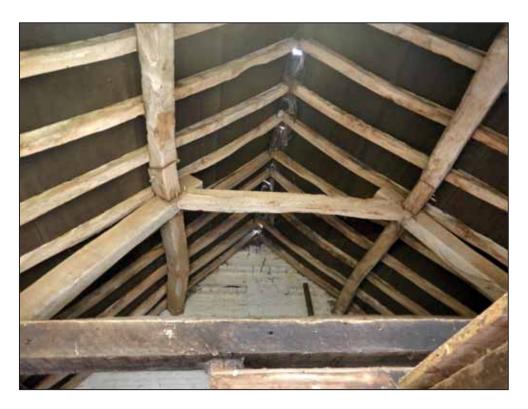
Plate 49: Dog Kennels modified roof structure, view to the W. 2m scale.

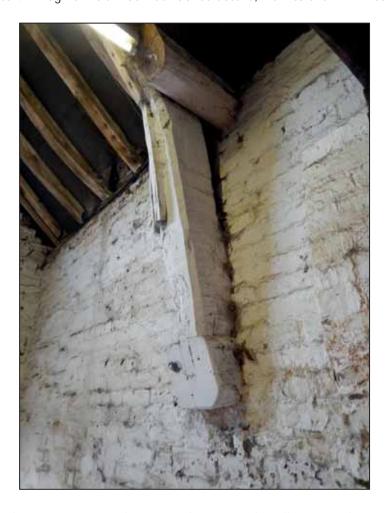
Plate 50: Dog Kennels, principal post, south wall, view to the SE.

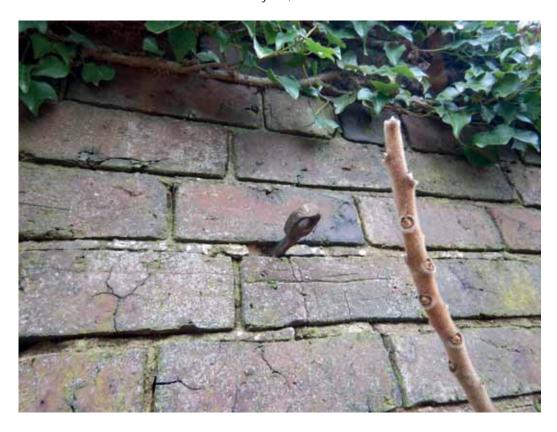
Plate 60: Eastern Courtyard, north external wall showing metal fixing. view to the SW.
