**EAST PITTEN FARM, YEALMPTON:
A DEVON FARMHOUSE
UNDER DEMOLITION**

Prepared for Le Page Architects

*By John Allan, Anthony G. Collings
and Andrew Passmore*

Exeter Archaeology Report No. 10.76

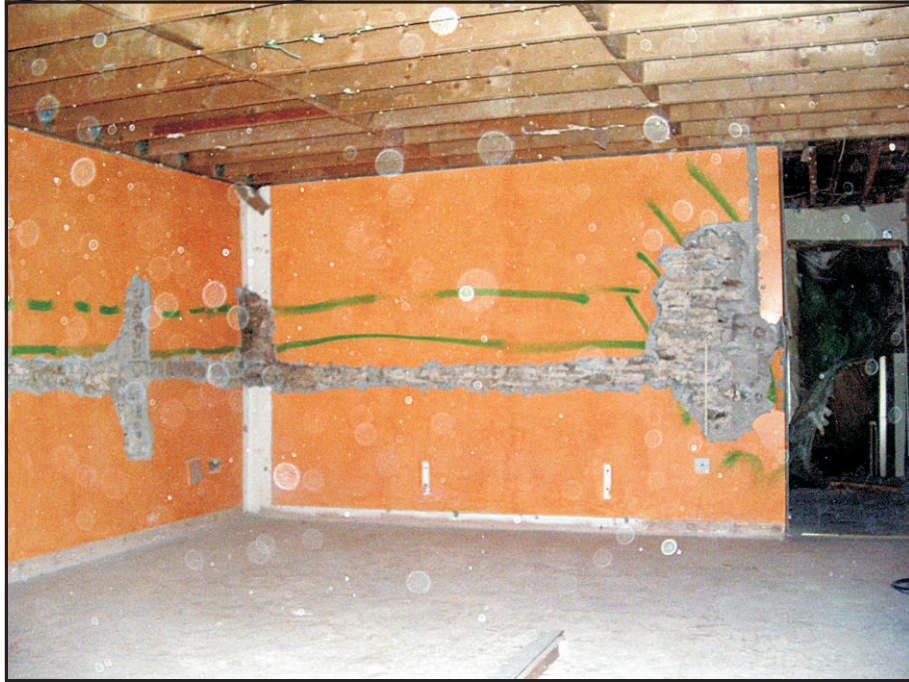
Stripping of a band of walling at a height of 0.9m around the entire room interior (Fig. 11) showed that only window – that in the S wall – is part of the primary fabric. A blocked primary doorway in the N wall led into the farmyard to the N; a second led into the yard to the S. A doorway giving access to the rest of the farmhouse was perhaps also a primary feature, although its N jamb consisted of 20C brick. The remaining walling consisted of featureless rubble.

Fig. 11 Interior of the W room after stripping.

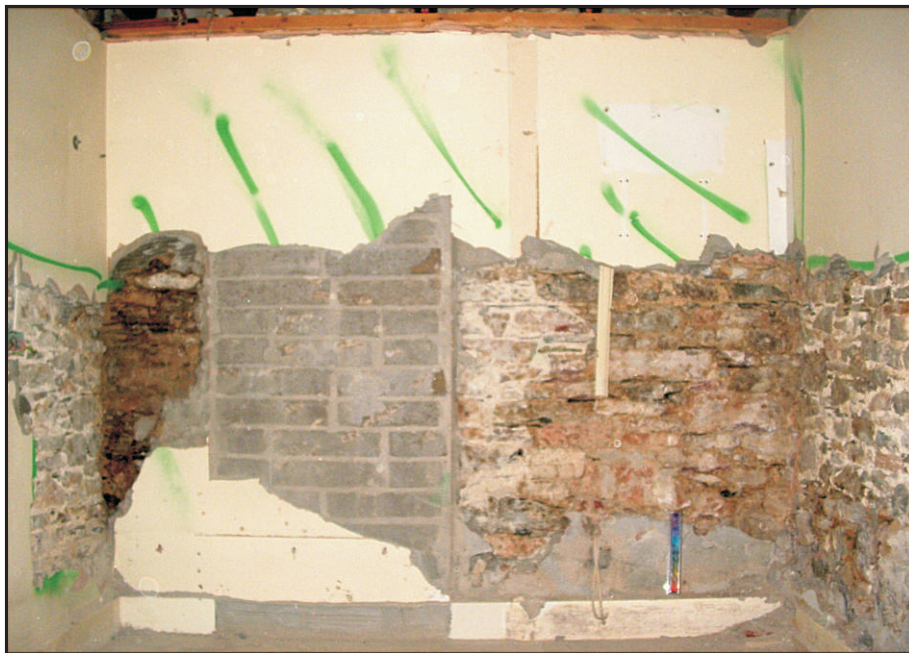
Wall stripping exposed the clay-bonded N wall, with its contemporary doorway leading to the N range, partially with lime-bonded jambs (Fig. 12). Both internal walls butted this wall; that forming the back of the hall fireplace was in a mix of clay- and lime-bonding. The doorway in the S wall, now leading into a modern porch, had

Fig. 12 The entry after stripping, showing blocked doorway in N wall.

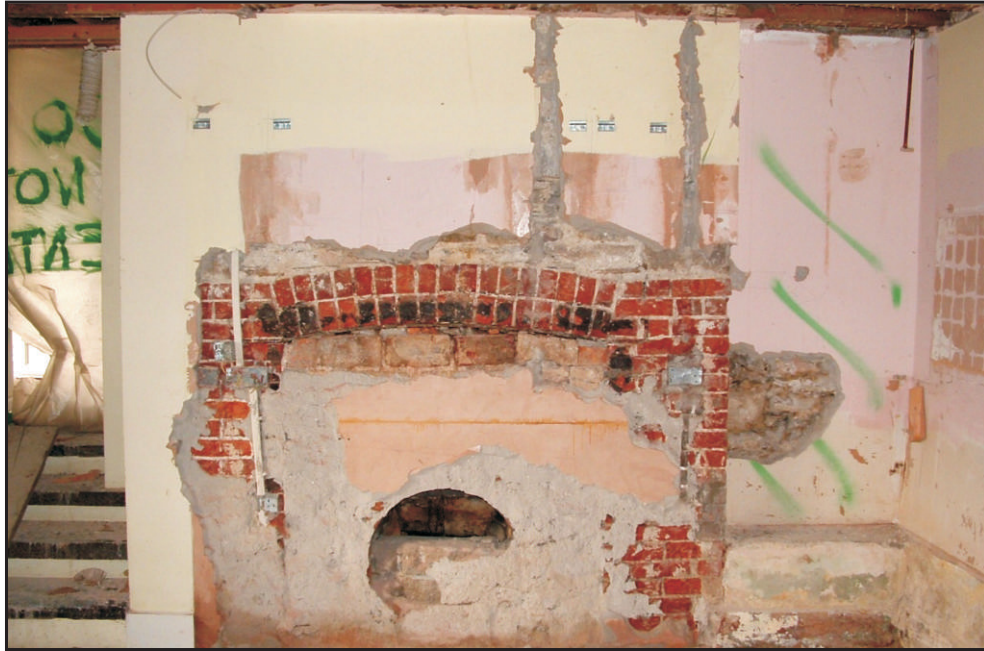
Stripping exposed a massive fireplace stack with an arched lintel and jambs of lime-bonded dark red brick, the remainder of the stack being of clay-bonded rubble (Fig. 13). A curving iron bar was incorporated into the brickwork during construction to support the lintel; it was upturned at each end to wrap around the brick courses. This was evidently effective; the brickwork had not settled. Blocks of wood incorporated at intervals in the jambs show that a wooden fireplace surround was used; a shadow of sooting in the brickwork shows that a bare band of unplastered brick surrounded the opening.

Fig. 13 The hall fireplace. Note iron bar supporting the lintel, wooden blocks for original fireplace surround, area of sooted brickwork exposed within the former surround, and blocking for 19th-century hob grate.

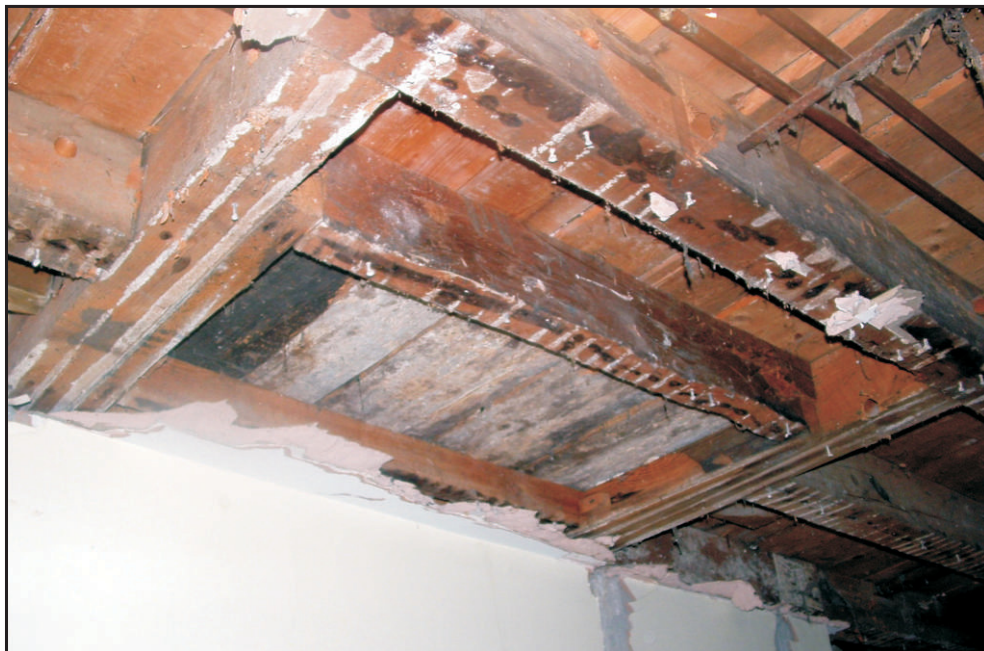
The arrangement of joists in the floor above the fireplace shows that an upper floor fireplace was intended from the first (Fig. 14). Trimmers pick up the floor joists in front of the stack. A joist box was built within the trimmers, with thick boards laid to take the hearth stone. Since this has a closed assembly which could not be installed once the entire floor was in place, this must be an original feature. An interesting constructional detail was the use of pairs of wedges to hold the mortice-and-tenon joints.

Fig. 14 Assembly of first-floor joists showing trimmers, joist box, and thick boards to support first-floor fireplace.

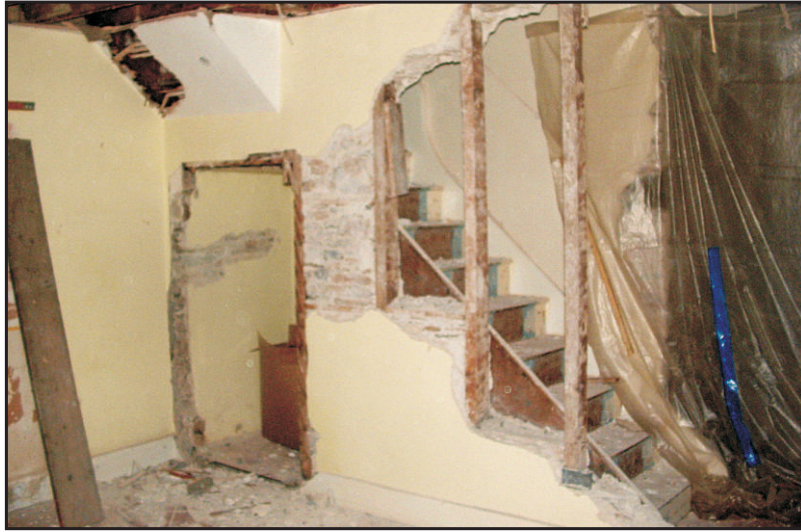
Stripping of the opposing (E) wall, which backs onto the stairs, exposed its stone-nogged frame incorporating a cupboard under the stairs (Fig. 15). The doorway between the hall and stairs had been demolished before our recording began, but was evidently an original opening, since there is no space for another in this partition. The decayed post marking the junction of partition and S wall survived in the entry.

Fig. 15 Hall, stairs and primary stair cupboard, viewed from the SE.

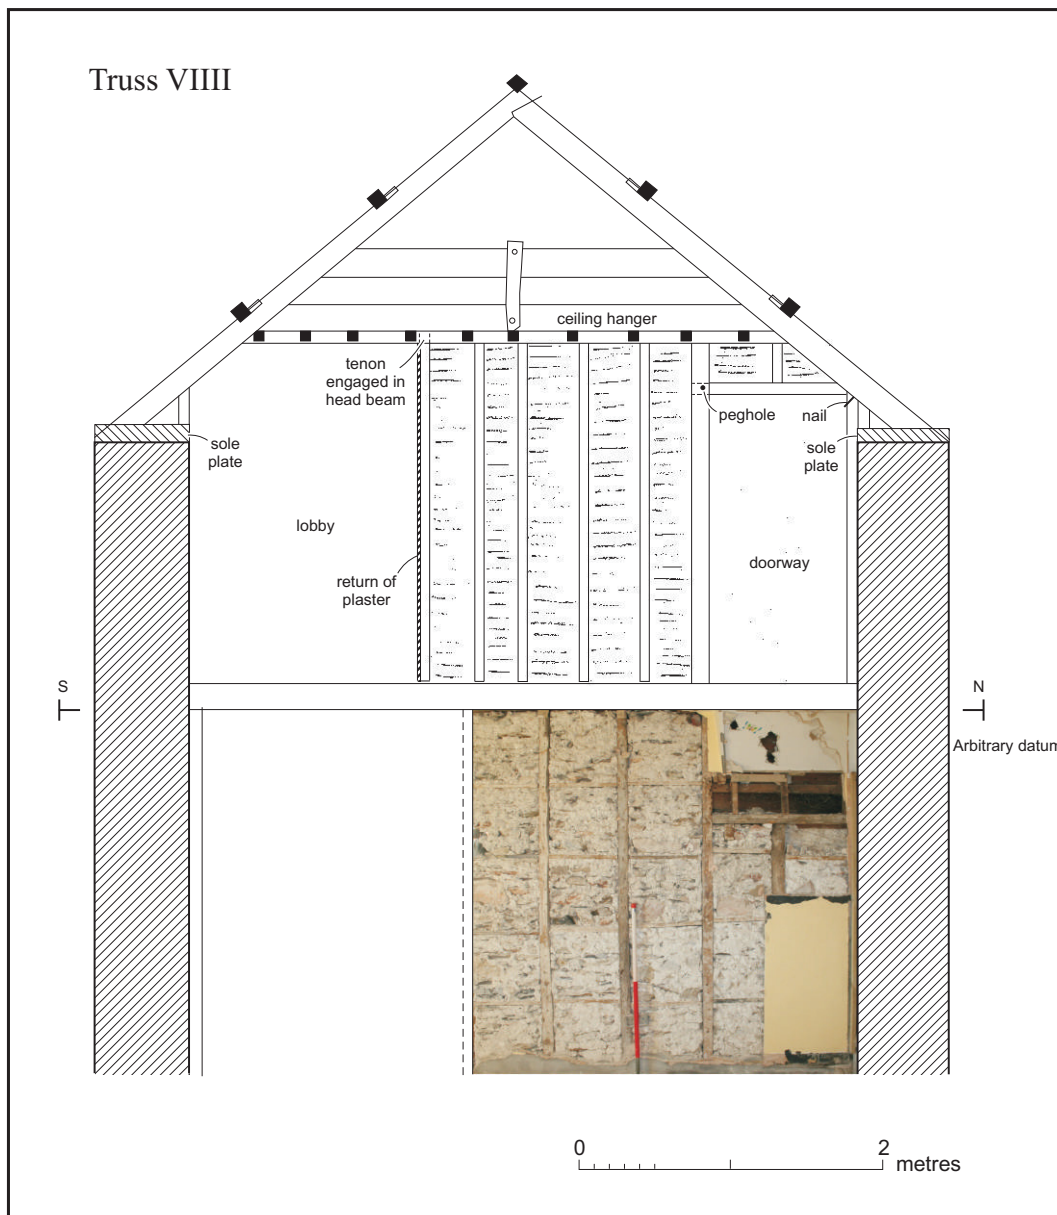
Removal of plaster showed that about half the old stone-nogged partition survives between the stairs and the parlour (Fig. 17).

Fig. 17 Section through S range at junction of parlour and stairs, with Truss VIII above.

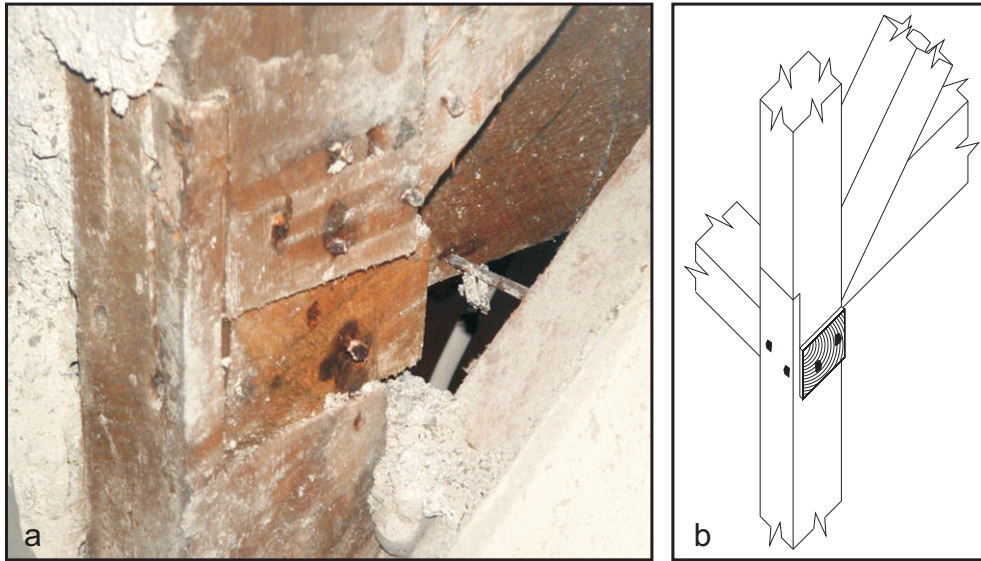
There is a splendid piece of carpentry at the top of the stairs, where six components of the structure meet in one place (Fig. 18a, with accompanying axonometric projection 18b). First, one of the studs of the ground-floor partition separating the hall from the stairs rises to form the corner post of the chamber above.

It is therefore larger than the other studs and square-sectioned. At ceiling level it incorporates a second timber – the horizontal head beam of the ground-floor partition, which is held in place by a tongue of timber rising from one side of the ground-floor stud. (Once this timber was in place the process of stone-nogging the ground-floor partitions could have proceeded.) Above these two timbers rises a third – the first-floor stud forming the corner post of the central chamber. Fourth, the trimmer from the floor assembly was laid over the partition rail; it is covered by the floor boards. Finally, a diagonal brace ties this assembly to the first-floor partition.

Fig. 18(a) The junction of timbers in the frame beside the stairs. (b). Isometric view of same.

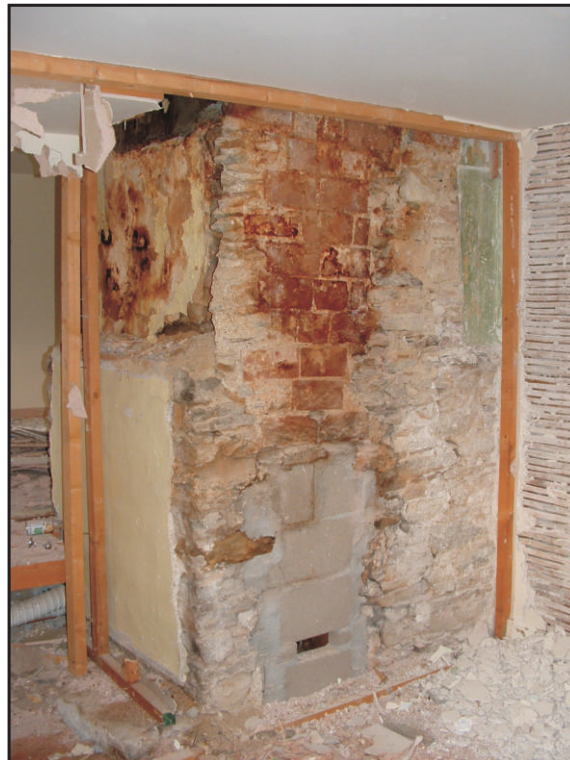
The hall fireplace stack rose through the central chamber, forming the most prominent feature of the room (Fig. 19). Here the flue for the first-floor fireplace appeared at first sight to be an inserted feature: whereas the stack was built of clay-bonded rubble, the fireplace and flue had been added to it in lime-bonded brick, the bricks being set on edge to achieve as thin an outer wall to the flue as possible. However, examination of the closed assembly of the joists below (described above: Hall) shows that this is in fact a primary feature.

Fig. 19 Central chamber: fireplace stack from SE.

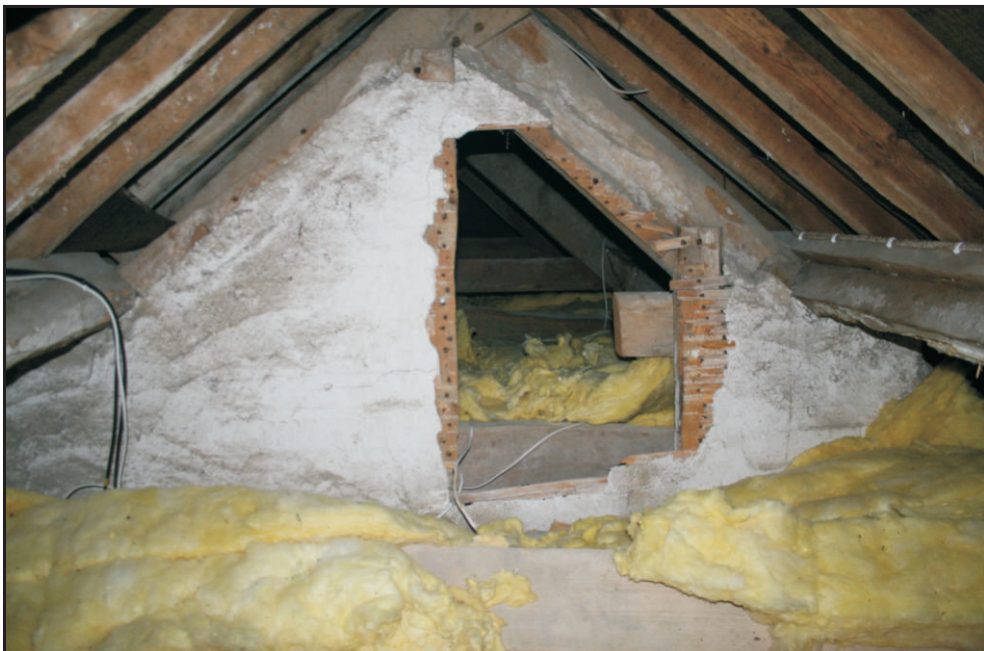
Trusses III and V were closed. Above the collar, truss III retains half its lath-and-plaster panel, with smooth clean lime-plastered finish on its E face, suitable for a chamber. By contrast, the W face consists simply of the exposed laths with the plaster

oozing between them, finished only with limewash. Although this partition no longer survives in the chamber below, clear evidence of its former presence can be seen in the underside of the room's ceiling beam, half of which remains lime-washed whilst the other half (protected by the former partition) is not. By contrast, part of the partition below Truss V survived, forming the division between the W and central chambers, abutting the N side of the chimney breast. In the roofspace above the panel of lath-and-plaster had been removed, but remnants of lime mortar survived in the angles between collar and principal.

Fig. 23 Roof truss III with partition rising to the apex.

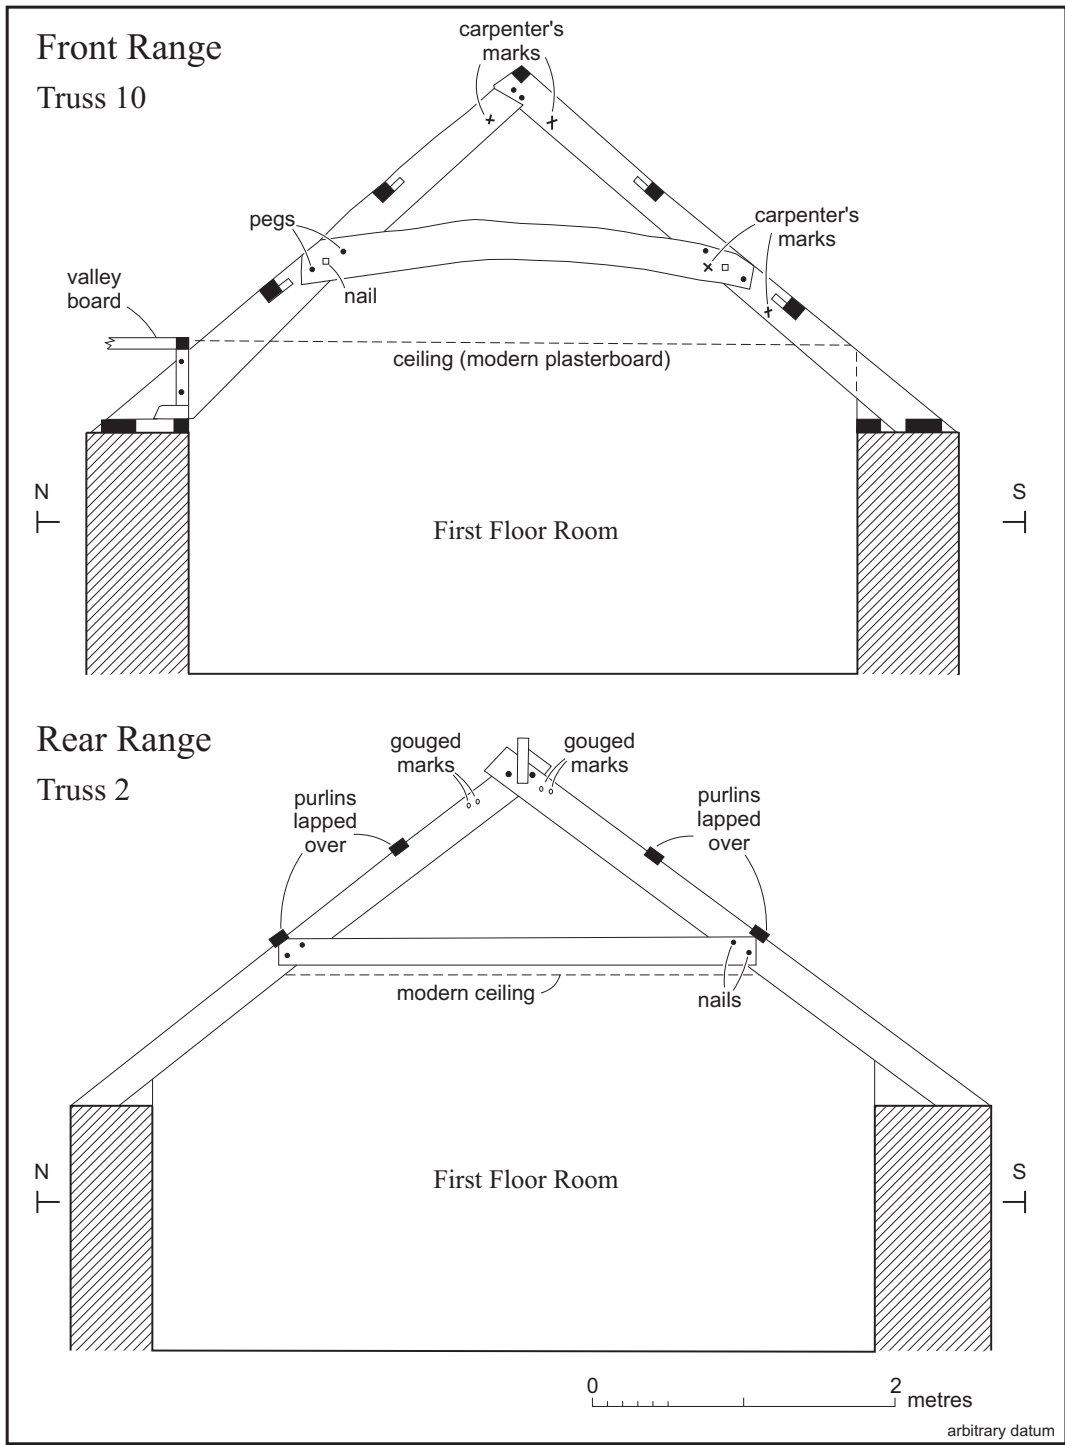
An observation which is crucial to the overall interpretation of the farmhouse was made in the wall top on the N side of the range (Fig. 24, upper, N side). Selective removal of plaster exposed a vertical timber rises above the sole piece on which the principal sits. Rather than being cut to the slope of the roof (normal practice), this rises above the line of the principal and supports a horizontal member bridging the valley between the roofs of the N and S ranges (Fig. 24, 'valley board'). Since the ashlar piece is sealed behind the primary plaster of *c.* 1700, it must have been installed in the primary building works. The provision of a valley appears to show that the two roofs are contemporary; this needs checking from the outside.

Fig. 24 Measured drawings of trusses in S and N ranges.

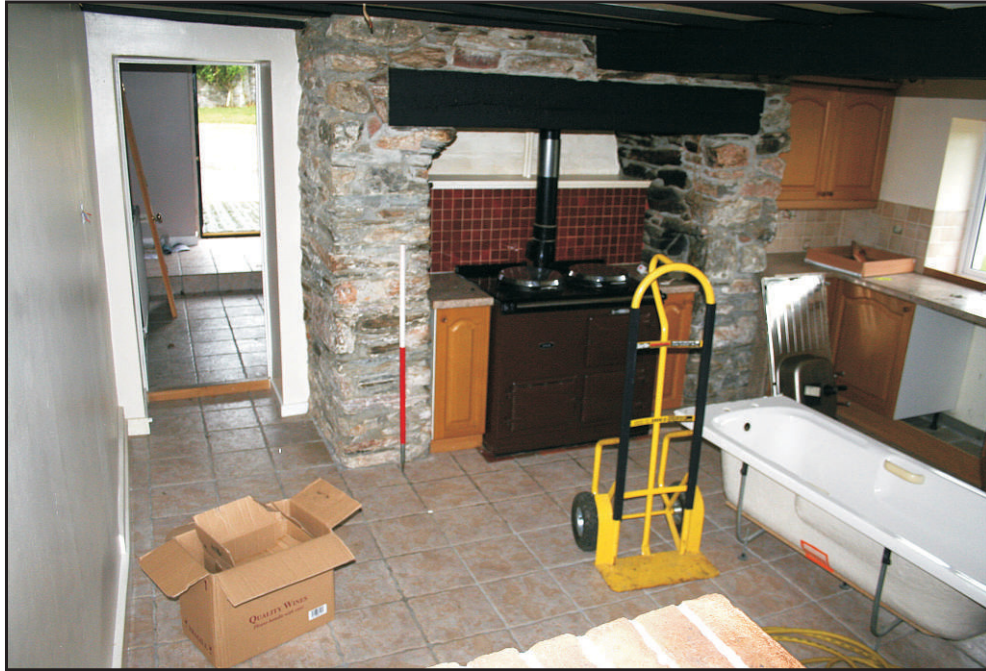
The only original feature visible before stripping was the large fireplace of mortar-bonded rubble, whose old lintel (no doubt of wood) has been removed to make it easier for a cook to operate an Aga within (Fig. 25). The scar of the old lintel is filled with cement; a reused railway sleeper forms a new lintel at a higher level. The fireplace masonry has been so daubed with grey cement that it might at first be taken as a modern replica, but selective removal of this layer showed that early lime-bonded masonry survives on the jambs and within the flue. Plain early rubble walling was also exposed in adjacent walling to the N.

Fig. 25 North range: kitchen fireplace.
