**HISTORIC BUILDING RECORDING AND  
ARCHAEOLOGICAL WATCHING BRIEF  
AT CHURCHLEA BARN,  
BROADWOODWIDGER, DEVON**

**Exeter Archaeology**

**Report No. 11.48**

**Project No 7106**

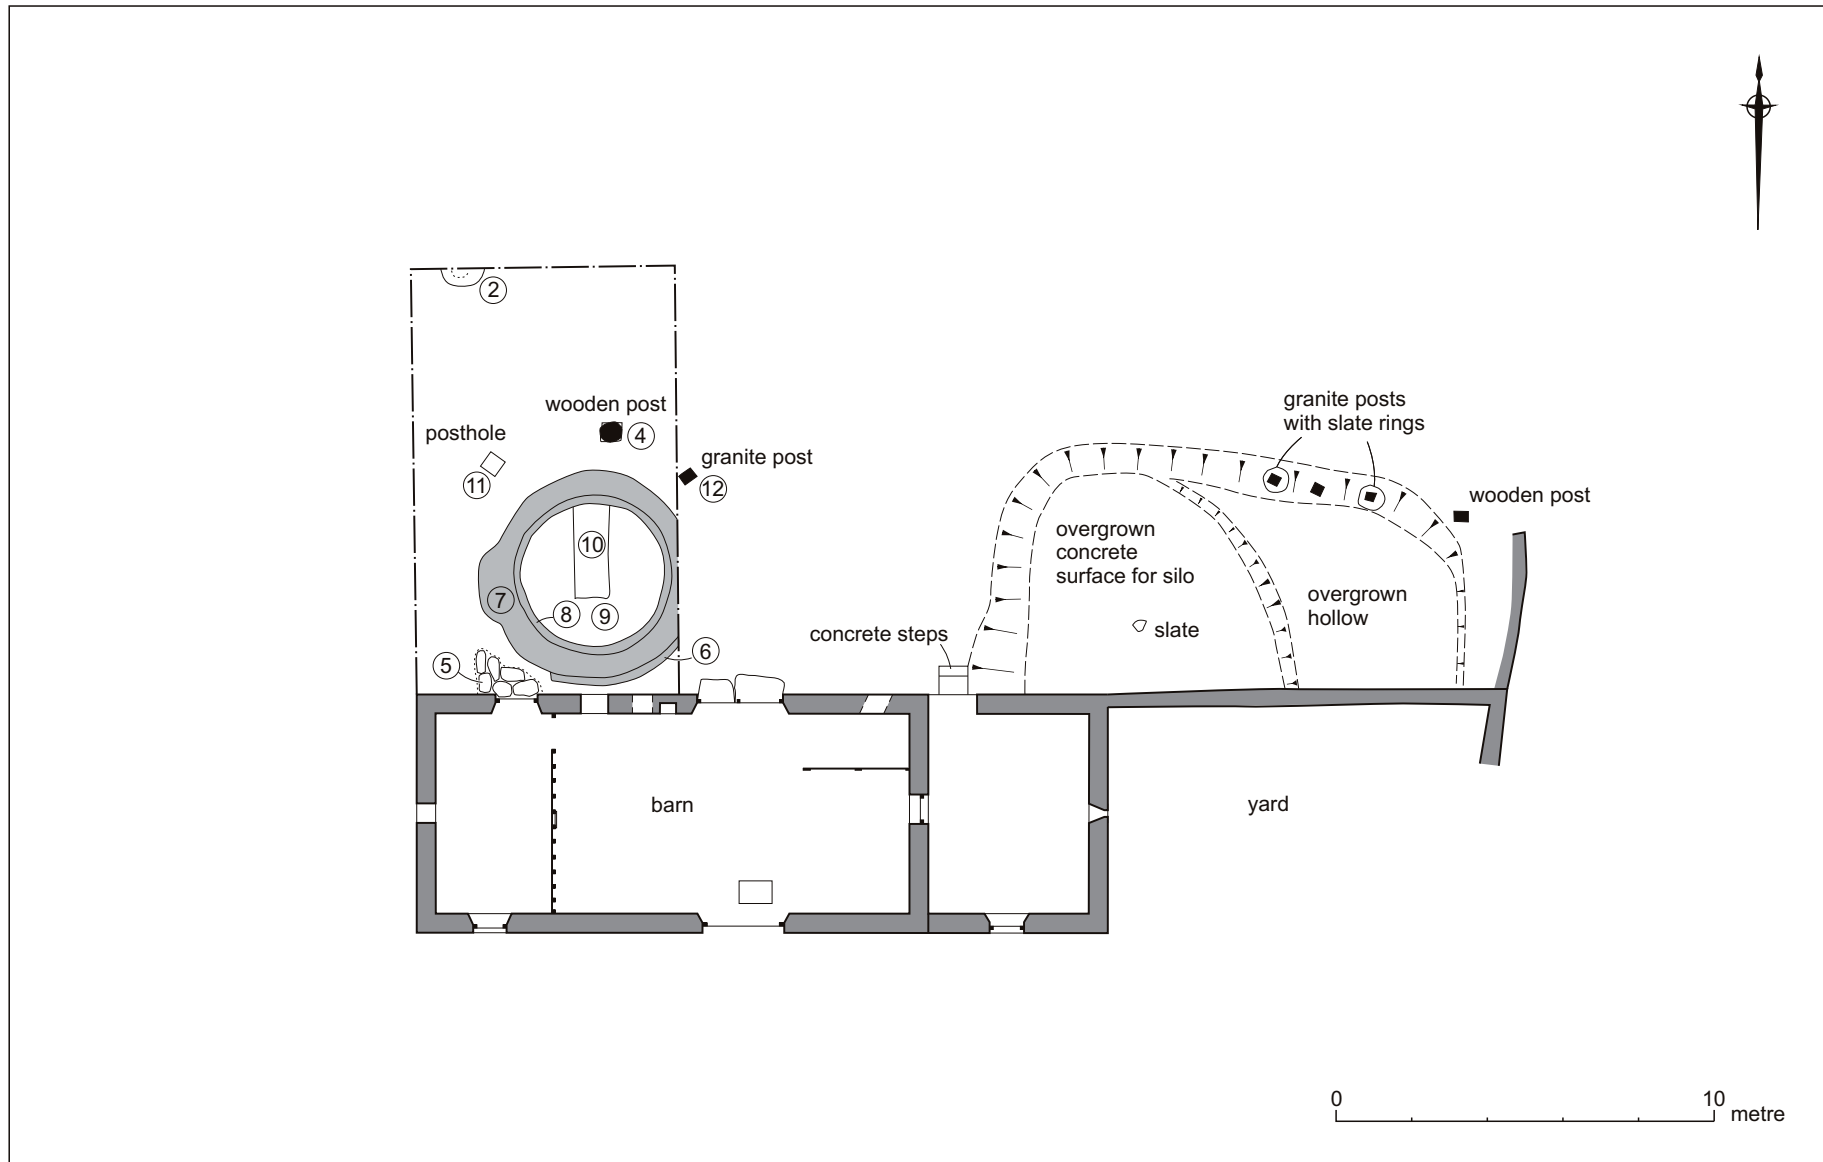
Fig. 6 Plan of the rear of the barn showing observations.

On the north side of the barn an area of 11m by 7m was reduced by between 0.60-0.80m; the west of this area dropped away naturally. Removal of up to 0.20m of modern rubble and soil exposed natural clay and rock over the northern third of the excavation. A small pit (2) was partially exposed, and measured 1.10m long by 0.45m deep. It contained a yellowish brown firm clay fill with stone and rare charcoal inclusions (3). To the south a large terrace, 0.80m deep, had been cut into the natural. In the base of this terrace a construction trench for the rear wall of the barn, backfilled with stone rubble, was exposed.

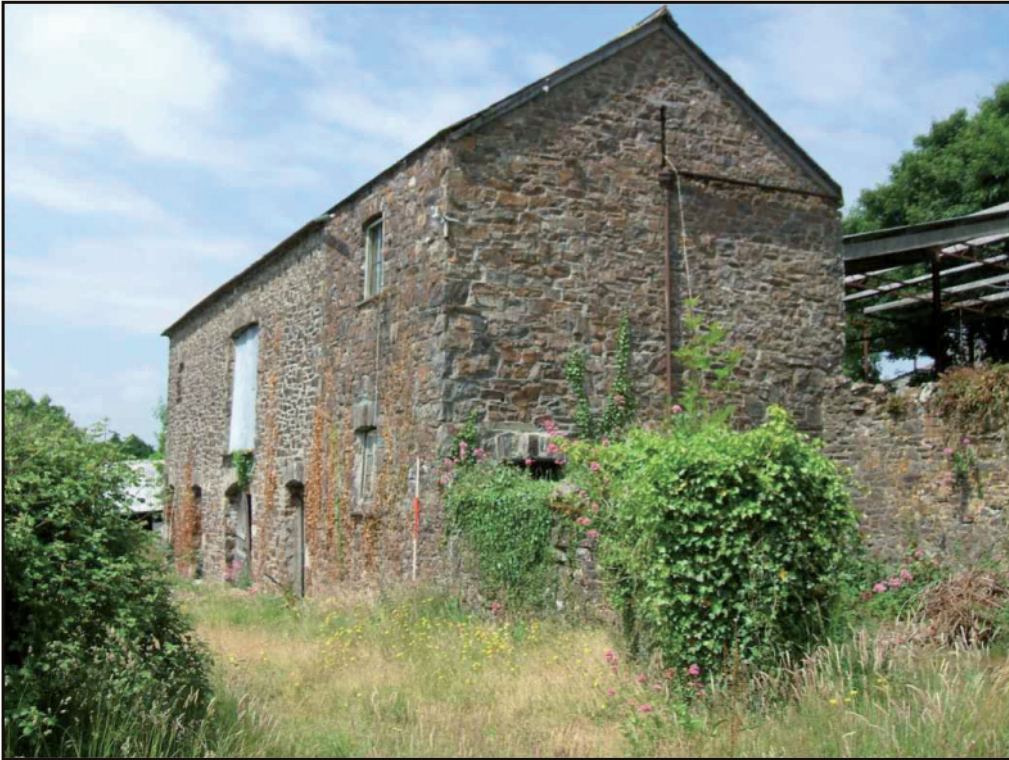
The barn is a two-storey, rectangular building constructed of local stone with a slate roof (Photo. 1). The structure is a bank barn, built into the hillside, with the ground floor entered from a terrace on its south side and the first floor entered from the (rear) north side. The south elevation incorporates a row of pigeon nesting holes. On both levels the building comprises large open western rooms and smaller eastern rooms, reflecting the main two-phase development of the building. The north and south walls of the eastern extension continue to the east forming two sides of a small yard or pen. A late 20th-century open-sided shed had been erected against the north side of the barn (see Fig. 1). This is not discussed further.

The eastern extension has a single room on each floor (Photo. 1). The ground floor room is entered from the adjacent yard via two doorways; the presence of two openings implies the room was subdivided, but no evidence for a partition, or stall divider, survives. The room has a glazed window in the south elevation and a splayed slit window in the north elevation. The only features in this area are a wooden feeding trough attached to the walls in the northwest corner, and a brick-lined trough in the southwest corner.

Photo. 1 South and east elevations of the barn showing yard wall in foreground, looking northwest. 2m scale.

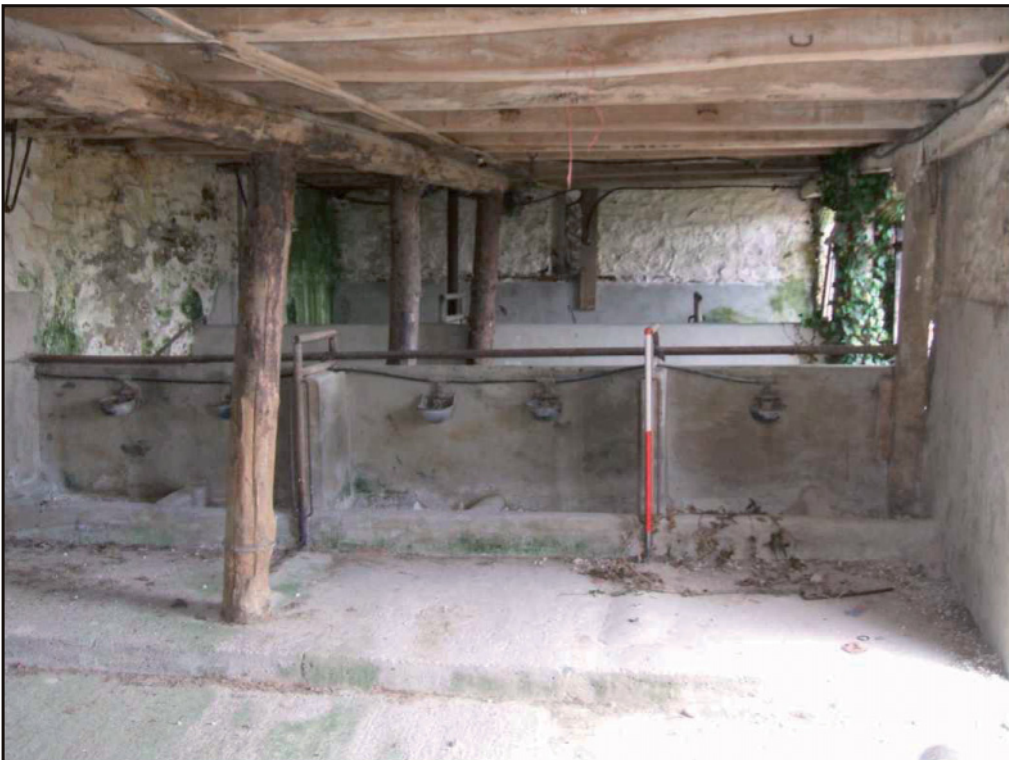
The ground floor is entered by four wide doorways in the south elevation, with wider doors incorporating slats to allow light and ventilation to the interior. The only other openings at this level are narrow slit vents in the east and west elevations. The original layout is not known, having been removed when the present later 20th-century cattle stalls were inserted. The doorways now lead into concrete and rammed chalk walkways, with the western doorway leading into a feeding passage (Photo. 2). The concrete cattle stalls are raised up from this floor and there are feeding troughs for 16 cows. Most steel stall dividers have been removed, although the water troughs and associated pipes survive.

Photo. 2 Ground floor showing the west stalls, looking east. 1m scale.

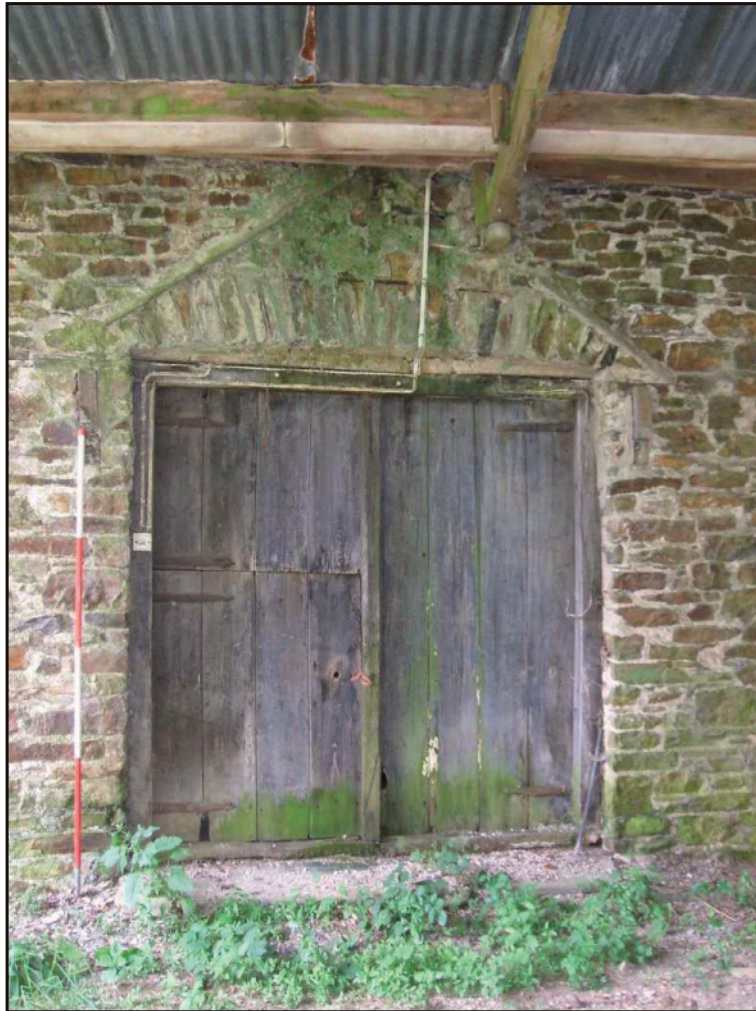
On the first floor is a pair of loading doorways; the doors themselves have been replaced. Over the north doorway is a scar of a removed pitched porch (Photo. 3). This doorway has a slate threshold. There is a further doorway in this elevation, again with a slate threshold, along with joist holes for a removed porch, and a raised loading (or more probably unloading) door in the east elevation. There is a single window opening in the south elevation and a small high-level vent in the west elevation. There are four other openings in the north elevation – a hole for the axle from the engine house, an internal recess, a narrow hole, and a later 20th-century opening for a pipe from the external silo. The latter would have fed into a hopper that is attached to the roof. The floor has a hatch to a feeding passage below. The western bay of the room has been divided with a timber post and plank partition (Photo. 4). This supports a mezzanine floor, which is accessed via a vertical ladder attached to the partition. The partition is a primary feature.

Photo. 3 Close up view of double door opening in the north elevation at first-floor level, showing scars of porch, looking south. 2m scale.

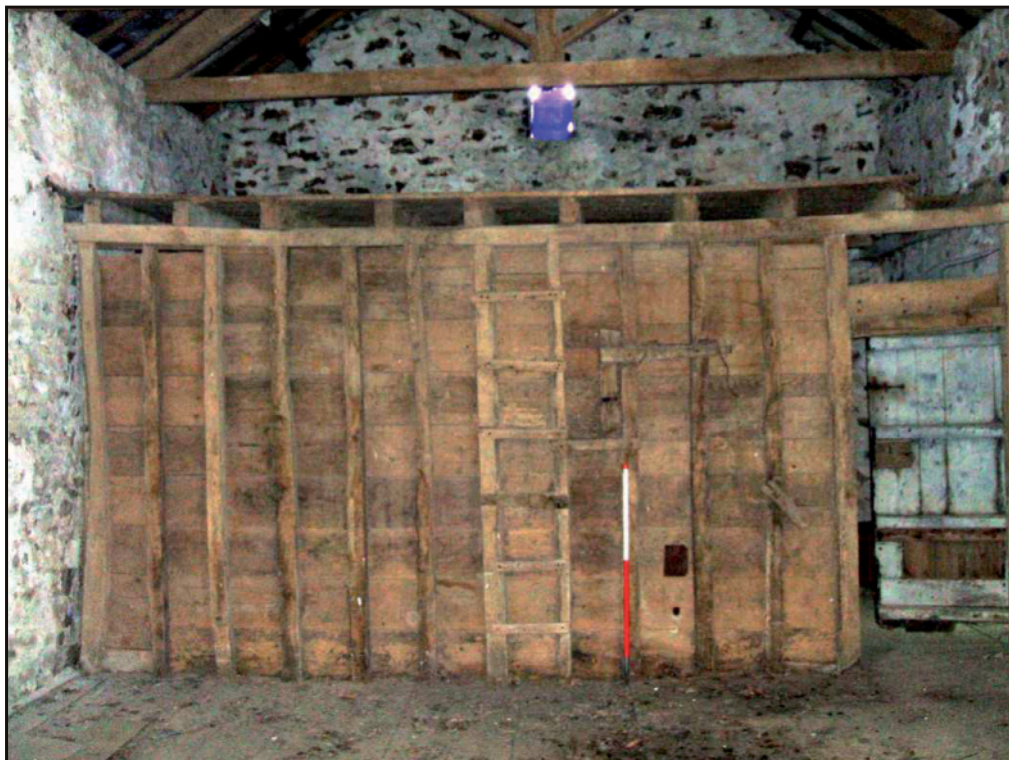
Photo. 4 First floor showing partition, looking west. 1m scale.

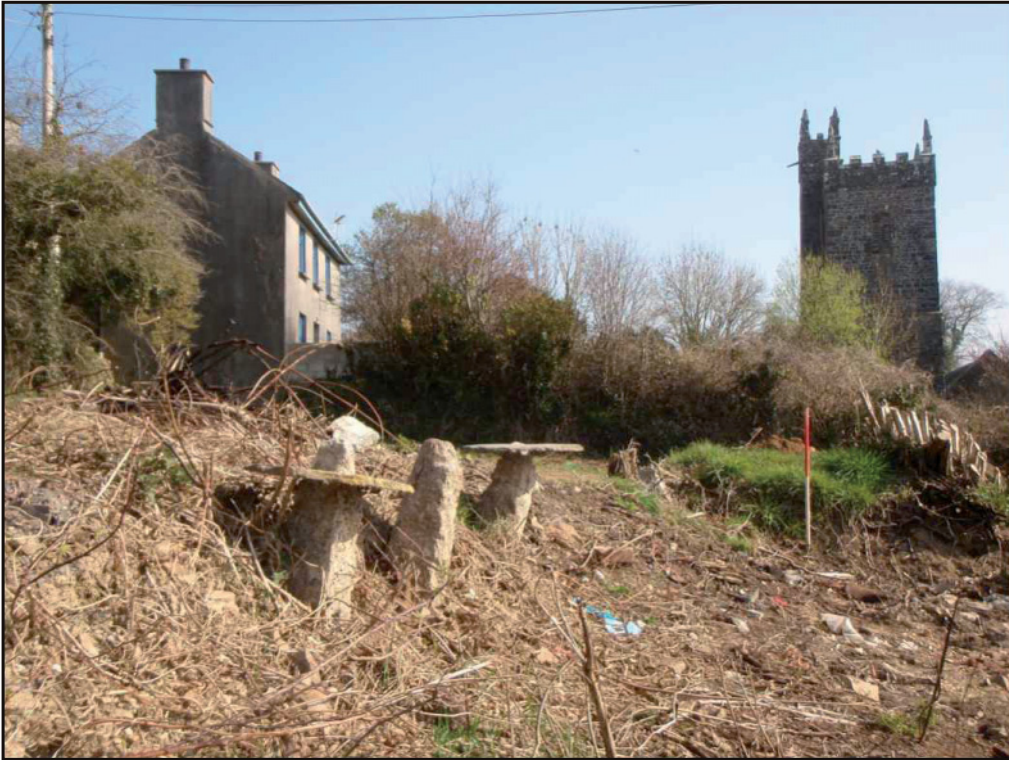
The clearance to the northeast of the barn had exposed a terrace which formerly held a silo. This has a concrete surface and has been partially infilled, mainly along its eastern end. The north side of the terrace is formed by a rotten wooden post, and a row of three granite posts - staddle stones from a small granary (Photo. 5). The posts measure 0.20-0.25m long, have tapered tops and display feather and tare quarry drill marks. Two of the stone posts have slate rings on the top to prevent rats climbing up the posts. These were 0.55 and 0.65m in diameter, and 30mm thick. The posts are on a slightly different alignment to the barn and must therefore represent the building shown on the 1884 OS map. The east side of this area is represented by a stone wall which appears to predate the later 19th-century yard to the south.

The presence of staddle stones indicates the building to the northeast of the barn was a granary. These buildings are rare on Devon farms, and tend to be of 19th-century date, and often sited above stables. The building was probably demolished when the barn was extended to the east, which would have required the removal of its south wall (see Figs 3 and 4).

Photo. 5 Granite staddle stones to the northeast of the barn, looking east. 1m scale.

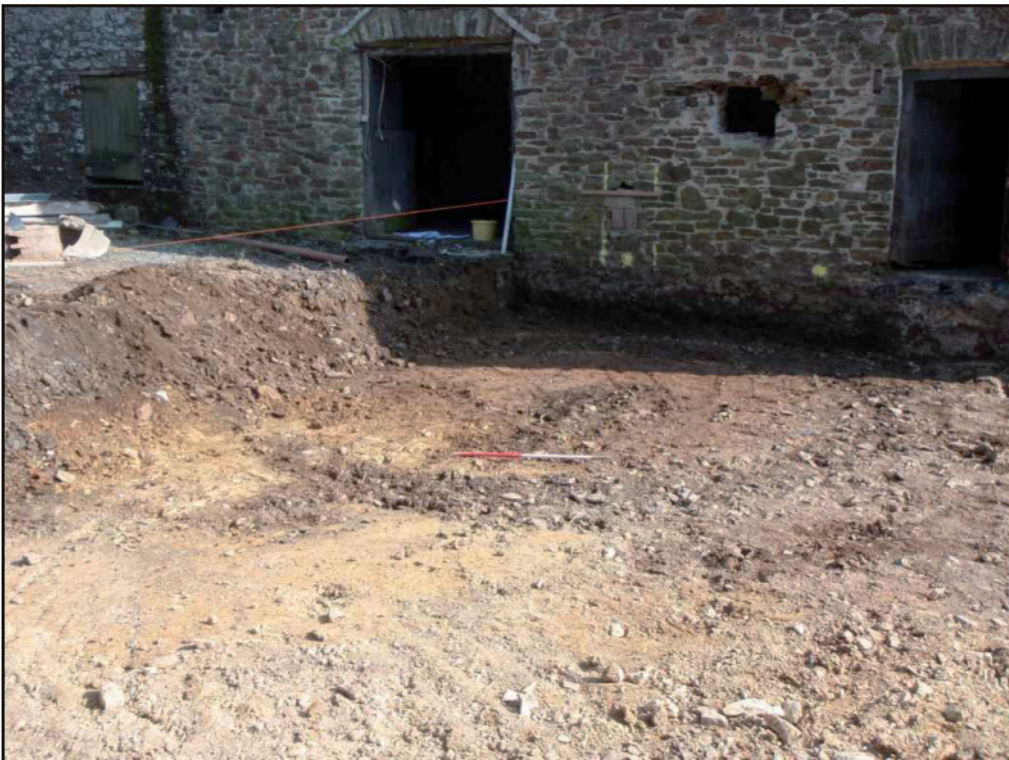
In the base of the terrace the outline of the engine house was revealed. Two substantial postholes were exposed (11 and 4), the latter containing the remains of a wooden post. On the east side of the excavation a granite post, measuring 0.40 by 0.30m wide and 0.70m high, was also revealed. The central post within the horse-engine had been removed, leaving a disturbed hollow infilled with shale and a charcoal-rich brown soil (10). Adjacent to this disturbance was a layer of greyish brown firm silty clay (9). Outside this was a circular path on which the horse/s would have walked (Photo. 6). This comprised a 0.65m wide area of cobbles (7), defined by 0.2m wide raised edgings of yellow clay and stone cobbles (6 and 8). Outside the west door of the barn lay the remains of a stone surface bonded in cream mortar (5); elsewhere this has been truncated during demolition of the engine shed.

Following demolition of the engine house, the terrace had been filled with a deposit of rubble and brown silty clay soil (5). Finds from this material included parts of a gear, horse harness and a sandstone sharpening stone. To the north of the position of the engine house a terrace for the 20th-century shed had been cut into the natural to a depth of 0.30m.

Photo. 6 Excavated remains of the horse engine, showing the hole for the axle in the adjacent wall of the barn, looking south. 1m scale.
