**AN HISTORIC BUILDING SURVEY  
OF THE NEW COOPERAGE,  
ROYAL WILLIAM YARD, STONEHOUSE,  
PLYMOUTH**

**Prepared for Urban Splash**

**Exeter Archaeology**

**Report No. 11.51**

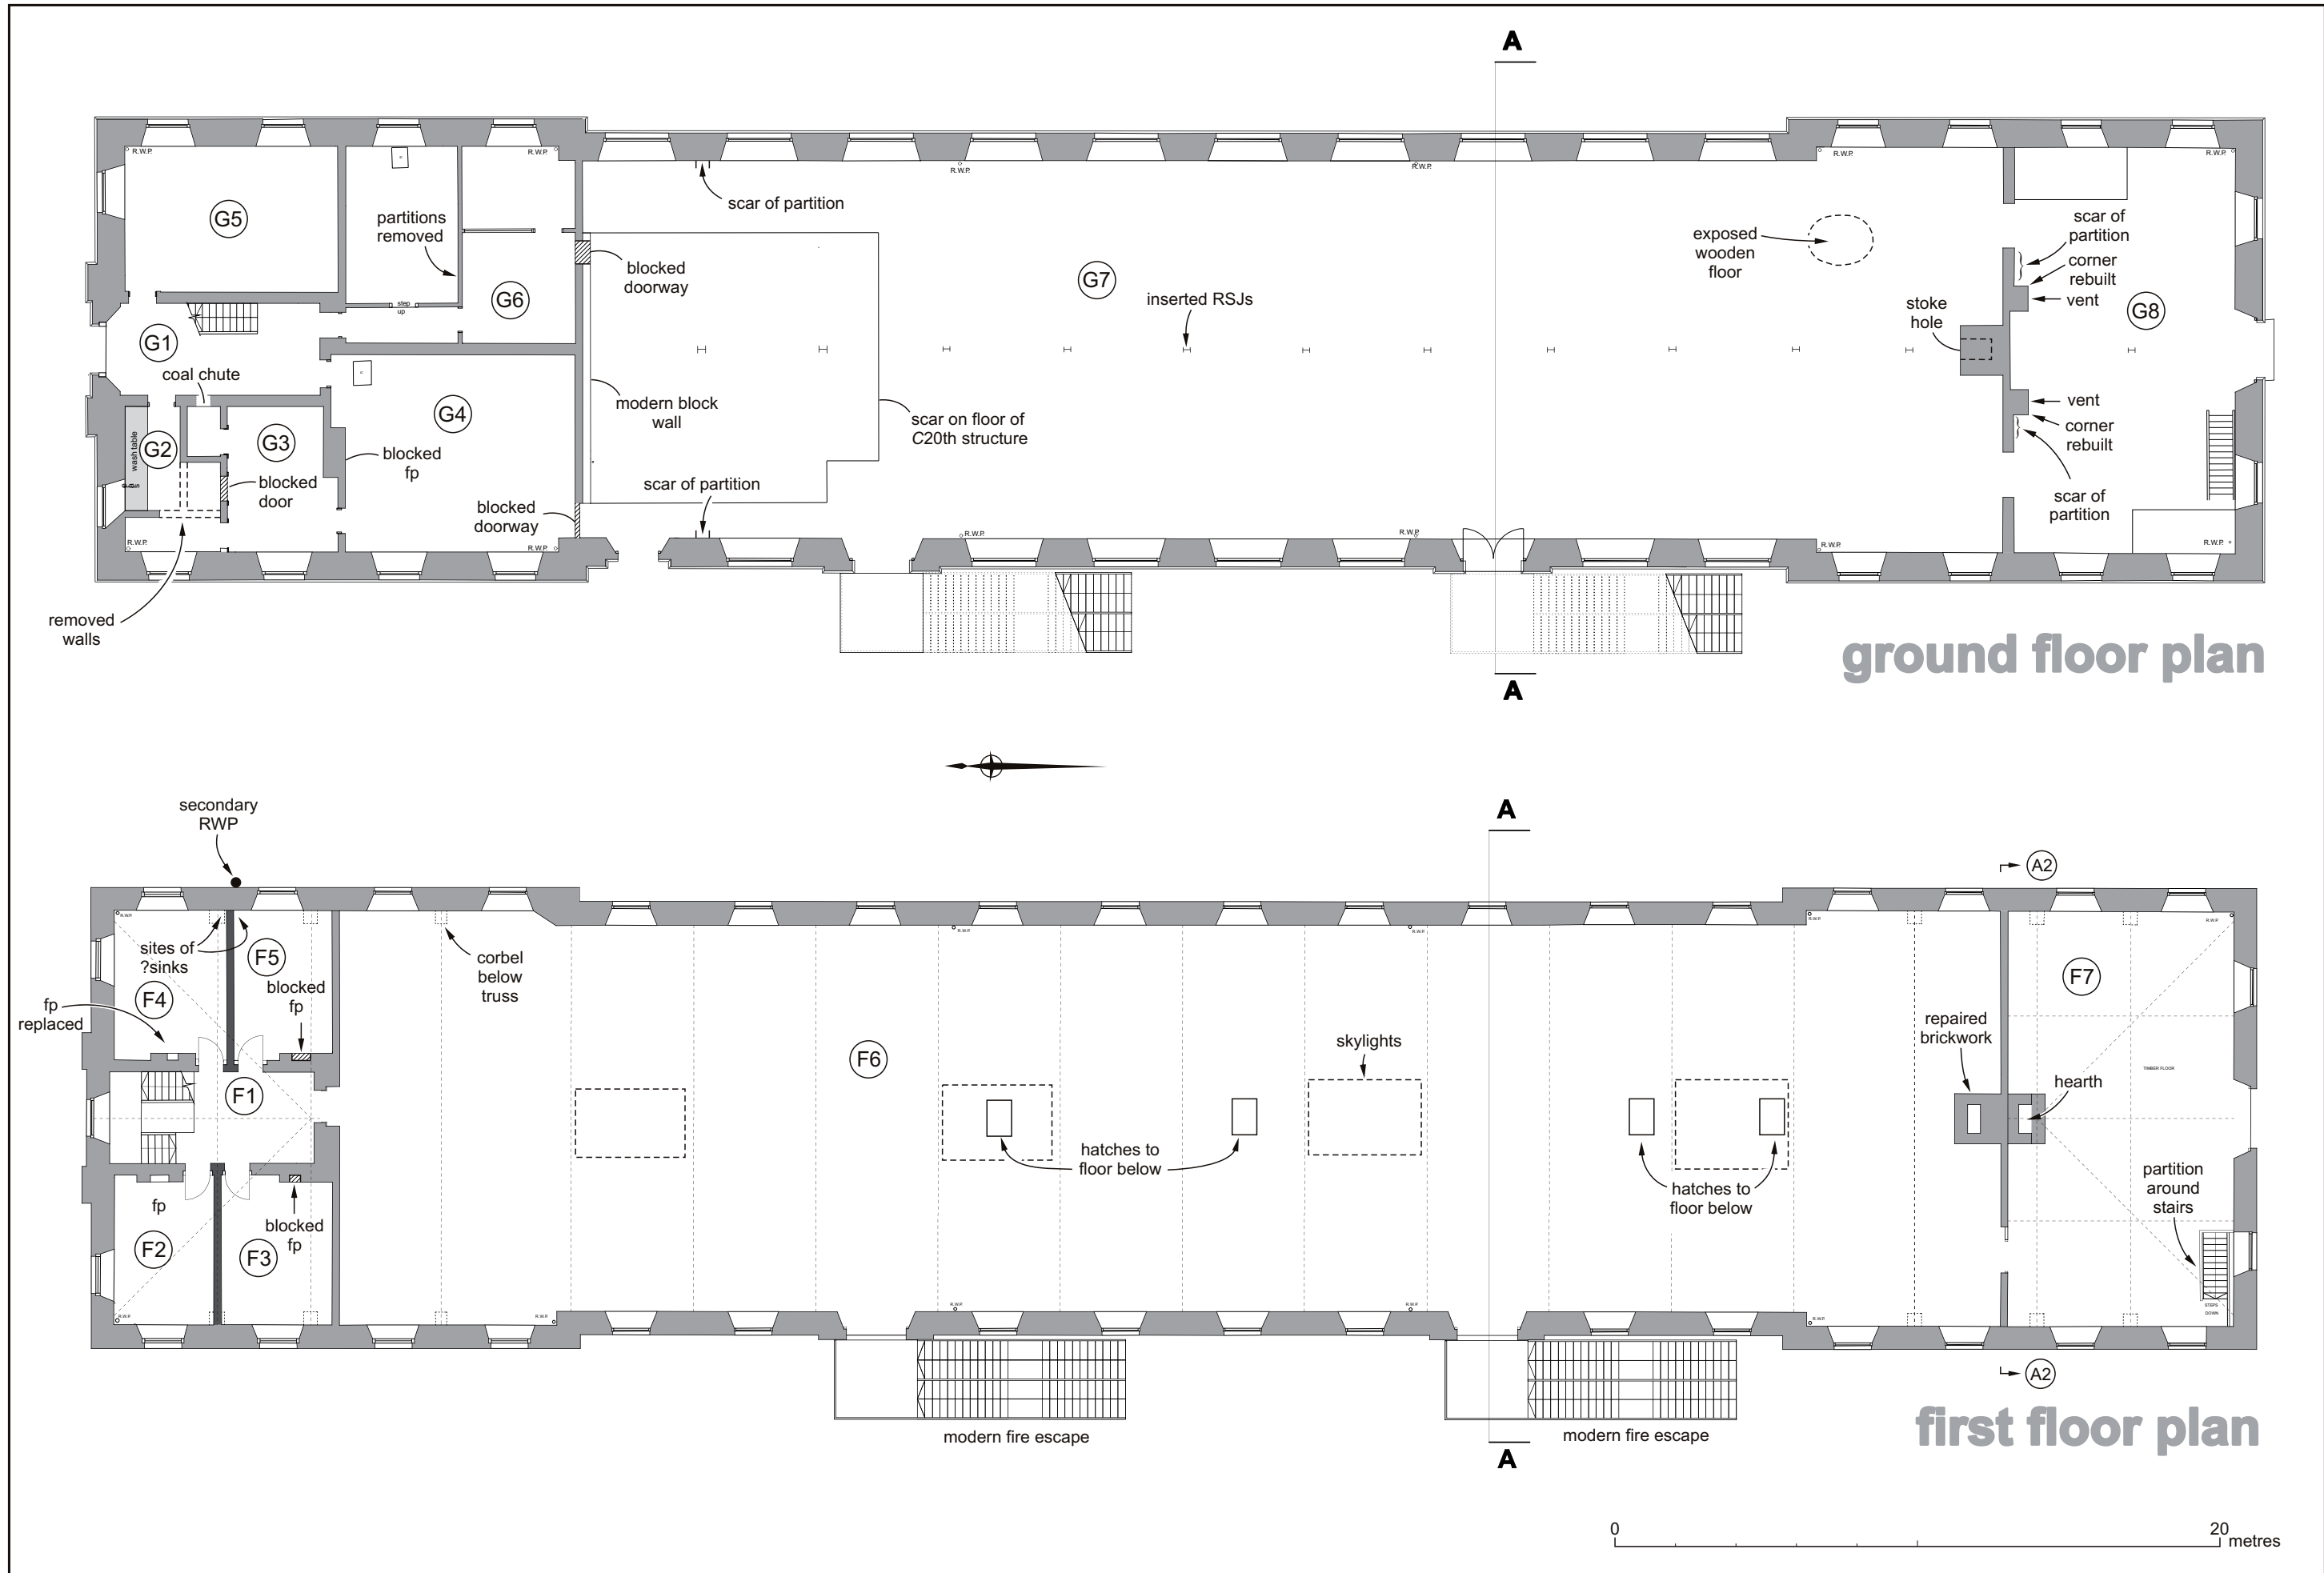
Fig. 4 Ground and first floor plans of the building.

The central door in the north elevation leads into an entrance lobby (Fig. 4, G1) which has a concrete staircase, with steel handrail, leading up to the first floor. This lobby currently provides access into five rooms, although this arrangement differs from that depicted on the 1910 drainage plan. Throughout the building most of the original door frames survive *in situ*; in rooms F2-F5 the doors are also in situ, but elsewhere they have been removed for refurbishment.

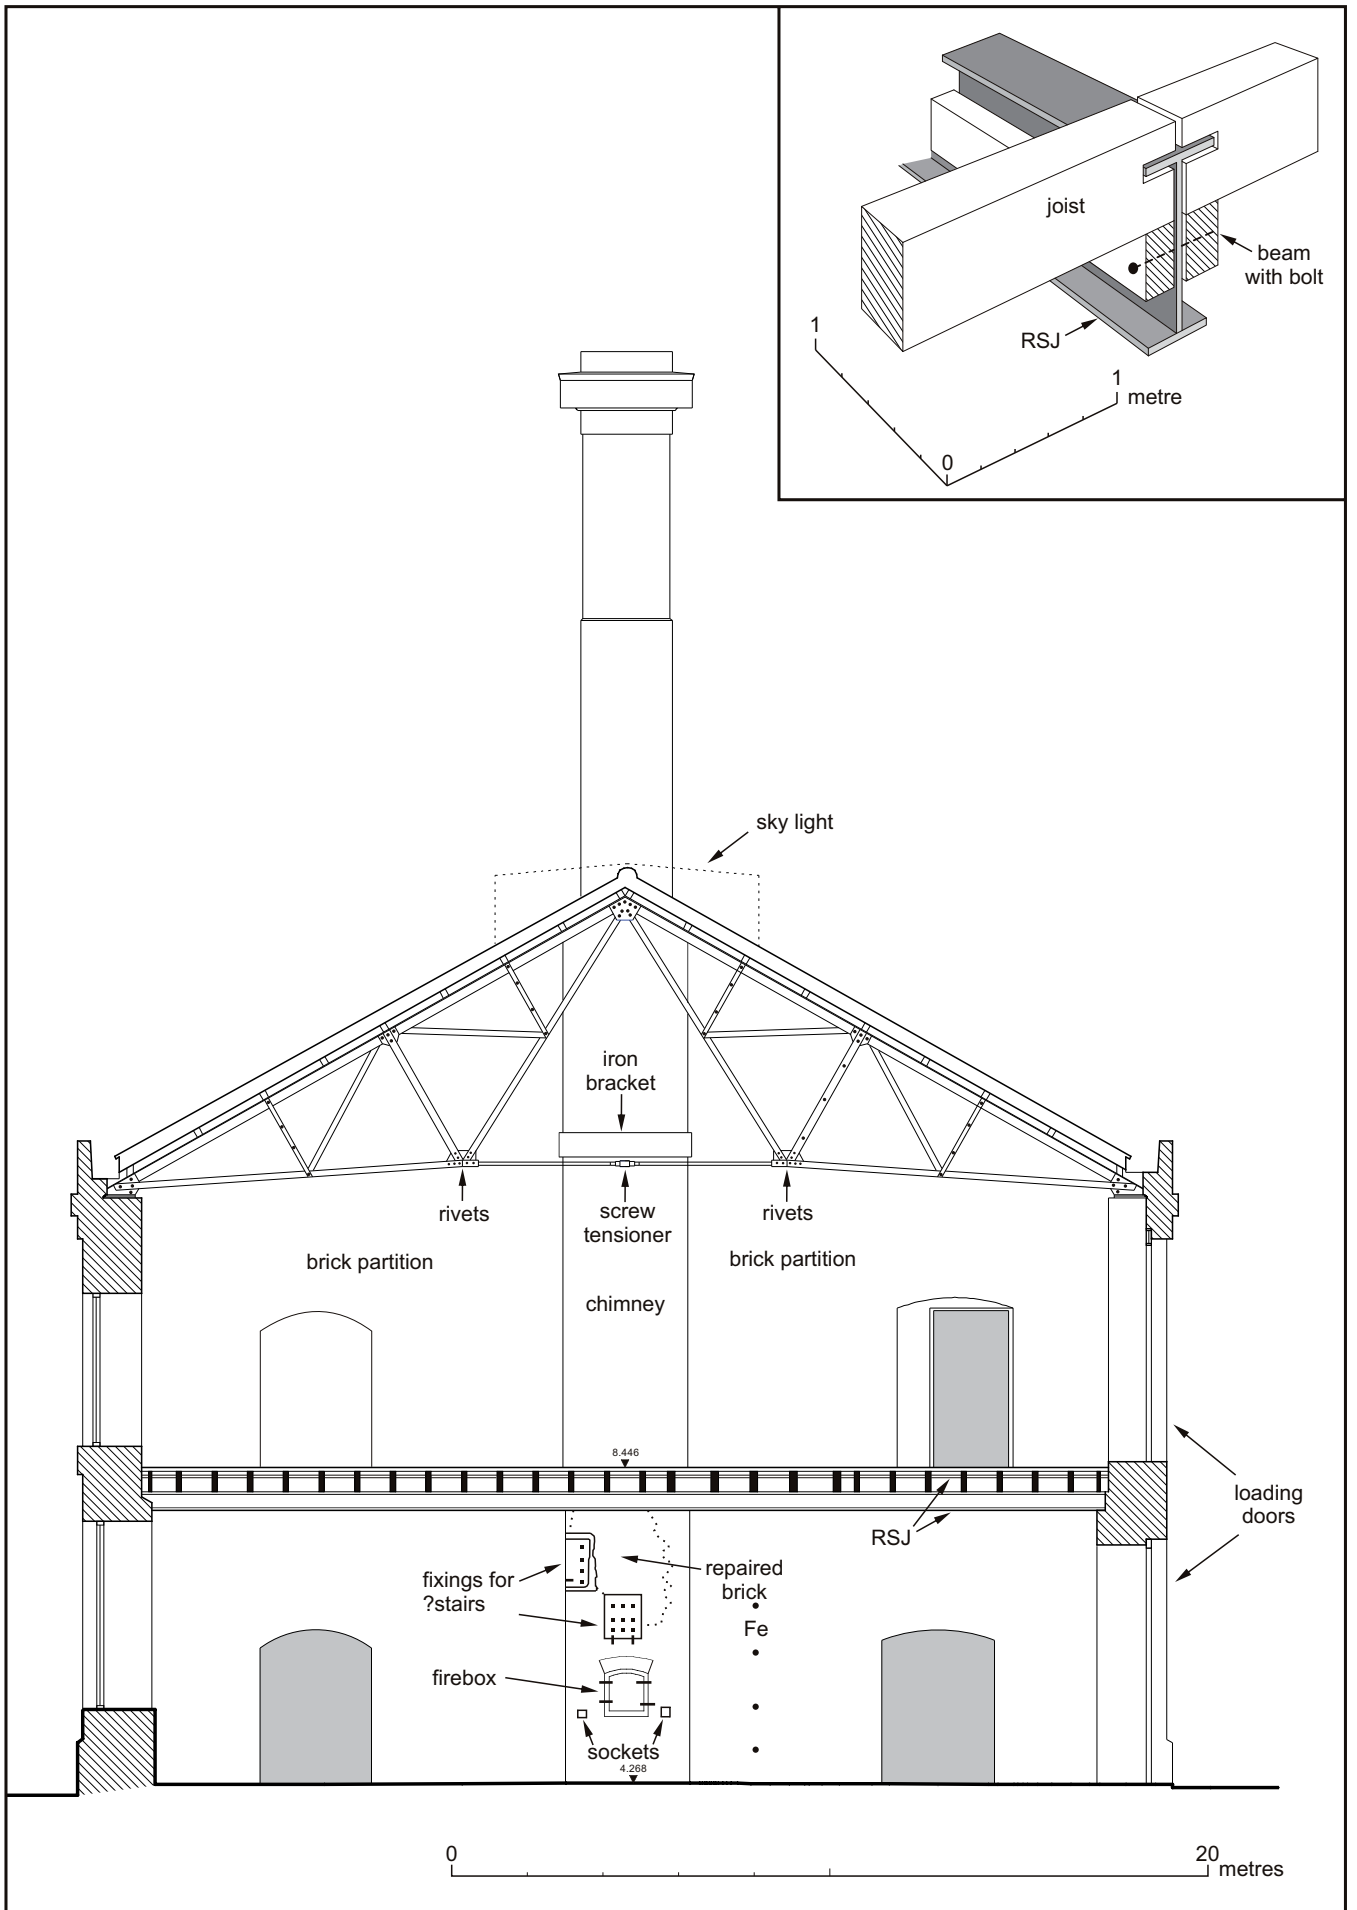
Fig. 5 Profile A-A through building and the partition wall along profile A2-A2. Inset showing detail of first-floor construction materials.

The first-floor is supported on a complex ‘beam’ and joist arrangement. The floorboards rest on rows of closely-spaced joists that span each bay. At their junctions, the joists are attached over the top of tall rolled steel joists (RSJs). The lower sides of the joists are supported by horizontal beams either side of the vertical element of the RSJs. These are attached to each other and the RSJs using nuts and bolts. Scissor braces are used between the joists. Two RSJs were required to span the width of the building, and these are fixed along the central axis of the building using external plates fixed with rivets. In general, this arrangement was originally visible, and the wooden elements were painted white. However, in room G8 nails (for laths) in the bottom of the joists indicate this area originally had a ceiling.

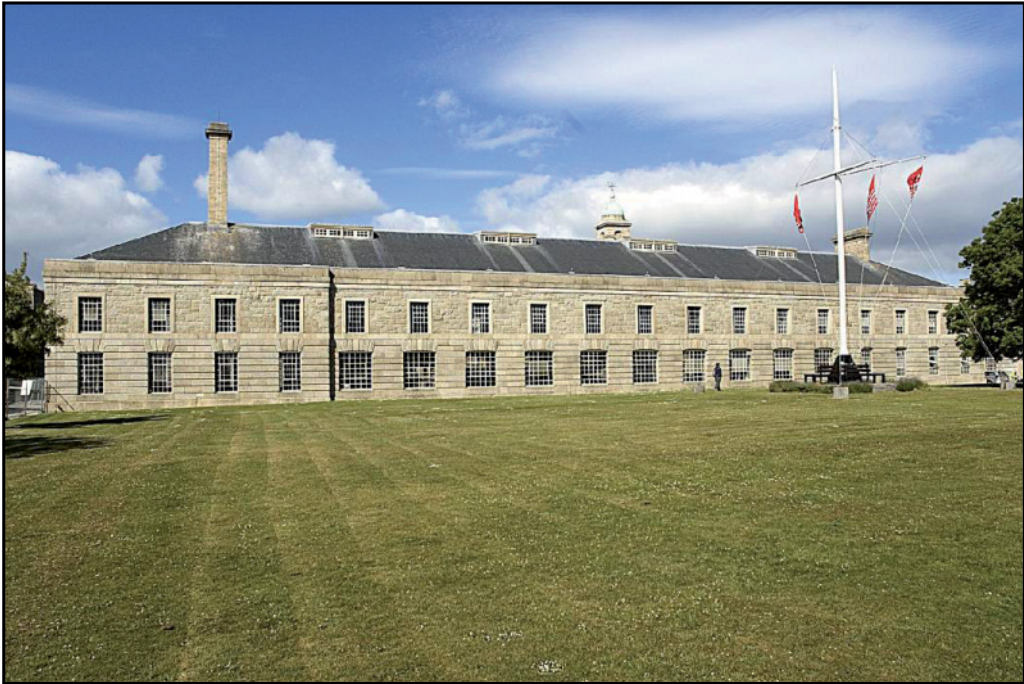
The New Cooperage is located beside the lawn, adjacent and parallel to the east wing of the Melville stores and offices (Fig. 3). The building is 18-bays long and two storied, with four bays at each end projecting outwards slightly from the central bays (Photos 1 and 2). The exterior is faced entirely in granite, which is in contrast to the early 19th-century victualling buildings, which are faced in limestone with granite dressings. The granite is however greyer than that used elsewhere, and must have come from a different source. In general, the 'Georgian Revival' style of the architecture compares favourably with the other buildings in the yard, the presence of plat bands, the design and layout of the window and door openings, and the tall, bold parapet stand out. The main difference is in the treatment of the facing stones. At first-floor level the granite is tooled roughly to a flattish finish, where the limestone blocks used on the upper floors of the other buildings they are dressed with smooth faces.

Photo. 1 East exterior elevation, looking west.

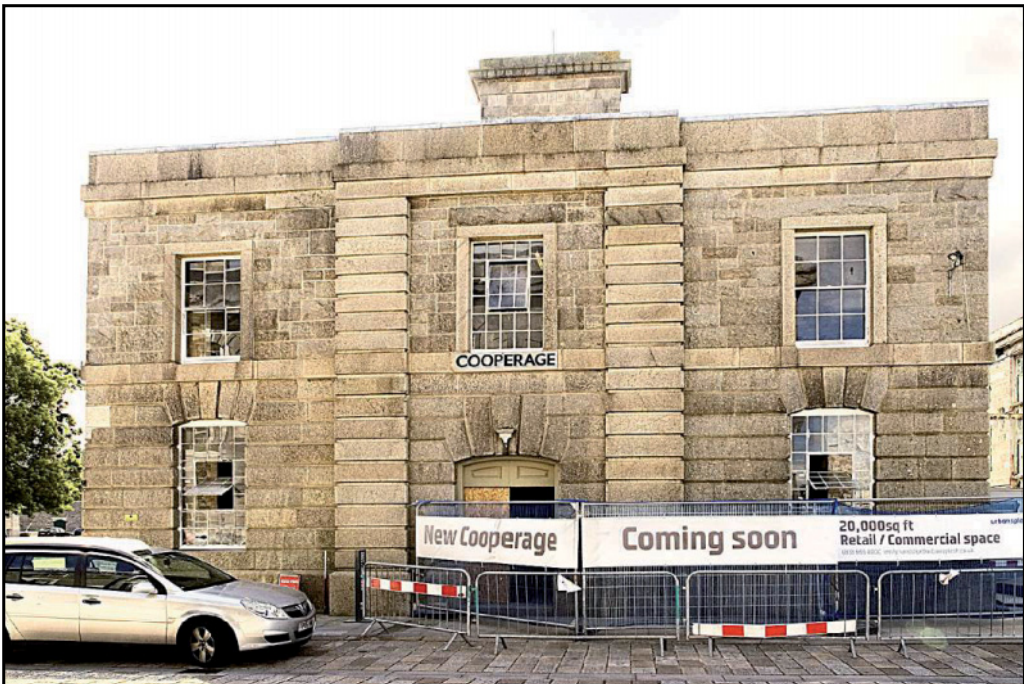
Photo. 2 North exterior elevation, looking south. 1m scale.

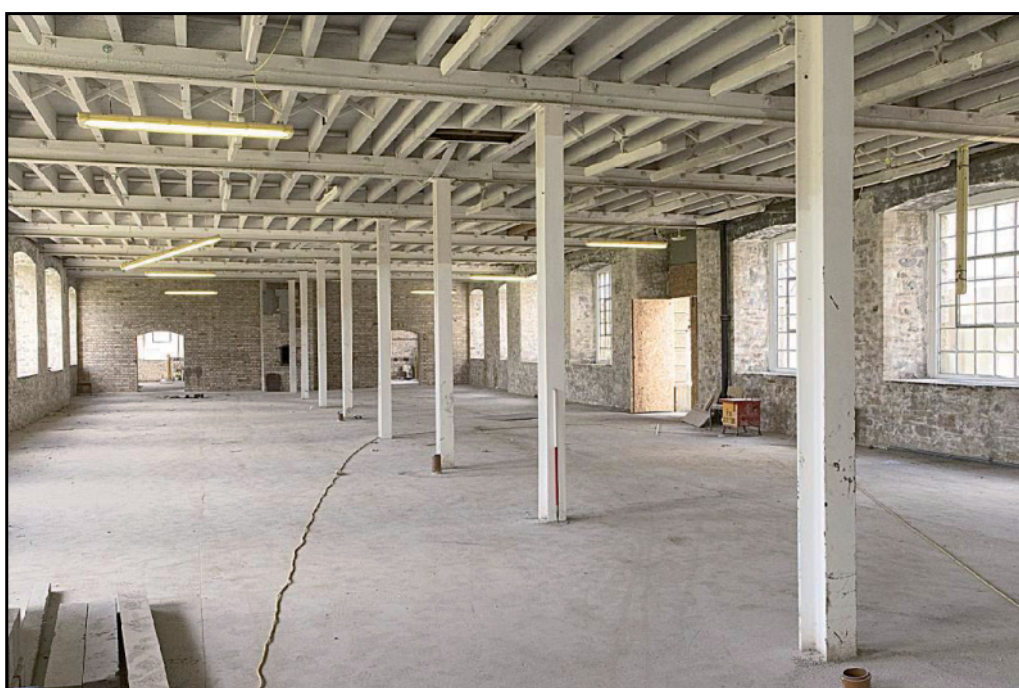
The central part of the building (G7) is currently a large open space (Photo. 4). The 1910 plan however, depicts the northern bay as being a separate room, and also shows a series of structures in the centre of the room. The scar of the dividing wall is visible on the east and west elevations. This room would have been entered using its own doorway in the west elevation. There is no evidence for the other structures, the present concrete floor obscuring any below-ground trace of their footings. In the later 20th century a large partitioned-off area was added to the north end of the room. This has been demolished, but a concrete block wall added against the north partition wall still survives.

Photo. 4 Room G7, looking south. 1m scale.

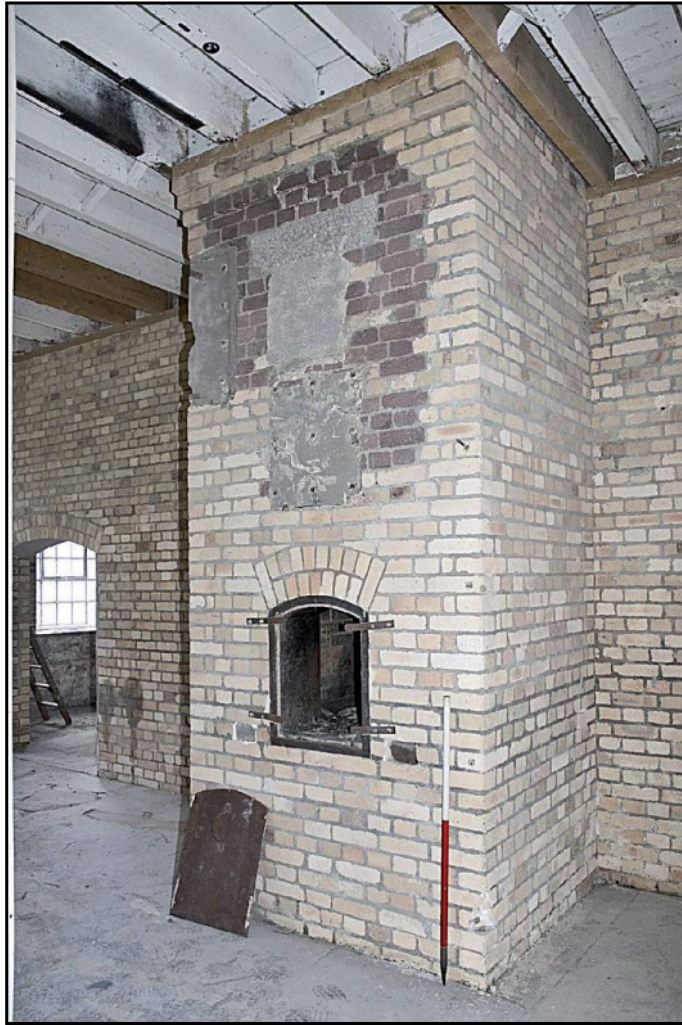
The main historical feature in this room is a brick chimney stack that is integral to the southern partition wall, but projects out into the room (Photo. 5). At waist-high level is a firebox with an iron doorframe and (removed) iron door. Above this is an area of replaced brickwork incorporating an opening – now blocked – with a granite lintel. The function of this opening is not clear, but is it possible that the brickwork reflects the position of a small copper used to heat water. Overlying this brickwork are two rectangular areas of cement with sawn-off metal and wood attachments. These resemble fixings for machinery but in this case may have been for the attachment of stairs leading to the high-level opening.

Photo. 5 Room G7, view of chimney with firebox, looking south-east. 1m scale.

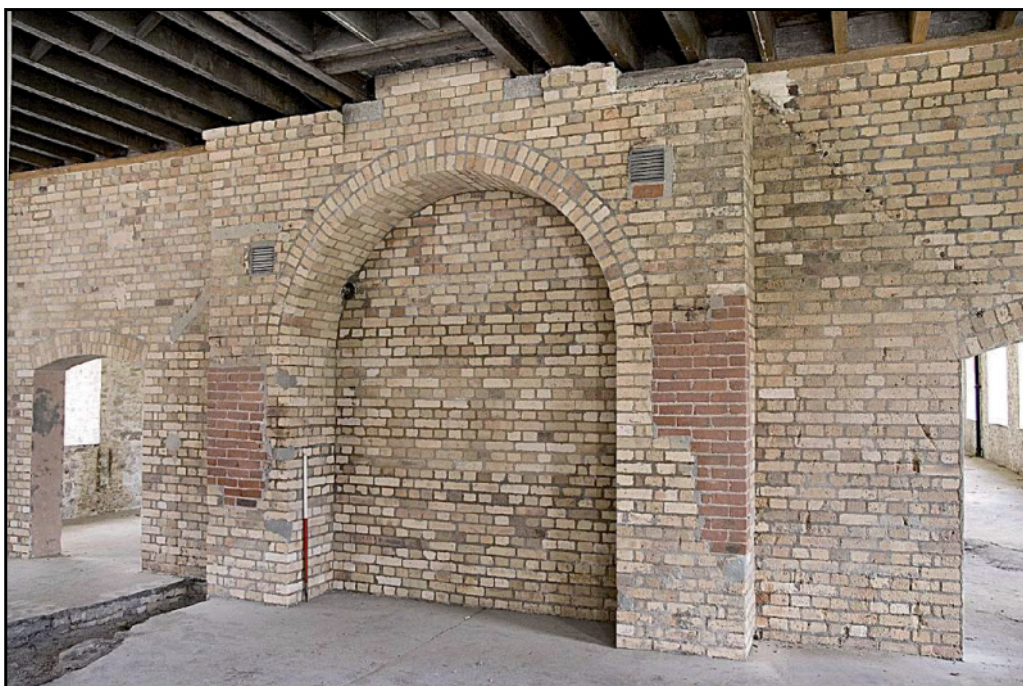
Room G8 is largely featureless. The main features are two brick, curving piers projecting out from the north dividing wall (Photo. 6). In each pier is an inserted high-level vent, below which are areas of repaired brickwork. These features must indicate some form of heating or firebox opening. Either side of these piers are scars of removed partitions. Their locations indicate that they are associated with the piers in some way, although what was taking place here, and why heat was provided, is not clear. In the southeast corner of the room is a steel staircase to the first floor. This has iron balustrades and handrail, and its treads are perforated. Adjacent to the west pier a limited exposure of buff yellow brickwork was noted in a service trench.

Photo. 6 Room G8, north partition wall showing arches, looking north-west. 1m scale.

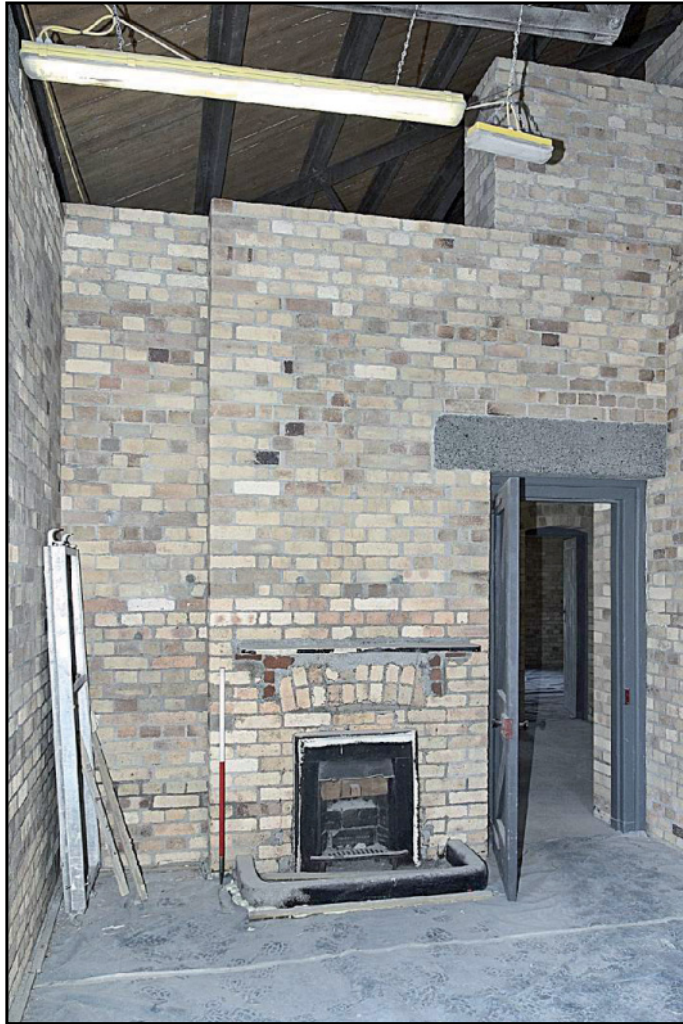
Photo. 7 Room F1, showing the fireplace and door, looking east. 1m scale.

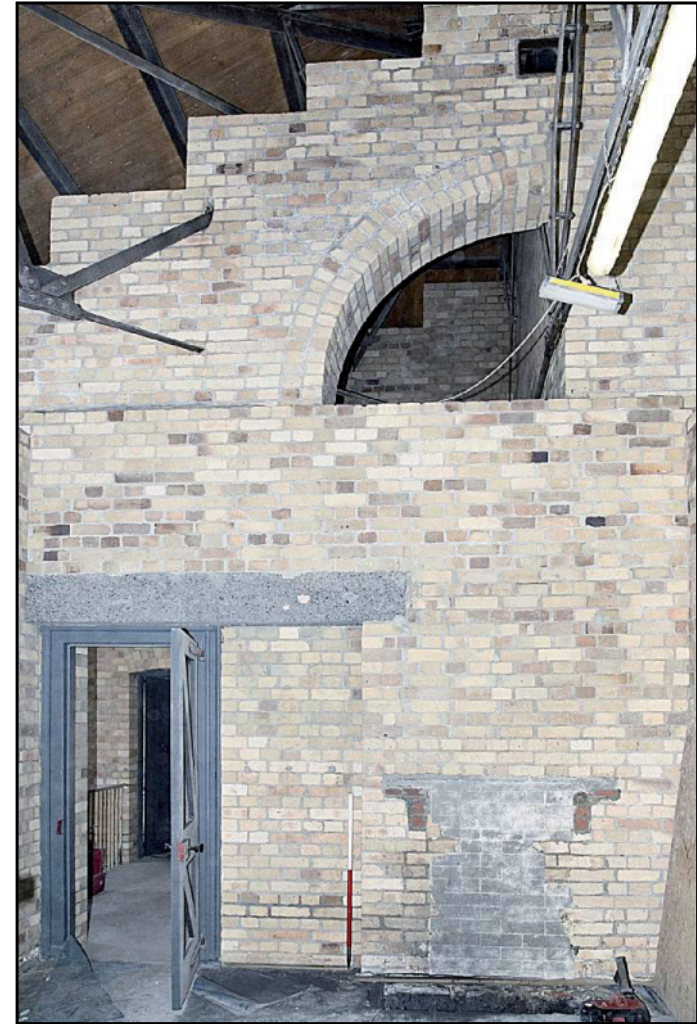
Photo. 8 Room F2, showing blocked fireplace, door and stepped and arched masonry containing flues, looking east. 1m scale.

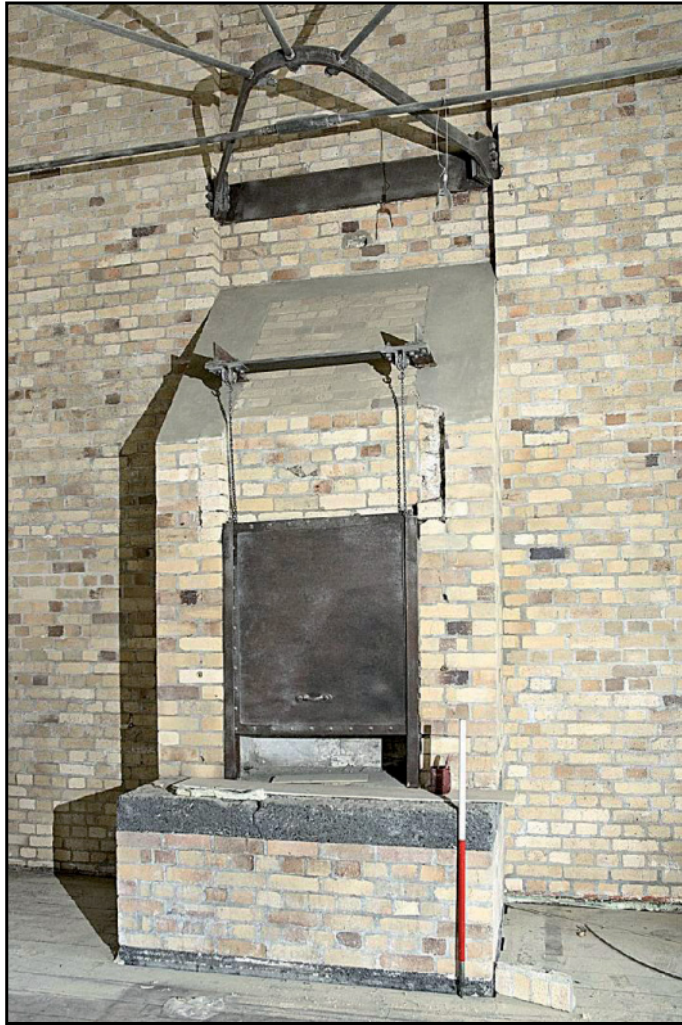
The stairs from room G8 lead into a very small lobby within room F7. Both the lobby and stair opening are divided from the room by a tongue-and-groove partition. The only other feature in this room is a hearth projecting out from the dividing wall with room F6 (Photo. 9).

This has a low concrete base and a firebox with a sliding door. The associated pulley mechanism only partially survives. There is a gas pipe fitting leading into the base of the firebox on its west side.

Photo. 9 Room F7, showing hearth in the north partition wall, looking north. 1m scale.

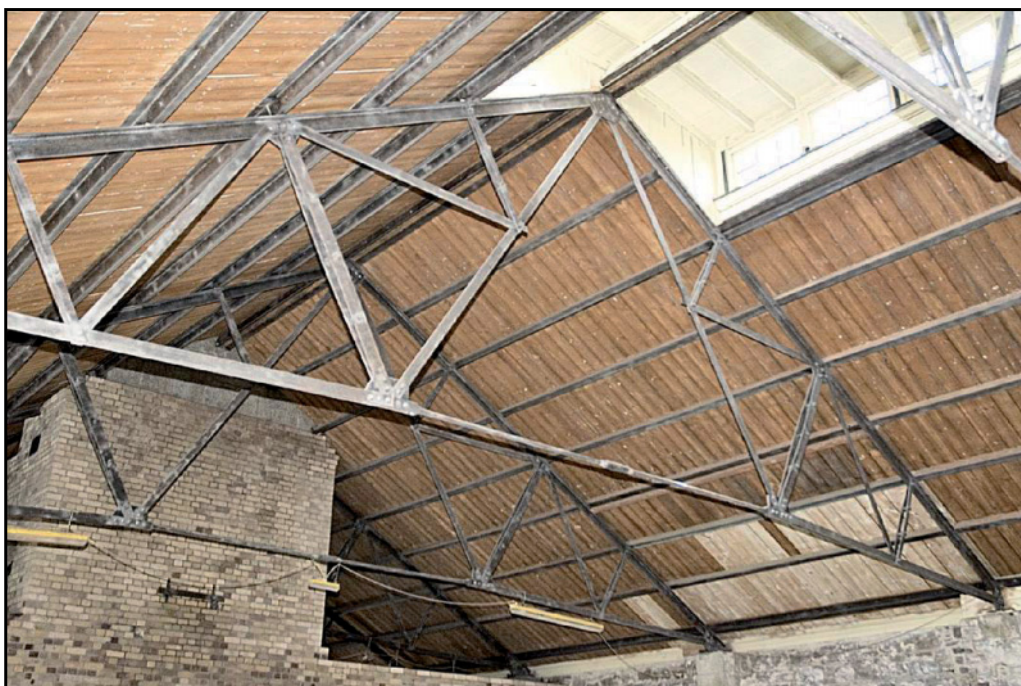
The roof is hipped at both ends, reflecting the arrangement in the earlier buildings, and is supported on 15 trusses with further half trusses supporting the hips (Photo. 10). The trusses are formed using thin steel bars and rods, joined mostly using nuts and bolts but with some rivets. Constructional details can be seen on Fig. 5. On each pitch are nine rows of RSJ purlins onto which boards are fixed. The roof is covered with slate tiles. The hipped ends are supported using half trusses, whose lower ends terminate on curved brackets that pass through the brick partitions. The main trusses rest on granite blocks (the equivalent of sole pieces) in the tops of the walls. However, in the wider end bays the trusses are the same width, and rest on projecting, tall granite corbels. This indicates that the roof was prefabricated, and was not designed to fit the shape of the building.

Photo. 10 View of the roof trusses and skylight above room F6, looking north-east.
