**HISTORIC BUILDING RECORDING  
AT KIGBEARE MANOR FARM,  
SOUTHCOTT, OKEHAMPTON**

**Prepared for Mr and Mrs Carragher**

**Exeter Archaeology**

**Report No. 11.55**

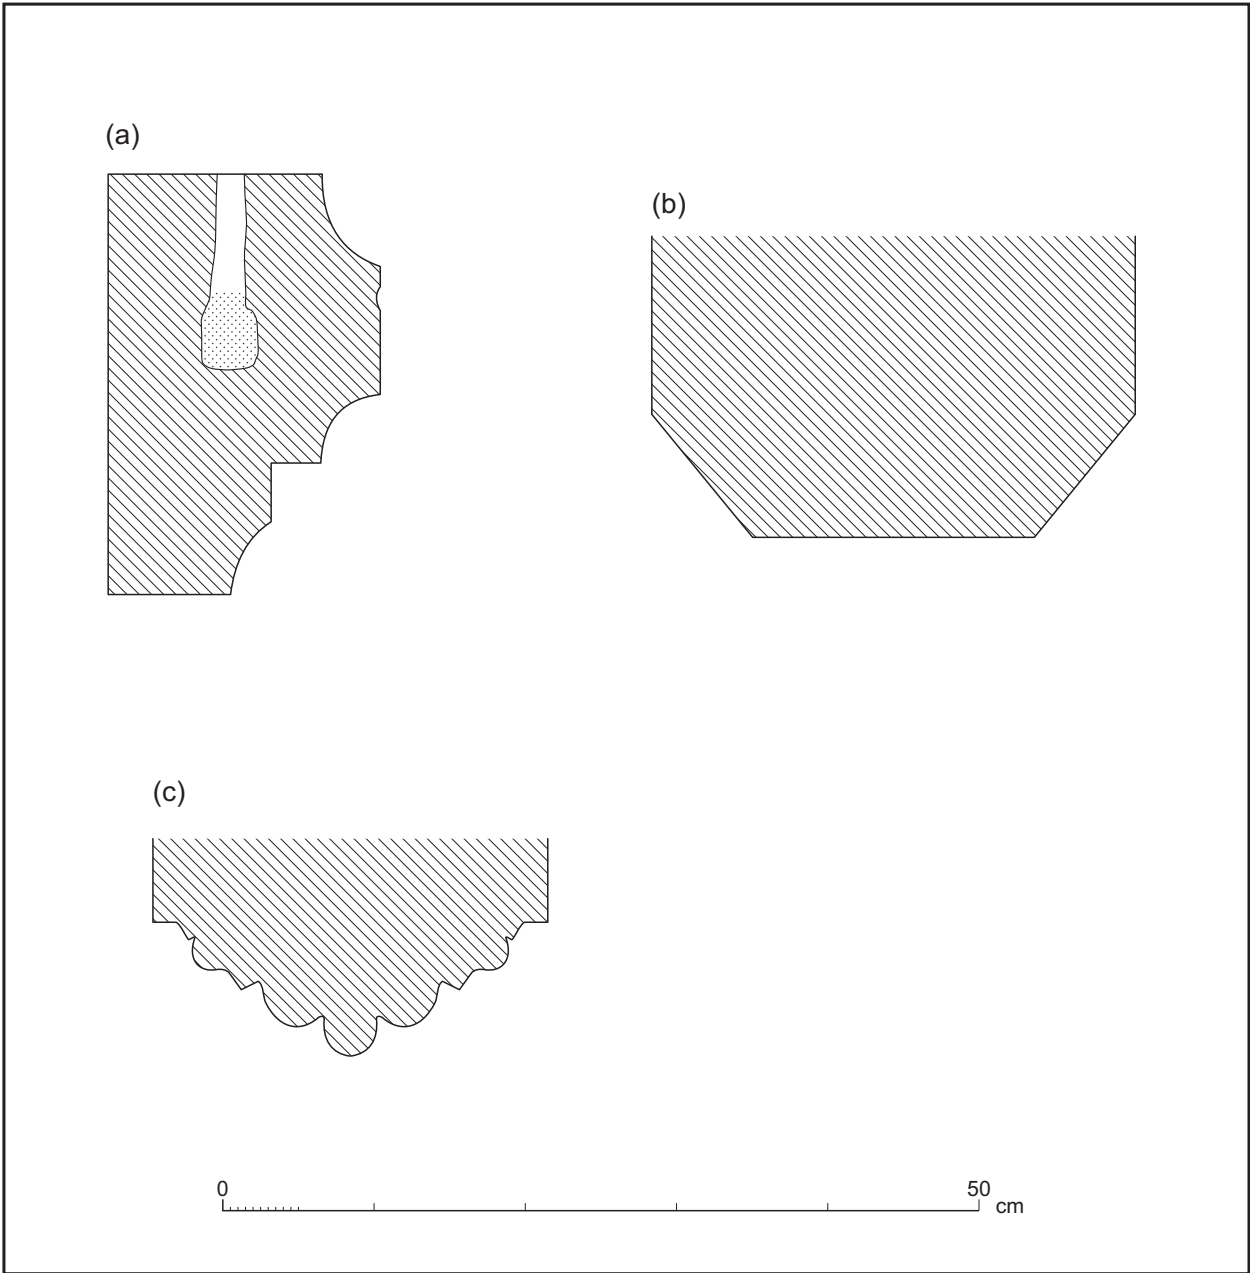
Within the farmyard are three agricultural and architectural relics. The architectural fragment is a granite door jamb with a rebate and hollow chamfers (Fig. 9). The agricultural items are a granite apple crusher brought into the site by the last owner, and a large, possibly early (given the use of crude iron nails), cider press. If this press originated on this site (i.e. it has not been brought in) then it must have been housed in the threshing barn since this is the only building tall enough to house the machinery.

Fig. 9 Architectural details: (a) loose door jamb in the farmyard, (b) chamfered beam in the cottage and (c) moulded intersecting beam in the cottage.

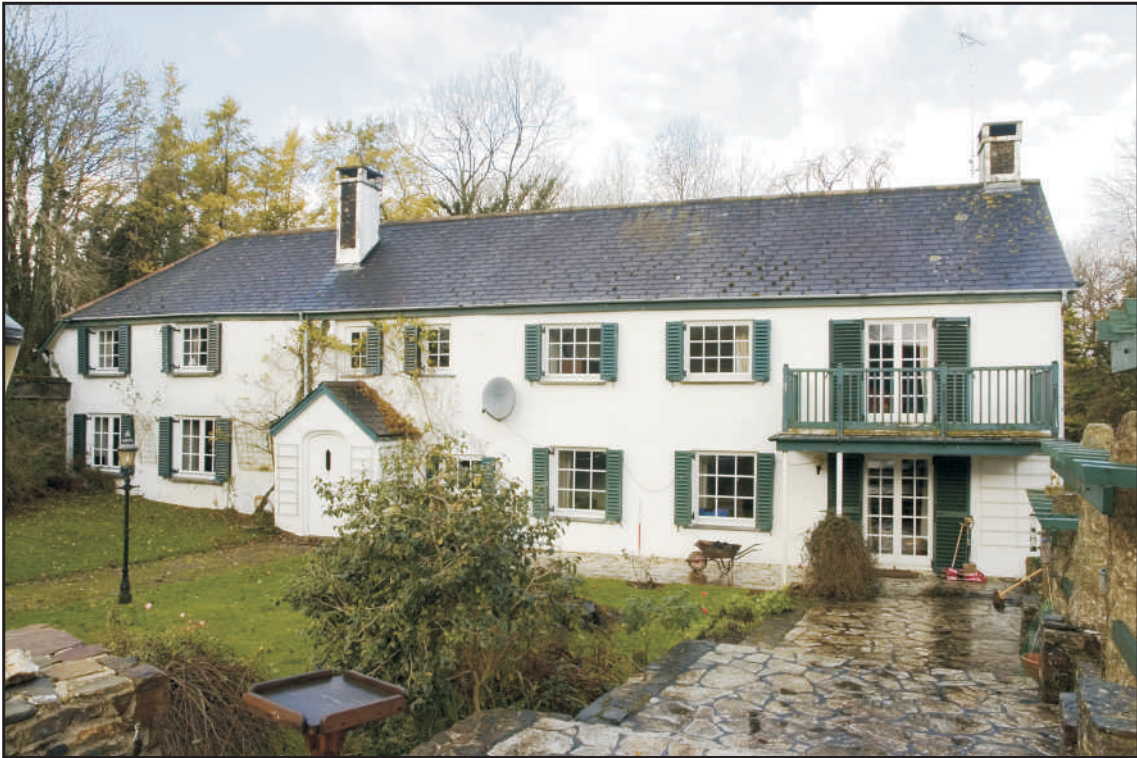
The farmhouse is located along the northwest side of the farm, with the main range aligned northeast to southwest (Photo. 1). To the northwest of this main range is a small courtyard garden flanked by further domestic ranges. The exterior appearance of the house building is dominated by large modern, 12-pane windows on both storeys, almost all with exterior shutters. The building's origins as a 3-room and cross-passage house can however be discerned, through the position of the porch defining the entrance to the cross passage, and the location of the chimney stacks, possibly inserted into some of the main rooms. Internally, most of the fixtures and fittings are also of modern origin.

Photo 1 The farmhouse, looking west. 1m scale.

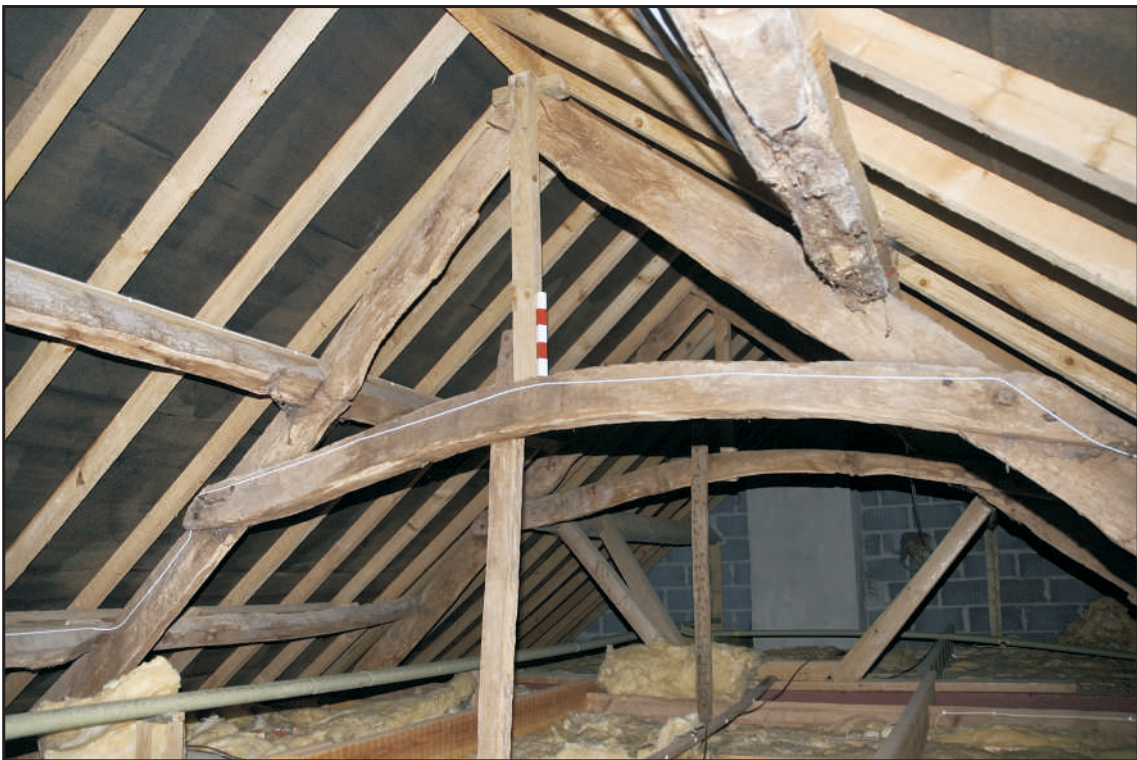
The roof over the eastern part of the house is supported on five trusses with principal rafters whose apexes are joined with a notch and a mortice and tenon, fixed with a peg (Photo. 2). The rafters are braced with halved lap-jointed arched collars, fixed using pegs and nails. These features indicate a construction date of around *c.* 1700. Some of the purlins are missing, but the remainder are a mixture of back and trenched purlins, with scarfed joints behind the trusses. Many retain pegholes for the attachment of batons. These trenches and purlins do not continue into the eastern bay, and this is evidence for this end of the roof having originally been hipped, rather than straight as in the present, rebuilt gable.

Photo 2 The roof of the main range of the farmhouse, looking northeast. 0.25m scale.

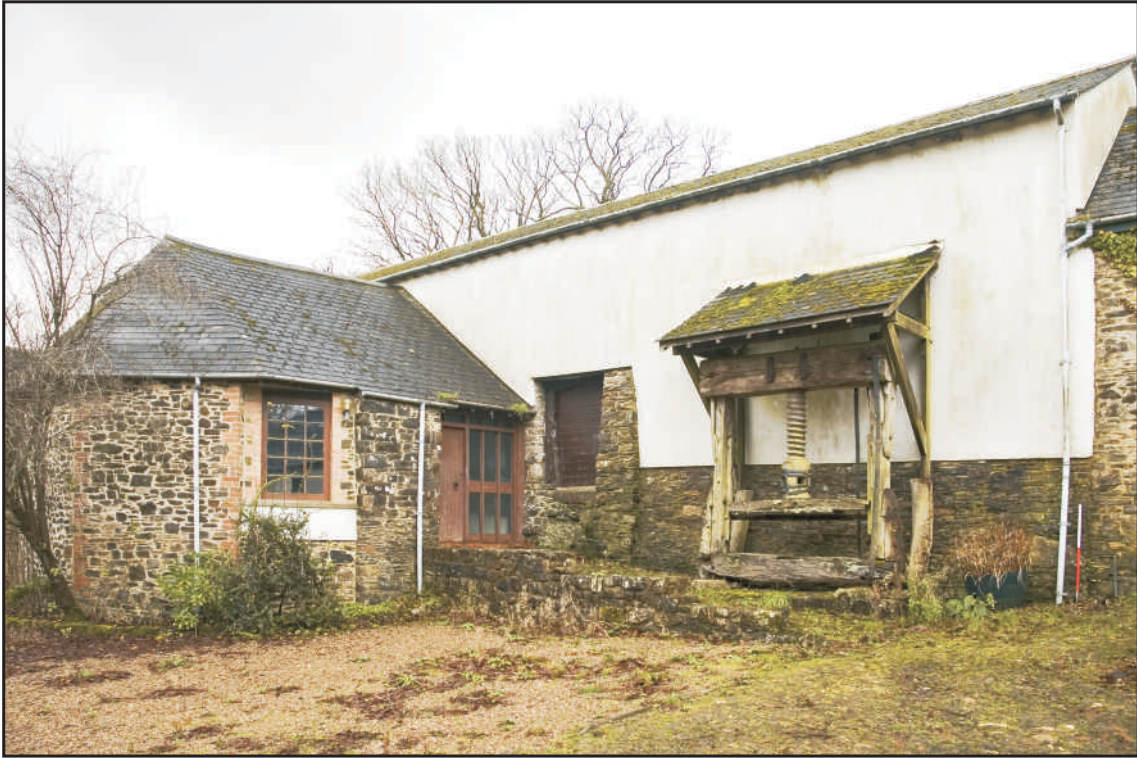
The threshing barn forms the southeast side of the farmyard and is the earliest of the farm buildings (Photo. 3). At 26m long the building is unusually large, which may reflect a high production of wheat on the farm. It is however, possible that the southern end of the barn is an extension. The building is constructed of rubble slate, with granite used for the quoins, bonded in hard white lime mortar. Parts of the northeast and southwest elevations are also constructed of cob, which on the latter elevation has been extensively rebuilt using brick, as well as concrete blocks piers supporting the roof trusses. The majority of the external elevations along with the internal northeast elevation are rendered. The building has a modern raised concrete floor, and the position of the doors and floor level in the adjacent engine house indicates the level has been raised by up to at least 0.50m.

Photo 3 The threshing barn and engine house, looking south. 1m scale.

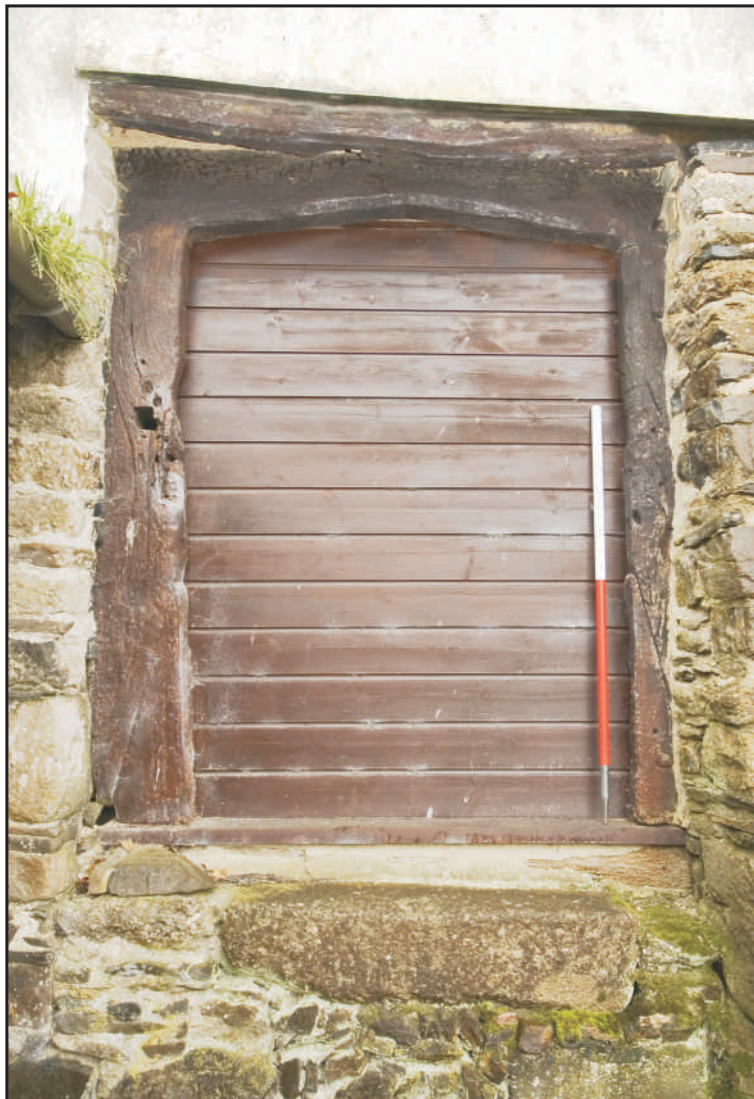
The barn is also unusual in the positioning of its doors. The building has two pairs of loading doors (which is not uncommon in larger barns and indicates the presence of double threshing floors), but whilst the openings in the southwest elevation (that faces southwest onto the prevailing wind and towards the fields) are typically tall and wide (to accommodate double doors) the openings on the northeast elevation are smaller. The current doors and their frames in the southwest elevation are modern, but chases for earlier door frames are present within the wall fabric. In the northeast elevation the southern door opening has been narrowed, which may be associated with the construction of adjacent engine house. The top modern step is a reused wooden beam that displays boltholes for the attachment of a circular iron post, along with two further boltholes. The north doorframe has been reused and comprises vertical wooden frames with a four-centre arched wooden lintel (Photo. 4). The lintel has a slight chamfer, which also partially extends down the frames, and is attached to the frames using pegs. The opening is blocked, but on inside of the frame displays secondary wooden brackets for door latches associated with the doorframe in its present position. The door frame originated in a domestic context, almost certainly from an exterior door, perhaps from the cross passage into the farmhouse. The north post incorporates a series of peg holes on its inside faces that may indicate a wooden partition (possibly a screen) was originally attached. Adjacent to both the doorways on the northeast elevation there is a single pier, with no evidence of a corresponding pier on the other side of the doorways.

Photo 4 The reused door in the threshing barn, looking southwest. 1m scale.

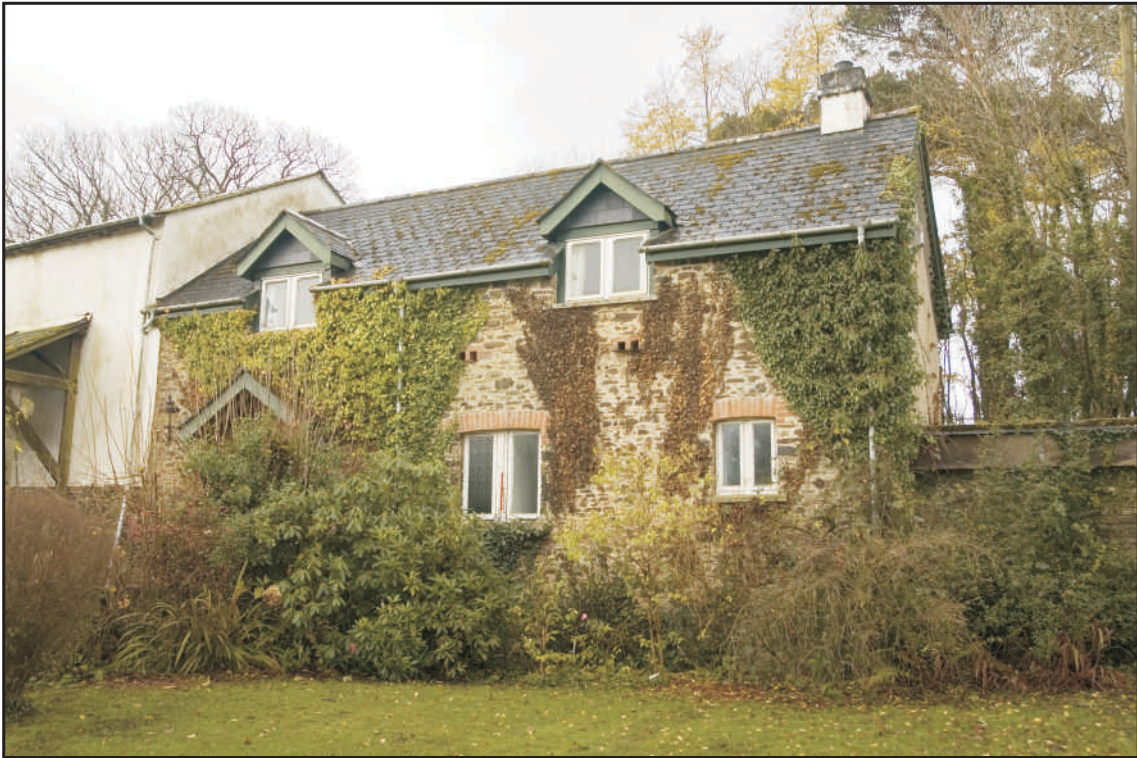
The cottage is attached to the north-west side of the threshing barn and may date to the late 18th or early 19th century (Photo. 5). The building is constructed of small slates and rarely blocks of granite, with granite quoins, bonded in gravelly white lime mortar. The building has been heavily altered several times during the 20th century. Where visible, all internal walls are constructed of plasterboard or concrete block, the latter material also being used to infill window reveals. A series of pigeon nesting holes are incorporated into the north-east elevation. The original layout is not known. However, the fenestration, although altered, appears to be original, and the positions of the stairs and fireplace may well reflect the original layout. On the first floor alterations have taken place to one of the window openings in the northeast elevation. The roof is covered with slate and is pierced by a chimney stack and first-floor dormer windows. Most of the trusses have been replaced but some principal rafters with halved lap-jointed apexes survive.

Photo 5 The cottage, looking southwest. 1m scale

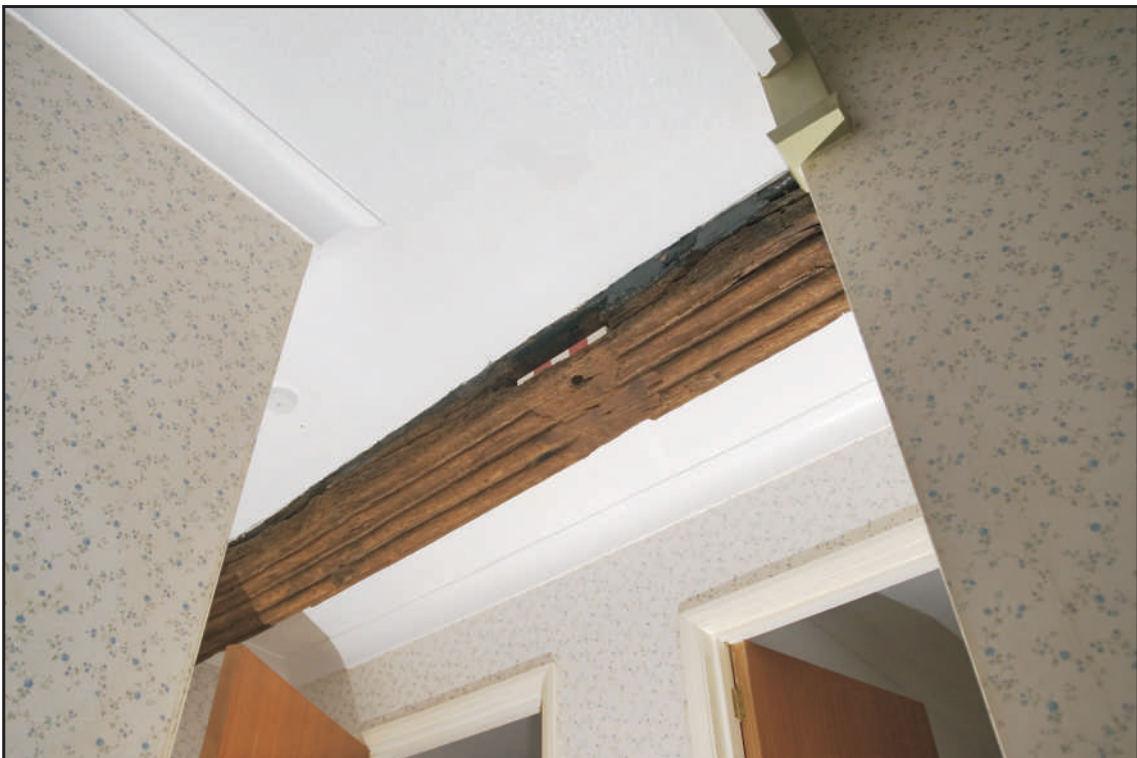
Almost all of the internal fixtures and fittings are modern. However, two beams have been reused to support the first floor. One beam displays large plain chamfers and has a mortice socket in its bottom face for a vertical post, and another socket in a side face for a smaller horizontal timber, probably a floor joist. The second beam is elaborately carved (Photo. 6) and would have formed part of an early 16th-century moulded intersecting beam ceiling, a type of ceiling found in some grand farmhouses and properties of wealthy individuals (e.g. as at Bowhill, a rural house now within the boundary of urban Exeter; Blaylock 2004, 112-117).

Photo 6 The reused beam from an intersecting beam in the cottage, looking southeast. 0.25m scale.

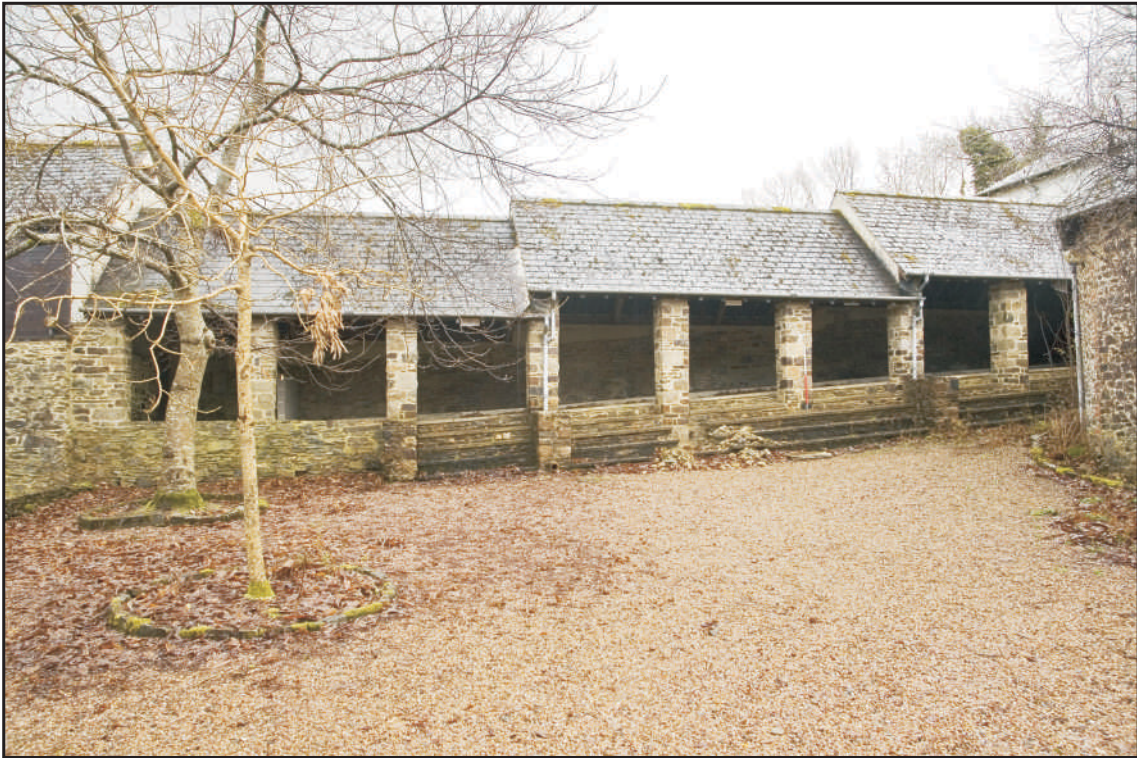
The shippon is attached to the threshing barn and forms the south range of the farmyard; the elevation onto the courtyard is open fronted (Photo. 7). The masonry is roughly coursed slates bonded in soft lime mortar, although in the east elevation a pale yellow stoney cob has also

Photo 7 The southern range shippon, looking southeast. 1m scale.

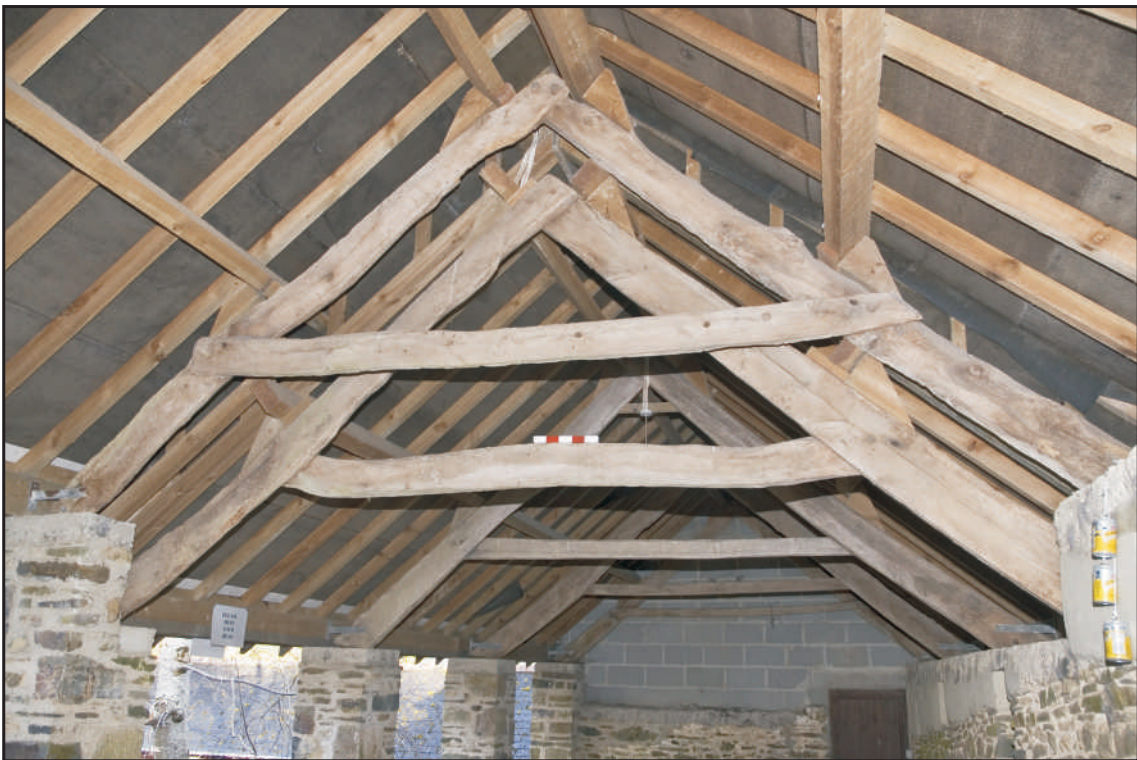
The roof has been replaced and the trusses are supported on modern granite piers (Photo. 8). The 10 original trusses have been reused, and are of A-frame construction with principal rafters with lap-jointed apexes, supported by applied and halved lap-jointed collars. All the joints are fixed with pegs.

Photo 8 The roof trusses in the southern range shippon, looking northeast. 0.25m scale.

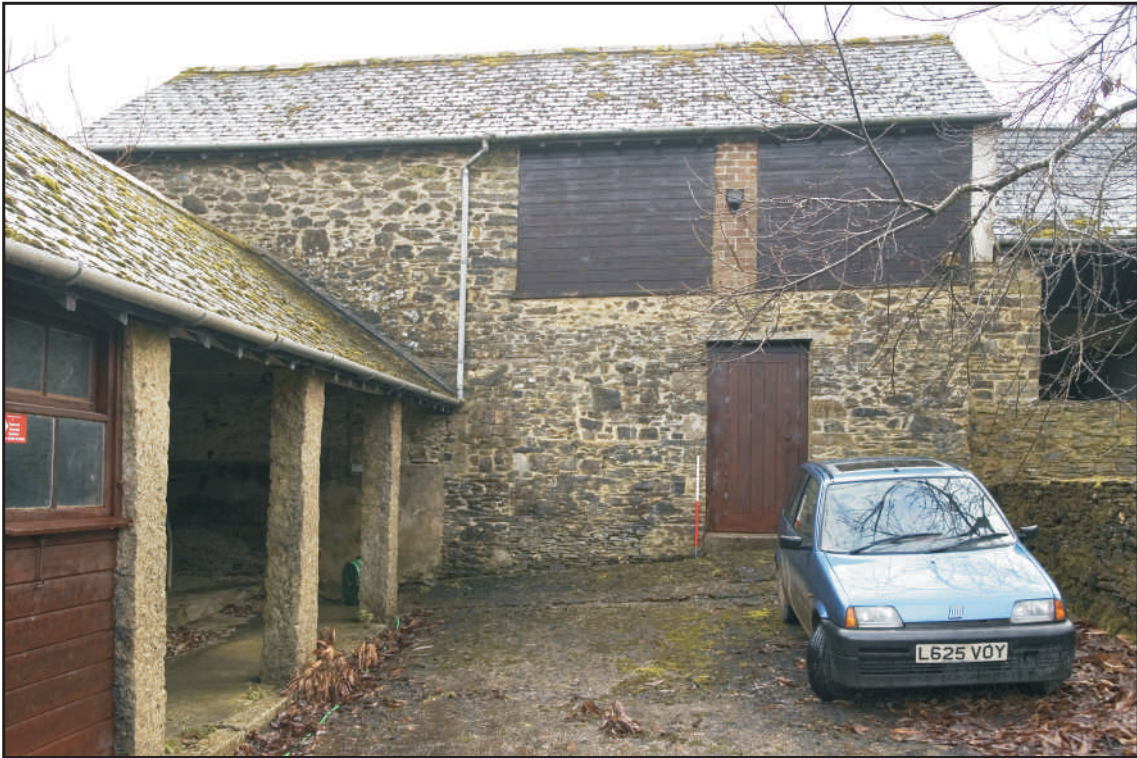
This is located in the southeast corner of the site and is attached to the shippon (Photo. 9). The building is set at a lower level to the shippon and forms part of a late 19th-century extension to the farm. The building is two-storied and is constructed of rubble slate bonded in soft off-white lime mortar with granite utilised for some door jambs and quoins, the latter being snecked. Excavation of a service trench in the yard to the north revealed that the front wall had been constructed directly onto the bedrock, which was present immediately below the concrete surface. The west gable is a modern rebuild. In the north elevation there is an open doorway into the courtyard, as well as a second doorway and two windows, all of which were blocked when the adjacent shippon to the north was constructed. This arrangement almost certainly indicates that the building was designed as stables rather than a cow house. There is also a doorway in the west elevation, leading into the adjacent cow house. In the east elevation is a doorway with an external step up from the adjacent track. This opening has red bullnose bricks used for jambs. The door has been partially blocked and converted into an aluminium-framed window. There is a large opening in the north elevation, partially blocked and converted with aluminium-framed windows.

Photo 9 The stables/cow house, looking southeast. 1m scale.

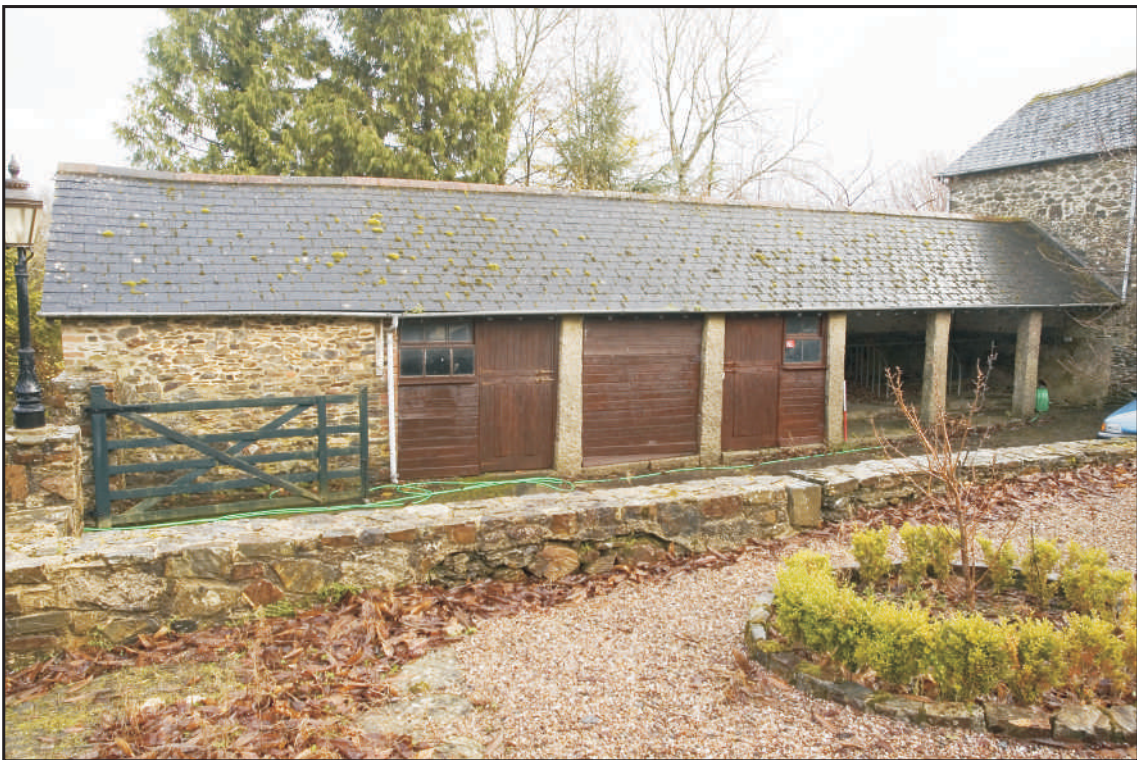
The east wall of this range is contemporary with the adjacent cow house, although it appears that the wall may have initially formed the side of the lower farmyard rather than part of a building, since the line of the west elevation of the shippon conflicts with a doorway in the north wall of the cow house (Photo. 10). At the north-west corner of the building are sneaked granite quoins that may have been reused and brought in from elsewhere. The shippon incorporates a small room at its northern end, perhaps a calf house or dairy. This room has a doorway in the north elevation, and windows in the north and east elevations, the former having been blocked. Both standard and bullnose bricks are utilised in these openings. The building was originally whitewashed, and the lower sections of the walls are rendered; this render is present throughout the range.

Photo 10 The east range shippon, looking northeast. 1m scale.
