**ARCHAEOLOGICAL BUILDING SURVEY, TRENCH EVALUATION  
AND WATCHING BRIEF AT THE FORMER WEST OF ENGLAND  
EYE INFIRMARY, MAGDALEN ROAD, EXETER**

**Exeter Archaeology**

**Report no. 11.58**

**April 2001, revised November 2011**

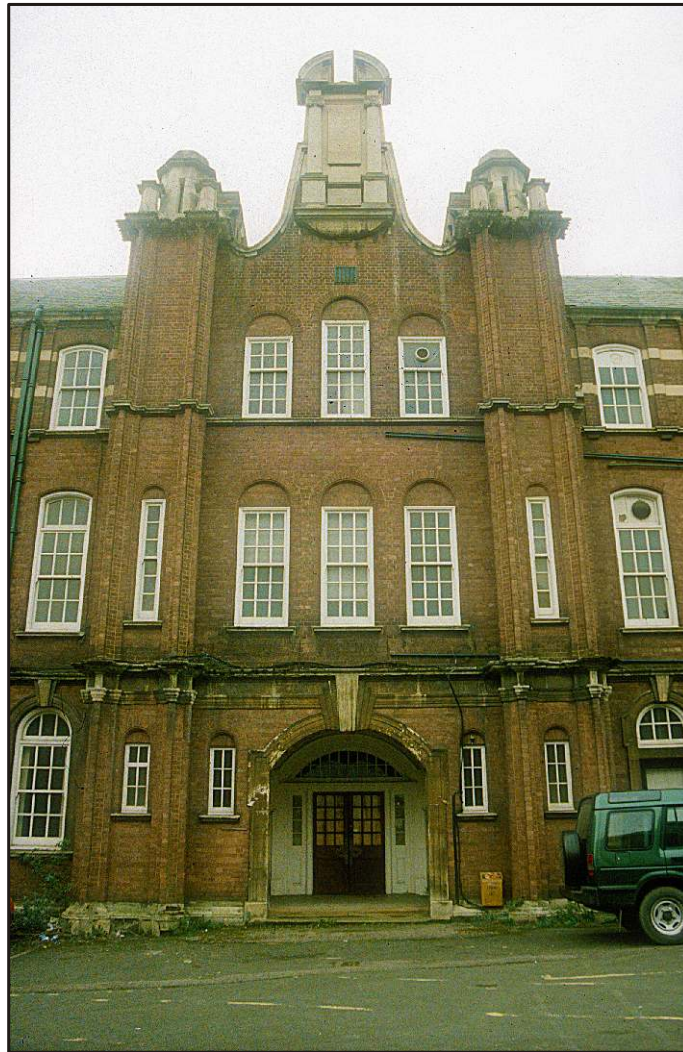
Plate 1 Main entrance to hospital. Looking south.

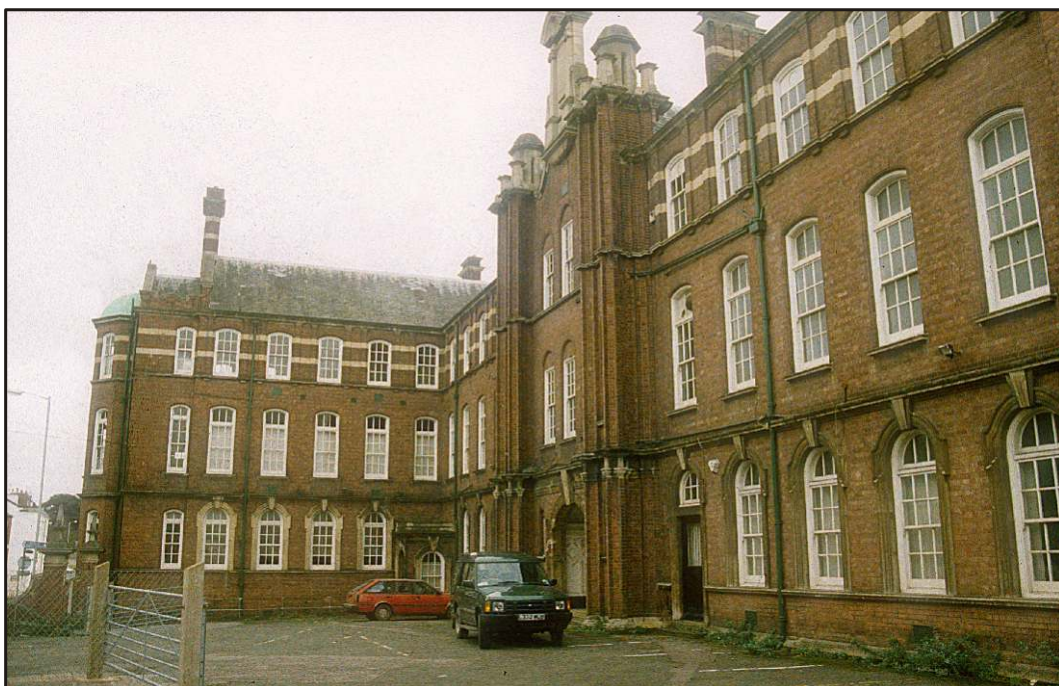
Plate 2 North elevation of hospital. Looking east.

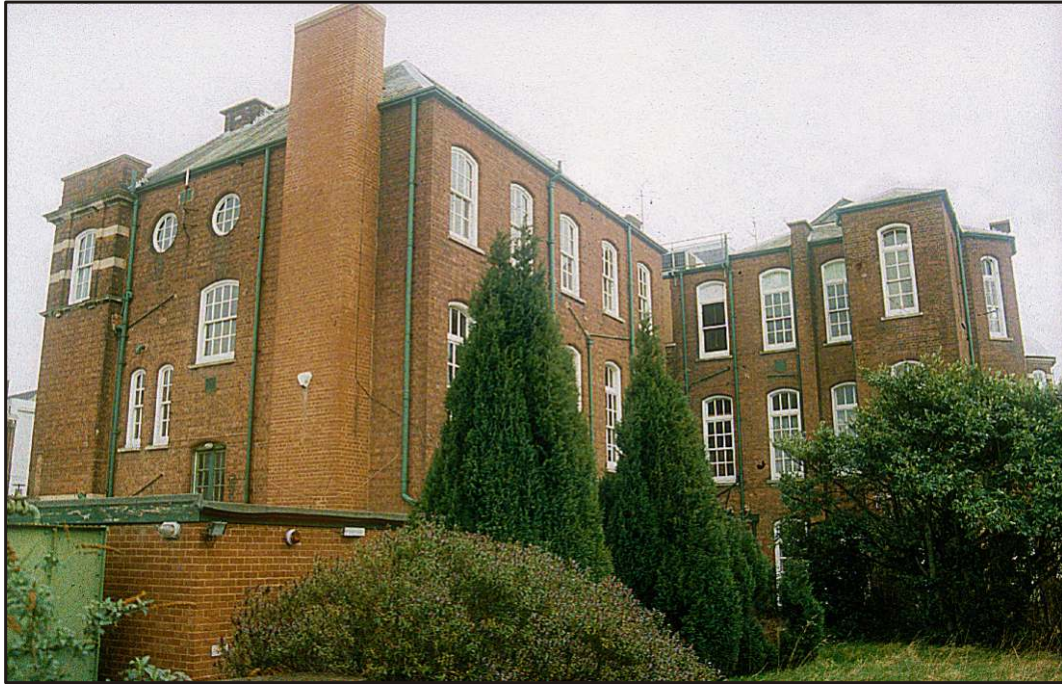
Plate 3 West elevation of hospital. Looking east.

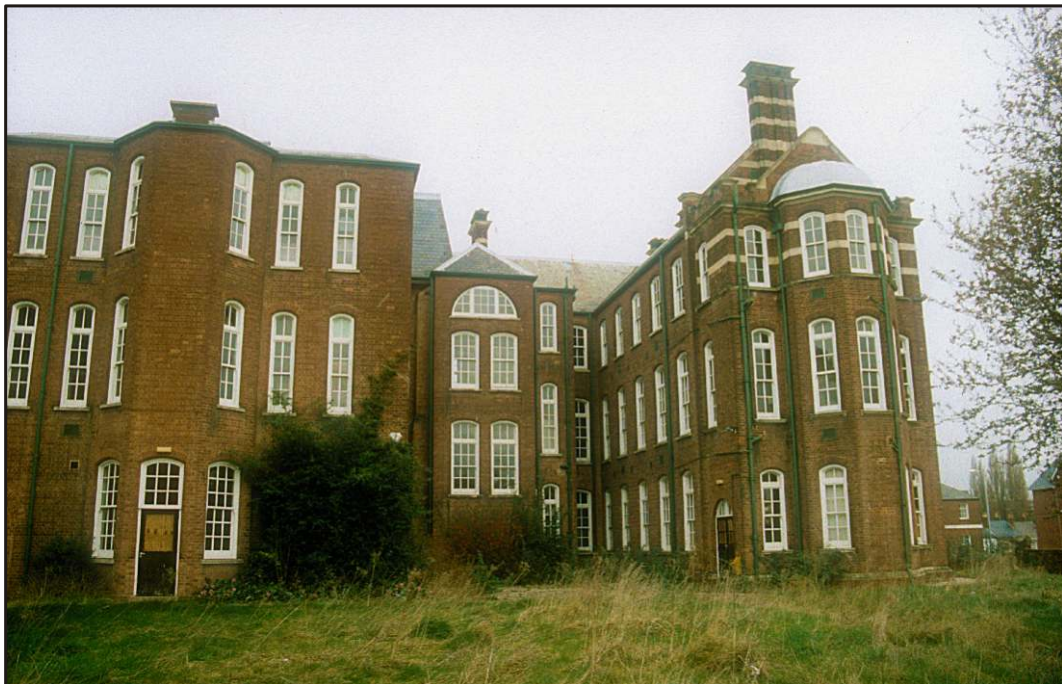
Externally, the only major change to the building has been the addition of a lift shaft at the rear, blocking two windows on each floor. A winch-room for the lift has been added to the roof. A low outbuilding, originally standing alongside the boiler house has been removed.

Plate 4 South elevation of hospital. Looking north.

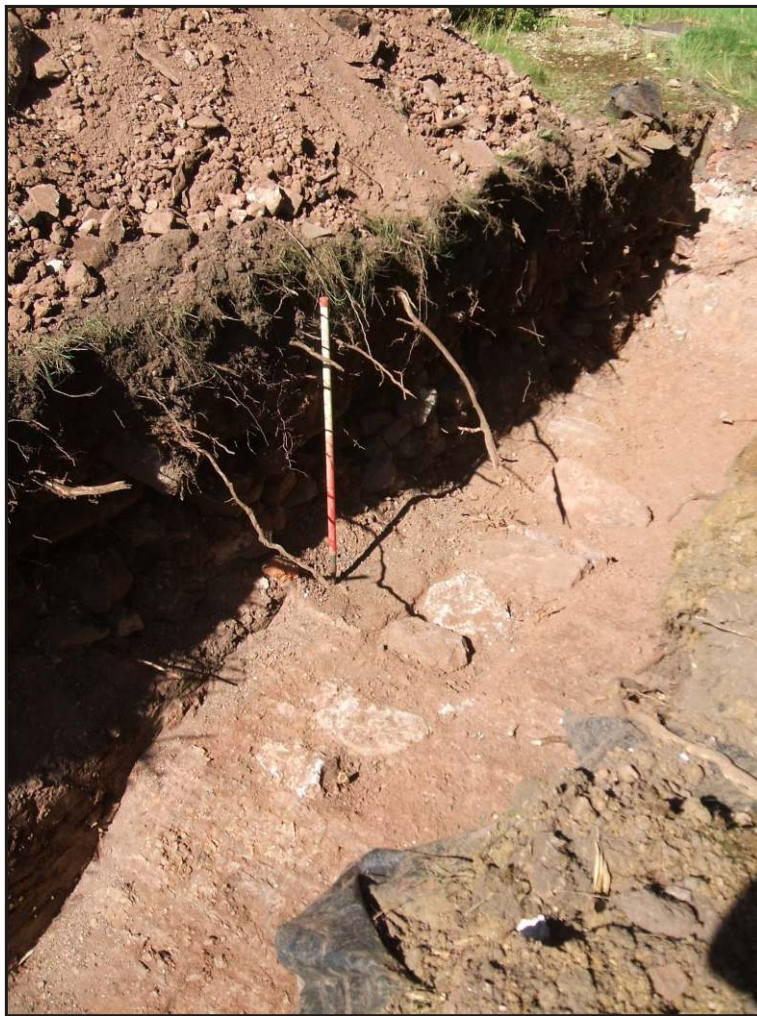
Plate 5 Trench 1, east end showing wall 106. 1m scale.

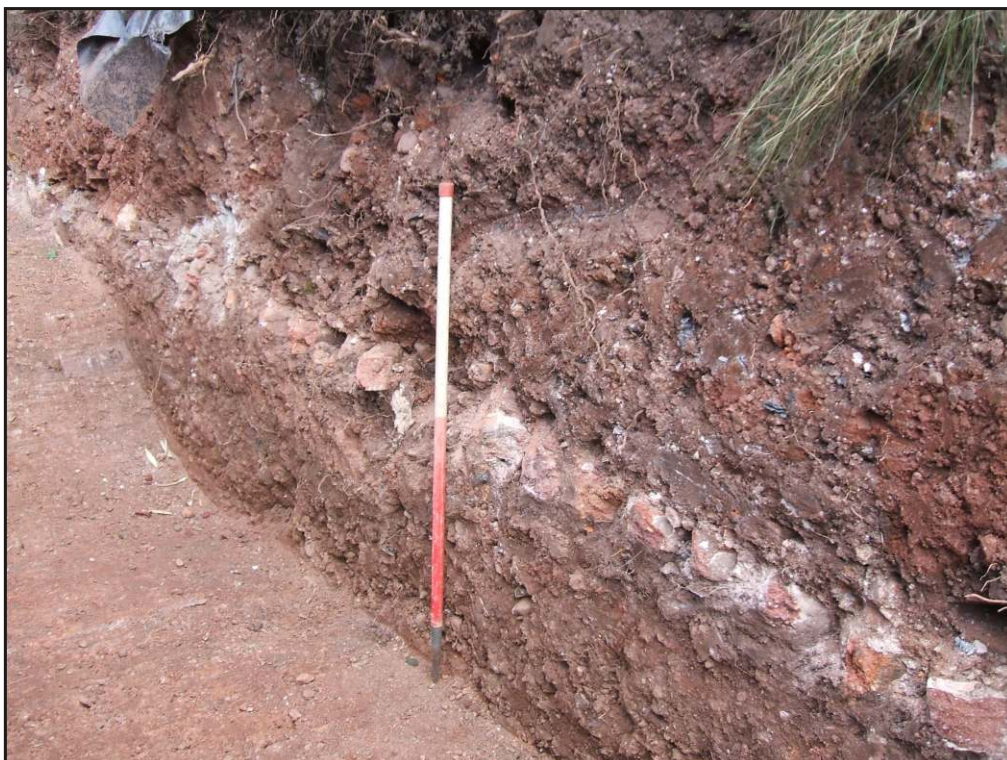
Plate 6 Trench 1, northwest-facing section showing surfaces 103 and 104. 1m scale.

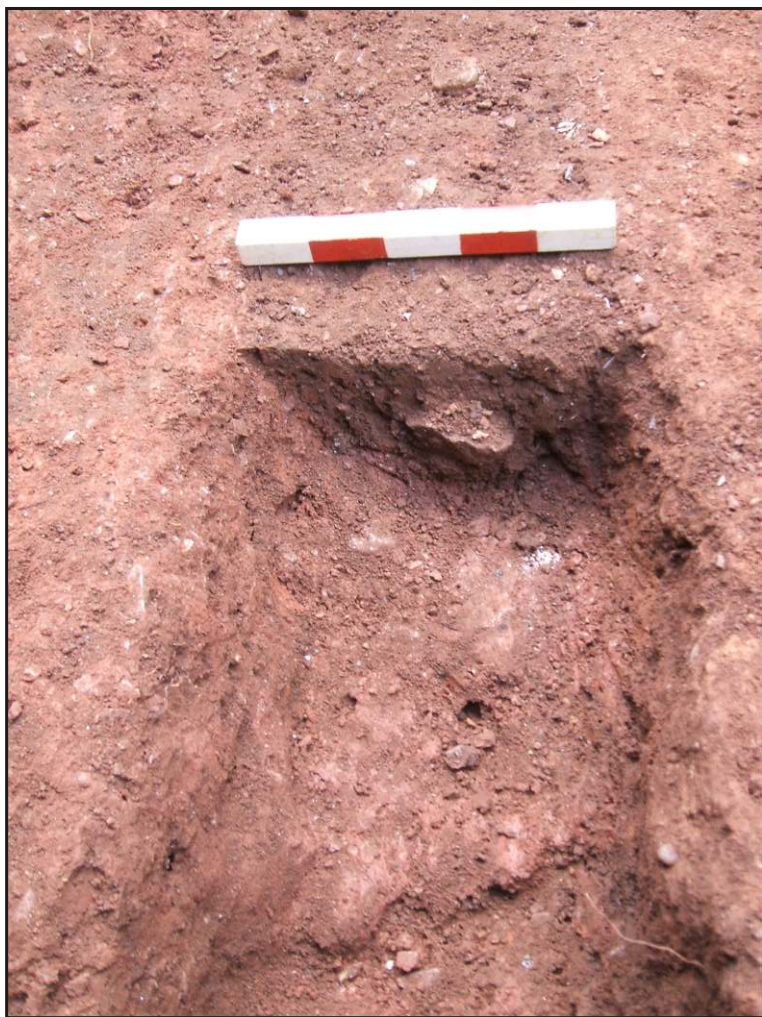
No evidence was found for features of a Civil War date, with the other early features (109 and 208) broadly dating to the 30 years either side of 1700. The features were parallel to each other and may be contemporary. Their exact functions are unknown but the character and fill of 109 indicates it was probably a planting trench within a garden.

Plate 7 Trench 1, section through planting trench 109. 0.25m scale.

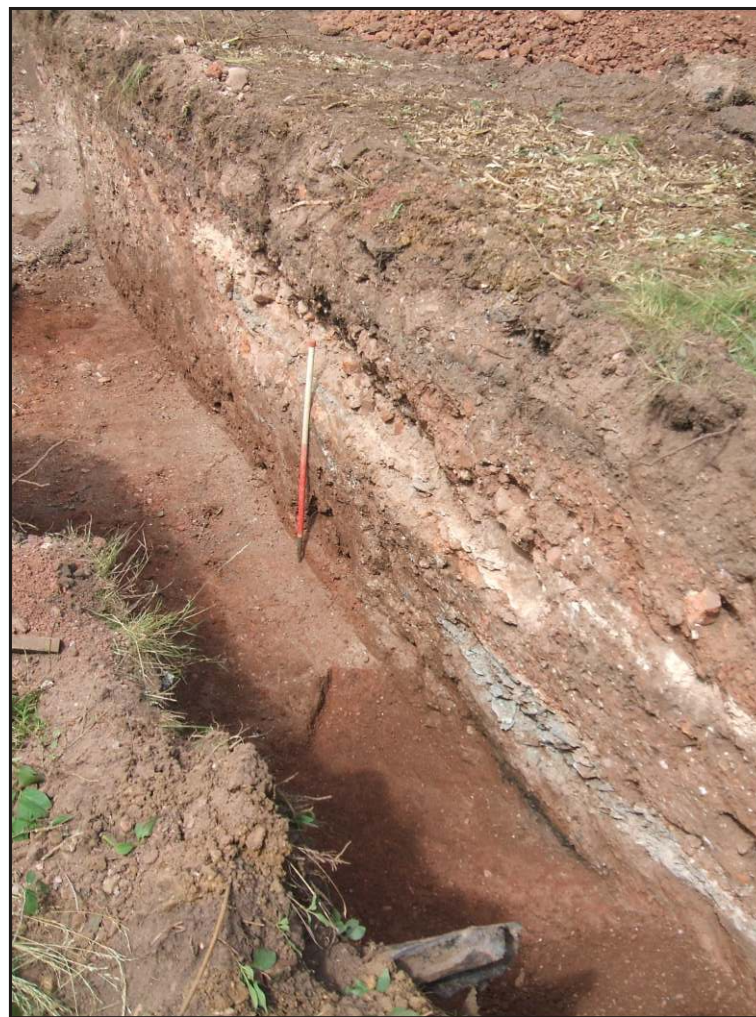
Plate 8 Trench 2, southwest-facing section with ditch 208 in foreground. 1m scale.
