**ARCHAEOLOGICAL BUILDING SURVEY
OF FARM BUILDINGS AT YARNER FARM,
DARTINGTON, DEVON
(Illustrations Incomplete)**

Exeter Archaeology

Report No. 06.36

May 2006

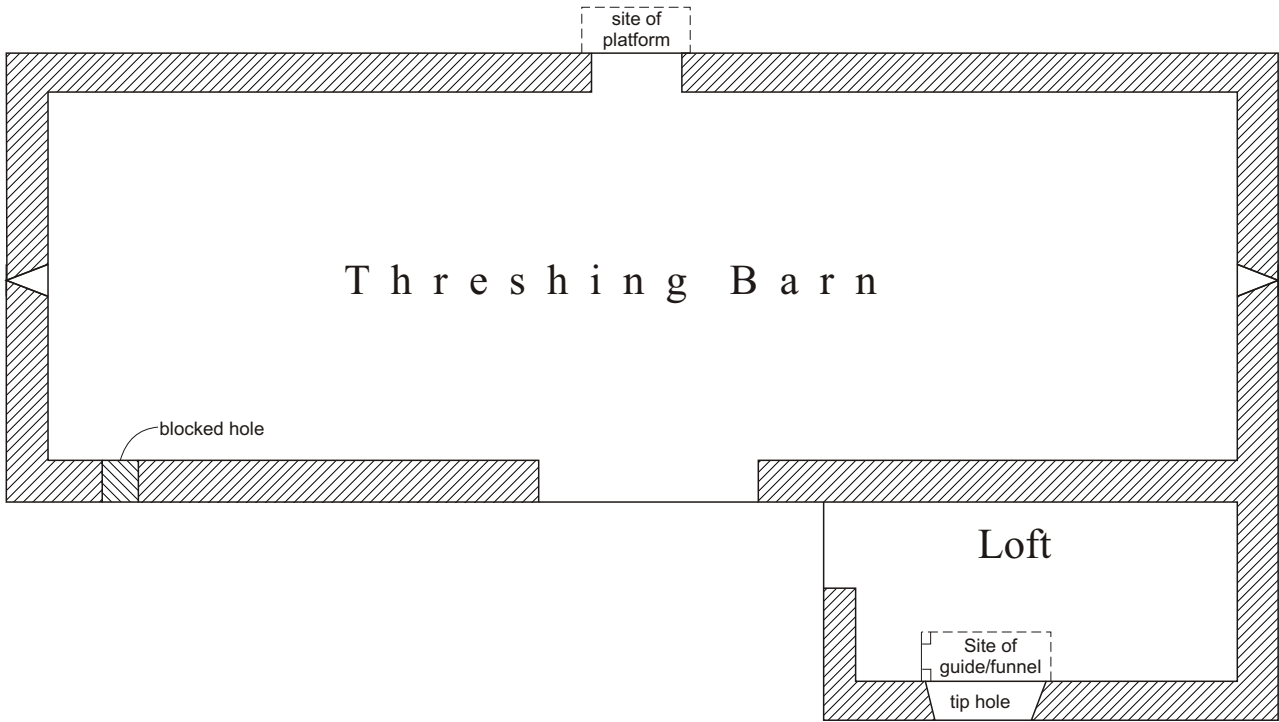
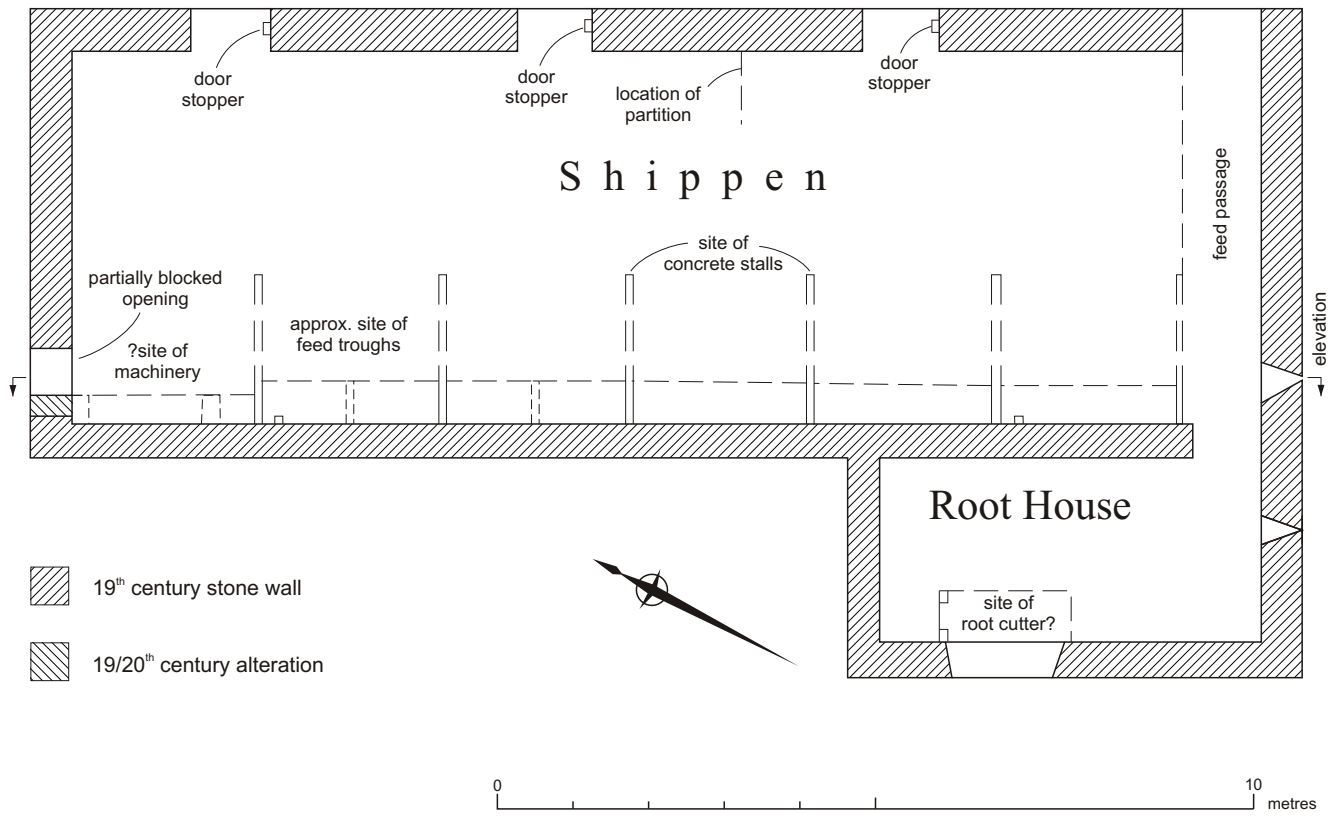
Fig. 3 Floor plans of shippen, threshing barn, root house and loft showing some reconstructed detail (based on original architects plans by Hopwood and Swallow with amendments).

This is a two-storey, north-east facing, L-shaped bank barn comprising a shippen with a root house on the ground floor (Fig. 3). A threshing barn was situated over the shippen and a small loft was over the root house. There are two distinct areas of stonework evident in the structure, although it is probably not a result of two major construction phases.

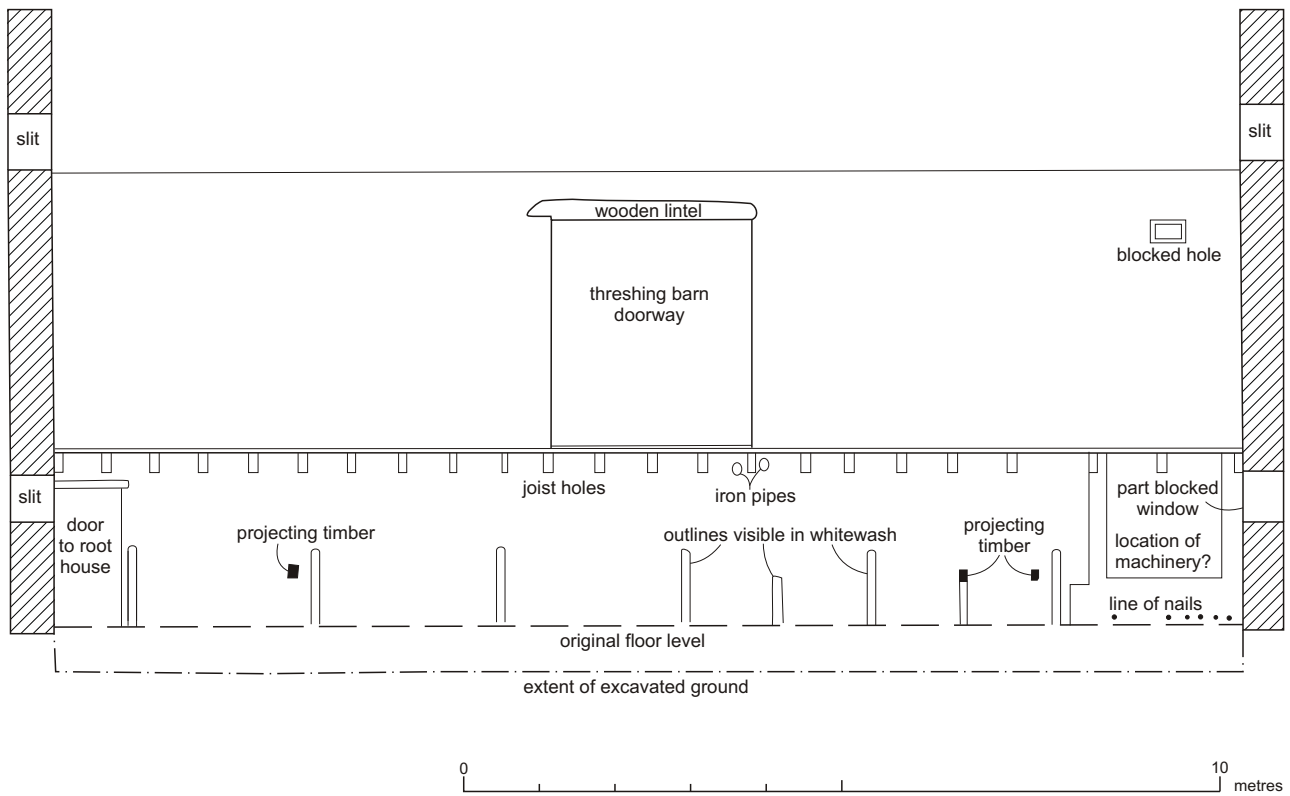
Fig. 4 Interior of south-western shippen and barn wall (view to south-west).

The surveyor was not informed of a partition being removed by the developer, although some concrete walling on the other side of the ground floor were. A series of marks of about 1.04m height and 0.10m width were noted along this elevation at

regular intervals of 2.30-2.34m. These marks may indicate the locations of former concrete cattle stalls along the south-western wall without the use of a feed passage along the front.

Other marks along the wall are less decipherable, although it's most likely that they were connected with the building's use as a shippen. Two wide (0.23-0.25m) vertical unpainted lines located at the northern end of the elevation form a border to a rectangular whitewashed area 0.60m from the former floor level. What this feature represents is unclear but, being situated at the end of a shippen and beneath a threshing barn, it is possible that it was for some framework connected in some way with the provision of feed for the milking herd. Possibilities include the location of a mill, grinding and crushing machine or simply storage racks. The location of this framework is also visible along the inserted stonework used to reduce the width of the window in the north-western elevation. This suggests that this internal feature was not a later addition to the building and led to the alteration of the window.

The purpose(s) of three projecting timber beams along this elevation are even less clear. One (0.10m wide) is located 3.10m from the southern corner, whilst the others (both 0.05m wide) are located near the northern corner. Of the latter, one is 2.76m from the corner and the other is 0.77m to its south. All three project about 0.12m into the building at an approximate height of 1.80m from the floor level. Whilst their purpose remains obscure, it is likely that the northern pair are at least related to one another.

Two metal pipes located beneath the wide barn doorway are angled upward, as if they ran along the barn floor rather than through the shippen. They are most likely a mid-late 20th century insertion and are possibly the remnants of a milk pipeline.

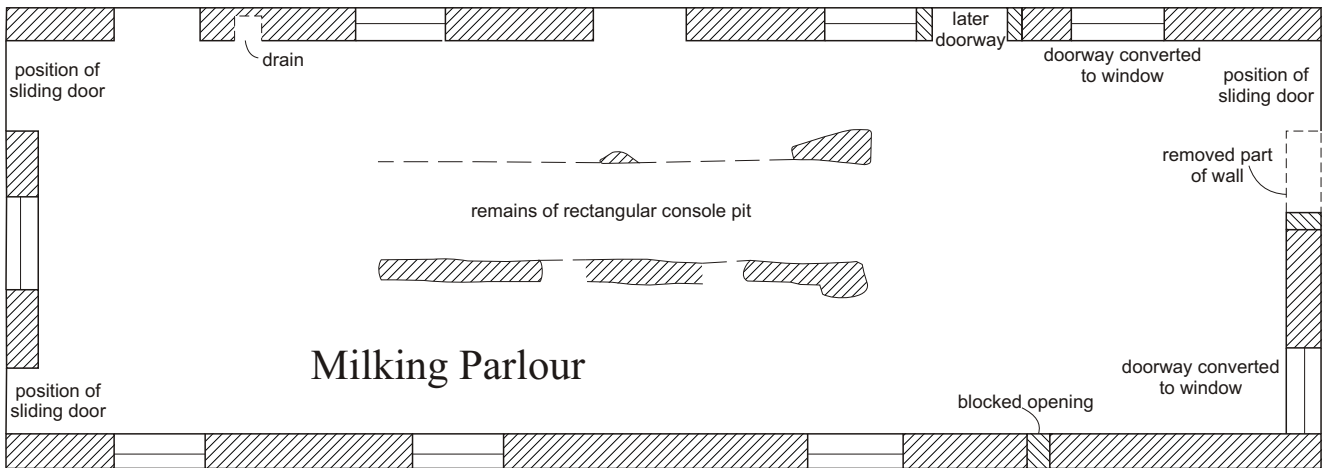
Ground Floor Plan of Milking Parlour

This is a circa mid 20th century structure (Fig. 5), perhaps of limited archaeological or historic significance, but built along traditional lines. The 1886 surveyed OS map indicates that the site was occupied by an open-fronted building (perhaps a linhay) and it is quite possible that the materials from this earlier structure were reused in the present building. No evidence of retained standing masonry from this earlier building could be identified which suggests it was completely demolished.

The floor and most of the internal fixtures and fittings had been stripped out prior to the site visit. Among the only notable remaining features within the building were whitewashed walls, which had been rendered over with cement to comply with dairying hygiene regulations. A few stones embedded in the floor, forming the

remnants of two north to south running parallel walls, mark the site of a rectangular lined console pit, common to late 20th century milking parlours.

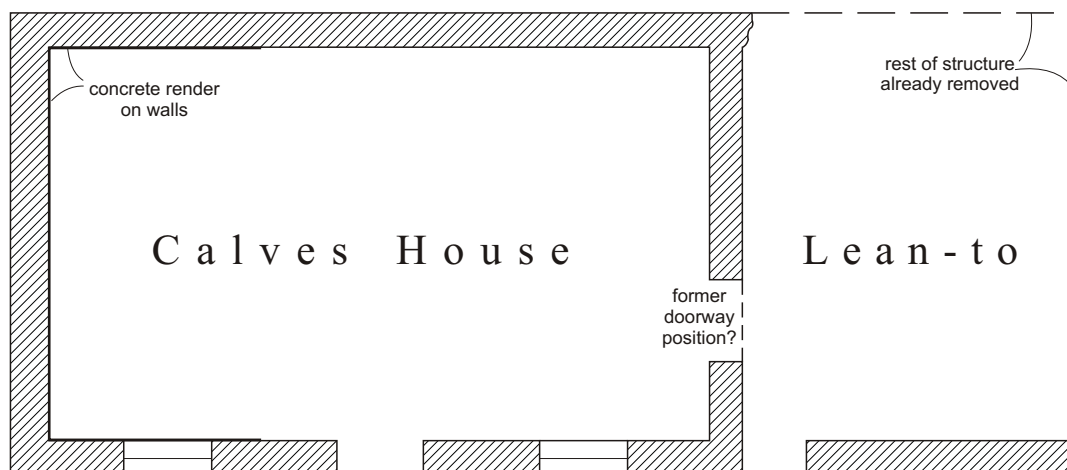
Ground Floor Plan of Calves House and Lean-to

This is a low, two storey stone-built north-west facing structure with a hipped roof and remains of an adjoining structure at its south-western end (Fig. 5 and plate 9). Its construction appears to be broadly contemporary with that of the milking parlour and map evidence suggests it is sited on ground previously unused for building, indicating a 20th century building date.

The interior survey of the building was again compromised by conversion work being already underway. The wall between the main building and the lean-to was being fitted with a new doorway during the site visit. The site foreman stated that this location was previously the site of a blocked doorway. There were, however, no traces of a former doorway left to be seen to provide further comment on.

The north-western end of the interior was largely finished with concrete render to a height of 1.52m. This render runs down the building a distance of 2.82m on both front and rear walls. The presence of this render is compatible with the building's use for livestock and the absence of any stall fittings does corroborate the information that the building was used for calves. Nothing now remains of the original lean-to interior.
