EAST DENSHAM FARMHOUSE, WOOLFARDISWORTHY: AN HISTORIC BUILDING EVALUATION

This report has been prepared by Exeter Archaeology and presents the results of an historic building evaluation of the Grade II-listed East Densham Farmhouse, Woolfardisworthy (SS 8209 0938; listed building no. 433933). The work was commissioned by Mr R. Bower of Dunn Marino Associates in advance of a planning application for alterations to the building. The work was required by the Mid Devon District Council Conservation Officer, and was undertaken in accordance with a brief provided by the Devon County Historic Environment Service (Reed 2008).

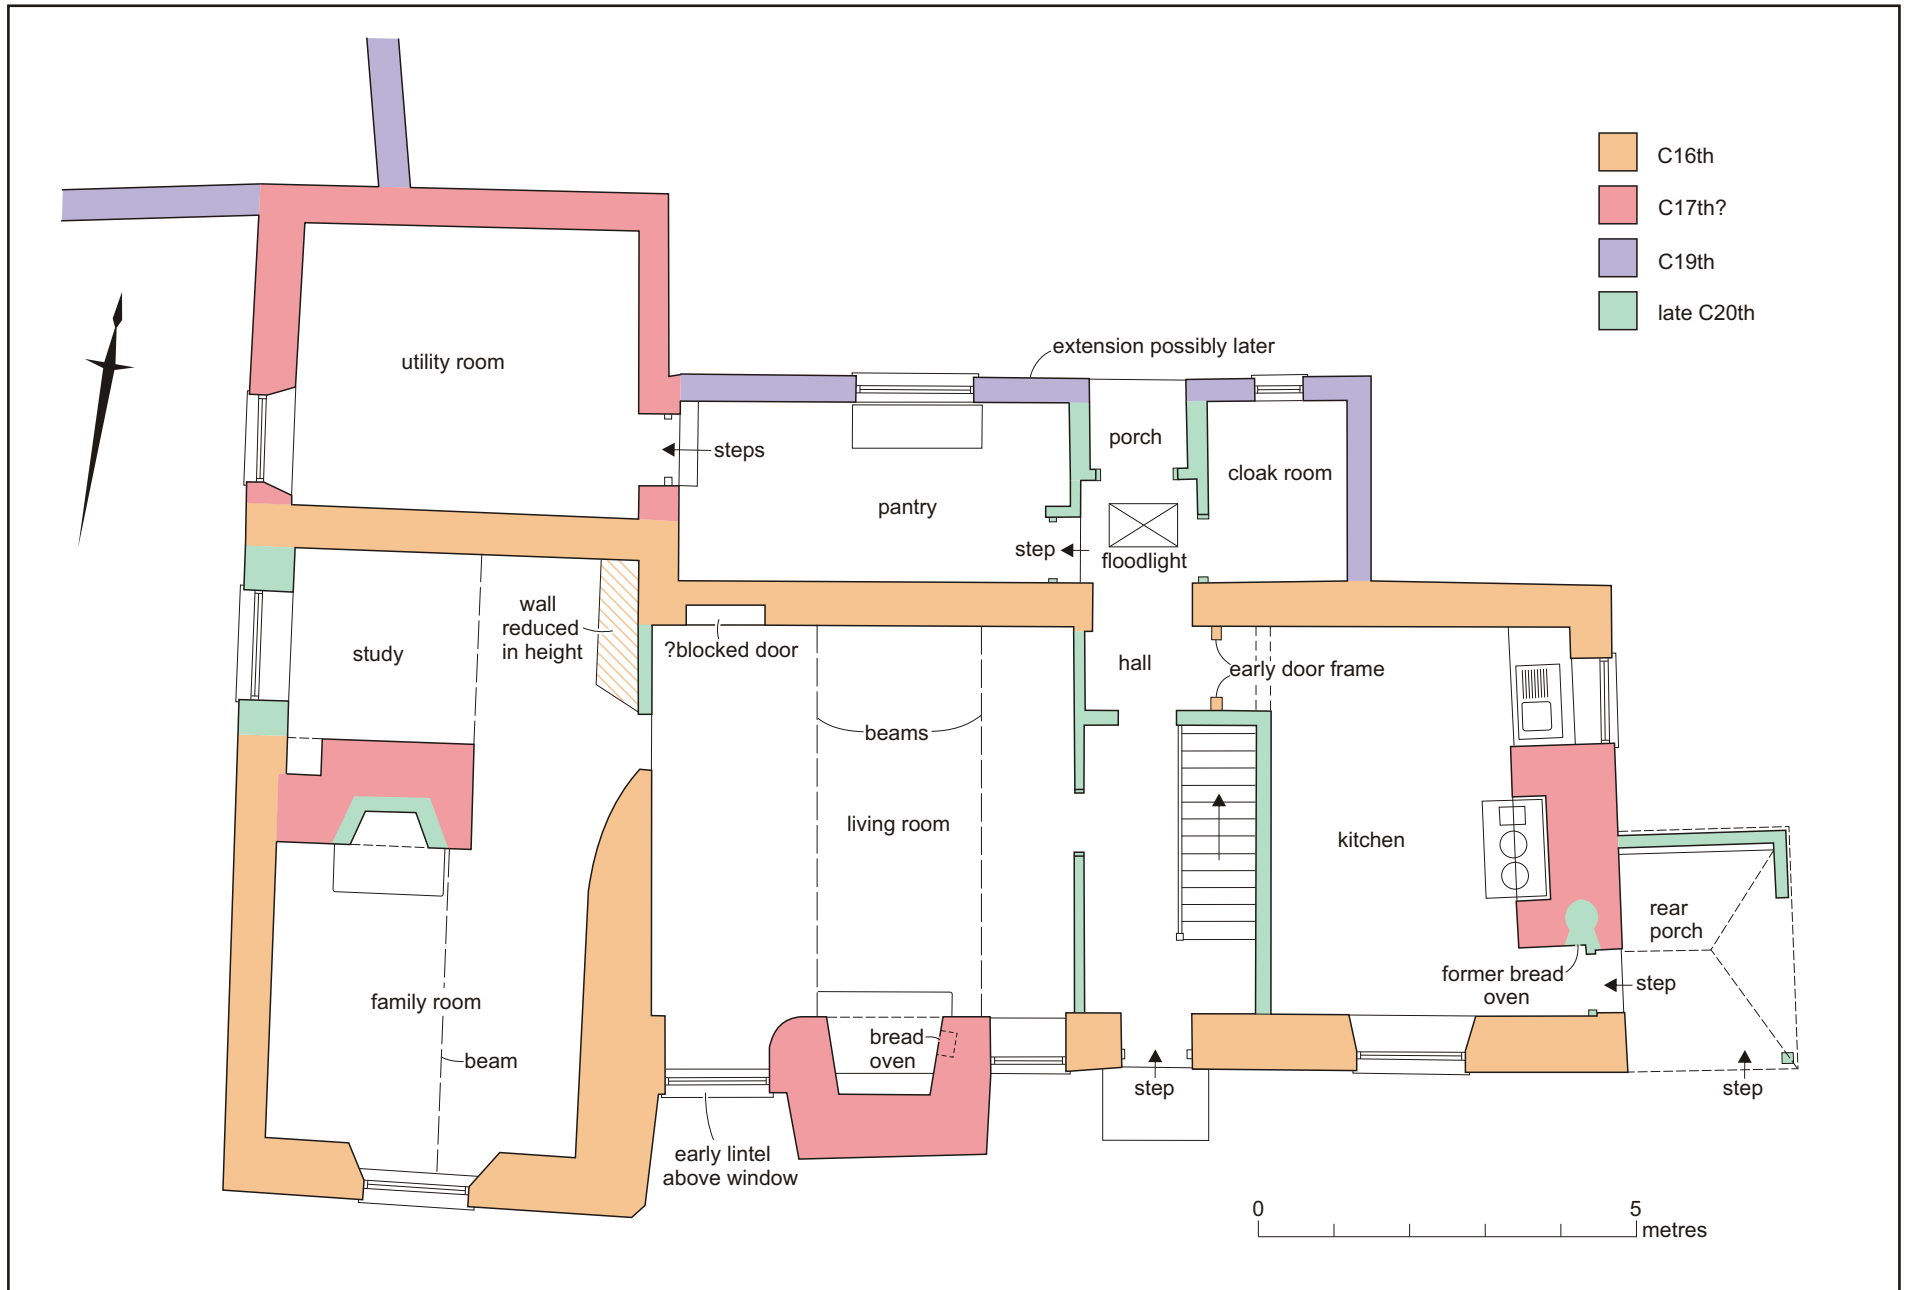
Fig. 1 East Densham Farmhouse, ground floor phase plan. Scale 1:100.

On the ground floor the layout of the main range comprises a central cross-passage flanked by rooms (the present kitchen and living room). A third room to the east of the kitchen was demolished, apparently in the 1970s. The walls of the cross passage have been widened and rebuilt, although an early, possible original, door and frame survive on its lower side, perhaps a fragment of a longer plank and muntin screen. The door has old graffiti and a broken 17th-century strap hinge. The door frame appears to be undecorated, but traces of a possible plain chamfer may survive on the rear face towards the present kitchen. The only historic architectural feature in the kitchen is a stone fireplace in the east elevation. This fireplace formerly contained a bread oven, apparently with its opening in the south side of the chimney stack rather than in the hearth, an unusual location for such a feature.

A lateral chimney stack is present in the living room apparently with a blocked-off bread oven. The oven door has been reset from the kitchen bread oven. The window opening west

of the fireplace retains an early (possibly late medieval) wooden lintel, with two rebates for vertical wooden mullions on its lower side, and on its outer face what appear to be two wide mortice sockets with rounded corners. The function of these sockets is unclear. The room is divided into three bays by two large beams with plain chamfers and stepped run-out stops. The present joists have been set/reset into earlier rebates in the beams.

The ground floor of the cross wing contains two rooms, although there is no access between them. The north room appears to be entirely constructed of stone. These observations may therefore indicate that the north room is an extension. In the south room there is a stone chimney stack, with later brick masonry inserted into the fireplace. The fireplace has a slightly arched wooden lintel with ovolo moulding suggesting a 16th- or 17th-century date. Above this lintel is a (possibly smoke-blackened) beam that displays a chamfer. The joists set into this beam have scars and nail holes relating to a former lath and plaster ceiling, now removed.

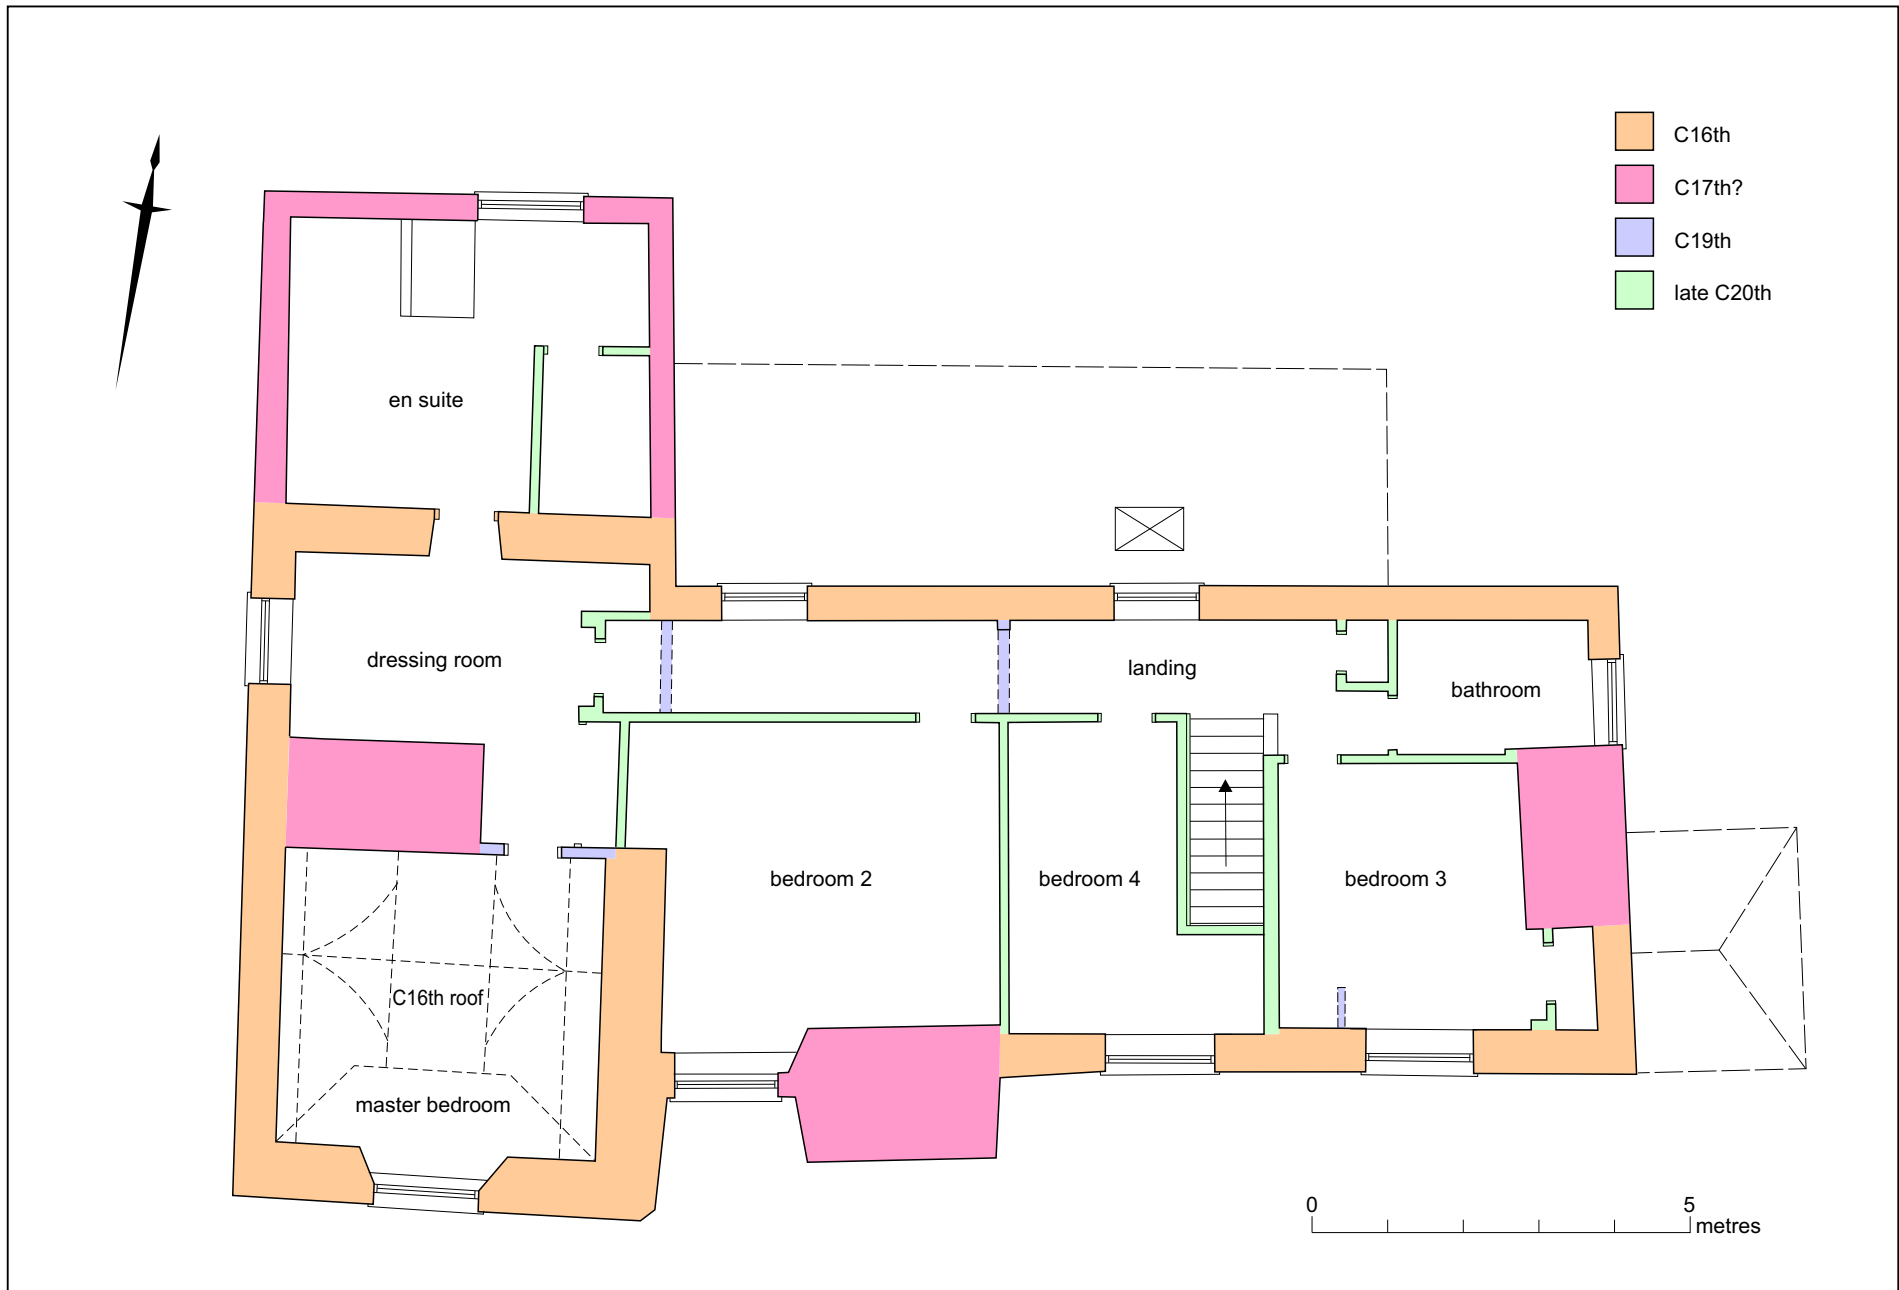
Fig. 2 East Densham Farmhouse, first floor phase plan. Scale 1:100.

On the first floor the main range contains three bedrooms along the front of the house with a bathroom to the rear, all served by a corridor along the back of the building. The partitions of these rooms are all believed to be modern, and where exposed, modern plaster has been utilised in their construction. The layout is however typical of the first-floor arrangements in cross-passage houses. The only historic features are the chimney stacks rising from the ground floor, a timber in the east bedroom and archways in the corridor reflecting the positions of trusses in the roof above.

The roof of this range was replaced in the 1970s; however, some lap-jointed rafters and side purlins of an earlier 19th- or 20th-century roof have been incorporated (some almost certainly reset) within the present roof structure.

The first floor of the cross wing contains a master bedroom, dressing room, and en-suite bathroom, with the dressing room being entered from the corridor in the main range. The current layout is defined by existing structural features. The north side of the master bedroom is partially formed by the stack from the ground floor fireplace. The adjacent doorway is set within a possible late 19th-century lath and plaster partition, and has a contemporary door frame with ovolo moulding and a high stepped stop. The dressing room and en-suite bathroom are divided by the cob end wall of the early range, with the bathroom being located within the extension.

The master bedroom is open to the roof and retains its late 15th- or early 16th-century arched-braced roof with two bays divided by an off-central truss. These timbers are currently visible as far north as the fireplace – the end of the room – but must have continued throughout the range. Further parts of the original roof survive above the dressing room in a mutilated condition. The roof of the bathroom is a 1970s replacement of an earlier structure. The visible truss is supported by jointed cruck wall posts extending down at least as far as the floor of the bedroom. The wall posts and arch braces are morticed into the principal rafters above the curve of the cruck. The top of the arch braces are attached to a horizontal morticed and tenoned collar. There are two rows of trenched side purlins, the ends of which abut each other where they are pegged into the principal rafters; the ridge purlin is diagonally set between the apexes of the rafters. Between the side purlins are curved wind braces, with a pair of wind braces surviving adjacent to the principal rafters. Both the wind braces and the arch braces have plain chamfers. All the timbers are smoke blackened, although there is evidence that some of the timbers (at least the purlins either side of the truss) were at some stage ceiled

over. The south end of the roof is currently a straight gable, but internally, there is an unusual stepped hip, possibly reflecting a modern covering up of an earlier steeper hipped gable. The trusses are extremely elegant and well carpentered, suggesting a high-quality roof.
