**ARCHAEOLOGICAL RECORDING
OF A BARN AT STEVENSTONE,
ST GILES IN THE WOOD, DEVON**

Prepared for Gale and Snowden Architects Ltd

Exeter Archaeology

Report No. 09.16

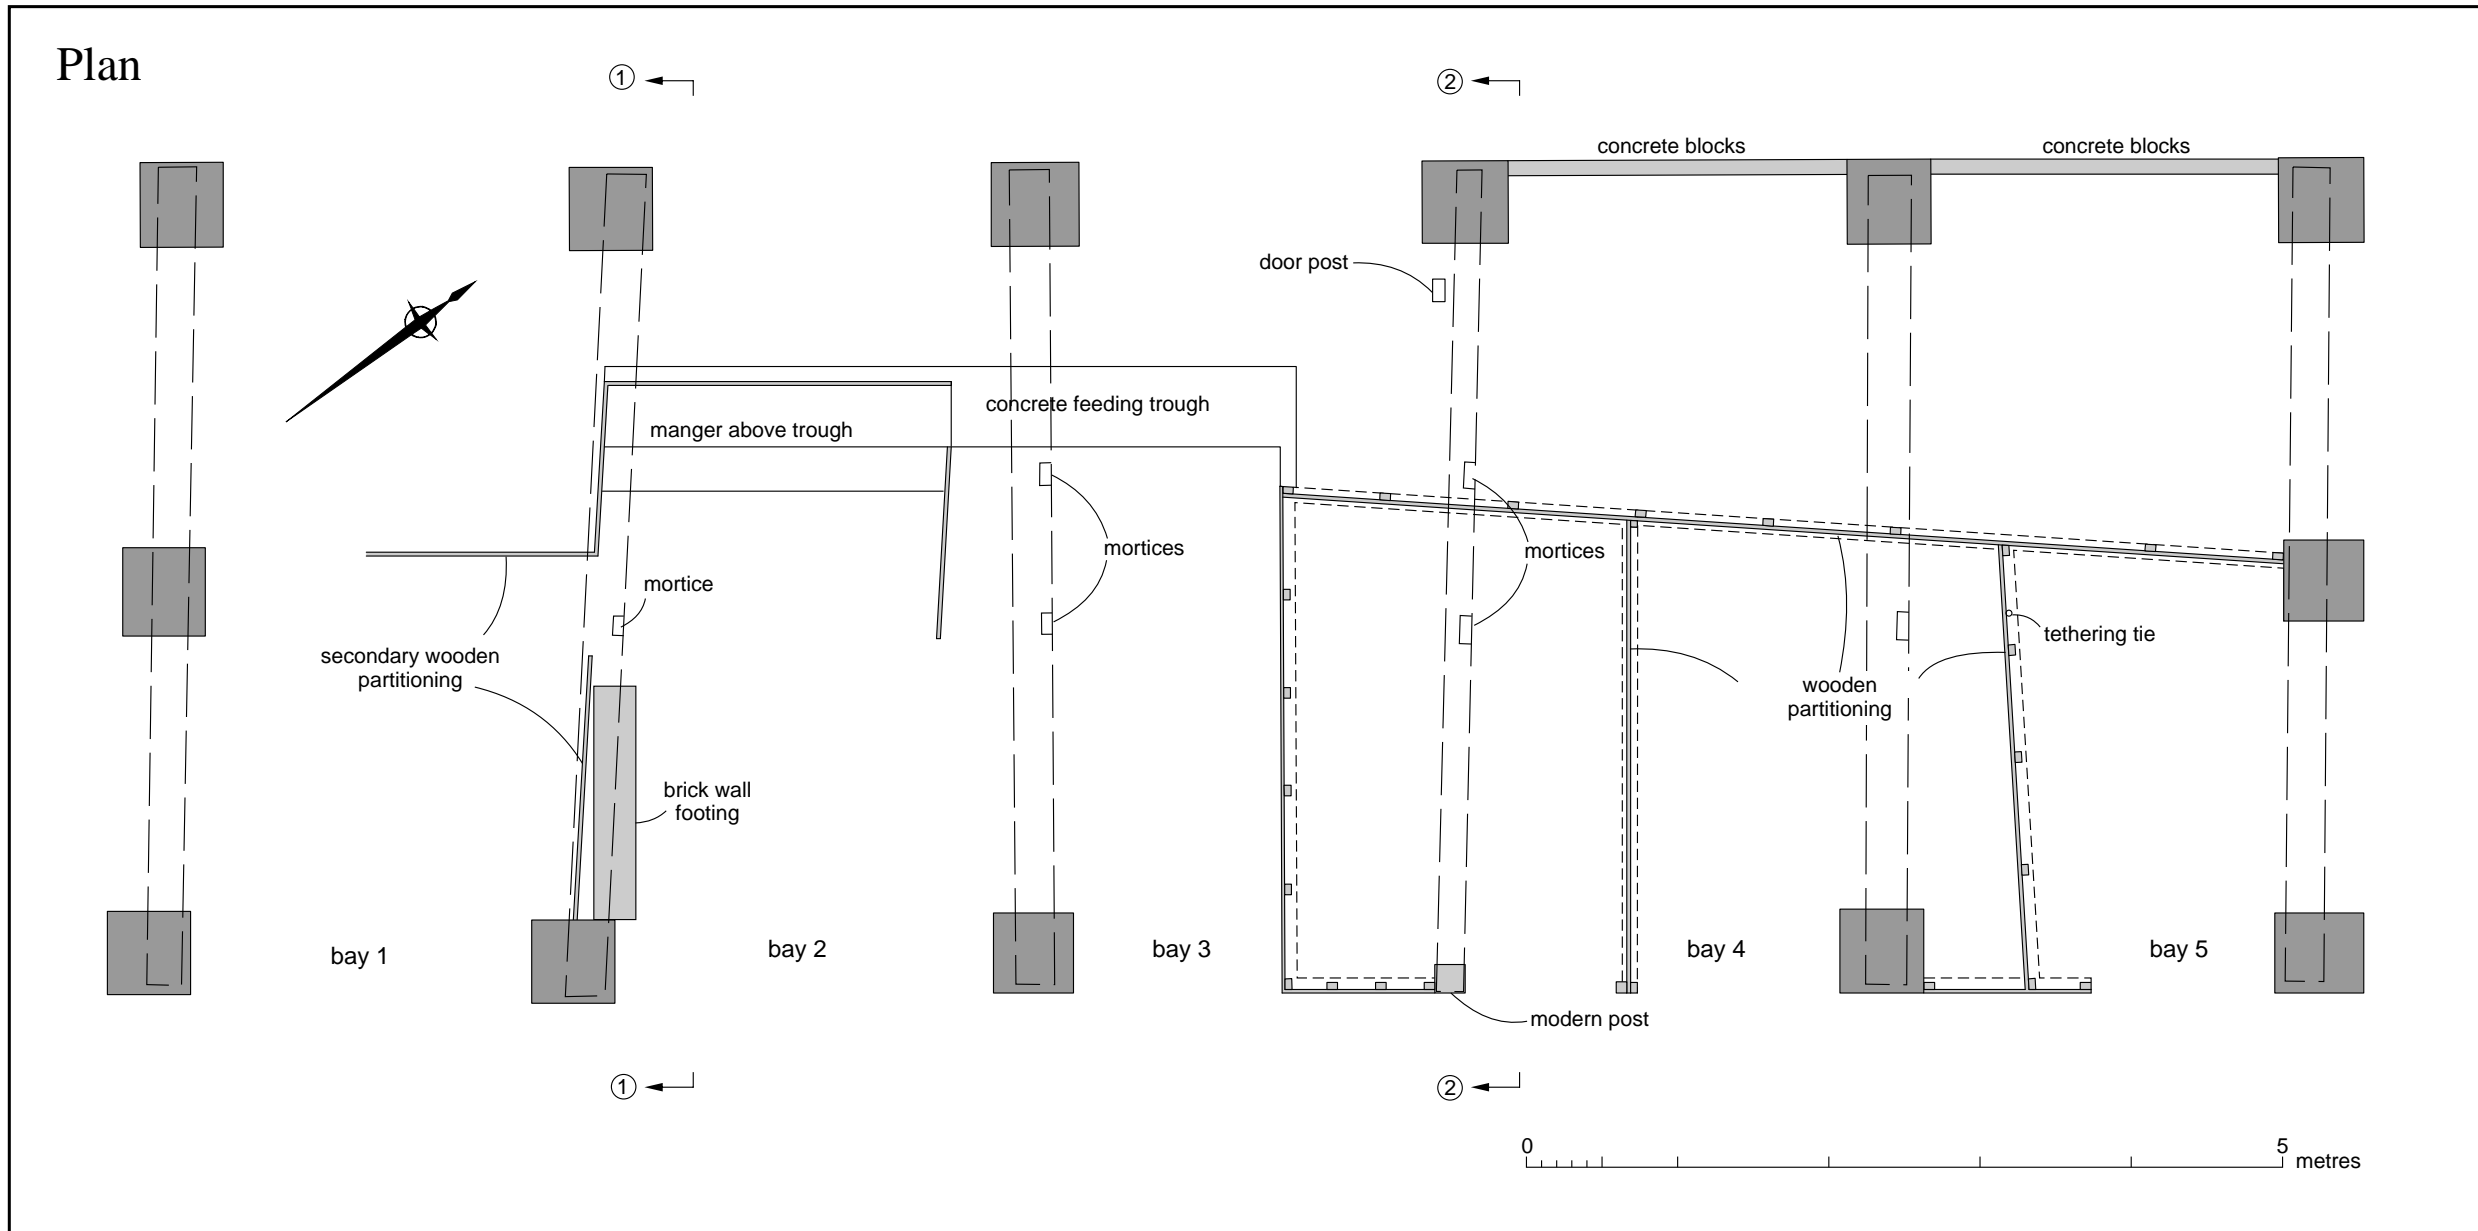
Fig. 3 Plan of the barn (based on Gale & Snowden Architects' drawing no. D-AL(0)004).

The barn is a rectangular, single-storey building, measuring 14.7m long by 5.5m wide, and is completely open fronted, but with an enclosed loft within the roof space. The roof trusses are supported on six pairs of piers along the long axis of the building, with a further pair of

There is little evidence for original or early ground floor partitions. Between bays 1 and 2 are the remains of a brick wall, at the same level as the footings of the piers. This brick wall has been truncated by later features and may be original or an early alteration. On all the internal tie beams there are sockets with nail holes for tenons of removed posts. These are located along the central axis of the building with further sockets also located to the west of this central row. None of the posts survived, having been superseded by later partitions.

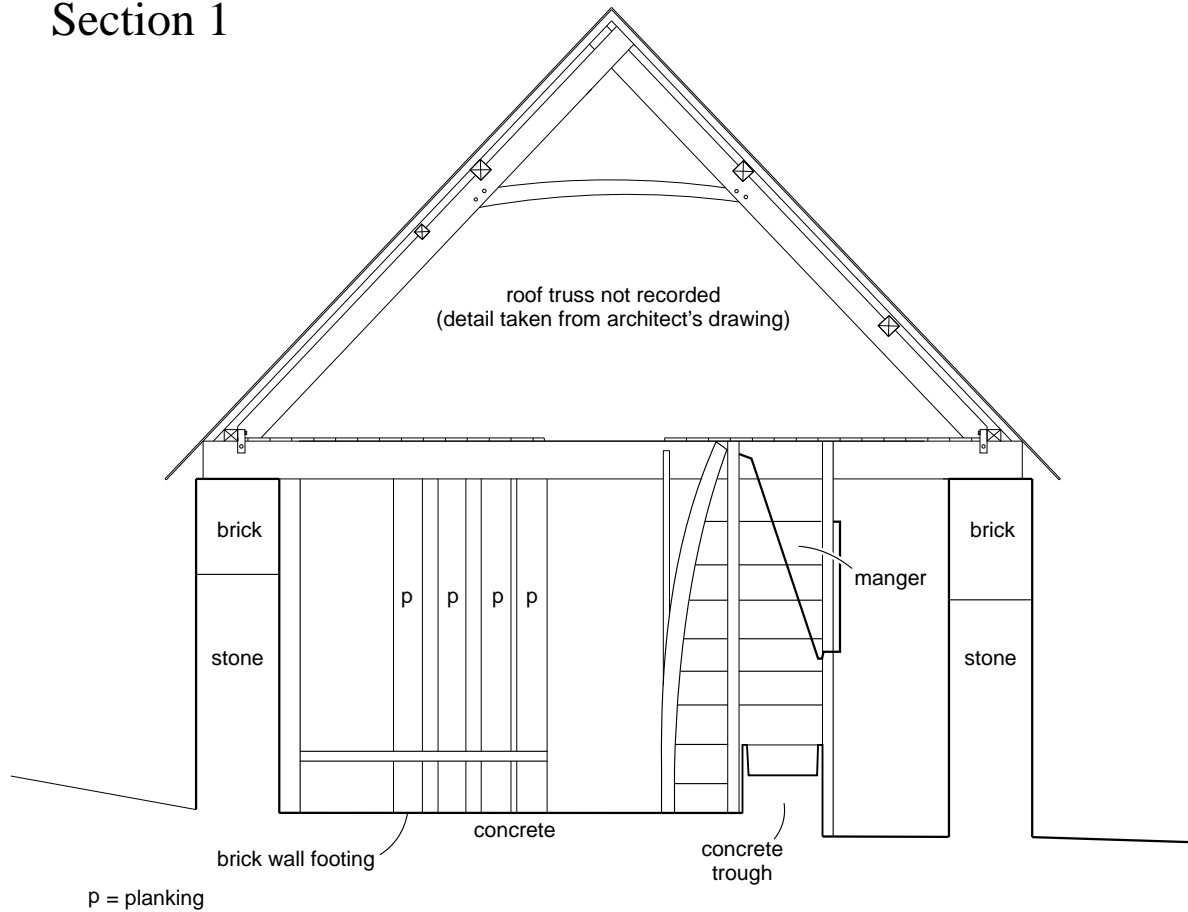
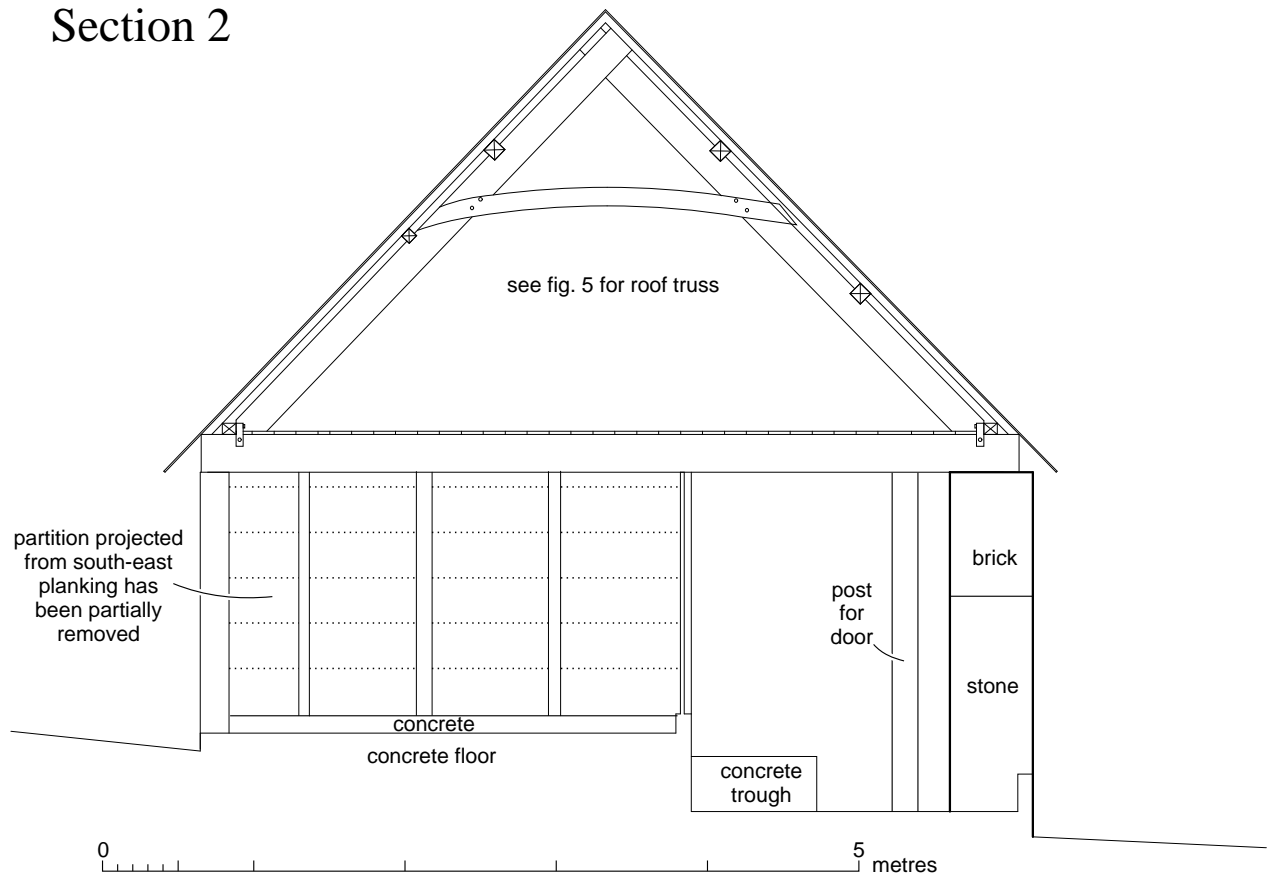
Fig. 4 Sections 1 and 2 showing ground floor features (based on Gale & Snowden Architects' drawing no. D-AL(0)004).

In bays 1 and 2 are remains of wooden partitions of vertical and horizontal planks hung from a wooden frame. Some of the timbers have been reused from an earlier partition or building. These partitions may be of 19th-century date and were retained into the 20th century when several of the bays were converted into cattle stalls. In bay 2 are the remains of a wooden manger, also retained when the barn was later upgraded.

In the 20th century the barn underwent extensive alterations to create cattle stalls. In the mid 20th century bays 2 and 3 were converted into stalls provided with a new concrete floor and a concrete feeding trough. In the later 20th century bays 3-5 were converted with a new raised concrete floor supporting wooden plank partitions that sit on a concrete block footing. The stalls were provided with concrete block feeding troughs and both wood and steel tethering posts (Plate 3). These stalls ‘face’ east and are served by a corridor allowing access to the feeding troughs along the west side of the barn.

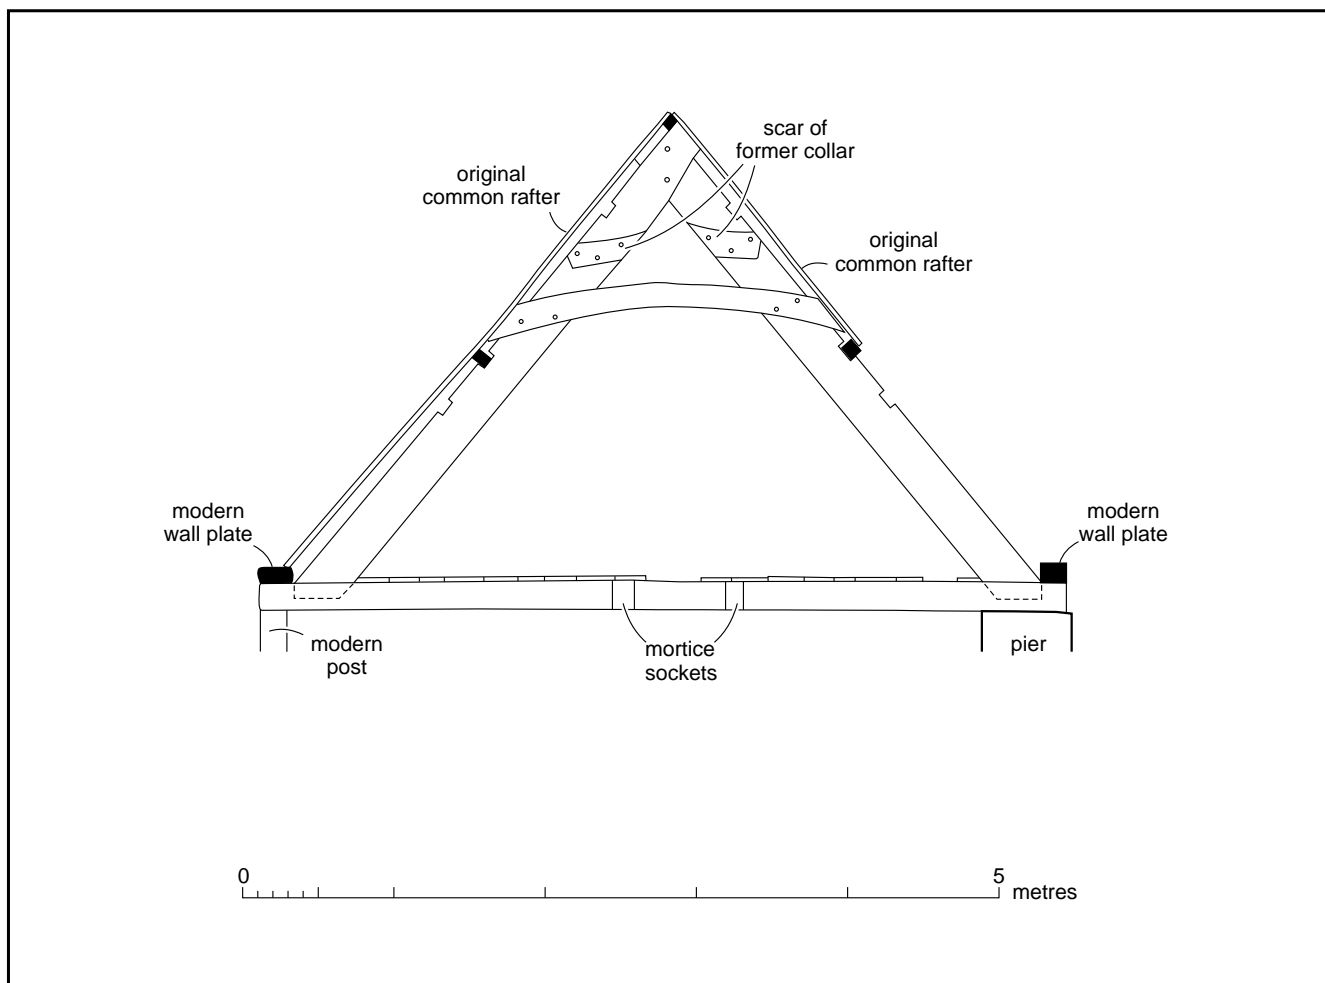
Fig. 5 Roof truss on line of section 2 (based on Gale & Snowden Architects' drawing no. D-AL(0)004).

Each pair of piers supports a roof truss. The trusses have been reused. Whether they derive from the barn or an earlier structure is unclear (see also *discussion* below). The trusses are formed by pairs of oak principal rafters lap-jointed and pegged at the apex. The feet of each principal rafter are tenoned into the top surface of the tie beams, but are not secured with pegs or nails.

When the roof was installed in the barn the original collars were replaced with new collars set lower down the rafters. The original collar was lap-jointed and secured to the trusses with pegs – three on each side. The shape of the notch in the rafters indicates the collar was cambered. The rafters display three trenches for side purlins, although only one is currently used. All three appear to be original features. Part of a slim diagonally-set ridge purlin survives, set between the apexes of the rafters.

No carpenter's marks were recorded during the survey. However, the roof was carefully constructed, and only truss 1 had been set back to front. The collars are slightly cambered and attached with lap joints and pairs of pegs. There is a pair of side purlins trenched within earlier sockets, scarf-jointed where necessary, and pegged to the rafters. The purlins support closely-spaced common rafters, that survive almost intact on the east side of the building, but only remain above the side purlin on the west side of the building. Between the trusses are diagonal braces. These are straight cut rather than the more wavy common rafters, and are almost certainly an addition to the roof structure.

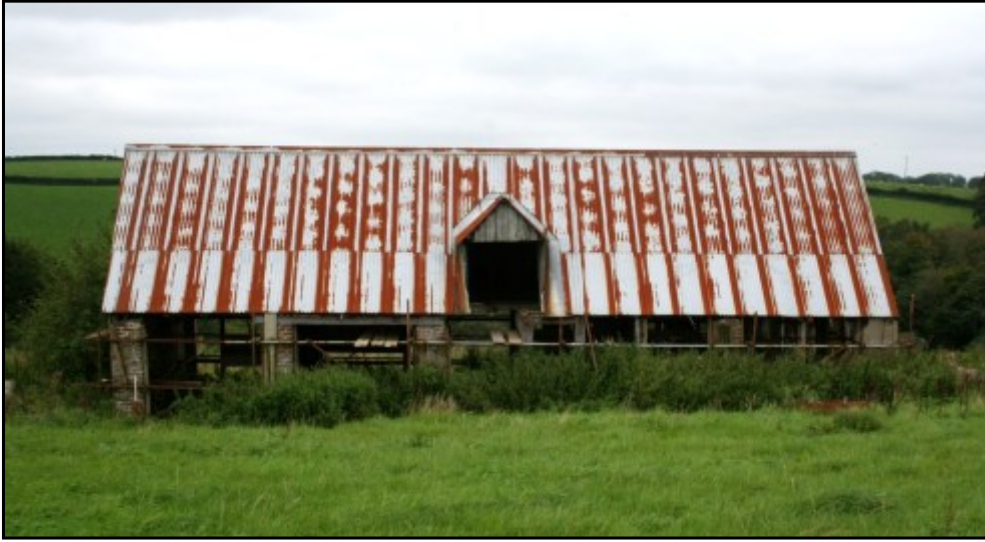
Plate 1 The barn, looking north-west. 1m scale.

central piers on the short axis. The piers are constructed of a coursed local stone on slightly projecting footings, with the upper sections utilising orange-red bricks (that have weathered to a dark red colour) containing coarse red sandstone inclusions (Plates 1-2). Both the stone masonry and the bricks are bonded in a hard white lime mortar with gravel, quartz and coal inclusions, possibly indicating that both builds are contemporary rather than the brick being a rebuild. The piers support wooden ties that divide the building into five bays.

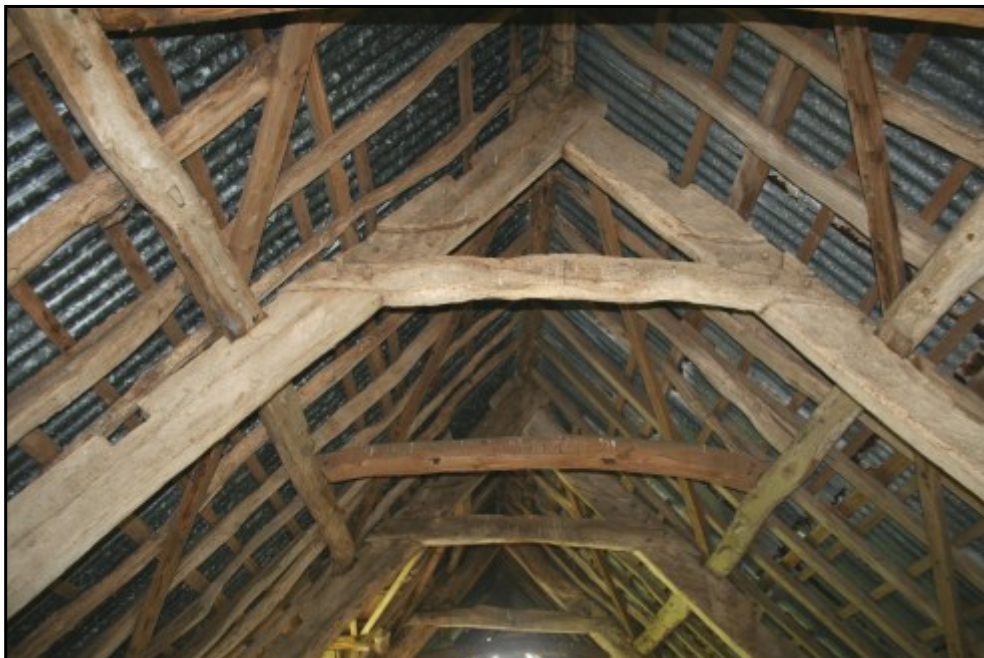
Plate 4 The roof, looking south-west.

There are no intermediate trusses, however, intermediate slightly cambered 'collars' have been added between the principal rafters, sitting on the side purlins. The removed 'collar' from the central bay is cambered with tenoned ends and a chamfer on its lower side, clearly indicating it has been reused from another building – probably a dwelling – with a completely different style of roof. In the east elevation a 'dormer'-style opening has been inserted into the central bay, clearly truncating the timbers and scantling of the original roof, to allow access into a loft. The roof covering is modern corrugated galvanised iron sheets on a wooden frame.

The roof of the building has been reused. The position of the original collars are too close to the current apex to have functioned properly as a 'brace'. It is likely therefore that the rafters were originally taller and prior to installation within the deer barn the apexes were removed, necessitating the use of new collars. These alterations probably indicate that the original roof was damaged, perhaps movement causing racking and damage to the ridge purlin and apexes of the trusses.
