**ARCHAEOLOGICAL
BUILDING RECORDING
AT FALLAPIT HOUSE,
EAST ALLINGTON, DEVON**

**Prepared for
Fallapit House Ltd**

Exeter Archaeology Report No. 08.73

November 2008

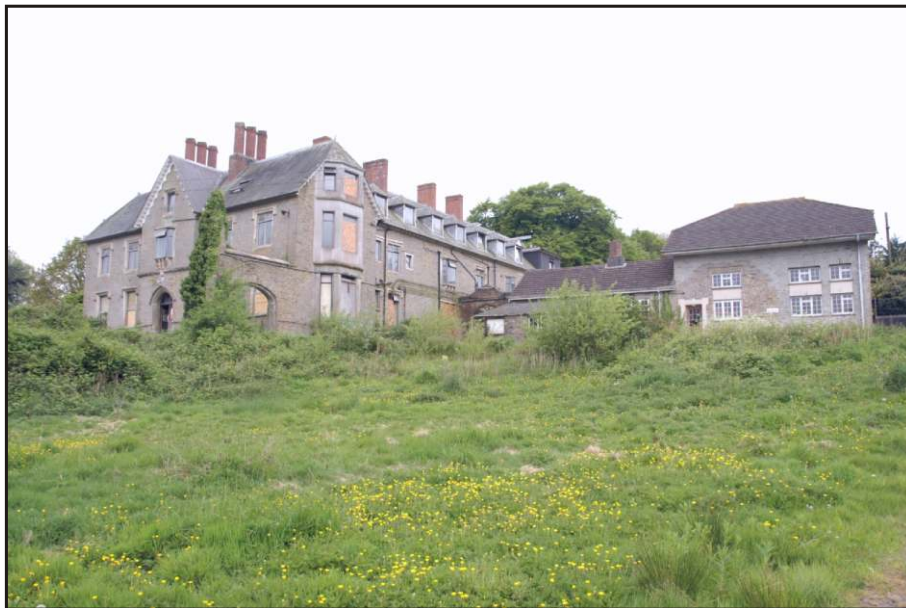
Fig. 6 View of the house from the north-east, showing the condition of the building prior to refurbishment and the heavily altered service ranges to the north.

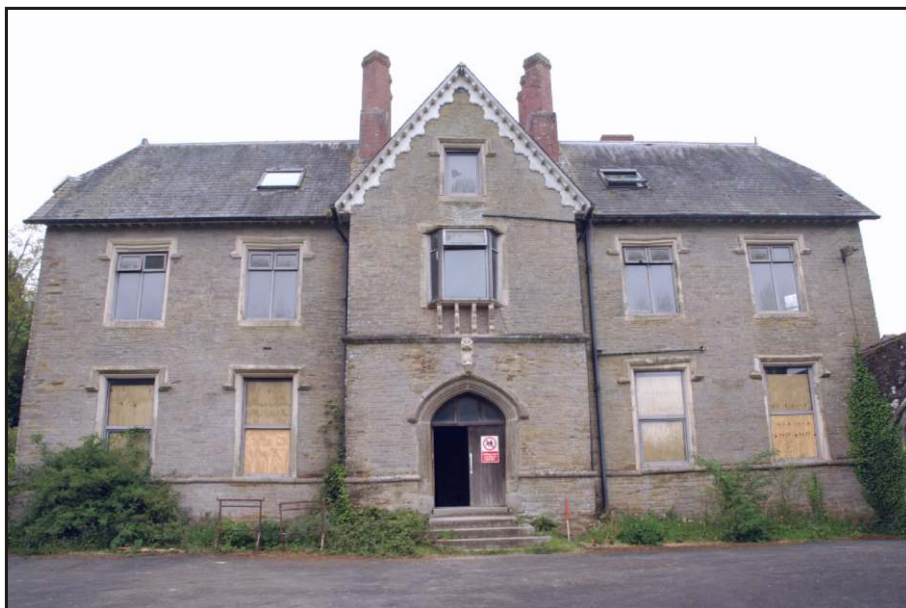
Fig. 7 View of the east elevation or entrance façade of the house showing the reused entrance archway and modern doors.

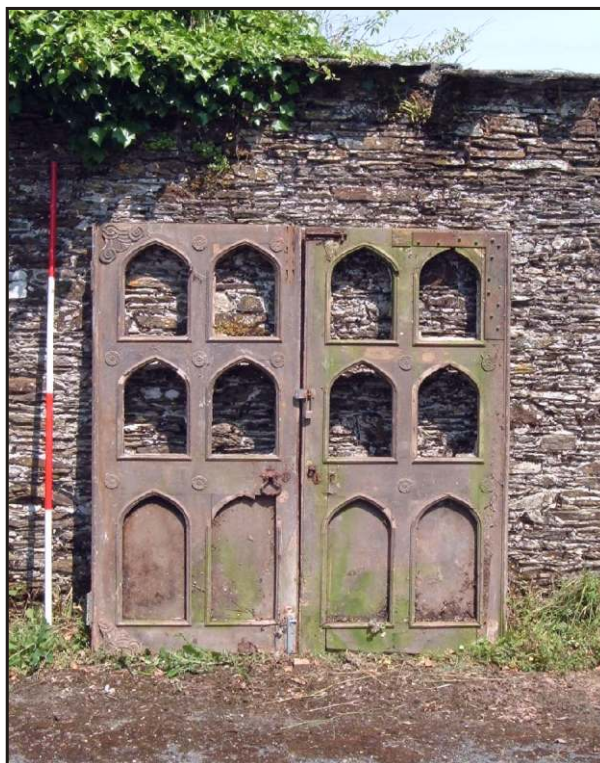
The main doors of the house had been replaced by modern doors at the time of the recording; however the original doors were discovered in a surprisingly good state of preservation, in a pile of lumber in the gardens to the west of the house (Fig. 9). The doors were massively constructed double doors in a naïve ‘Gothick’ style, each with six arched panels. The two upper tiers of panels had been glazed, and carved rosettes decorated the stiles and rails. At the outer corners of the doors were bizarre ornaments, neither exactly foliate in character, nor obviously derived from strapwork motifs. The fanlight above was originally subdivided by intersecting ‘Y’-tracery in the ‘Churchwarden’s Gothic’ manner; this had been replaced by a single pane of glass, but was fortunately recorded in an early photograph (Fig. 10). The un-archaeological character of the Gothic ornament may suggest that these doors had survived from the early 19th-century house.

Fig. 9 Detail of the original front doors of the house, recovered from a lumber pile near the top of the site.

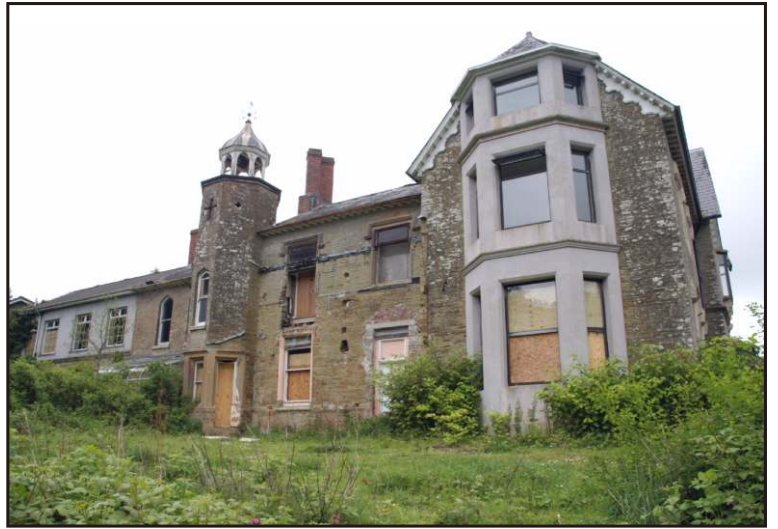
Fig.12 View of the south façade of the house showing alterations made since c.1869 (compare Fig.5).

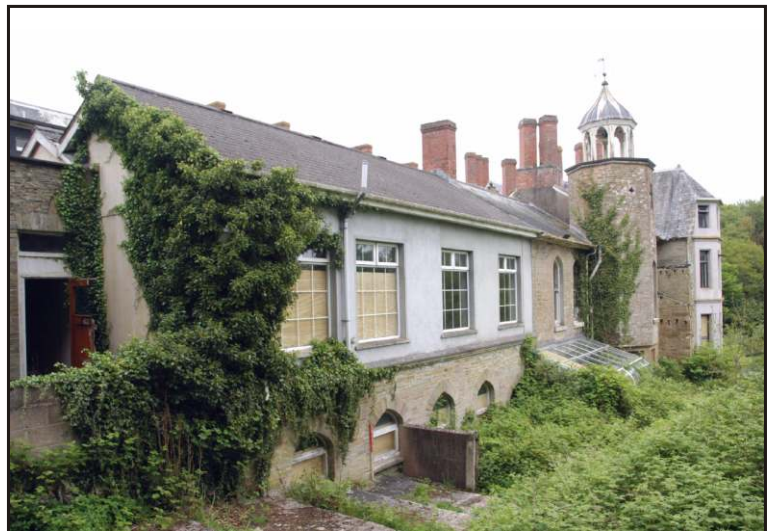
Fig.13 The south elevation of the late 19th-century extension to the south-western range, showing the unusual roofline and 20th-century alterations to the upper floors.

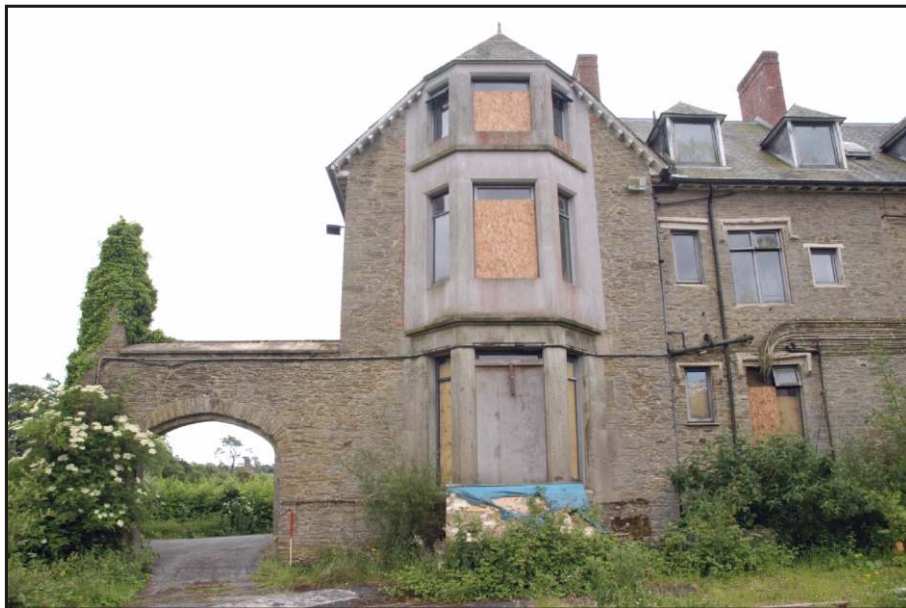
Fig. 15 View of the north elevation of the main house showing the rear view of the archway and the inserted bay window. A vertical break in the masonry of the upper floor may be discerned on the extreme right.

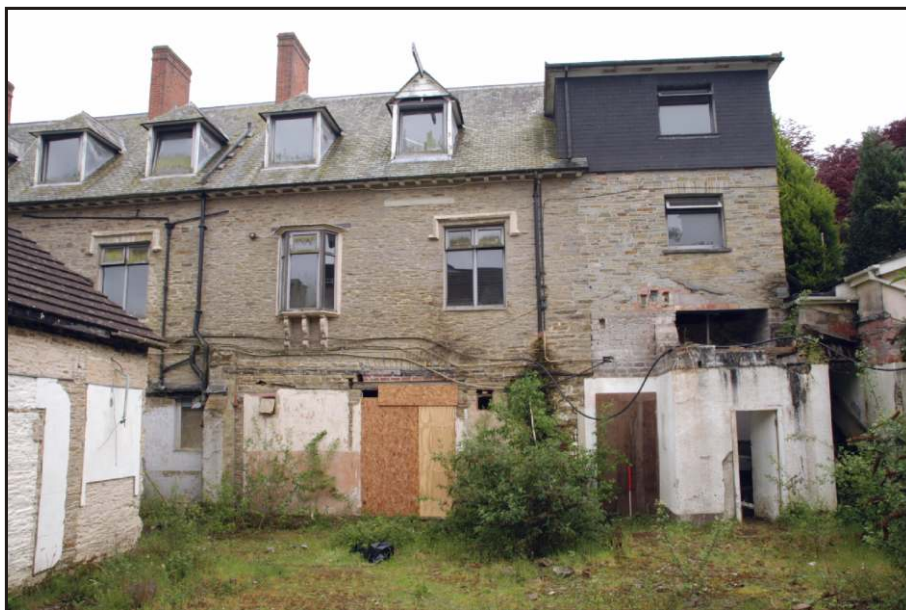
Fig. 16 The western end of the north façade of the service range, showing the extent of 20th-century alterations.

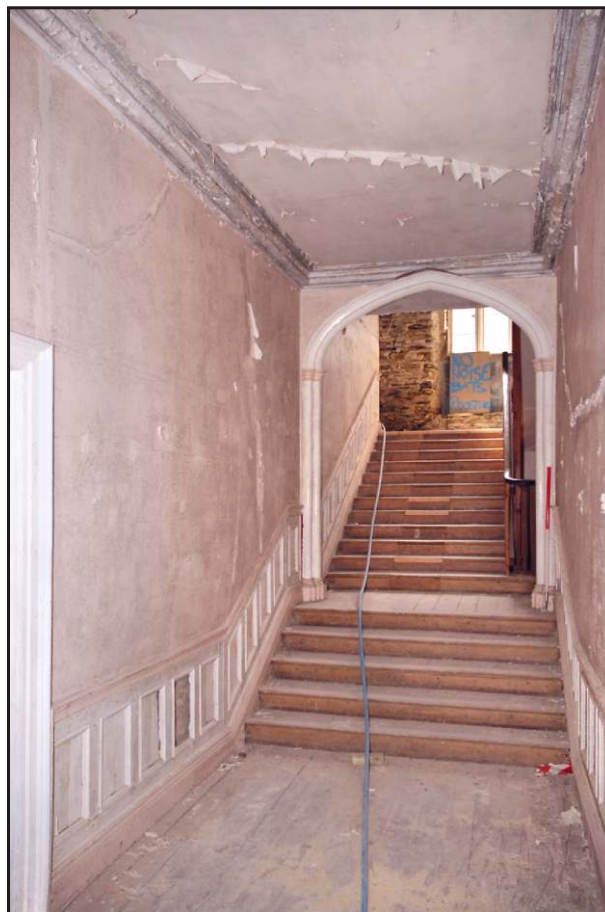
Fig. 20 The main corridor, looking west towards the foot of the staircase. The collision between the top of the archway and the cornice and the widened staircase can clearly be seen.

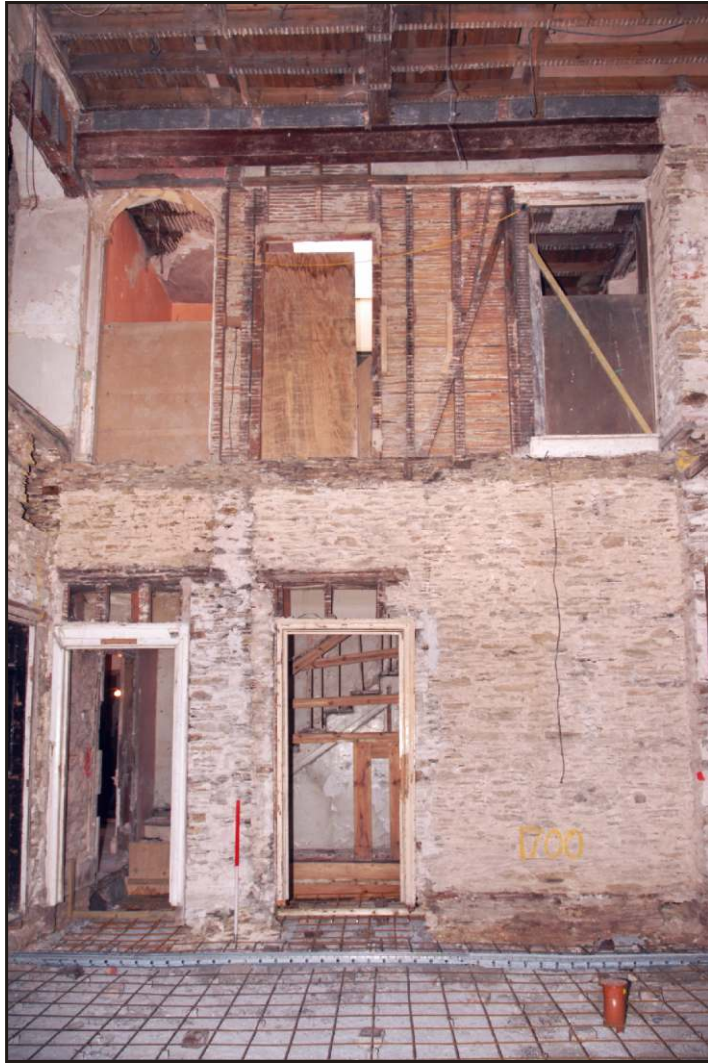
Fig. 23 View of the mid 19th-century partition between the service stair and the rooms in the service wing, showing later 19th-century alterations to the openings and the character of the structure.

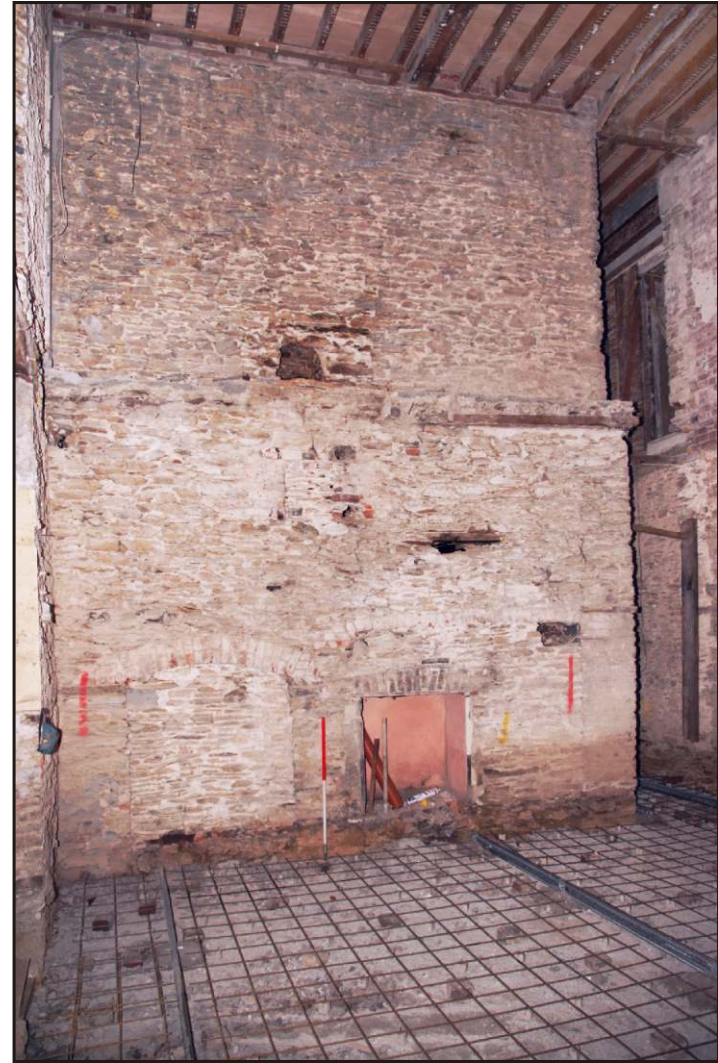
Fig. 24 View of the fireplaces in the eastern wall of the old kitchen, showing the blocked openings and traces of the earlier roofline of the range as a wall scar above.

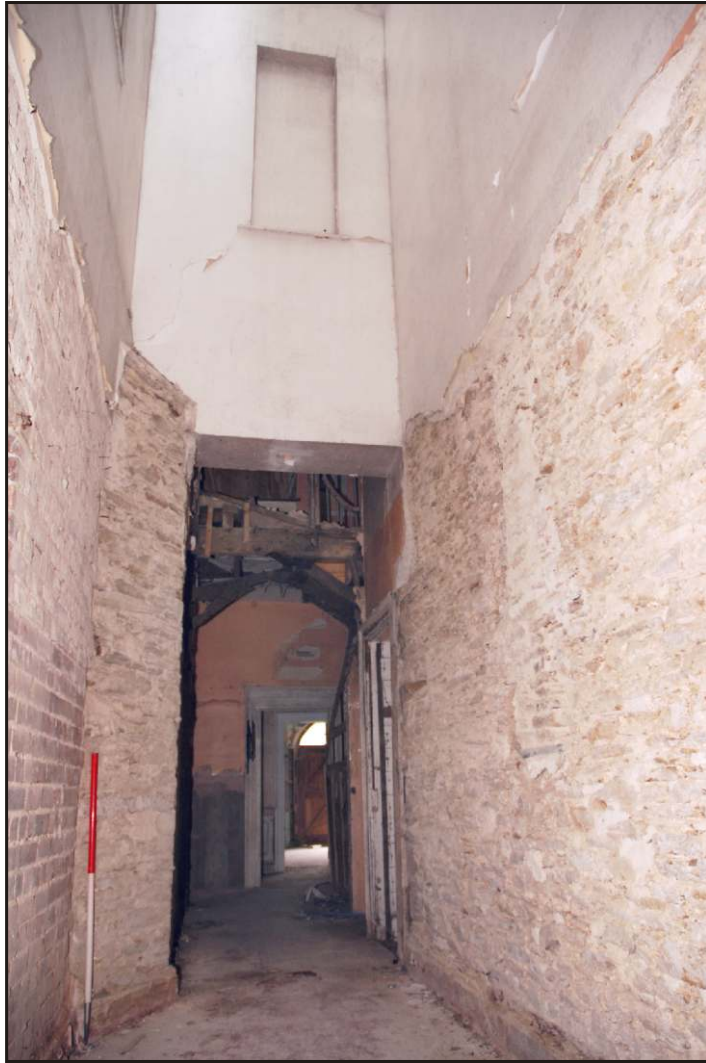
Fig. 25 The corridor or light well alongside the old kitchen, looking towards the service stair, showing blocked windows on the first floor and an enigmatic chase in the wall (right).

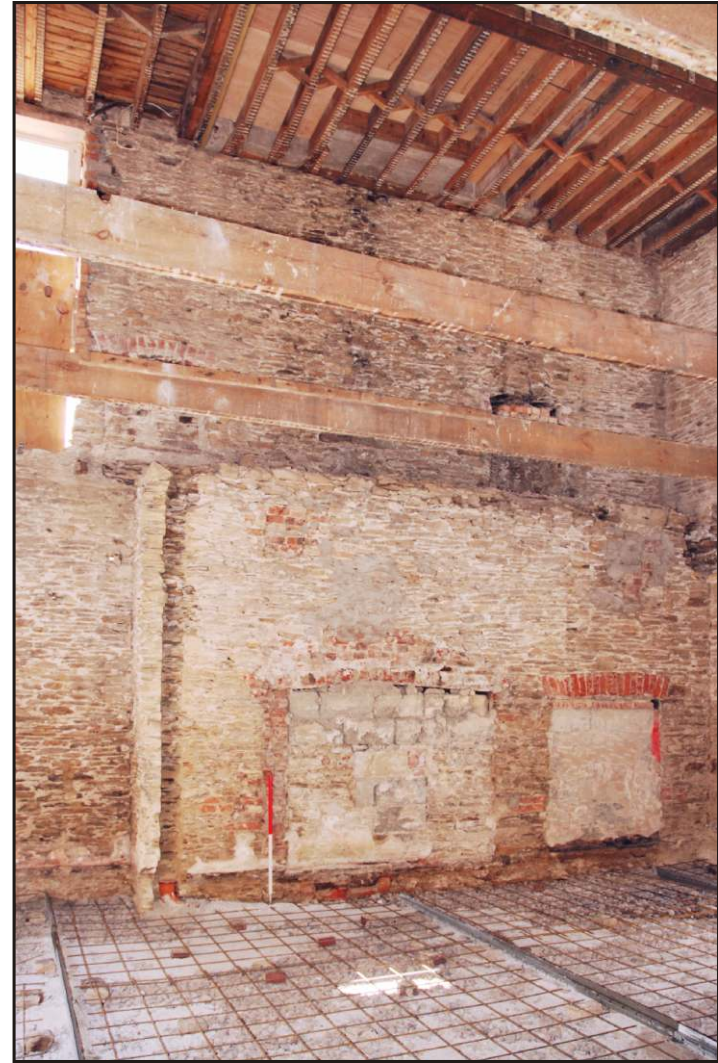
Fig. 26 Blocked fireplaces in the west wall of the new kitchen and in the rooms above, showing the character of the mid 19th-century fabric.

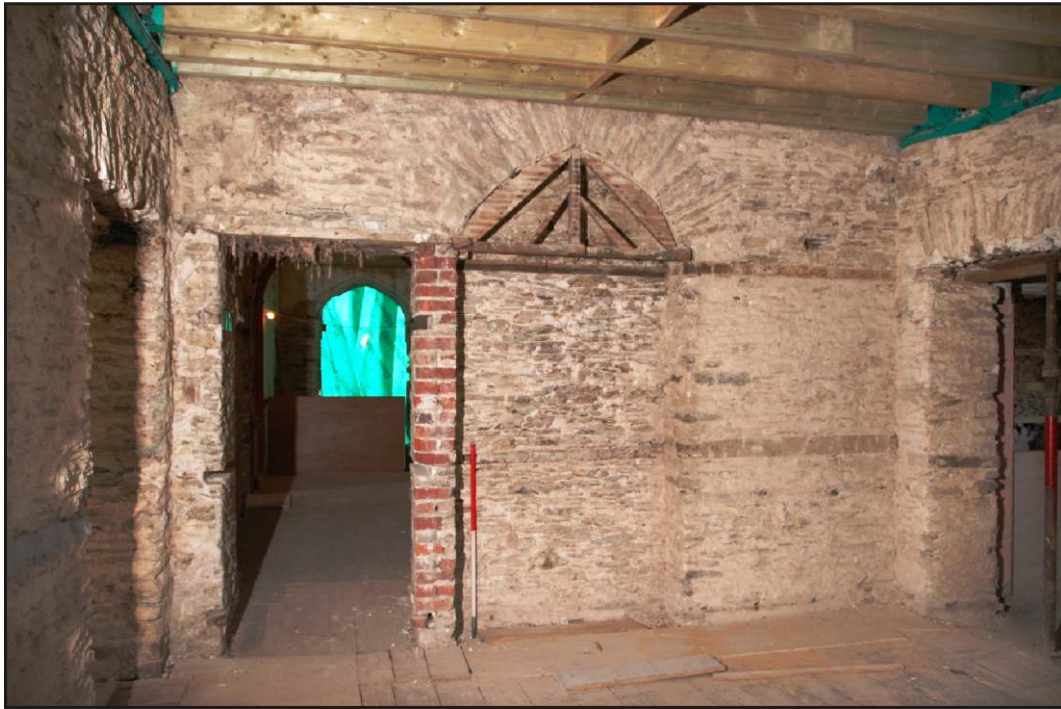
Following the stripping of the plaster the structural history of the room was revealed as still more complex (Fig. 28). The rectangular alcove in the west wall proved to have replaced an arched alcove with a two-centred arch and stone voussoirs, the head of the arch having been infilled with timber struts to convert it to a rectangular form. One jamb of the archway had been rebuilt in brick, presumably when the doorway alongside was made in the 19th century. Although it initially appeared likely that the archway would have opened directly onto the landing, this proved not to be the case; the archway and the north wall of the landing conflicted in alignment, and the masonry within the archway was integral with the walls alongside. The timber lacing of the walls continued across the rear of the arch showing that this feature was always a shallow alcove.

Fig. 28 View looking east in the central first-floor room, towards the main stairs and landing, showing the arched alcove as revealed by the building works, and 19th-century attempts to disguise it.

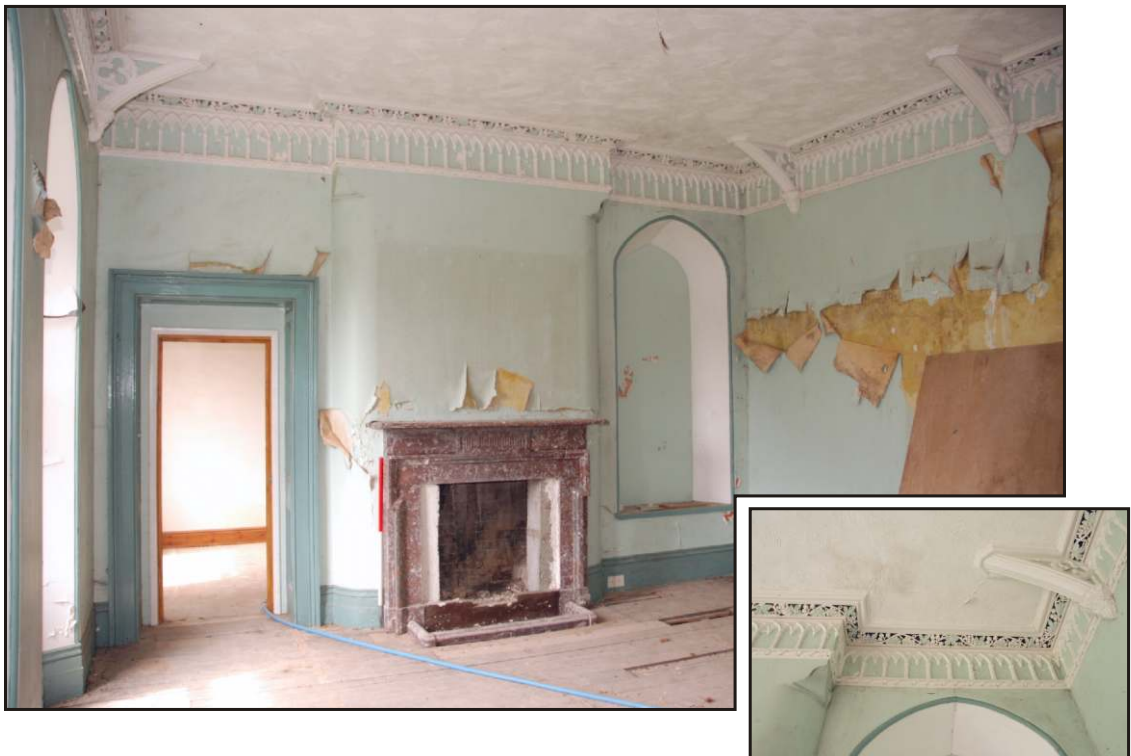
Fig. 29 View of the first-floor ballroom looking east, showing the marble fireplace, plasterwork and blocked windows and openings into the conservatory beyond (detail of the plasterwork inset).

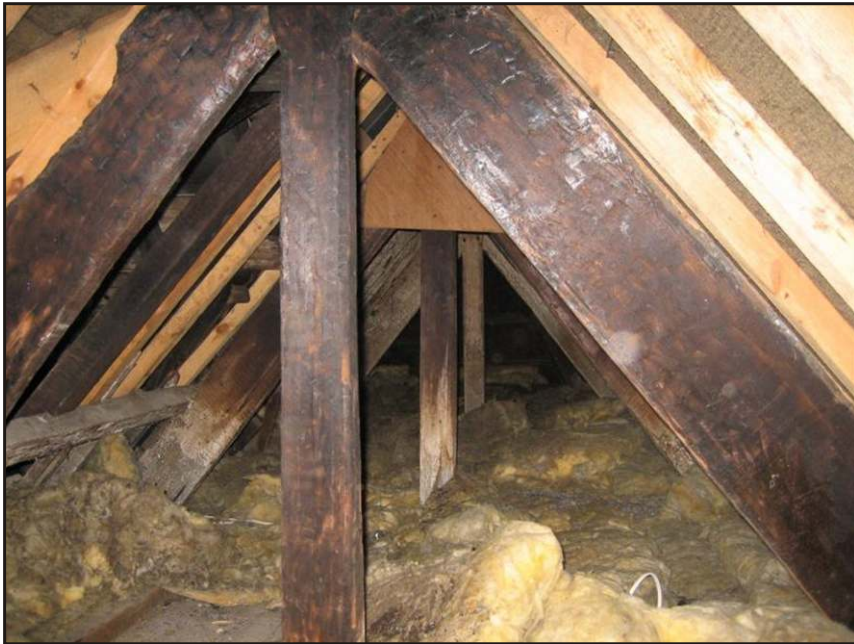
Fig. 32 Evidence of charring and fire damage to the ?19th-century roofs of the northern part of the house following a minor 20th-century fire.

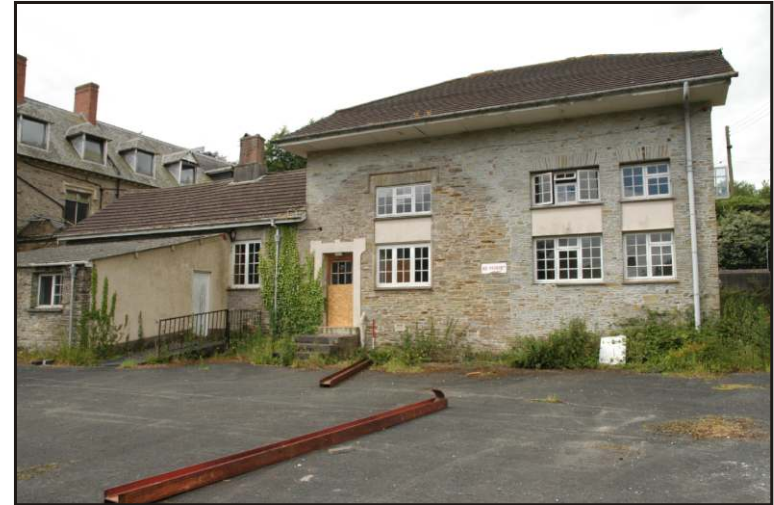
Fig. 33 The eastern range of the service buildings, showing the extent of 20th-century alteration.
