# ARCHAEOLOGICAL RECORDING OF A WAREHOUSE AT KING STREET, BIDEFORD, DEVON

Prepared for Mr D. Johnson

**Exeter Archaeology**

Report No. 09.111 (6820)

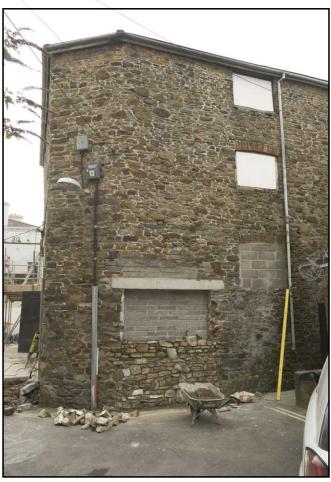
The warehouse is a rectangular, three-storey building, with an angled north-east corner, respecting the alignment of King Street (the earlier building also had an angled corner, and this seems to imply that King Street was laid out after the construction of some of the early warehouses along the quay.) The warehouse includes an integral single-storey range attached to the south elevation, which has been extended to the east. The original part of this range has a pitched roof supported on a single purlin. The slate roof covering and associated batons are modern. At the west end the warehouse incorporates a small cottage. This part of the building was not entered due to dangerous stairs and floors.

The building is constructed of roughly-laid local slates and sandstone bonded with a hard gritty white cement with gravel, brick and coal inclusions. The windows in the north, south and east elevation are aligned both horizontally and vertically in a regular grid pattern. Above the windows on the ground and first floors are shallow red brick arches. All of the windows have wooden frames, but they are of varying designs with

Plate 1 The warehouse viewed from King Street, looking south-west. 1m scale.

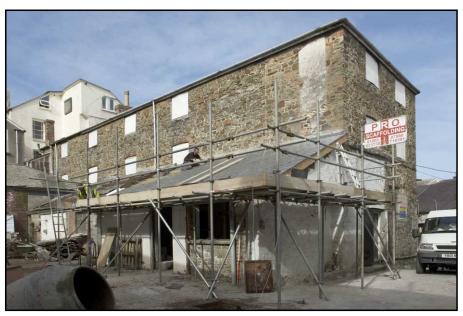
The warehouse sits within a large courtyard, which at various times had been completely infilled. Some of the more recent outbuildings have been demolished.

Plate 2 The warehouse viewed from its courtyard, looking north-west. 1m scale.

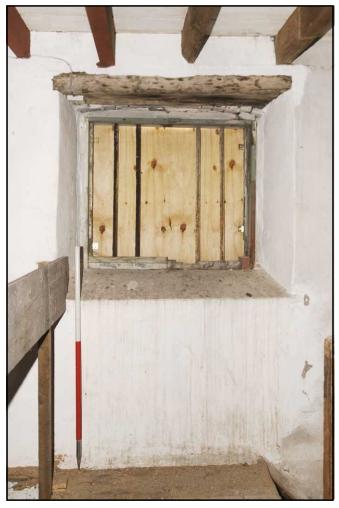
different architectural features including plain central mullions, moulded central mullions, evidence for glazing, and internal pintles for shutters. The only common element is the presence of four iron security bars on the outside of each window. The dividing wall between the warehouse and the cottage is angled at its north end and 'abuts' a row of windows. This appears to have been a deliberate feature to allow, on the upper floors, a single window to provide light into both the warehouse and the cottage.

Plate 3 Close-up view of a first-floor window, looking south. 1m scale.

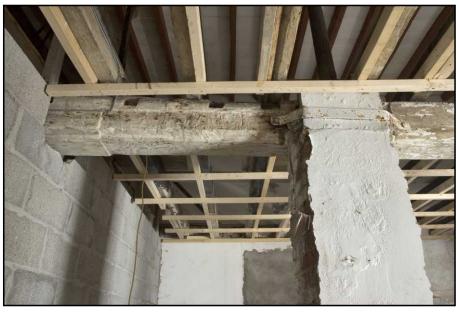
The first floor is supported on a large reused oak beam displaying joist sockets. The joists in the present building rest on the beam rather than in sockets, and are randomly painted black and white, probably indicating they have been reused, possibly from a domestic context. The beam is supported on a brick pier, and a modern concrete block pier. In the western part of the warehouse this beam is joined to a second beam and they are supported on a plain circular cast-iron column. The present stairs to the first floor are located against the south elevation. However, there is evidence in the floorboards, and from sawn-off joists at the present stair locations, to indicate they have been relocated from a position adjacent to the west elevation. They might have been moved when the ground floor above the cellar was raised.

Plate 4 Reused beam supporting the first floor, looking west.

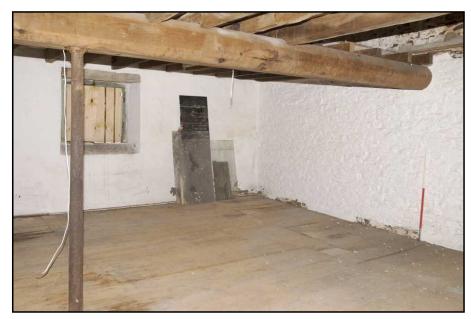
timbers. At the eastern end of the building is a large dressed wooden beam, and at the western end a mast destined for a sailing ship had been used. The mast had been fully turned but displayed no evidence for actual fitting into a ship, the only other distinguishing features being sockets for the floor joists. As with the floor below, the stairs to the first floor had been moved from a position on the east elevation to their present position against the south elevation.

Plate 5 View of the first floor showing a ship's mast reused as a beam, looking south-west. 1m scale.

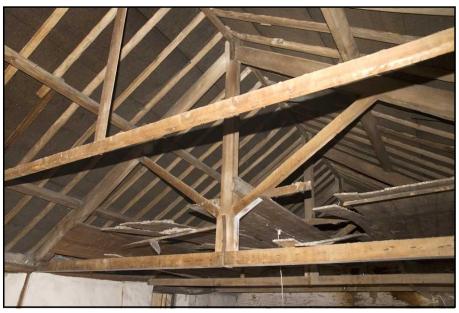
The roof is a 20th-century recovering in slate tiles and is supported on six tie-beam trusses with king posts and diagonal struts. The lower ends of the king posts are attached to the tie beams with iron straps. The east end of the roof is hipped with further timbers at the north-east corner where the roof is carried over the angled masonry below. The rafters support two rows of staggered back purlins, as well as a ridge purlin. The roof space had been partially boarded over using tongue-and-grooved boards fixed both horizontally to the base of the tie beams, and vertically to the sides of the trusses, meaning that some bays were fully open. This may indicate that the loft was used for the storage of delicate goods, such as textiles.

Plate 6 Roof trusses showing boards, looking south-west.
