# Devon County Council Historic Environment Record

## **Beaford Mill**

### **Appraisal of the Roofs – November 2008**

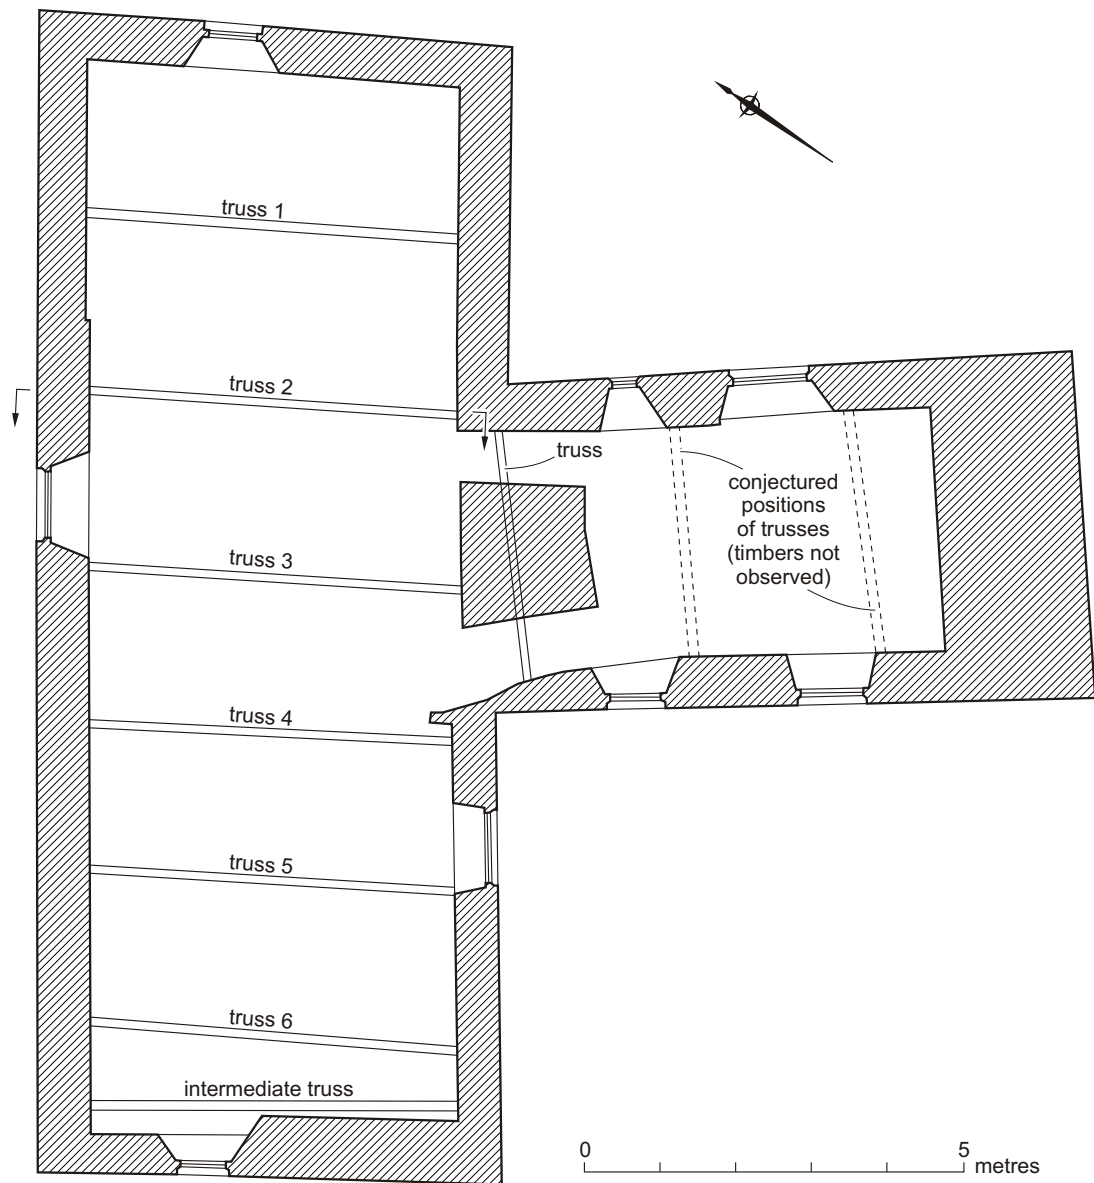
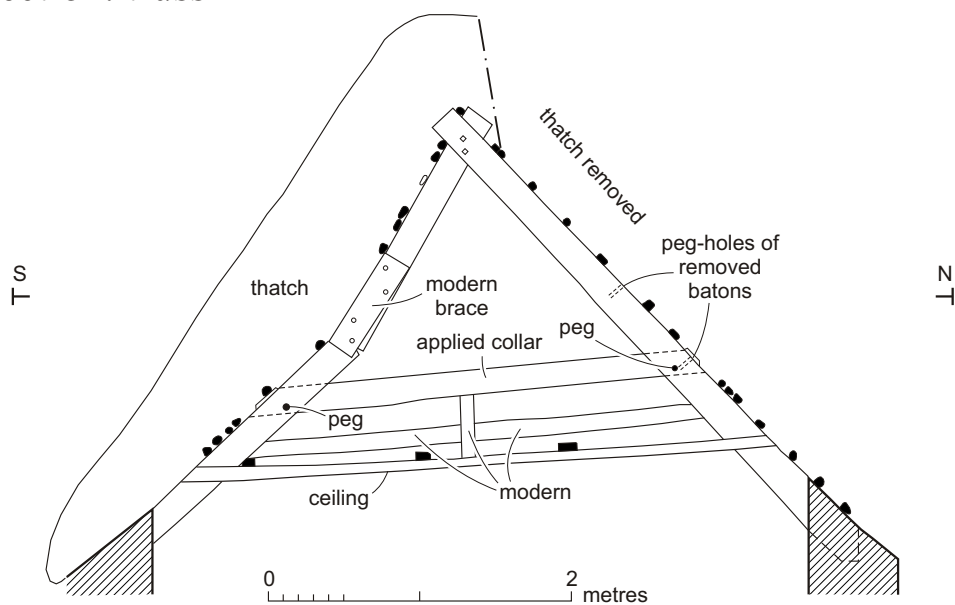
Fig. 4 Plan of first floor and section through truss 2.

The roof structure comprises six A-frame trusses constructed of pairs of principal rafters with collars. The apexes of the rafters are lap-jointed with wooden pegs, and the timbers cross indicating they were designed to support a ridge purlin although such a feature is not currently present in the roof. The trusses are braced with high-level applied collars fixed with wooden pegs. Their high level relative to the length of the purlins indicates that they were designed for a building with a first floor. Several of the collars are wavy probably reflecting the nature of the timber used, and consistency in this patterning indicates that some of the collars were cut from the same tree. There are no side purlins to the roof and no evidence (e.g. sockets or trenches) could be observed on the rafters for positions of former purlins. The roof is covered with thatch, and this is supported on rows of small poles that act as 'purlins' or batons.

The roof is currently ceiled at a height that differs throughout the range, and the rafters project below the ceilings into the first floor rooms. Immediately above the ceiling the trusses have been braced with the application of further collars fixed using bolts. These timbers may also act as a support to the ceilings.

Several recent repairs, probably carried out by the last owner, were noted. In the centre of the roof horizontal timbers have been added as braces between the collars with smaller vertical batons added between the original and later, lower collars. These timbers have presumably been added to counteract racking of the trusses caused by the lack of, or historic removal of, horizontal purlins. At least two of the purlins have snapped, possibly caused by the weight of the thatch above, and have been 'stitched together' using metal plates.

*The roof of the main range:* draw a sample truss, prepare a better photographic record than could be undertaken as part of the appraisal, along with any necessary further written notes on its construction.

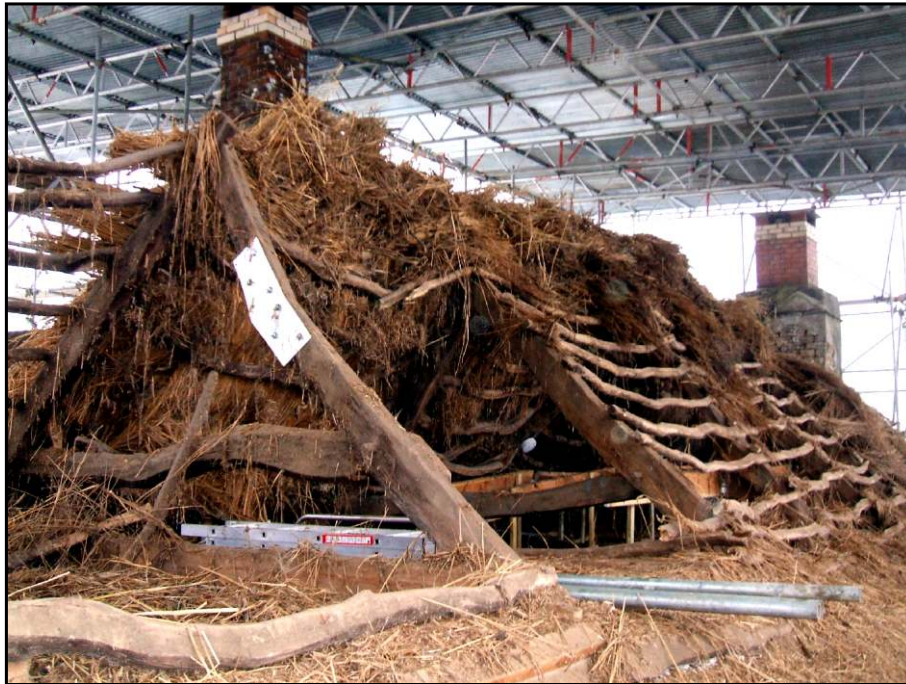
Pl. 1 The north side of the roof following removal of thatch, looking south-west.

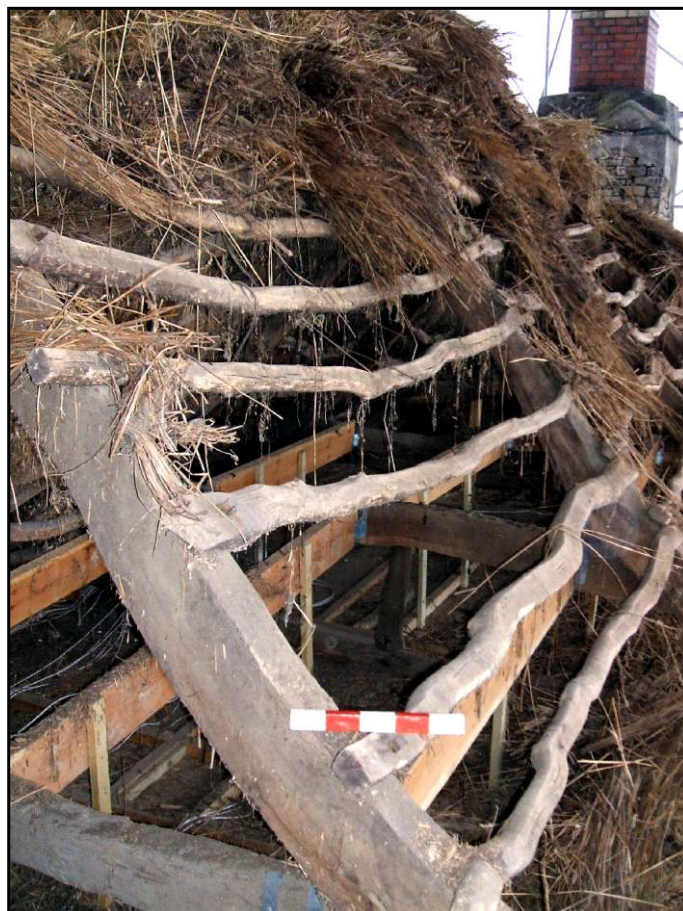
Pl. 2 The roof between trusses 2 and 3 showing thatching batons, looking south. Scale 0.25m.
