**ARCHAEOLOGICAL RECORDING AT  
LOWER KING'S MILL,  
CULLOMPTON, DEVON**

**Prepared for  
The St Regis Paper Company Ltd**

**Exeter Archaeology**

**Report No. 09.43**

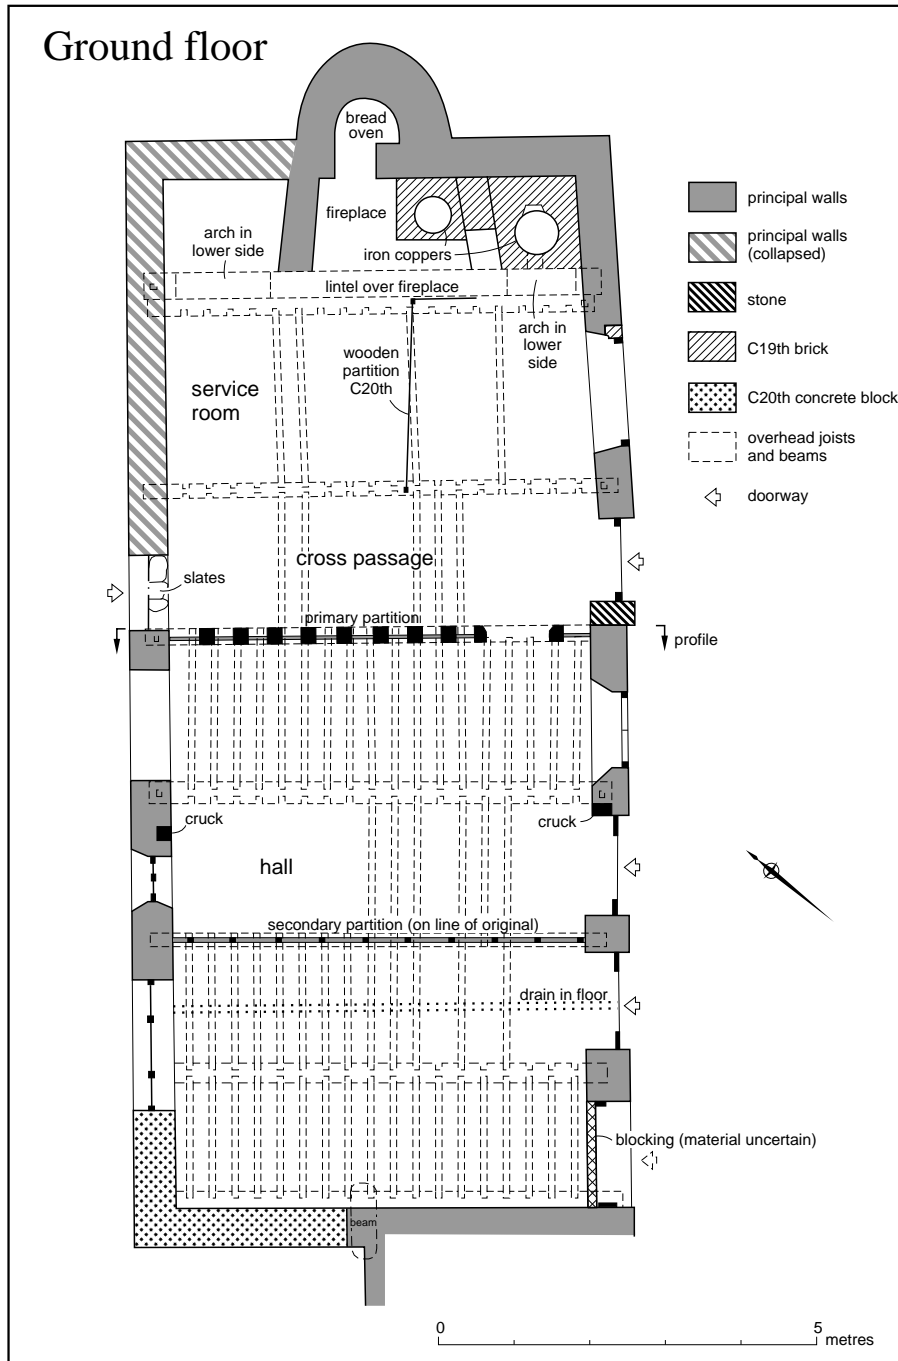
Fig. 2 The house, ground floor plan.

The cross passage is defined by opposing doorways, with a surviving screen on the upper side dividing the passage from the hall. The screen sits on a stone cill, and retains part of the upper

plate and posts, including two doorframes with ovolo mouldings facing the passage. The screen was originally infilled with daub supported on horizontal rods, some of which survive; elsewhere regularly-spaced rows of sockets for the rods are visible. The door in the screen has been removed and infilled with wattle and daub, and is covered by a coat of whitewashed plaster that has also been applied across the screen (Pl. 3). The screen on the lower side of the passage does not survive.

Each room is divided into two bays by substantial timber beams with wide chamfers and large run-out stops. The upper sides of these beams contain sockets for the first-floor joists, many of which survived. Several of these beams have square sockets on their undersides at their ends where the beams slot into the walls. These could have supported upright timbers, but none were present in the current building. This must indicate that the beams have been reused from an earlier building.

In the south-east elevation, in addition to the cross passage entrance, there are further door openings into the hall and parlour. These appear to be original although this is an unusual layout. One of the doors into the parlour has been blocked. The surviving doors have thick wooden frames with ovolo mouldings. The doors themselves are made from planks with bottom and interior nailed batons. The western door has been altered with the addition of laths and a window opening covered with wire mesh. This alteration is probably contemporary with a concrete floor containing a drain in the adjacent room. In the hall is a splayed window with internal shutters (Pl. 4). The doors and the windows have T-shaped strap hinges and base plates, which generally date to between the second and third quarters of the 17th century (Alcock and Hall 1994, 24). There is a second (inserted) window in the south-east elevation, providing light to the service room. The south doorway of the cross passage has been moved to the east, with the insertion of a stone pier. This must predate the 19th-century alterations, since this was not executed in the brick used elsewhere in the house. The original door and its frame have been retained, and it is entered from its own lobby within a later extension.

Incorporated into the north-east elevation of the service wing is a large chimney stack serving a ground-floor splayed fireplace with a contemporary projecting semi-circular bread oven. The bread oven has a roof of tar-covered slate, and is lined with granite flagstones. Either side of the fireplace are recesses. Both the recess and the fireplace are surmounted by a large lintel that displays curved openings on its underside over the recesses, and supports the chimney stack at first floor level. Adjacent to the lintel is one of the chamfered beams supporting the first floor. This does not contain joist sockets on its east side, indicating the recesses were not covered at first floor level. The fireplace and the southern recess contain circular iron 'coppers' for heating water. These coppers are set into brick surrounds that incorporate fireboxes with cast-iron doors and grills into lower-level ash boxes.

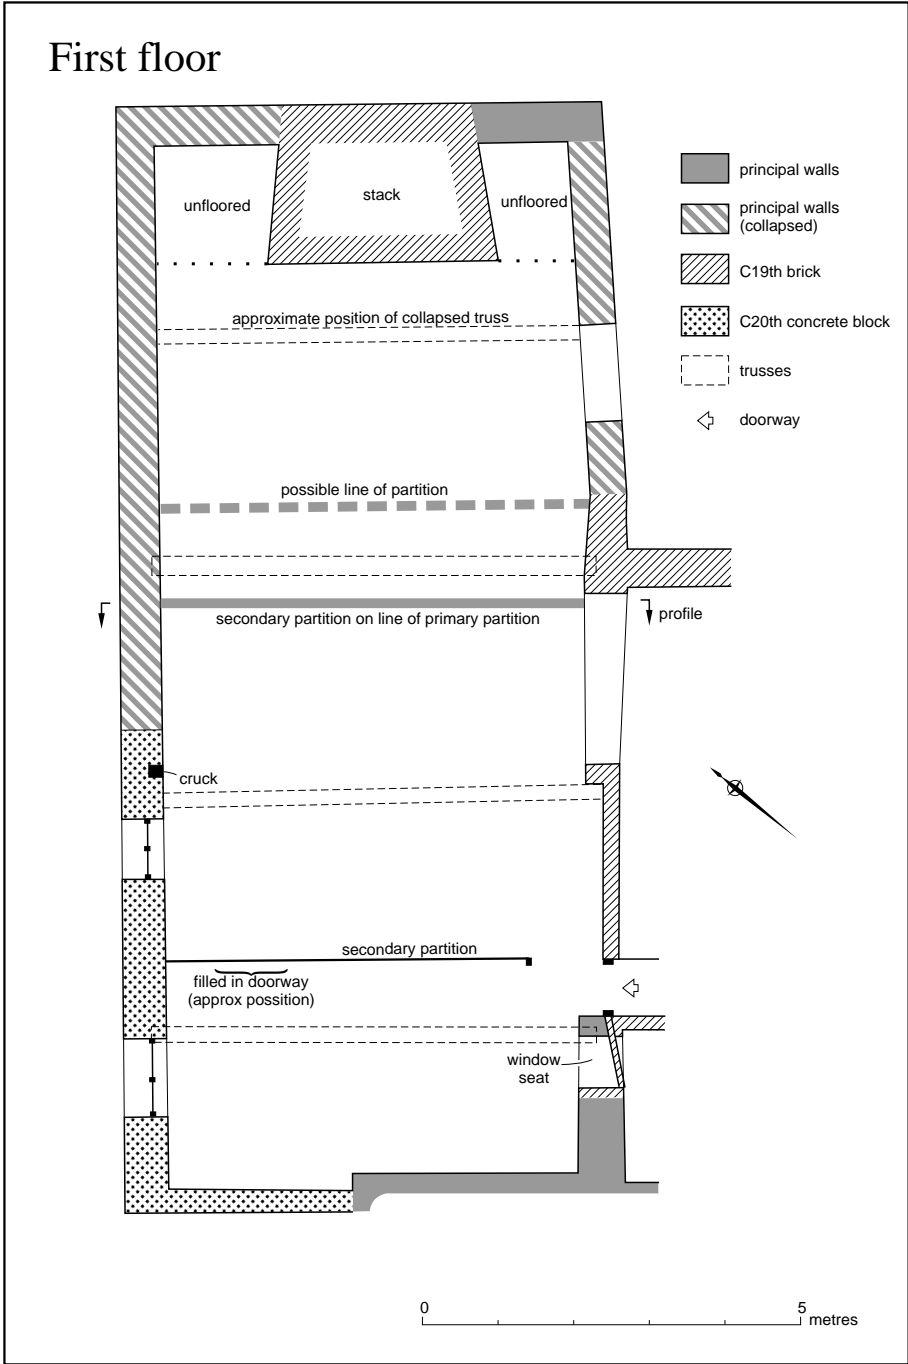
Fig. 3 The house, first floor plan.

The layout of the first floor in its original format is not known. The beam above the surviving ground-floor screen contains mortices for a removed first-floor partition on the same alignment. No other evidence for any other original first floor partitions was observed.

At an unknown date prior to the 19th-century two lathe and plaster partitions were added – one on the line of the earlier partition, the second to the west – creating two rooms at the west end of the building. There were doors in the north sides of these partitions – one now blocked – probably indicating the location of a former corridor along the north side of the building, a typical position for a corridor in a cross-passage house. Following 19th-century alterations to the house complex (see below) the corridor serving the two rooms at the west end of the first floor was removed, and the room was entered via a new corridor from the extension to Lower King’s Mill House. A new door was inserted into the west partition, and the earlier door blocked.

The layout of the rooms to the east could not be established, since this part of the structure had collapsed. However, there was evidence for a (probably 19th- or 20th-century) weatherboard partition, with a large central opening. Due to the collapsed nature of the building, and removal of the chimney stack, it could not be established whether there was a first-floor fireplace within the stack. However, a cast-iron grate recovered by the contractors from the building is of a different design to those in the extension to Lower King’s Mill House, and must have come from a first-floor fireplace. The chimney stack above the first floor is constructed of brick.

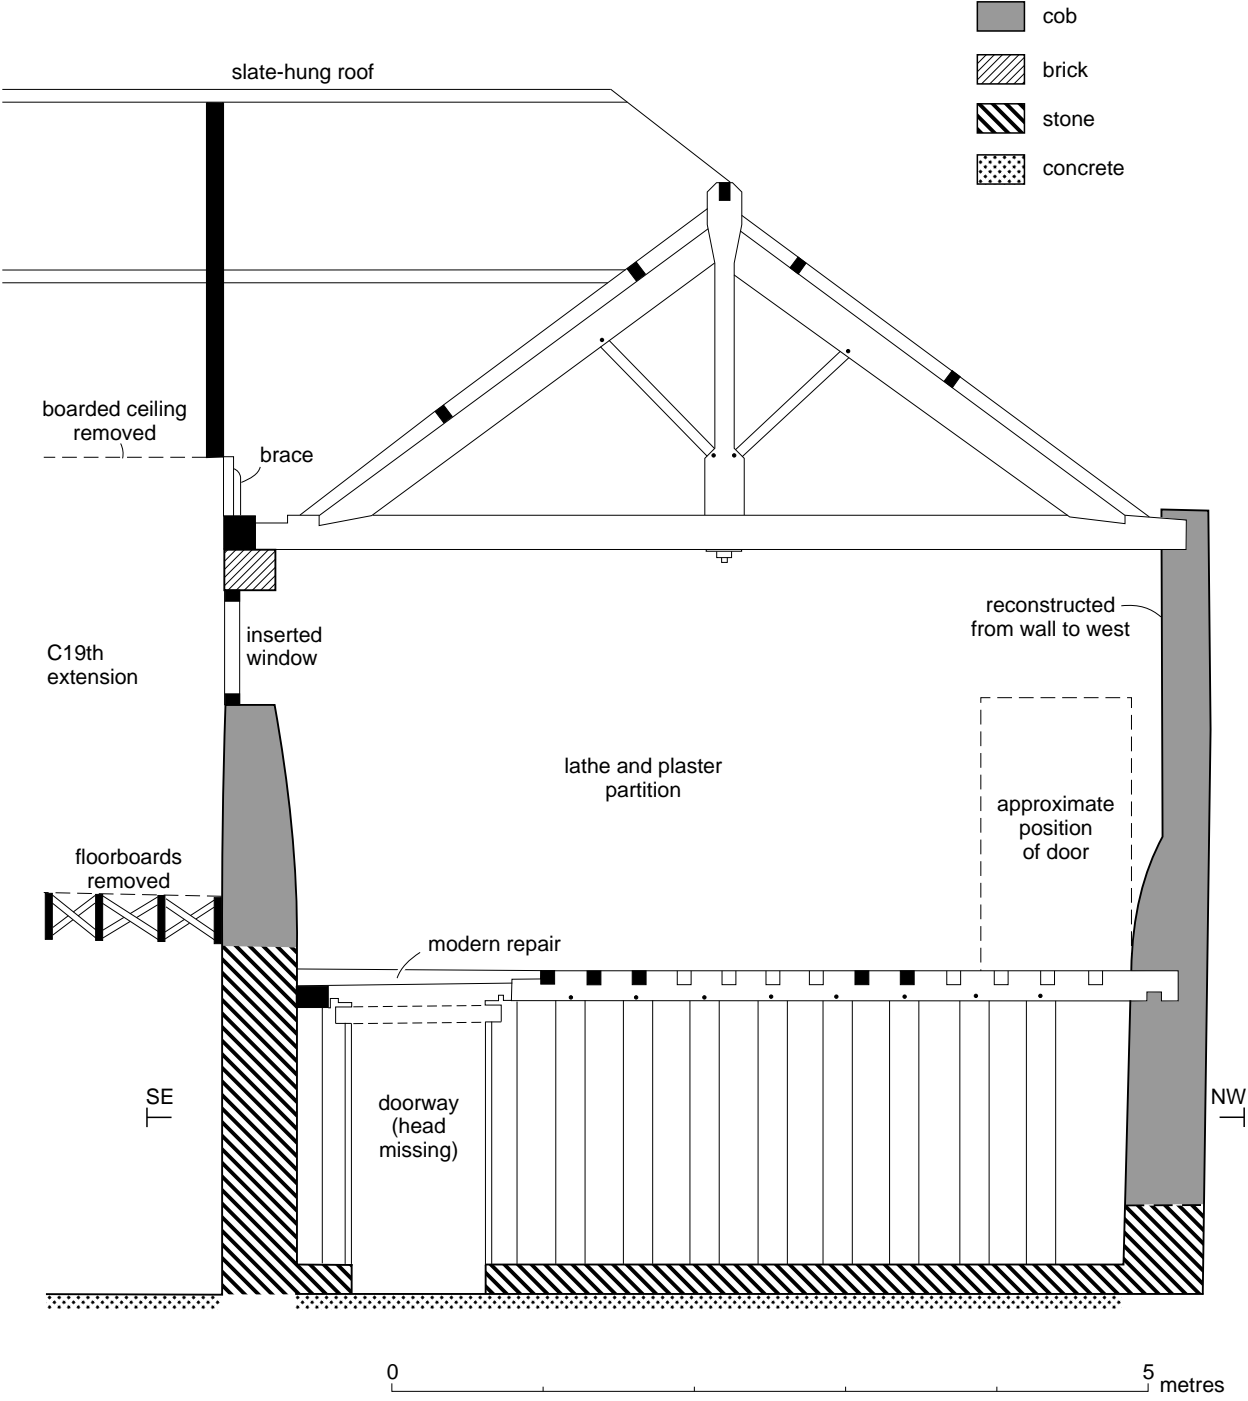
Fig. 4 Profile through the house.

The roof of the building was completely replaced in the 19th century. However, there are a pair of partially surviving wooden crucks built into the north and south elevations (Pl. 4). The cruck in the north wall rests on a pad. The upper sections of the crucks have been removed and their form cannot be reconstructed. The present roof is slate hung, supported on tie beam trusses with king posts and diagonal struts, fixed with both wooden pegs and iron bolts. The roof is contemporary with the roof of the extension to Lower king’s Mill House. On the eastern truss, which was extensively examined following removal, there are a series of carpenter’s marks ‘III’. Other than the crucks, there is no evidence of the original roof, but some of the purlins are scarf jointed and appear have been reused from an earlier structure.

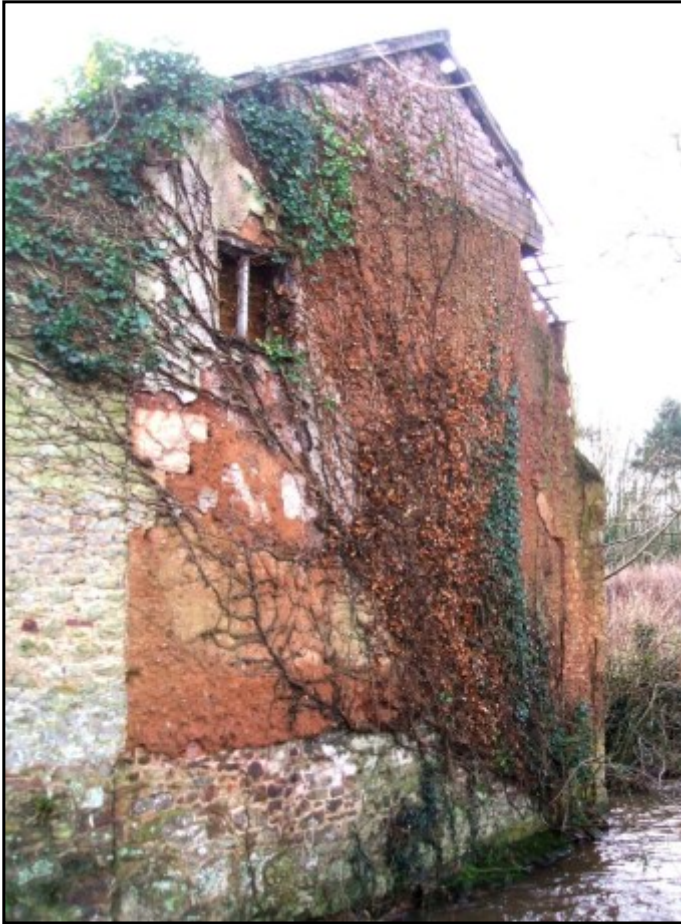
There are single and double doors fronting a courtyard in the east elevation, with small-paned windows above (Pl. 1). There are further tall, narrow early-19th-century metal-framed windows at first floor level with slightly arched heads, which are almost certainly inserted into earlier loading doors. In the north elevation there is a small, high level, wooden-framed two-light window. The inner side of this window has been blocked in brick. In the west elevation is a large loading door, also blocked in brick.

Plate 1 The north elevation of the barn, looking south-west.

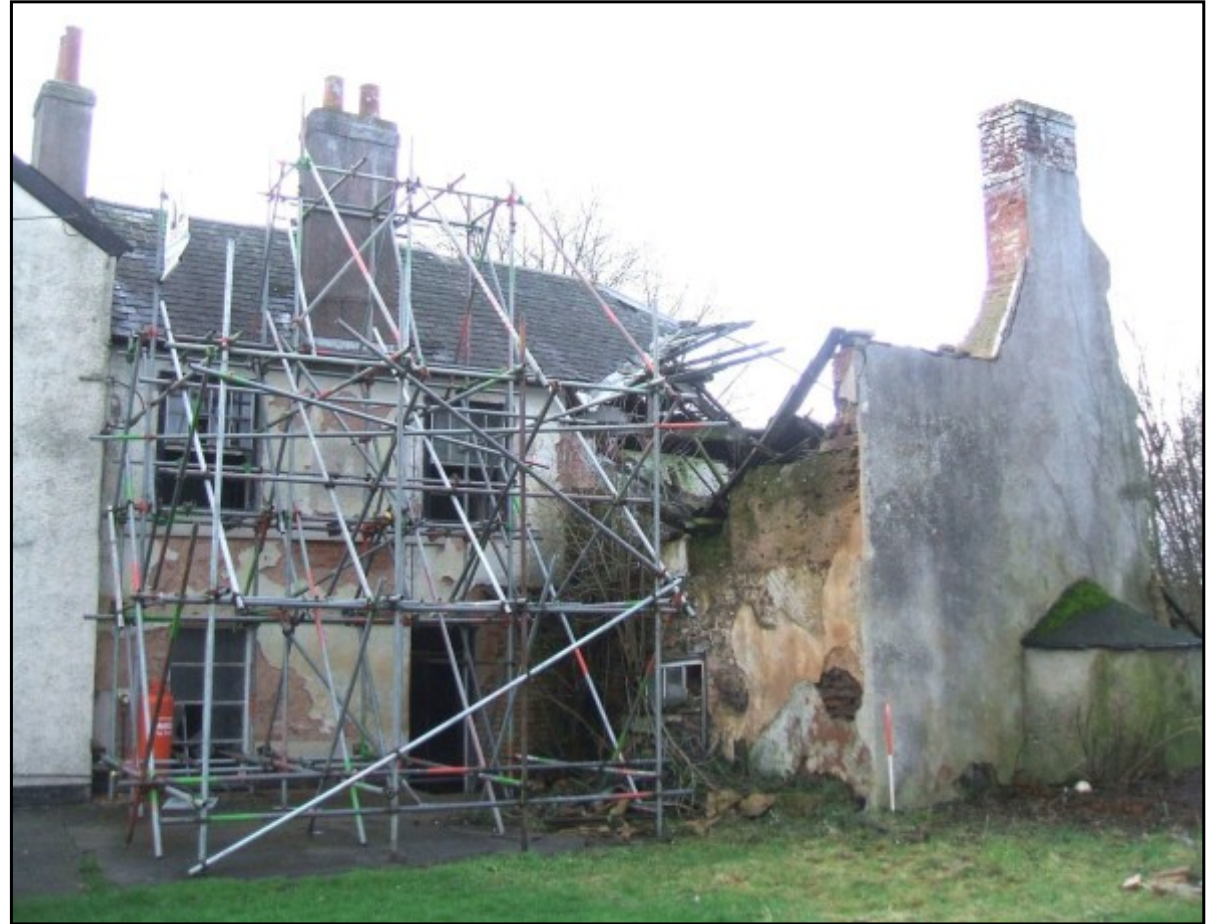
Plate 2 The west end of the house, showing the bread oven (right), looking west. 1m scale.

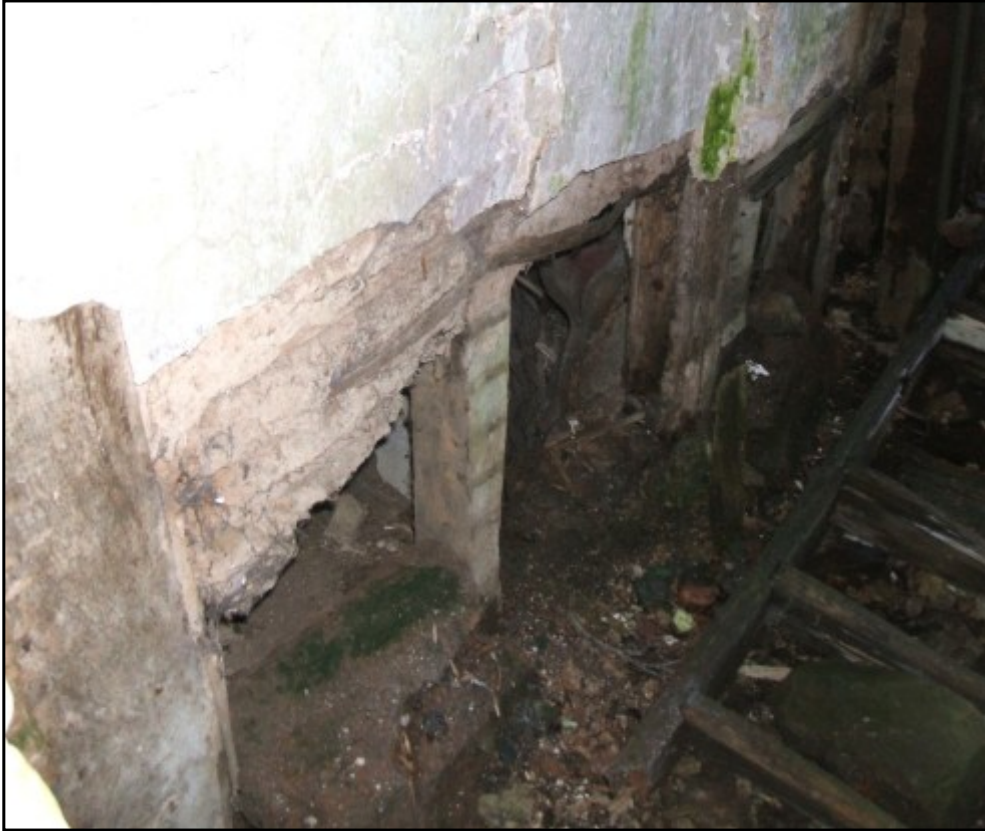
Plate 3 Screen, showing infilled doorway, looking north.

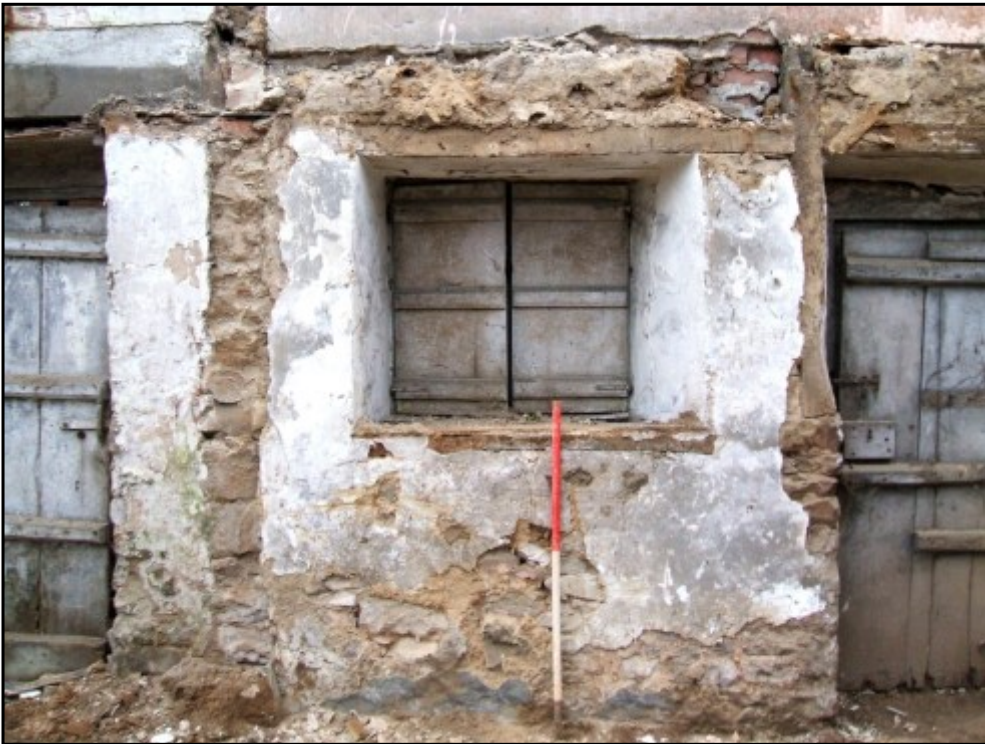
Plate 4 East internal elevation of the house showing scar of screen, window shutter, and cruck, looking south-east. 1m scale.
