**THE ADMIRAL VERNON INN,  
ALPHINGTON, DEVON:  
ARCHAEOLOGICAL RECORDING 2007-9**

**Exeter Archaeology**

**Report No. 09.32**

**April 2009**

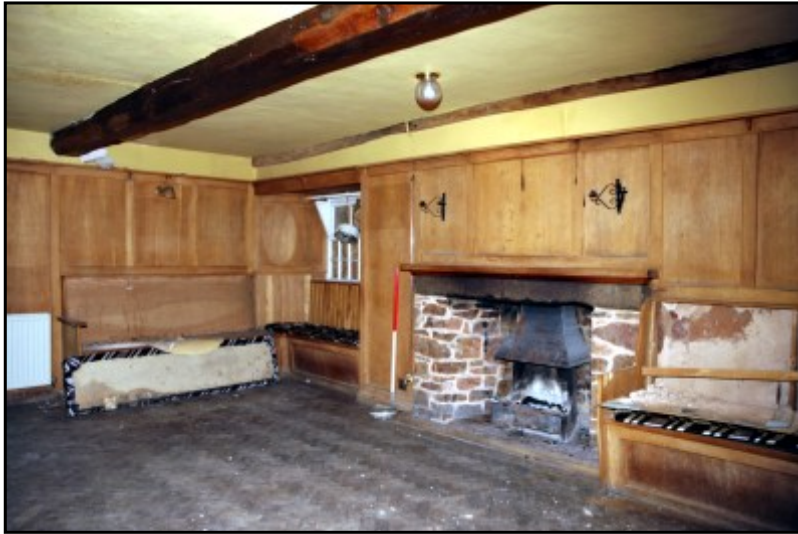
From the main doorway of the inn, it is apparent that the interior has been severely altered. A small lobby had been created within the doorway in the late 20th century, and a modern bar and serving area had been built to the west of this, with wide openings serving the rooms to north and south. The ceilings in the bar area had been entirely replaced with modern joists braced with herringbone strutting, supported on rolled-steel-joists which had been inserted in place of the original beams. The whole centre of the first floor and parts of the adjoining ceilings had been altered in this way. These alterations included the complete removal of the internal partitions defining the original rooms, destroying the historic plan of this area of the house.

Fig. 9 The interior of the northern room, prior to stripping, showing the extent of internal alterations.

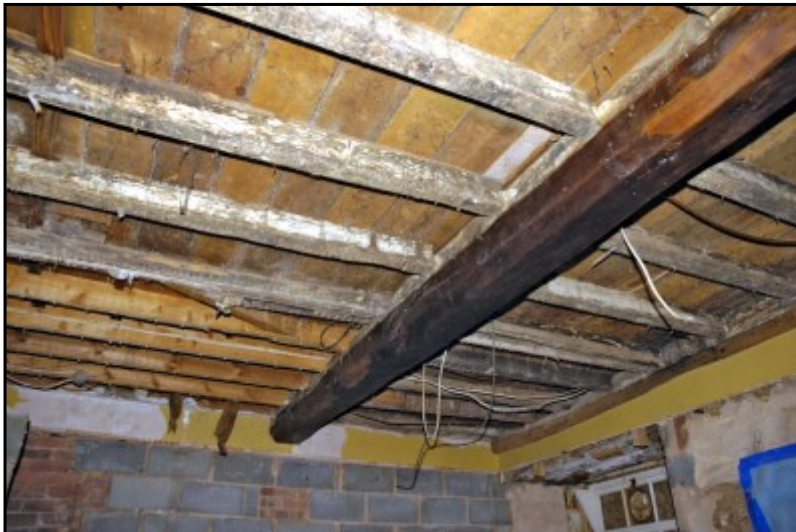
The joists were substantial squared timbers running from north to south, which survived across much of the ceiling, despite the removal of the wall and beam on the south side of the room (Fig. 11). The original joists showed traces of whitewash, which was valuable in demonstrating that the ceilings were originally unplastered, with their timberwork exposed. No traces of decorative painted schemes were apparent on the joists, although these might be detectable by a professional paint conservator. The floor boards were unpainted and must be later replacements added after the room was ceiled with lath and plaster.

Fig. 11 View of the ceiling following stripping showing primary joists and the probable position of an inserted staircase infilled with modern joists (bottom left).

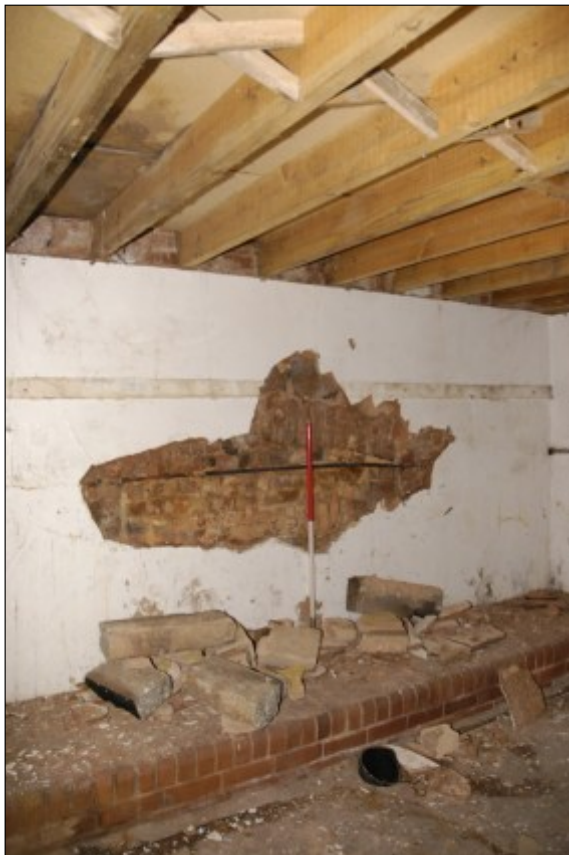
Following the stripping of the interior it became apparent that the cross wing had been extensively rebuilt in the late 20th century. The first-floor structure was entirely of 20th-century date, with herringbone strutting between the joists. Most of the existing window openings were modern, though they may have replaced earlier openings for which no evidence survives. In the west wall of the cross wing a large fireplace was revealed (Fig. 14). This had a wide segmental arch of brick and brick jambs. Further stripping of the plaster showed that the face of the wall had been extensively rebuilt in mixed rubble incorporating some large, red/orange bricks. It seems likely that this represents the replacement or repair in the 19th century of an earlier fireplace of a similar large size, perhaps due to the failure of its jambs or lintel. The prominence of the chimney breast externally certainly suggests a large fireplace in this wall. It may be assumed that this room served as a kitchen.

Fig. 14 View of the west wall in the north-western cross wing during stripping, showing the blocked kitchen fireplace and the modern first-floor structures.

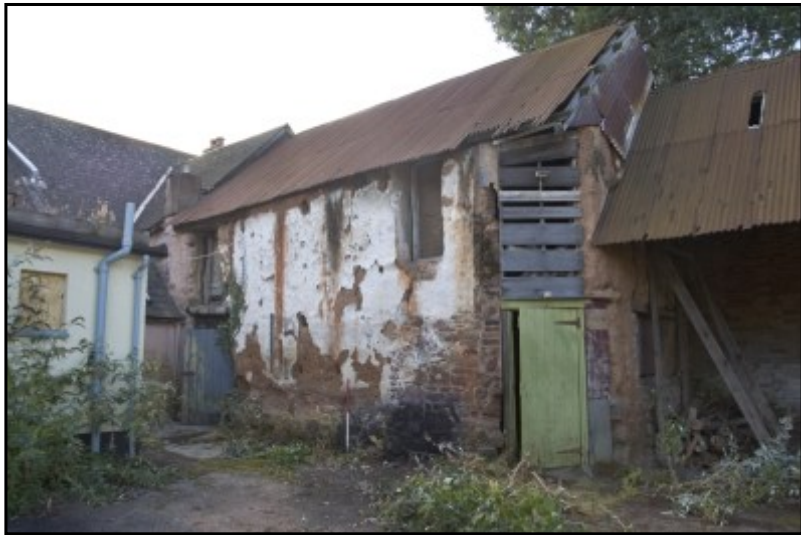
The western part of the elevation shows signs of much alteration, perhaps in the context of the addition of the projecting building. Much of the cob walling has been replaced by stone and there is some evidence of a further doorway, blocked in stone. Above this, on the first floor, is a further doorway which may have been served by an external stair associated with the projecting structure, as the loft does not seem to have had any other means of external access. The north-western corner of the building has been truncated and chamfered away and a new doorway cut through the corner, fitted with modern doors.

Fig. 21 The main elevation of the stable before refurbishment, showing the truncated corner.

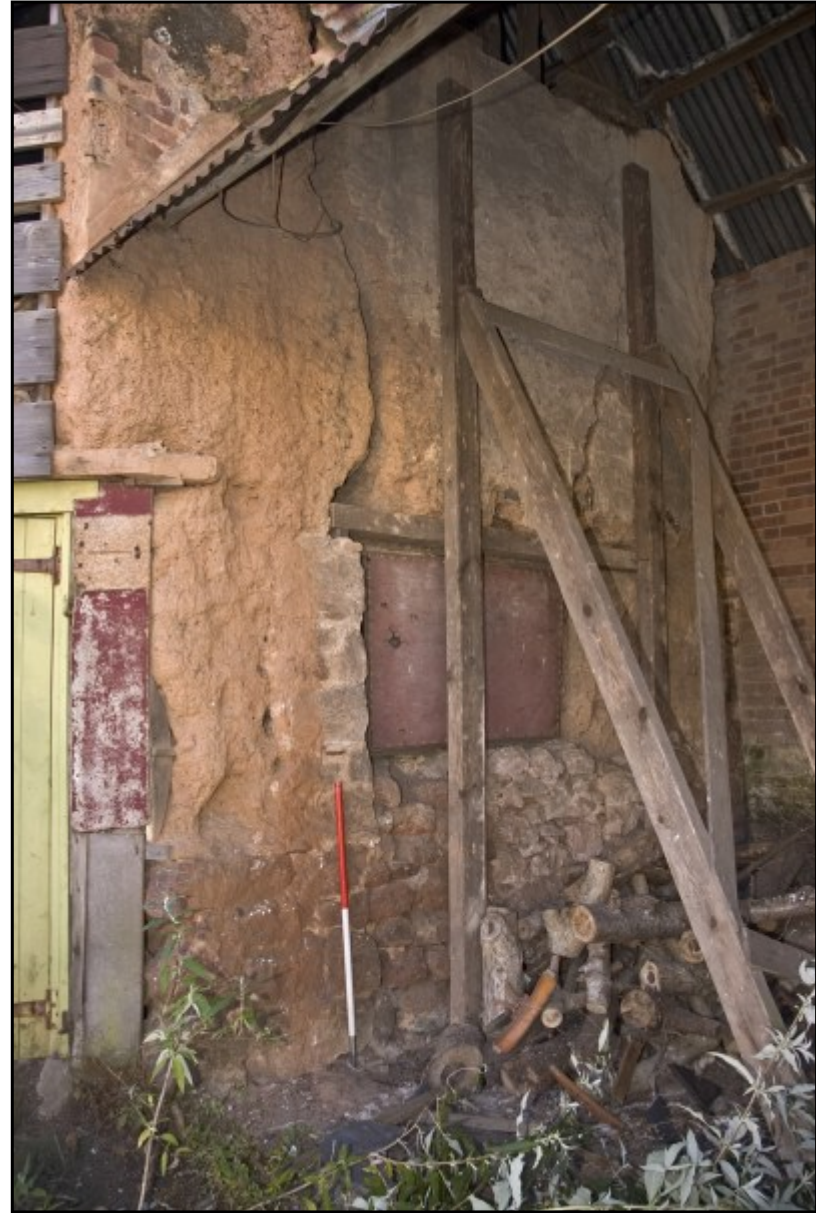
This substantial cob wall was in very poor condition at the time of recording. It had become severely fractured and was falling outwards, supported only by crude timber shoring (Fig. 22). It has since been demolished and rebuilt in cob blocks.

Fig. 22 Detail of the west gable wall of the stable prior to rebuilding, showing its parlous condition.

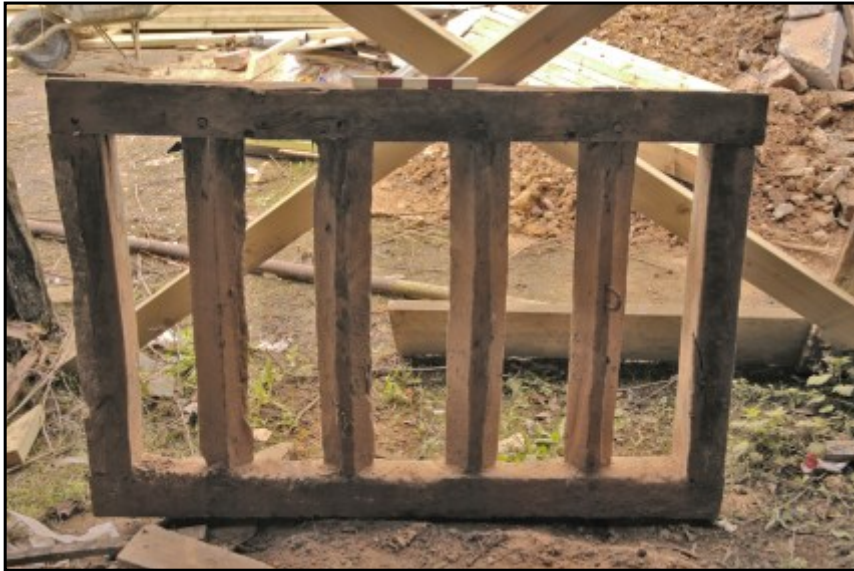
The wall had a low stone plinth, interrupted by a wide opening with a replacement timber lintel. This clearly represented a doorway opening into the adjoining linhay, but it had been partially blocked at some stage and converted into a window. The window remained *in situ* behind modern panelling, and consisted of a stout rectangular wooden frame, pegged at the corners and with four large, diagonally-set mullions, each with a pentagonal section (Fig. 23). The window had never been glazed and had no rebates. The only evidence for shutters was a pair of pintles driven into one of the mullions near the centre of the window, and a staple associated with these in another mullion. Any shutter associated with this ferramenta would have closed only two of the lights, leaving three lights open. This suggests that the shutter was not primary, but was perhaps added after the side lights of the window had been blocked or boarded up, reducing a five-light window to two lights only.

The window is of great interest as an example of a particular type of unglazed window found in medieval and post-medieval buildings in western England and south Wales, usually in agricultural buildings or service rooms, but occasionally in domestic contexts, particularly in low-status houses. Examples of this type of window in east Devon, recorded in surveys by Exeter Archaeology, have included a window from a service room in an early 16th-century gentry mansion at Bowhill, Exeter<sup>18</sup> and a similar window from a domestic context in a large medieval house at Great Gornhay, Tiverton.<sup>19</sup> The position of the window in the building, within a blocked doorway and looking out into the interior of the linhay, strongly suggests that the window was not *in situ*, but had been removed from its original position and reset here. Its original position is unknown, although it is possible that it was removed from the north wall in the 19th century when the rectangular building was erected against it, blocking the window in this wall, and then reset within the former doorway in the west wall. It may thus originate from within the present building. As it could not be reused in the present development it was removed from the site and is now in temporary storage.<sup>20</sup>

Fig. 23 Detail of the early window salvaged during demolition of the gable.

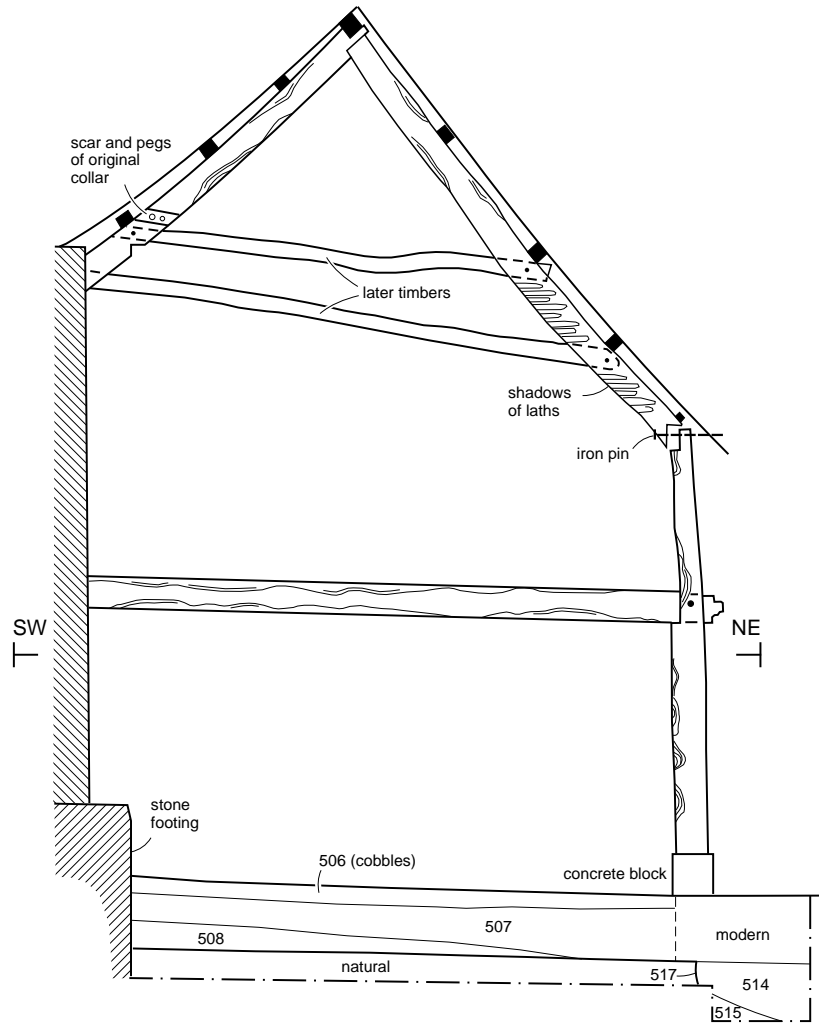
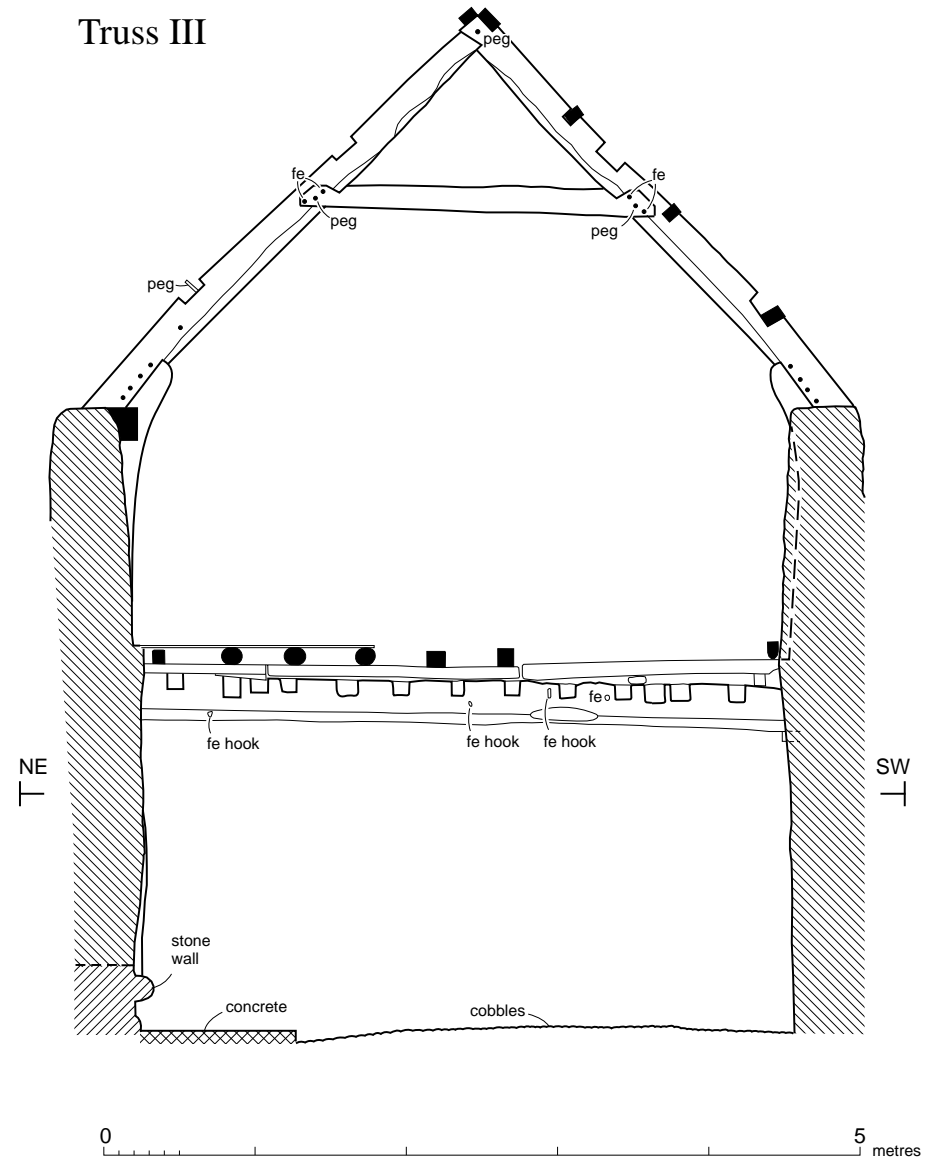
Ditch 517 (Fig. 26, section 1) was steep sided, and contained three gravelly clay fills (514-516). The uppermost fill (514) – a firm black gravelly silty clay – contained three sherds from a 17th-century Frechen stoneware medallion jug. This fill also contained an abundant quantity of waterlogged burnt charcoal and wood (which has not been assessed). The fills appeared to represent a deliberate infilling of the ditch, and the quantity of the burnt material in 514 must represent the remains of a deliberate burning activity, perhaps of a fence associated with the ditch.

Fig. 26 Measured drawings of the sections of the linhay and stables showing the details of their construction, and a section through the deposits below the linhay.

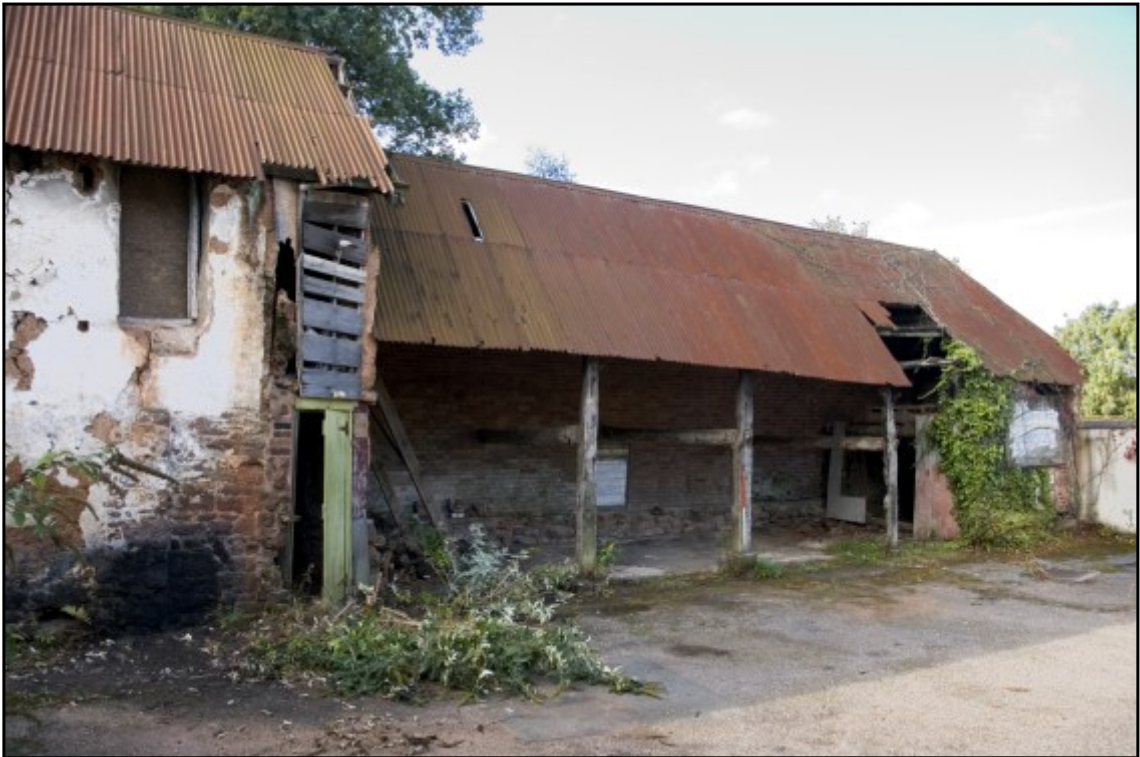
The linhay (Figs 26, 28) truncated the earlier stable and was clearly of later construction. It has now been demolished and replaced with modern housing. It was a very simple structure of five bays, consisting of a roof supported on wooden posts, forming an open-sided shelter with a solid rear wall. This south wall was originally of cob and stone, and was perhaps retained from the earlier building to the east, but it was demolished in the 20th-century and replaced with a modern brick wall, laid in stretcher bond. The west wall of the building survives. It is also of cob, showing the scar of the demolished rear wall. The ground floor area of the linhay at this end had formerly been enclosed with a partition clad with broad, elm

Fig. 28 View of the linhay prior to demolition, looking south west.
