**A RAPID BUILDING SURVEY OF
No. 16 SMITH STREET, DARTMOUTH**

Report No. 06.56

June 2006

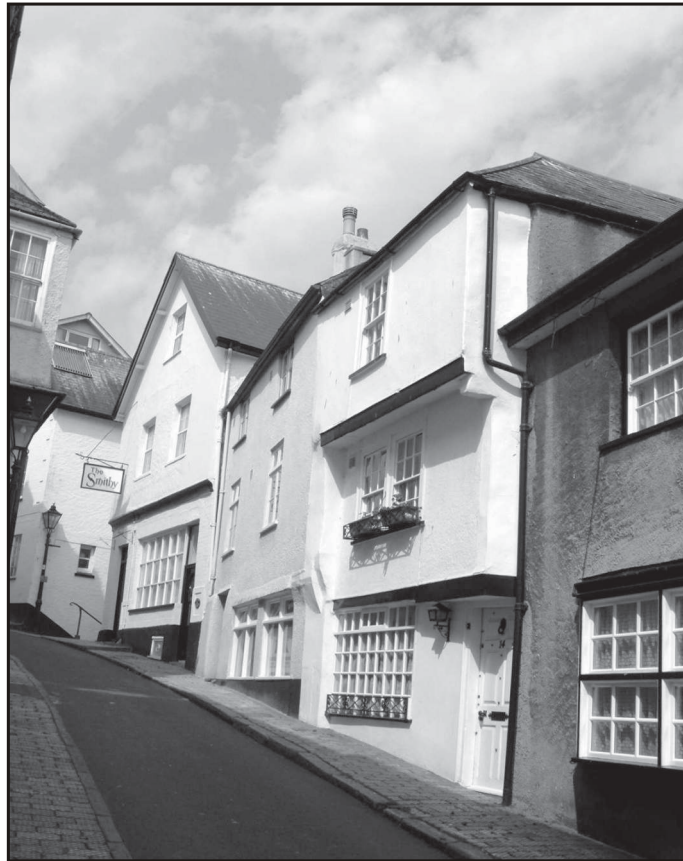
The site slopes steeply downward both to the east (down Smith Street) and to the north, towards the churchyard. The Smith Street frontage (Fig. 4) stands three storeys high; it is now covered with modern pebbledash. The ground floor retains the remains of a corbelled party wall beside No. 14, and there is a pronounced change in wall thickness between the ground and the first floors at the left (western) side of the frontage, suggesting the survival of early masonry on the ground floor. Above the ground floor the front is flat; it could not be seen at any point during the site visits, having been repaired and repainted, but its form suggest a 19th-century date. The first and second storeys each display a pair of modern windows – tall cross ones on the first floor, smaller ones above – arranged unevenly in the front.

Fig. 4 The frontage on Smith Street.

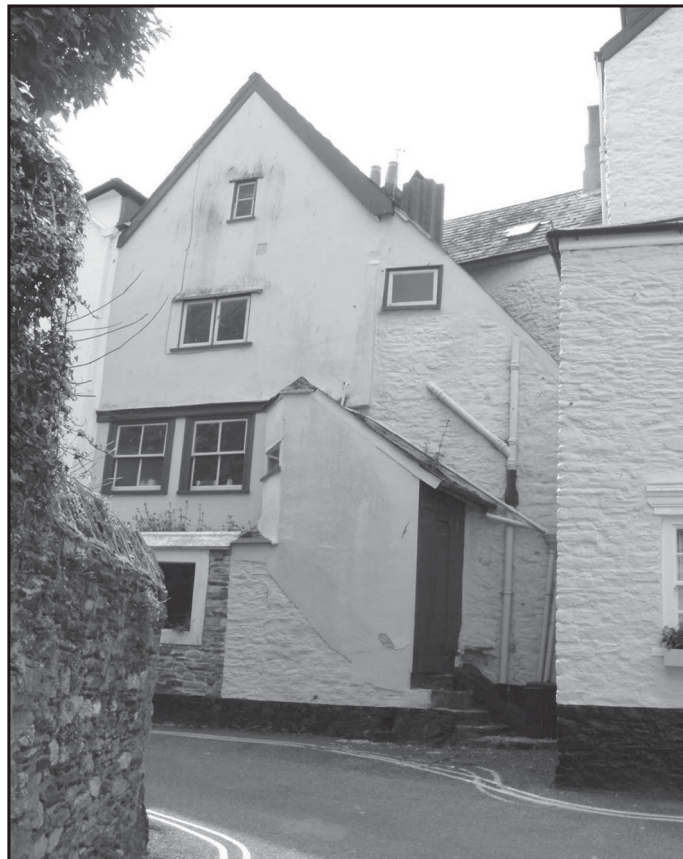
On the north side (Fig. 5) a tall asymmetric gable four storeys high faces onto the street. At ground floor level is an old stair of stone rubble; it is now enclosed by a timber-framed covering structure, discussed below. To the south (left) of the stairs is one of the town's water conduits, which bears the date 1852. This butts against the stairs of No. 16, showing that the stairs are older than that date. Above the conduit rises the plastered gable of the frontage, with modern window openings. This kind of treatment often covers a timber frame, and this proved to be the case in this instance. To its right (west) is a wall of rubble; behind it, at the centre of the house, is a second wall of small rubble supporting the eaves of the front block.

Fig. 5 The rear of the property.

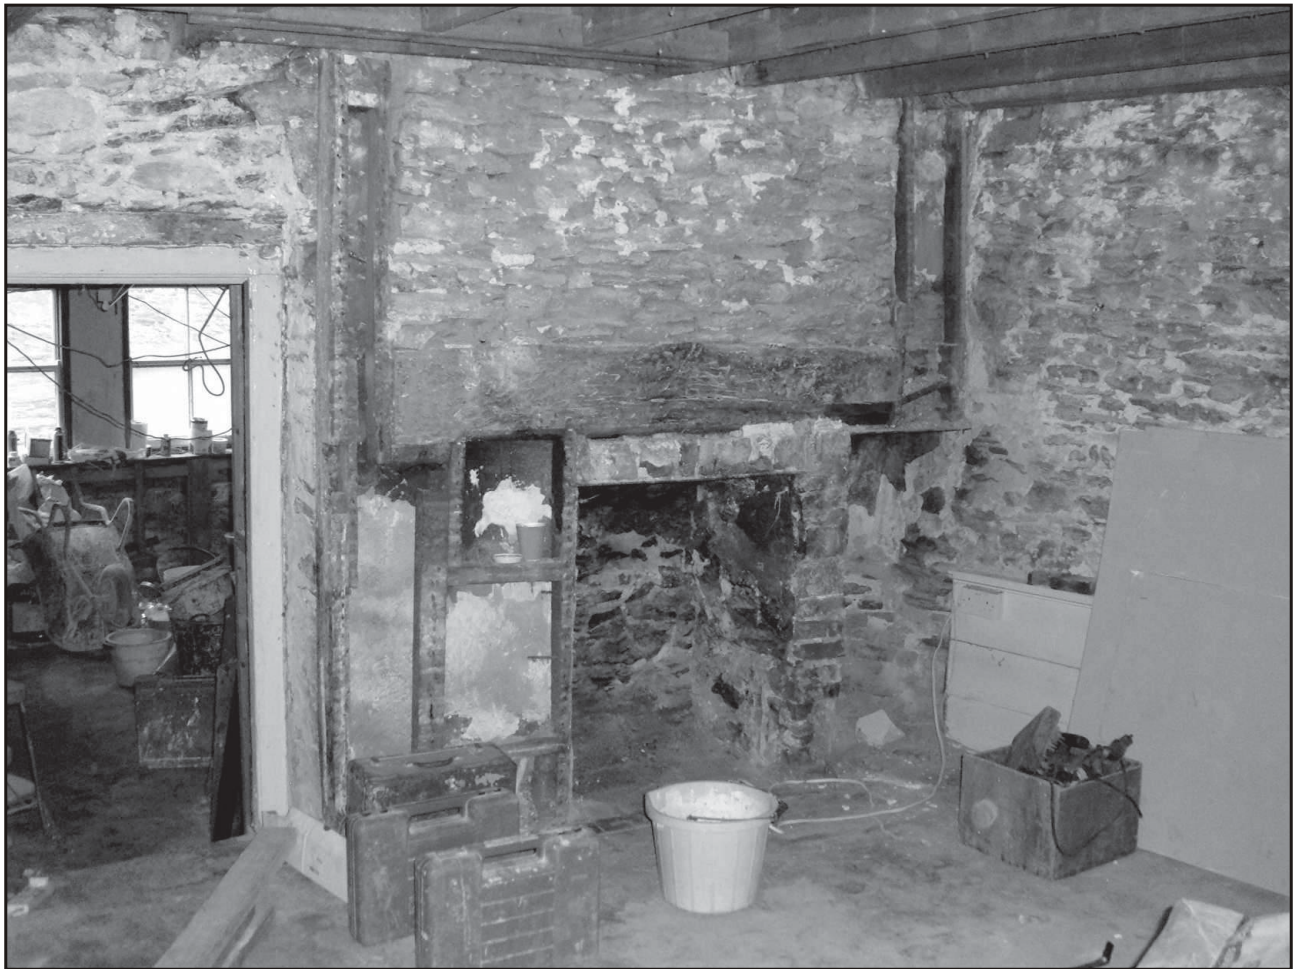
At the back of the room, a fireplace stack of late 16th- or early 17th-century type abuts the party wall (Figs 6, 19). As first constructed it consisted of a breast of local clay-bonded slate rubble sitting on a fine oak lintel, which in turn sat on a pair of projecting wooden consoles overhanging the stone jambs of the fireplace opening; the console to the right has been removed. The lintel has a chamfered soffit and stepped and chamfered stops; its vertical face was subsequently hacked with an axe to provide a key for plaster render. To the right of the jamb on the right side is a small and low cupboard recess which seems to be an original feature. In the late 18th or 19th century the original large opening of the fireplace was reduced by the insertion of a smaller brick fireplace, with attendant light softwood framing packing the area below the lintel, and on each side of the projecting stack, creating a flat face to the fireplace surround.

To the left of the fireplace stack, contemporary clay-bonded stonework extends only a few centimetres (Figs 6, 19); to its left is later lime-bonded walling associated with the insertion of a bead-moulded door frame of late 17th- or early 18th-century type. The door frame is intact but the door has been removed.

Fig. 6 The ground floor front room showing party wall (right), 17C fireplace with 19C fireplace below (centre) and 17C/18C doorway (left).

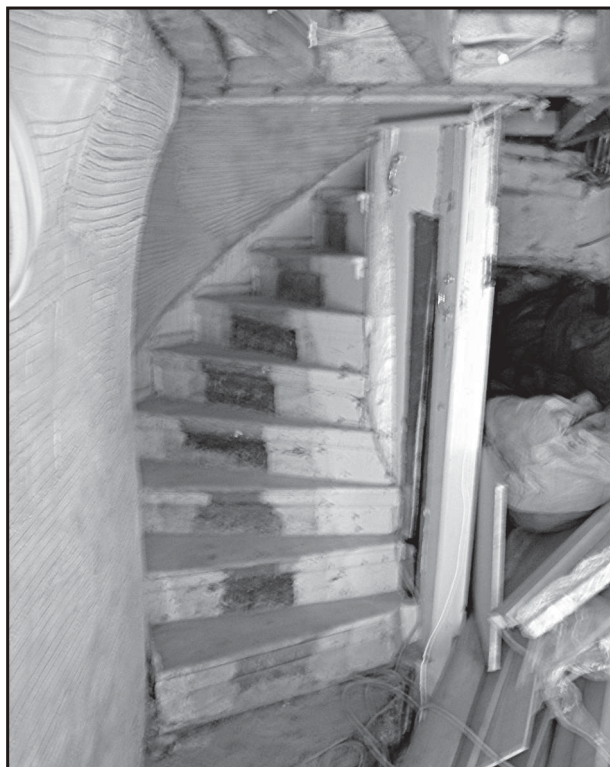
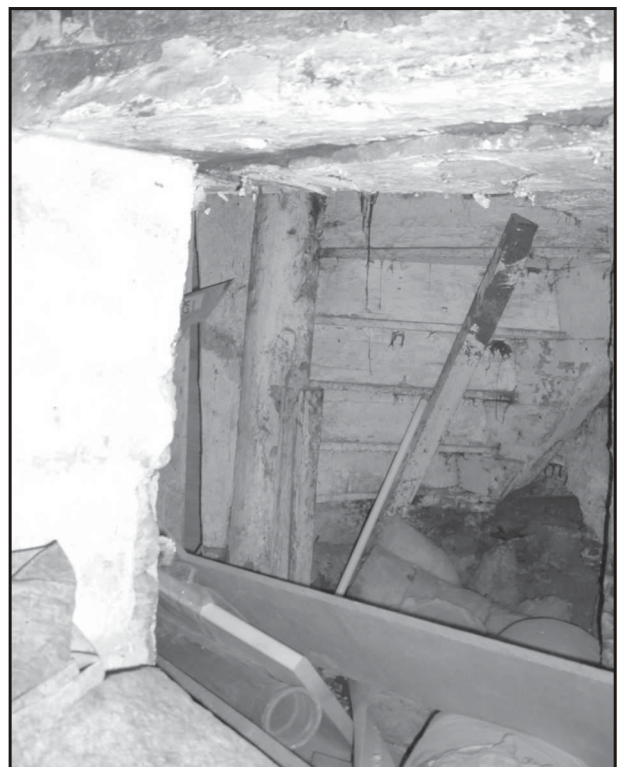
On the west side of the front room is a passage leading from a modern front door to a newel (spiral) staircase (Figs 7, 19). At the time of our visits the stone walling beside the passage had been plastered. The beefy and plain central pine newel post of the staircase, slightly tilted to one side and sawn off at the top of ground floor level, appears to be an original late 16th- or early 17th-century feature; it retains the pegs of the original stair treads, in a different position from those now visible. The present treads have a string (skirting) against the curving outer wall – not a feature of early staircases of this type – and coarsely handled wooden strips on the fronts and sides of each stair tread; clearly the original stair treads had been replaced in the 18th or early 19th century.

Fig. 7 The staircase at ground floor level: front and back views.

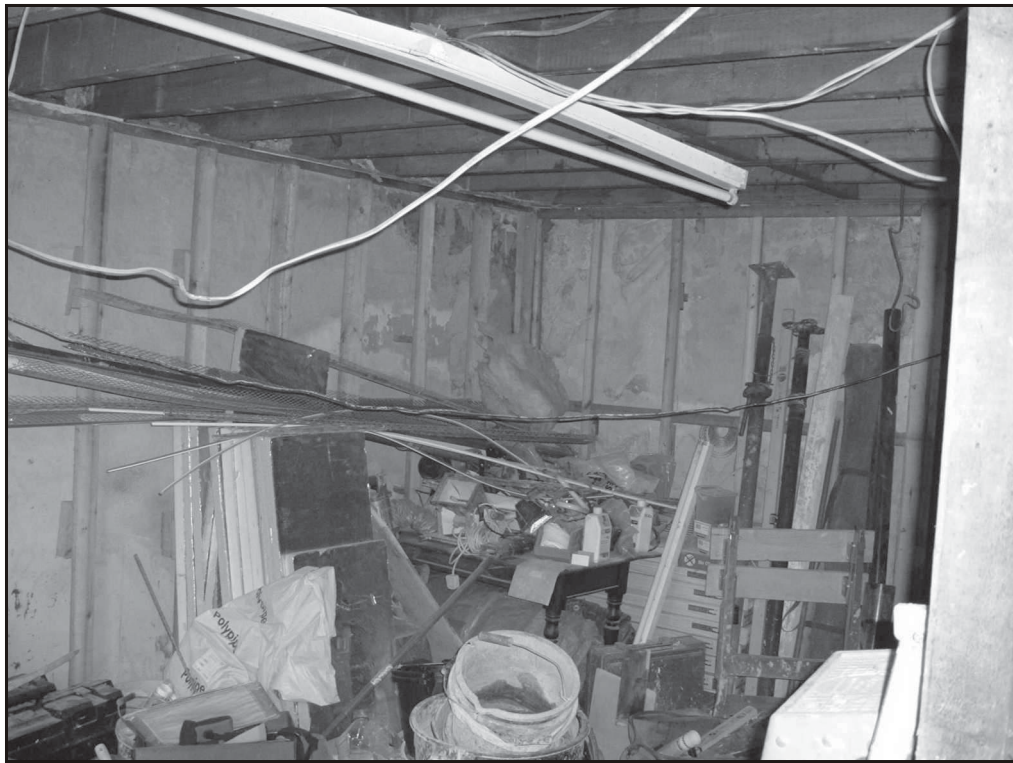
A single room occupies the rear of the property. At the time of our visits the stone walls on its east and south sides (the party wall with No. 14 and the back of the fireplace) remained plastered and featureless (Fig. 8). The back wall, facing the church, had been stripped, exposing 19th-century brickwork below the sash windows (Fig. 9). The removal of plasterboard showed that the ceiling joists were all 19th-century or later in date (Fig. 8). The west wall, however, retains the impressive remains of a large 19th-century oven, far larger than a conventional domestic one and clearly a baker's oven.

Fig. 8 The rear room, ground floor at the time of recording, showing party wall (left), back of chimney breast, and modern joists.

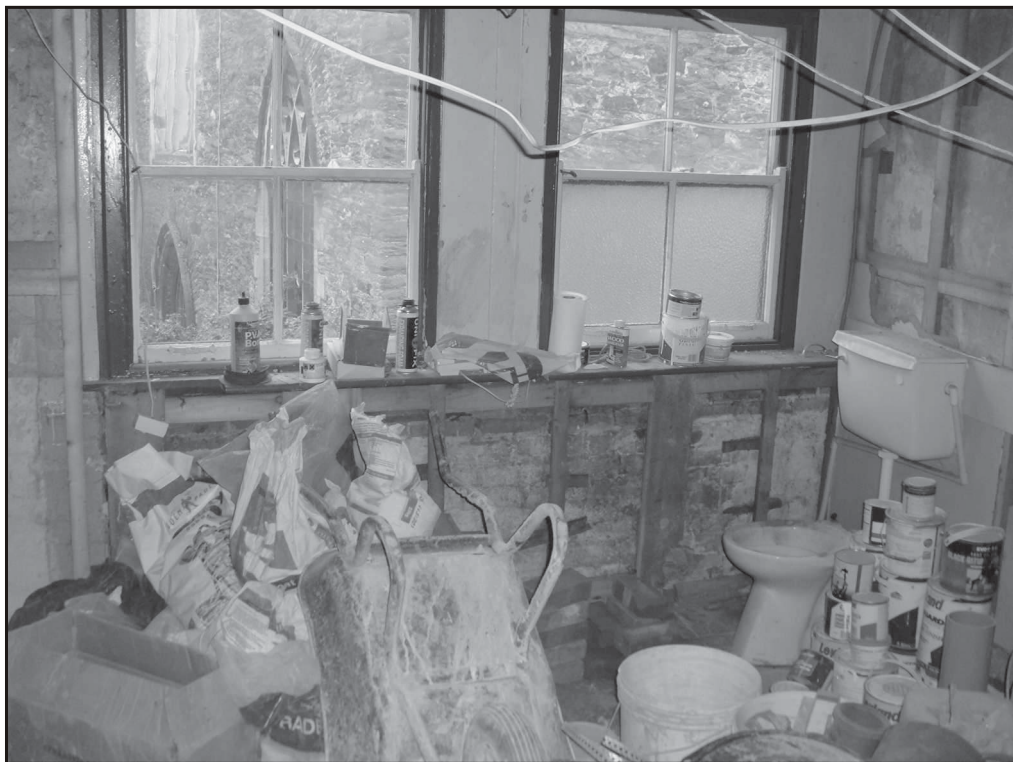
Fig. 9 The rear room, ground floor, showing modern brickwork below the window.

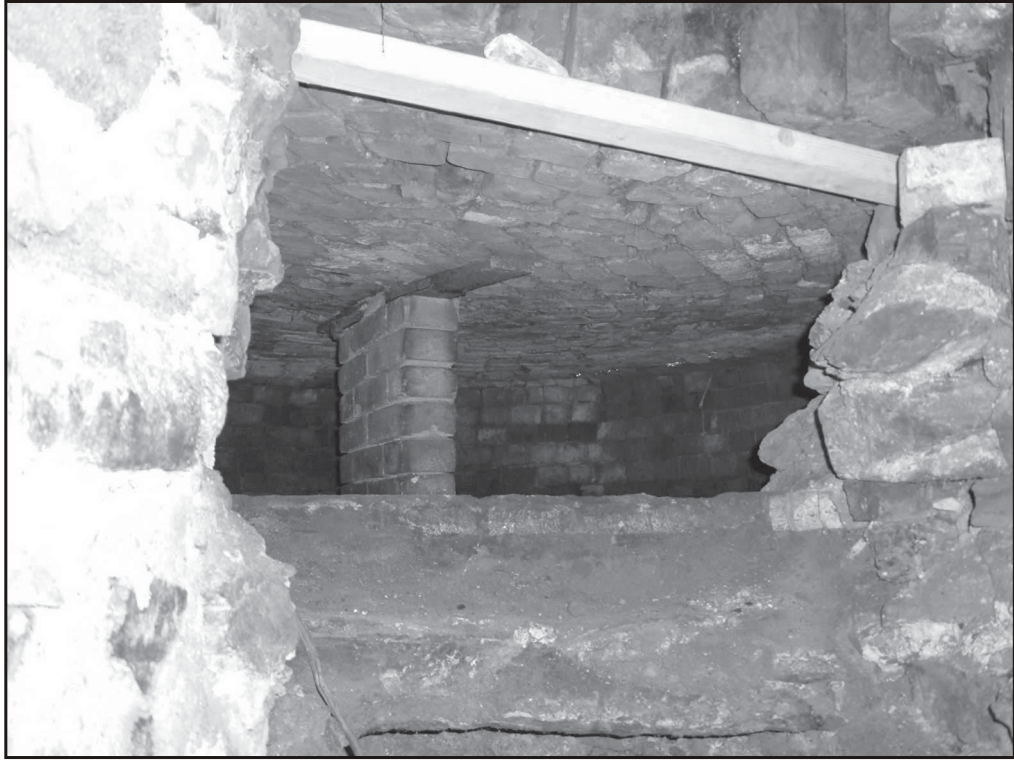
This consists of two superimposed chambers. The upper one, which was readily accessible, was the main circular oven, some 3.05m wide internally. Its floor is formed of plain unglazed square ceramic tiles measuring on average 0.3m (one foot) square, arranged in eleven rows, the tiles of each row being staggered in relation to the adjacent rows (Fig. 18). Around this floor rise walls of coursed brickwork standing 0.44m high, from which springs the vault, which consists of concentric bands of brick headers (Fig. 10). A stack of bricks six courses high and two bricks long stands at the centre of the oven floor, above which sits a cast iron bar which carries the weight of the centre of the vault, allowing the formation of an almost-flat ceiling (Fig. 10). Below the oven is the stoking chamber. This was full of ash and debris at the time of our visits, so could not be inspected fully. Its ceiling is formed by the bed of the oven above; one side of the springing of an arched opening below the bed of the oven was visible.

Fig. 10 Bakery oven, showing floor, central pedestal and bar supporting the vault.

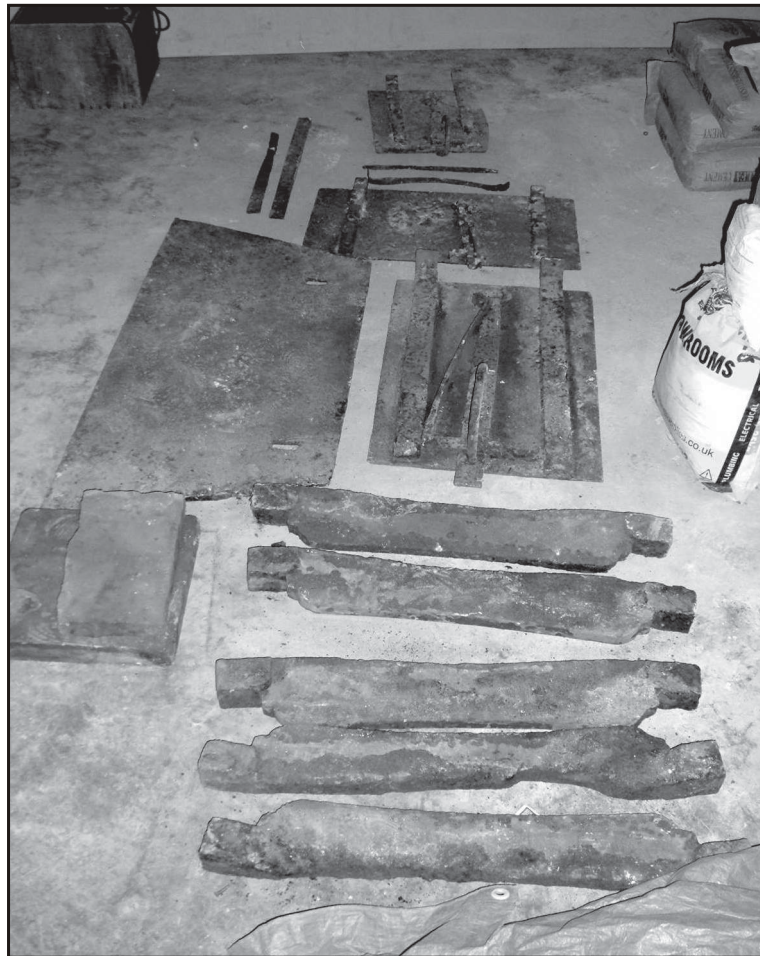
The heavy cast iron fittings of the oven had been removed from their original positions but dumped in the blocking of the oven when it was abandoned (?in the early 20th century), and were retrieved from backfill by the builders in 2006. They comprised five heavy bars with dished upper faces which appear to have formed a raised grate in front of the stoking chamber; three doors, two of which were those for the oven and stoking chamber; the massive surround to the oven door, with cast-in pintles for hanging the door; a trapezoidal plate which would fit on the floor of the area in front of the oven; and various lighter bars of iron (Fig. 11). This oven is an impressive piece of 19th-century building practice, and certainly deserves to be displayed. The massive cast ironwork suggests a date in the mid 19th century.

Fig. 11 Bakery oven: cast iron fittings.

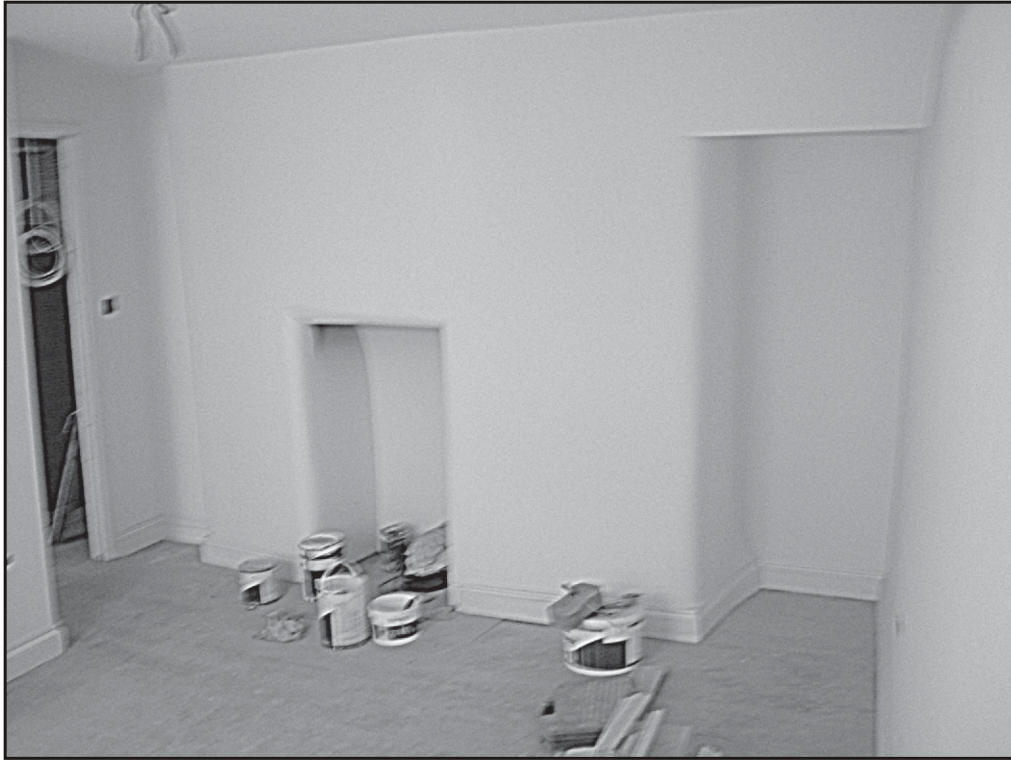
At the time of our visits these room had been freshly plastered, so little could be recorded. The eastern room (Fig. 12) retains a small fireplace; prior to our visit, its oak lintel, similar to that on the ground floor, had been visible and it is probable that the two are contemporary with one another, belonging to the late 16th or early 17th century. To its right (east) is a recess (Fig. 12); inspection of this feature from the rear showed that it was a secondary doorway cut into the wall, subsequently blocked up.

Fig. 12 Front room, first floor at the time of recording, showing 17C fireplace (left), and later doorway cut through adjacent wall (right).

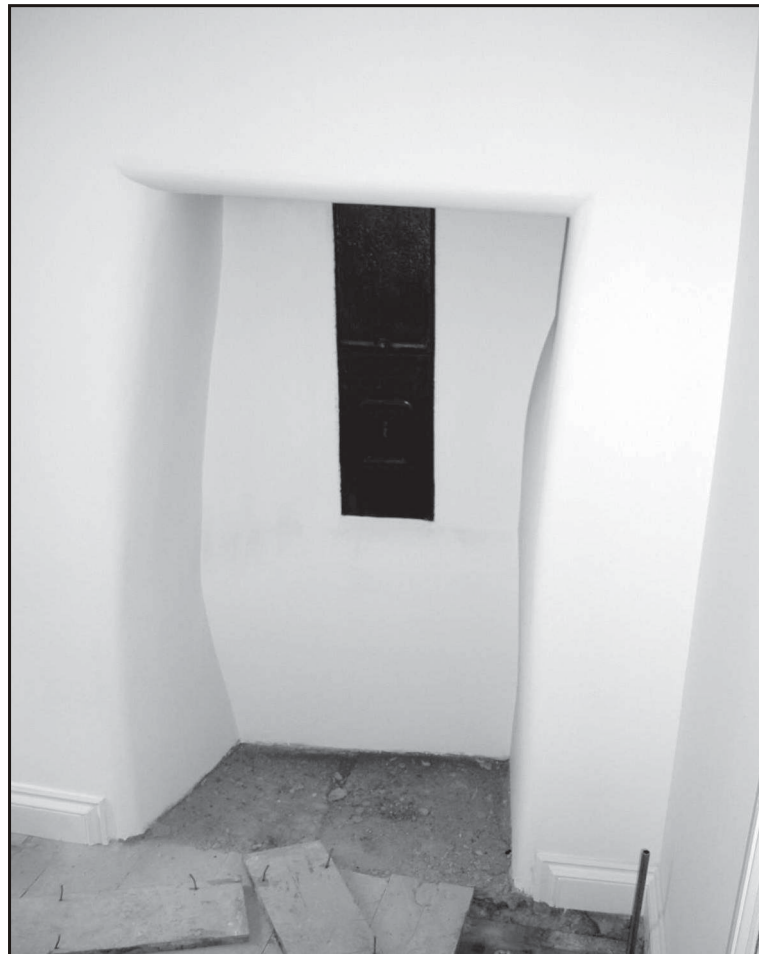
The room over the ground floor passage to the west contains a fireplace stack, within which is a 19th-century cast iron flue cover (Fig. 13); this may be presumed to have operated with a raised hob grate, now removed. No other features are visible. Although the structure of the stud wall between the two front rooms was not visible, this is a light affair and is very probably of 19th-century date.

Fig. 13 Front room, first floor: 19C fireplace in party wall.

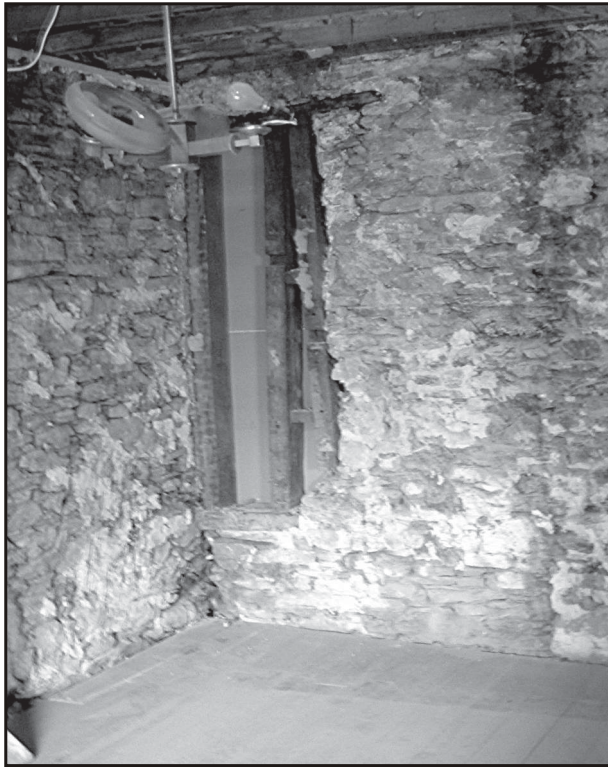
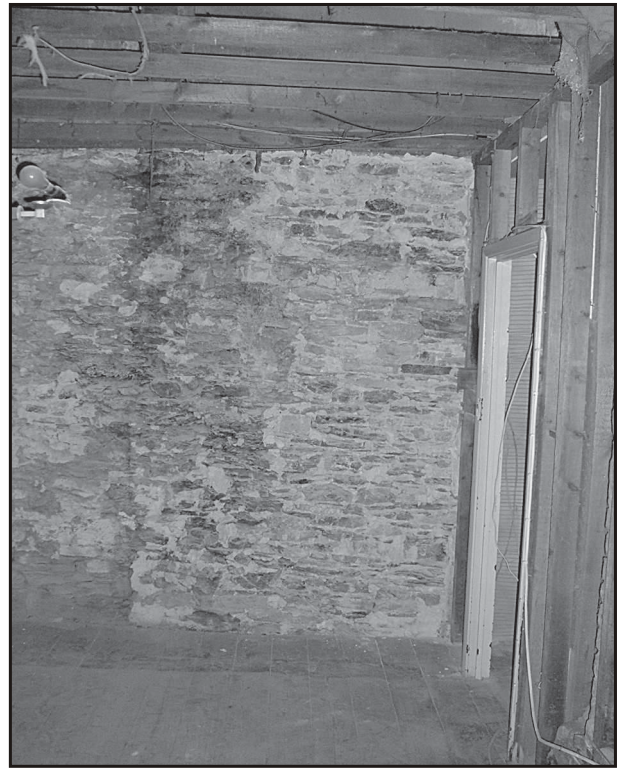
At first-floor level this dividing wall displays two distinct phases of masonry, distinguishable by the use of clay bonding in the earlier fabric and white lime mortar in the secondary work (Fig. 14, right; Fig. 20, phase 2 and 3 rubble). This change corresponds with the change between the two different phases at ground floor level, and likewise probably reflects changes to the access between the front and back rooms in the late 17th or early 18th centuries. The phase 3 stonework on the first floor marks the infilling of a feature at the back of the fireplace stack; it seems likely that this was a doorway. It is possible that the blocking of the earlier doorway was the insertion of a new doorway at the eastern side of the wall (Fig. 20, 'blocked doorway'). This too was subsequently abandoned, being infilled with three studs.

Fig. 14 Rear room, first floor, showing party wall (left) and rear of 17C stack. Note change in mortar in the centre of the right hand view.

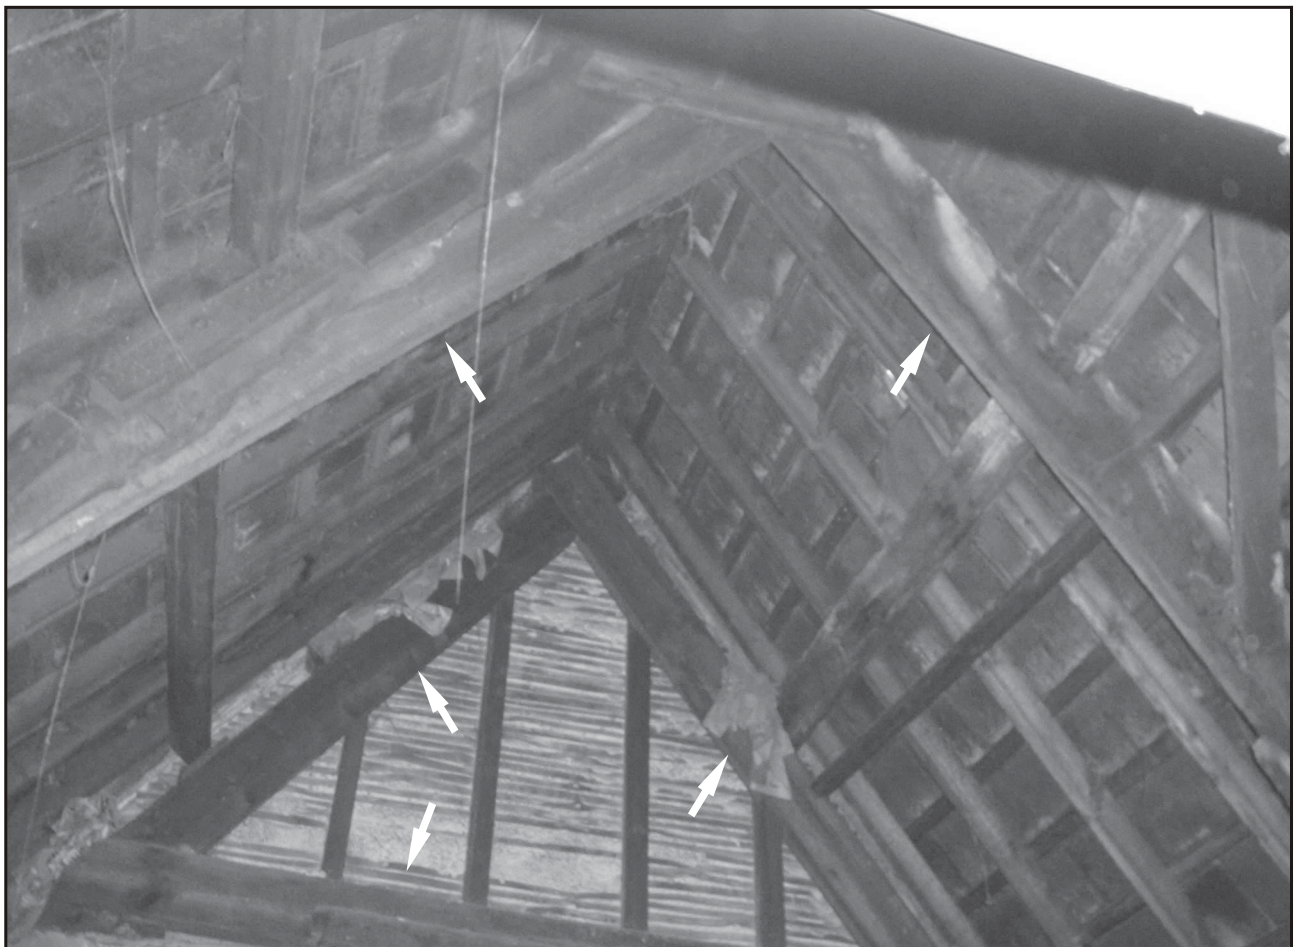
The northern gable of this room was only partially visible. It is apparent that the apex has been renewed in the recent past: new battens and fresh render cover the old principals and collar (Fig. 15 but inspected from a distance). Lower down the

structure, beside the first-floor windows, there are also signs of recent repairs, but on the east side a the massive oak post is just visible behind older lime render, making it clear that there are at least some remnants of a substantial timber-framed façade of the late 16th or early 17th century. Should this frontage undergo further repairs in the future, this would deserve fuller investigation.

Fig. 15 17C roof over rear room looking north, showing old trusses and purlins (arrowed), with recent re-roofing and rebuilt back wall.

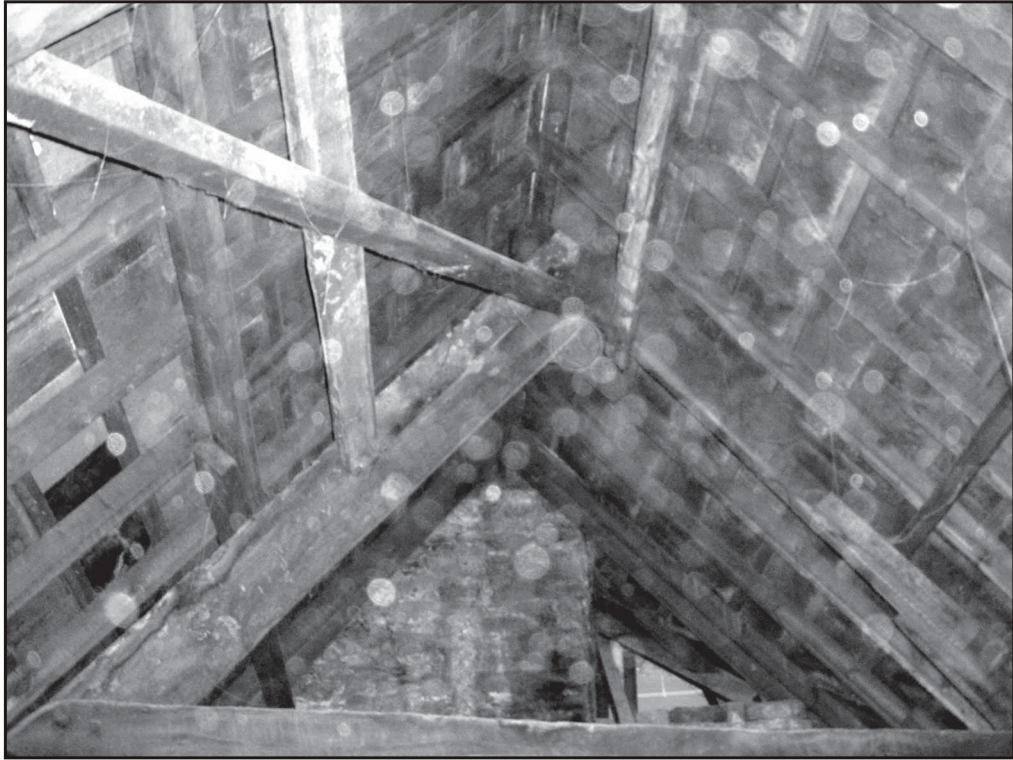
Fig. 16 17C roof over rear room, looking south.

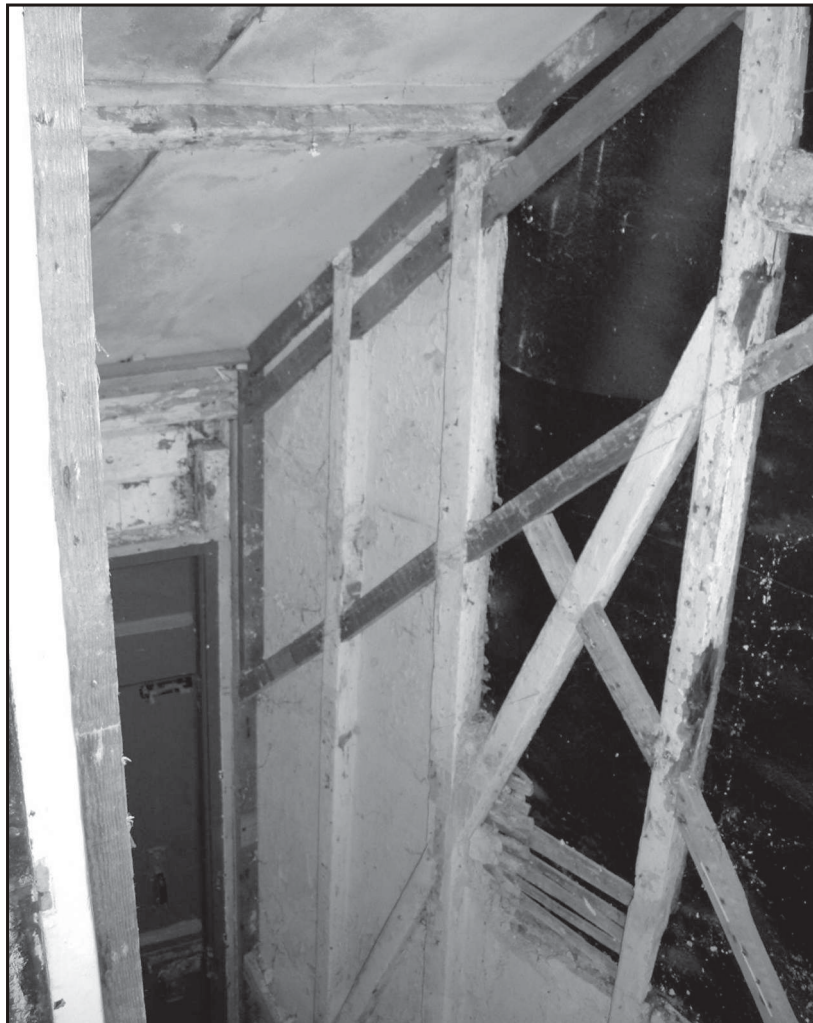
It has been explained (above) that the flight of stone steps leading down towards the churchyard at the back of the house is of some antiquity; it could well be part of the late 16th/early 17th-century house. The roofed wooden structure covering it is not of such an early period: its wall, sitting on the steps, is built of thin sawn lengths of softwood, simply nailed together. The structure is likely to be of 19th-century or later date, although fairly crude and simple things of this sort are hard to date. Photographic evidence or study of topographical drawings might show whether it is the successor to an earlier structure doing the same job.

Fig. 17 The rear stairs.

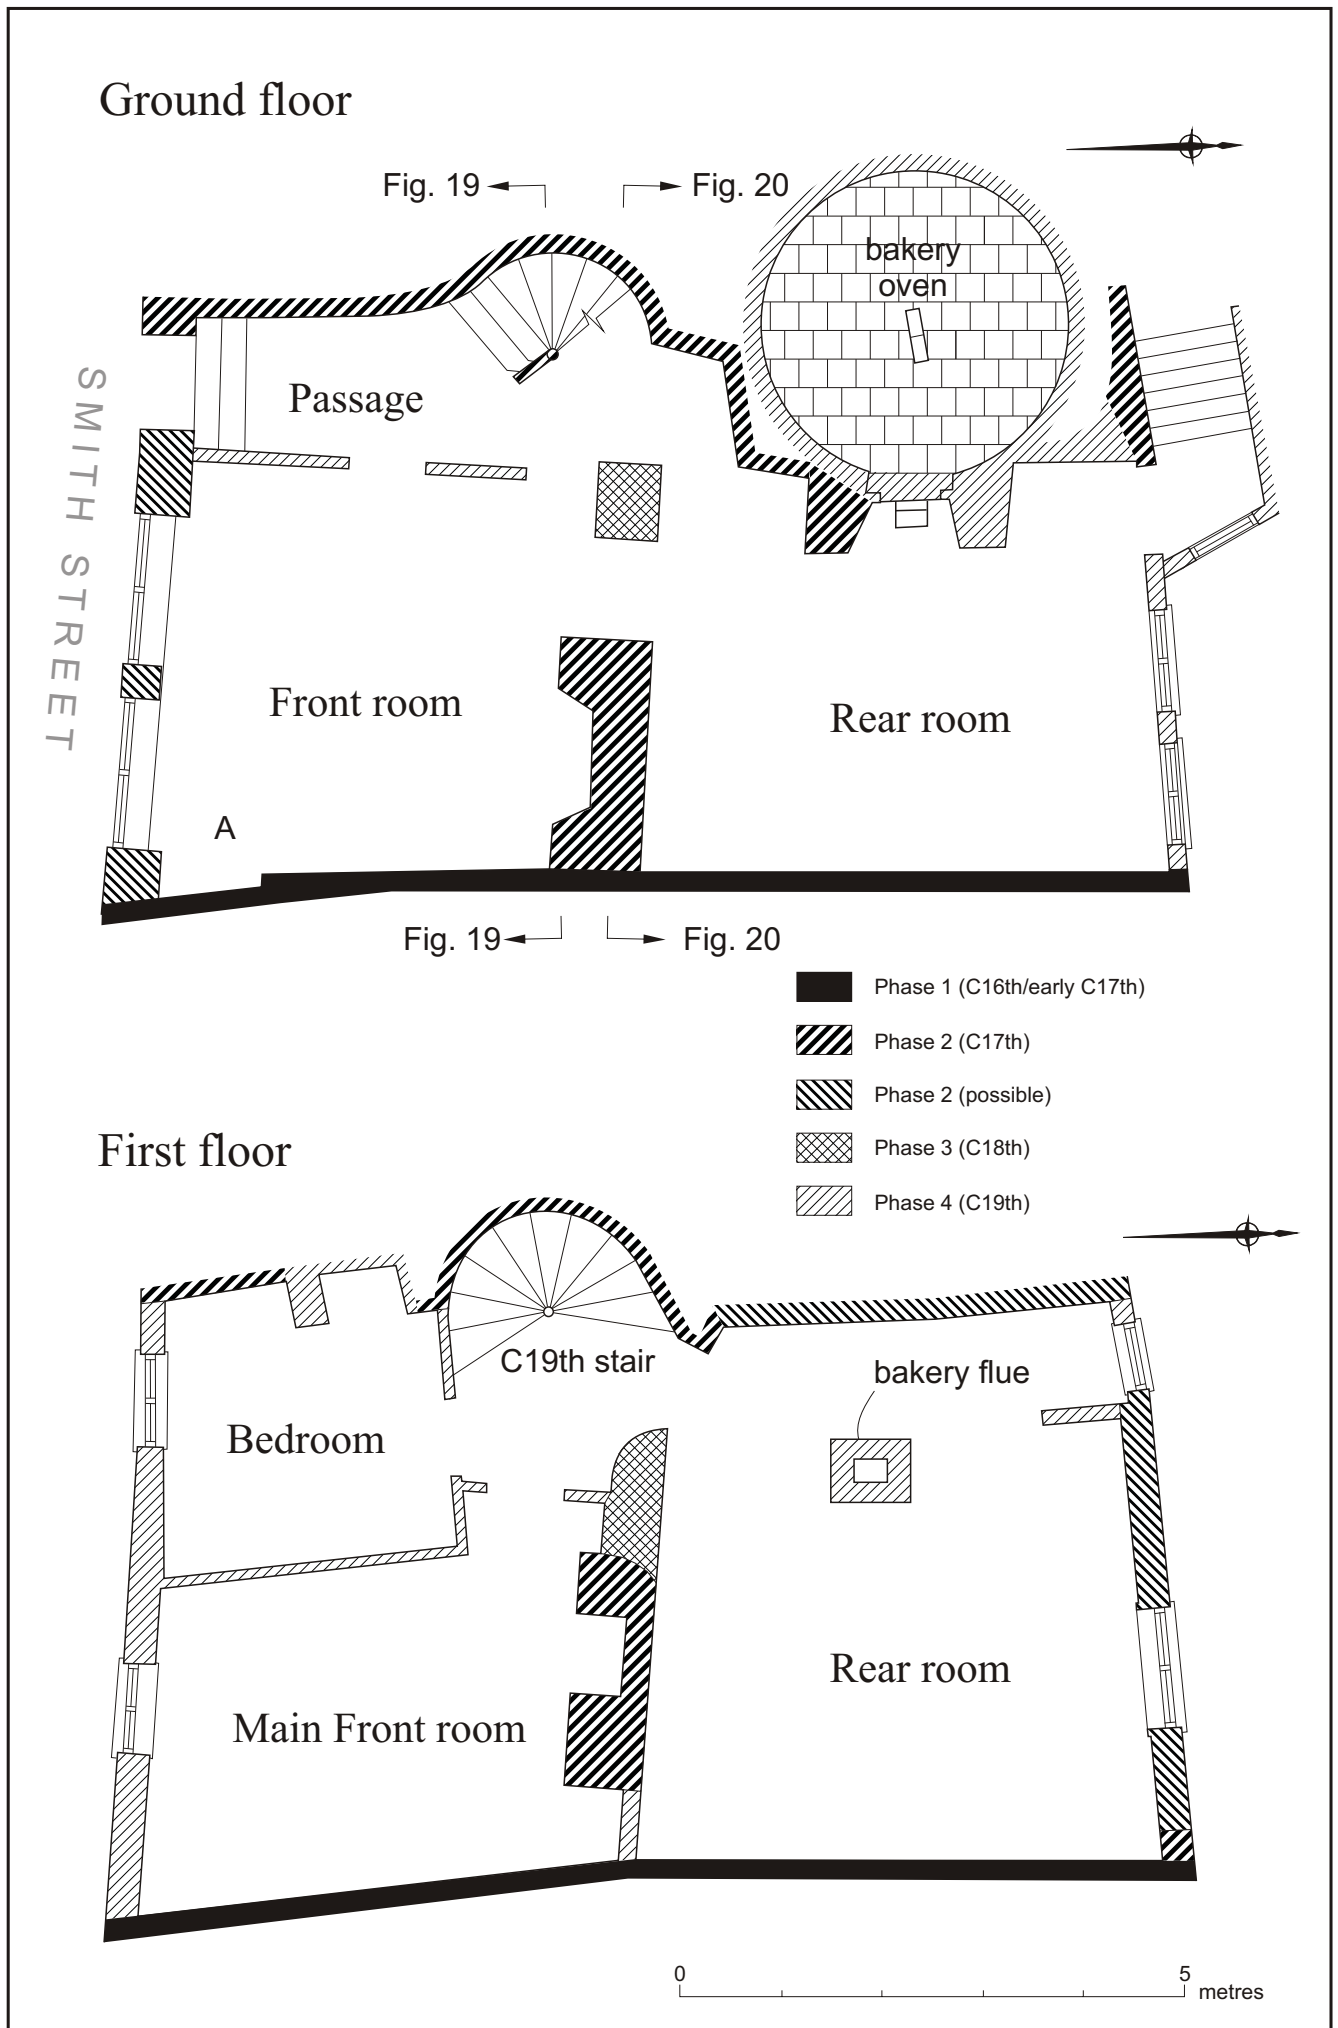
Fig. 18 Plan of ground and first floor.

The oldest feature (phase 1) is the party wall with No. 14, which consists of small local shale rubble set in clay bonding; traces of lime plaster render remained. Only one feature was visible in the wall: it stepped backward close to the frontage (Fig. 18, point A). This kind of feature commonly represents the recess into which a door could be folded back. In this instance it is unclear whether this indicates that the front door was originally on this side of the room, or whether this is a survivor from an arrangement earlier than the standing house. It is not impossible that it represents an intention to build with a side passage on this side of the house but that this was abandoned when the house was built.

Inspection of the surrounding jambs shows that the 19th-century oven was built within an earlier large stone fireplace, of which the left jamb and the rubble stonework of the breast above had survived, including on the left side the first voussoir (arch stone) of the demolished fireplace lintel. Further plain rubble masonry extends on the northern side of the fireplace (Fig.18). These are all probably components of the 17th-century house.

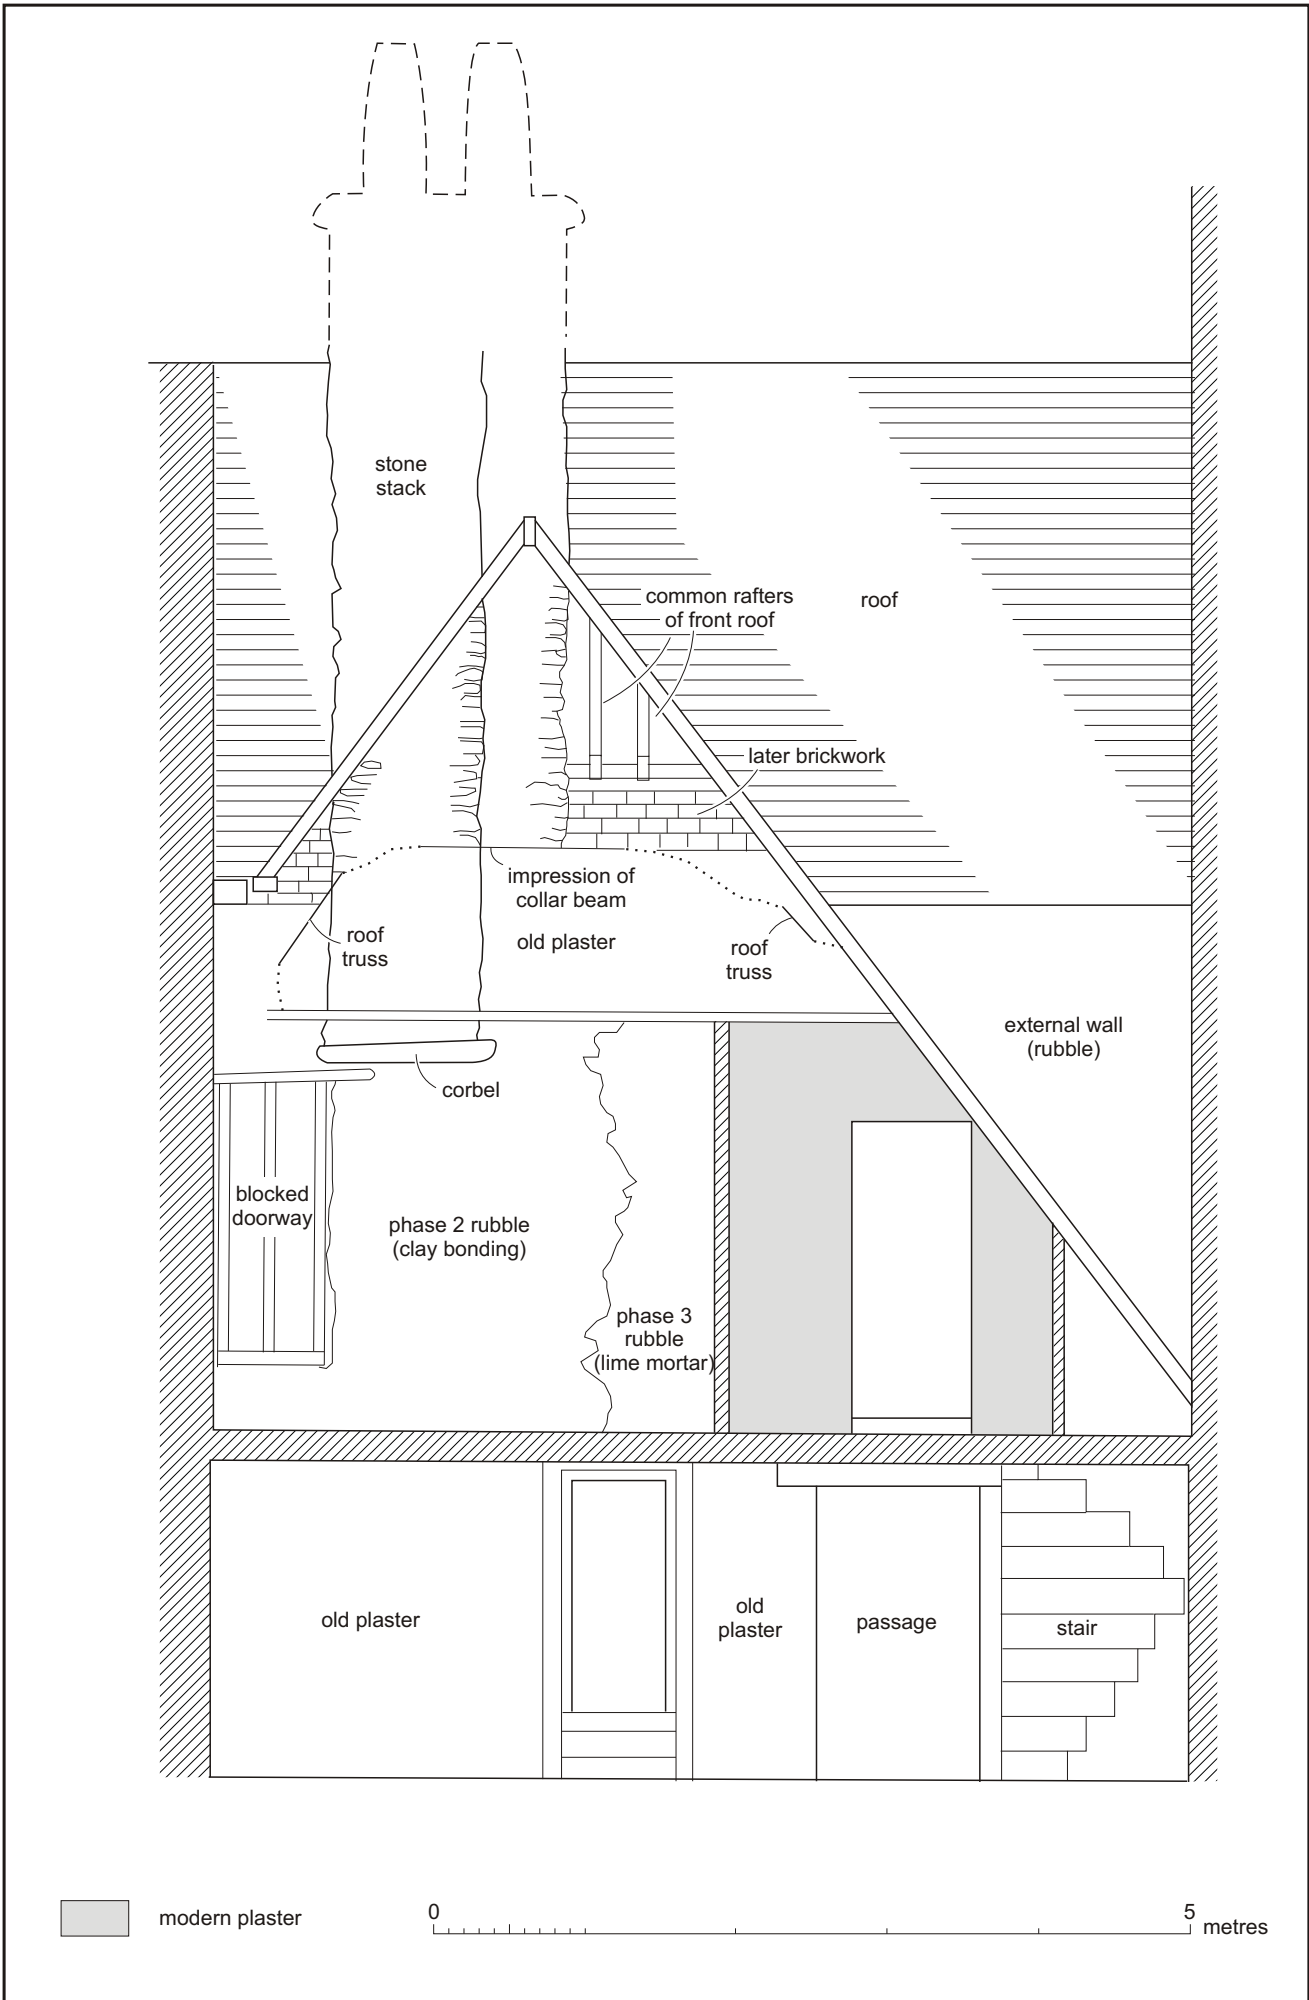
Fig. 20 Elevation of rear wall of back range.

The first-floor room to the rear had largely been stripped at the time of our visits, allowing important observations to be made regarding the interpretation of the house. Its oldest visible wall is the party wall with No. 14, which consists of clay-bonded shale rubble overlain by lime plaster containing horse- or cattle-hair. The only visible feature in it was a horizontal strengthening timber; there certainly were no openings. The rubble wall dividing the front rooms of the house from the back, which incorporates the front room fireplaces, abuts this (Figs 14, 20). This wall rises high into the roof space; when first built it was featureless at first floor level but incorporated the corbel supporting the back of the projecting stack of the fireplace of the front room on the second floor (Fig. 20).

Changes to this room are evident in the dividing wall between the front and rear rooms, but these were high in the roof and inaccessible. The stone stack of the late 16th- or early 17th-century house rose above the adjacent rubble wall. Subsequently the adjacent walling was raised in brick (Fig. 20, 'later brickwork') – possibly to provide a slightly higher roof for the front block when it was rebuilt in the 19th century, or perhaps to replace a timber frame supporting the roof.

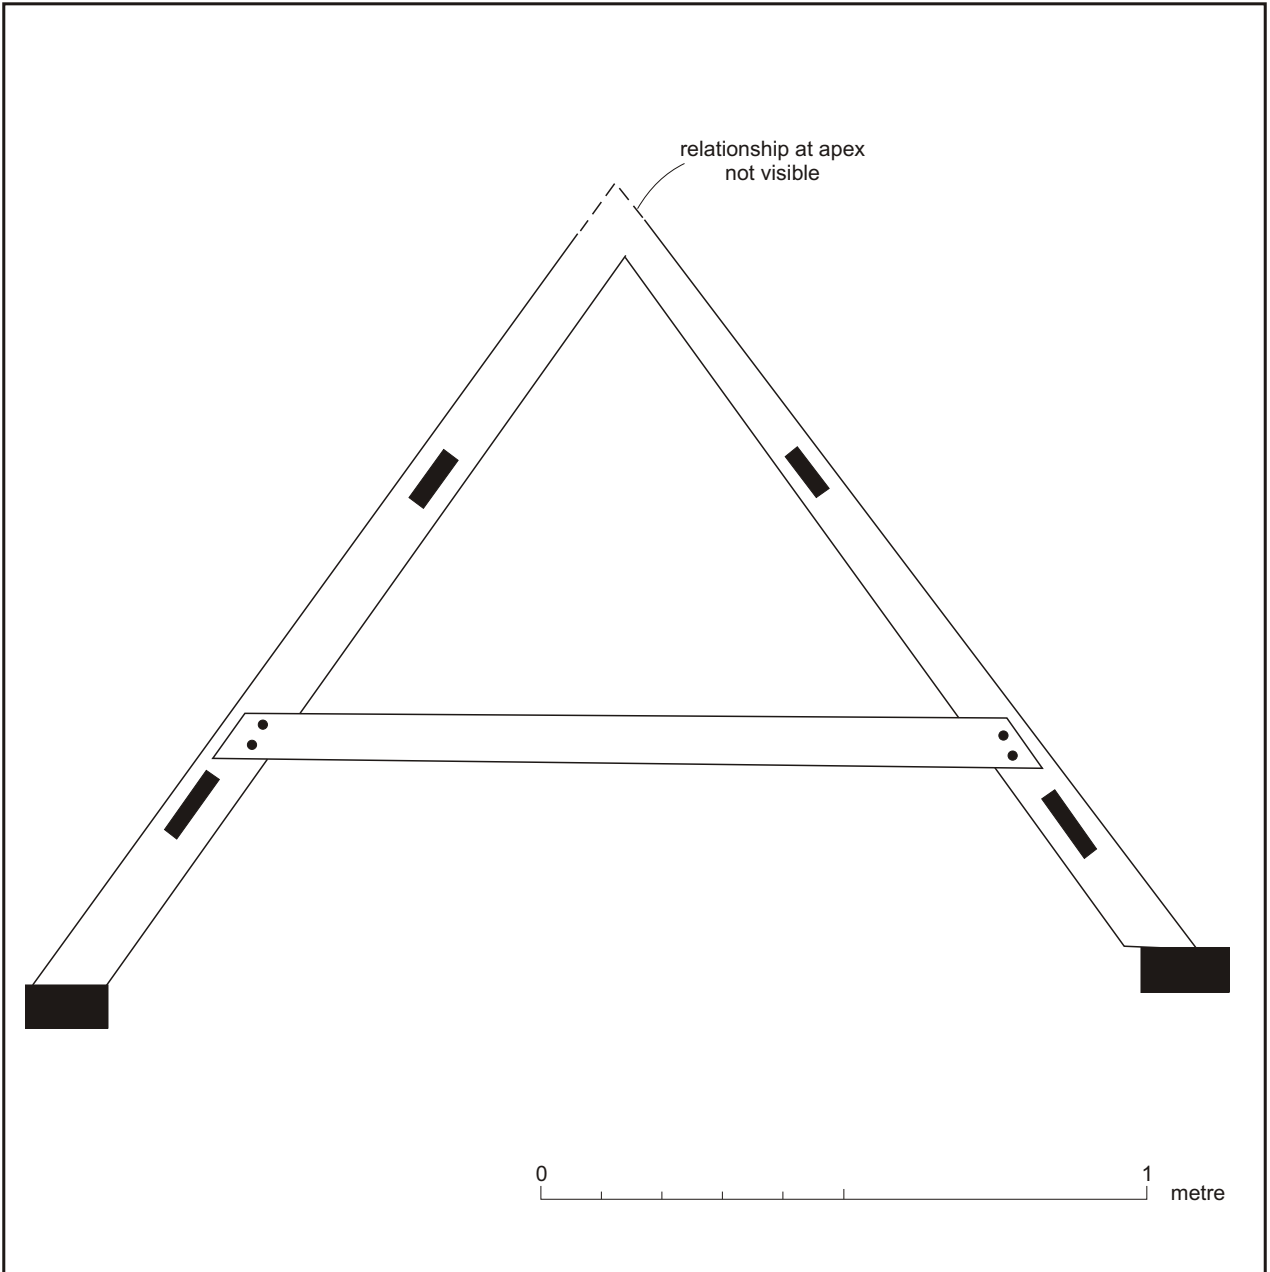
At the centre of the room is an open 'A' frame truss with a straight collar, fixed to the principals at each side by two large wooden pegs (fig. 21). There are mortice holes for threaded purlins in the principals. The northern truss for this roof forms the top of the northern gable of the house; the southern truss, beside the chimney stack, has been replaced, but the scar of its collar and the lower parts of the principals are visible in the lime plaster still surviving above the modern ceiling of the first floor (Fig. 20, 'roof truss' and 'impression of collar beam'). In the apex of the roof, far out of reach, the principals can be seen to cross, with the ridge piece carried above them (Fig. 15); the form of joint could not be seen. An upper purlin survives on the eastern slope of the roof but the western slope seems to have been largely replaced. A new tie beam has been installed at the northern end.

Fig. 21 Roof truss of rear block.

In the new scheme it is proposed that a mezzanine floor will be inserted in the northern first-floor room, entailing the removal of a tie beam in the present roof. The beam is a repair of the 19th century; we see no reason to object to its removal.
