**HISTORIC BUILDING RECORDING AND
WATCHING BRIEF AT
EAST DENSHAM FARM,
EAST WOOLFARDISWORTHY, DEVON**

Exeter Archaeology

Report No. 09.102

September 2009

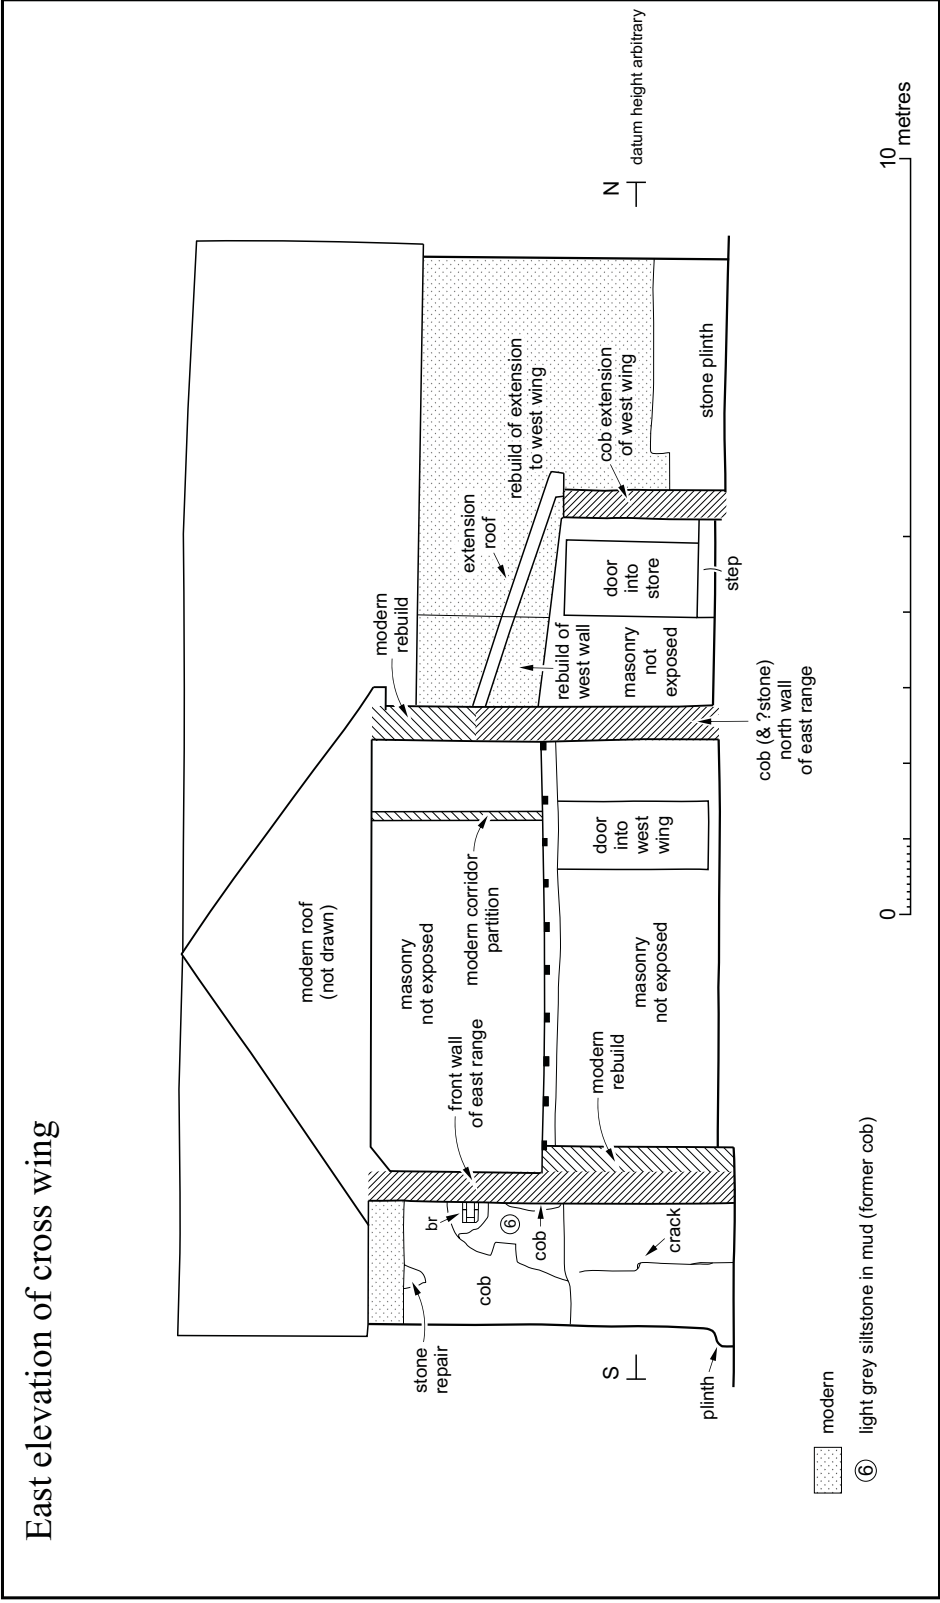
Fig. 11 East elevation of the cross wing. Scale 1:100.

The north extension is constructed of stone and may have been constructed in two phases, with the west elevation representing a rebuild of the earlier wall. Much of the fabric of this extension has been rebuilt in the 20th century (Fig. 11).

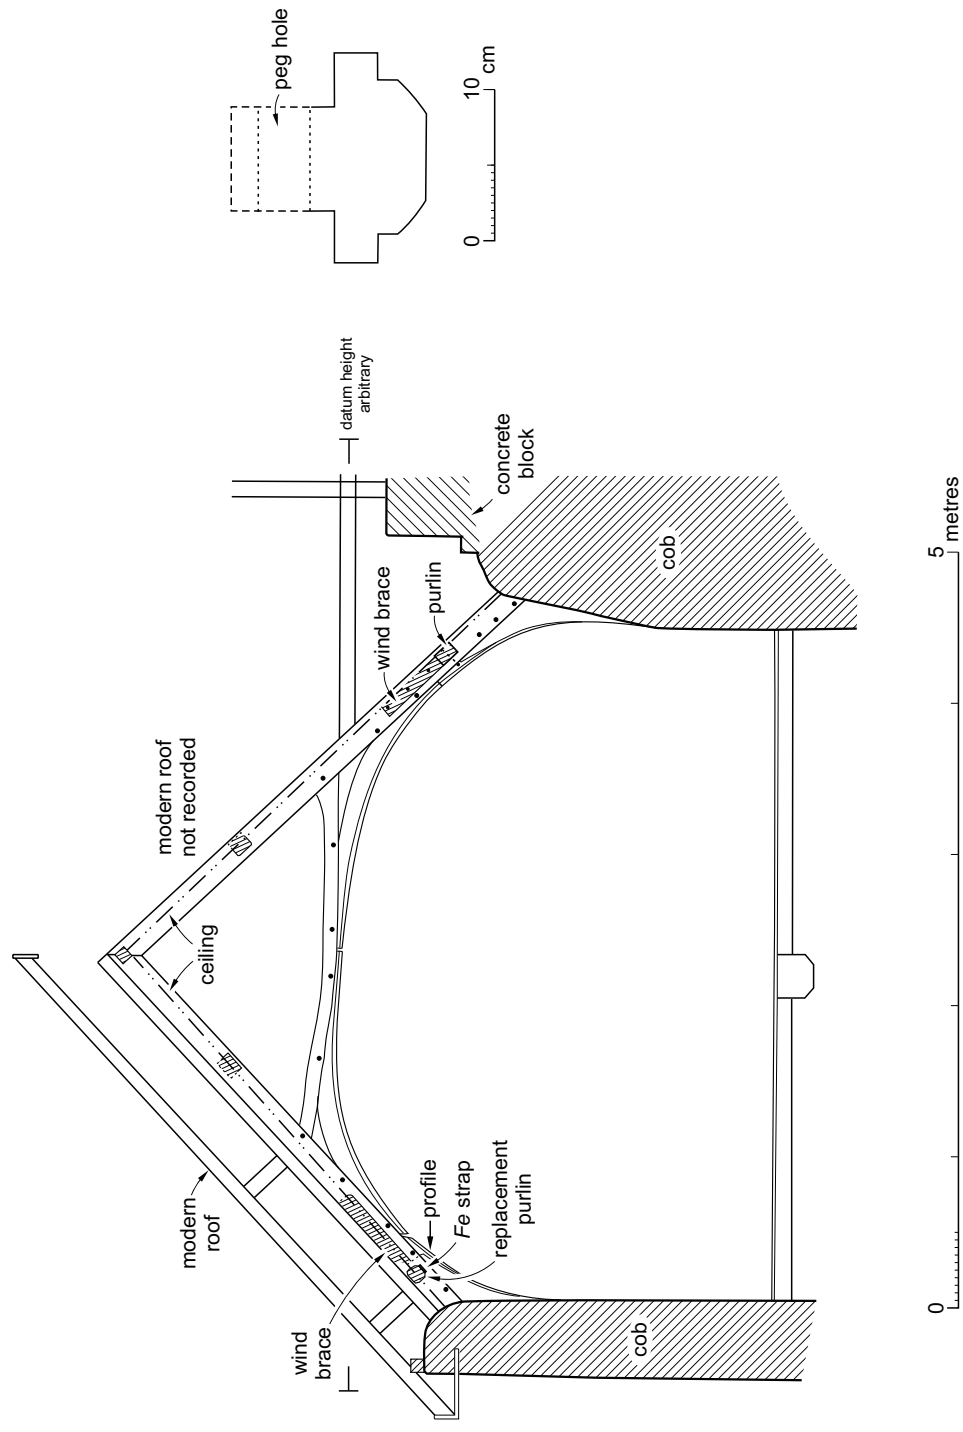
Fig. 13 The south truss in the cross wing. Scales 1:50 and 1:5.

The roof has three bays divided by two trusses, of which only the southern truss survives intact. The principal rafters are supported on side-pegged jointed cruck posts with curved heads forming the lower arch braces, which extend down at least as far as the floor of the bedroom. The curved crucks terminate just above the level of the lower purlins; their upper extremities are secured to the principal rafters at this point by a single face peg, presumably because extending the cruck tenons any higher would have fouled the sockets for the purlins. Above this level the curved crucks are succeeded by curved arch braces which rise to the underside of the collar beam.

There are two levels of butt purlins, tenoned into the sides of the principal rafters and secured with pegs. The ridge tree at the apex is diagonally set. Between the upper and lower side purlins there were originally pairs of curved wind braces in each bay. Four wind braces survive, and the presence of the missing ones is attested by vacant sockets in the upper purlins and long slots in the sides of the principal rafters. Both the wind braces and the arch braces have plain chamfers, and all the joints are secured with pegs. All the timbers are smoke blackened, although there is evidence that some of the timbers (at least the purlins either side of the truss) were at some stage ceiled over.

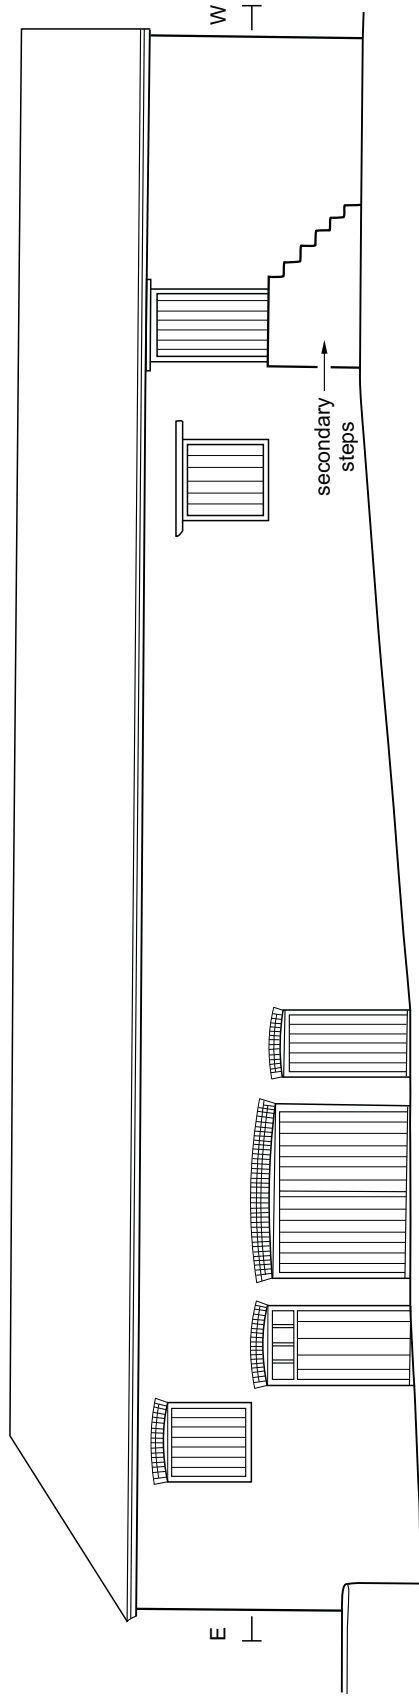
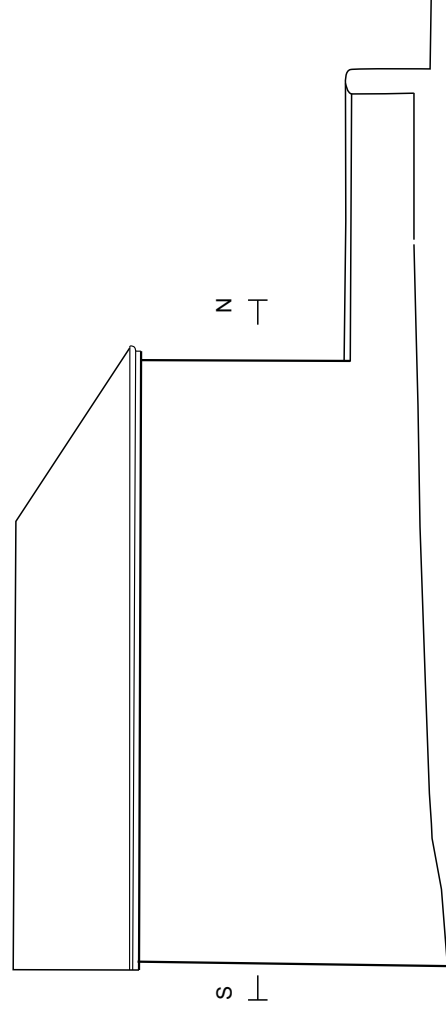
Fig. 17 North and east elevations of the linhay and shippon. Scale 1:125.

This elevation is two storeys high and constructed from coursed random rubble incorporating large blocks of stone as quoins as well as generally within the walling. The stone employed is an iron-rich shale and the roof is slated, with black-glazed ridge tiles. At the east end at first floor level there is a hatch to the loft above the shippon. This is a primary feature with stone jambs and a low, hardly segmental arched head of red bricks laid as two courses of headers. The hatch door has a wooden frame and is planked, with spear-headed strap hinges. The latch is operated through a small hole and has a large wooden catch.

On the ground floor the primary doorway to the shippon is very handsome, with stone quoins and a brick head like that previously described, with a timber frame and an internal fanlight, decorated with chamfers and run-out stops. Above the door, which retains one spear-headed strap hinge and one plainer one (which might be a repair), is a four-light fanlight fixed to pivot outwards. Immediately adjoining this and clearly also contemporary with it is a very wide opening with a segmental arch of three courses of headers. The frame has chamfers and run-out stops. The doors, with a variety of strap hinges, are modern replacements. Adjoining this doorway is a smaller doorway communicating with the main body of the linhay. This door has a two-course arch and its door has no fanlight. The door is loose and has strap hinges and a timber latch mechanism operated through a hole. The chamfered doorframe has iron pintles threaded through it and secured with bolts. Roughly at the centre of the elevation is an area of disturbed stonework and mortar. This may be a patch repair of damage caused by a localised failure of the roof covering above.

Towards the western end of the building the loft over the linhay is accessed by a hatch. This has been much repaired, particularly above the timber lintel and below the concrete sill, yet the opening is probably a primary feature. The frame has no chamfers; the door has an array of old strap hinges but has fallen from its frame. The doorway to the loft above the root store also has a timber lintel and no chamfers or wooden latch, and has been partially covered in zinc sheeting. The steps by which this doorway is approached are of modern concrete and it is uncertain what provision there was originally. There is a blocked

The east elevation of the shippon has no openings or architectural features.

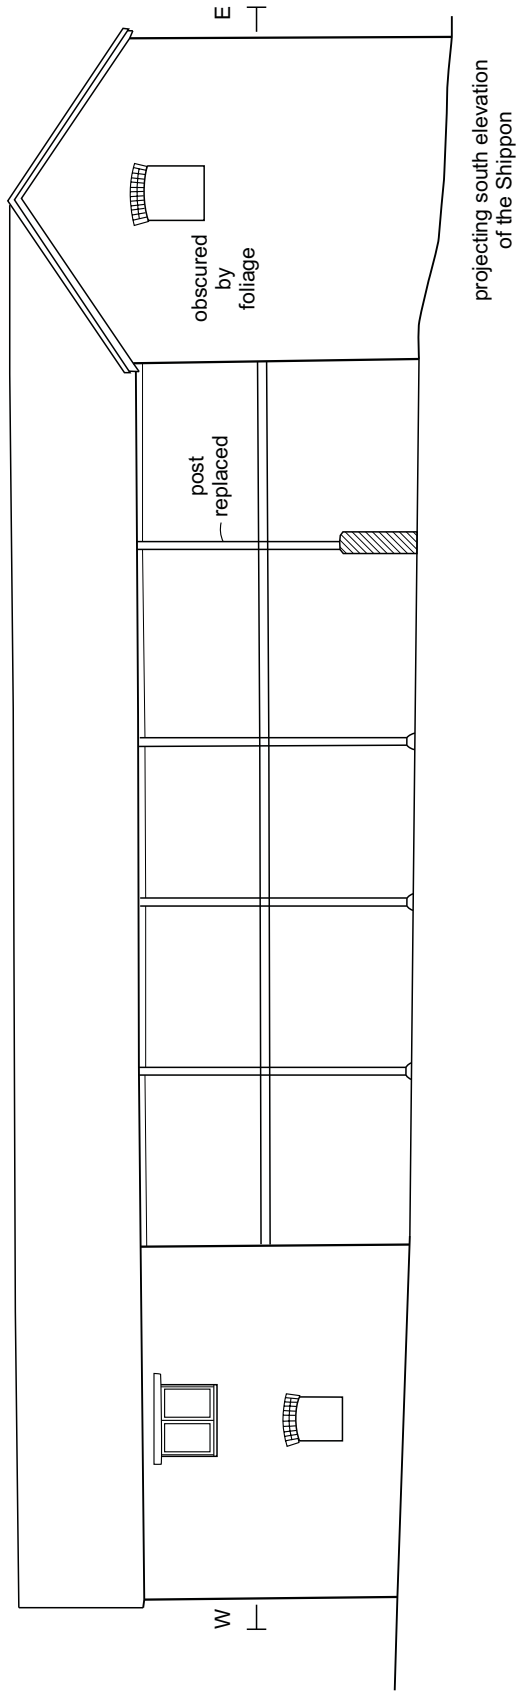
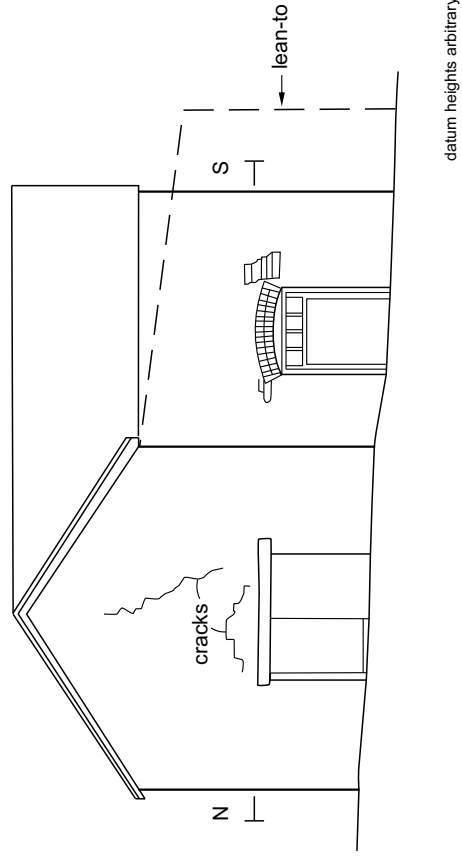
Fig. 18 South elevation of the linhay and west elevation of the shippon. Scale 1:125.

The south elevation of the root store has fractured quite badly at the corner. This elevation has a small arched opening on the ground floor with a two-header course arched lintel, and no surviving frame. On the first floor is a two-light mullioned window which appears to have been glazed. This opening retains a single iron saddle bar.

The south front of the linhay is supported by four posts, three of which rest upon stone 'staddles'. The posts are substantial and probably reused, since they have a number of redundant sockets and contain pintles which appear unrelated to the present structure. The posts rise to clasp the ends of the tie beams supporting the roof trusses, and the first-floor beams are let into their rear faces and secured from the front by bolts. A horizontal timber forming a bressumer to the first floor is housed in a rectangular chase in the front face of each post. The joists are housed in notches cut into the tops of the beams. The fourth post has been removed and has been replaced with a timber prop resting on part of the stone wall dividing the linhay.

The western face of the shippon in the eastern wing faces the linhay and has a series of joist holes (still with the ends of the joists protruding) showing where the first floor structure has been removed. The shippon is entered by a handsome doorway with a chamfered frame, fanlight and two-courses of brick forming the arched head. The door is missing.

The south, gabled elevation of the shippon is almost entirely obscured by ivy and cannot be easily inspected. The only feature visible is a first-floor window with a brick arched head.

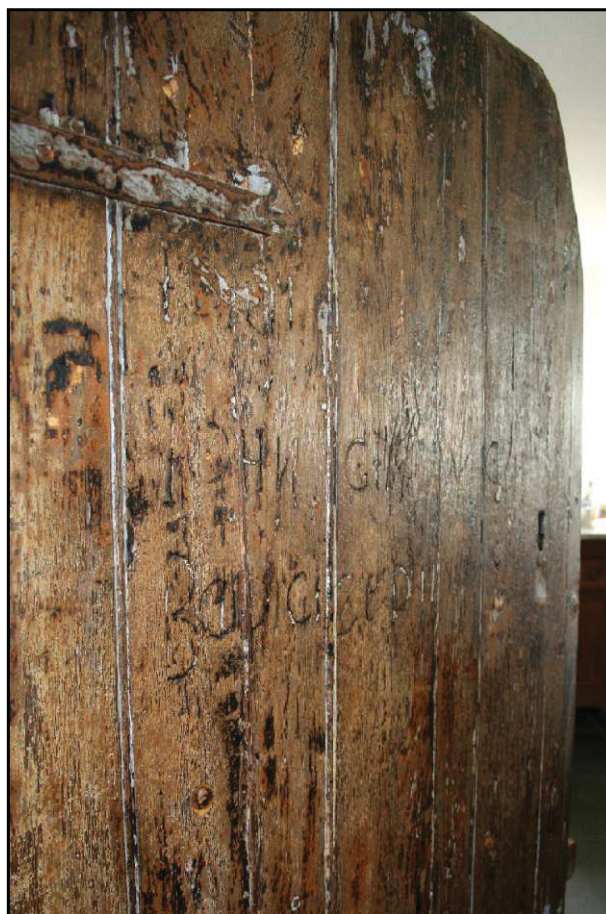
The walls of the cross passage have been widened and rebuilt, although an early, possible original, door and frame survive on its lower side, perhaps the only surviving fragment of the screen dividing the passage from the kitchen. The door has ancient graffiti and a broken 17th-century strap hinge. The legible portions of the graffiti read 'John Gi_was Baptised HW' on two lines, with further text of 'John' and 'WH' (Pl. 2). It is worth noting that no suitable candidates for the identification of these initials appear in the outline history of the occupants and owners of the house given above. The door frame appears to be

Pl. 2 The graffiti on the kitchen door, looking north-west.

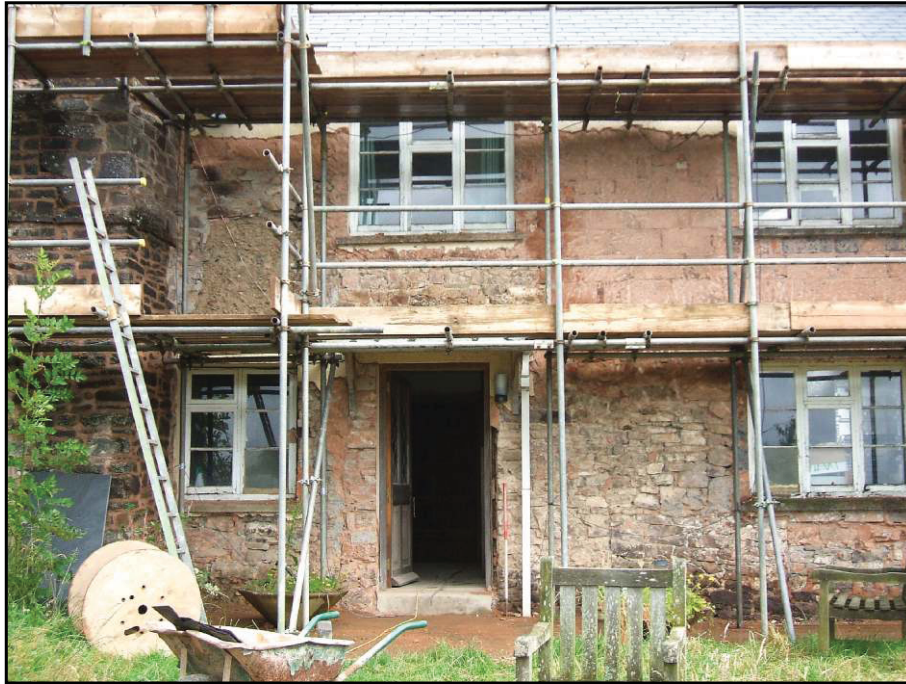
The present south doorway of the cross passage has been narrowed from the original opening (Pl. 3). No similar observations were made on the north elevation, since this elevation now forms an internal wall and render was not stripped from the masonry.

Pl. 3 The east range of the farmhouse, south elevation, showing narrowed cross passage and other alterations, looking north. 1m scale.

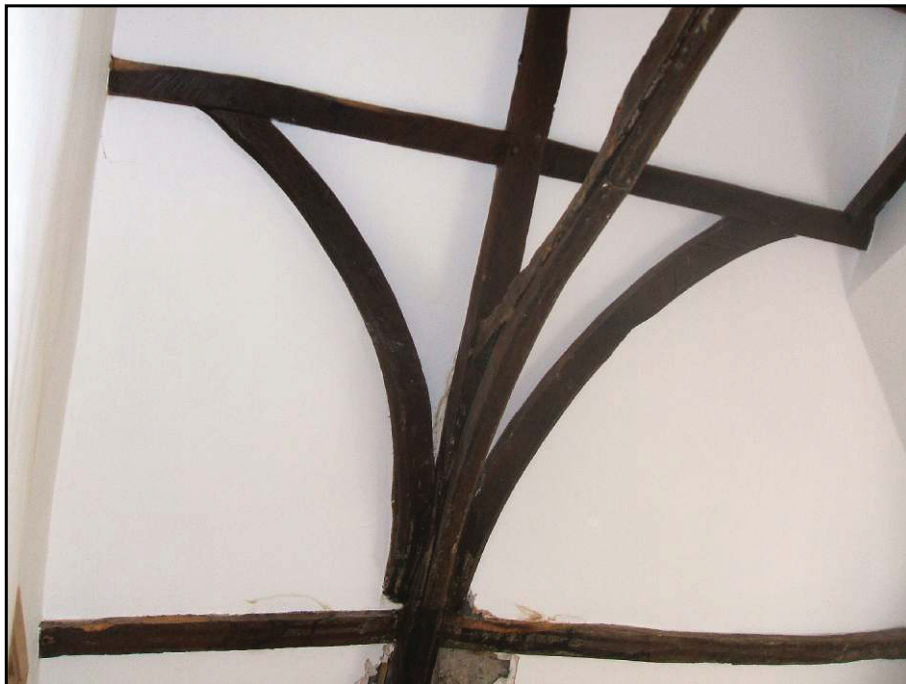
Pl. 4 The medieval roof of the cross wing, showing the south truss and wind braces on the east side of the roof, looking south-east.
