**ARCHAEOLOGICAL RECORDING OF  
EAST RUCKHAM FARMHOUSE,  
CRUWYS MORCHARD, DEVON**

**Exeter Archaeology**

**Report No. 09.126**

**December 2009**

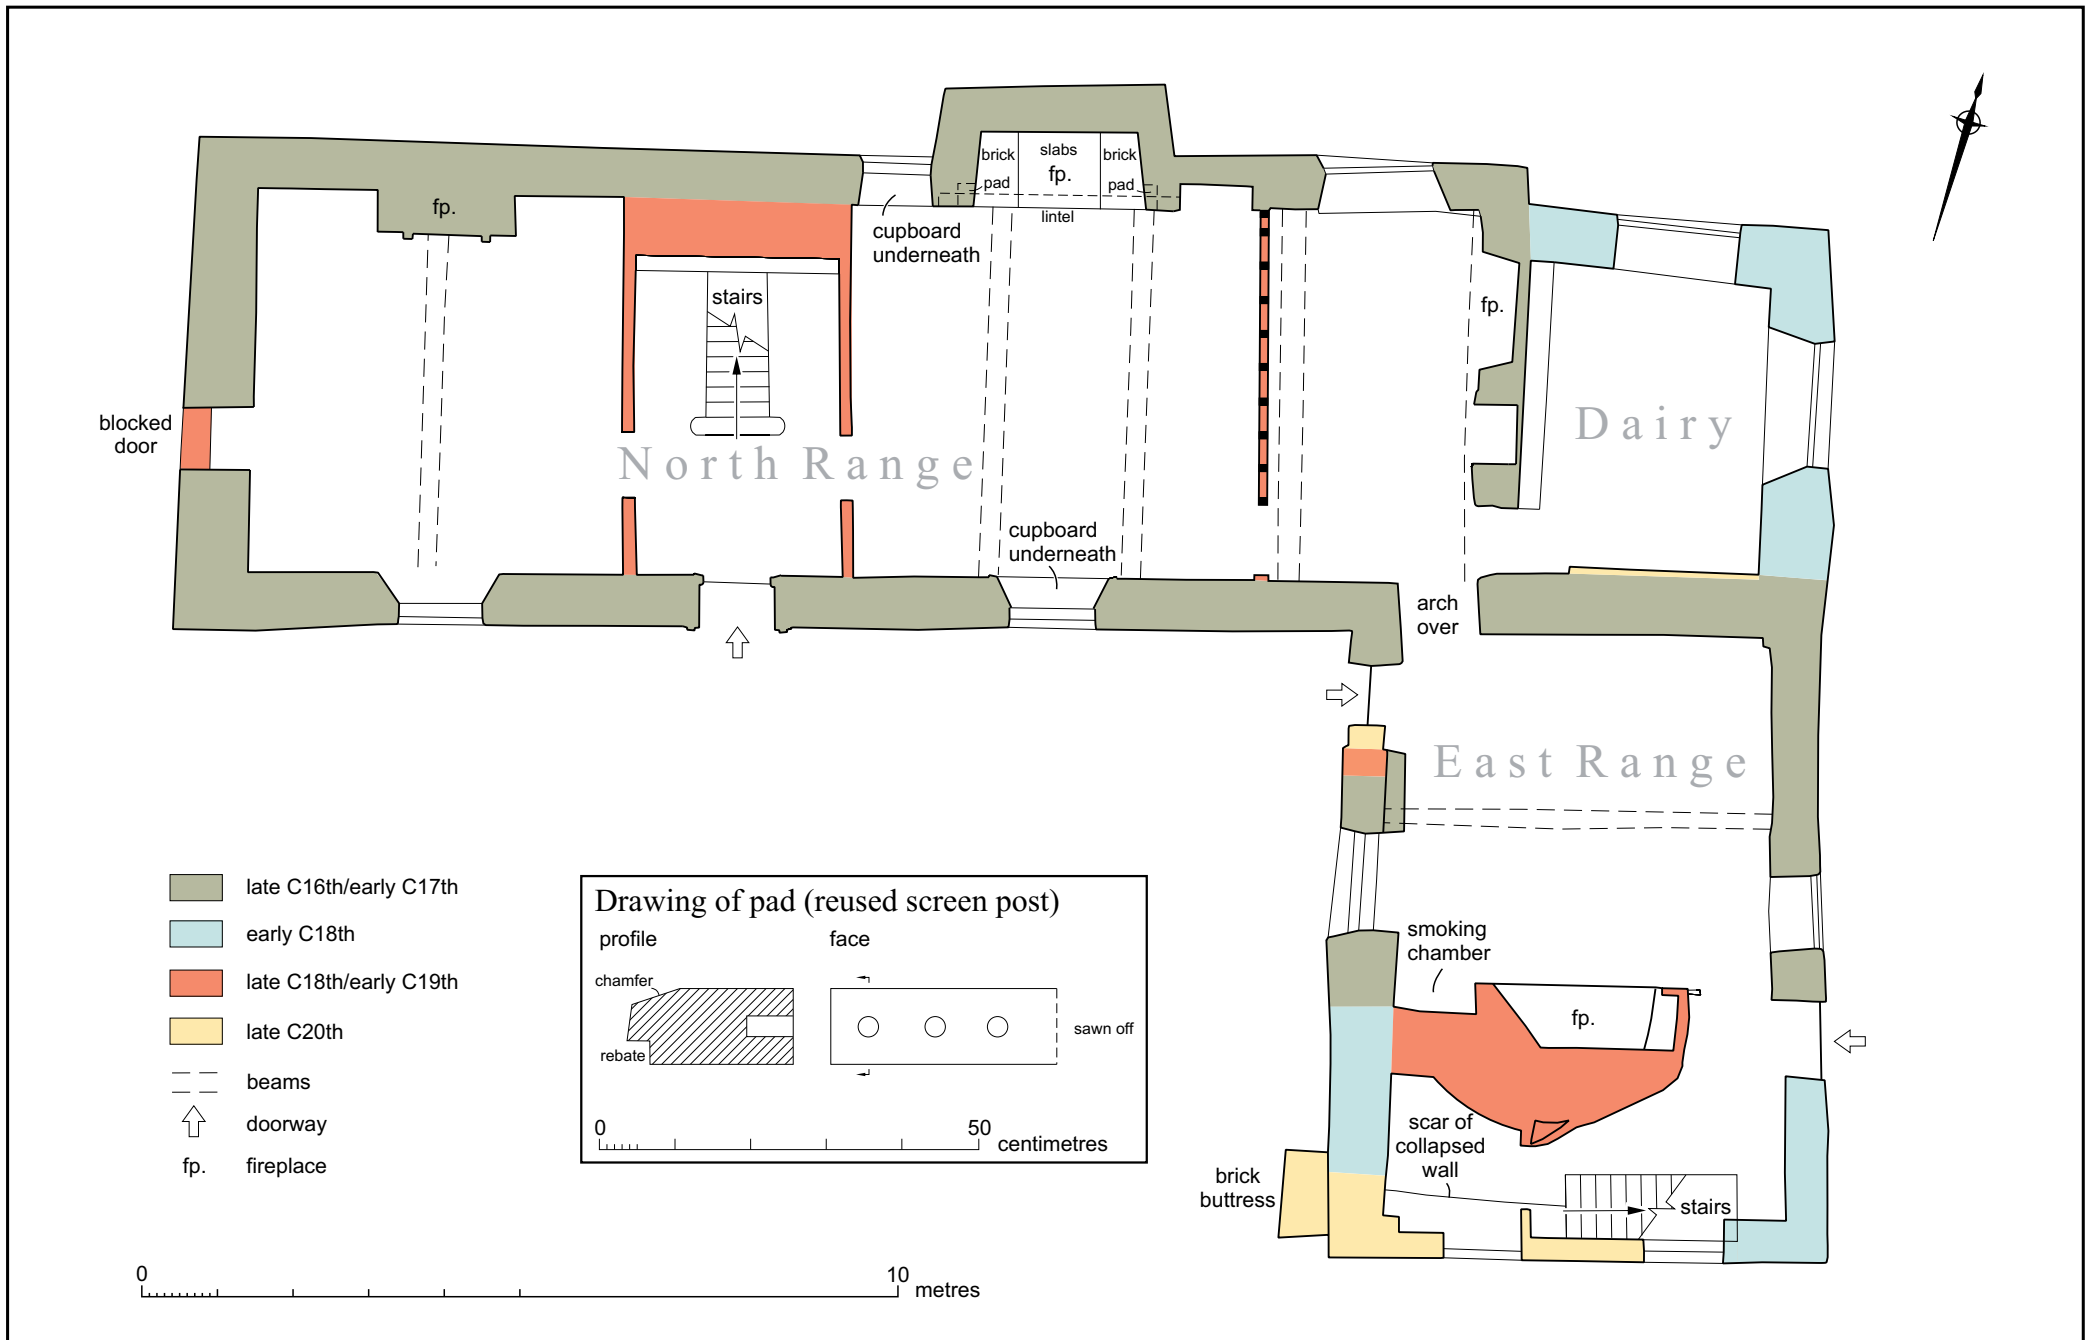
Fig. 2 Phased plan of the ground floor.

The partition between the existing kitchen and dining room was removed. This partition was identified during the evaluation as part of the Georgian reordering of the house and its position did not reflect the earlier layout. The partition is constructed of 10 vertical studs set into a horizontal sill, and interrupted by two diagonal braces. The partition was originally faced on both sides with lath and plaster, and this material only survives at the south end of the partition to a maximum height of 1.20m. During the 20th century the gaps within the partition were infilled with drilled bricks, finished with cement render, to a height of 0.80m above the floor. These were covered with at least three layers of 20th-century wallpaper prior to the installation of the present kitchen units. The west side of the partition has been refaced with tongue and grooved panelling.

In the eastern extension to the north range observations of the ceiling were made. A single original east-west aligned joist survived, displaying scars of lath and plaster on its underside associated with its contemporary ceiling. All other joists are modern, as is the plasterboard ceiling along with its recycled historic cornice.

In the dining room the modern fireplace surround and lintel was removed to expose an earlier, larger fireplace. The remains of a brick surface survived in the hearth, truncated by a later stone slab surface. The lower sides of the fireplace have been lined with white-painted cement render, scored to create an impression of bricks. The bricks and render had been obscured by stone rubble, which was inserted when the present fireplace was installed. A massive lintel spans the fireplace and this is supported on wooden pads in the projecting jambs. These pads have been reused from sections of a doorframe that originated in a wooden screen. On one face the pads display a chamfer and a rebate for the door, whilst on the opposite face are small circular holes for sprung laths. The presence of these pads indicates that the fireplace was added, or more likely altered, after the screen's passage went out of use and the screen was dismantled, perhaps in the late 18th century.

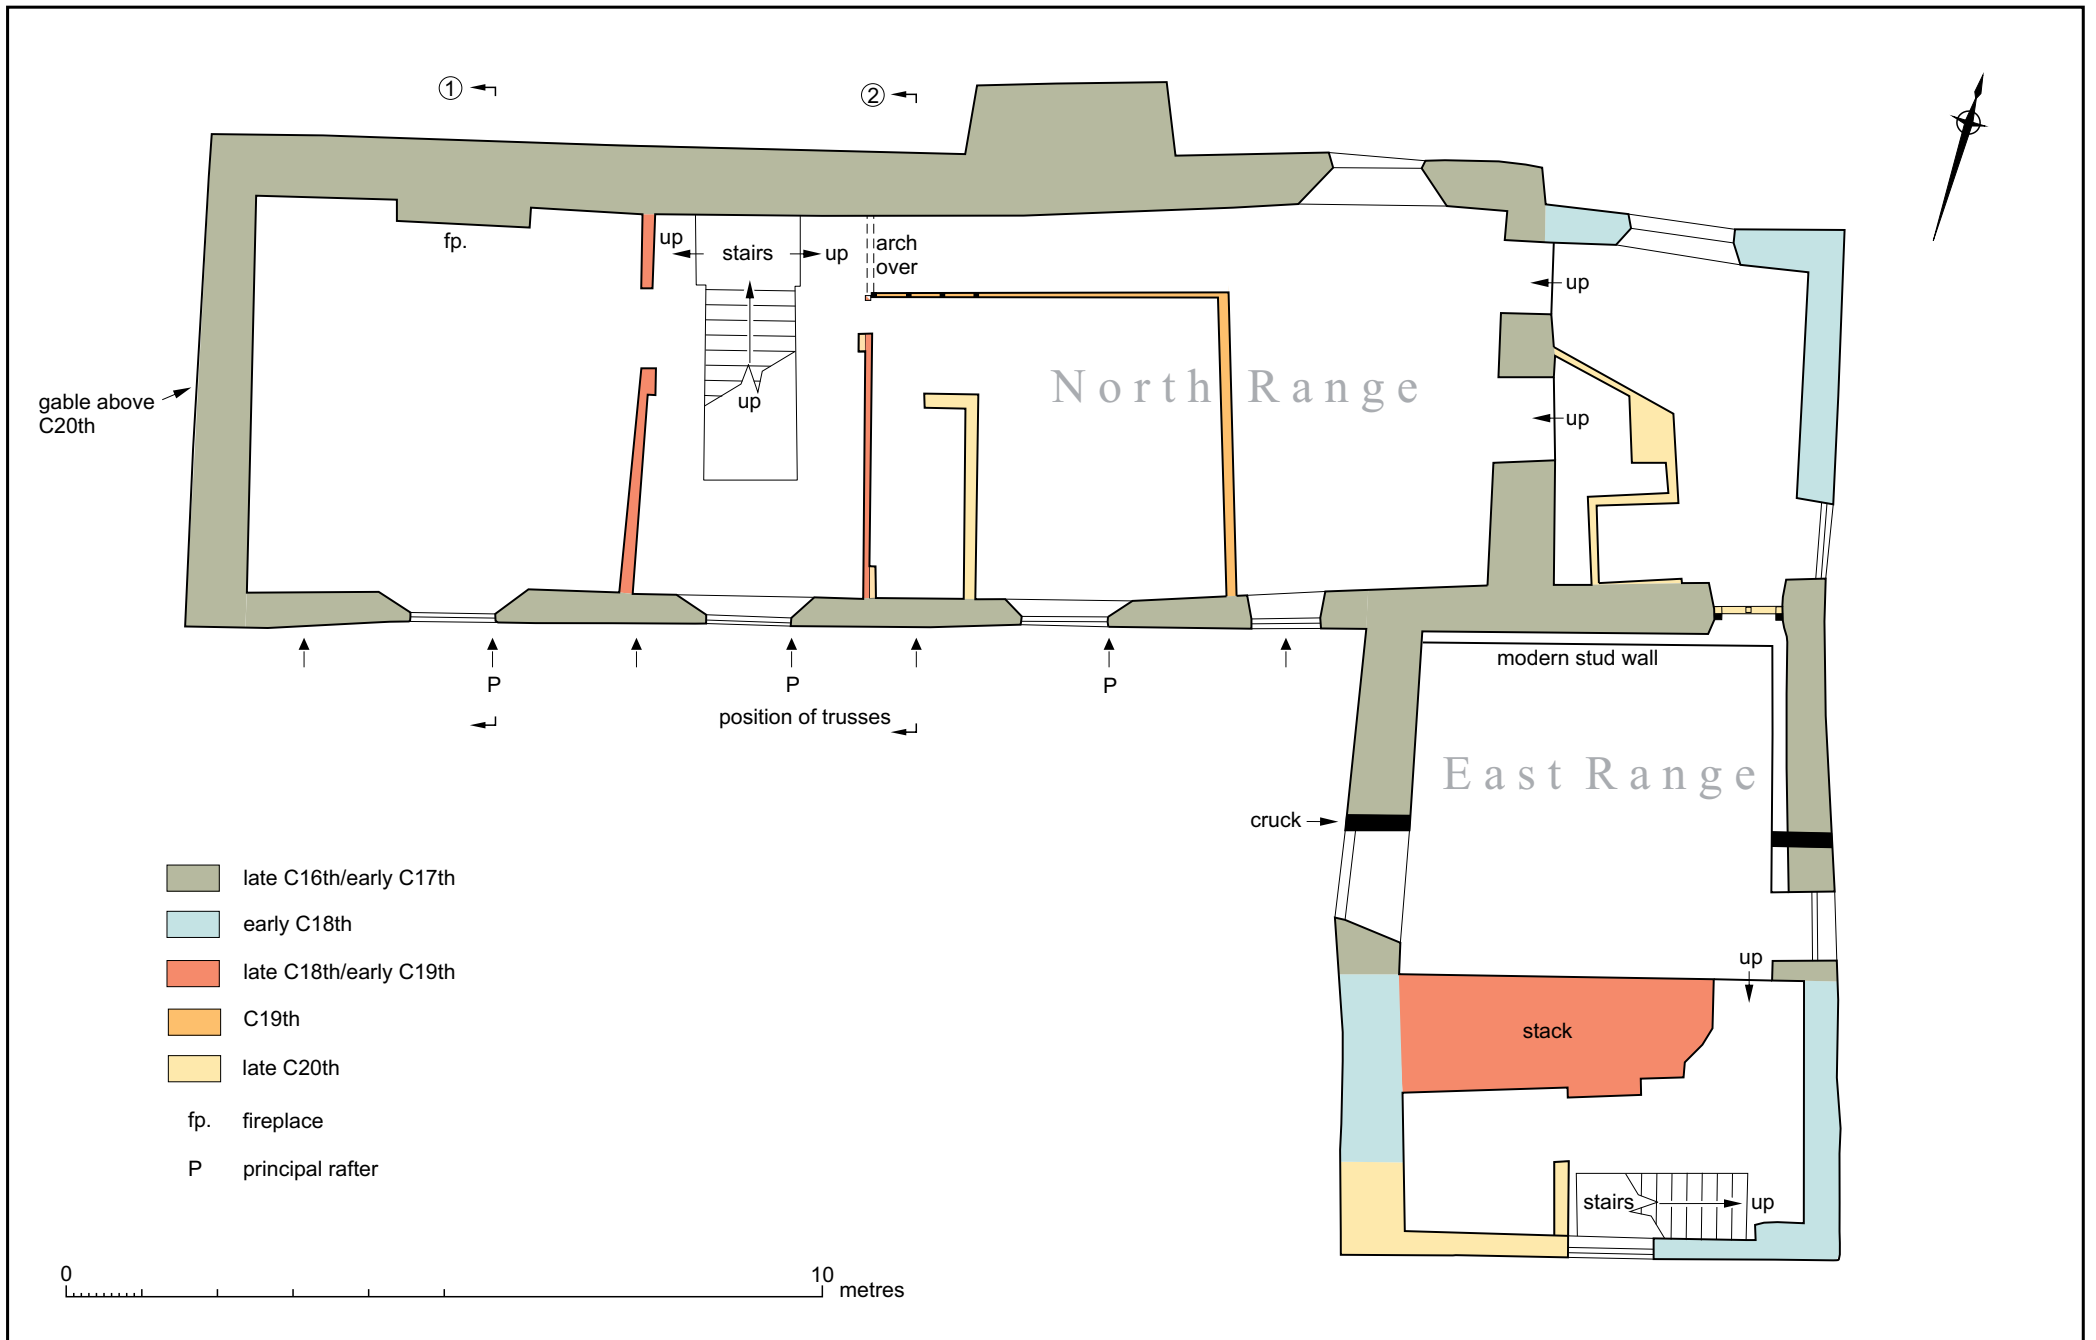
Fig. 3 Phased plan of the first floor.

The partitions defining the central bedroom and the adjacent corridor on the north range were removed. Although observations were limited, a sequence of four phases of development and alterations were recorded. The earliest phase is the construction of the farmhouse, represented on the first floor by lime-rendered walls. The second phase represents the division of a room

(or rooms) from the landing above the stairs. It is likely this arrangement was similar to the present layout. The north elevation of the farmhouse was obscured by a new lath and plaster false wall to create a flat surface, and the same material was used for the partition between the landing and room/s to the east. Here two vertical doorposts were exposed, along with wooden framing above the door where lath and plaster survived. The joints of this partition are pegged.

The third phase represents the subdivision creating the present corridor and central bedroom with a lath and plaster partition. This partition comprises a series of vertical studs that were partially exposed, set into a sill at floor level and bisected by a diagonal brace. At the entrance to the corridor from the landing is a horizontal beam attached to which are four curved pieces of wood forming an arch, also covered with lath and plaster. Nails were used throughout this work. The final phase of alterations relates to modern redecorating and include the provision of a new plaster face to the corridor elevation of the partition, and wooden piers over the top of the stairs in the landing.

The opening in the north elevation of the east range was unblocked and the adjacent cupboard removed, exposing the original plastered cob walls hidden behind modern plasterboard and stud walls. In places two phases of plaster were visible, the inner layer with a light grey whitewash, and the outer layer painted white. The opening itself is splayed and was for a door. The doorframe is painted softwood with a simple curved moulding retaining its catch mechanism. Since this door opens from the first floor of the north range extension it is likely to date to, or after, the 18th century.

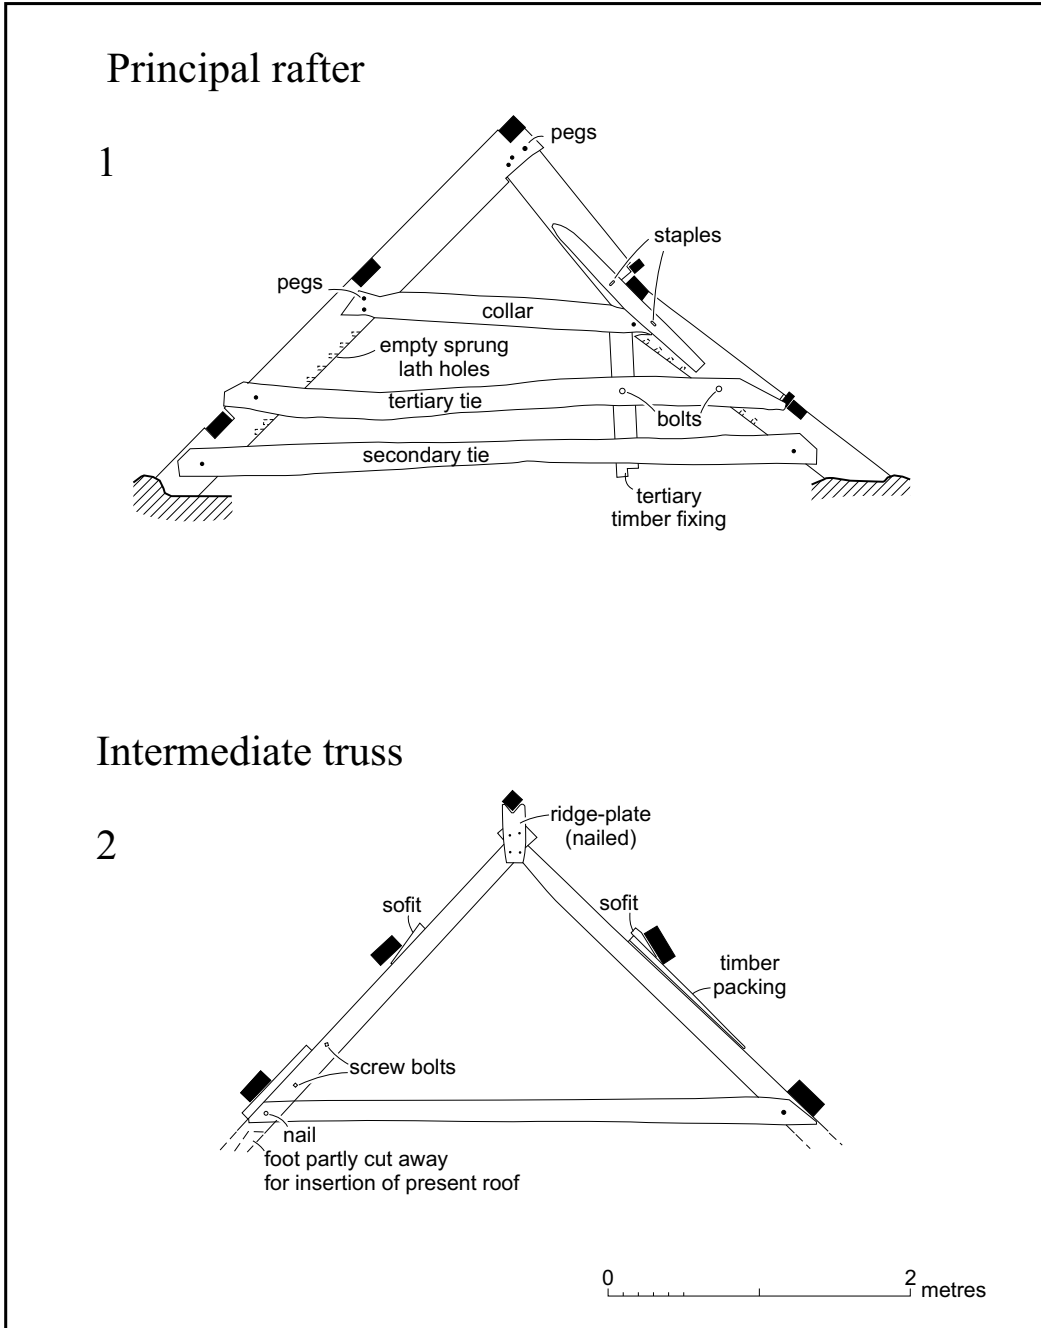
Fig. 4 Roof trusses of the north range.

The roof structure of the north range comprises three primary trusses with three intermediate trusses, and a hip truss at the west end. The intermediate trusses are of 19th-century date and given the long span between the principal trusses it seems highly likely that these replaced earlier intermediate trusses although there is no direct evidence for earlier trusses (some bays with large spans have however been recorded in farmhouse roof structures). The roof is in a poor condition and several phases of historic repair and additional supports to the trusses were recorded.

The principal trusses are half lap-jointed at their apexes where they support a diagonal ridge purlin, and have high-level half lap-jointed collars, all fixed with wooden pegs. There are two rows of trenched purlins on each side of the roof, butt jointed where they are attached to the principal rafters. A number of repairs to strengthen the roof have taken place in the 19th and 20th centuries. All three trusses have secondary applied collars just above the ceiling, whilst the western truss also has a third applied collar, with further bracing set between the two earlier collars.

All the principal rafters display evidence for partitions, i.e. they were 'closed', and the roof space formed part of first floor rooms or chambers. The roof space had been ceiled over by the 19th century when the intermediate trusses were added, and probably occurred when the house was 'Georgianised'. Below the collar of the western truss there are horizontal holes for sprung laths and traces of paint only on the eastern face of the rafters indicating that the west bay was ceiled over at a low level, below the hip of the roof, and that the next bay was open as high up as the collar. The central and eastern trusses have paint extending the full height of the trusses, on their western and eastern faces respectively. The collars of both trusses also incorporate mortice sockets for removed vertical posts. Above the collar on the eastern truss painted lath and plaster survives, laid onto wooden boards that are attached to the collar and rafters.

The intermediate trusses were added, probably in the late 19th century, to provide support to the earlier roof, particularly the sagging upper row of purlins. The principal rafters have lap-jointed apexes supporting yokes that hold the original ridge purlins. Each truss has a low-level bolted collar. The original purlins rest either on the rafters or on pieces of wood attached to the rafters.

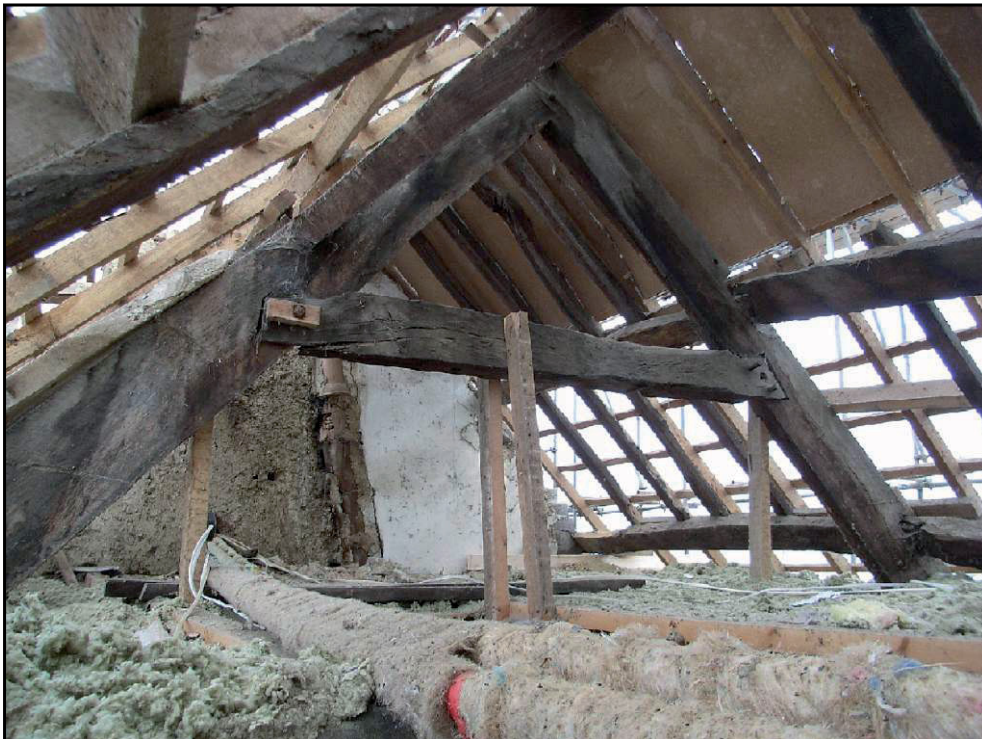
Pl. 2 The truss in the east range, looking north-east.

Within the east range there is a single jointed-cruck truss composed of a pair of principal rafters with a pegged half lap-jointed collar, and two pairs of trenched purlins with scarf joints behind the truss. The collar has been additionally strengthened during the mid 20th century with the inclusion of a single iron screwed bolt to at either end. The replacement purlins are smaller than the primary purlins accommodating only three-quarters of the notched space within the principal rafter. There are primary and replacement common rafters, all scarf-jointed and pegged to each rafter. The principal rafters have additional sections of nailed timber attached to them raising the height of the roof structure to accommodate the present 20th century rafter arrangement.
