**ARCHAEOLOGICAL BUILDING RECORDING
AND WATCHING BRIEF AT
GREAT BEERE, NORTH TAWTON, DEVON**

by
R.W. Parker and A. Farnell

Exeter Archaeology

Project No. 6444

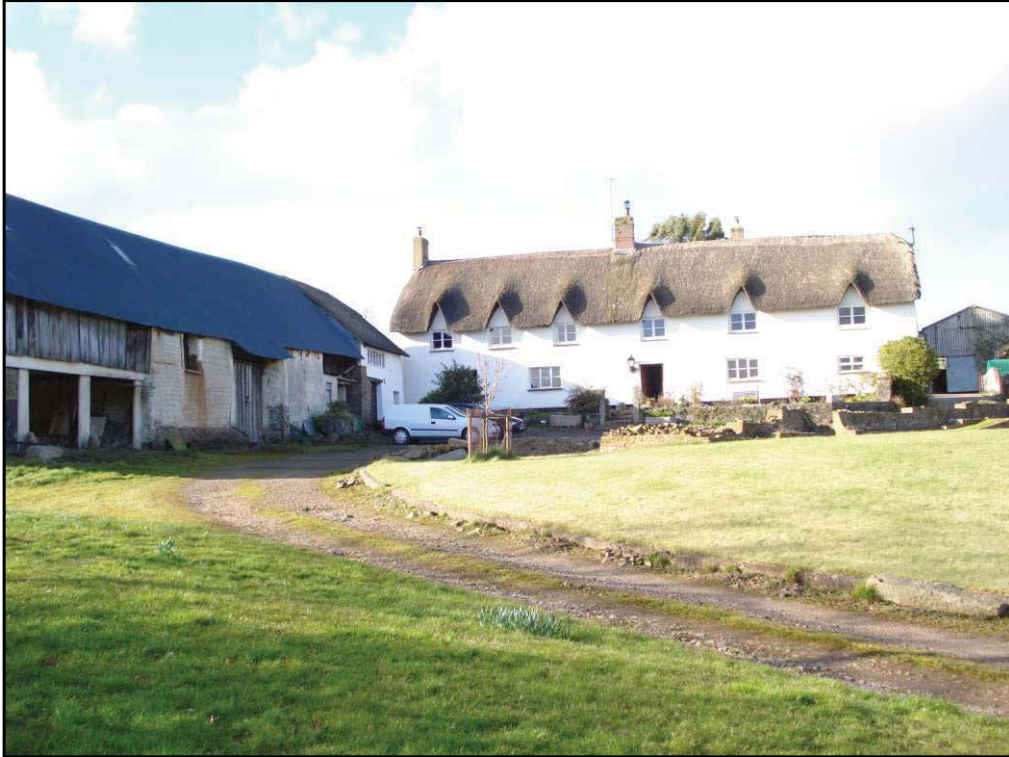
Fig. 2 General view of the buildings, looking north, showing the farmhouse with the barns lying along the western side of the former farmyard.

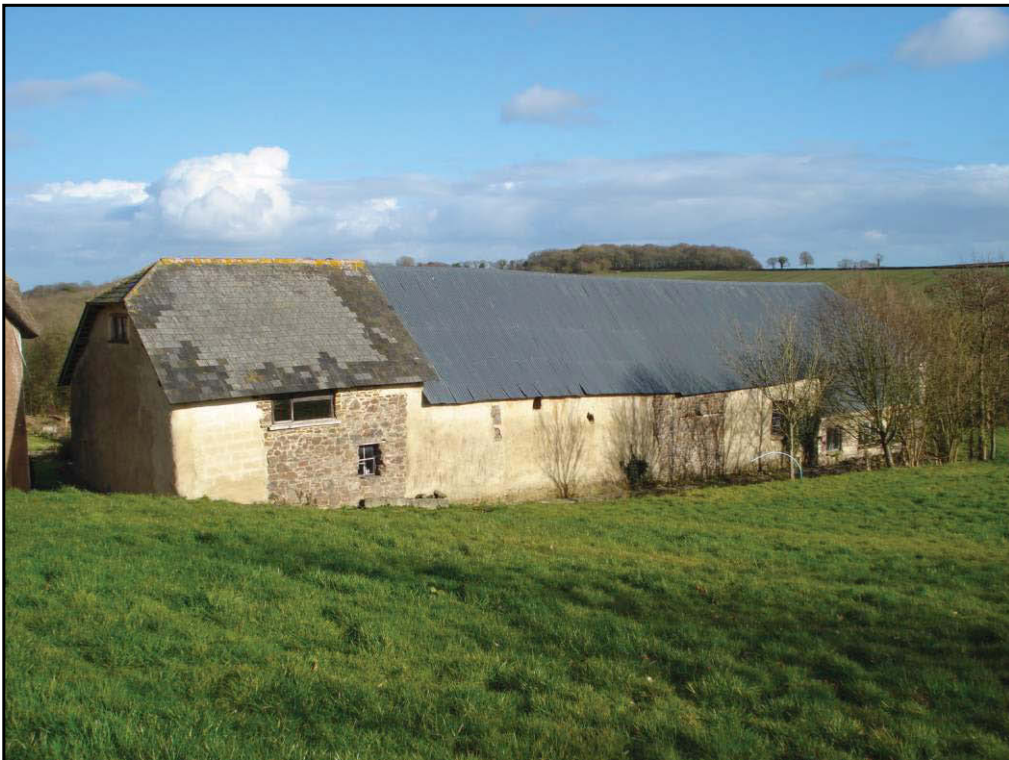
Fig. 3 General view of the farm buildings, looking south east, showing the rear elevation prior to conversion.

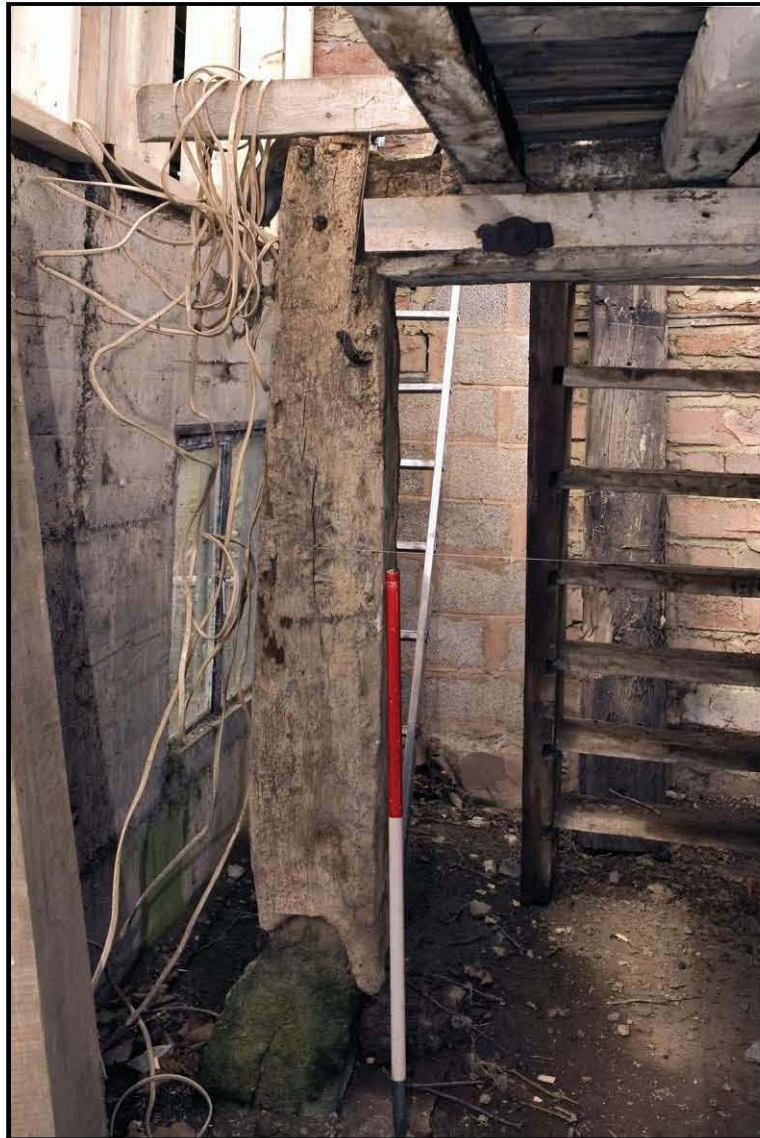
Fig. 4 Detail of the assembly of the southern linhay, showing the staddle stones and the truncated posts.

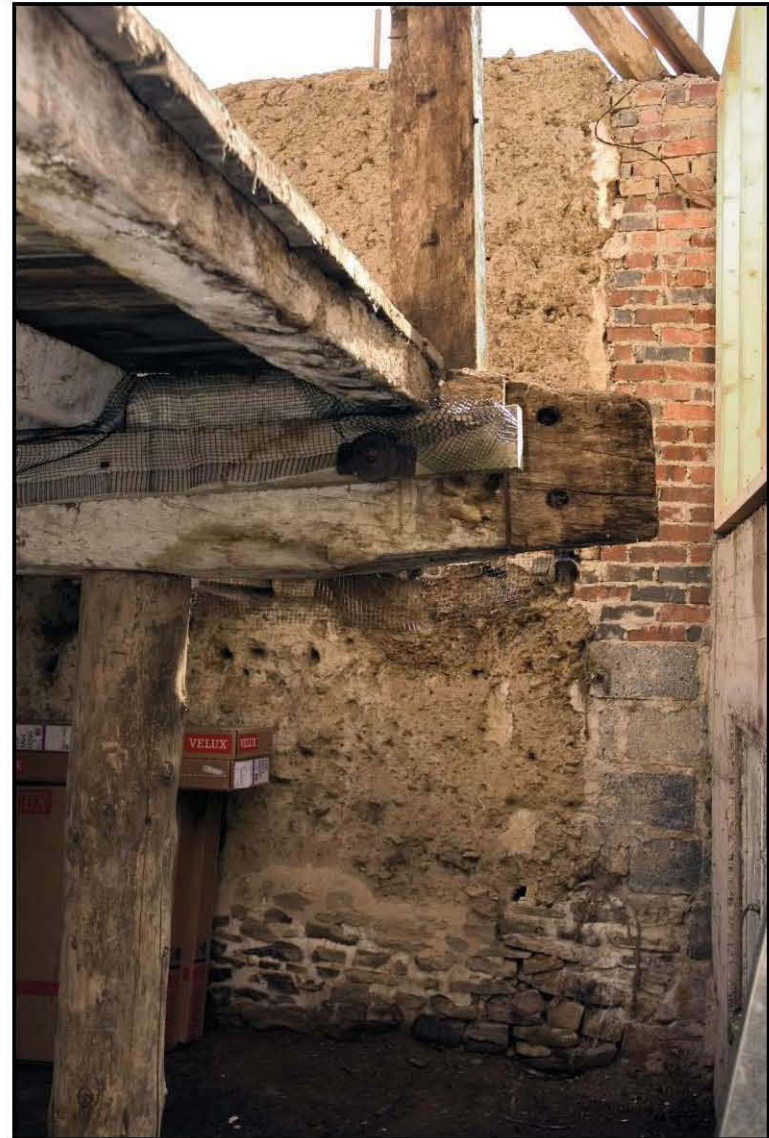
Fig. 5 Detail of the assembly of the southern linhay showing one of the tenons on the first-floor beams revealed by the removal of a post and its replacement by a modern timber prop.

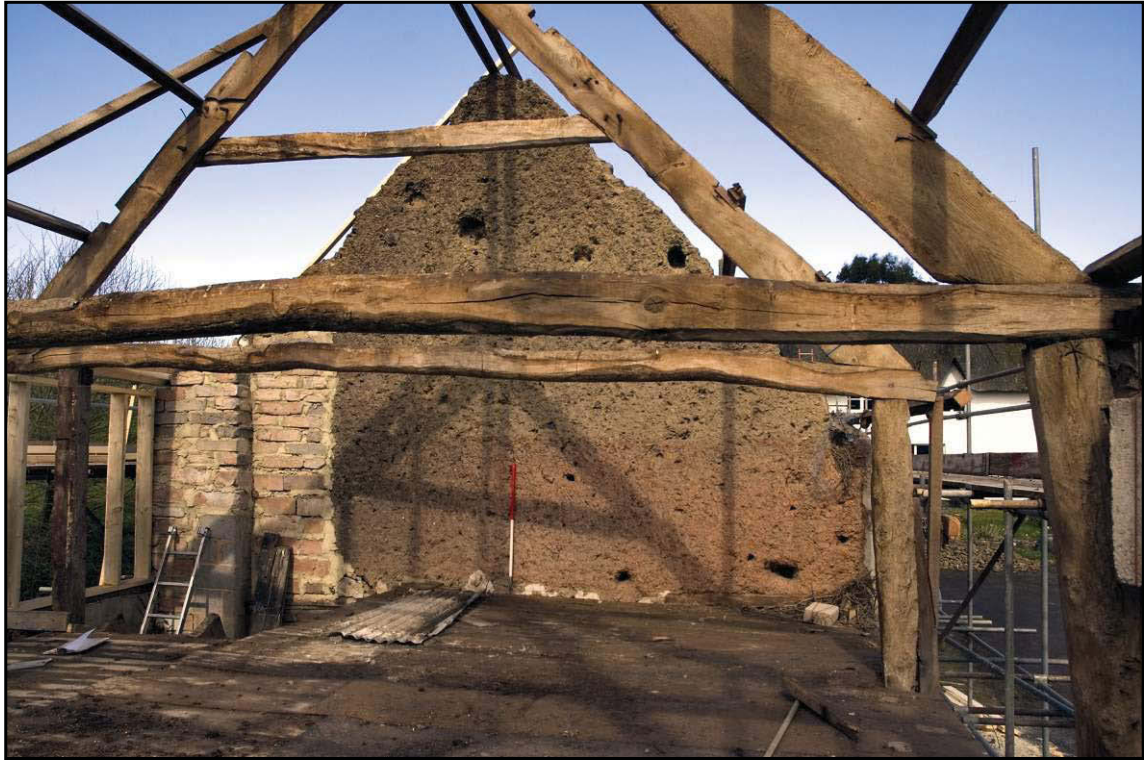
truss blades and in the south side of the other (Fig. 6). A collar spanning the truss in this way, fixed to alternate sides of the principals, is an unusual feature; this detail may suggest a mistake in the carpentry or, perhaps the reuse of the timbers.

Fig. 6 View of the upper floor of the linhay showing the roof construction and the cob wall with areas of modern patching between the linhay and the barn.

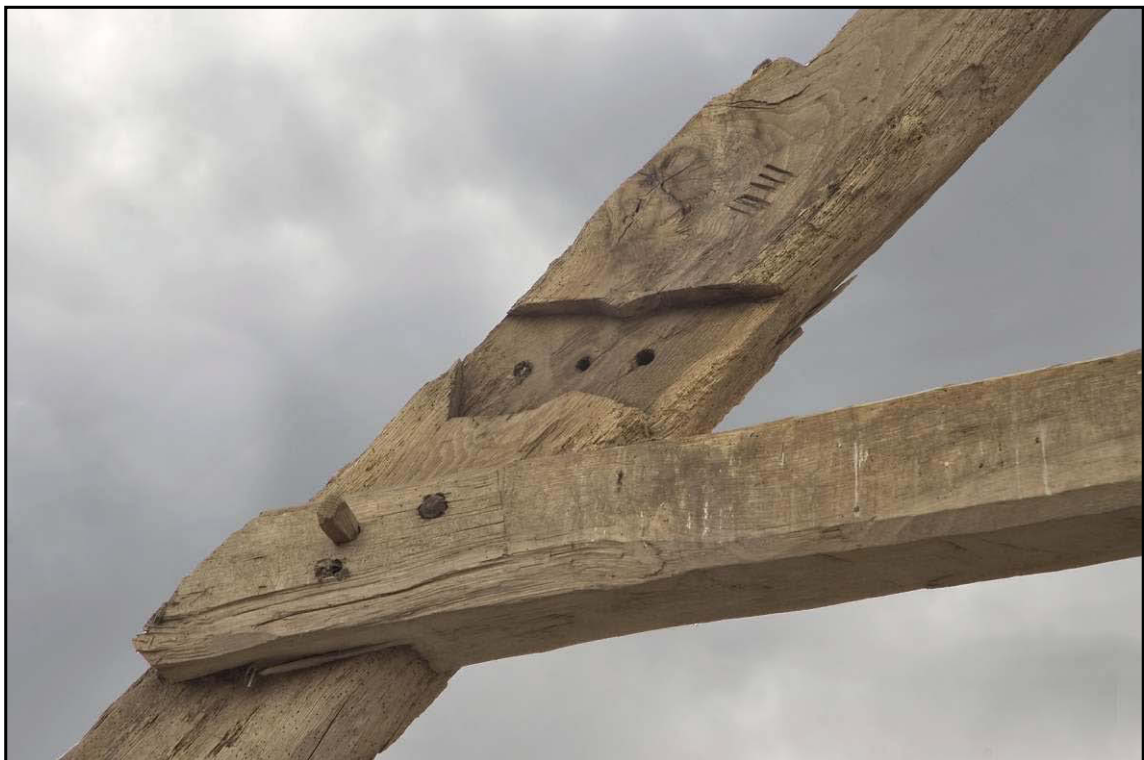
Fig. 7 Detail of one of the roof trusses showing carpenters' marks, redundant sockets for the collars and for trenched purlins and the fixings of the applied collars.

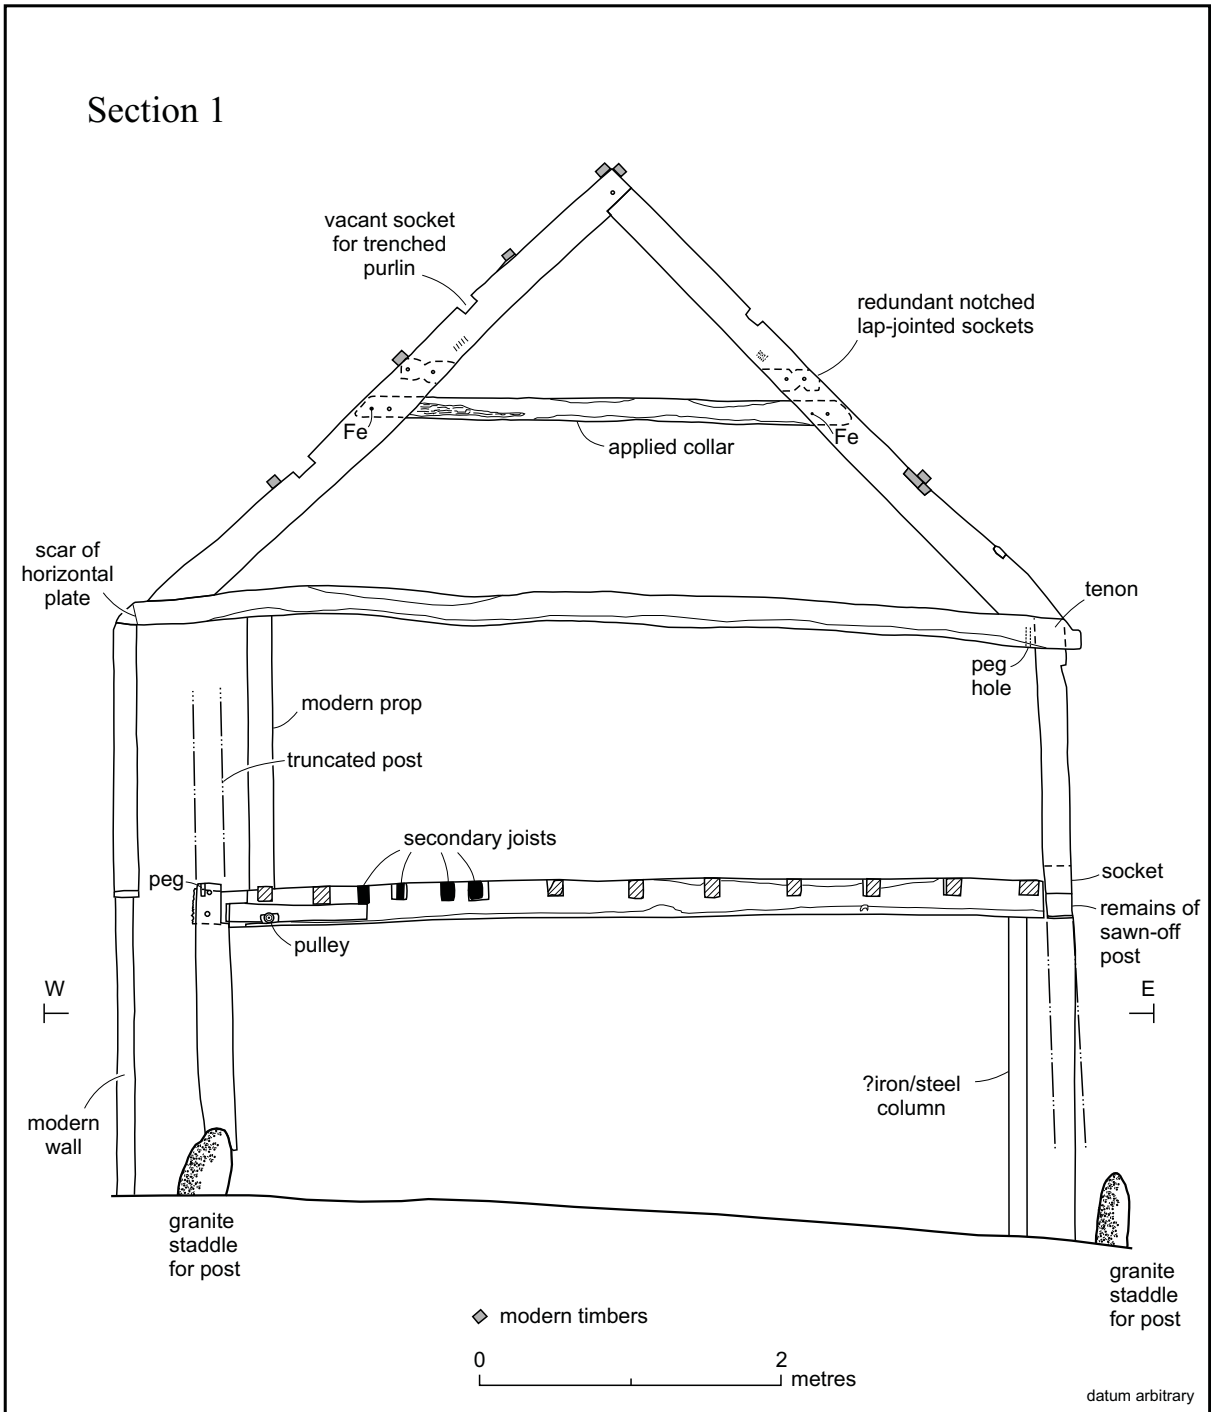
The roof is oddly misaligned with the stone staddles which must have been intended to support the building (Fig. 8). The eaves on both sides of the roof lie at least 0.5m to the west of the staddles. The supporting posts would thus have had to incline steeply, or bend westwards, in order to link the staddles and the eaves. The reason for this misalignment is uncertain. If the projection on the west side was deeper because it was intended to oversail a mass wall the timbers would surely have been seated in the masonry or cob in the conventional manner and there would not have been staddles and posts on this side. The posts on both sides of the building certainly suggest that the building had two open fronts to west and east. It is possible that the structure of the west wall varied slightly; it certainly had a bresummer or plate beneath the eaves, unlike the east side, and this might have been associated with insubstantial walling such as timber cladding or weather-boarding. The wall might even have been fitted with a screen of timber louvres to allow ventilation but protect the stored crop from the worst of the prevailing winds.

Alternatively the misalignment of the roof and the staddles may be accidental; a consequence of the structural failure of the building. It is possible that these two bays had begun to collapse westwards, drawing the roof with them. In order to prevent the collapse of the building the present west wall was built further west to support the collapsing roof, the original supporting posts were partially removed, the first-floor beams truncated and the first floor beams adjusted to meet a new, vertical, east wall. This might explain the misalignment of the roof and why the present eastern wall lies well within the apparent footprint of the original structure.

Fig. 8 Section of the southern part of the building showing a typical roof truss. Note the mis-alignment of the roof trusses and the staddles.

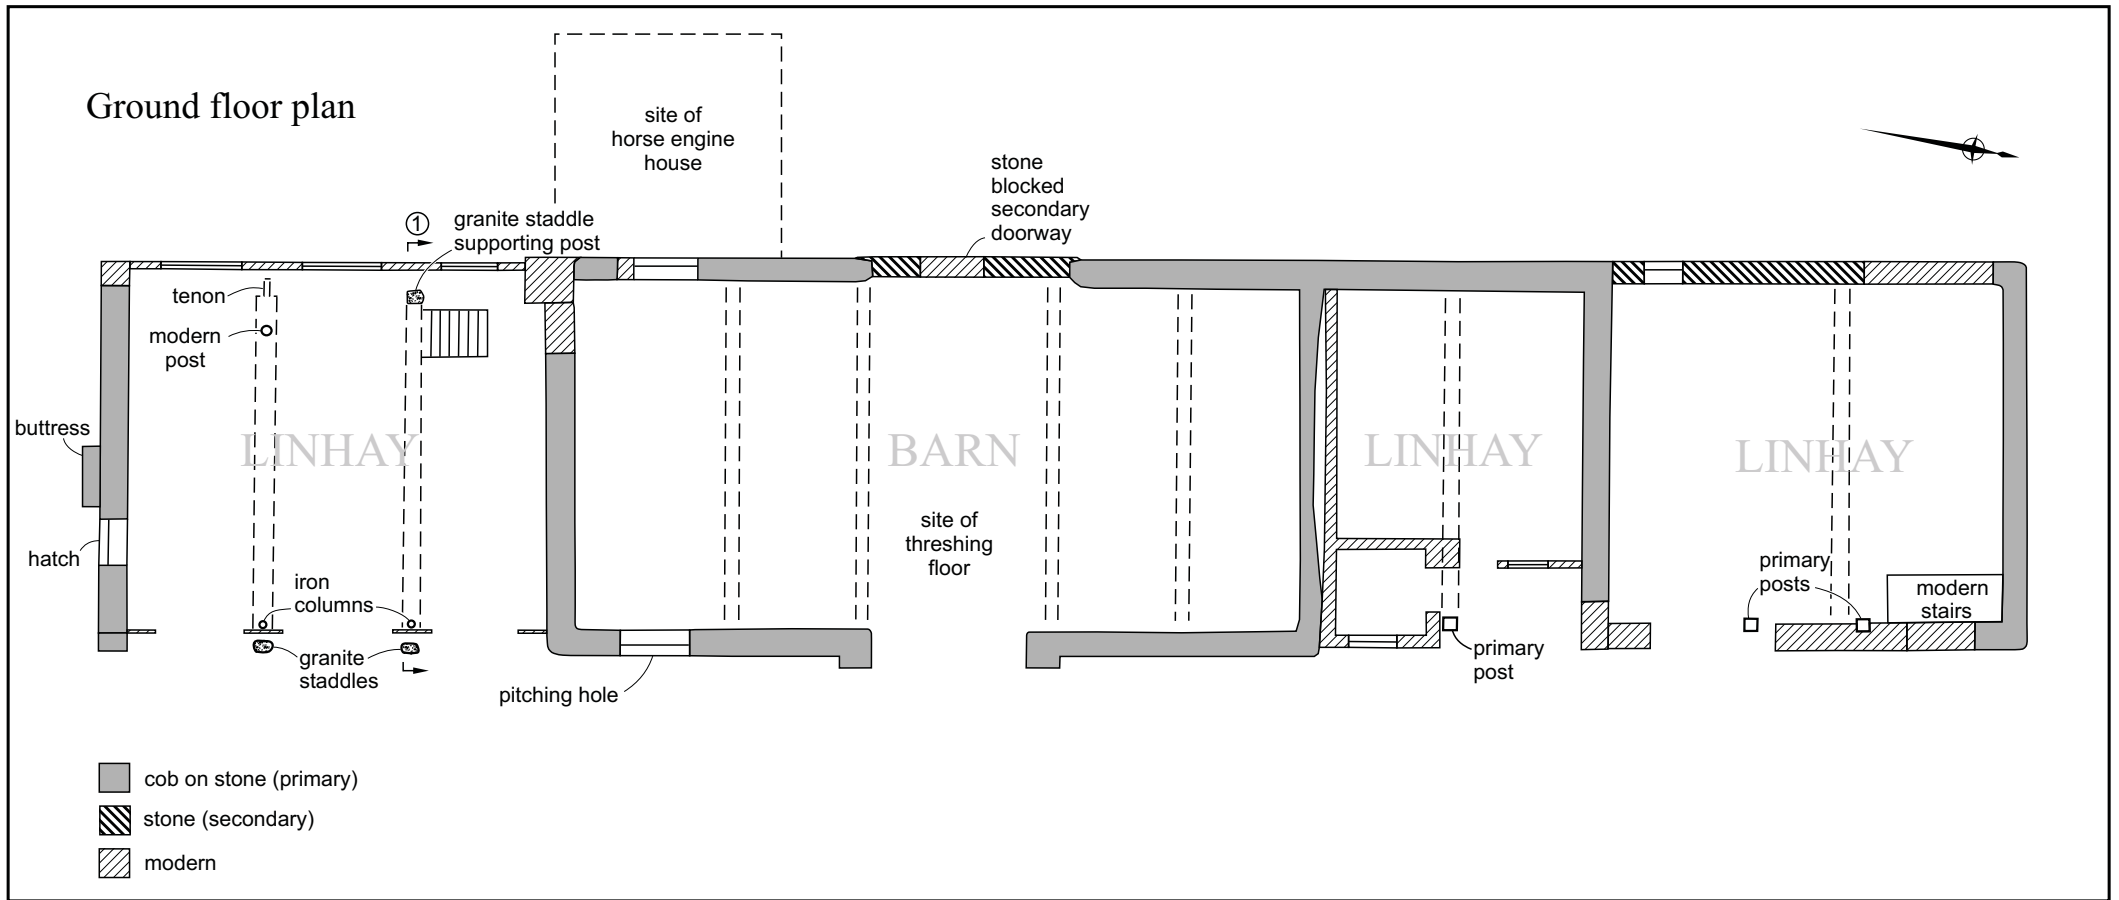
Fig. 9 Sketch plan of the building at ground floor level indicating the suggested phasing of the fabric. Scale approximately 1:125.

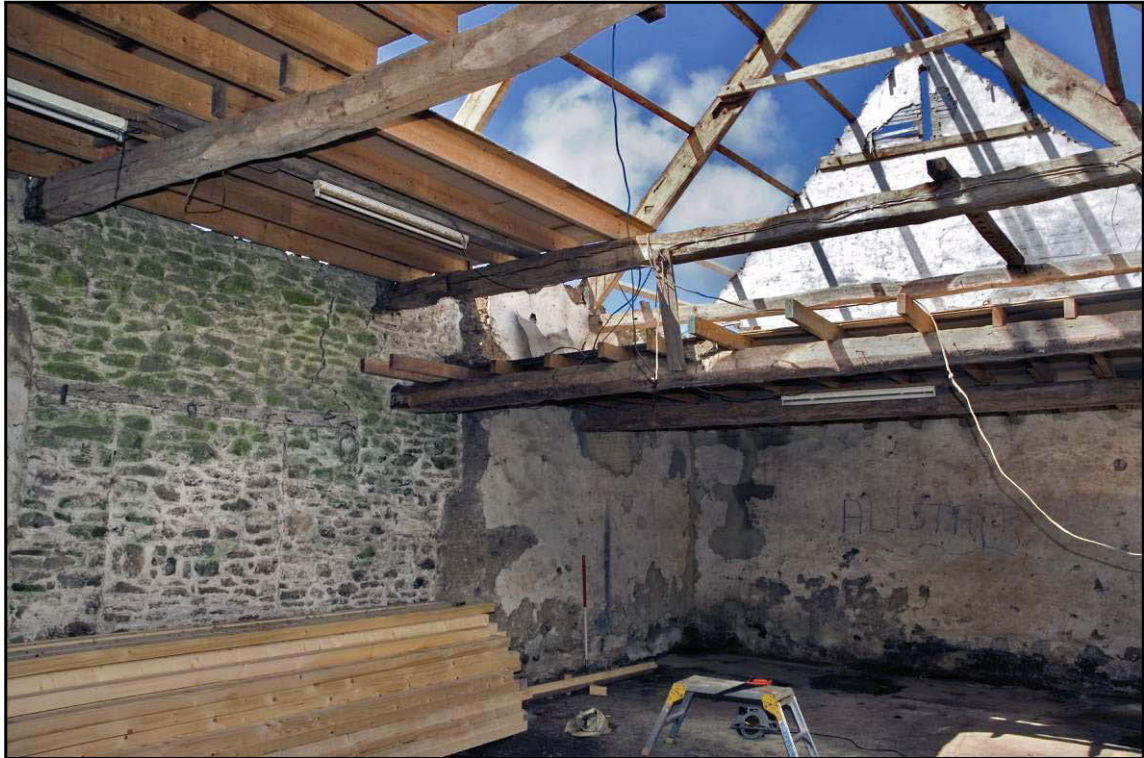
The interior of the barn was fully plastered to ensure cleanliness (Fig. 10). The space was not originally divided into storeys; although the interior is crossed by beams containing vacant sockets, these lie at an awkward level in relation to the tie beams, which suggests that the room was intended to be open to the roof. The lofts or mezzanine floors at either end seem to be later additions and the existing joists and flooring of these platforms are all modern.

Fig. 10. View of the interior of the barn showing the character of the roof, the plastered walls and the blocked openings and stone intrusions in the west wall.

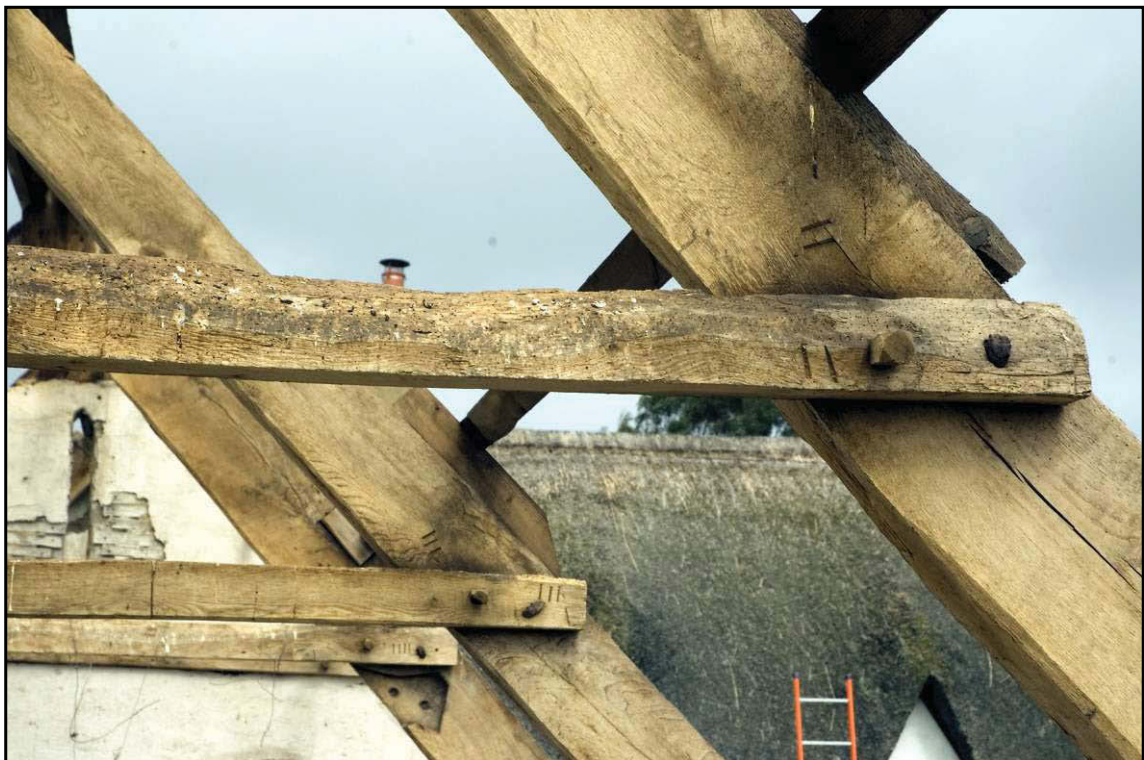
The adjoining truss to the north is marked 'II' on the south face on the eastern principal rafter, collar beam and apex (Fig. 11). This truss is also without sockets for earlier collar beams and the existing applied collar is presumably the original. To the north the next truss is marked 'III' in the same positions and also has a straight, applied collar. The northernmost truss over this section of the building is marked 'IIII' on both blades at the apex and on the collar and eastern principal. This truss has an applied yoke at the apex and also shows two vacant sockets for notched lap joints below the collar.

Fig. 11 Detail of the roof trusses over the barn, showing their markings and the details of their collars.

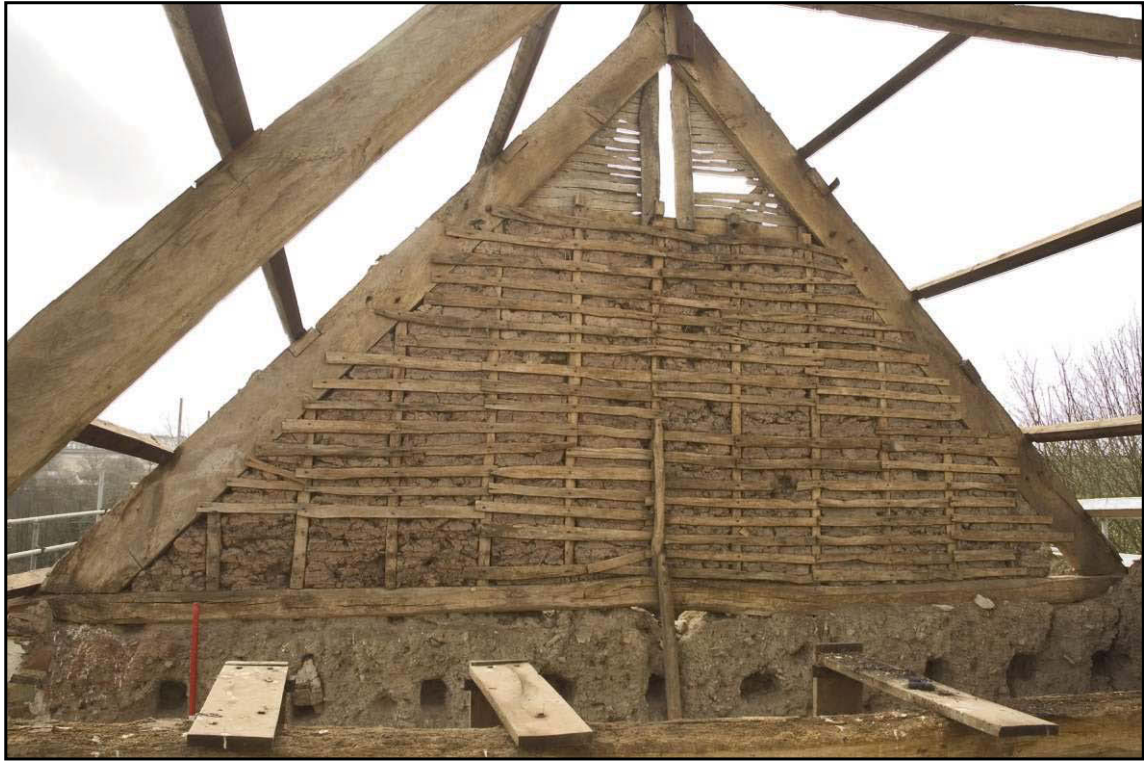
Fig. 12 View of the timber-framed partition at the north end of the barn showing the cob infill held in position by cleft laths and the ventilator at the apex.

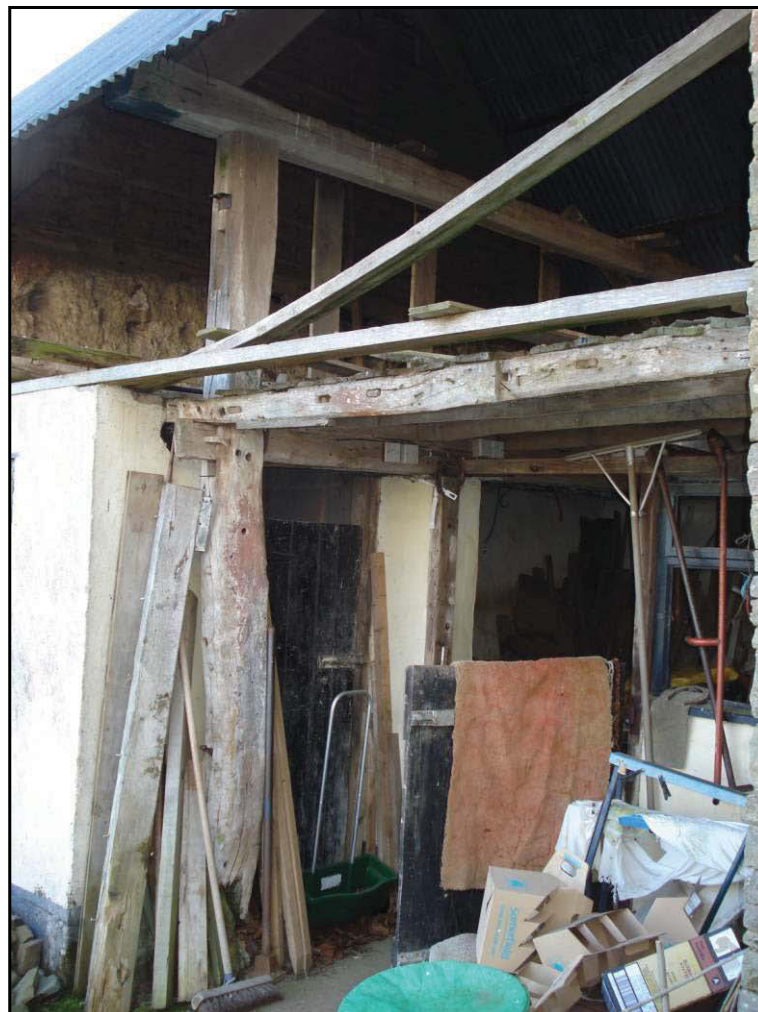
The original eastern front of this linhay is supported by a tall post, which survives *in situ* (Fig. 13). This post appears to be tenoned into the tie beam of the roof, like those in the southern part of the building, and rests on a stone staddle. The post receives the tenon at the end of the first-floor beam in a large open mortice in its western face. The tenon passes through the centre of the post to project beyond it for some distance and is secured externally with a large cleat. This does not seem to be the original fixing; two redundant peg holes are visible in the sides of the post to accommodate pegs securing the original joint. One of the first-floor joists rests on the tenon, extending the first floor beyond the post.

Fig. 13 Detail of the construction of the linhay to the north of the barn showing the post resting on a staddle, the projecting tenon at first-floor level and the mortice betraying the former high level of the floor.

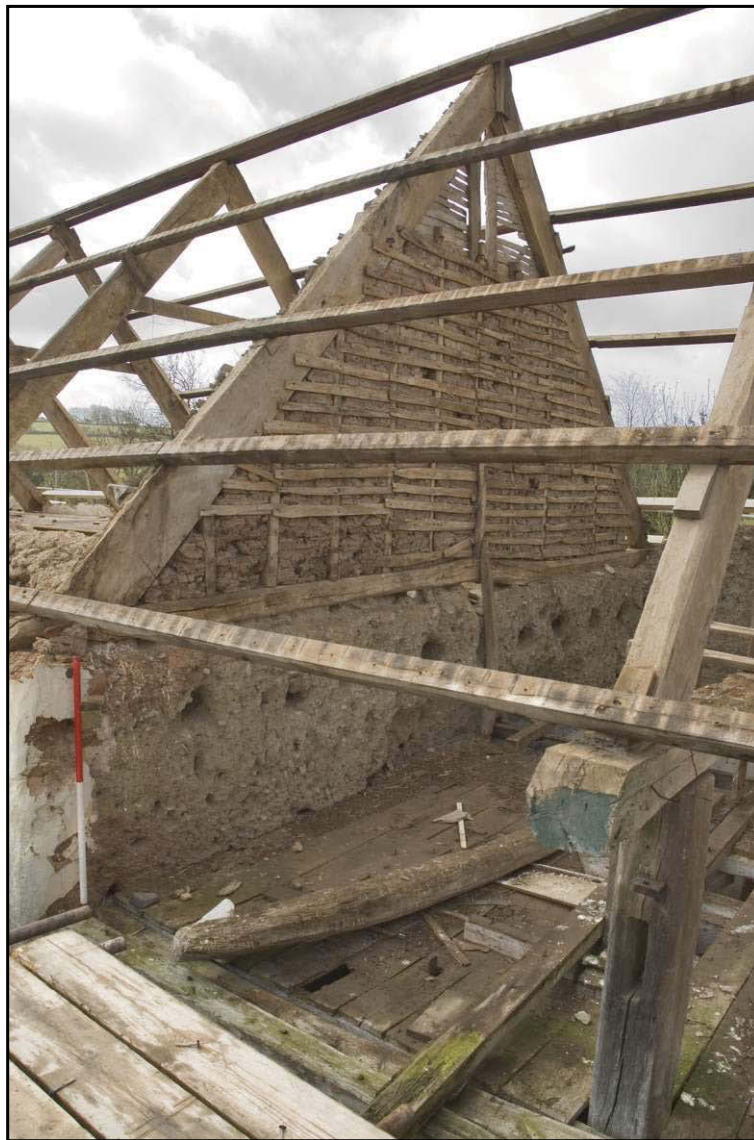
Fig. 14 View at first-floor level showing the sockets for the raised floor level in the linhay north of the barn and its relation to the roof structure.

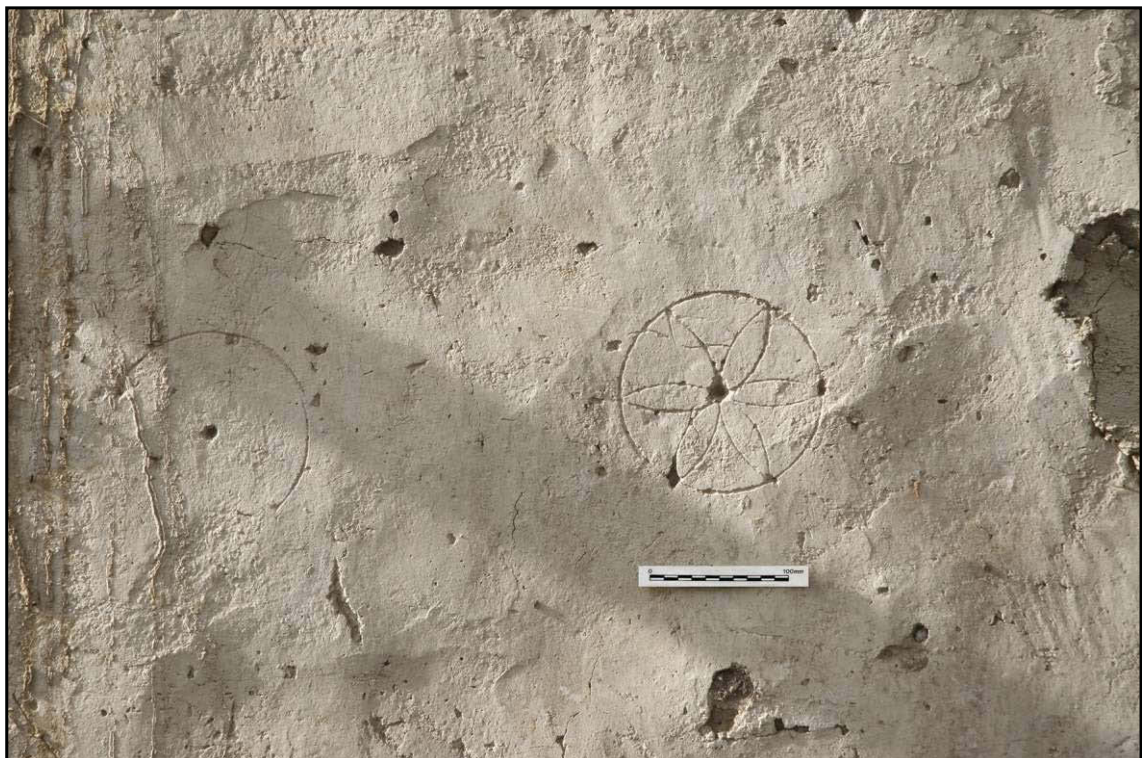
Fig. 15 Detail of some of the 'daisy wheels' or 'witch mark's in the plaster of the upper floor.

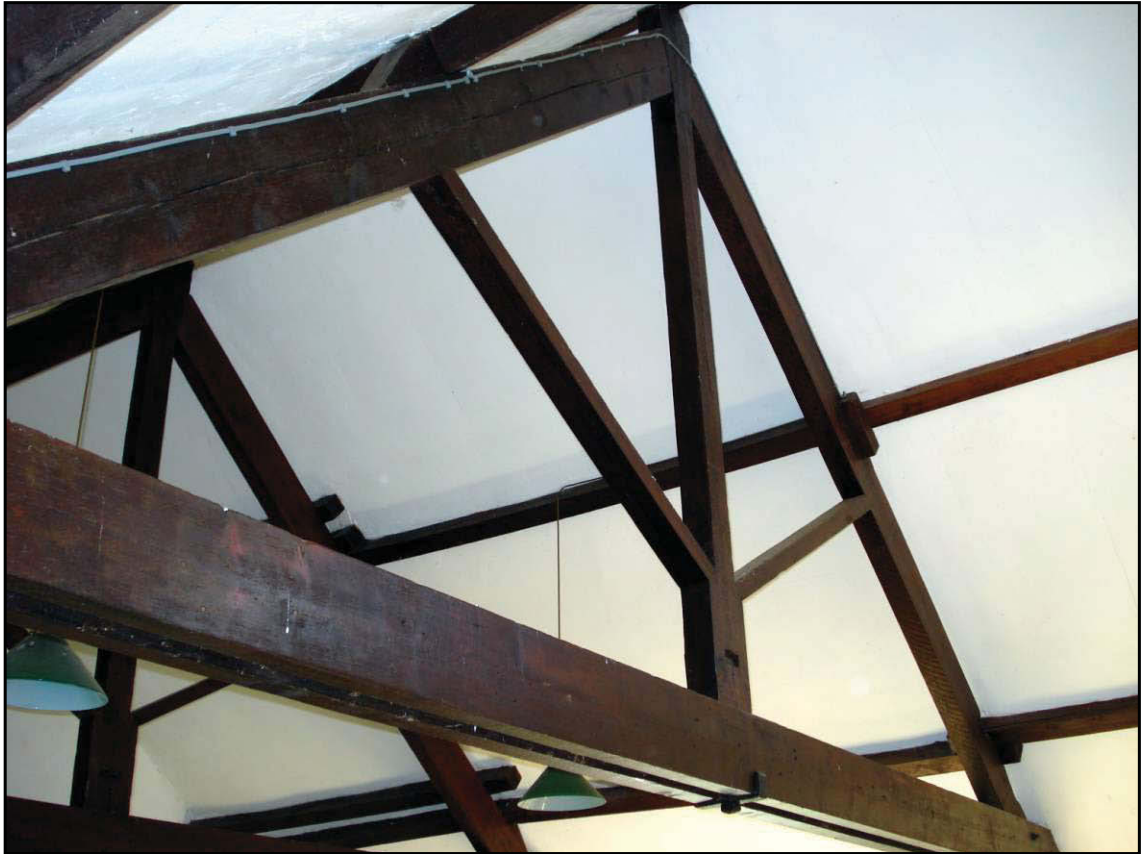
Inside this part of the building the floors have been renewed. The first floor now extends for two bays and incorporates an original floor beam; however, it is probable that there were originally three bays and that the floor beam is reused in this position. The walls are plastered and no early fixtures now remain. The first-floor has also been extensively altered; the roof is a modern replacement supported by king-post trusses on raised eaves and it is likely that the whole roof has been renewed (Fig. 16).

Fig. 16 Detail of the replacement roof trusses over the northern end of the building.
