**ARCHAEOLOGICAL RECORDING
AT CHERRYCOMBE,
LUTON, NEAR IDEFORD, DEVON**

Project No. 6423

Report No. 10.31

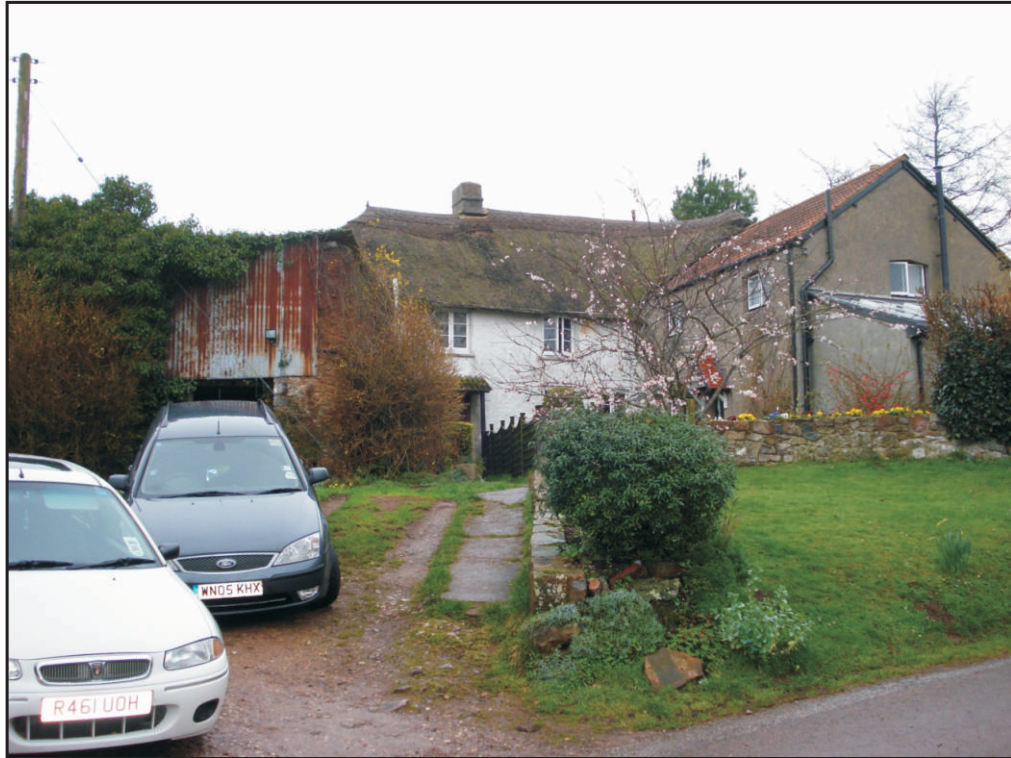
window where parts of an early rubble stone wall survives, cut by the modern doorway (Fig. 2, left)

Fig. 2 General view of the buildings, showing the barn (left) main house (centre) and north wing (right).

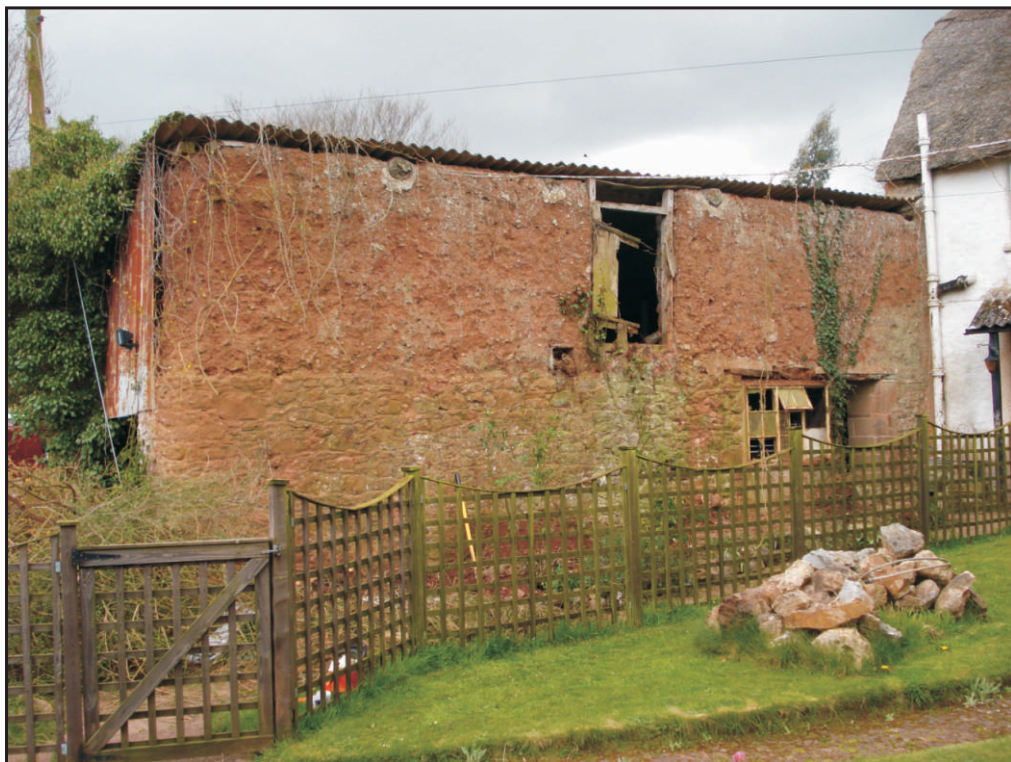
The north elevation of the barn looks onto a small courtyard garden between the buildings, and may possibly have been its principal elevation. The lower part of the wall is mostly of limestone rubble, rising to approximately the height of the first floor and without any signs of redundant openings, whether doorways or windows. At the western end of this wall is a single opening combining both a window and a doorway. The western jamb of the doorway has been partly rebuilt in concrete blocks and a metal 'Crittall' window has been inserted alongside. This may conceivably replace an earlier window opening.

The upper part of the elevation is of richly-coloured red cob and also contains no signs of blocked openings suggesting first-floor windows. At the centre of this part of the elevation is a large first-floor door which must have served as a loading door (Fig. 4). The doorway and frame are in the final stages of decay but appear to date from no earlier than the 19th century, with an insubstantial lintel and door posts and long, narrow unadorned strap hinges supporting a plank door. An unusual feature survives below the door. This appears to be a beam socket containing the end of a large squared beam, but its sides are, most unusually, lined with oak boards, while the base of the socket is formed by a further squared timber. The reason for this reinforcement of the socket is unclear. It is perhaps possible that the socket supported a cantilevering feature, either internally or externally, which needed extra reinforcement to prevent its pulling out of the cob wall. This feature might perhaps have been a projecting external structure such as a loading platform; however, against this conjecture is the absence of a corresponding socket on the other side of the opening which seems to preclude such a platform. An internal structure is also possible. It has not been possible to resolve this uncertainty.

Fig. 3 General view of the north elevation of the barn.

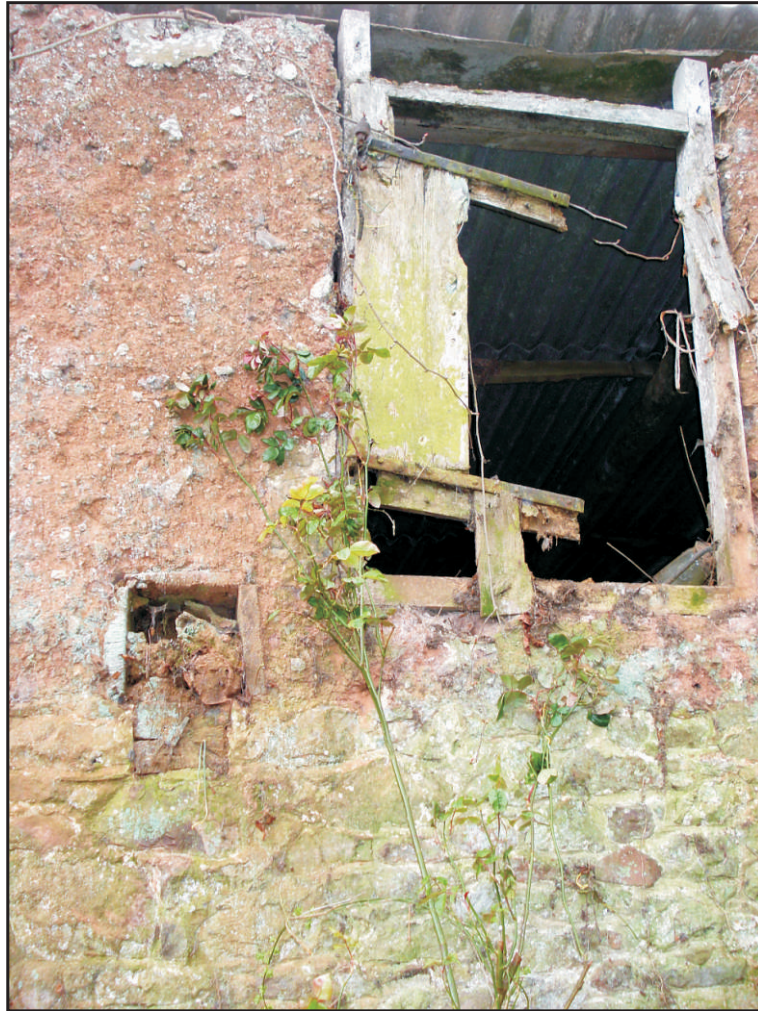
Fig.4 Detail of the first-floor loading door in the north elevation showing the reinforced socket below the doorway.

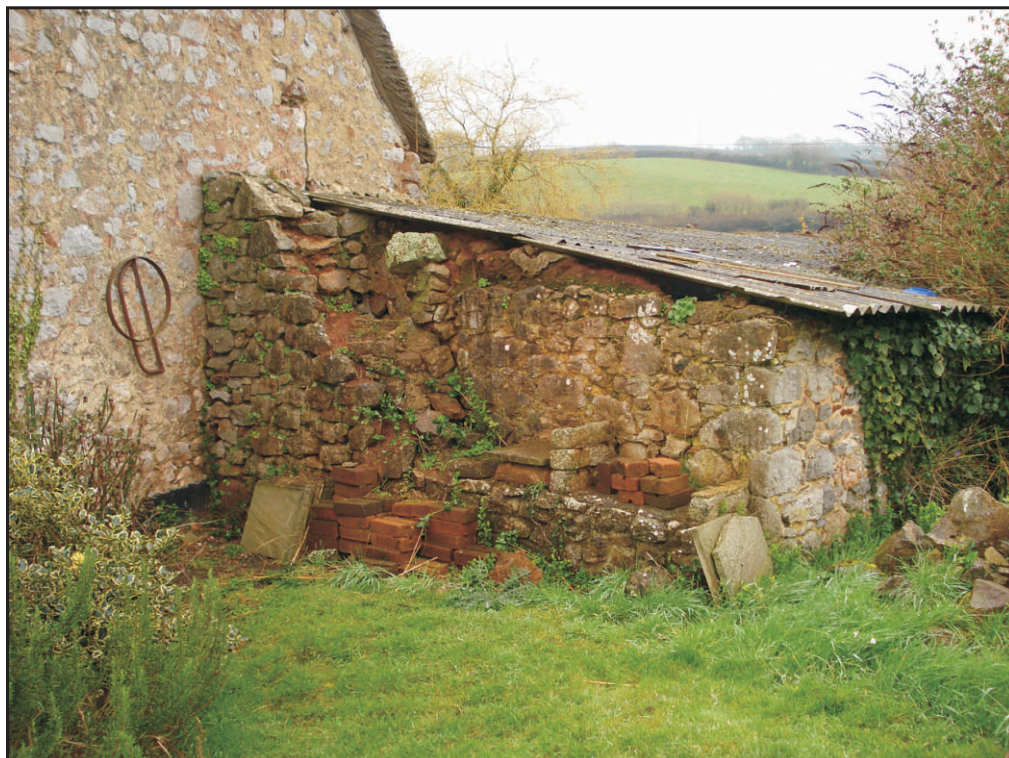
This is the best preserved and most easily identified part of the original building, though the greater part of the wall is deeply buried by the rising ground. From the exterior the early masonry can clearly be distinguished from the later fabric by the greater width of the early walling. This survives as a roughly triangular area of masonry with much-eroded clay bonding rising steeply to the north to butt against the southern gable wall of the adjacent cottage. The wall has been partially demolished, exposing the shafts of two chimney flues. The present roof of the building is supported by a narrower wall built over the early masonry and aligned with its inner face rather than the full width of the chimney, so that the shafts of the former chimneys are now simply open to the sky. Above the existing roofline of the barn, in the end gable of the house, part of the jamb and lintel of a doorway may be seen (Fig. 6). This doorway must formerly have linked the first floors of the house and barn, and this clearly shows that the barn must have been a full storey higher than at present. The original roof and upper storey have been removed, either at the 19th-century rebuilding of the barn or during 20th-century alterations when the present roof was constructed.

Fig.5 External view of the west wall showing the remains of the original building overlaid by 19th-century masonry relating to the rebuilding of the structure for agricultural use.

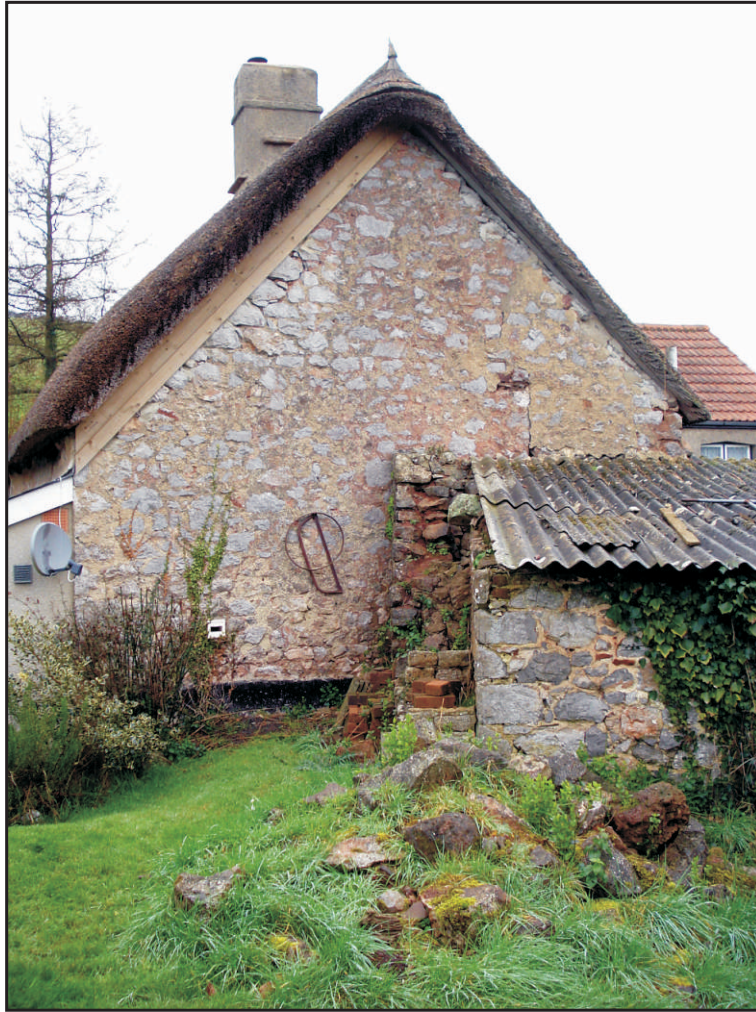
In the north wall of the room, immediately adjoining the two fireplaces and at both levels, are blocked doorways on both floors which communicated with the adjoining cottage (Figs 6, 7; bottom right). These doorways are mostly concealed by a large modern oil tank and are completely blocked in stone. No detail of their door-frames is visible and they are therefore difficult to date. Their proximity to the fireplaces is also unusual; however, given the configuration of the two ranges, it would be impossible to place the doorways in any other position. The upper doorway was a tall opening whose timber lintel can still be traced in the wall above the roofline.

Fig. 6 View of the gable end of the cottage showing the remains of the communicating doorway in the upper parts of the gable.

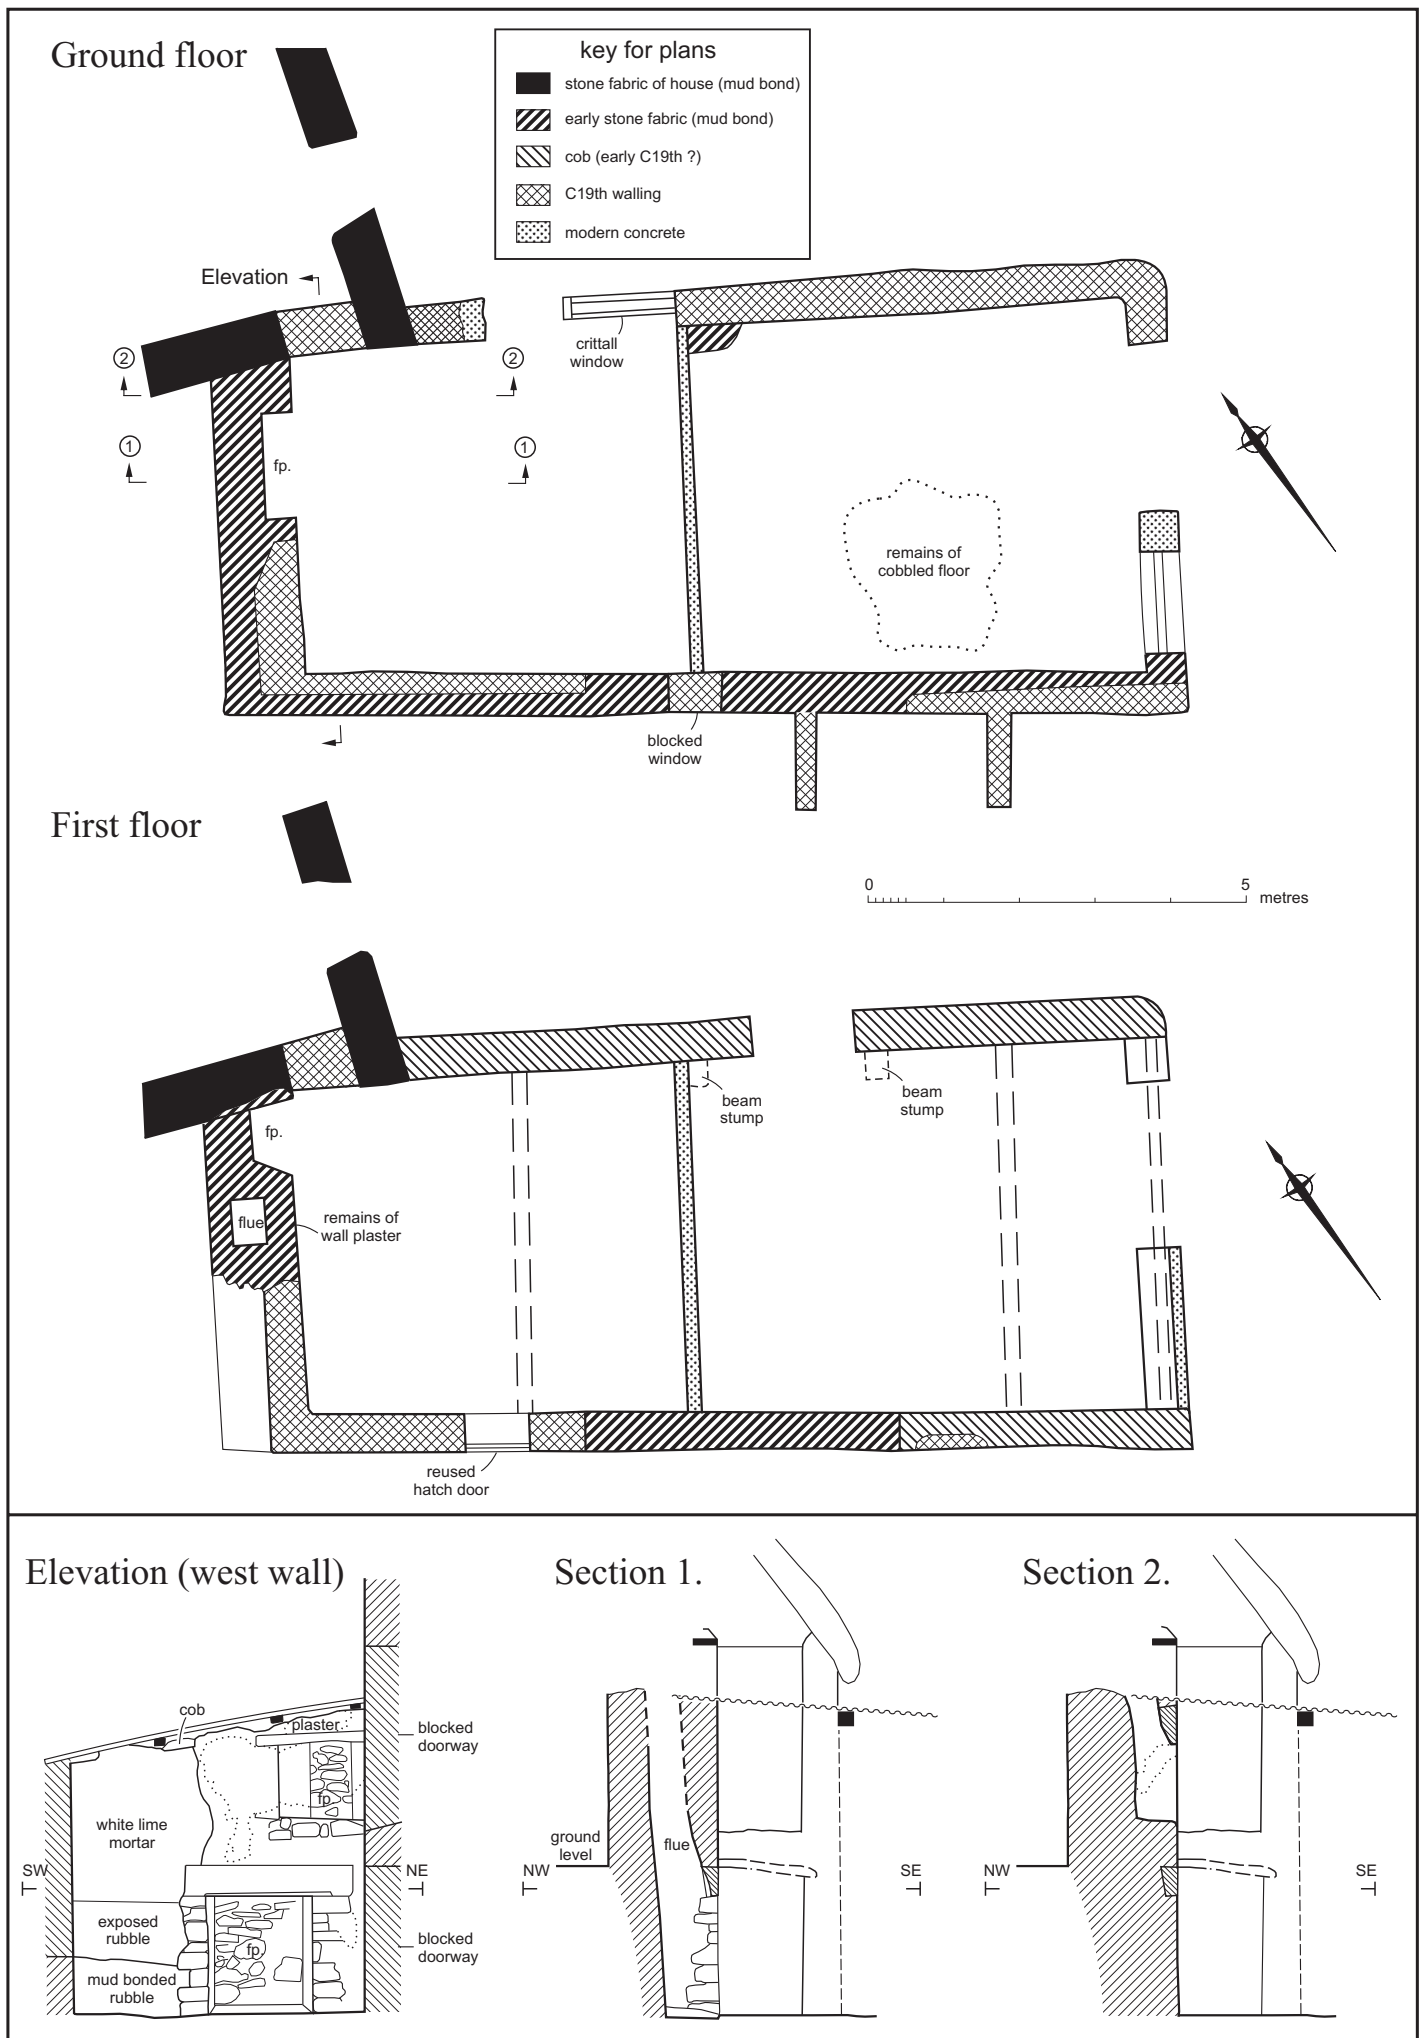
The interior of the west wall is the area of greatest interest since this preserves two fireplaces relating to the earlier structure. The ground-floor fireplace has un-moulded jambs of stone rubble and a massive, chamfered timber lintel. The chamfer on the lintel is wider than the opening, which suggests that the fireplace has been narrowed by rebuilding the northern jamb to the south of its original position. No breaks in build are visible to show the limit of this rebuilding and an alternative possibility is that the lintel has been reused or that it was simply too large to begin with. The lintel has straight-cut stops respecting the original width of the opening and is scored for plastering. The hearth has been truncated and it is evident that floor levels within the building were lowered to their present level during the 20th-century alterations by the removal of earlier surfaces.

Above the fireplace, at first-floor level is a further small fireplace with plastered reveals and an un-moulded timber lintel. The plastering survives both within the fireplace opening and on the wall face surrounding it. Neither fireplace is easy to date stylistically; fireplaces of this type were common from the 16th to the 18th centuries. Both fireplaces are domestic rather than industrial in character.

A break running down the centre of the wall just beyond the southern jamb of the lower fireplace clearly shows that the southern part of this wall has been rebuilt or refaced. The original mud-bonded walling is visible at the base of the wall. Above this masonry is bonded with white lime mortar and a building lift or break in the work can clearly be distinguished. This secondary masonry is clearly separate from the fabric of the chimney breast alongside and must relate to a phase of rebuilding. It rises as high as the roofline where the remains of cob walling which once rose still higher above this, are visible just below the modern corrugated-asbestos roof. This suggests that the rebuilding of the walling pre-dates the present roof; the truncation of the building to its present height was presumably a 20th-century development.

Fig. 7 Phased plans of the building, at ground and first-floor level, showing the probable date of the fabric. Elevation and sections through the fireplaces.

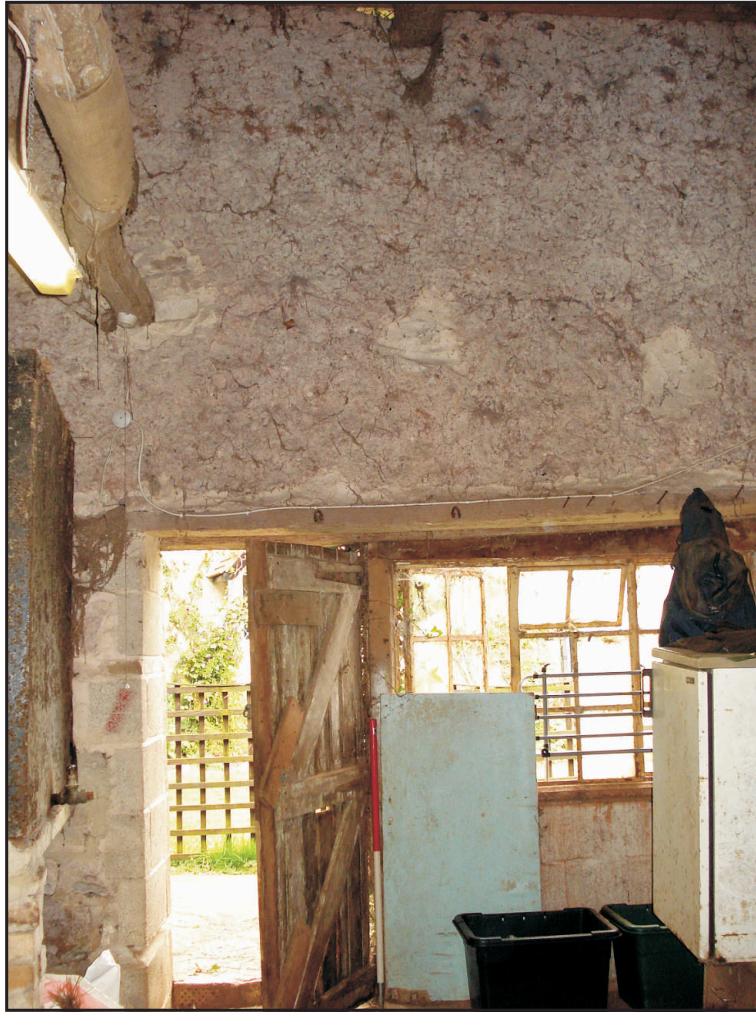
Towards the eastern end of the barn two projecting beam ends survive in the north wall. These have been sawn off flush with the wall, but show as the stumps of two very substantial timbers without stops. One of these beam ends corresponds with the reinforced joist socket which has already been noticed externally. The absence of stops may show that these timbers were perhaps reused in this context when the north wall was rebuilt in its present form. The levels of these beam ends in relation to the sockets in the western parts of the building were substantially lower, suggesting that the rebuilt building was divided into two areas, on different levels. The footings of a projecting structure of mud-bonded masonry at the centre of the building may represent part of a dividing wall between these areas, but this does not survive; the interior is currently divided by a modern timber partition.

Fig. 8 Internal view of part of the north wall showing the sockets for vanished beams.

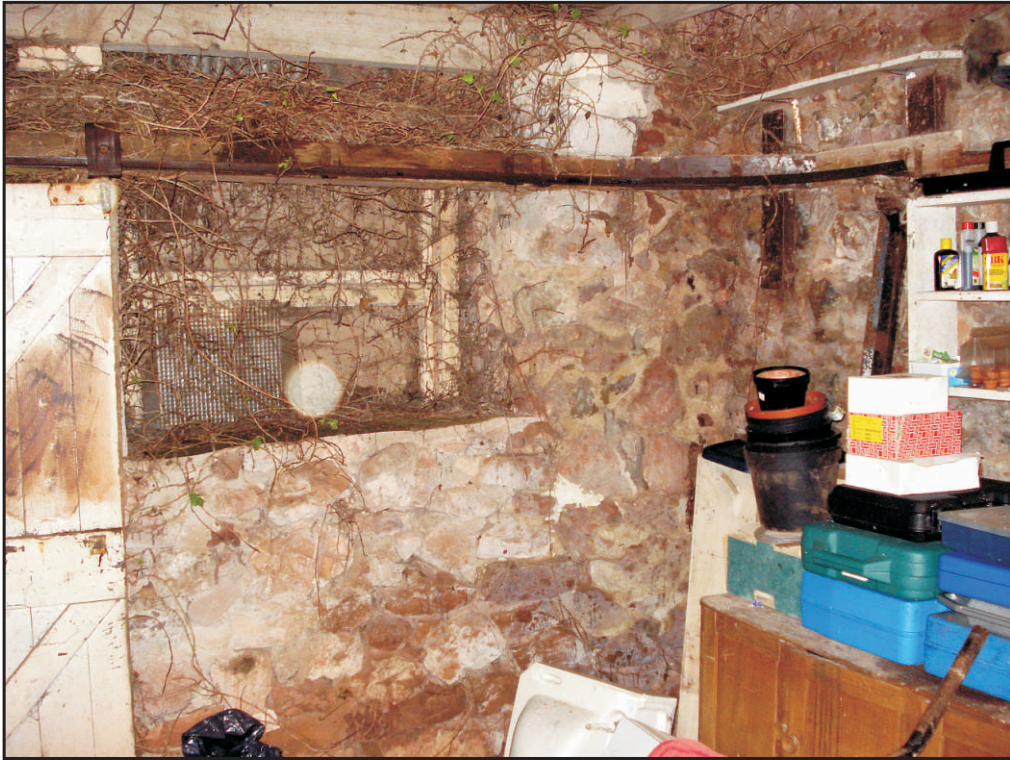
As previously noted the east wall of the building had been completely reconstructed in the 20th century with the exception of a small area under the window alongside the main entrance doors. This was of mud-bonded rubble and may have been primary fabric (fig. 9). At first-floor level the entire frontage of the building had been replaced with timber framing, clad with corrugated iron. None of these timbers showed any sign of reuse and it is probable that this part of the structure dates from the modern rebuilding when the present roof was constructed.

Fig. 9 Detail of the interior of the east wall showing the possible early fabric below the window.

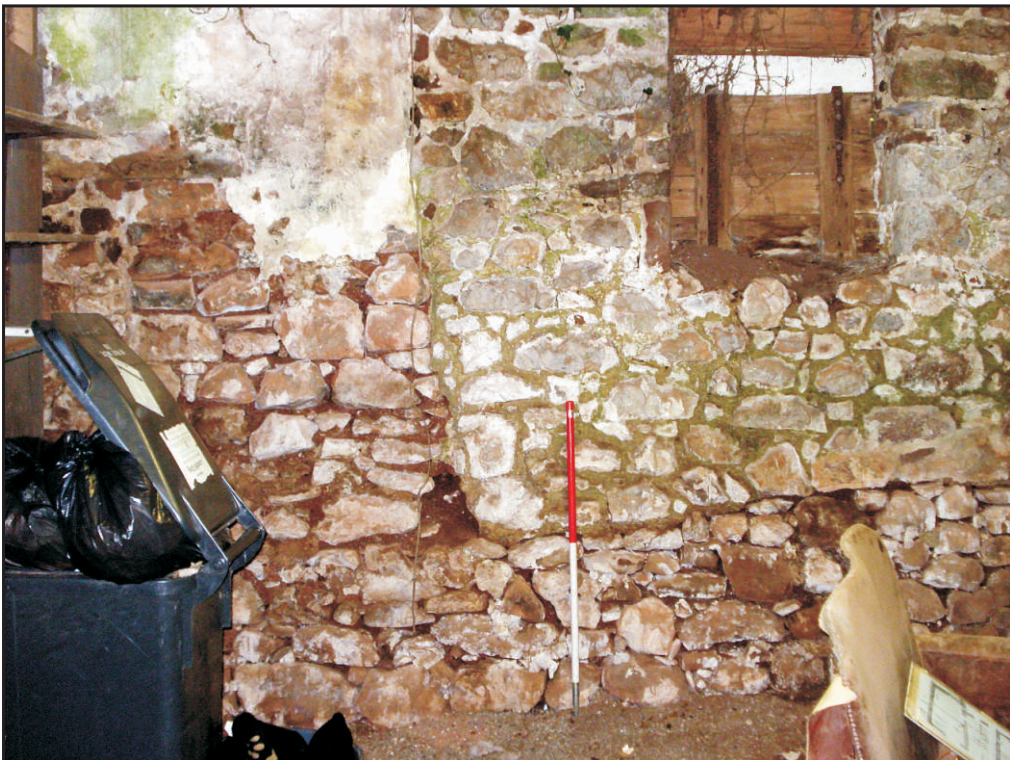
This wall was of great interest because the phases of its construction were exceptionally clear (Fig. 10). The lower part of the wall could be seen to be constructed from mud-bonded rubble representing the footings of the original structure. Within the western room, close to the dividing partition, this mud-bonded masonry rose higher, almost to roof level, and retained evidence of wall plaster similar to that above the fireplaces in the western wall. This must represent a further upstanding part of the original building, perhaps preserved on account of the pigsties abutting it to the south. A blocked opening with a timber lintel is just visible, bisected by the modern partition dividing the building. This may represent an original window opening.

Cutting through the primary masonry to the west of the window and clearly distinguishable from it by the colour of the mortar is a large area of secondary masonry bonded with white lime mortar. This is presumably 19th-century fabric added after the building was rebuilt for agricultural use. A window in the upper part of this wall was partially blocked with timber boarding, perhaps part of a shutter or doorway originally hung within one of the openings. The shutter retained an ill-matched pair of strap hinges which appeared to be of 19th-century date.

Fig. 10 Internal view of the south wall showing building breaks and features in the western part of the structure.
