**BUILDING RECORDING  
AT 9A CATHEDRAL CLOSE,  
EXETER, IN MAY 2010**

**Exeter Archaeology Report No. 10.27**

**May 2010**

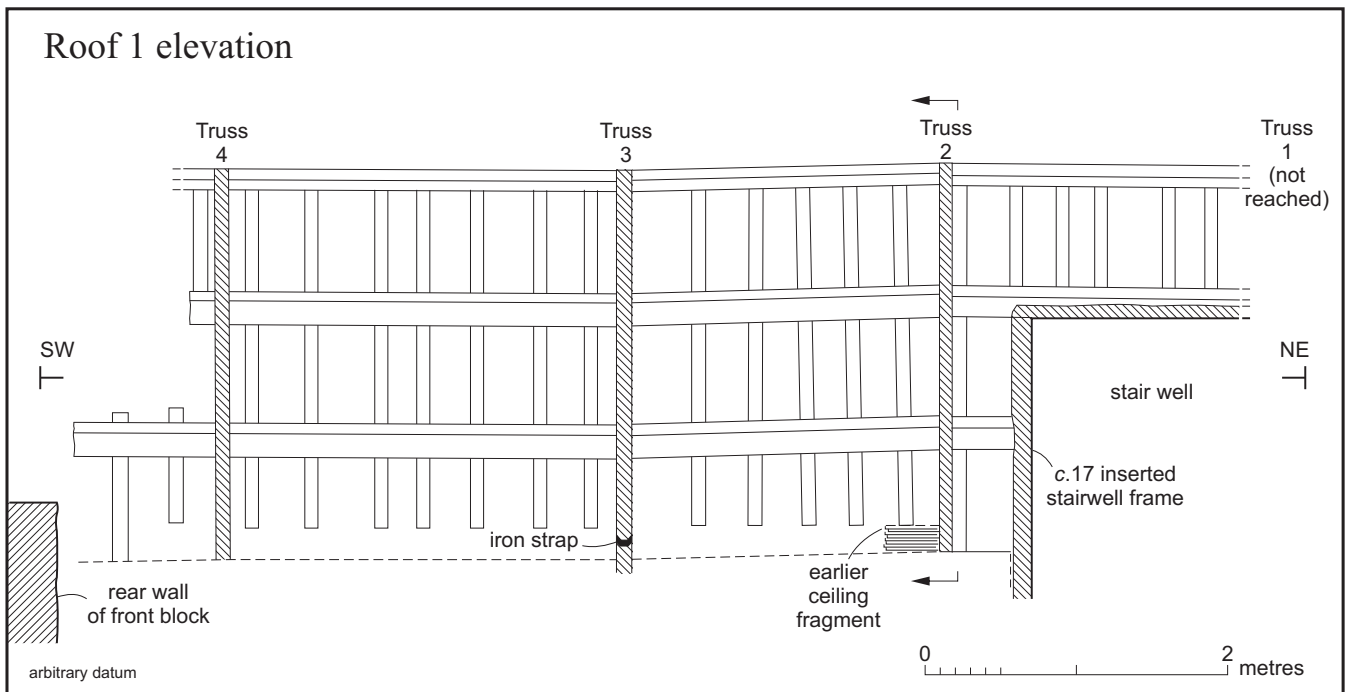
On the SW side of Truss 2 a small area of lath-and-plaster is preserved in the roofspace above present ceiling level (Fig. 2b, 'earlier ceiling fragment'). This shows that before the present ceilings were inserted, probably *c.* 1700, an earlier ceiling had been installed about 0.3m above the present one. Corresponding evidence is not visible elsewhere in the roof but this appears to show that there was an upper-floor room here before *c.* 1700. The feet of the adjacent common rafters had been cut away precisely at the height of this ceiling (Fig. 2b); this was perhaps a crude way of removing it before installing a new ceiling.

Fig. 2b Measured elevation of SW slope of Roof 1 (minor flaws and distortions of timbers not shown).

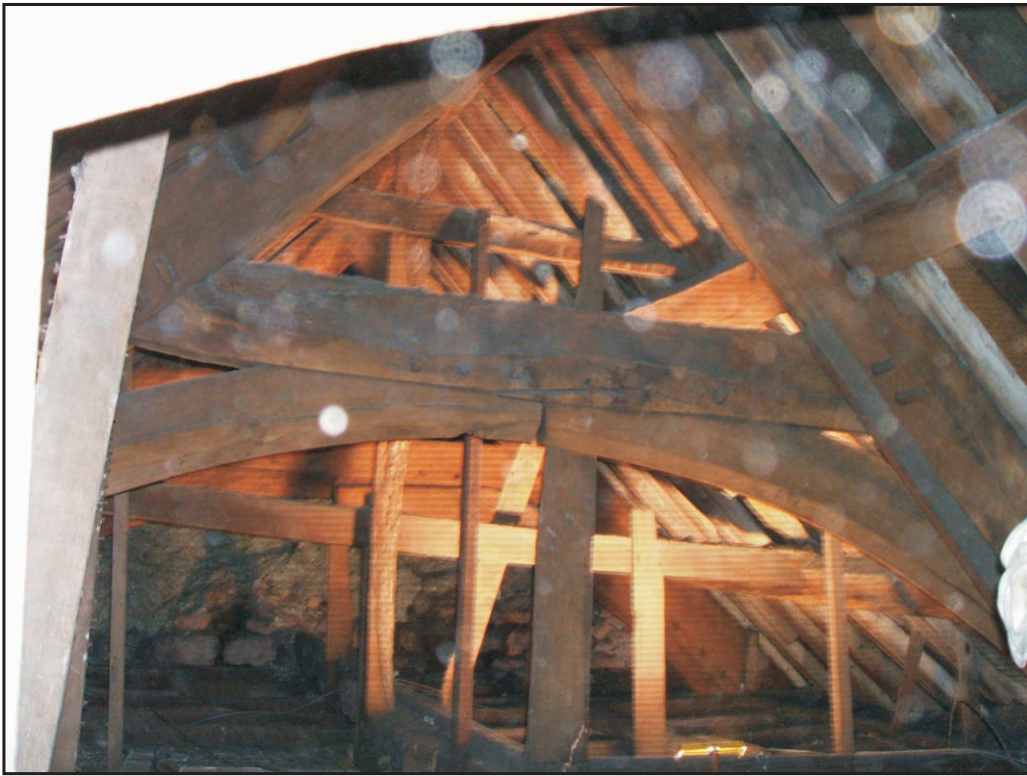
Fig. 3a Roof 1 looking SW, with Truss 3 in the foreground and the wall-top of the front range visible below insulating material in the background.

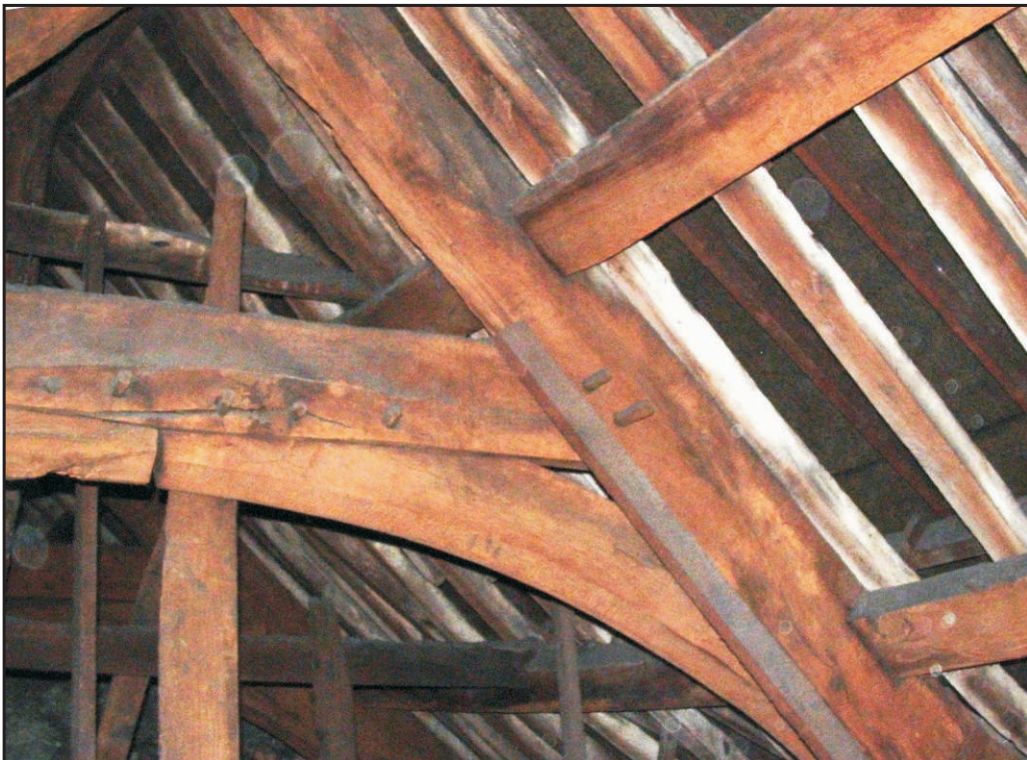
Fig. 3b Roof 1, Truss 3 from the NE, showing upper and middle purlins and arch bracing.

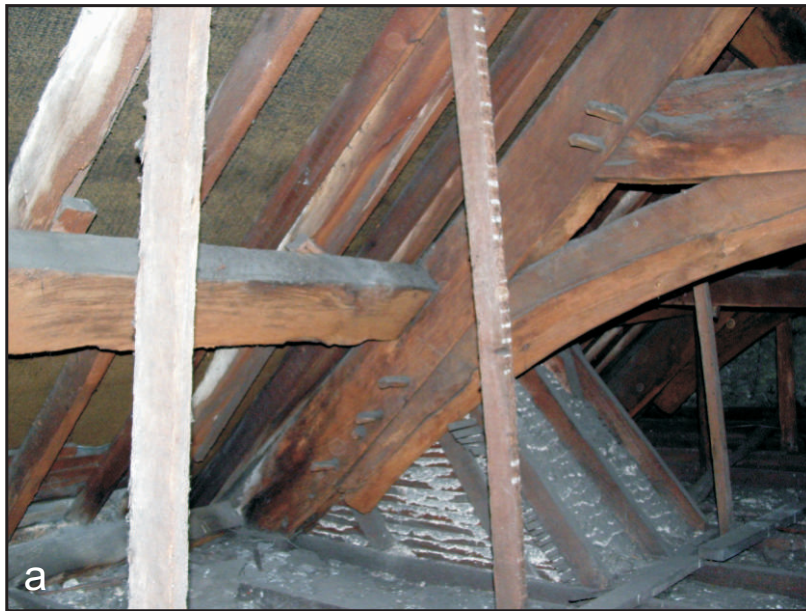
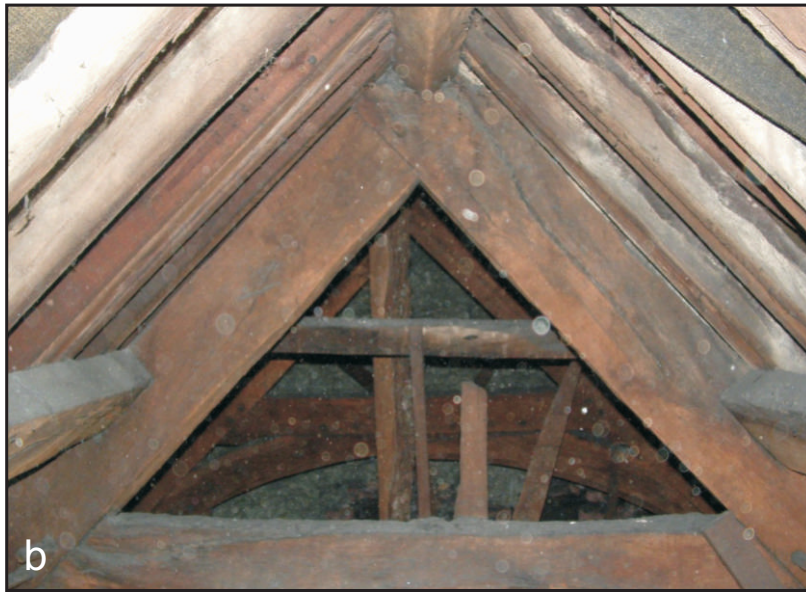
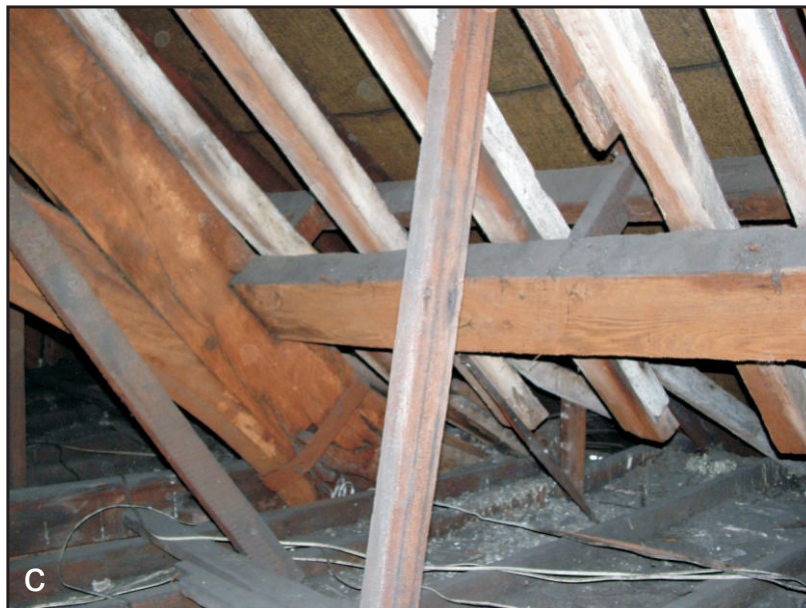
To create sufficient headroom in the new first-floor room below Roof 1, the lower sections of the arch bracing, which would have projected from the wall below, were taken down. This evidently created a serious problem on the courtyard side of Truss 3, which cracked and came close to breaking

before being supported with an iron strap (Fig. 5). A new series of purlins and common rafters (not shown) was laid over the medieval roof slope towards the courtyard.

Fig. 5a-c Roof 1, Truss 3 from the NE and NW, the latter showing later strapping of the principal.

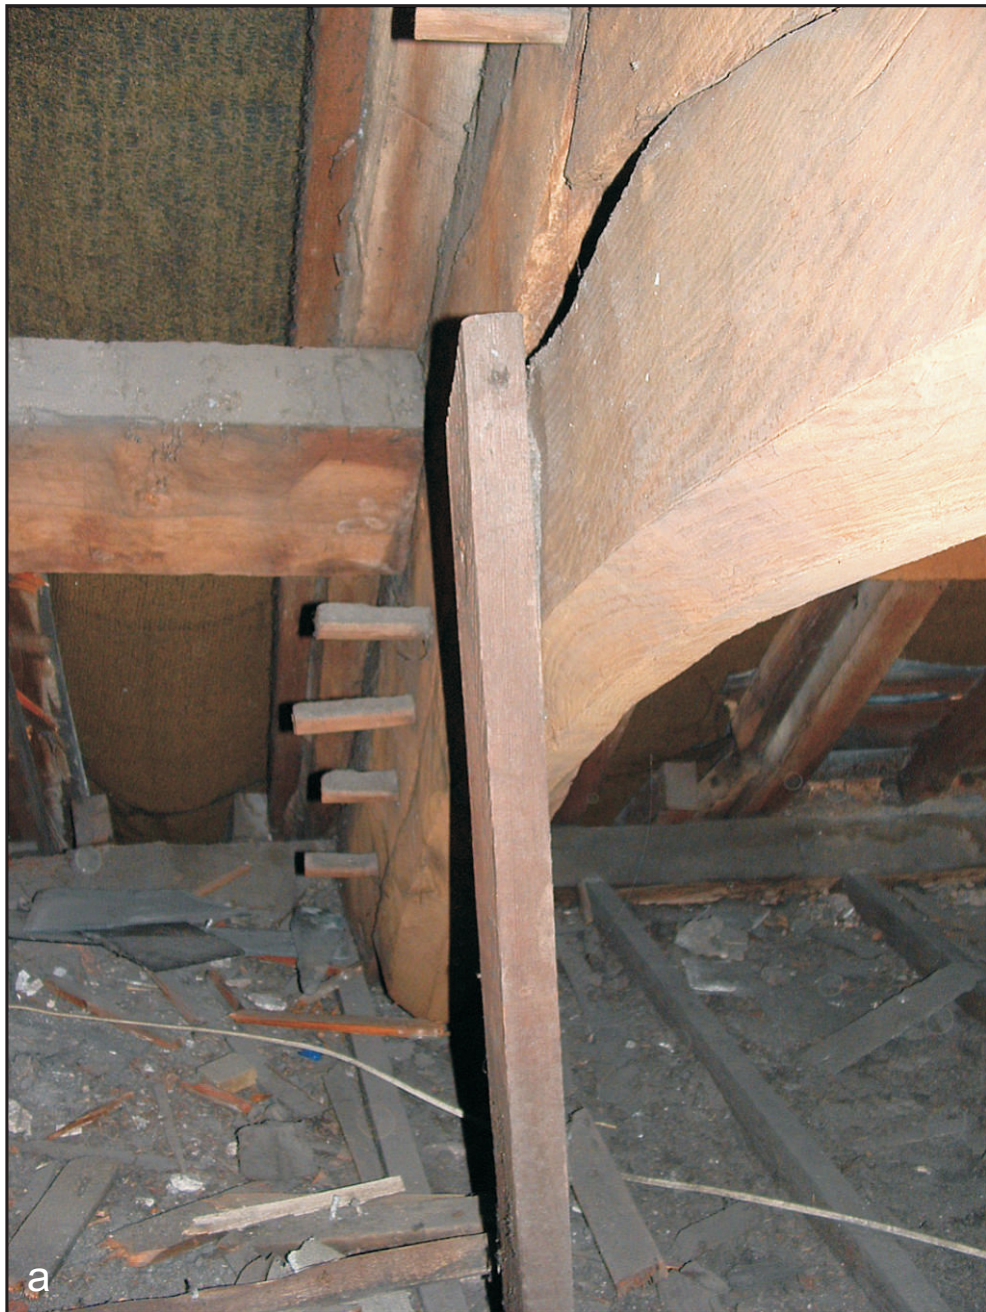
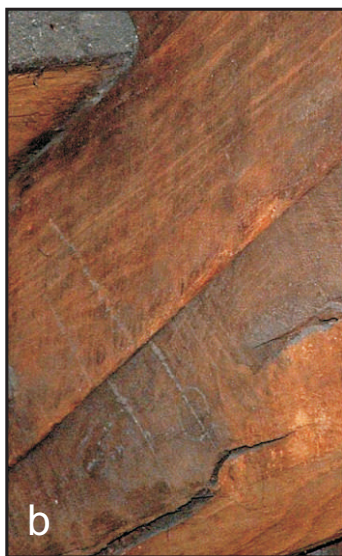
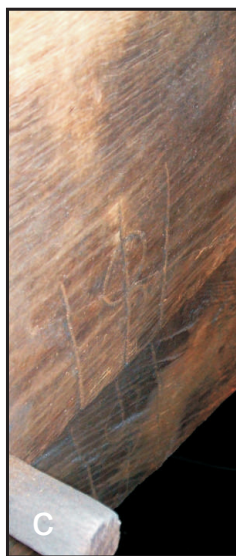
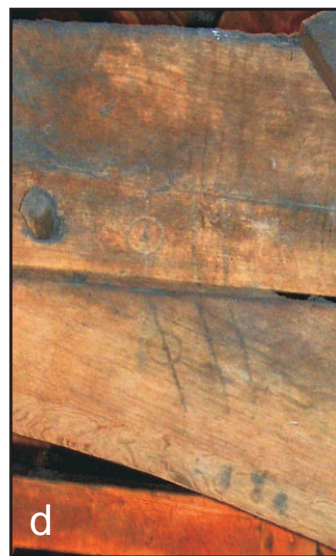
least three carpenters' marks – long scribed strokes typical of medieval work, two with circular brace marks (Figs 2a, 6b–d; a thorough search was not carried out). Examination of the faces of the principals shows that each has one sawn face (with diagonal saw-marks whose angle changes in places – characteristic signs of the use of a see-saw) and one axe-trimmed face (scooped axe-marks, visible in very oblique light). They are positioned so that the sawn face – the superior finish – is at the rear (NE) of the room. Elsewhere (e.g. in the magnificent roof of the refectory of Cleeve Abbey, Somerset) it has been shown that medieval carpenters arranged the trusses so that the better face was seen from the high table. The rear of the room may therefore have been its high end. The roof is very clean.

Fig. 6 Roof 1 carpentry details. (a) Projecting pegs. (b) Carpentry mark, Truss 2, NW slope. (c) Truss 2, SW slope. (d) Truss 3, SW slope.

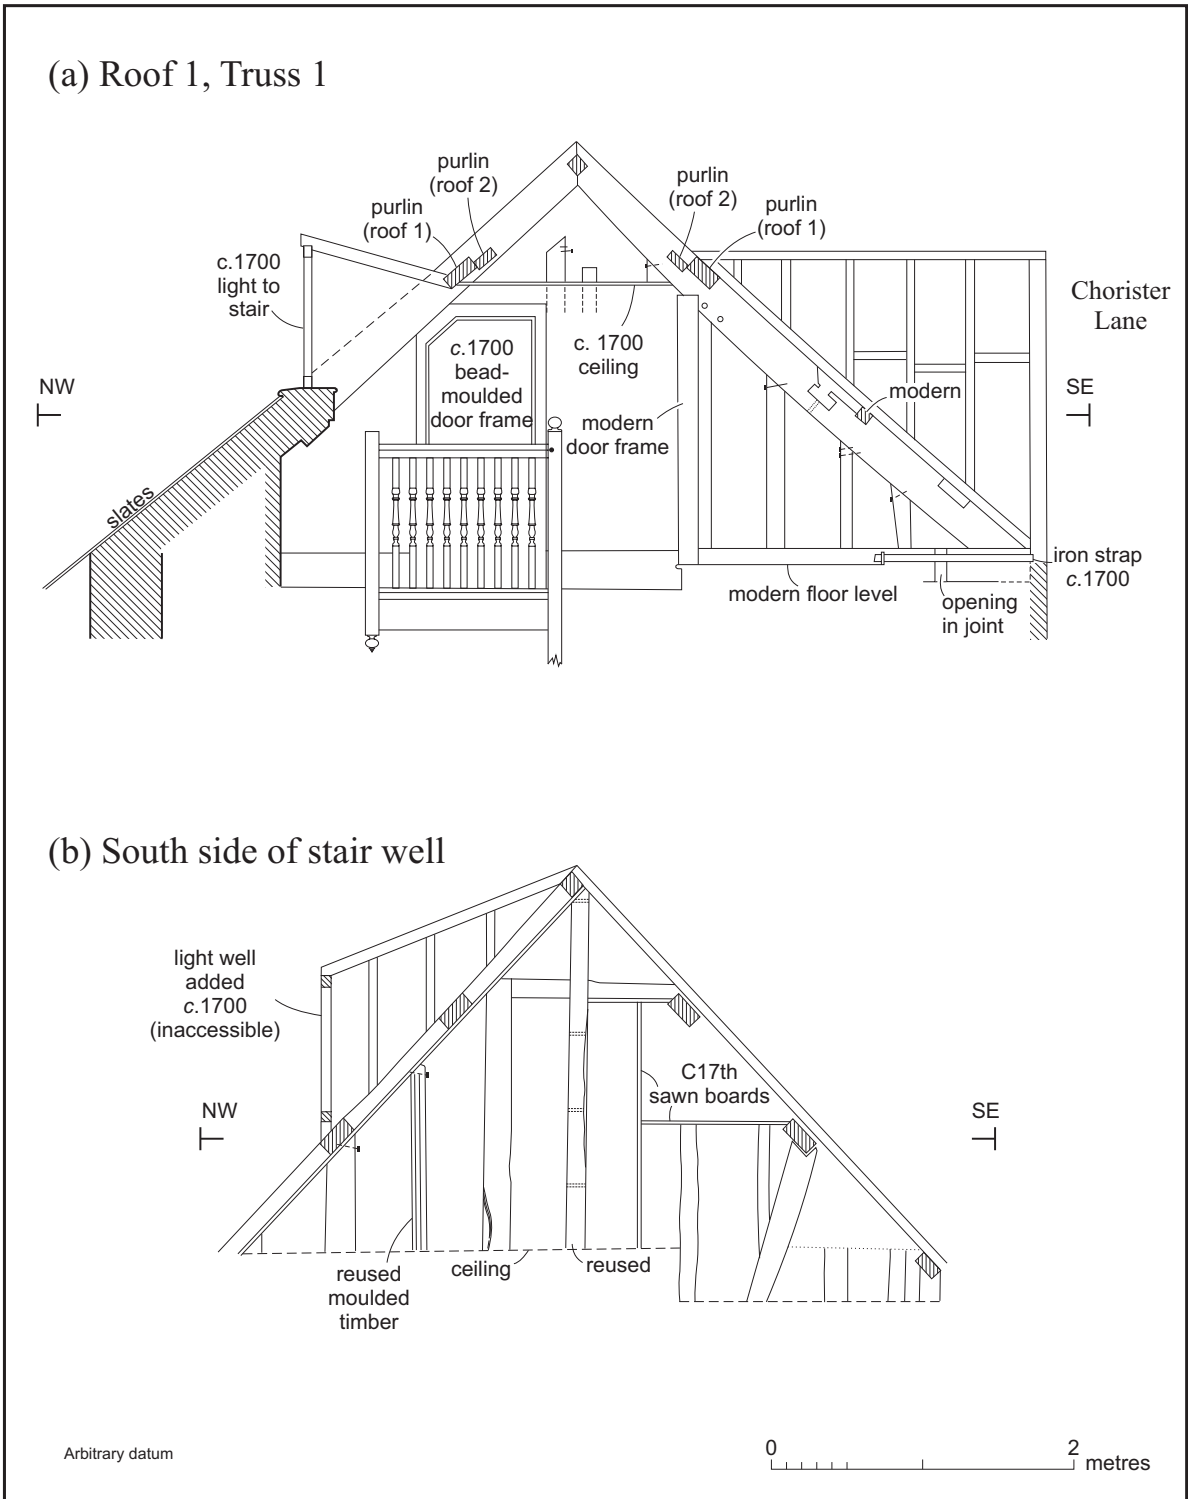
About half of one side of the closed truss was exposed in the box room above the stairs, and the apex could be reached above the ceiling of the staircase (Fig. 7a). Its principals, ridge piece and purlins correspond precisely in position and dimensions to those of the open trusses, but it lacks the arch-bracing. Vacant mortice holes for lower and middle purlins were visible in the face of the exposed principal, indicating the positions of timbers removed *c.* 1700 (see below); the two upper purlins survive, since they provided the support for the ceiling inserted at that time. The lower purlin mortice had not been cut through the thickness of the entire timber, confirming that the roof did not extend beyond this point; had the roof continued, this would have run through the principal. The truss formerly had a collar, indicated by a pair of vacant peg holes in the principal (Fig. 7, below 'purlin (roof 1)', but this has been removed. The principal is jointed and pegged into a tie beam, most of which was exposed at floor level. Surprisingly, this is made in two lengths, joined with a tenon close to the SE end of the truss.

Around middle of its length, around the central purlin, the visible principal had suffered distortion – generally about 20mm of bowing, increasing to 40mm immediately around the purlin. This had certainly taken place before the 17th century (when studs were packed below to support it) and very probably soon after the timbers were installed and still green. This almost certainly reflects distortion arising from the great weight of the medieval roof slates, the mortice hole for the purlin providing a particularly weak point in the principal.

Fig. 7 Roof 1. (a). Measured elevation of the closed Truss 1 from SW, with 17th-century and later additions on each roof-slope. (b). Measured elevation of 17th-century framing.

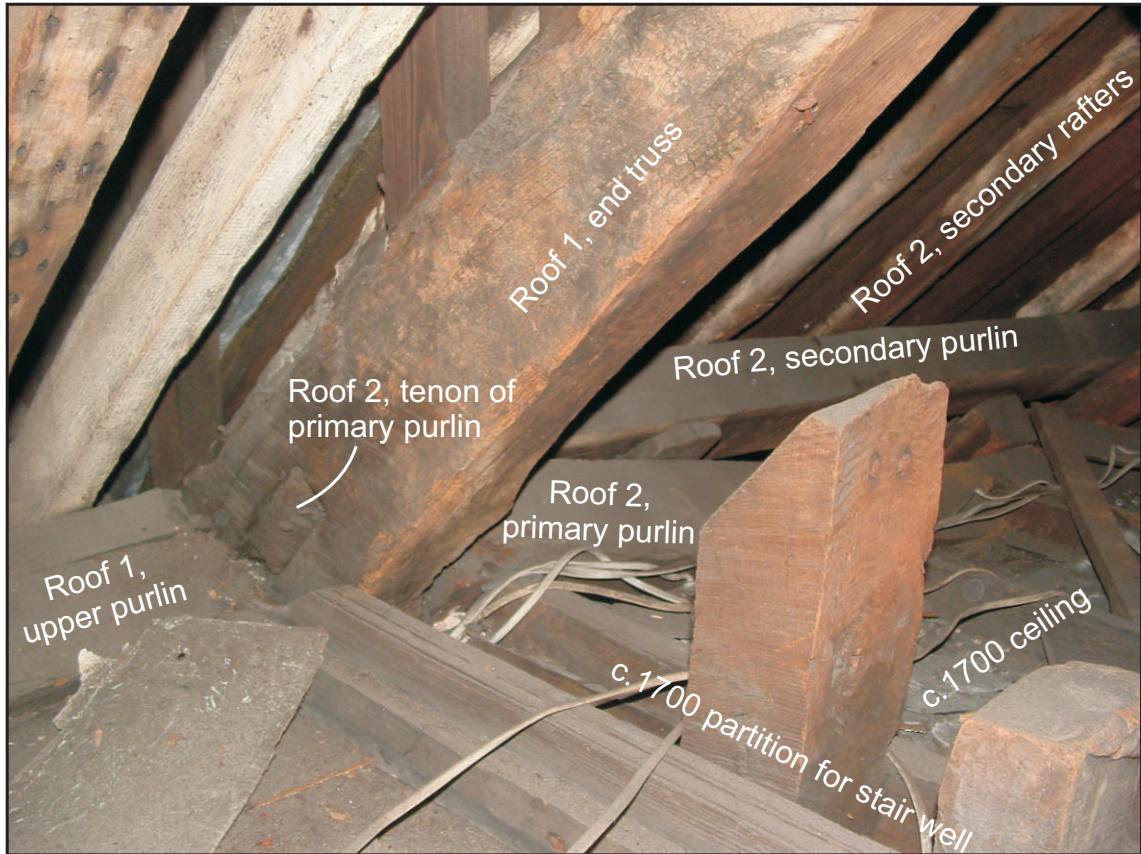
By the time that the remodelling was carried out, the end bay's Truss 1 had settled alarmingly, opening up a gap of *c.* 100mm in its tie-beam, with corresponding settlement of a similar extent in the ridge. The absence of the collar is likely to reflect the fact that it had probably broken. This slumping was counteracted by the insertion of some stocky studs into the frame, with a horizontal iron strap at tie-beam level. At the same time, a skylight was inserted to light the top of the stairwell.

Fig. 8a The top of Truss 1 from the SW, showing principal and purlin of Roof 1, inserted tenon for purlin of Roof 2, distorted purlin of Roof 2 and later replacement roof-slope of Roof 2. The vertical timbers at the front are the top of the 17th-century studs added into Truss 1.

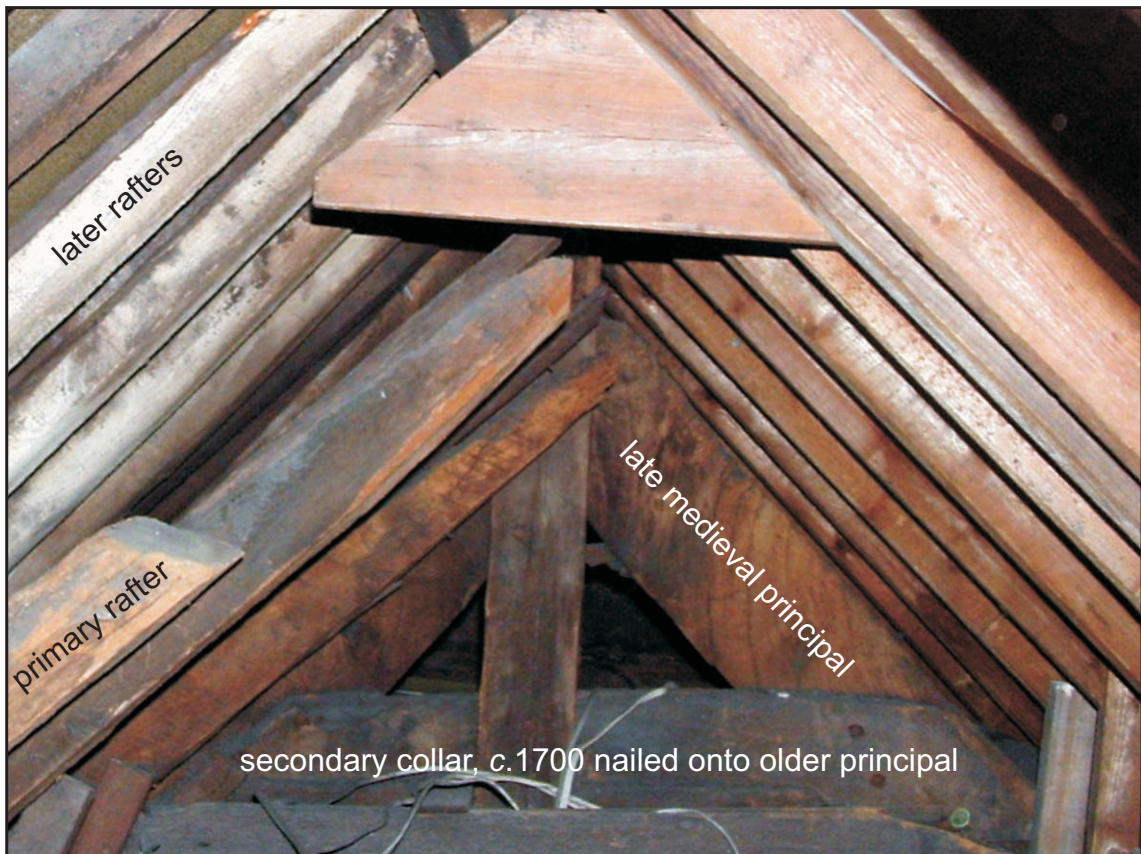
The room over the rear of the range has a simpler medieval roof, now somewhat mutilated. Its principal trusses and purlins survive; blocked mortice holes indicating former collars can be seen in each truss (visible within loft room). On this occasion it was possible to examine the relationship between this roof and Roof 1, which showed that the latter had already been erected when Roof 2 was installed (Fig. 8a). The upper purlins of Roof 2 were neatly cut into the principals of Roof 1, Truss 1, a little above those of the adjacent roof.

Fig. 8b The top of Roof 2, seen in the roofspace above its ceiling.

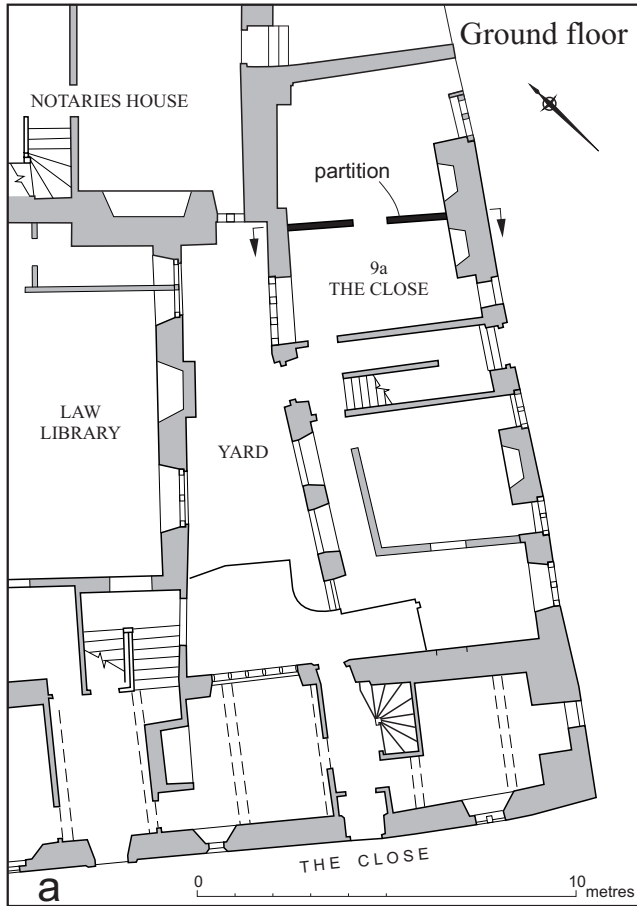
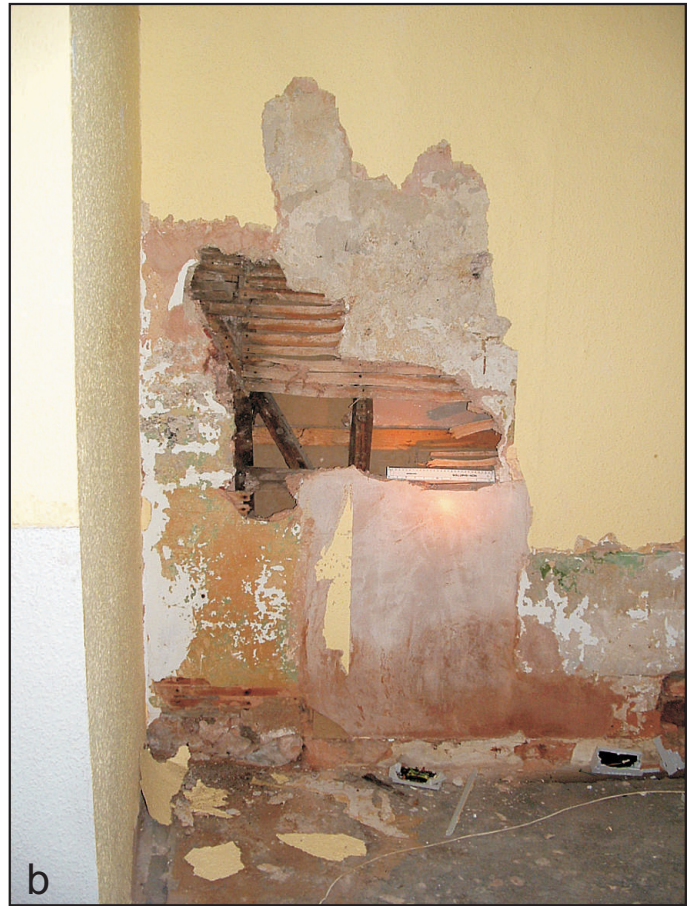
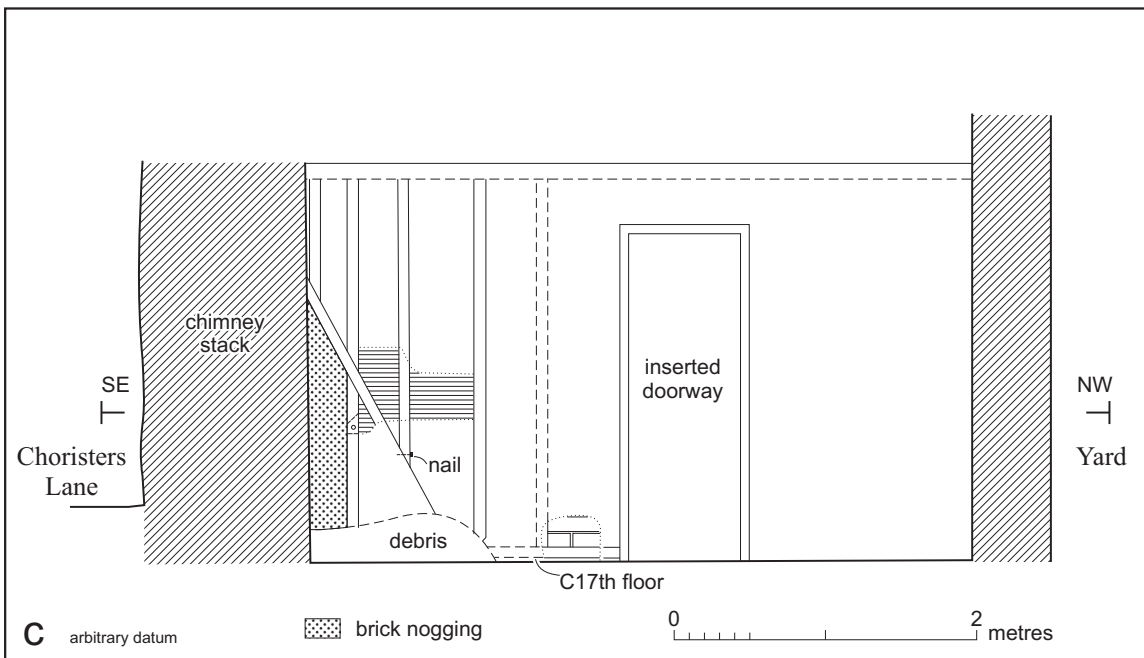
The frame has a base rail, sitting on an earlier thin grey (?ash or lime-and-ashes) floor; both were visible near the centre of the room. To the SE, collapse of lath-and-plaster at chest level exposed a series of thin straight studs, nailed to a steeply sloping diagonal brace. At least one of the uprights is reused; it shows a redundant mortice hole for a joint. Most of the panels between the studs are voids with lath-and-plaster covering (including fine animal hair in the plaster); the exception is the panel beside the outer wall, which is infilled with nogging, some at least of it brick. At shoulder height this panel is heavily soot-stained, confirming the presence of an adjacent fireplace.

This form of partition is typical of the late 17th and early 18th centuries; there are many similar examples of *c.* 1660–1720 in Exeter and Topsham.

Fig. 9 Ground-floor partition, c. 1700. (a). Location. (b). View. (c). Measured record.
