**RECENT OBSERVATIONS
DURING BUILDING WORKS
AT 8-9 THE CLOSE, EXETER:**

INTERIM REPORT to AUGUST 2009

Exeter Archaeology Report No. 09.93

August 2009

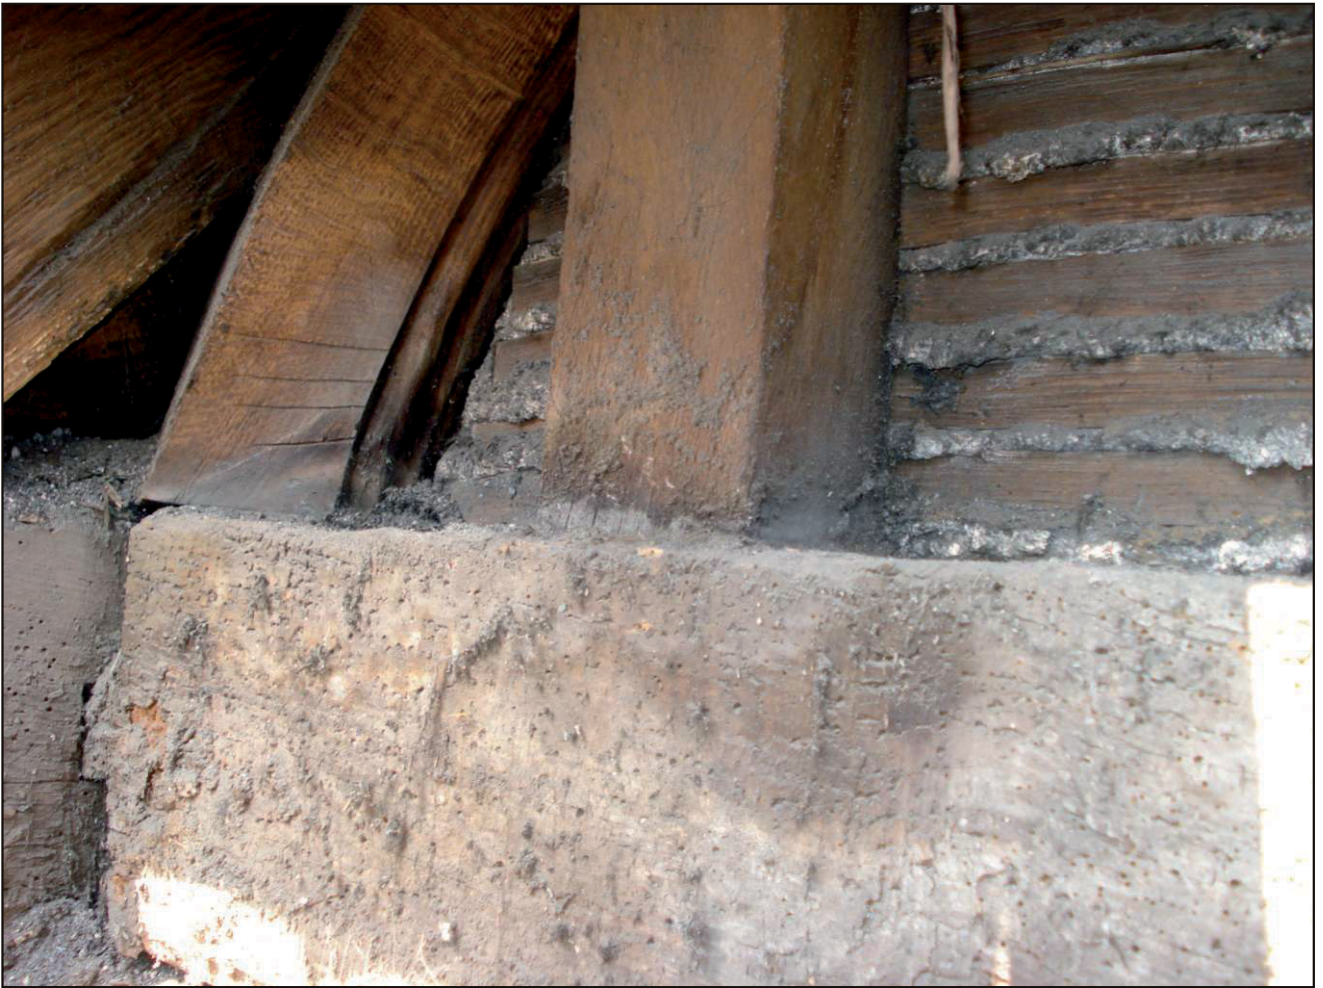
One important piece of evidence visible in this area was the treatment of the wind braces, whose moulded faces extended behind the present ceiling (Fig. 2). There can be no doubt that the roof was not originally ceiled beneath the rafters, as at present, and that all the timbers were originally fully displayed.

Fig. 2 Detail of the hall roof showing clean timbers and the moulded face of a windbrace protruding behind the later ceiling.

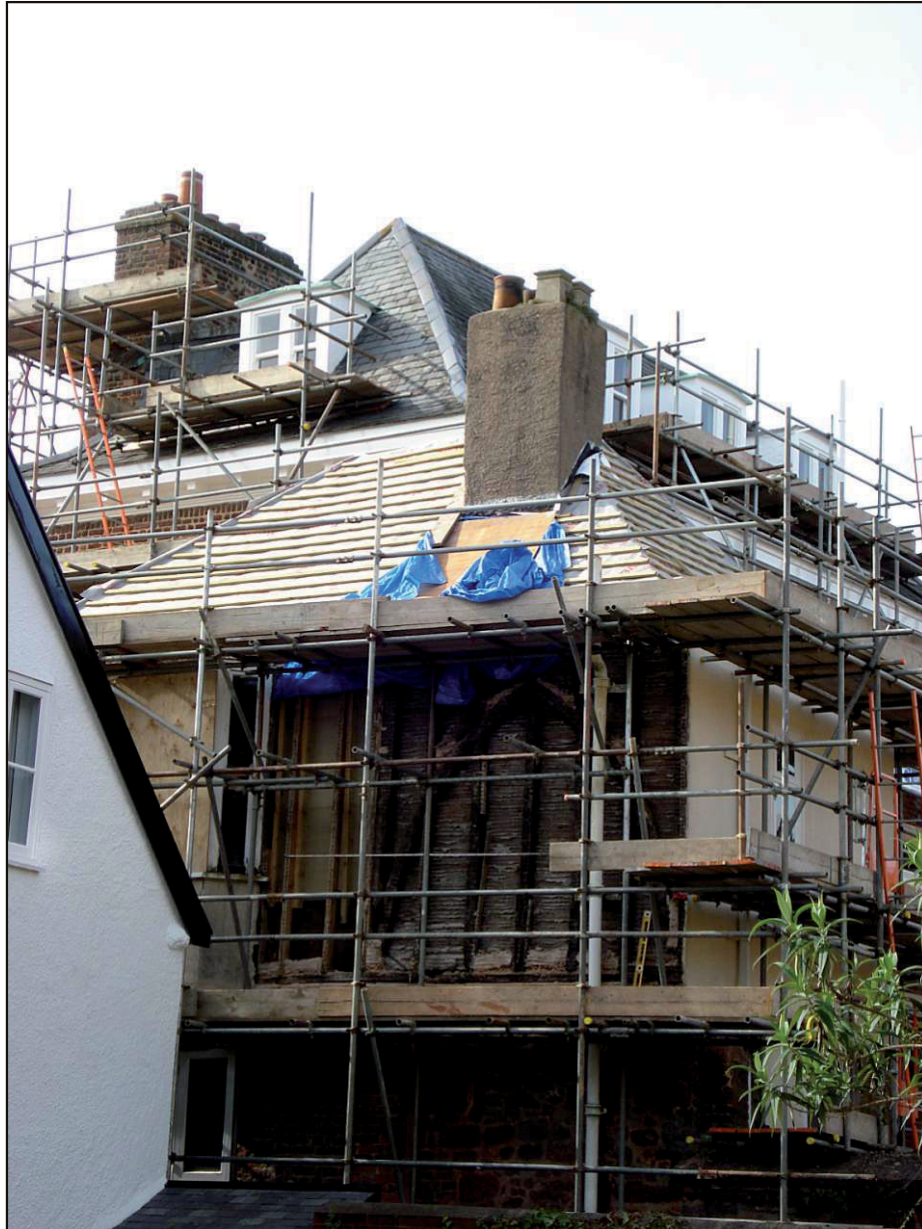
Upon removal of the rendered surface of the wall the timber structure of the upper storey was found to be bulging out over the lane by as much as 0.18m. The timber framing consists of substantial but slender vertical studs in oak, linking a sill beam and head beam of similar scantling. The vertical studs are braced by a pair of curving braces forming a pointed arch (Fig. 3). All the timbers are secured with spikes or nails rather than pegs. The surface of the timbers is highly corroded, as though they had been exposed to the weather. This may imply that the original render was recessed within the panels to expose the timbers; however, no evidence of any fixing to secure the infill panels was apparent and it is uncertain how the panels were finished.

Both the sill and top rail of the frame appeared to be intact, the bulge in the wall occurring not because of the decay of the sill, but because of the failure of a halved scarf joint at the centre of the sill. Some of the timbers bore traces of redundant sockets and appear to have been reused from an earlier structure. The scantling of these timbers suggests that of common rafter trusses and it is possible that they are parts of the earlier roof structure reused in this position.

The majority of the timbers were in good condition, though the stud at the north-eastern limit of the façade had entirely perished, and the larger stud to the south-west, which presumably lay at the centre of the original wall frame had partially perished at the base. The section of the frame to the south-west of this stud had been renewed in the 19th century, presumably when the existing oriel window was inserted. It is uncertain whether further elements of this frame survive to the south-west of the oriel, though this is very likely.

Fig. 3 View of the pavilion block showing the exposed framing prior to repairs.

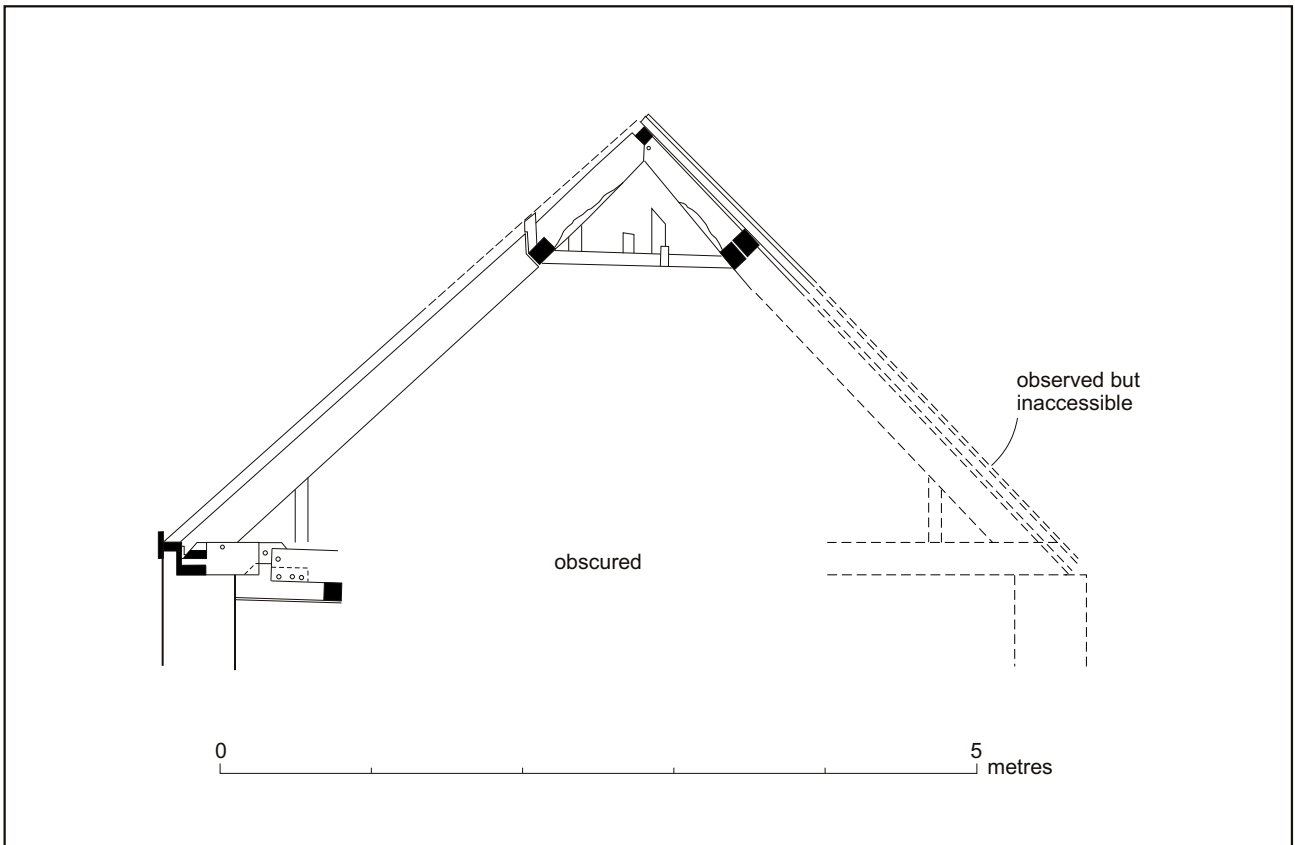
The apex of the south-western truss of the central roof was the only part initially exposed. This truss lies on the line of the partition separating the staircase from the attic room in the north-eastern part of the building (Fig. 9). The tops of two principal rafters were observed, meeting at the apex in a vertical joint, one tenoning into the other and secured by a single peg. There was a diagonally-set ridge tree, though this does not appear to have been an original feature; the present ridge tree is an addition in softwood probably dating from the 17th century. No sign of a collar beam was visible, perhaps because this was at a lower level, and is now either concealed within the fabric of the partition or has been wholly removed.

The purlins are tenoned into the principal rafters with bare-faced tenons secured from the underside with pegs. The original purlin on this side of the roof still remained in position but could be seen to have bowed, distorting the original roof structure. A later roof structure of purlins and rafters had therefore been superimposed above this. On the north-western side of the roof the additional purlin was trenched into the earlier principal rafter; like the ridge tree, these roof timbers are perhaps a 17th-century addition or repair.

Fig. 9 Section through the central roof of No. 9a showing the south-western truss. Scale 1:50.

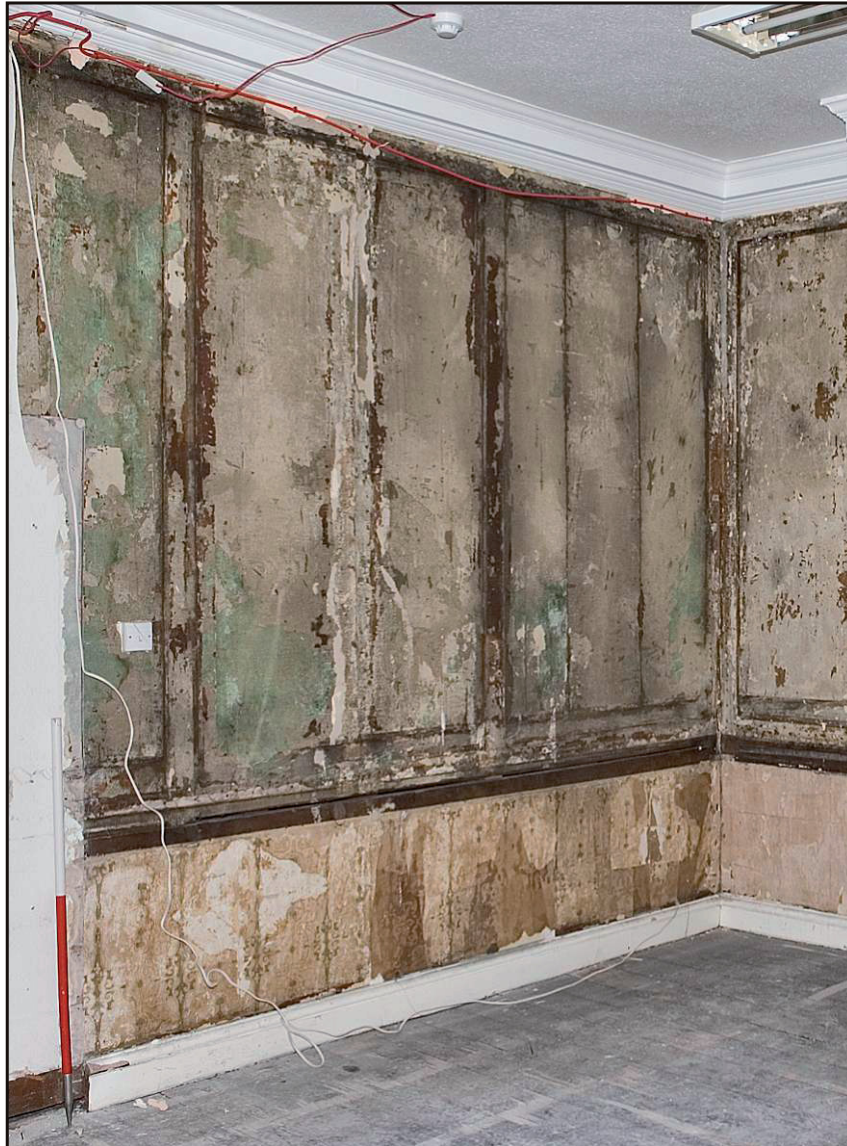
The panelling was probably mutilated during the late 18th or early 19th century when the room was modernised, possibly at the same time as the sash windows were inserted to replace the original casements. The projecting bolection mouldings were removed and reused as fillets fixed to the rear of the panels, to which the remaining panels, suitably augmented by extra fillets of waste material, were nailed to produce a flat surface suitable for wall hangings or paper. The wall paper seems to have been applied directly over this flattened surface, though there is some evidence of hessian or canvas backing glued over the panels to support other layers of wall paper.

Fig. 13 View of the late 17th century bolection-moulded panelling in the ground floor west side room. Scale 1m. View south-east.

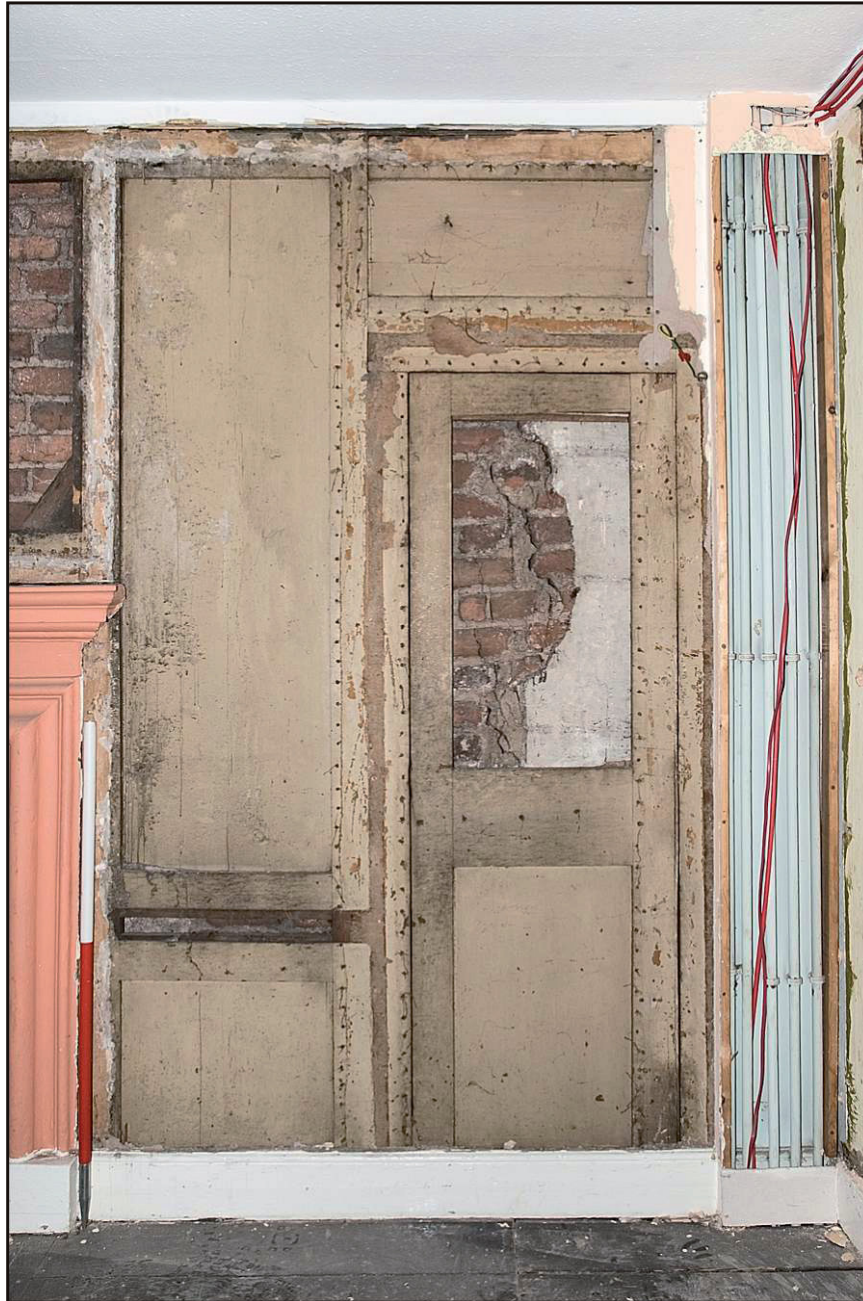
To the north of the fireplace one section of panelling incorporates a door which opens directly into a brick wall, with no sign of any alcove behind it (Fig. 16). This panel also bears traces of applied mouldings which surround and respect the door and relate to a missing dado rail. The panels are surrounded by rows of nail holes suggesting that they were covered with cloth hangings. The pattern of nail marks respects the moulding around the door, but not the dado rail, which must have been broken off before the hangings were applied. This suggests that the hangings were secondary. Bizarrely, although the hangings respected the outline of the door, the nail marks occur in the frame around the door rather than in the door itself, and the hangings would thus have sealed the door shut. As the door is redundant in this position it seems certain that the panelling is reset in this context. It is uncertain whether the hangings were added before or after the relocation of the panelling to this room, though the fact that the hangings sealed the door suggests that this may have been the case. Why the shape of the door was still respected after this is unknown.

Fig. 16 Details of the panelling in the second floor, south-east room showing the anomalous door and nail marks. Scale 1m. View south.

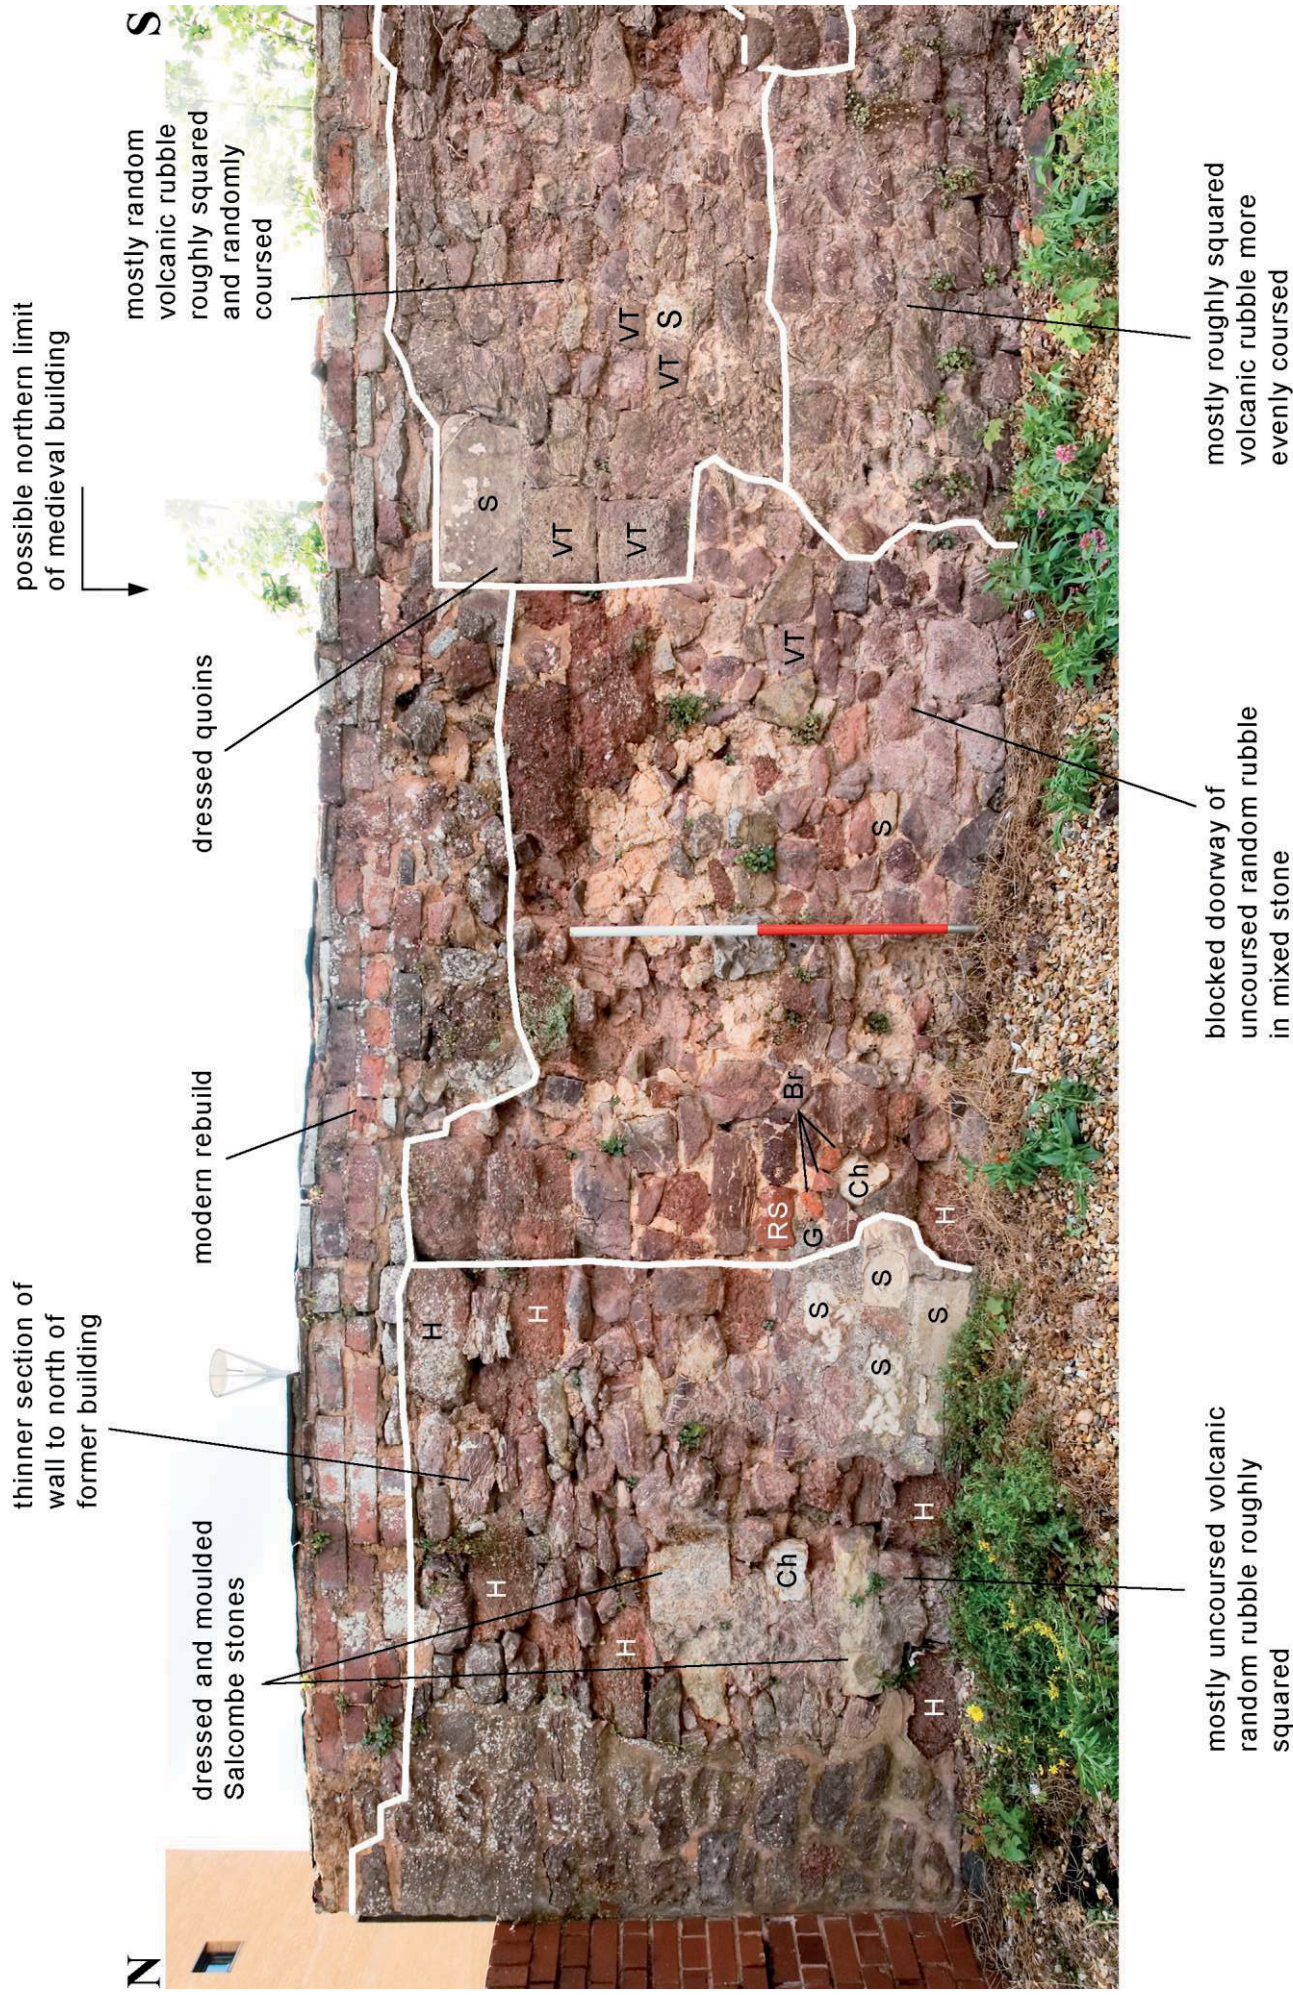
The north-eastern part of the wall is of mixed geology, incorporating dressed and moulded blocks of Salcombe stone. This part of the wall incorporates a blocked opening, perhaps a gateway linking the two parts of the Archdeacon of Totnes' property. The north-western jamb of this opening is visible in the form of a vertical break, interrupted at the base by a later phase of Salcombe stone repair. The south-western limit of the opening is represented by a group of dressed quoins which are undercut by the blocking, but which may represent the corner of the demolished building (see below).

Fig. 18 View of the north-western elevation of the north-eastern section of the boundary wall, showing the blocked gateway and quoins. Scale 1m. (See Fig.21 for masonry key.)

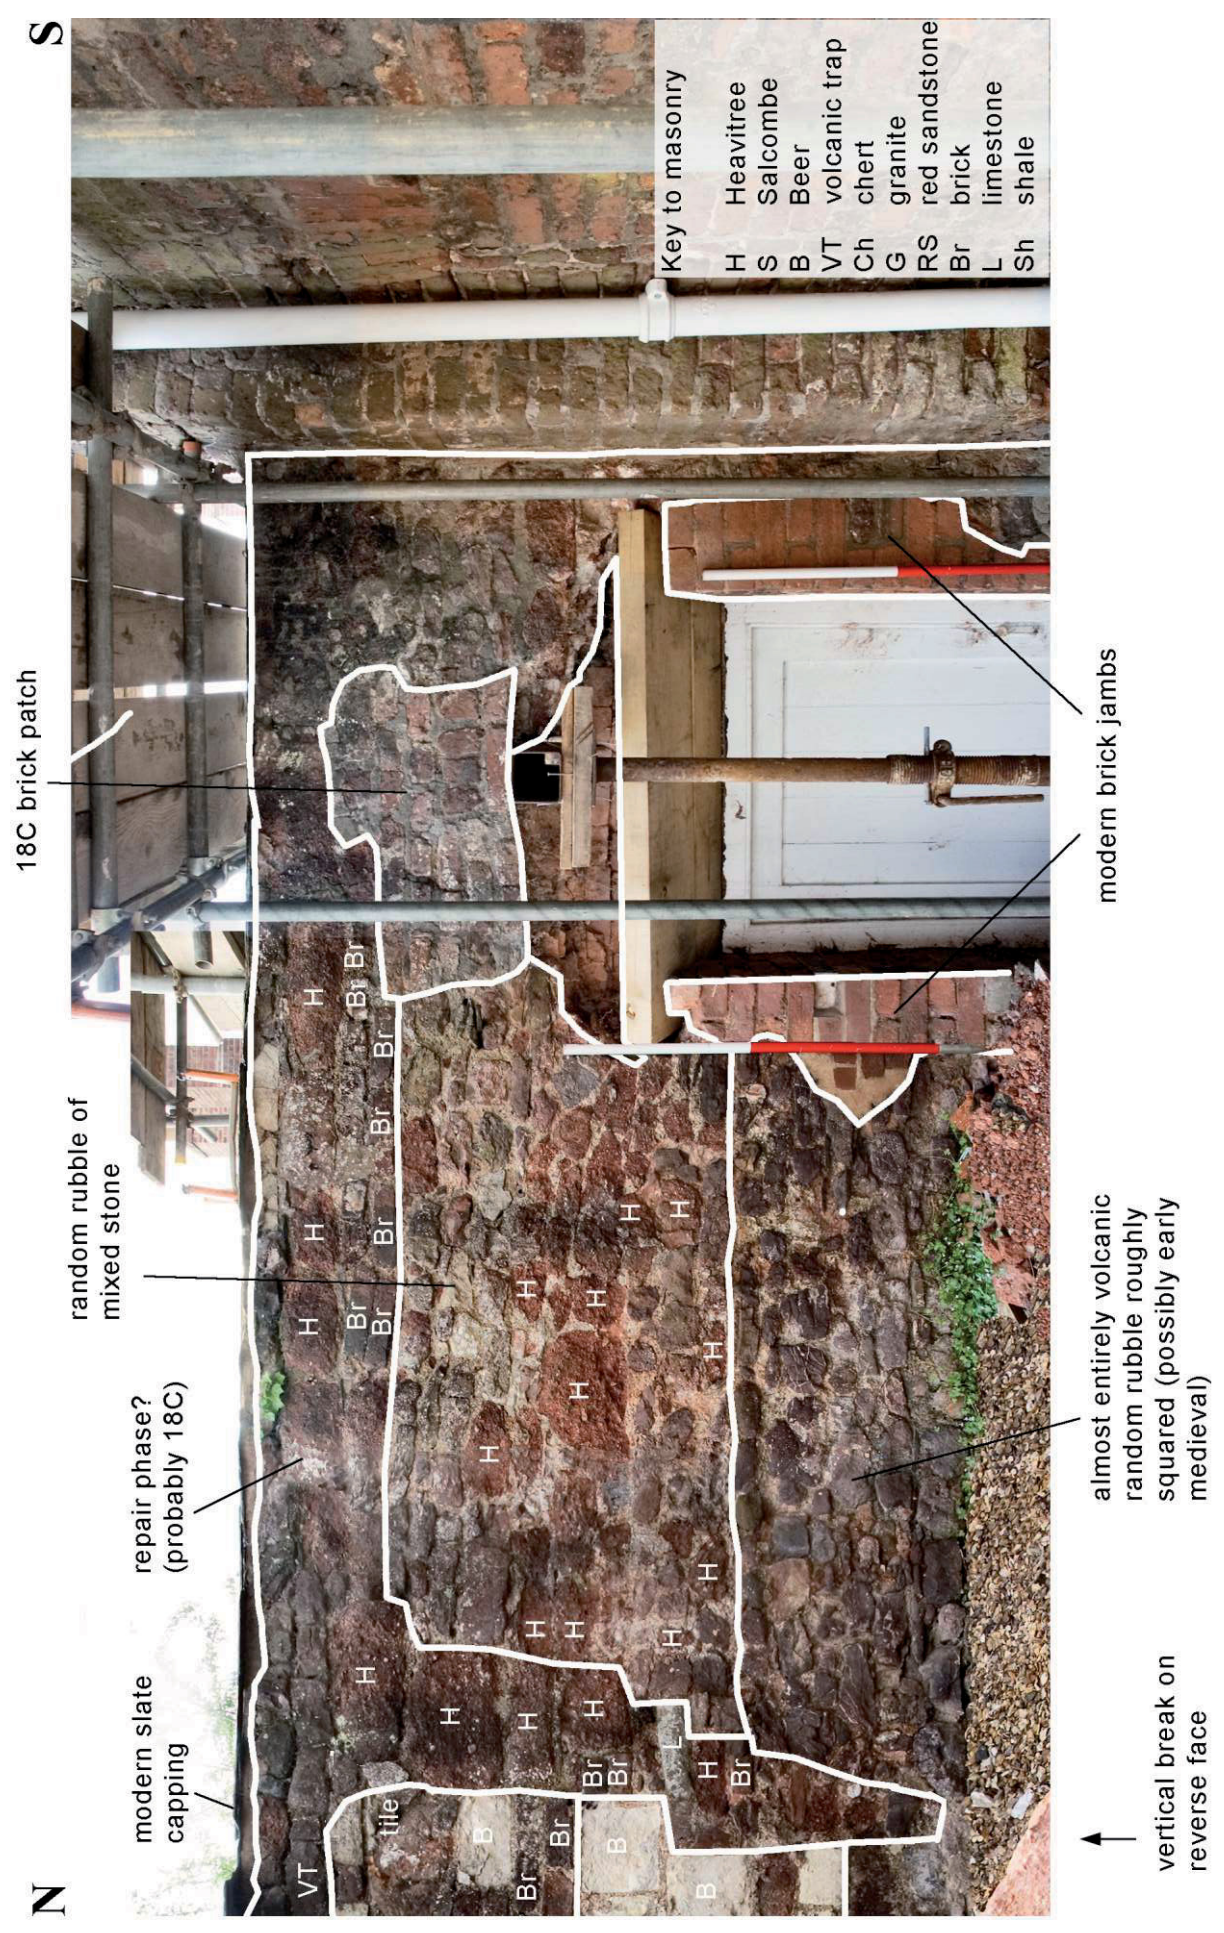
These two phases of wall end in a vertical break *c.*3.00m south-west of the southern quoins of the former building (Fig. 21). South-west of this division the wall has at least three phases divided by horizontal breaks. The lower section of masonry consists almost entirely of roughly-squared volcanic rubble and is possibly of late-medieval date. The next phase above this is of volcanic stone mixed with Heavitree breccia. Above this is a later phase of heightening or repair that extends over the Beer stone fabric to the north-east and downwards vertically to fill the vertical break. This fabric is of random rubble of Heavitree breccia, volcanic trap and limestone mixed with occasional bricks. These are coarse-textured handmade bricks of probable 18th-century date.

Fig. 21 View of the south-western section of the boundary wall, showing the vertical break and doorway. Scale 1m.
