**ARCHAEOLOGICAL RECORDING  
DURING REPAIR WORKS TO  
46 HIGH STREET, EXETER**

**Exeter Archaeology**

**Report No. 09.127**

**November 2009**

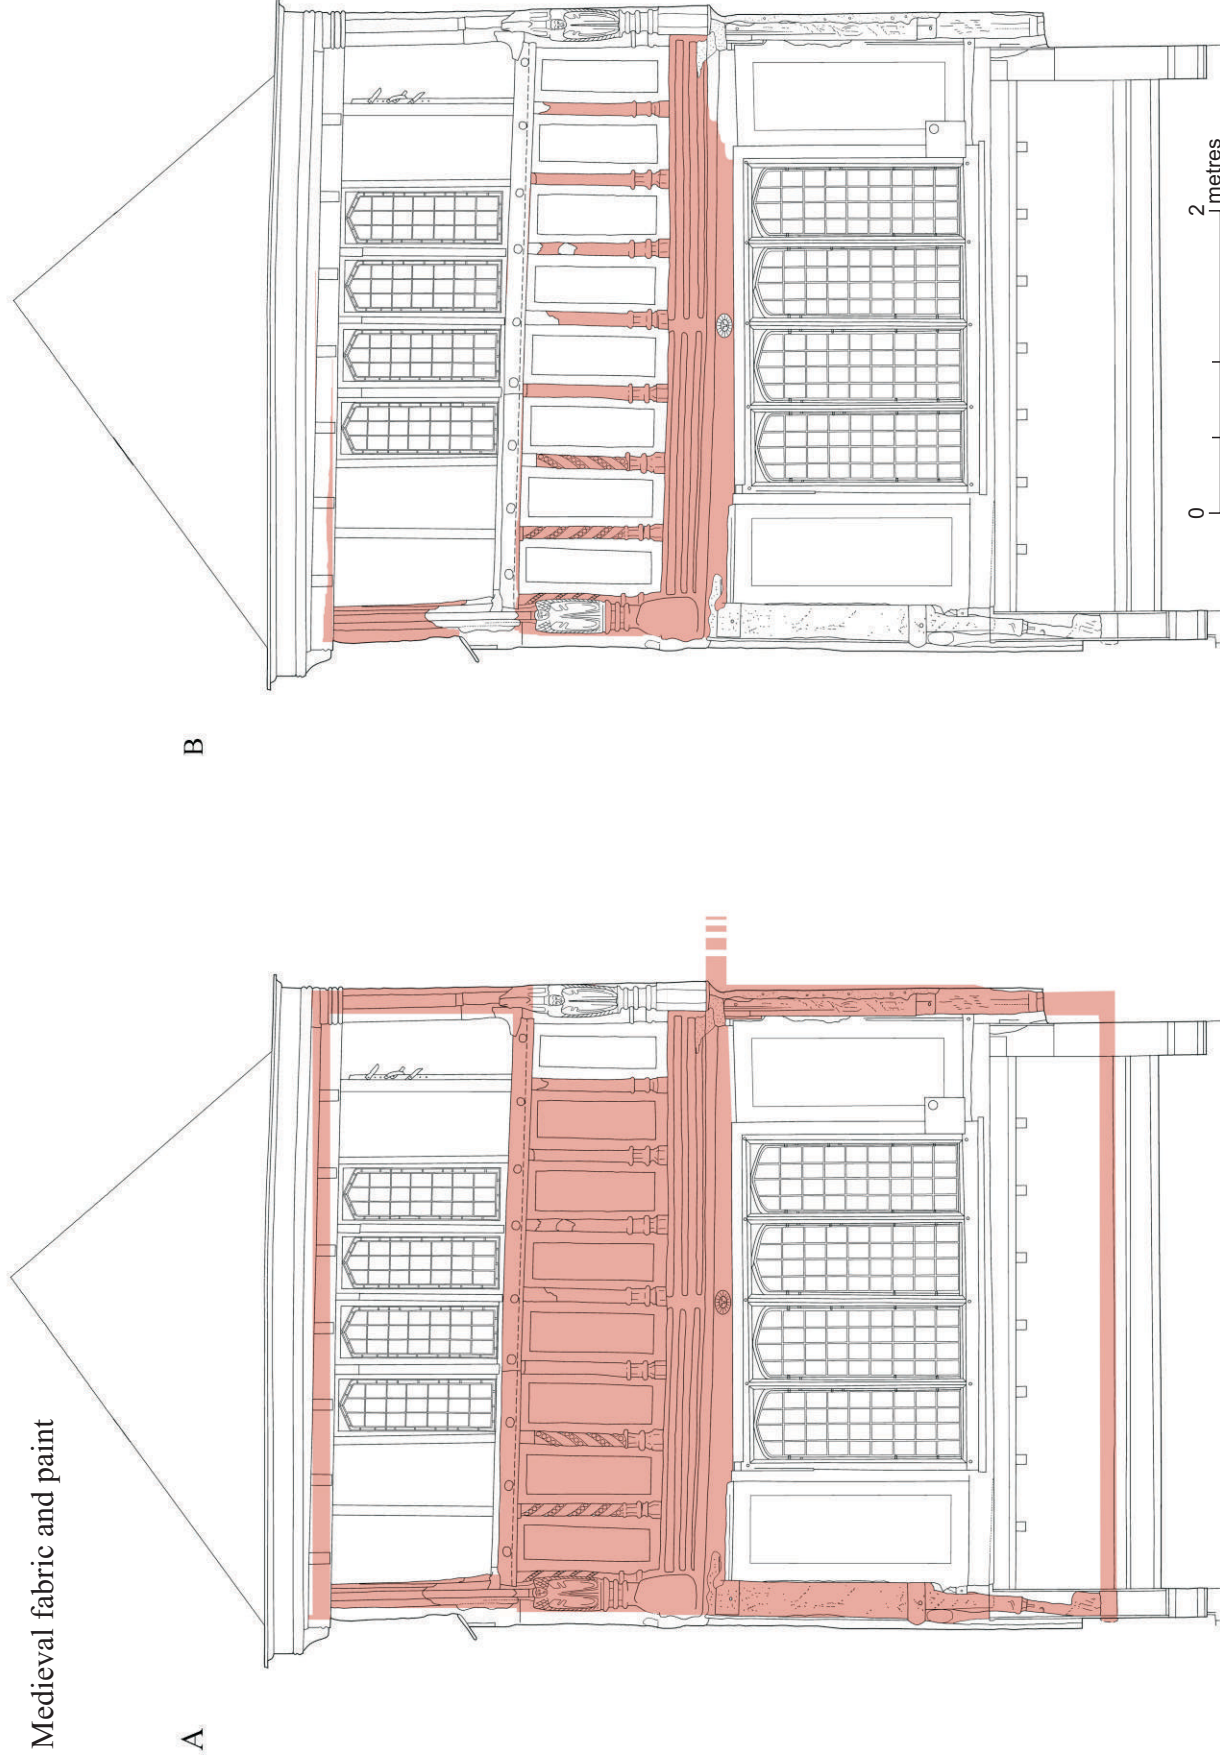
Fig. 3 Drawings of the front elevation showing (A), areas of surviving medieval fabric within the facade and (B), areas of surviving medieval fabric within the facade. Scale 1 : 50.

The survival of the medieval fabric in the building façade is illustrated in an elevation drawing which shows the extensive loss of original timbers on the first floor and the upper section of the second floor (Fig. 3A). The removal of the first-floor windowsill beam may have contributed to the slumping of the façade and the consequential failure of the roof drainage that led to the extensive damage to the remaining medieval fabric.

Although the many thick layers of modern paints have contributed to the damage of timbers in some areas, they have also nevertheless preserved extensive areas of original paint. The areas considered likely to retain medieval paintwork on the frontage are depicted in Fig. 3B.

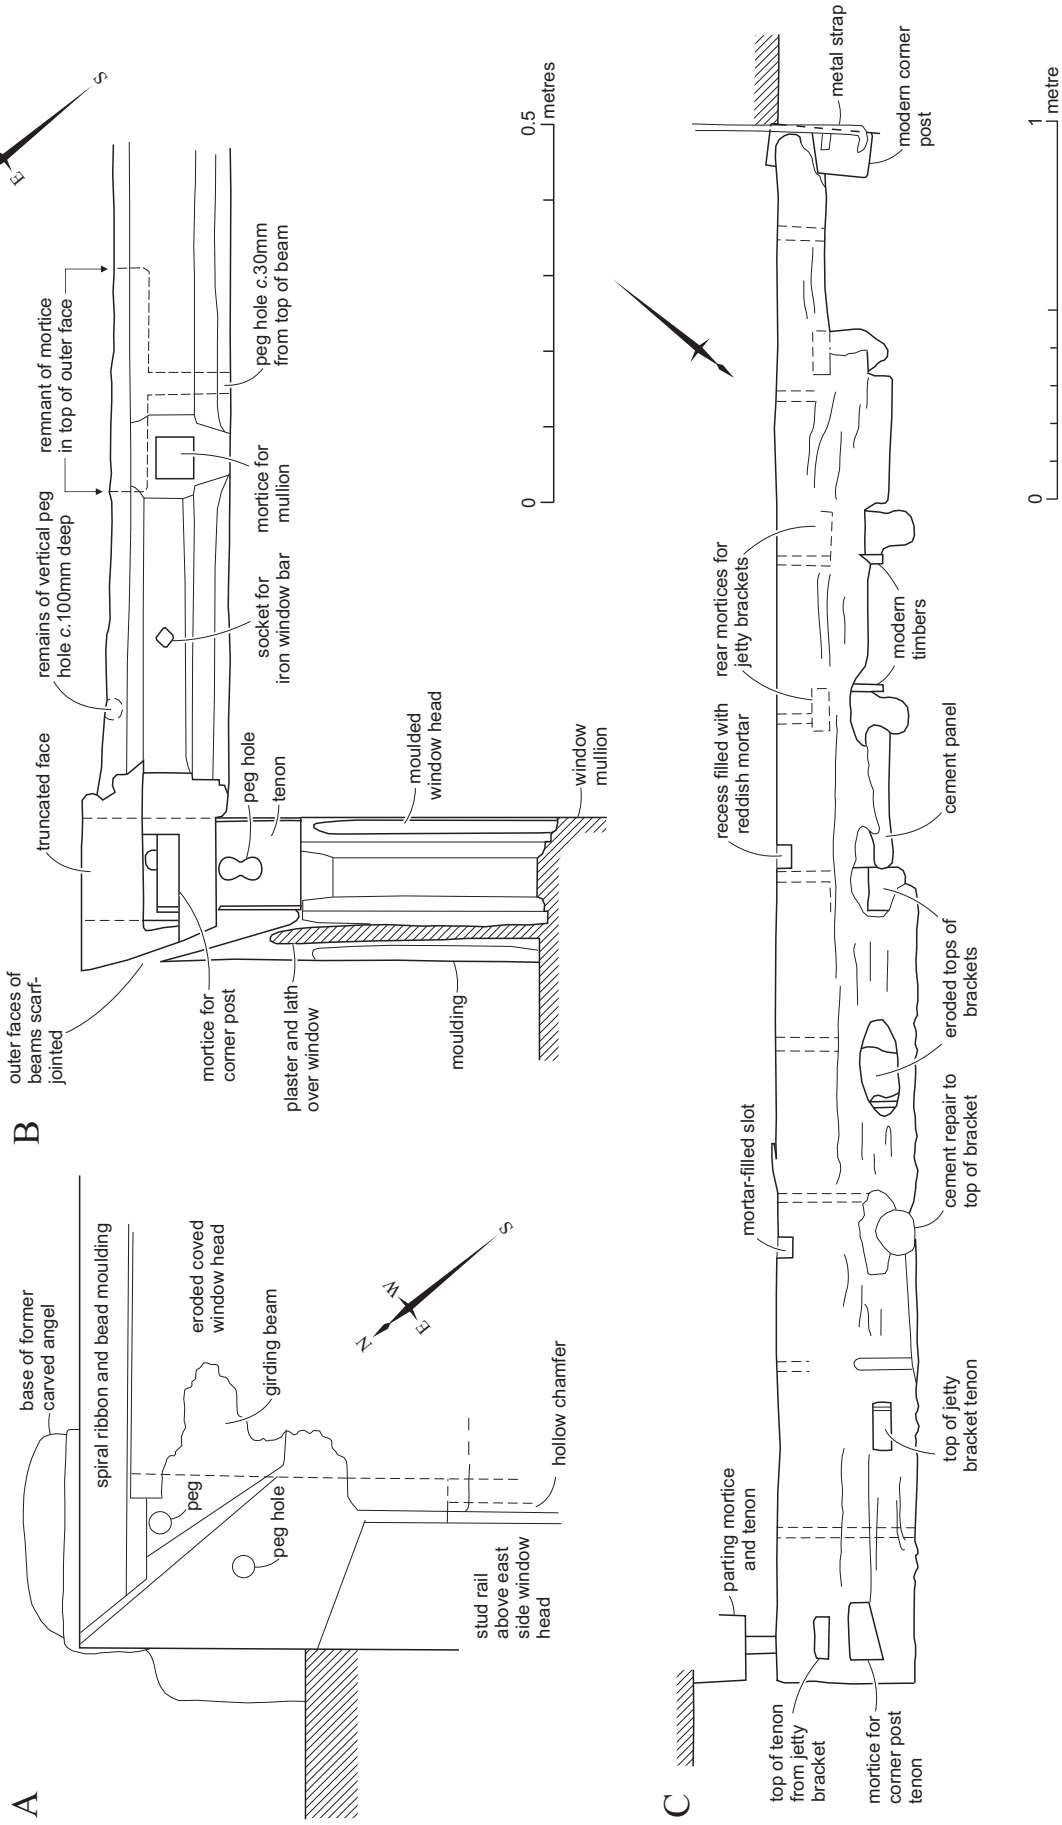
Fig. 5 Worm's eye plan views of (A), joint between first-floor girding beams at east end and (B), joint between second-floor window heads at east end. (C), Plan of second-floor window sill beam *in situ*. Scales 1:10 and 1:20.

Despite lying beneath the leadwork, the spiral ribbon and bead moulding was in poor condition. It is not entirely clear if further decay has occurred since the steel bracing had been added, but very little paintwork remained on this timber. There are areas of cement repair visible along its lower edge. Considerable decay of this beam had occurred at the north-west end where water damage was the primary cause (Fig. 5C).

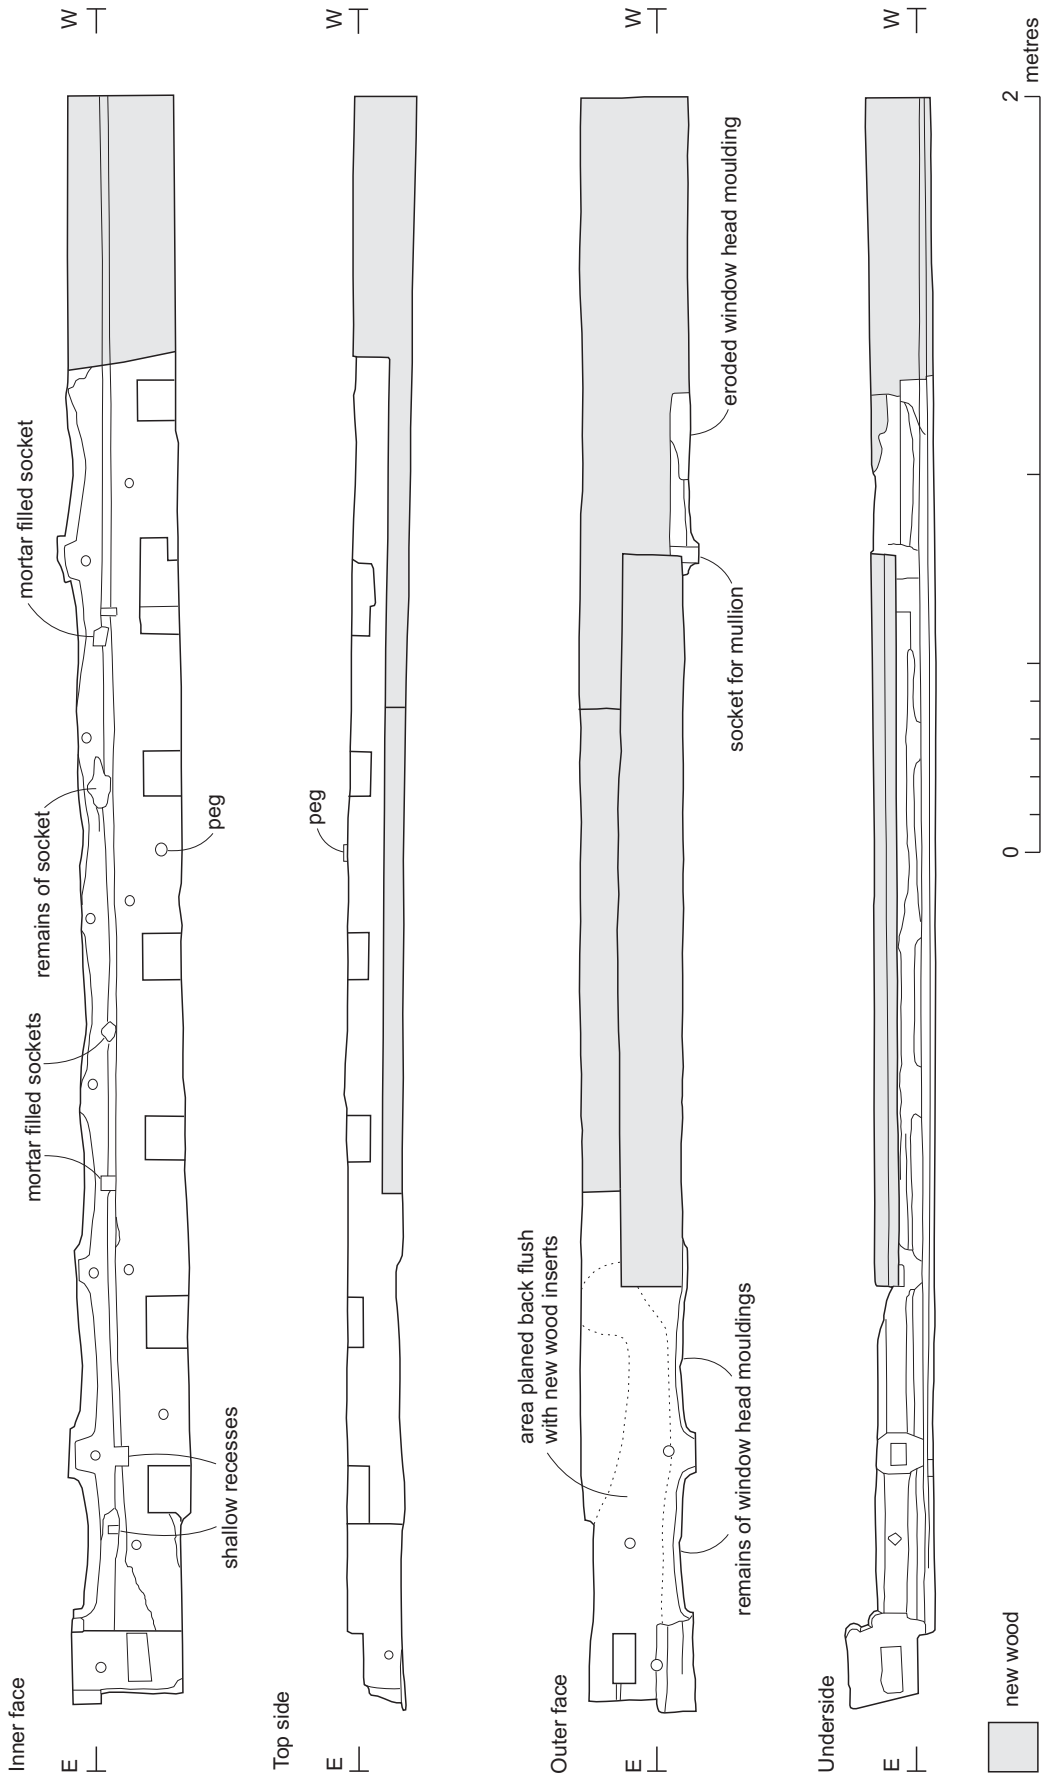
Fig. 9 Window head beam from second floor north façade during renovation. Scale 1:20.

Such head mouldings survive at least in part on the second-floor window head-beam. These were fully recorded following removal of the timber (Fig. 9). The outer face of the timber had been hacked back, presumably to accommodate the modern cornice. The inner face was largely intact, complete with all but one of the eight Tudor-arched window-heads, that of the extreme west end having largely decayed. During the repair program the outer face was planed flat in the defaced areas and new oak timbers spliced in.

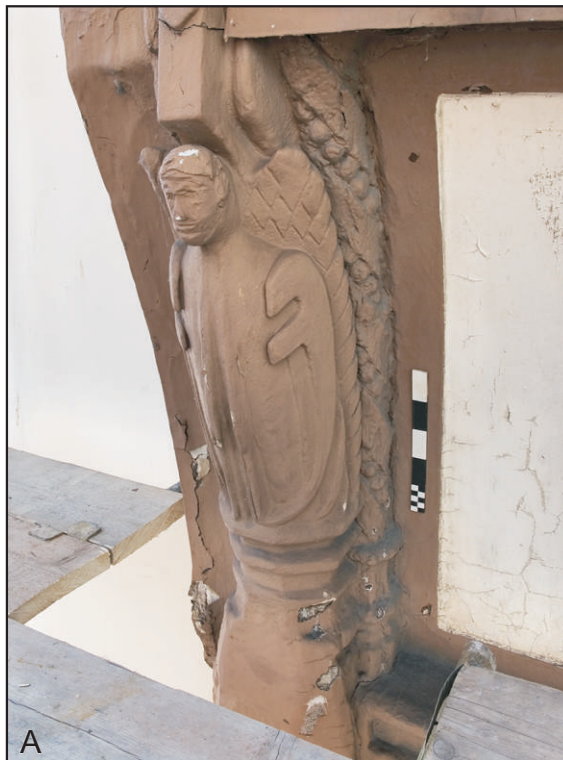
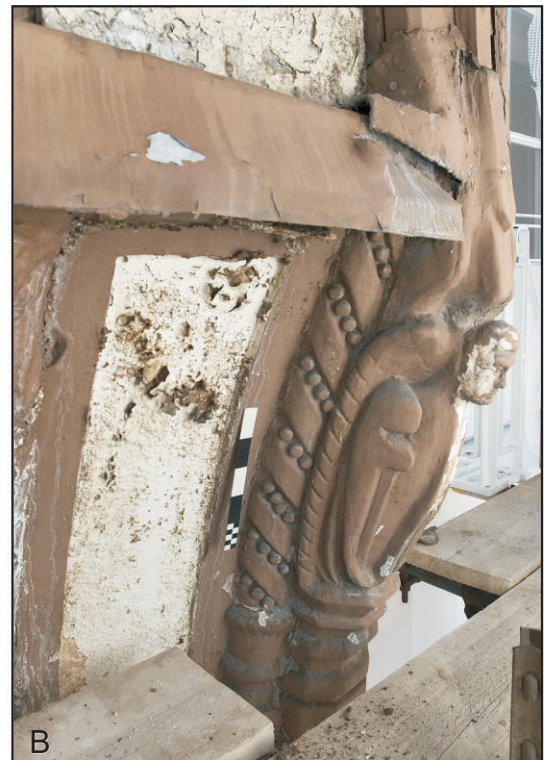
The angel adorning the eastern end of the façade is a cast replacement in white gypsum plaster (Pl. 2a). It has been replaced since it was drawn in the 18<sup>th</sup> century (Pl. 12; Fig. 12). The plaster and wood cladding of the adjacent areas of the north-east face may be associated with this phase of work. The original timber base to the angel remains.

Pl. 2 Second-floor corner jetty post figures, (A) C18th/19th cast gypsum angel at the east end, (B) C20th cast cement angel and adjacent spiral ribbon and bead-moulded jetty bracket at the west end. Scale 0.25m. Views (A) south-east, (B) south-west.

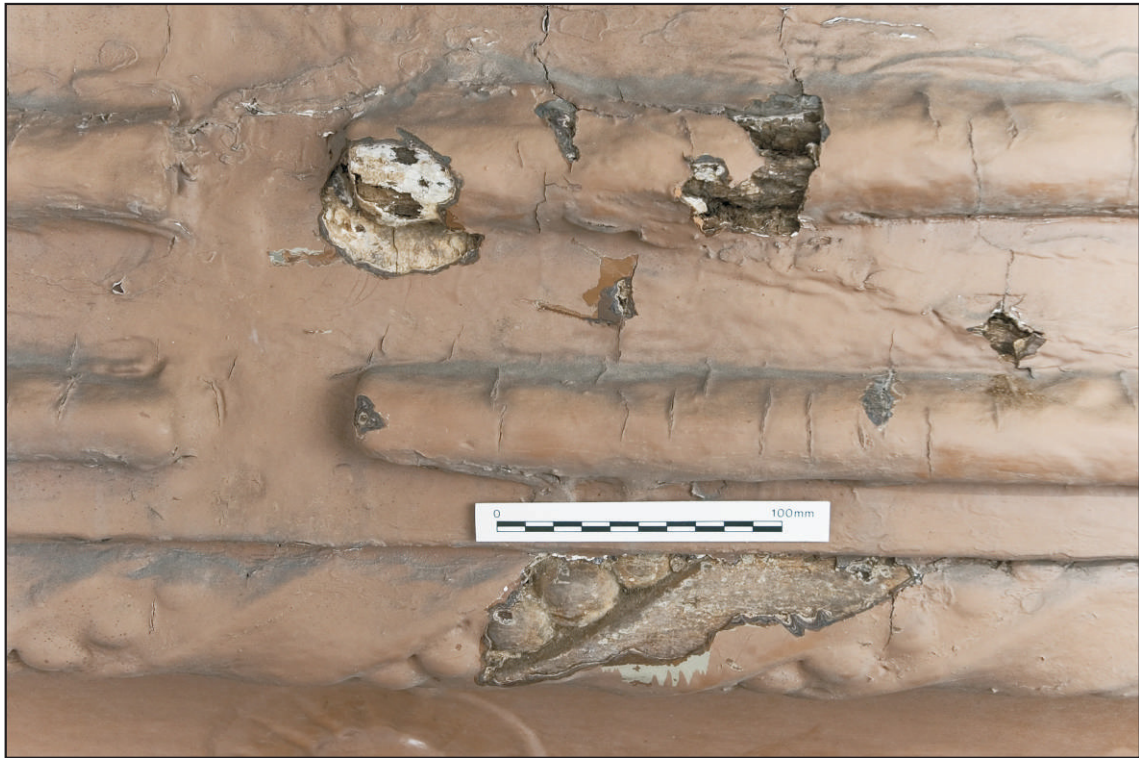
Pl. 3 Detail of the roll-moulded girthing beam with spiral ribbon and bead moulding below. Note thickness of paint layers obscuring the carving detail. Scale 100mm. View south-east.

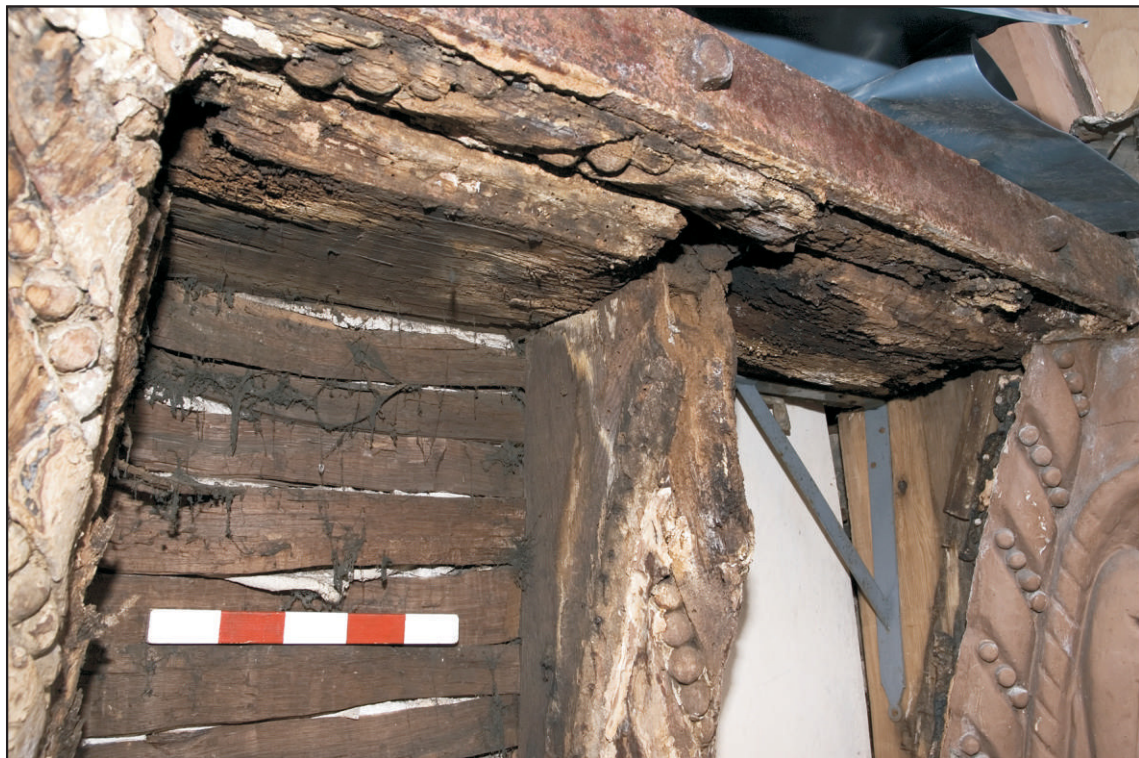
Pl. 4 Second-floor windowsill beam with spiral ribbon and bead moulding clamped between steel straps. Modern panel infills have been removed from between the jetty brackets. Scale 0.25m. View south.

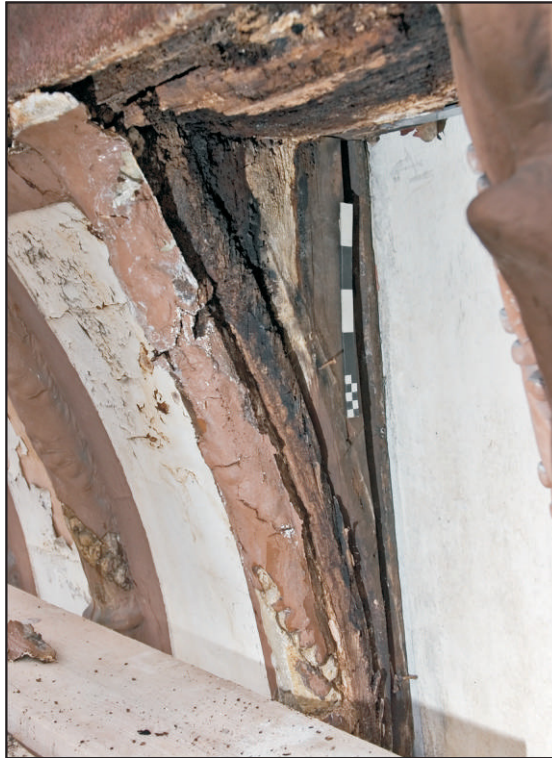
Several of the jetty brackets had been patch-repaired in plaster. This work is probably contemporary with some of the panel infill outer facings. Plaster on plain or riven oak laths are presumed to form some of these, the offset frame of each panel built up in plaster to a depth of *c.*6mm. The remaining panels were surfaced in cement with masonry paint over. The present panel-facings obscure part of the original mouldings on the jetty brackets. The modern infill of one of the panels was removed allowing full view of the side profile of the bracket. Two grooves for oak laths were visible, a straight inner groove running parallel to, and just inside, the inner face of the bracket, and a curved outer groove running parallel to, and just behind, the spiral ribbon and bead moulding (Pl. 5).

Pl. 5 Detail of a second-floor covered jetty bracket after removal of the modern panel showing the grooves for lath and plaster infill. Scale 0.25m. View east.

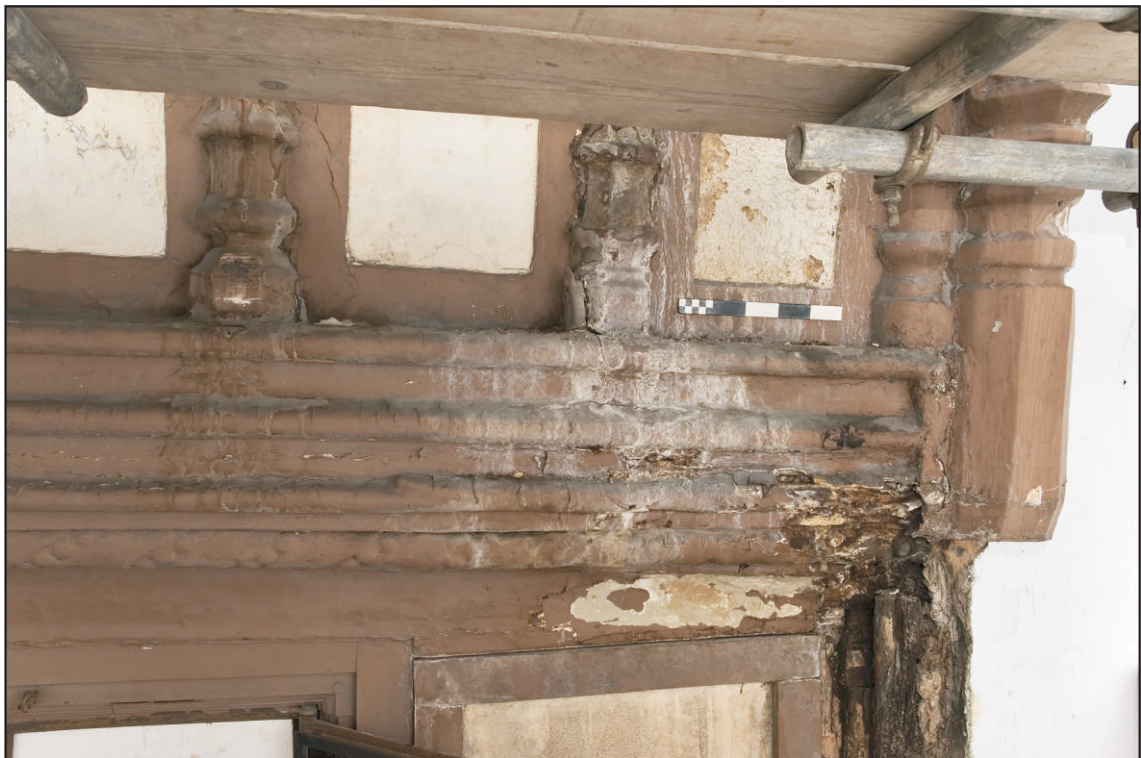
Much of the damage to the façade has occurred at the west end adjacent to No. 47 (Pl. 6). A longstanding problem with roof drainage leading to overflow from the building's parapet has resulted in the loss of the westernmost second-floor jetty bracket. A modern timber was found beneath the cement angel but this provided no structural support. This end of the moulded girding beam and coved head-beam may have been previously repaired, though this area was so badly decayed as to have been unrecognizable as wood.

Pl. 6 Detail of the west end of the facade showing the deterioration of the timbers of the second floor. Scale 0.25m. View south-east.

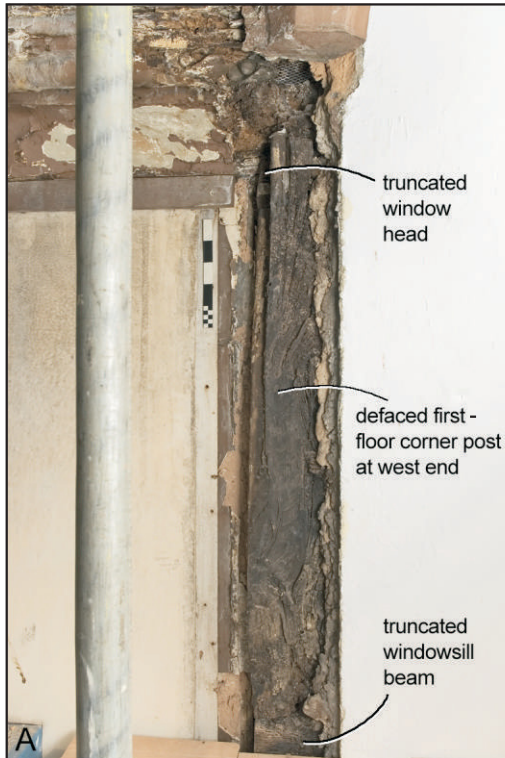
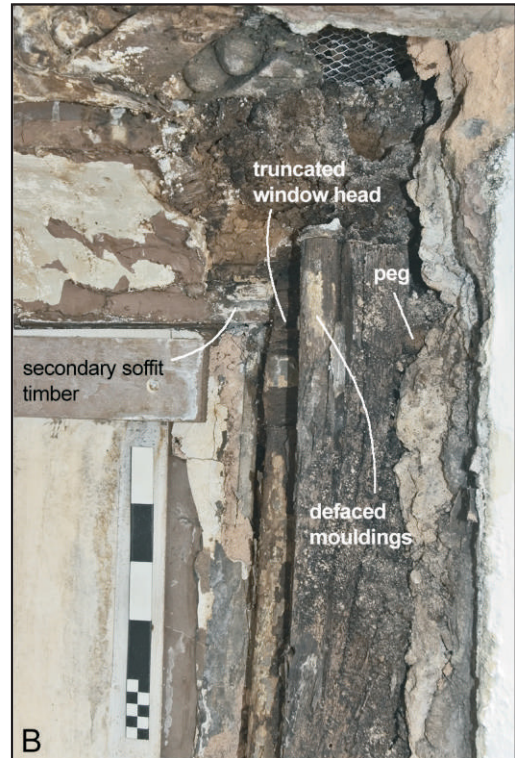
Pl. 7 Views of the first-floor corner post at the west end showing (A) overview with truncated head and sill beams, (B) detail showing the position of a tenon peg and the remains of mouldings. Scale 0.25m. View south-east.

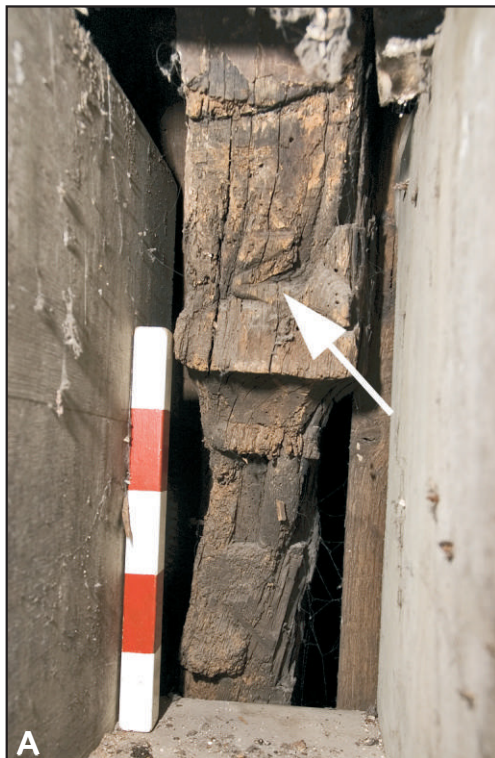
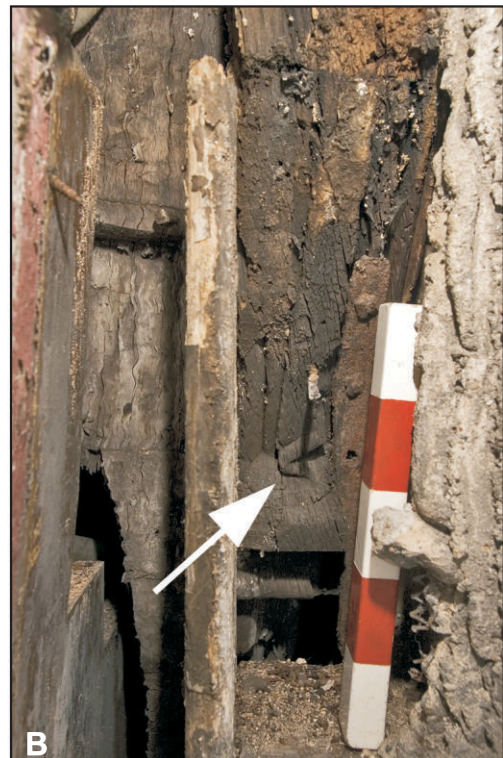
Pl. 8 Details of the first-floor corner jetty brackets showing similar remains of carving detail possibly depicting draped clothing. (A) east-end jetty post. (B) west-end jetty post. Scale 0.25m. View south-east.

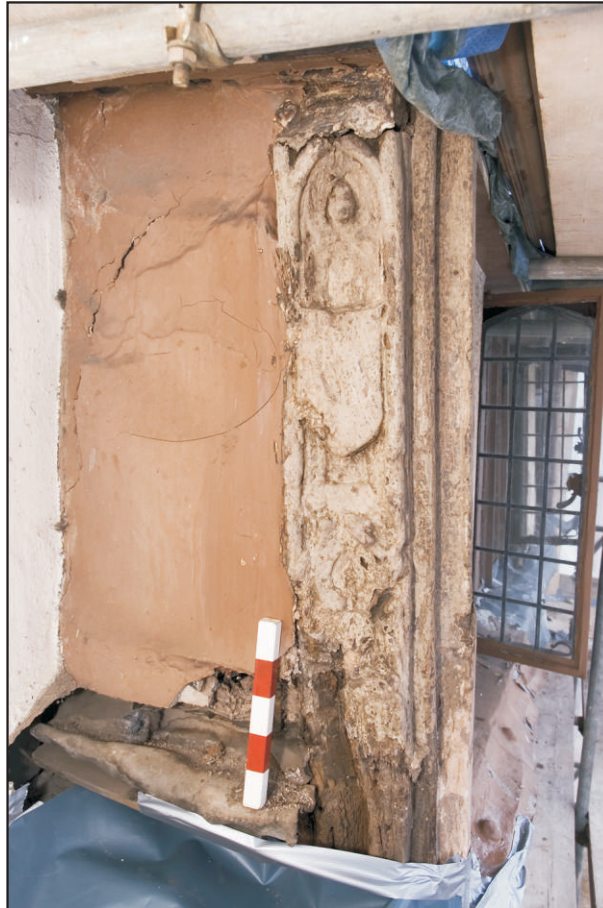
Pl. 9 View of the second-floor corner post at the east end showing lancet and shield carvings after limited paint stripping. Scale 0.25m. View south-west.

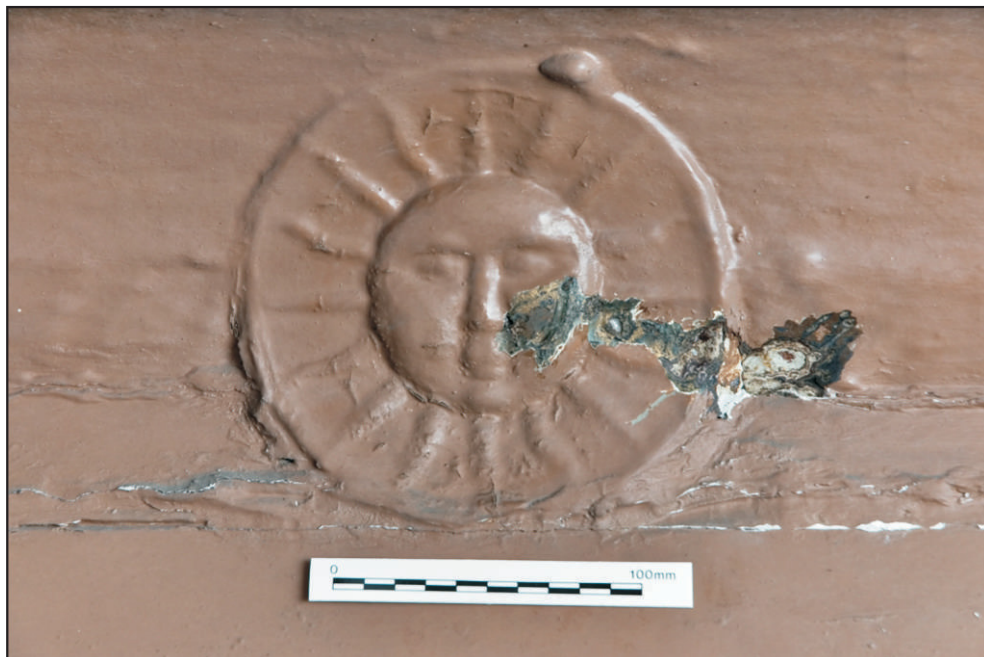
Possibly contemporaneous with the eastern angel is the insurance plaque fixed to the coved head-beam beneath the moulded girding beam (Pl. 10). Signifying the owner to be a signed-up member of a fire insurance scheme, these plates along with their associated policy number would ensure that, in the event of a fire, the relevant company's own fire fighters would attend the fire. This particular emblem bearing the image of a sun is, not surprisingly, the mark of the Sun Fire Office which was established in 1710. This particular plaque appears to be a later variety pressed from a tinned iron plate. Scraping of the paint layers on the plaque revealed a thinner coating overall compared to the underlying timbers and some signs of gold paint or leaf were visible.

Pl. 10 Detail of the C18th/early C19th fire insurance plaque attached to the first-floor covered window head. The sun emblem appears to be pressed in tin-plated iron. Scale 100mm. View south-east.

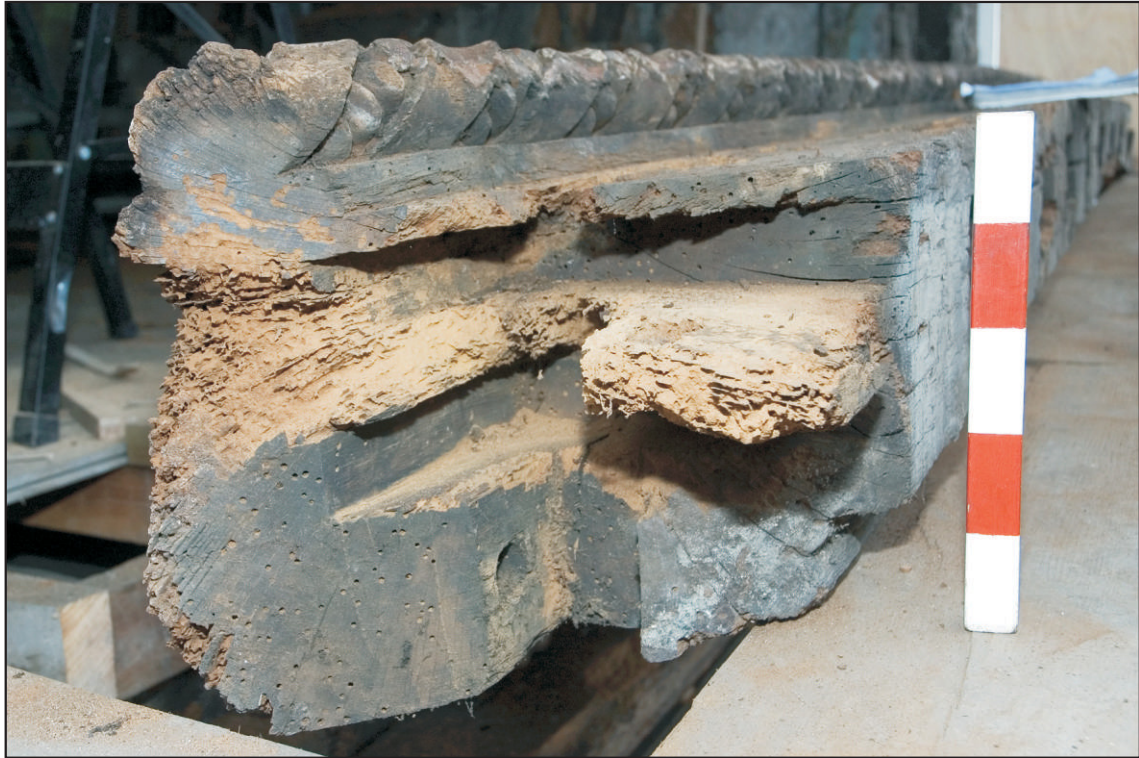
Pl. 14 Detail of the second-floor moulded girding beam after removal from the facade showing the mitred joint incorporating three interwoven tenons. Note the mortice with peg hole for the upper corner post. Beam is viewed upside down. Scale 0.25m.

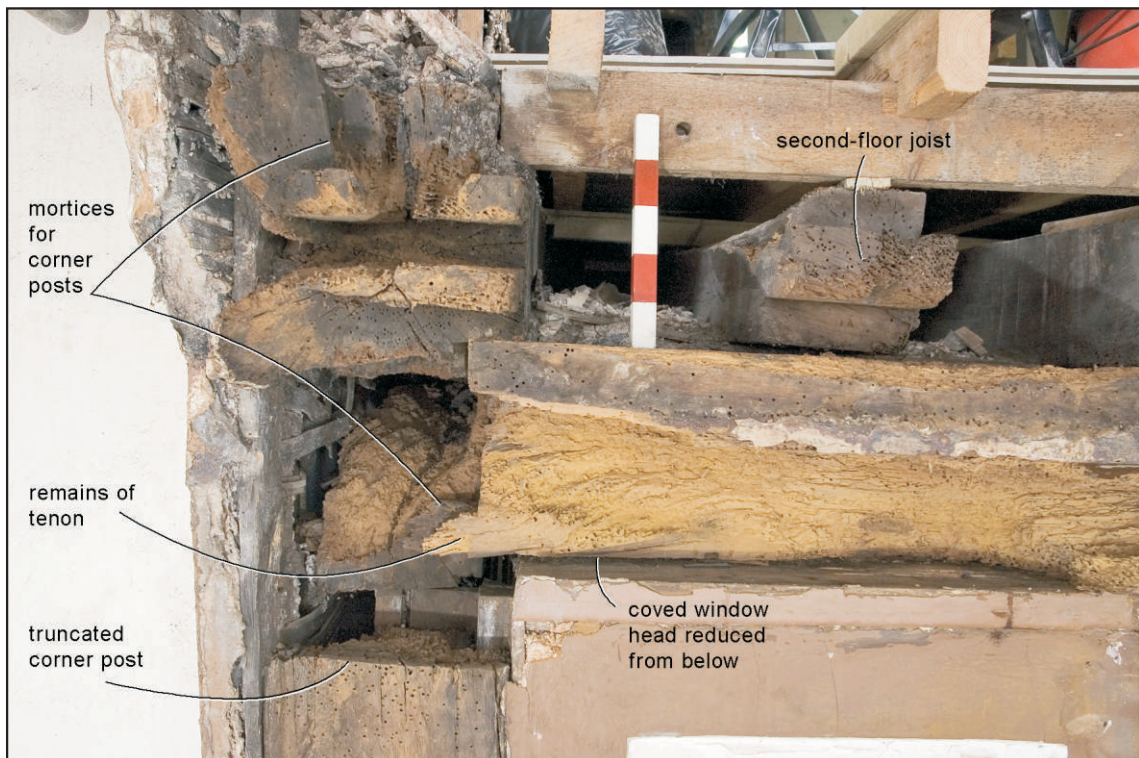
Pl. 15 Detail of the east end of the second-floor covered window head showing the remains of joints to adjacent timbers and the resulting gap created by truncation of the head beam following the insertion of later windows. Scale 0.25m. View south-east.

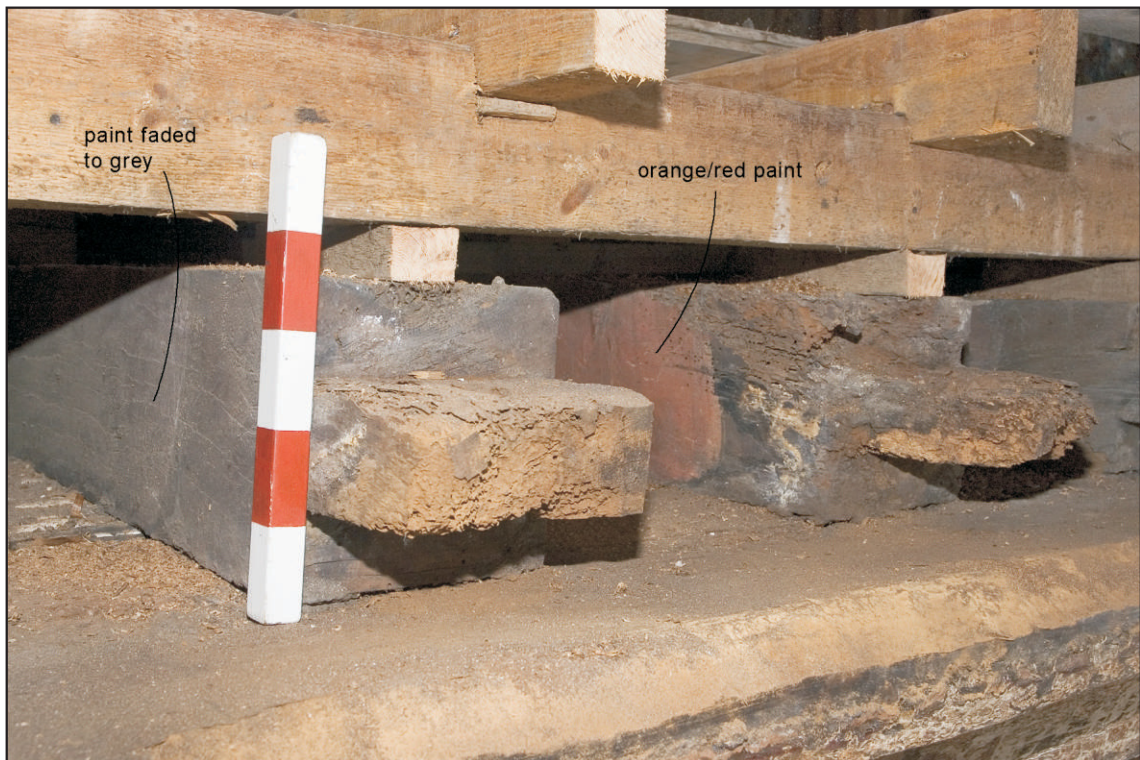
Following the removal of the moulded girding beam from the ends of the second-floor-joists, it was possible to examine these timbers. They were found to have been painted in a colour scheme of orange/red and another colour now faded to grey. The joists were painted alternately in the two colours with no discernible pattern with each timber coloured the same on both sides and presumably the soffits as well though this was not verified, because the present ceiling conceals them (Pl. 17). During the works, floorboards were lifted adjacent the front on the first and second floors. The opportunity was taken to draw the positions of the joists (Figs. 8A, 10). It was also noted that considerable reinforcement had been applied to the first-floor-joists at the same time as providing attachments for timber framing beneath the modern shop jetty. The present second floor has been wedged level with packing timbers and beams over the original joists to counter the slump of the façade.

Pl. 17 View of the second-floor joists, after removal of the girding beam, showing alternate colours painted onto both sides and also presumably the soffits. Scale 0.25m. View south.

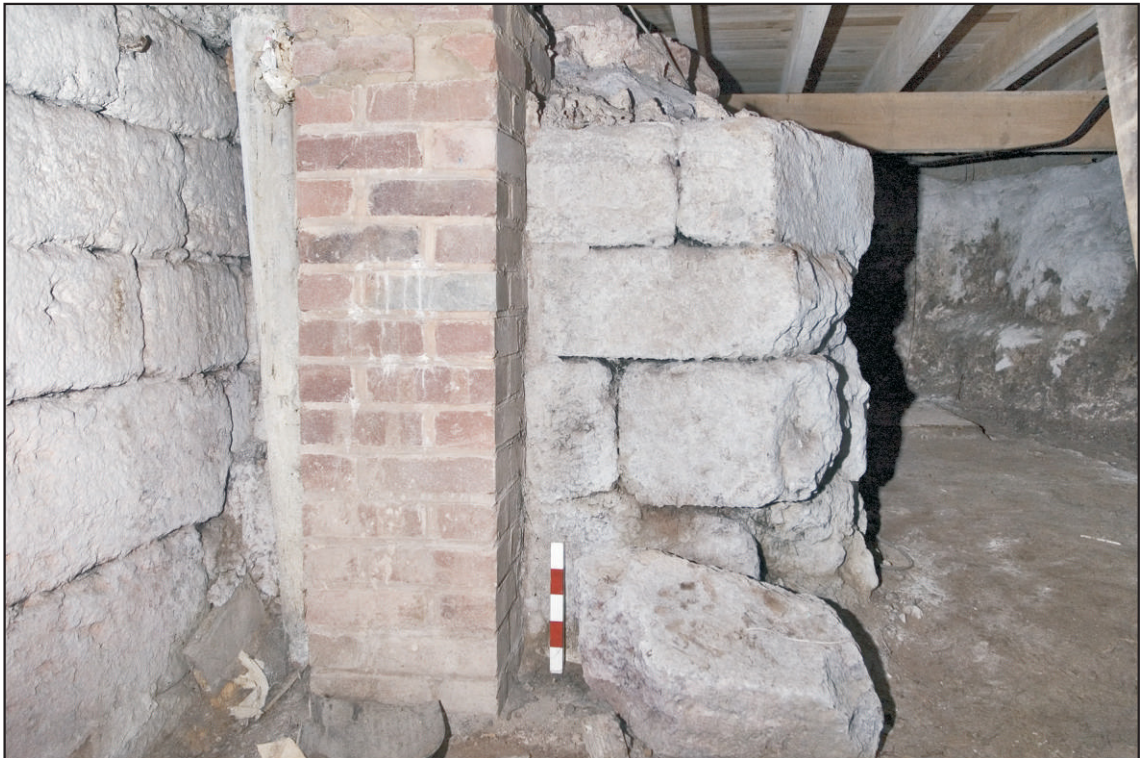
At the rear of the room was evidence for a cellar light in the south-east wall. It had been broken through and the ground beyond roughly dug out without revetments. The stub of wall on the north-east side of this breach bore a splay suggesting a probably narrow window (Pl. 19).

Pl. 19 View of the stump of the breached south-eastern cellar wall showing the splayed reveal of a former window. Scale 0.25m. View south-east.

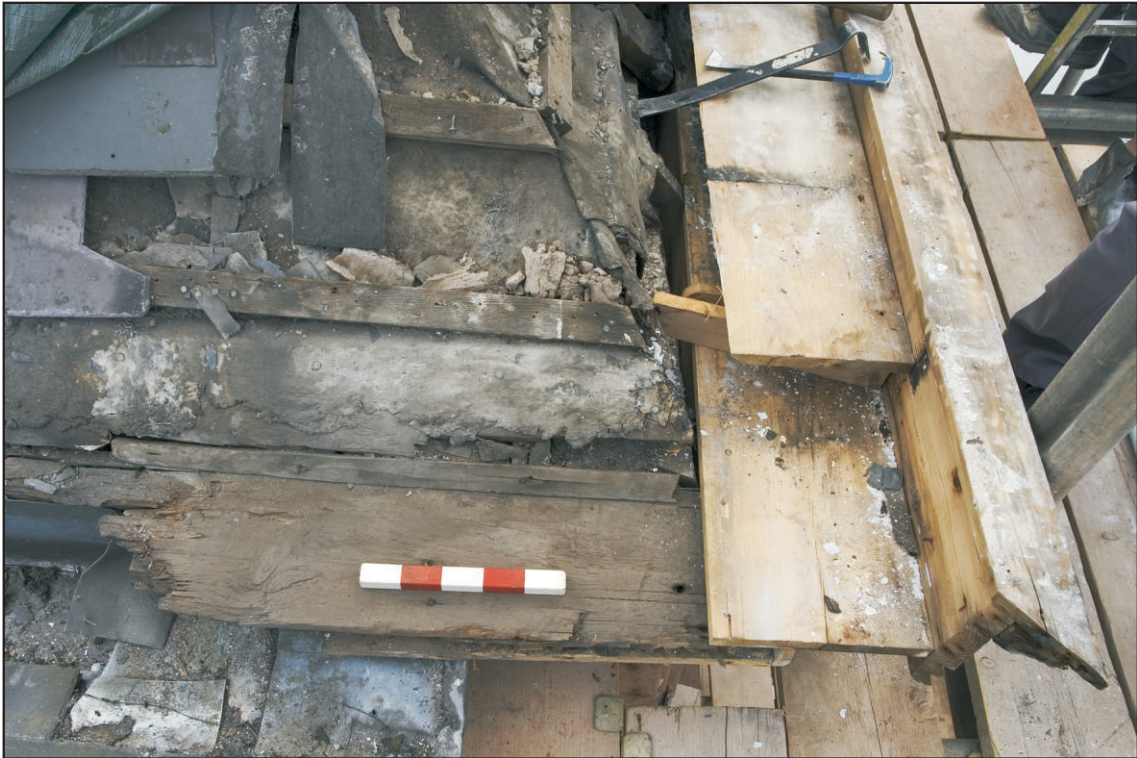
During the repairs to the roof drainage, slates and flashings were raised on the north-east side of the building. This exposed the remnant of a horizontal plank which, from its position, must have been the original base board of a parapet gutter (Pl. 20). The rafters of the eastern pitch of the roof support this in ending well short of the length required for eaves. This parapet probably extended around the whole frontage of the building, perhaps finished with a crenellated top. The shallow roof pitch would have rendered the roof largely invisible from the ground, giving the building a rather imposing fortress-like appearance.

Pl. 20 View of the north-east corner of the roof showing the remnant of a timber base to a former parapet gutter that was later made redundant following the in-fill of Lamb Alley with No. 45. Scale 0.25m. View south-west.
