**A SECONDARY PHASE OF
ARCHAEOLOGICAL MONITORING AT
8 COLLETON CRESCENT, EXETER**

Exeter Archaeology

Report No. 10. 87

Project No. 7282

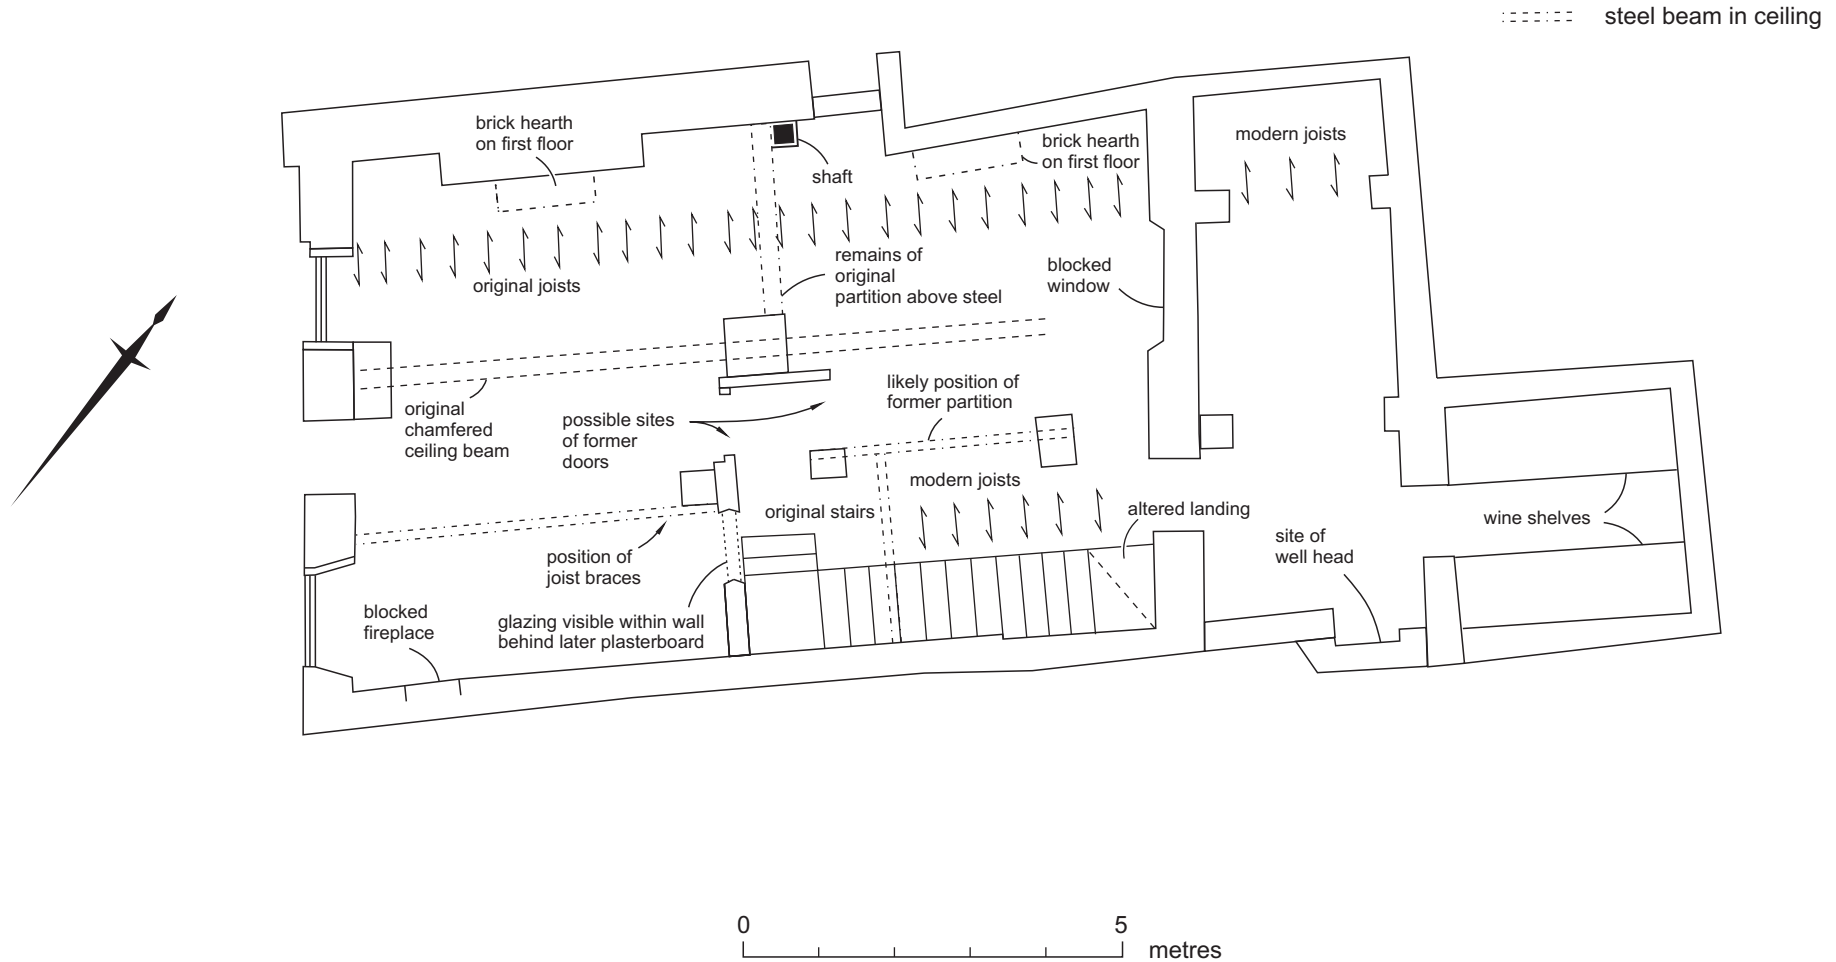
Fig. 1 Plan of the basement showing features observed. Scale 1:100.

At 5.69m from the front wall is a steel beam at high level that supports the remains of an original brick cross-wall (Photo 4). At 2.69m above ground the original brickwork is built into the north-west wall. It is supported at its south-eastern end by the same concrete block pillar that supports the paired steel beams running lengthways through the building. On the south-eastern side of this pillar, more original brickwork was visible indicating a former wall running lengthways in the centre of the basement. This lay adjacent to original studwork that suggested a partition wall on the line of the existing wall at the bottom of the main flight of the stairs. There were mortices within the timbers along with an extra stud that suggested a possible former doorway at the foot of the stairs into the front room(s). Further to the south-east within the same cross-wall, glazing behind plasterboard was visible (Fig.1). This was later opened up for a new doorway exposing a modern stair light window.

8, Colleton Crescent
Basement Plan
Features

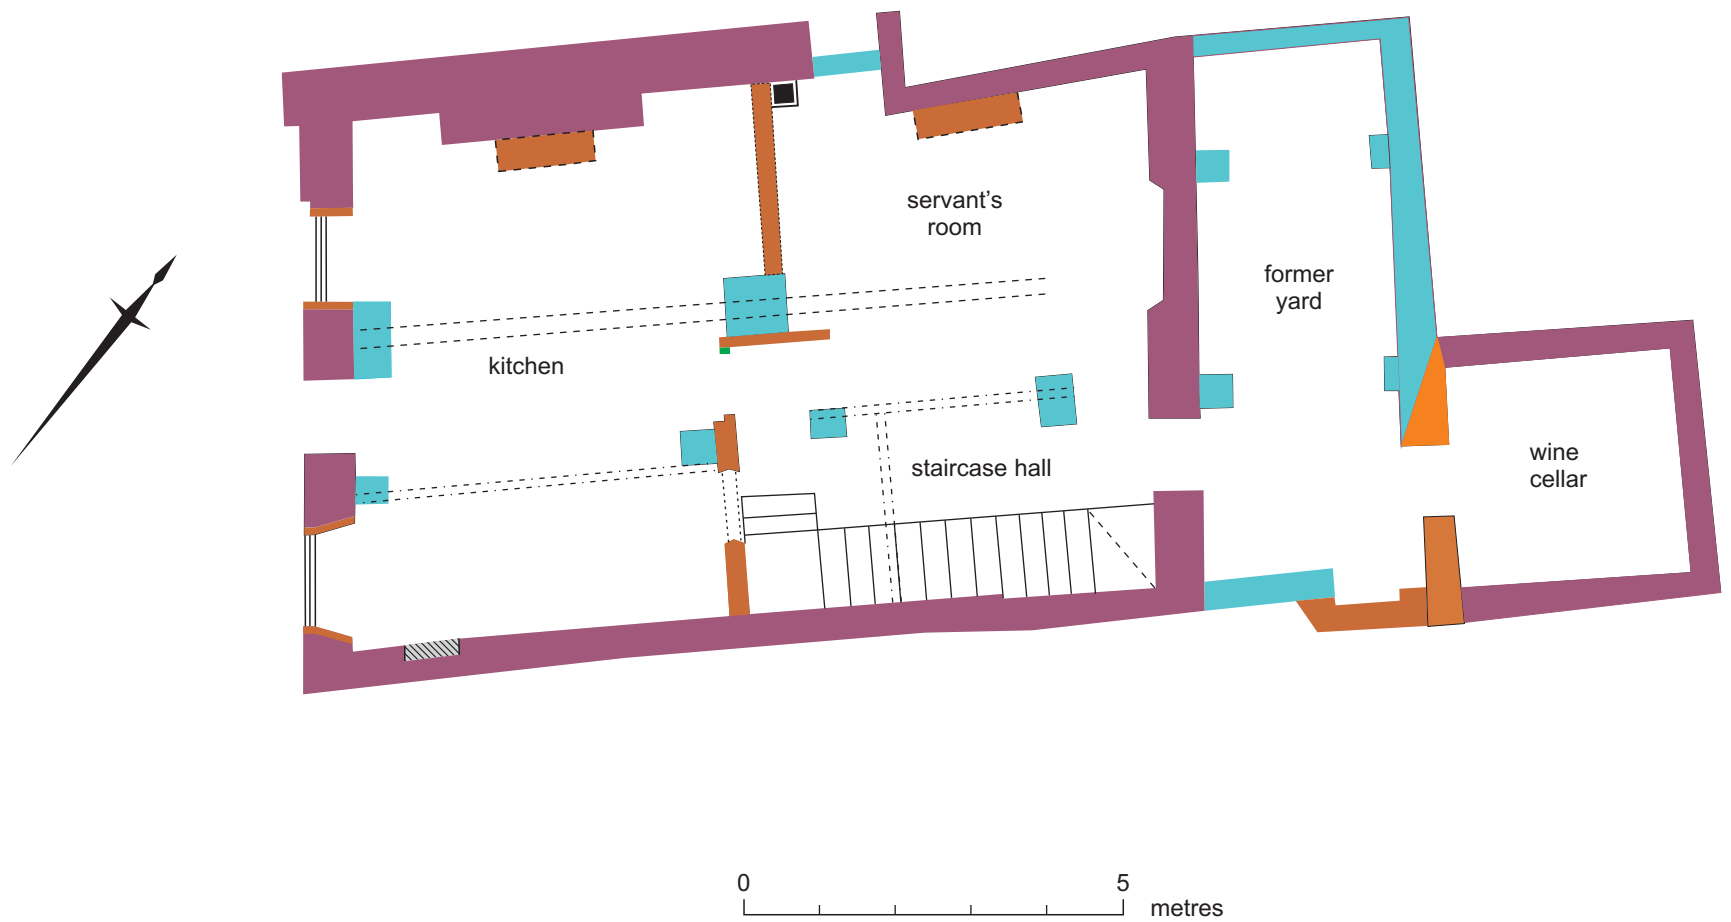
Fig. 2 Plan of the basement showing the existing fabric and suggested room layout. Scale 1:100.

Although the direct evidence for the original internal room divisions within the basement is small, there is enough, together with other circumstantial indications, to develop a plan of the original layout. The original chamfered beam displayed no evidence for studwork timbers beneath it and therefore must have been supported on columns or cross-walls. With no evidence for column support this implies that this beam was positioned near midway in the room between supporting walls. Therefore, if there *was* a partition at the front of the basement it is likely to have been between the front door and the south-east window. However, this was where a row of apparently original joist cross-braces were seen (hardly necessary if a partition wall is present). The blocked fireplace in the south-east wall appears to be a later insertion as the bonding mortar of the brick flue differs from the surrounding stonework. A partition may have been inserted at some later date, forming a room at the south-east end of the basement. In the primary phase of the house, however, the front of the basement appears to have been a single large kitchen room (Fig. 2).

The original room layout at the rear of the basement is defined by the remains of brick partition walls and studwork. The high-level remnant of the brick cross-wall, midway within the basement, defines the division of the rear room from the kitchen on the north-west side (Photo 4). The eastern boundary to this room is suggested by the remnant of brick wall near the foot of the stairs. A door is suggested from the kitchen to the rear of the building by way of the exposed studwork in the centre of the basement. This suggests a door in line with the front door of the basement. The blocked window in the rear room would have been centrally placed within the room's back wall (Fig.2).

8, Colleton Crescent
Basement Plan
Existing Fabric

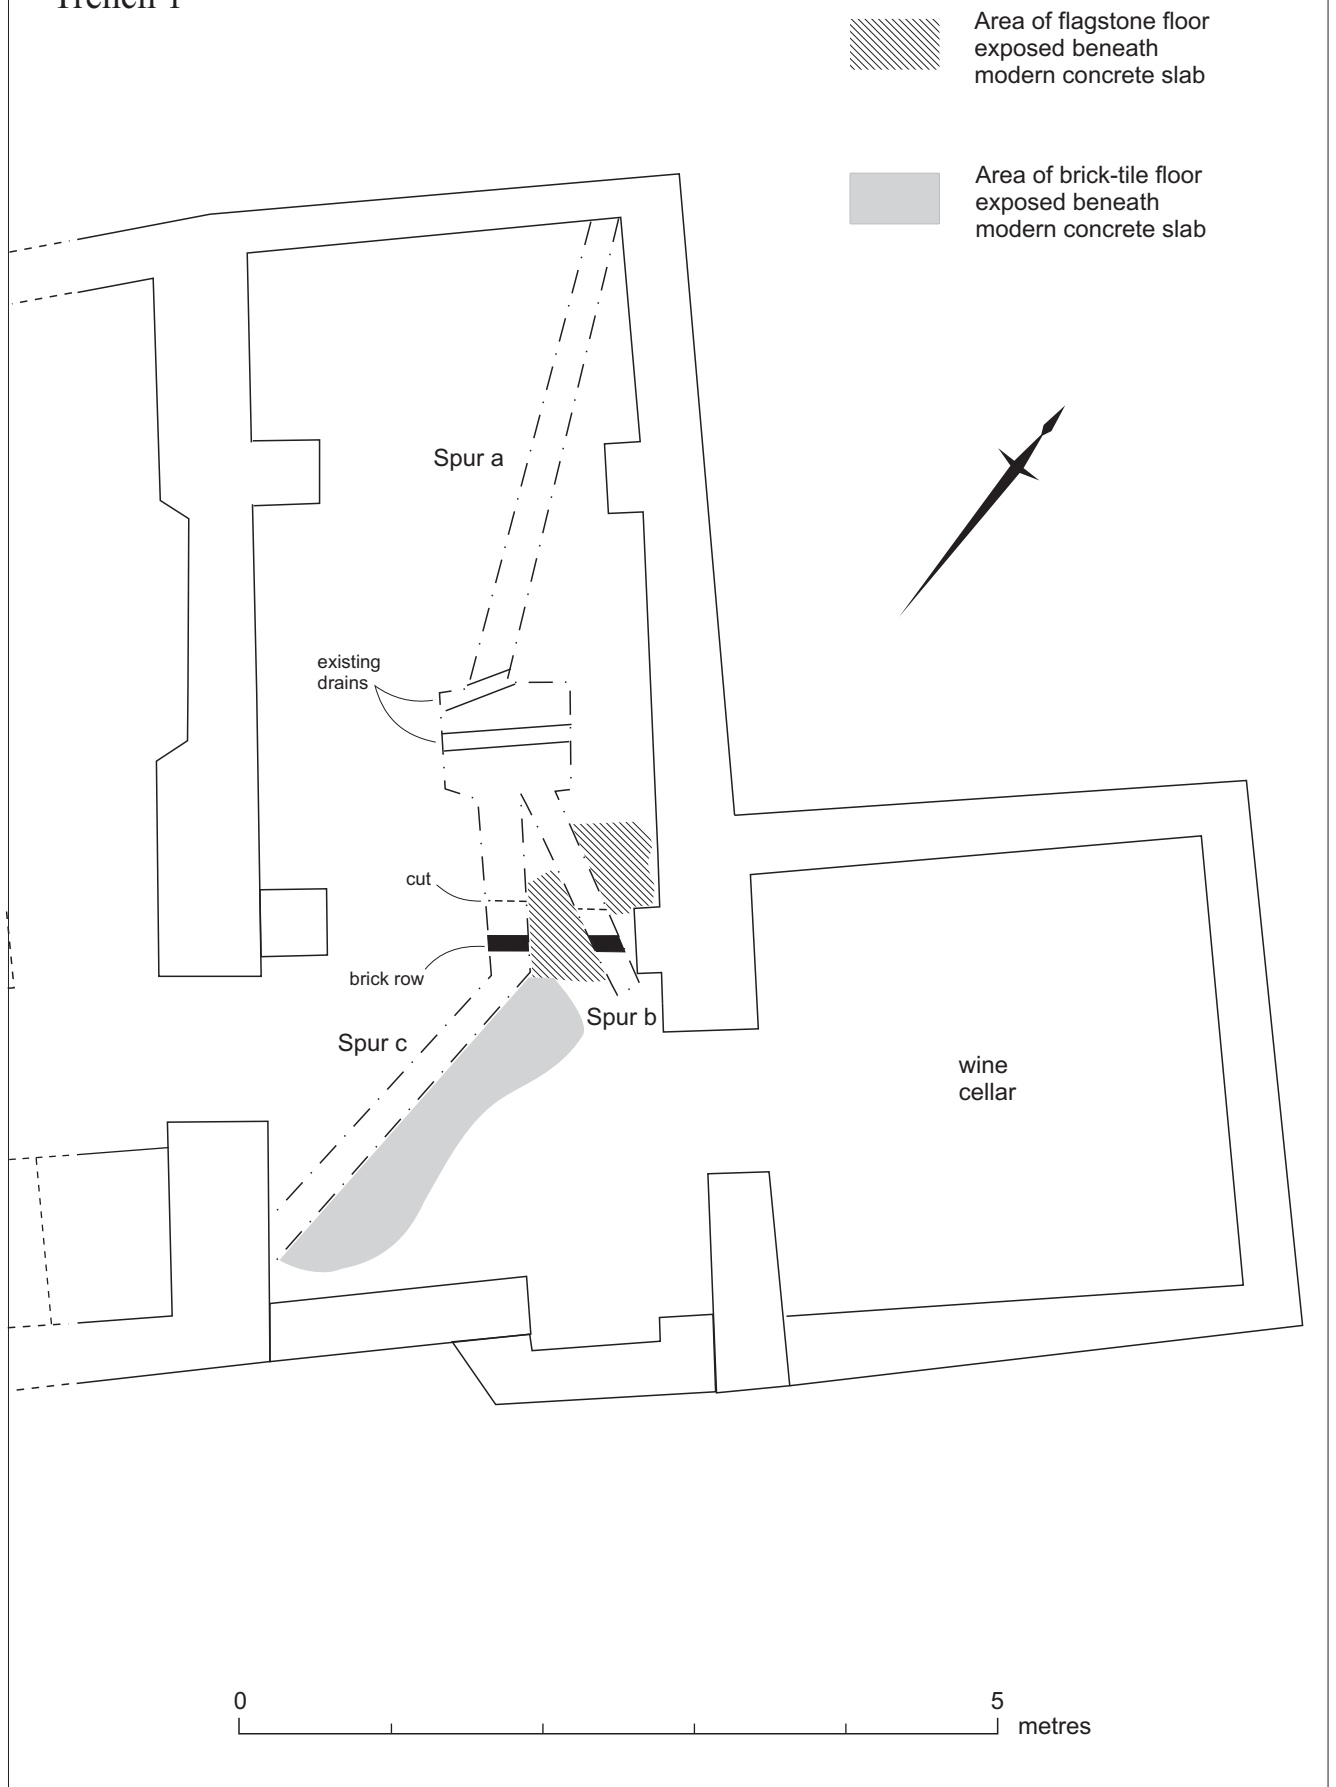
Fig. 3 Plan of the basement showing the location of drainage Trench 1 and the areas where stone and brick-tile flooring were revealed in section. Scale 1:50.

The extent of the paving was limited. Beginning at 3.90m from the north-west wall it continued south-eastwards to 4.84m where it was replaced with 40mm-thick brick floor tiles. These surfaces were exposed in section within Spurs b and c of the trench as illustrated (Fig. 3). Cutting the natural subsoil in Spur b of the trench from $c.4.50$ m to $c.4.67$ m from the north-west wall was an area of concrete, infilling the base of the trench at 0.47m below surface. A similar cut was visible in Spur c at $c.4.48$ m to $c.4.70$ m from the north-west wall, with reddish brown gritty clay in place of concrete. The eastern limit of this cut-out was edged with a single row of bricks, present in both trench spurs, on a bearing of $c.220^\circ$. Immediately east of the bricks in both spurs appeared to be firm, purplish brown, natural clay subsoil.

8, Colleton Crescent
Basement Plan
Trench 1

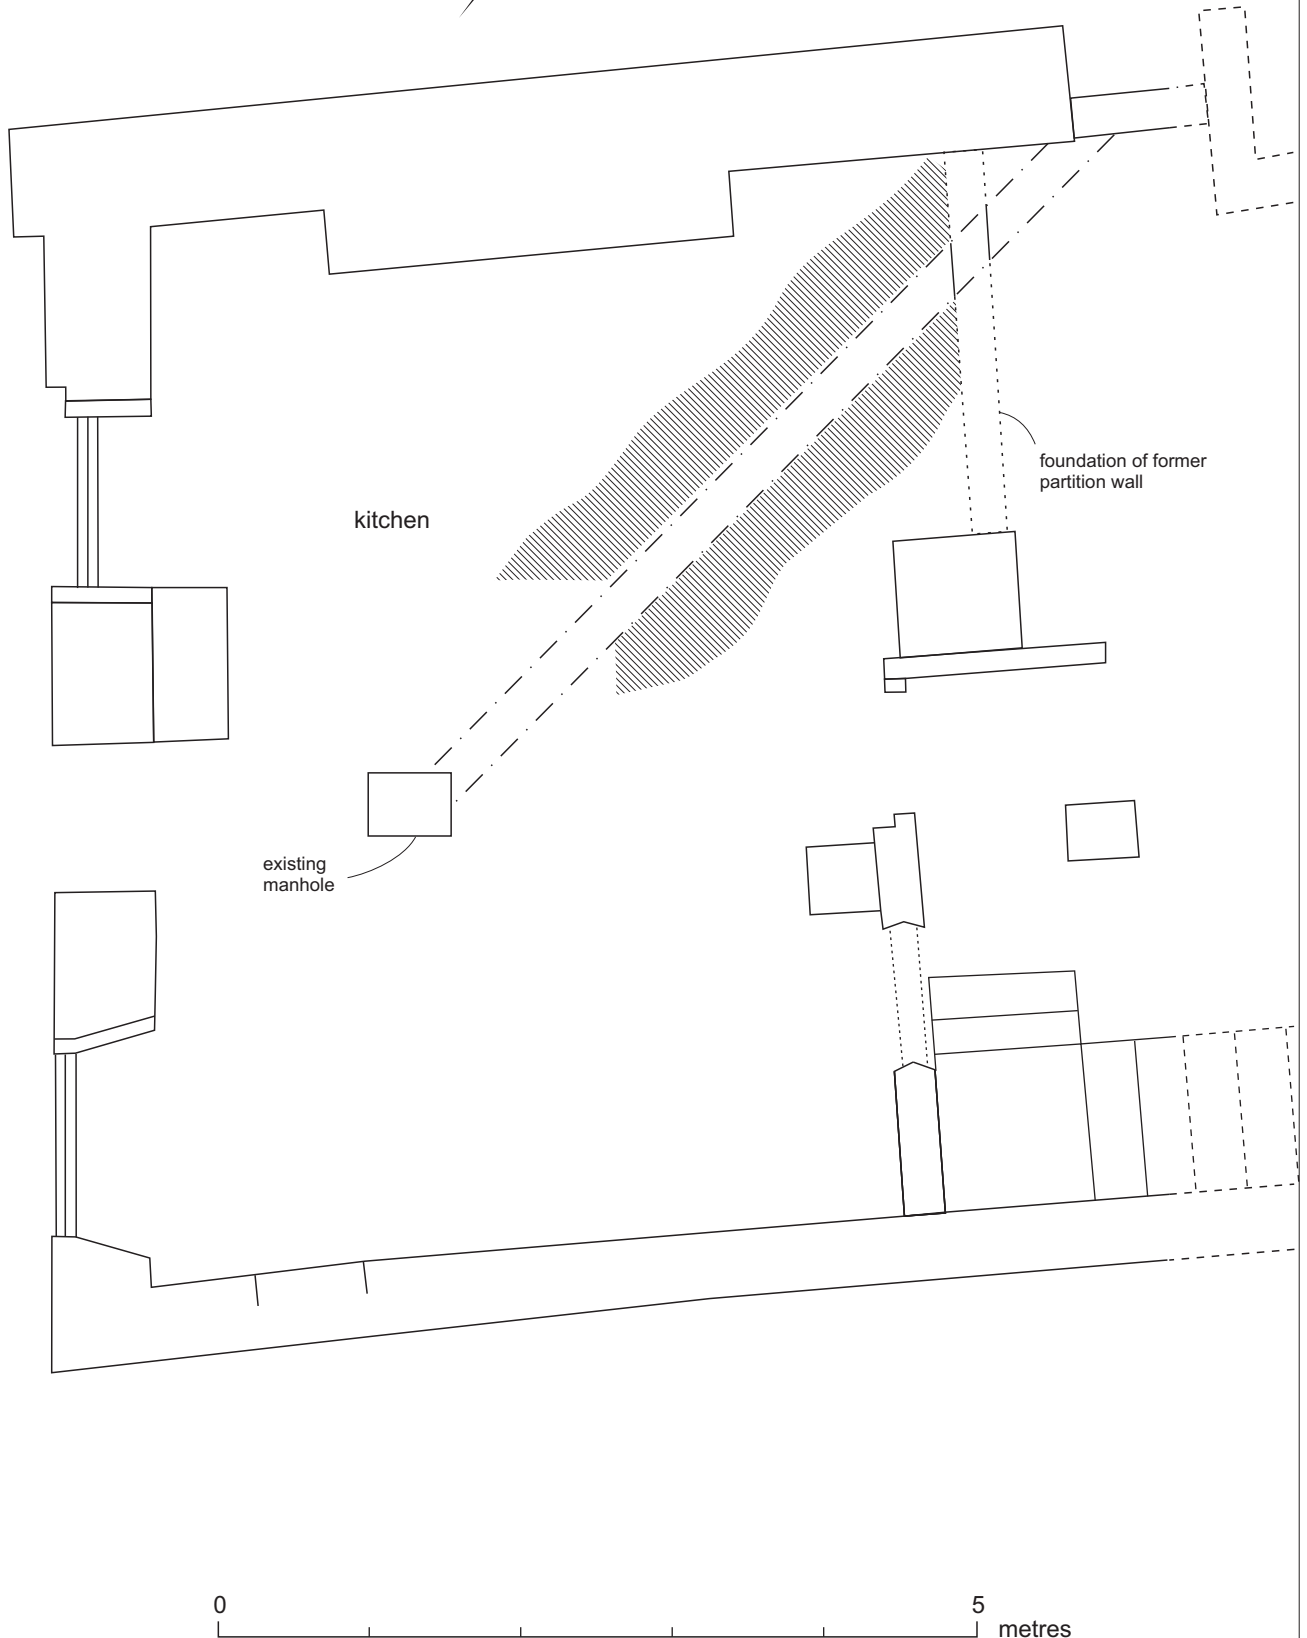
Fig. 4 Plan of the basement showing the location of drainage Trench 2, with the shaded area indicating the approximate position of flagstone flooring exposed in section. Scale 1:50.

A further drainage trench (Trench 2) was dug in the front basement room to connect to an existing manhole $c.2.00$ m north-east of the front door (Fig. 4). The 300mm-wide

8, Colleton Crescent
Basement Plan
Trench 2

Area of flagstone floor
exposed beneath
modern concrete slab

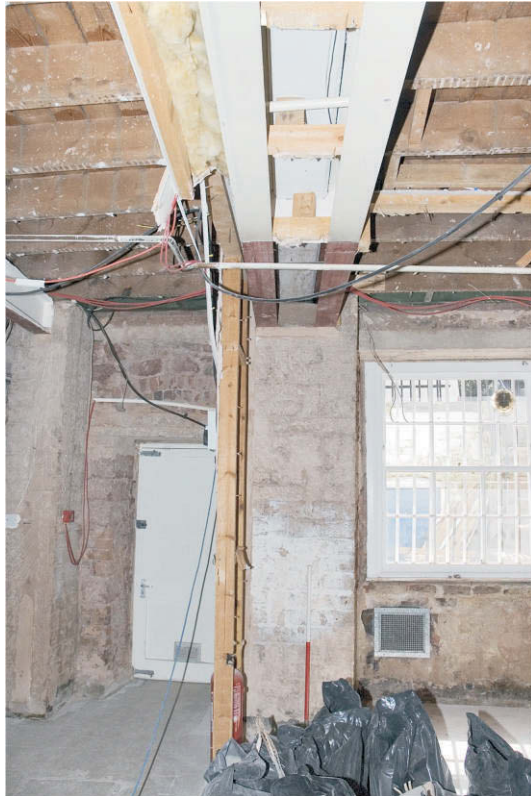
The C20th ceiling plaster was removed exposing original joists measuring 230mm x 40mm with evidence of the former lath and plaster ceiling. The joists exposed in the front room were supported by three steel beams, supported themselves by blockwork pillars. A pair of steel beams lay to either side of an original chamfered timber beam running lengthways through the building (Photo 1). Positioned between the front door and the north-west window, it extended almost the full length of the basement, stopping 1.36m short of the original rear wall (Fig. 1). The beam measured c.250mm x 280mm deep and the southern end exhibited the remnants of a possibly original pale

Photo 1. The front basement room showing the original chamfered ceiling beam flanked by a pair of modern steel beams. Scale 1m. View south-west.

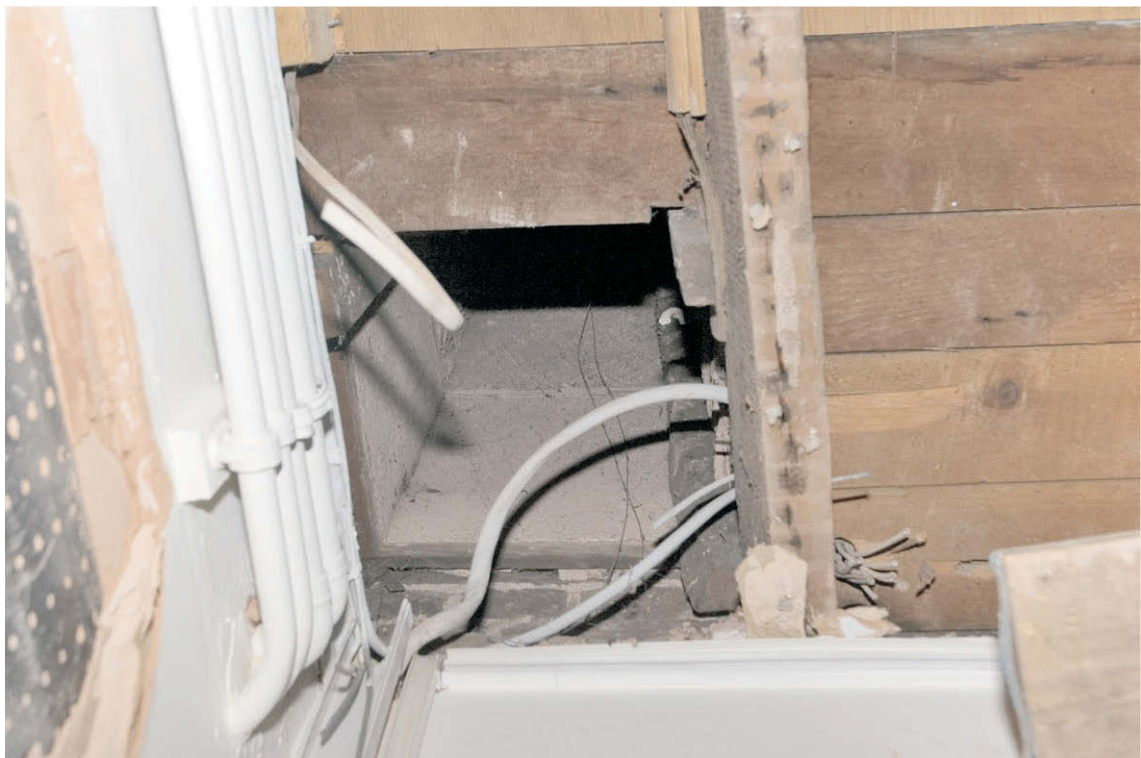
A shaft was seen running through the ground-floor rear room as seen from the basement which perhaps served as a service lift. This was situated on the north-west wall just north-east of the steel beam that supports the remains of an original brick partition.

Photo 2. View of the possible service lift as seen from the basement rear room on the north-west side. View north-west.

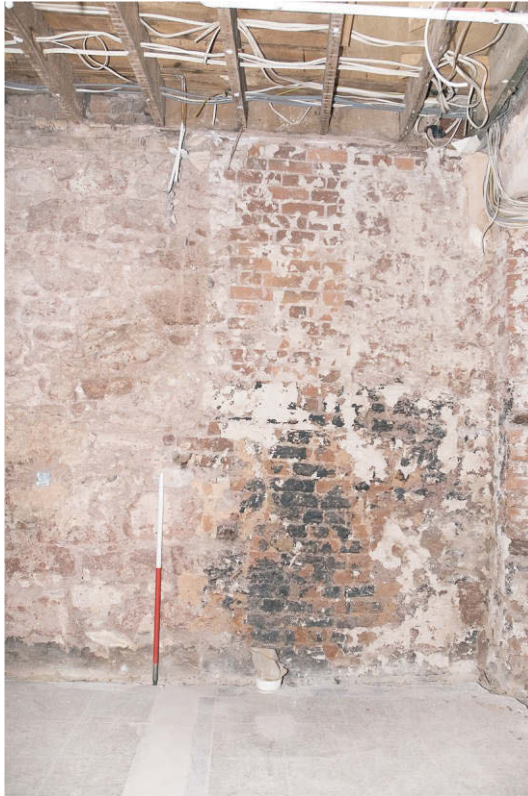
The south-east wall was largely stone, apart from three coarse-textured bricks set in a row and a floor-to-ceiling column of brickwork towards the south-west end. This latter constituted a former flue, now blocked (Photo 3). The upper section of brickwork, representing the chimney flue, consisted of coarse-textured mid-brown bricks bonded in a pale buff lime mortar that differed from the surrounding stonework. This extended from 1.37m from the floor to the top of the wall and from 0.80m to 1.45m from the front wall. The blocking-brickwork of the former fireplace was also of mid-brown coarse-textured bricks, but bonded in a sandy, friable, light brown lime mortar. The brickwork of the blocking extended from 0.63m to 1.38m from the front wall. These bricks had the remains of a black pitch coating on their faces.

A brick stack was exposed in the south-east wall of the kitchen, now blocked. The bricks were bonded in a pale buff lime mortar that differed from the surrounding stonework suggesting this was a secondary insertion.

Photo 3. The front basement room showing the brick chimney flue with brick blocking exposed in the south-east wall after stripping. Scale 1m. View south-east.

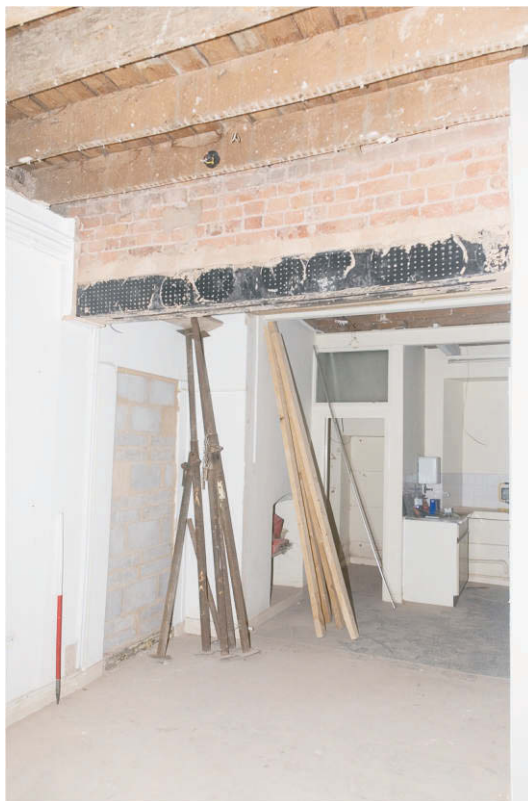
The upper section of an original brick partition wall survives above a steel beam on the north-west side of the basement. Brick footings for this wall were also seen during groundworks.

Photo 4. The front basement room showing the high-level remains of an original brick partition wall, supported by steelwork, that divided front from rear rooms on the north-west side. Scale 1m. View north.

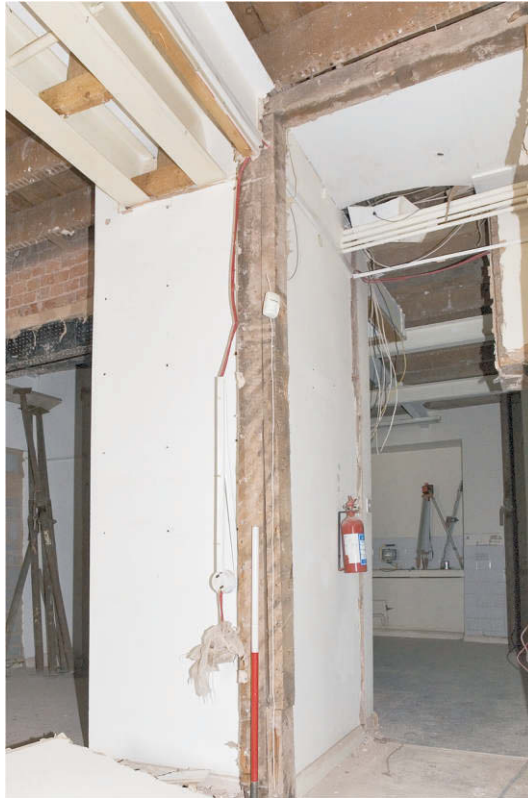
Photo 5. Original studwork between the front and rear rooms of the basement on the south-east side, with mortices for a stud and a possible door-head beam. Scale 1m. View north.

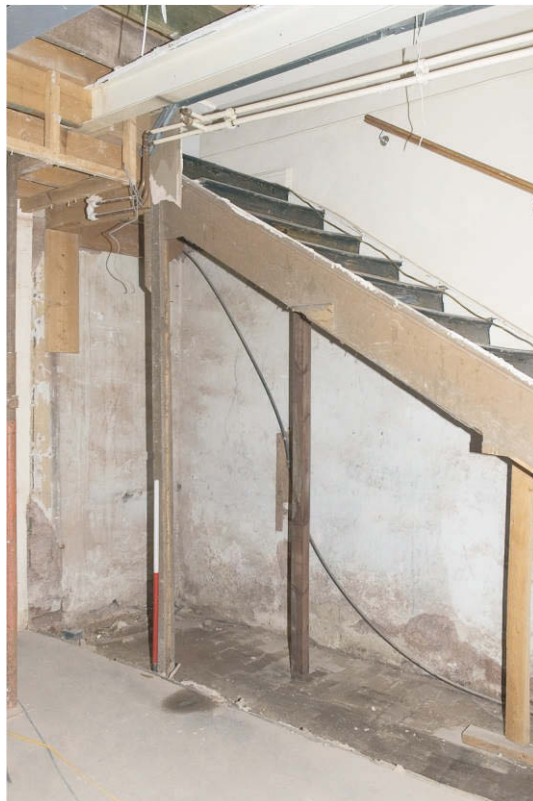
Exposed fabric above the stairs revealed cutaways in the joists to allow sufficient headroom. The original closed string of the stairs was exposed revealing a cavetto moulding (Photo 6). Below the stairs, alterations to the original quarter landing at ground-floor level could be seen, showing a riser had been eliminated. On the ground beneath the stairs an original brick floor surface was exposed with a slot beneath the outer edge of the stairs, presumably for timber framing. The original wine cellar in the north-east corner of the Basement remained unchanged (Photo. 10).

The closed string of the stairs was revealed with a cavetto moulding.

Photo 6. View towards the original basement stairs with an original brick floor below, exposed after the removal of a screen wall. Scale 1m. View east.

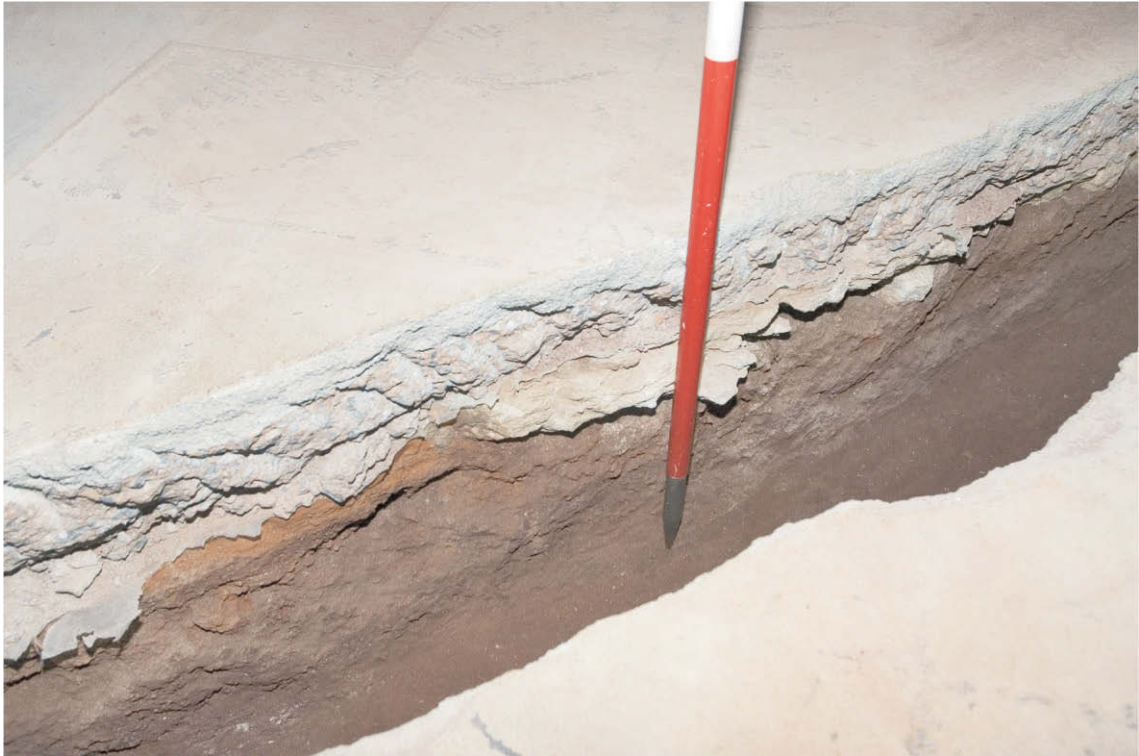
trench ran from the blocked door in the north-west wall in a north-south orientation. The excavation cut through 200mm of concrete over a plastic damp-proof membrane. Beneath the membrane over much of the area were flagstones of the same pale greenish-buff Purbeck stone seen in the rear of the basement (Photo 7). South of a point *c.*2.40m from the large concrete block stanchion at the front of the basement, the flagstones had been removed. In their place was a layer of red sand of varying thickness up to a maximum of 50mm. Whole flags appeared to have been removed prior to the concrete floor, as there were no broken slabs visible and the polythene DPM overlay the red sand. Beneath the DPM and the flagstones was a make-up layer of mid-brown gritty sand containing brick fragments and lime mortar lumps. This lay on purplish brown gritty natural clay at a maximum depth of *c.*0.37m. At the extreme north end the edge of excavation was higher than the natural subsoil. The depth of the trench extended from *c.*0.28m at the north to 0.60m at the south on a gentle incline towards the manhole.

Photo 7. View of the drainage trench in the basement front room showing the southern limit of a flagstone floor below the modern concrete. Scale 1m (0.50m in view). View north-west.

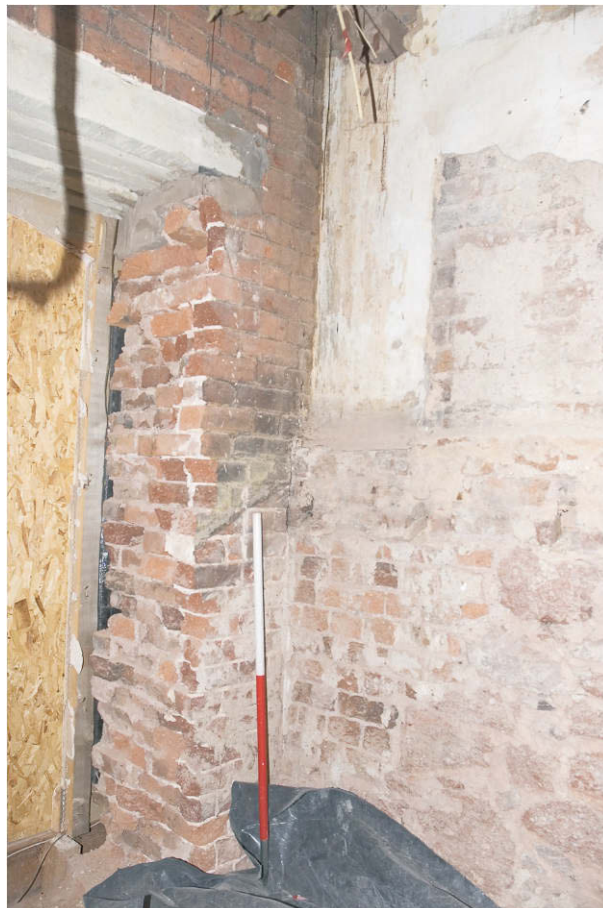
The adjacent door in the north-west corner was exposed on the exterior wall. This was shown to be a later insertion with bricks crudely forming the new jambs of the opening (Photo 8). Above the doorway was a modern concrete lintel.

Photo 8. View of the original brickwork of the rear wall of the building at ground-floor level, showing the inserted door, with a concrete lintel, in the north-west corner. Scale 1m. View west.

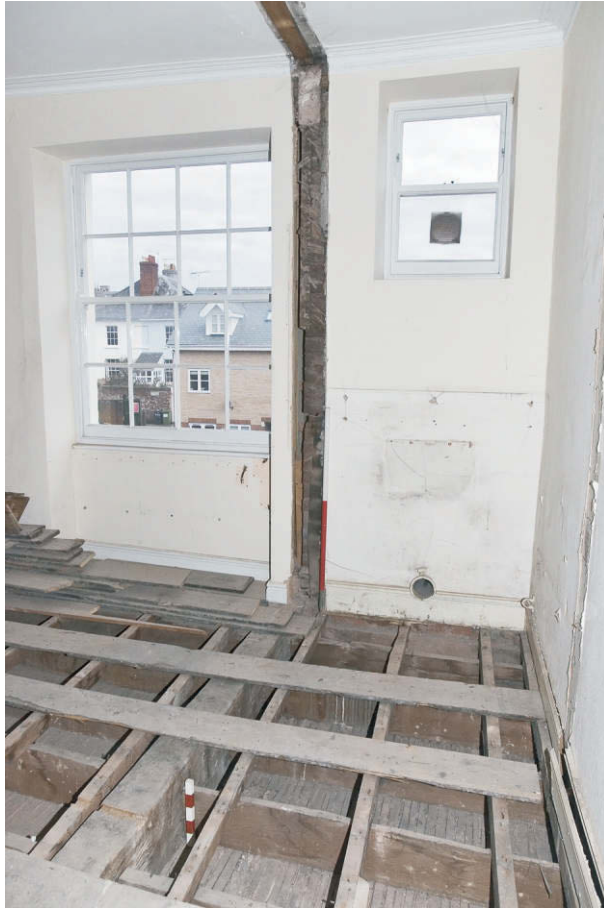
Floorboards were lifted throughout this floor revealing a similar large central beam running from front to back, this time meeting the rear wall. The removal of a modern toilet partition in the north-west room exposed the splay for the original window in the rear wall (Photo. 9). The front rooms on this floor appear to be original with the stud wall supported by a large beam extending from the front wall and into the Hall. The removal of a late bathroom in the north-west room leaves only original partitions remaining.

Photo 10. The second-floor rear room following the removal of a modern partition and the raising of boards, exposing a large floor beam and the original window splay in the rear wall. Scale 0.25m. View north-east.

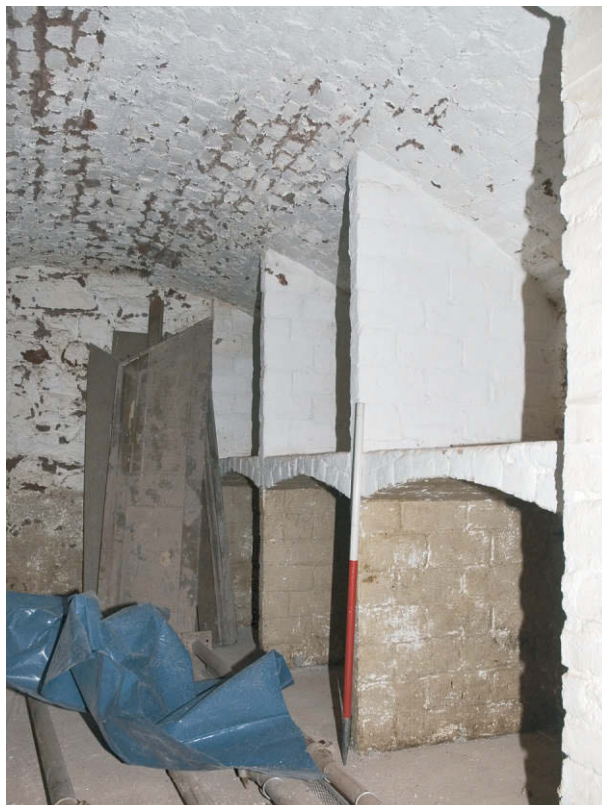
Photo 11. A view of the wine cellar in the north-east corner of the Basement. Scale 1m. View north-east.
