**Historic Building Survey of Nine Buildings at Hazelden Farm,
Marden Road, Cranbrook, Kent, TN17 2LP
with Results of the Watching Brief on the Barn**

**Project No: 4062
Site Code: HAZ09**

ASE Report No. 2010086

May 2010

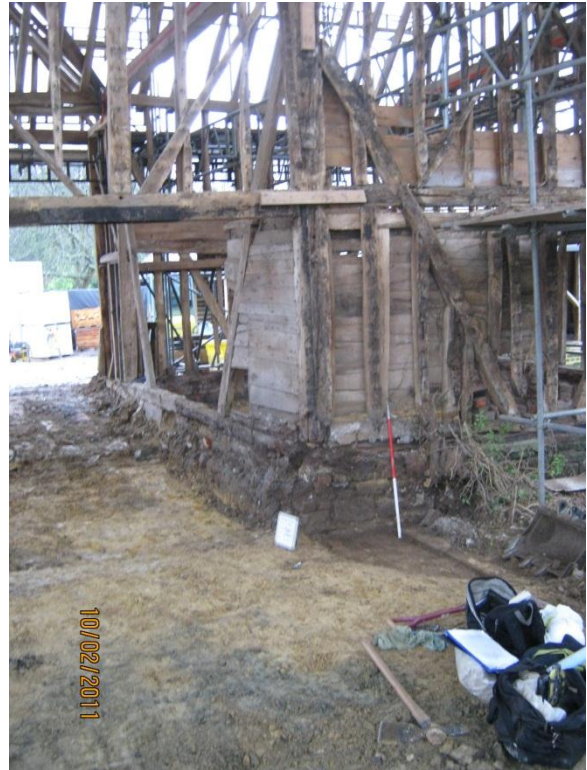
A Watching Brief carried out within the footprint of the barn during ground reduction revealed three features of 19th-century or later origin. A small brick platform or base was located within the 20th-century rear extension, respecting the limits of that later build. It is suggested the brickwork formed a level, stable base for machinery related to the late addition of grain silos within the barn, the construction of the rear extension and the laying of the concrete screed.

Plate 63: The Barn Watching Brief – brick platform in rear extension abutting Period A rear barn wall

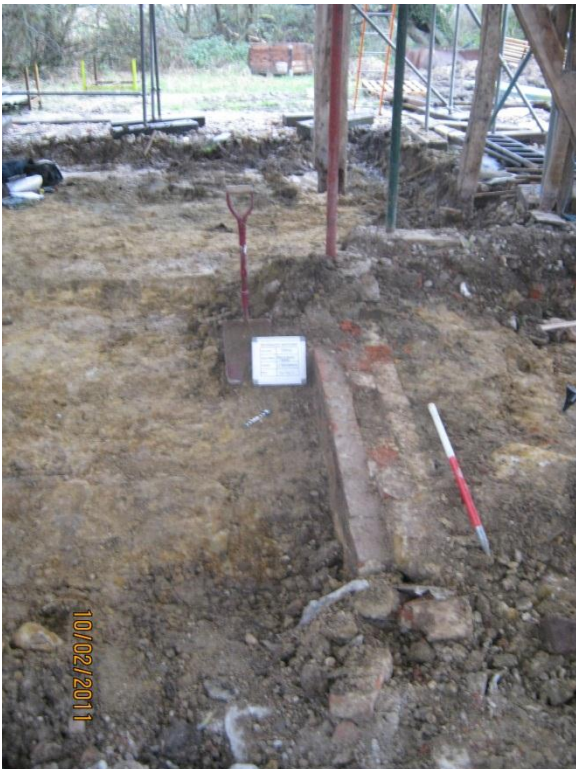
The brick wall footing of a sleeper wall for the eastern truss was also revealed which may represent a later intervention carried out when the east bay of the barn was converted to an oasthouse. The final feature was a drain, situated within the eastern end bay. The drain may have been inserted when the oast was out of use and the building utilised for stock accommodation. All features were cut into the natural subsoil and sealed by a 20th-century concrete screed.

Plate 64: The Barn Watching Brief – the brick footings on the line of truss C-C

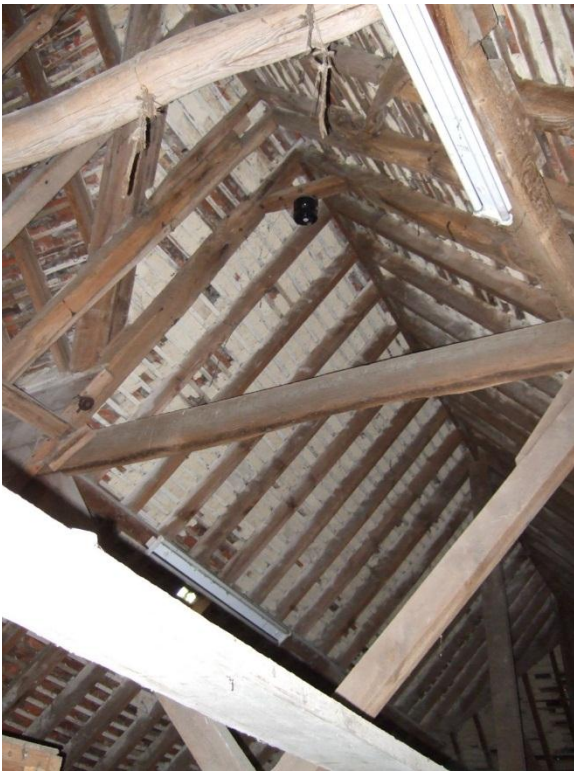
which rafters measure 130 mm x 170 mm below the purlin but only 130 mm x 110 mm above. Each end of the roof was hipped: the northern terminal remains, but the southern hip and associated hip and jack rafters have been removed (Plate 68). The surviving central jack rafter rises to a high-set collar jointed into the principal rafters (Plate 69), which gives the hip a very shallow pitch. Indeed, the roof itself is quite low, and has a relatively shallow pitch, especially considering that it was thatched (evidenced by rope stains). The surviving purlins have now been cut just beyond the collars, though they seem originally to have extended to the hip rafters.

Plate 68: The Oast – Period A southern high-set collar retained but hip removed

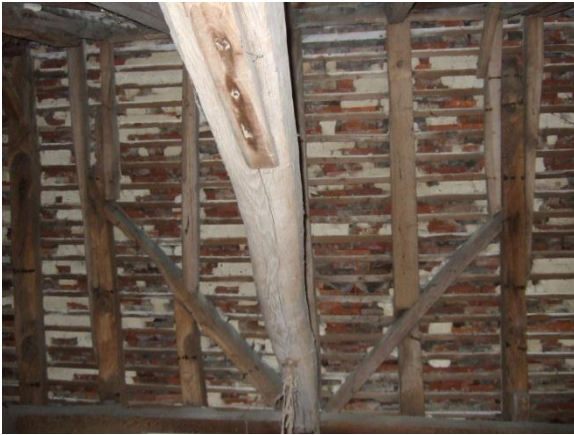
Probably due to the water run-off to which the rafters were now exposed, the ends of the two full-length rafters either side of the conical flue have rotted. This must have occurred after the flue was built, but before the roof was altered again in period C, as, prior to the removal of the flue, repair splints were added to both sides of both rotted rafters. As is indicated by the rope stains which extend across both the original timbers and the new repairs, the roof was still thatched during this period (Plate 70).

Plate 70: The Oast – indications of the location of the Period B cowl, removed. Staining indicates thatch cover before and after cowl insertion

- 7.4.20 The period-B conical flue and cowl were removed and the cut rafters were replaced at this period, the period-C timbers being fixed to a ridgeboard
