**THE FARMHOUSE, STANWELL FARM, BEDFONT ROAD,
STANWELL, SURREY, TW19 7LY**

**HISTORIC BUILDING RECORD
(ENGLISH HERITAGE LEVEL 3)**

Report No. 2012243

December 2012

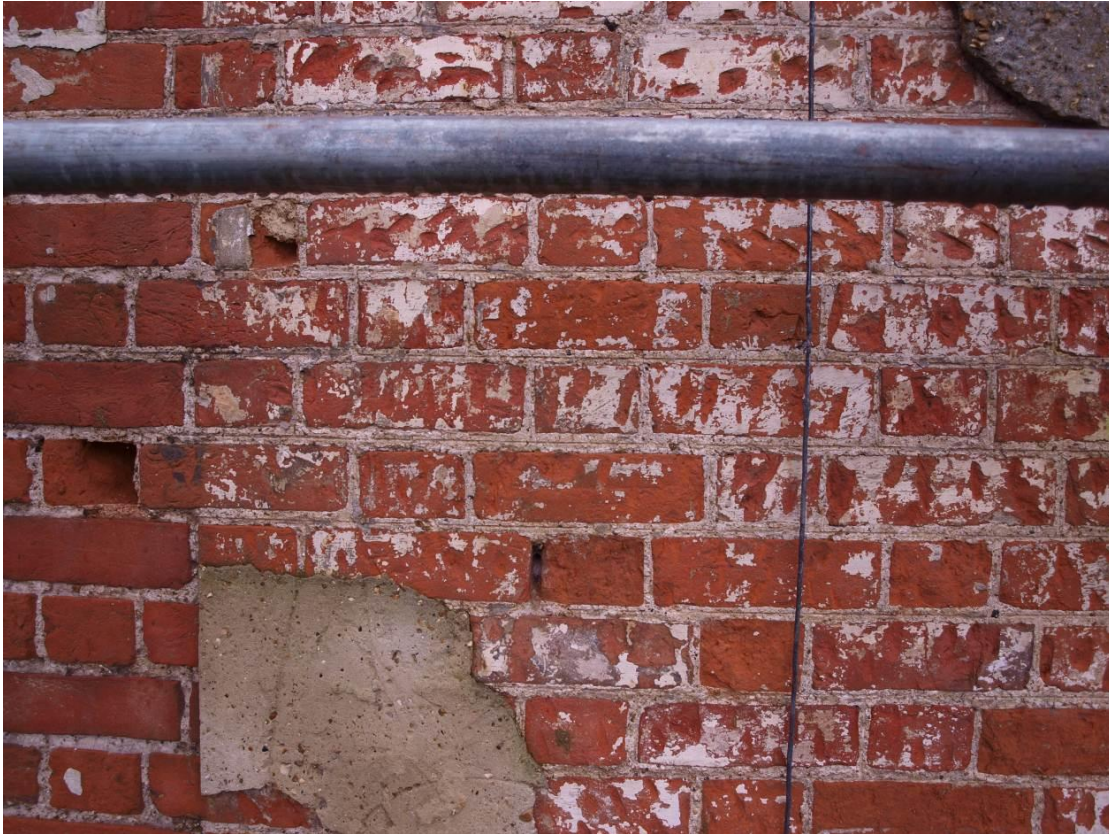
Plate 1: Penny-struck pointing to brickwork of east elevation, looking west (13)

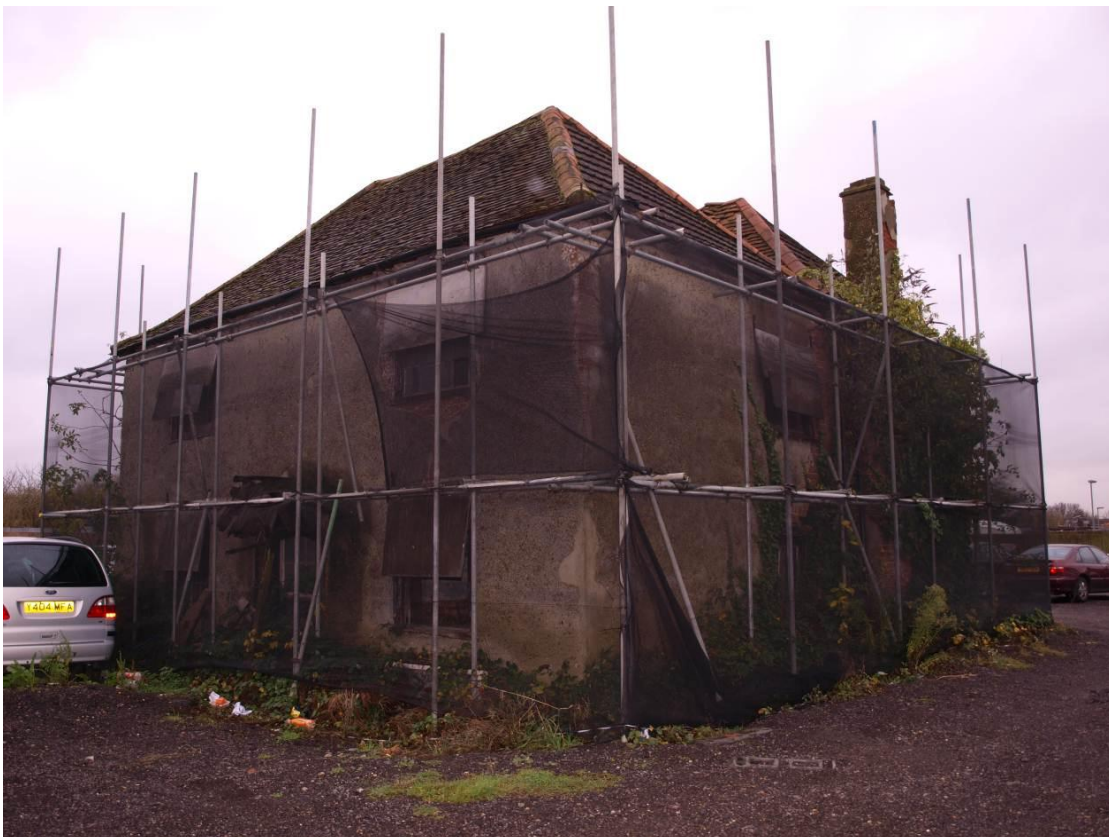
- 5.2 The principal elevation (Fig. 12; Plate 2) contains a central doorway with door of two lower flush bead-moulded panels, with upper glazing of 3x2 panes. It is shielded by a small double-pitched porch formed of boards meeting at a ridge board and covered with sheet asbestos; a supporting post survives at the north-west corner. The doorway is flanked on either side by a single window, and there are two further windows on the first floor. Unless stated otherwise, the surviving windows comprise eight-over-eight pane un-horned double-hung sashes with slender glazing bars, typical of the late-18th or early-19th century.

Plate 2: Principal (north) and west elevations, looking south-east (2)

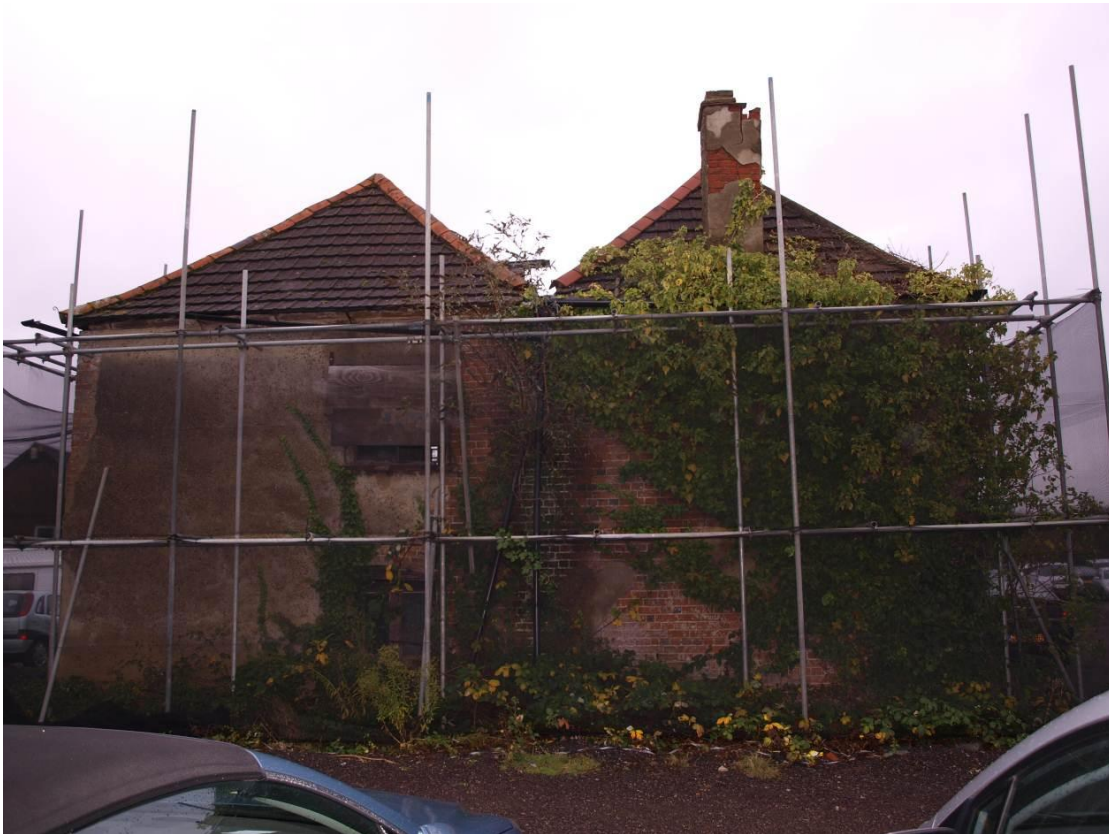
Plate 3: West elevation, looking east (3)

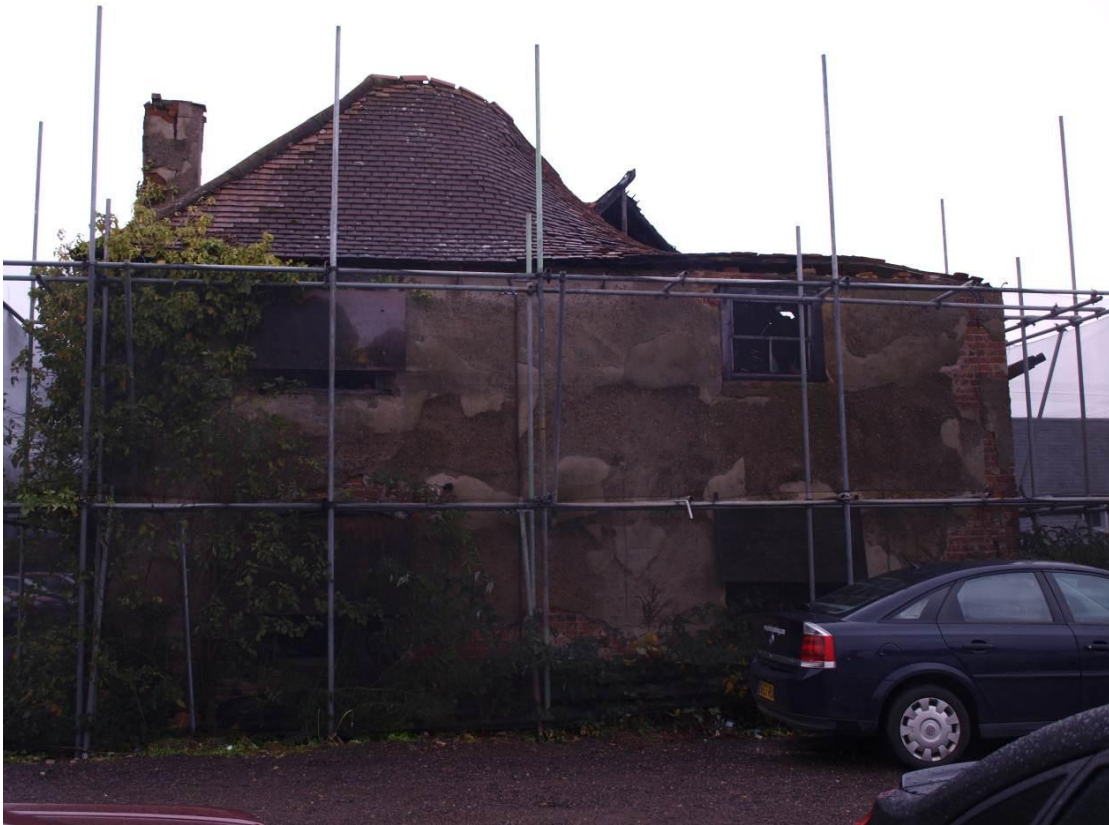
- 5.4 The south elevation has four windows: two on each floor (Plate 4). The ground floor sashes are missing, while on the first floor, the eastern of the two windows has been replaced with a two-over-two pane sash. The roof on this side has been re-covered in modern plain clay tiles and the eastern half has collapsed inwards.

Plate 4: South elevation, looking north (6)

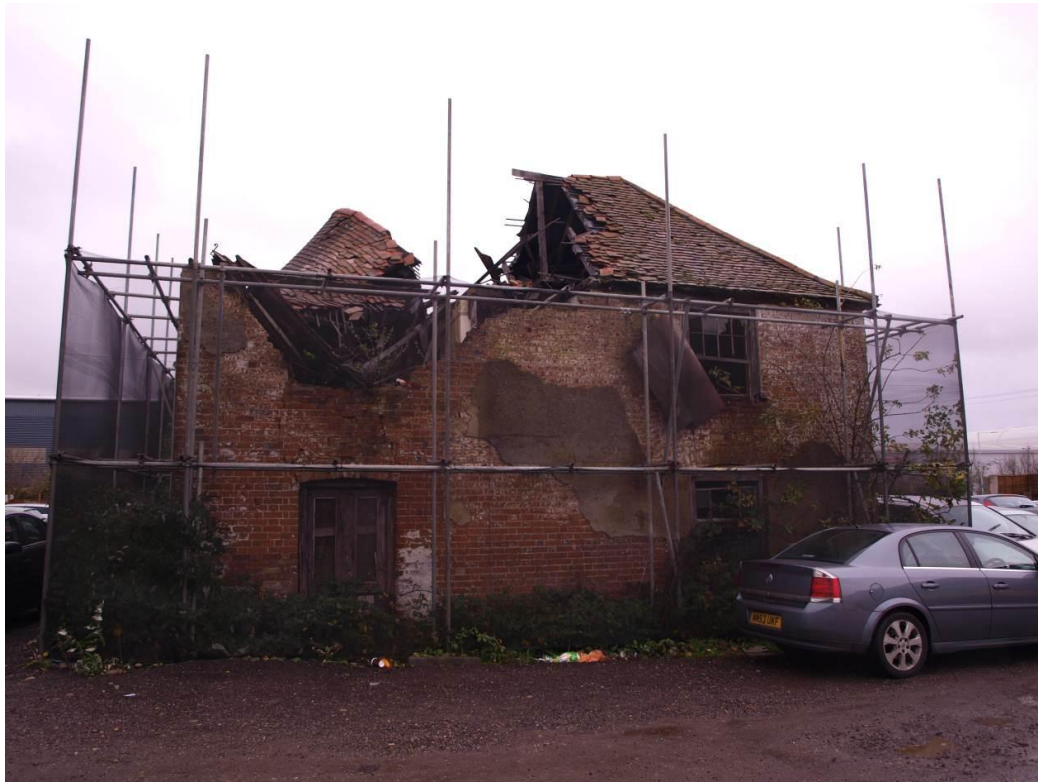
- 5.5 The east elevation, which would have faced onto the farmyard, contains a wide doorway (south) and a window (north), with two further windows on the first floor (Plate 5). The doorway contains a creased door with four lower panels with robust mouldings, and two tall upper lights. The sashes are missing from the window above the door.

Plate 5: East elevation, looking west (8)

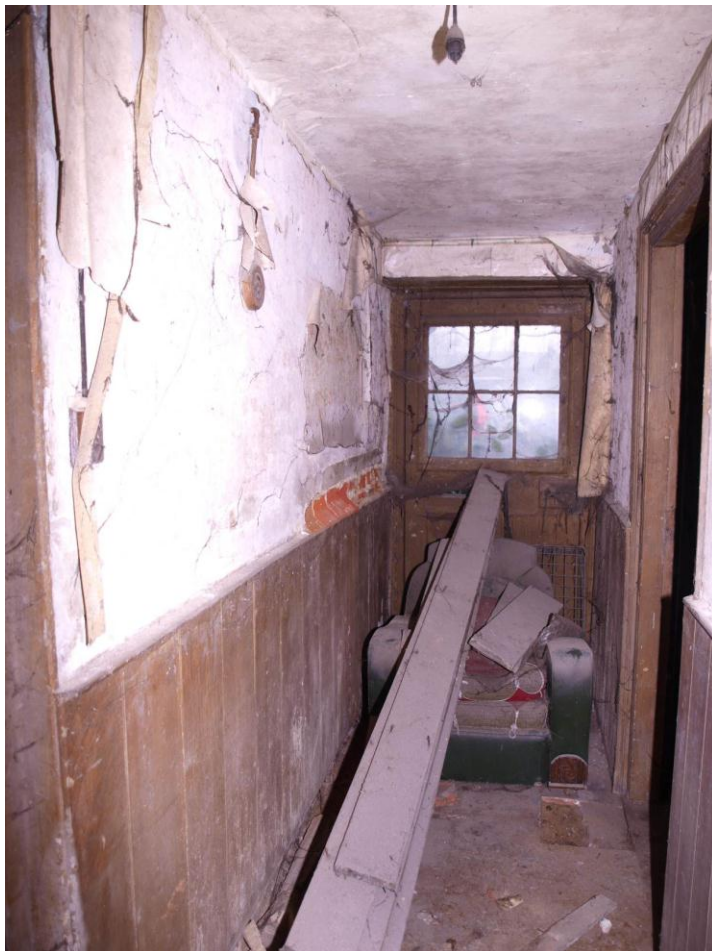
Plate 6: Entrance corridor, looking north (14)

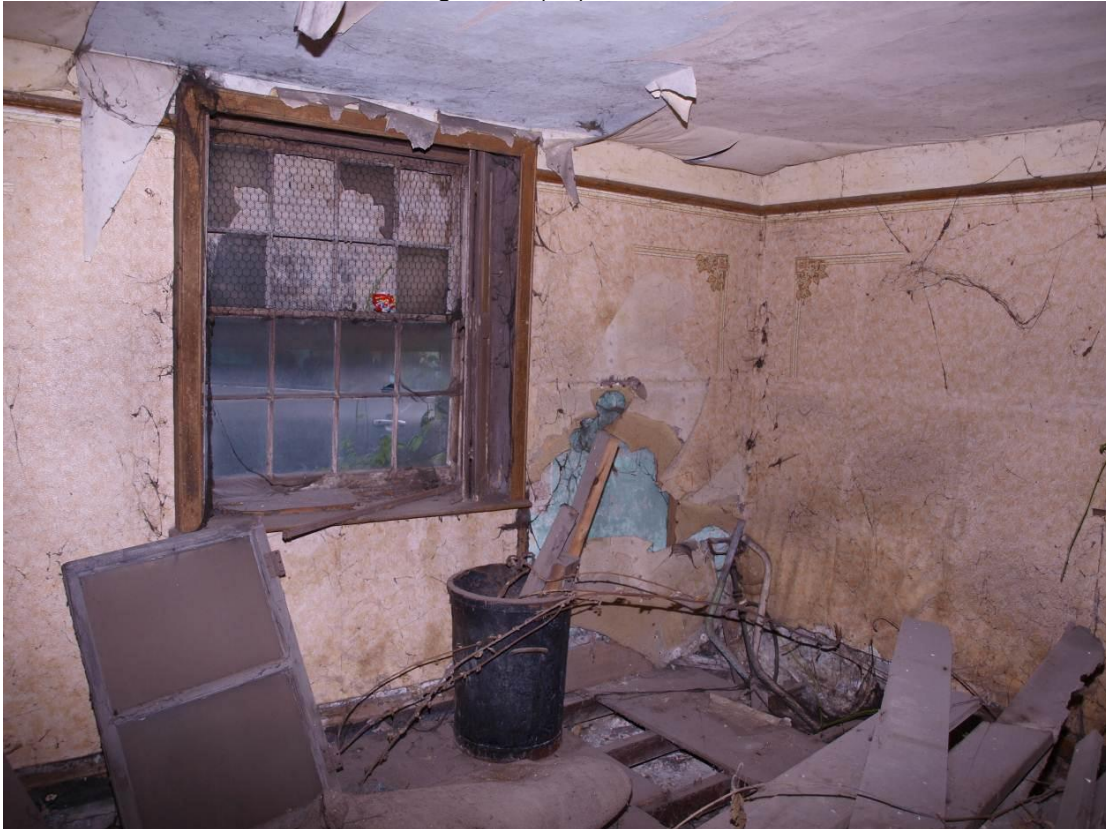
Plate 7: Room 1, looking north-east (15)

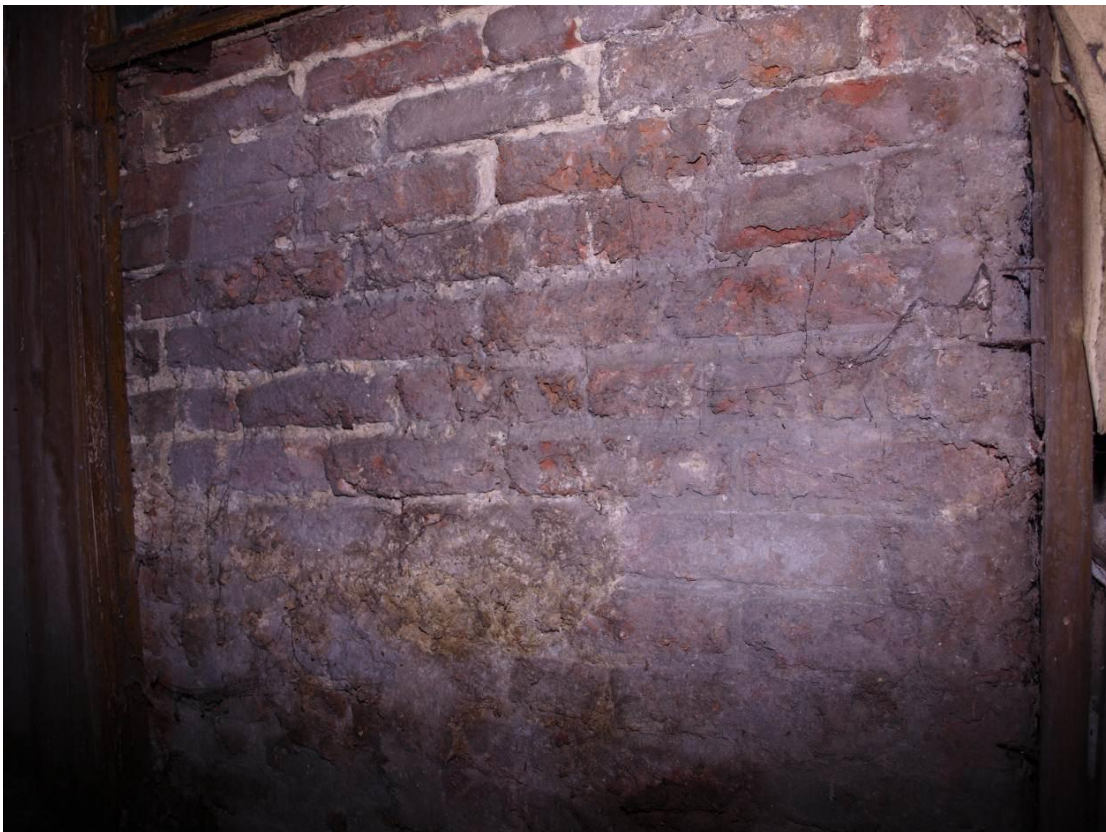
Plate 8: Earlier-looking brickwork on west side of chimney-stack, Room 2, looking east (21)

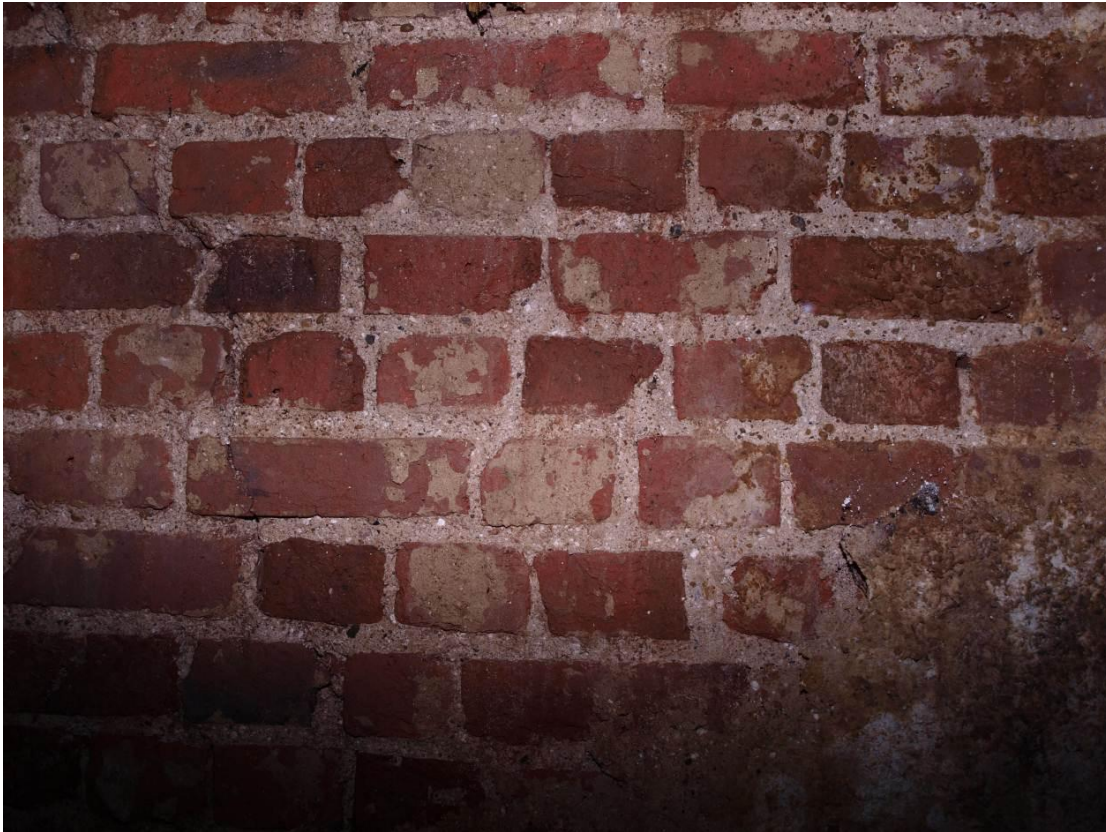
Plate 9: Late-18th/early-19th century brickwork to west wall of Room 2, looking west (20)

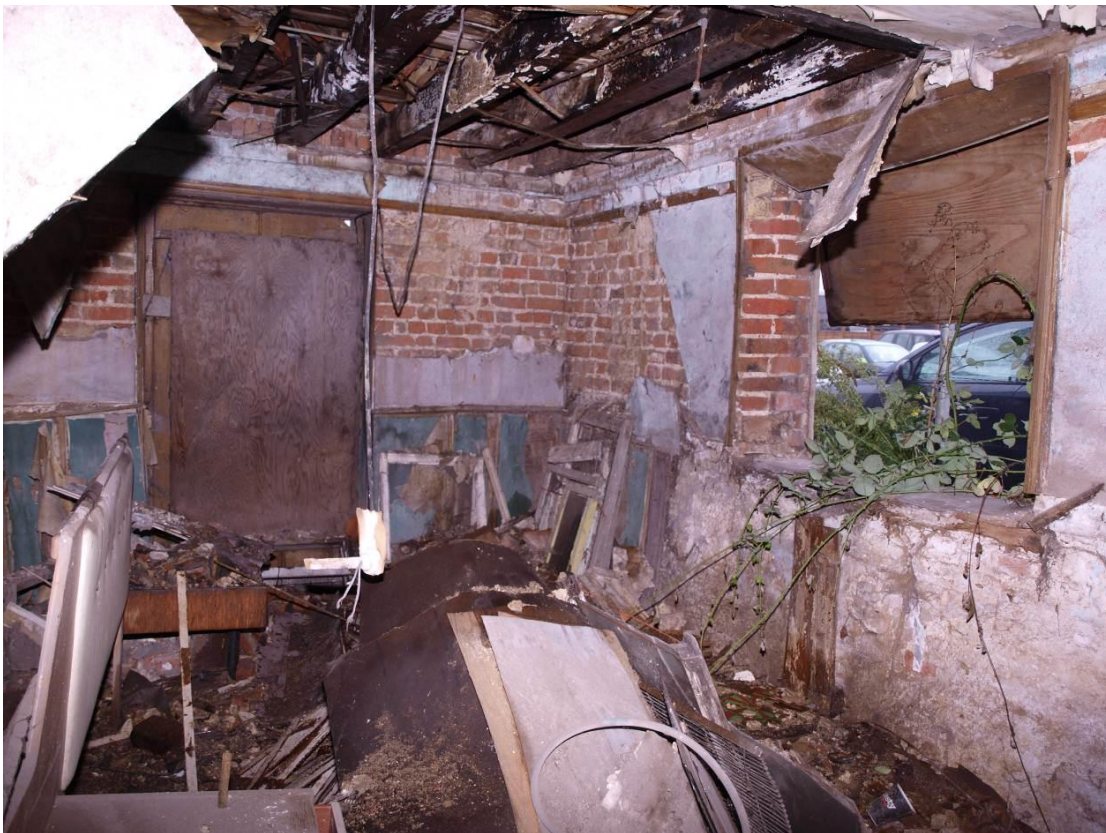
Plate 10: Room 2, looking east (19)

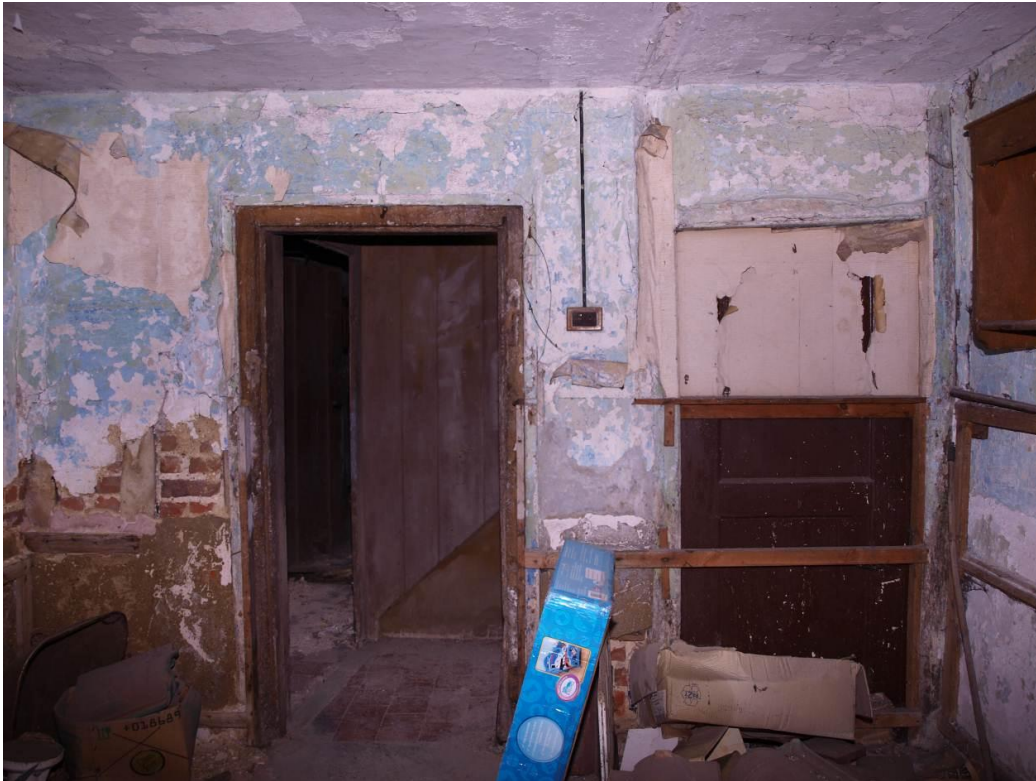
Plate 11: South wall of Room 3, looking south (23)

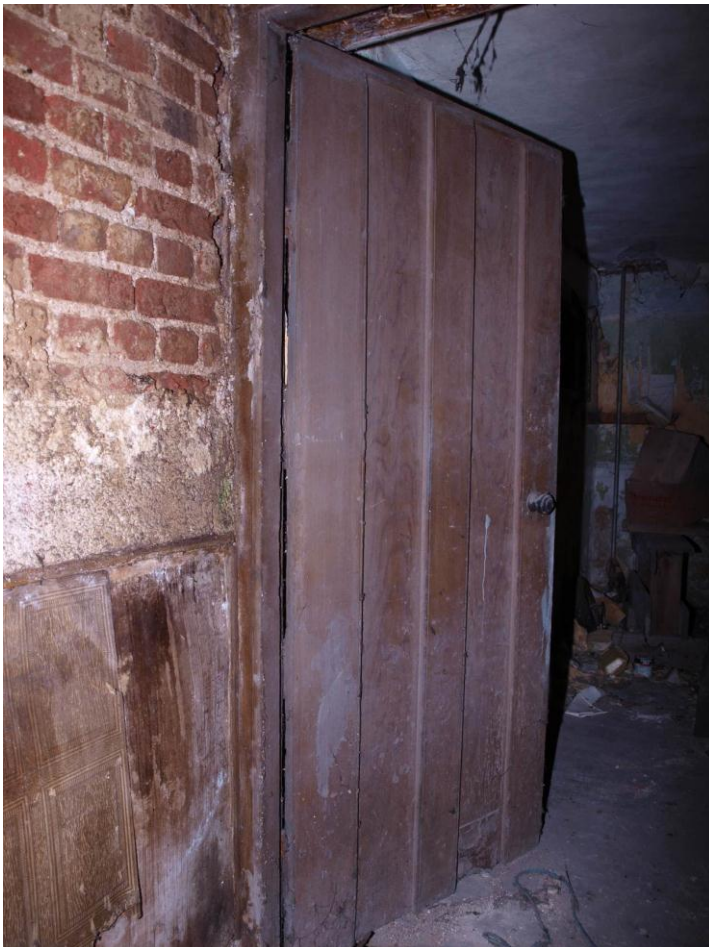
Plate 12: Door to Room 4, looking south-east (29)

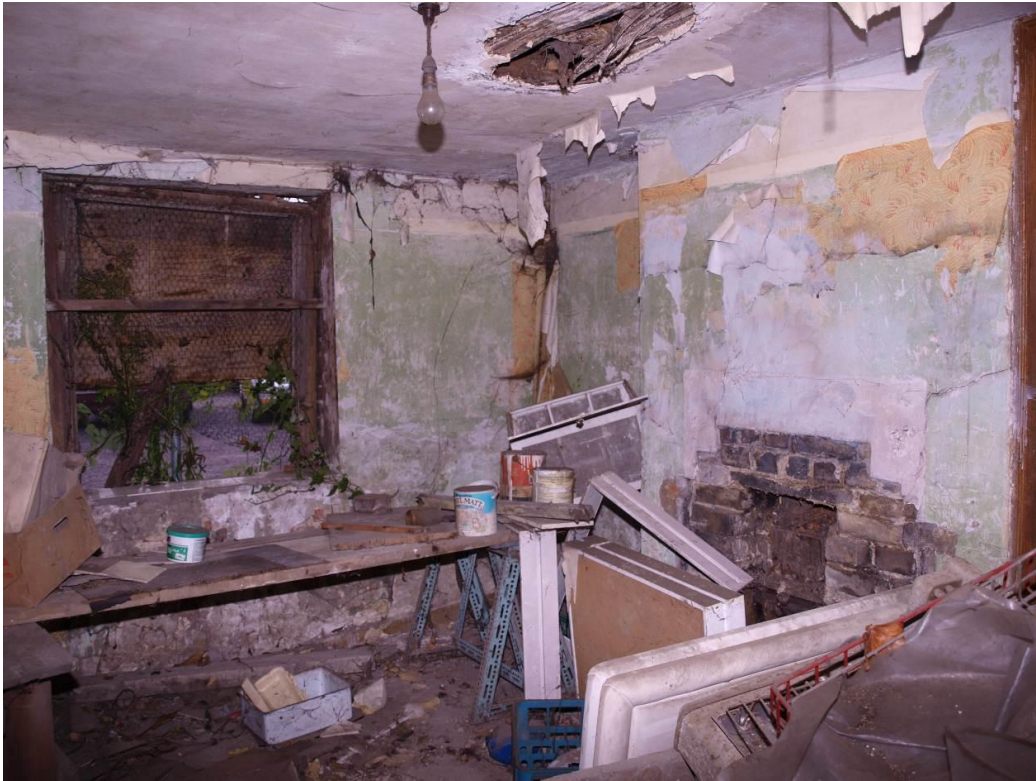
Plate 13: Room 4, looking south-west (28)

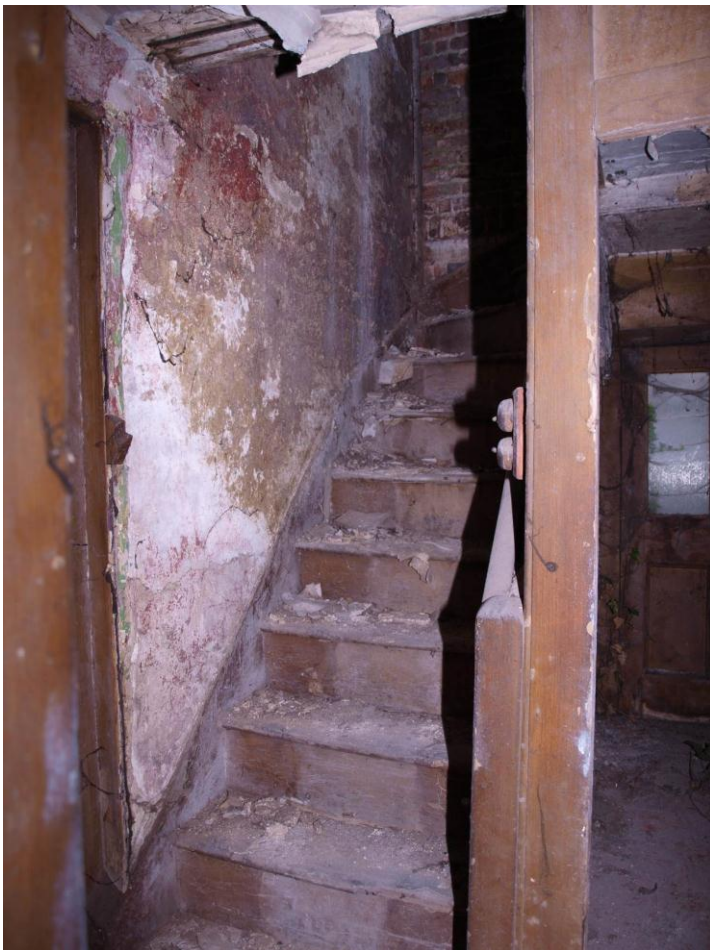
Plate 14: Staircase, looking west (27)

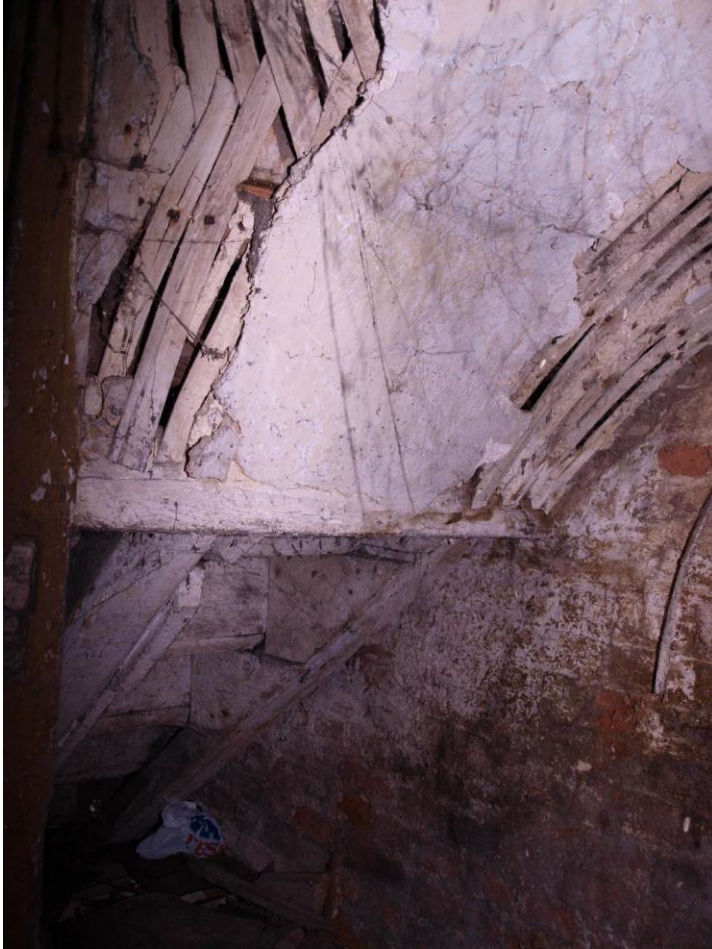
Plate 15: Under-side of staircase, looking east (26)

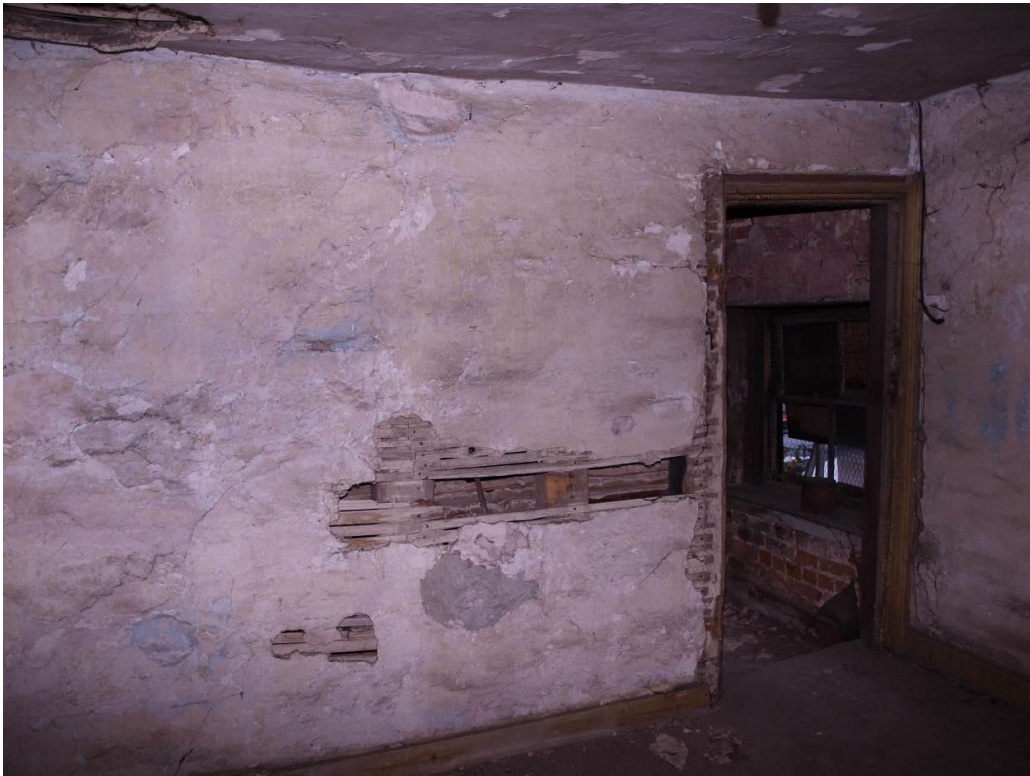
Plate 16: South wall of Room 5, looking south (34)

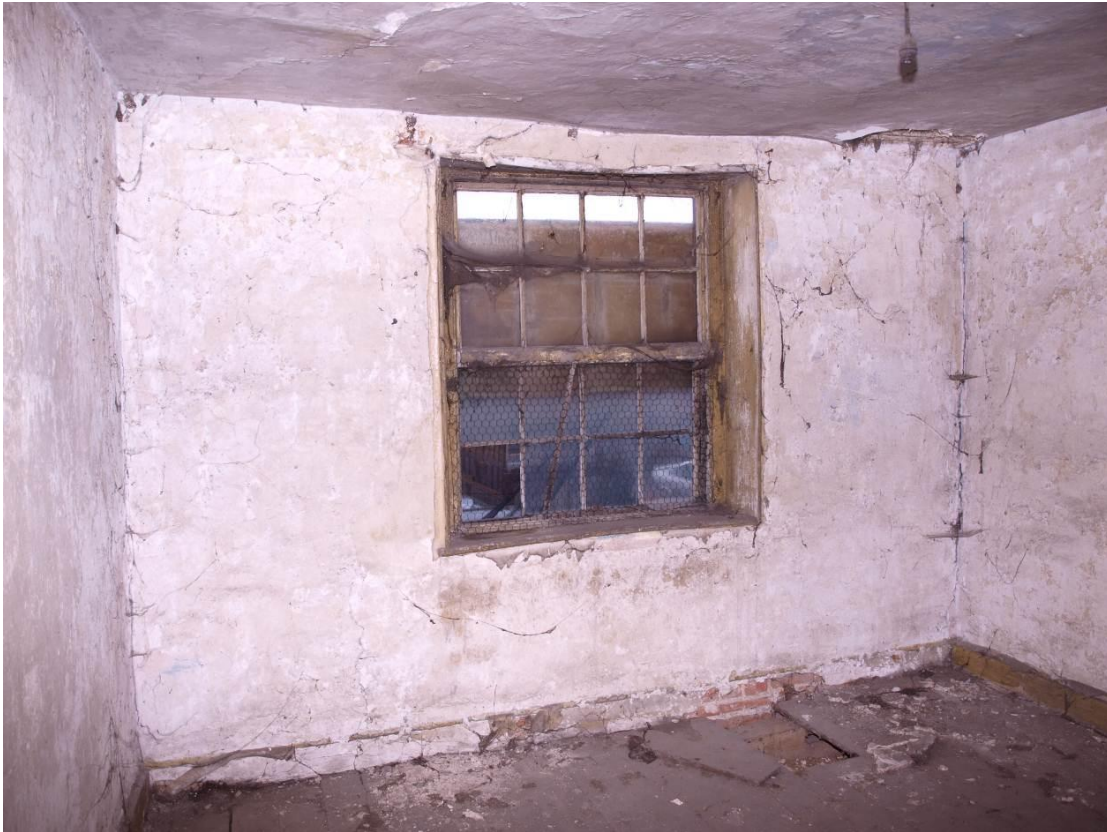
Plate 17: Room 5, looking north (33)

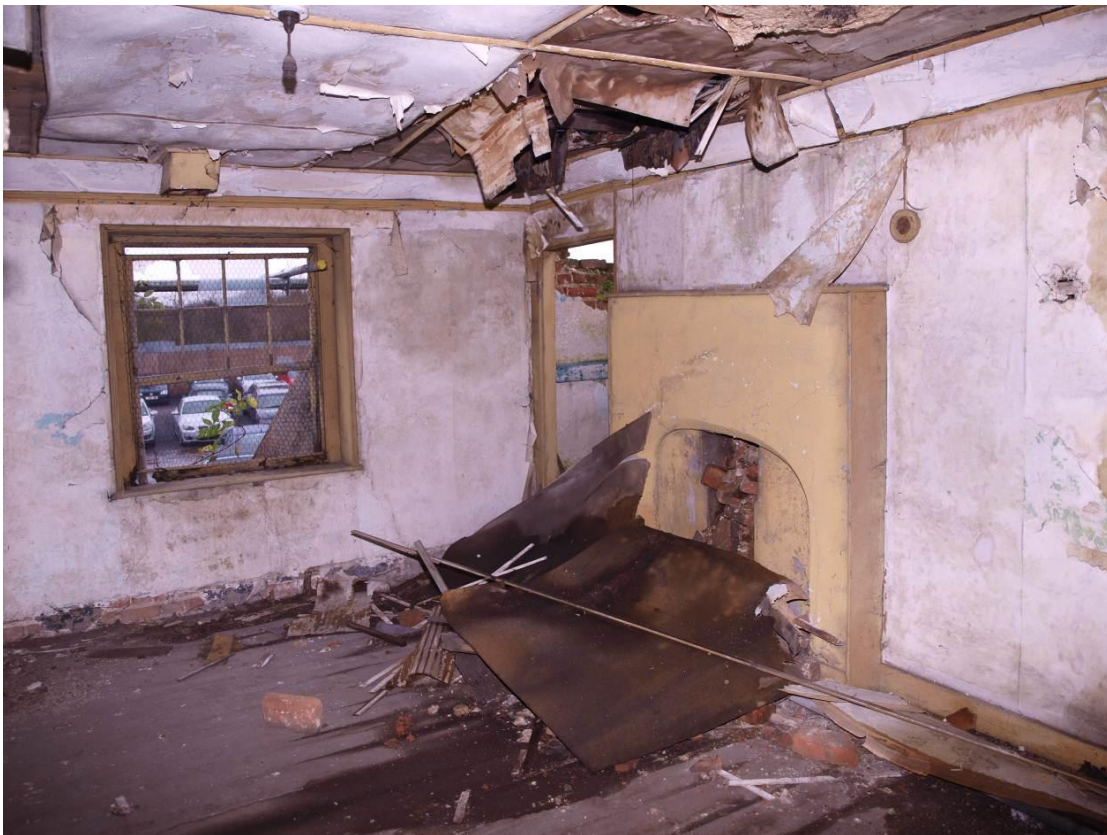
Plate 18: Room 6, looking south-east (31)

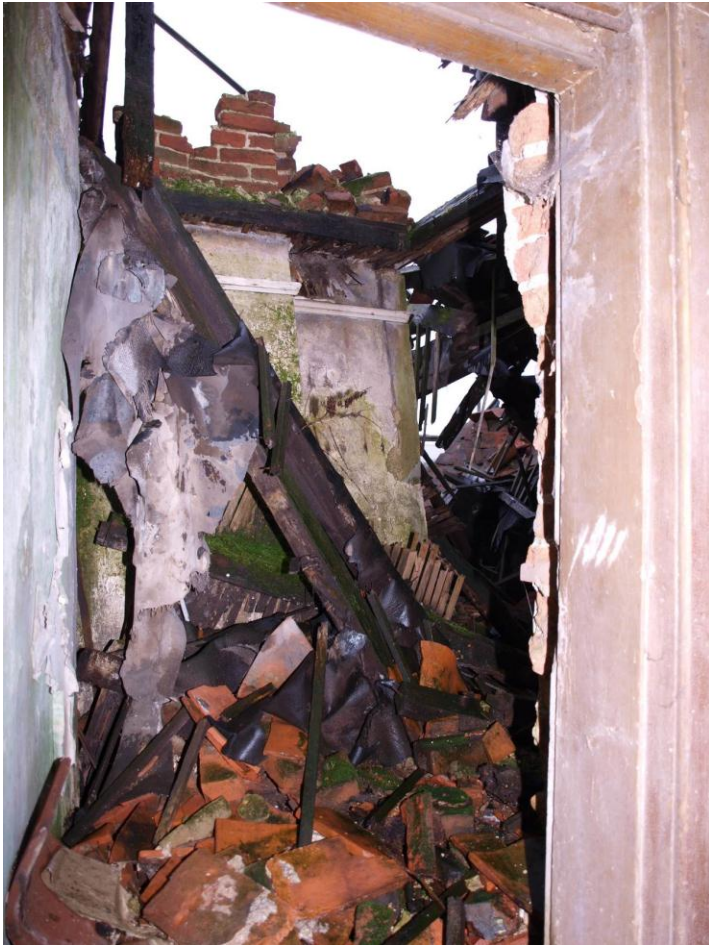
- 5.16 Room 7, a further bedroom, was viewed only from its doorway (Plate 19). Adjacent to the doorway, within the wall between this room and Room 6, there is visible a short section of wall-plate. It is not clear whether this relates to the present structure or an earlier one. The south and east walls each contains a single window aperture, while the north wall contains the large chimney-stack. Above ceiling level, the stack has collapsed, bringing the roof down into this room. There was no early brickwork visible within the stack at this level. The

Plate 19: Room 7, looking east (32)

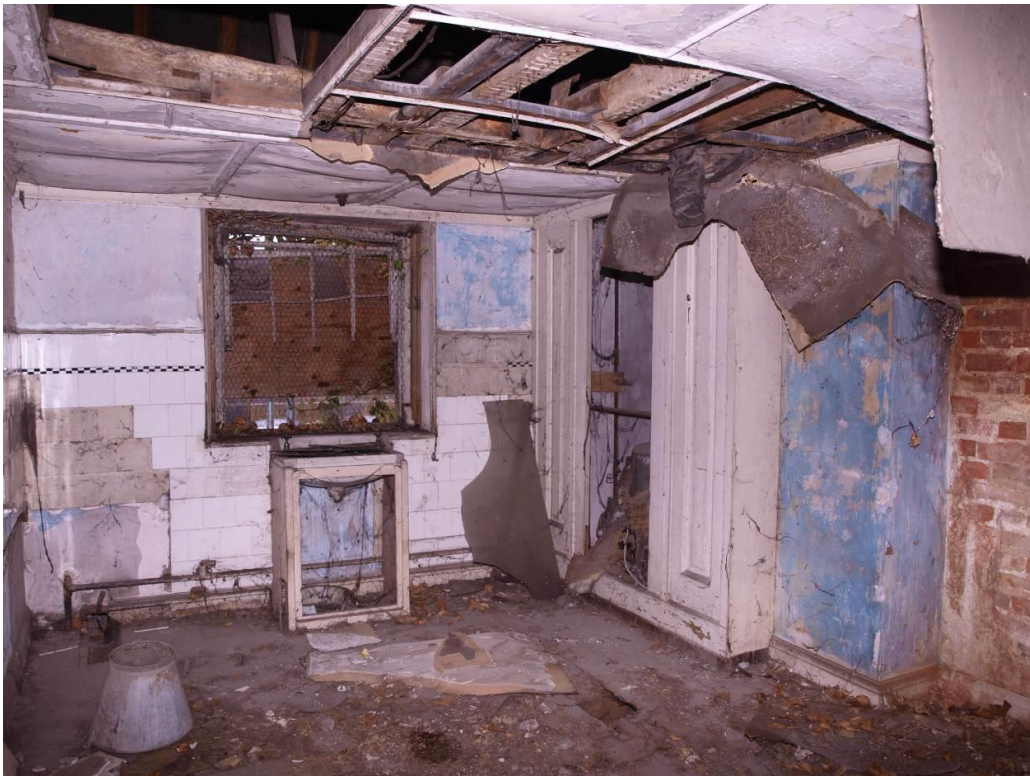
Plate 20: Room 8, looking north-west (36)

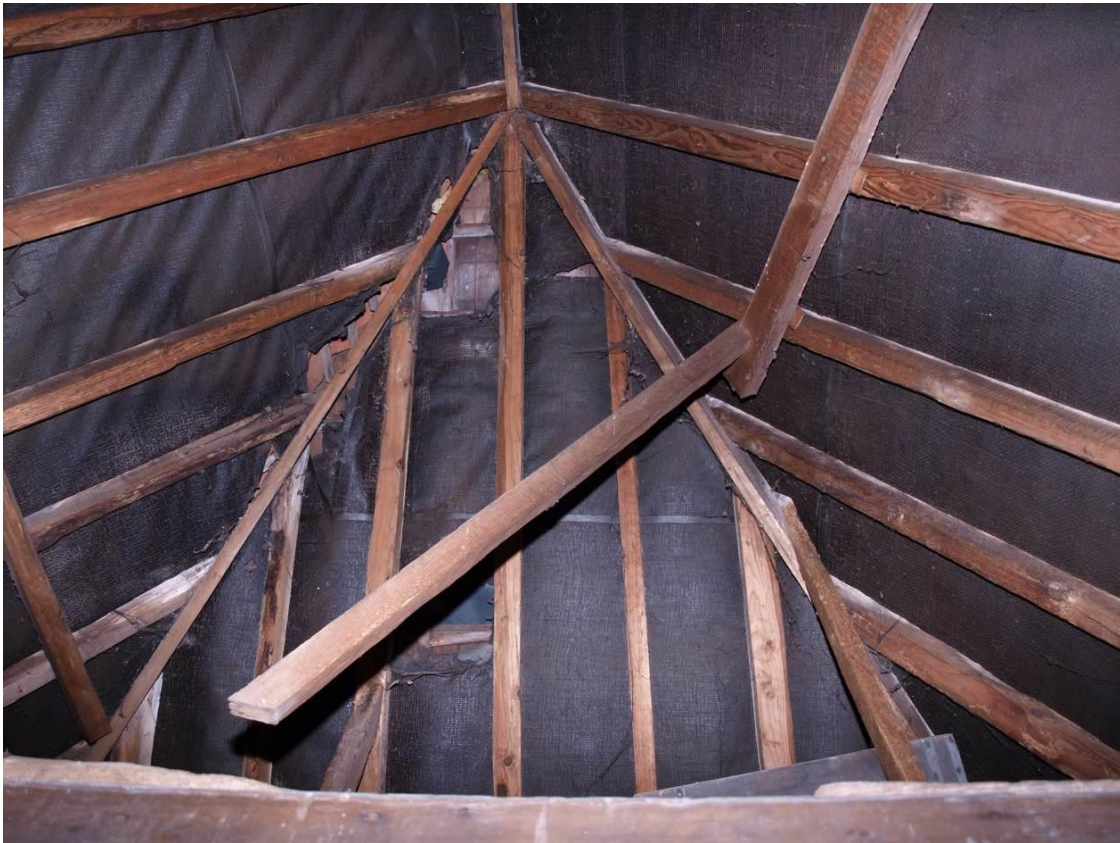
Plate 21: Roof structure visible over Room 8, looking west (37)
