**FORMER 'SHIP AGROUND' PUBLIC HOUSE
142 LEA BRIDGE ROAD, HACKNEY, LONDON, E5 9RB**

**HISTORIC BUILDING RECORD
(English Heritage Level 2)**

**Commissioned by
Singh Sabha Gurdwara North East London**

Report No. 2013154 (rev. 1)

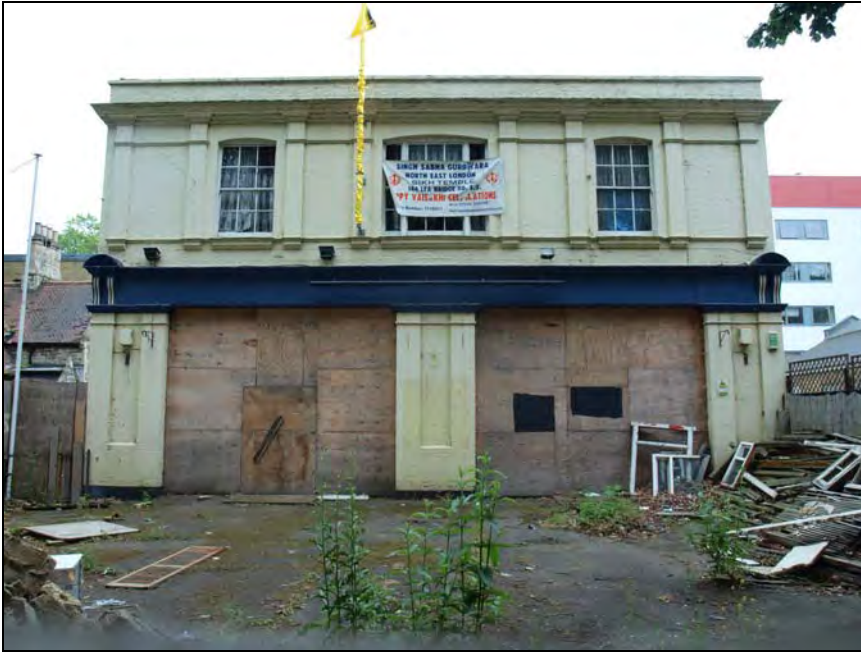
Plate 1. Northwest elevation. Facing southeast (06)

5.2.5 Above the fascia panel the façade is divided into seven sections by projecting pilasters which start five courses above the fascia, rising from moulded corbels to capitals below the cornice (Plate 1). The pilasters have two string courses of moulding, one near the base which extends across all the sections and forms window sills, the other five courses from the top and extending only across the blind sections, being broken in those that contain windows (Plate 3).

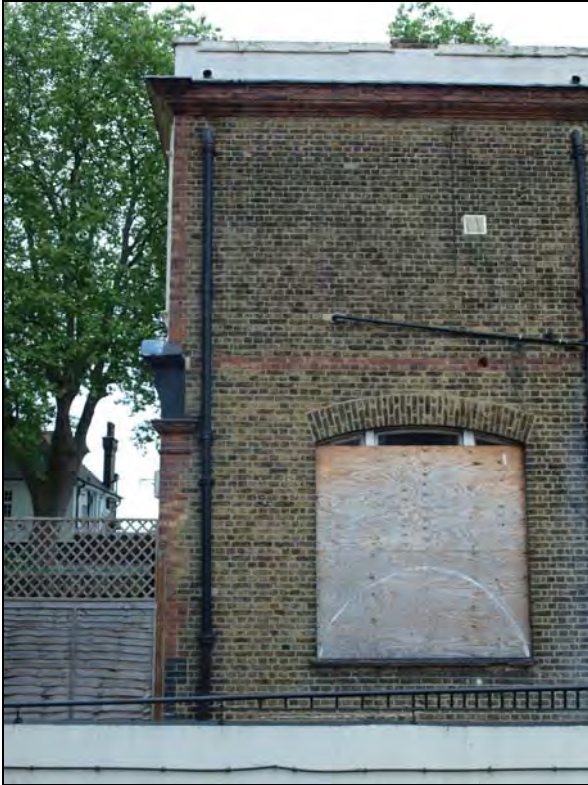
Plate 5. Southwest elevation, window & decorative string course. Facing northeast (04)

5.3.6 The cornice is of moulded red brick, and is continued from the principle elevation (Plate 5). Above this is a painted parapet to the roof, pierced by drainage channels at either end and in the middle where the roof valley is located. The parapet has a narrow string course, presumably of tile, overlain by a coping of header bricks. The string course and coping are broken in two places where the vestiges of chimney stacks rise above the parapet. These only survive to a single course (Plate 5).

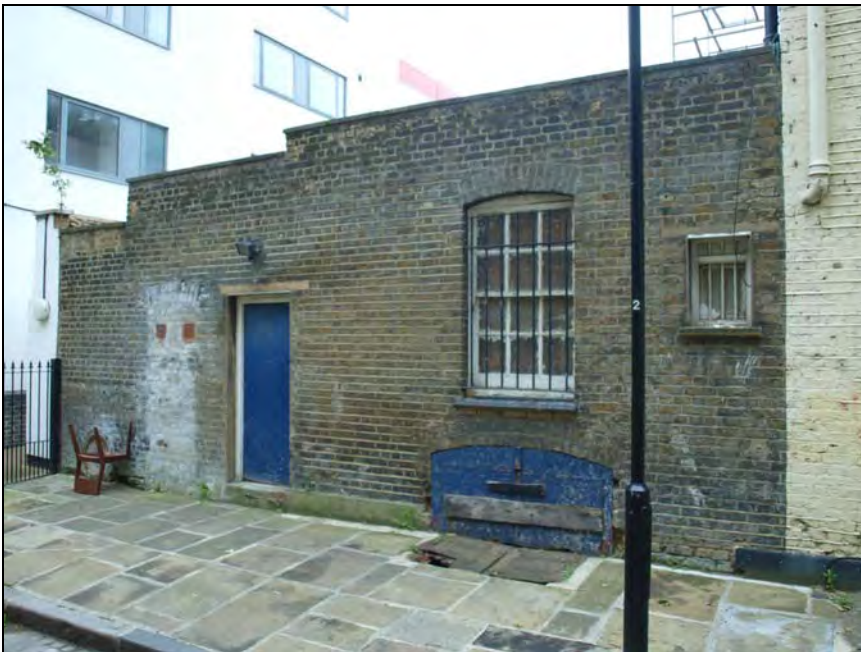
Plate 10. Northeast elevation, oblique view of rear section. Facing south (09)

5.4.5 The single storeyed part of the elevation is again in three sections of different heights, stepping down towards the rear of the property (Plate 10). It holds six openings, a small window adjacent to the main building, a larger window and access to the cellar, a door, a blocked door, and a small circular opening at ground level (now blocked). The small window is wooden framed with a single light of frosted glass, and has integral bars (Plate 11). The sill is of concrete, as is the head. The larger window, directly above the cellar access, is a 12 light wooden sash window with wooden sill and arched brick head. The head is formed by two courses of headers on edge, closed at either side by a stretcher on edge (Plate 11). The cellar opening also has an arched head of

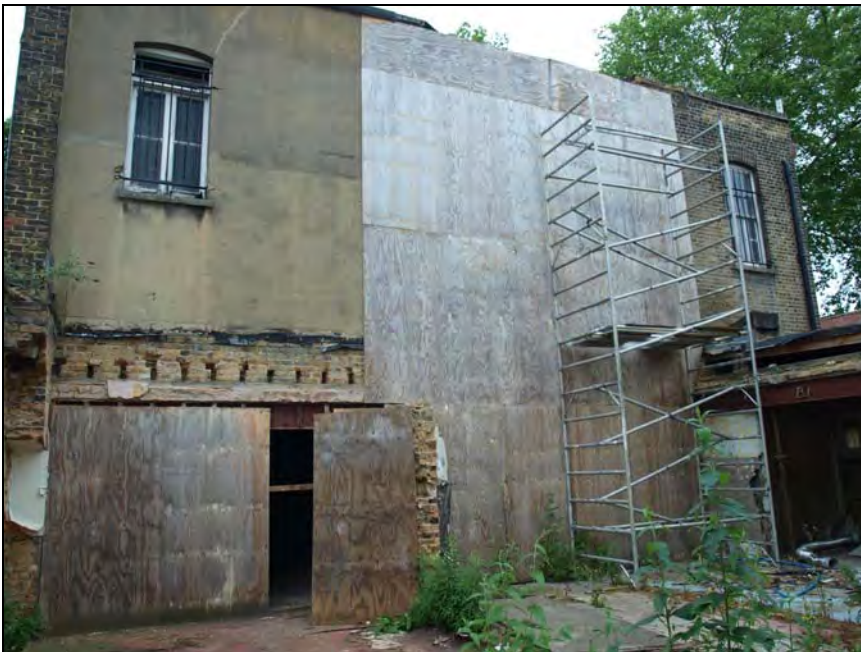
Plate 14. Southeast elevation, general view. Facing north-northwest (17)

5.5.2 The southern part of the elevation is rendered above the line of the previous outbuildings, and holds a window at first floor level (Plate 14). The current window is a casement of four lights with a vertically hinged light above. Given that all the other equivalent windows are 12 light sashes, this is most likely a replacement.

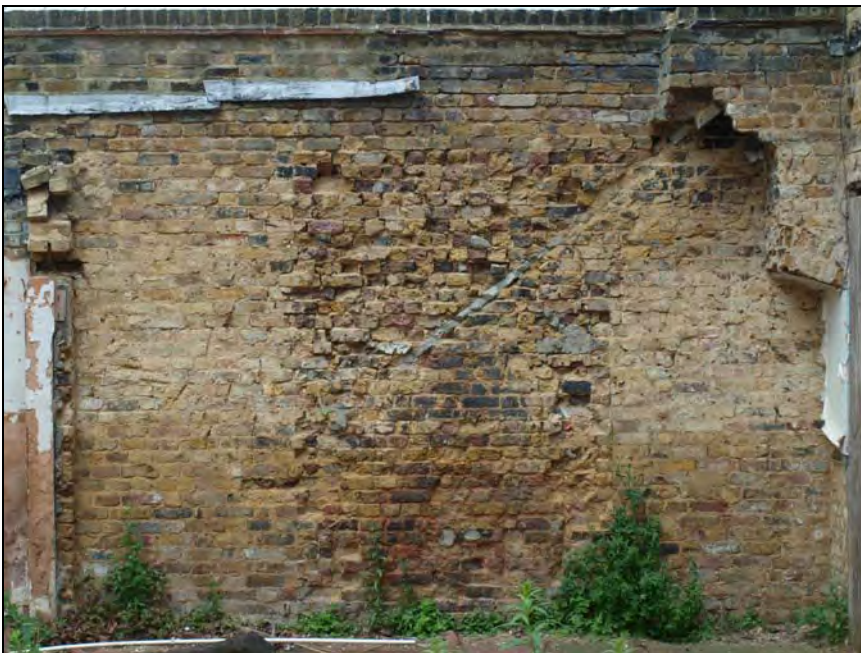
Plate 16. Southwest boundary wall. Facing southwest (20)

5.8.4 A broad scar is also apparent, with signs of burning at the base (Plate 16). This corresponds with the location of a fireplace illustrated on a drainage application drawing dated 19th November 1931 in what was, at that date, the pub’s Tap Room (Figure 9).

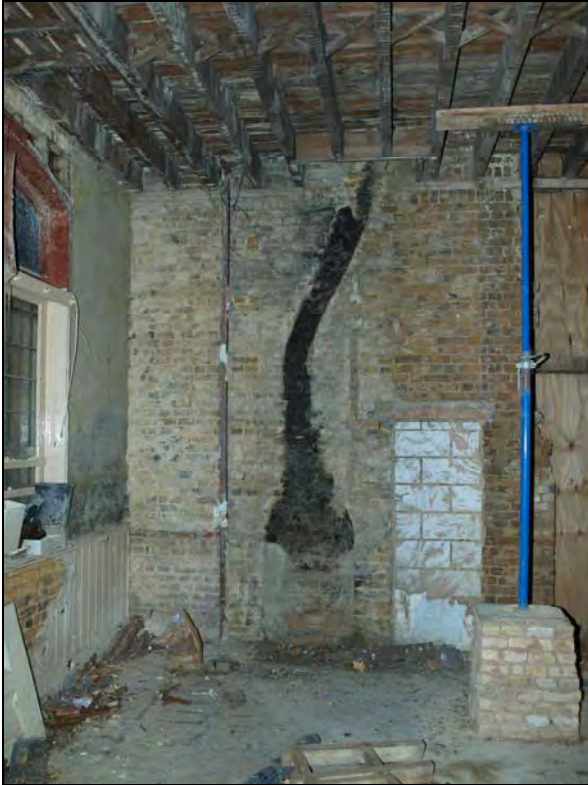
Plate 27. Interior, ground floor, eastern part of rear wall. Facing southwest (44)

- 5.6.13 The joists to the floor above have two transverse bands of cross strutting to provide extra rigidity, one either side of the central transverse beam (Plate 28 and Plate 27). Above the side door and windows the first two joists are broken by hearths for four fire places in the first floor (Plate 32), the two bands of cross strutting being flush with the outer edges of these hearths.

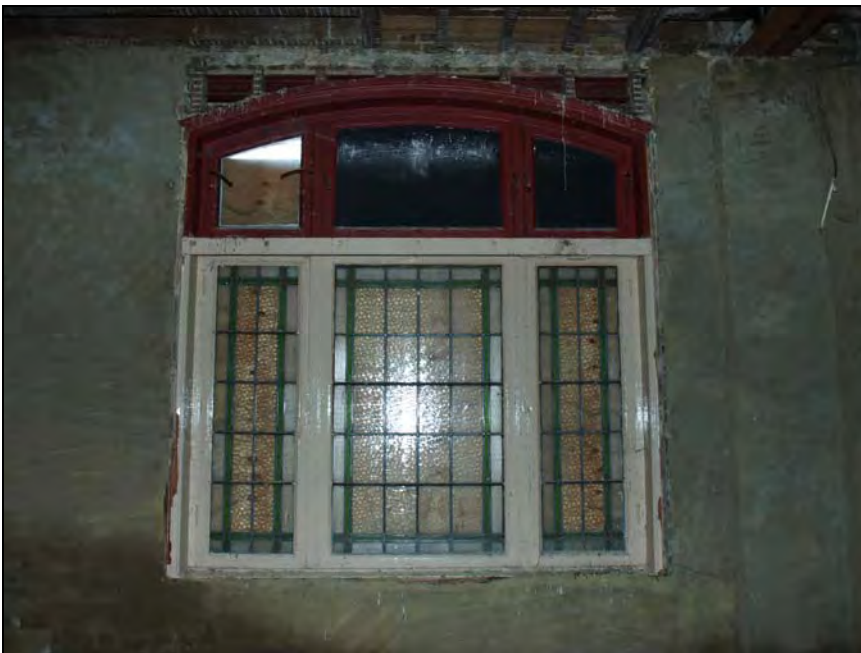
Plate 30. Interior, ground floor, window in side wall. Facing southwest (37)

- 5.6.11 The windows are all identical, comprising a large fixed central section with narrower flanking hinged casements to either side (Plate 30). These all contain leaded frosted glass lights with a narrow inset border of green glass. Above are three sections with a spanning moulded arch head. These three sections match the widths of the windows below, and are hinged along their lower edge, opening inwards from the top, and fitted with clear glass. The top of the opening is supported by a reinforced steel joist which would previously have been screened by panelling.

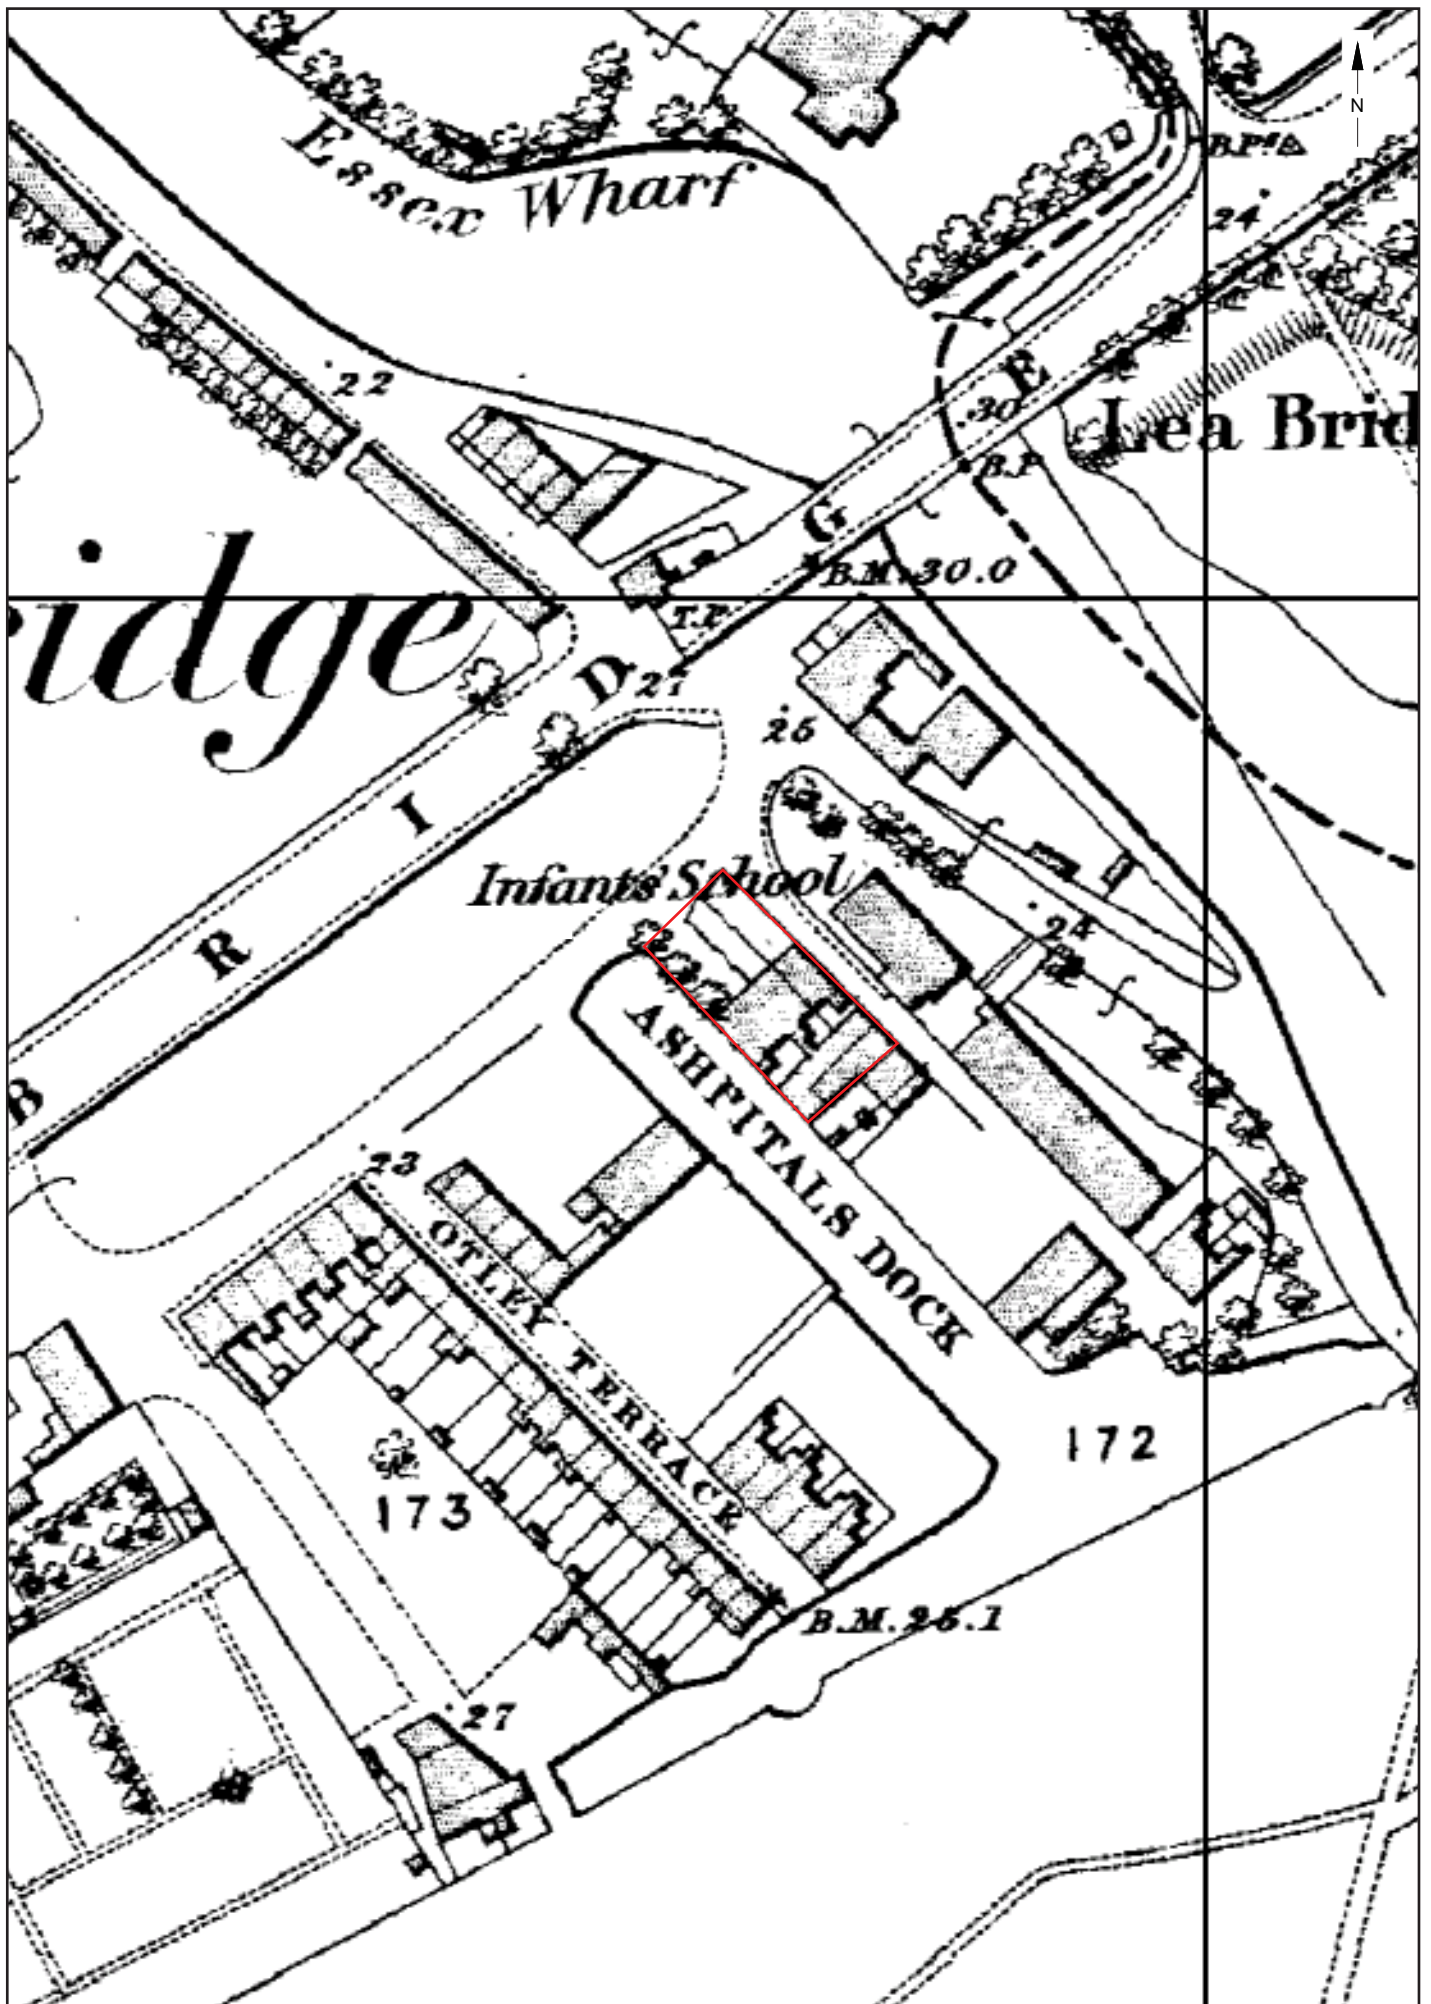
© Archaeology South-East		'Ship Aground', Lea Bridge Road, Hackney	Fig. 3
Project Ref: e2668	June 2013	1870 Ordnance Survey (1:2,500). Approximate site area in red.	
Report Ref: 2013154	Drawn by: GH

- 4.7 The Ordnance Survey of 1870 shows buildings on the site, and a boundary running through the site suggests there were at least two separate properties, if not three (Figure 3). The building at the southwest boundary of the site, adjacent to Ashpitals Dock, appears to have an outshot to the rear. It also depicts a further linked building to the rear of the site, its south-eastern wall on the line of the current rear boundary wall of the Ship Aground.

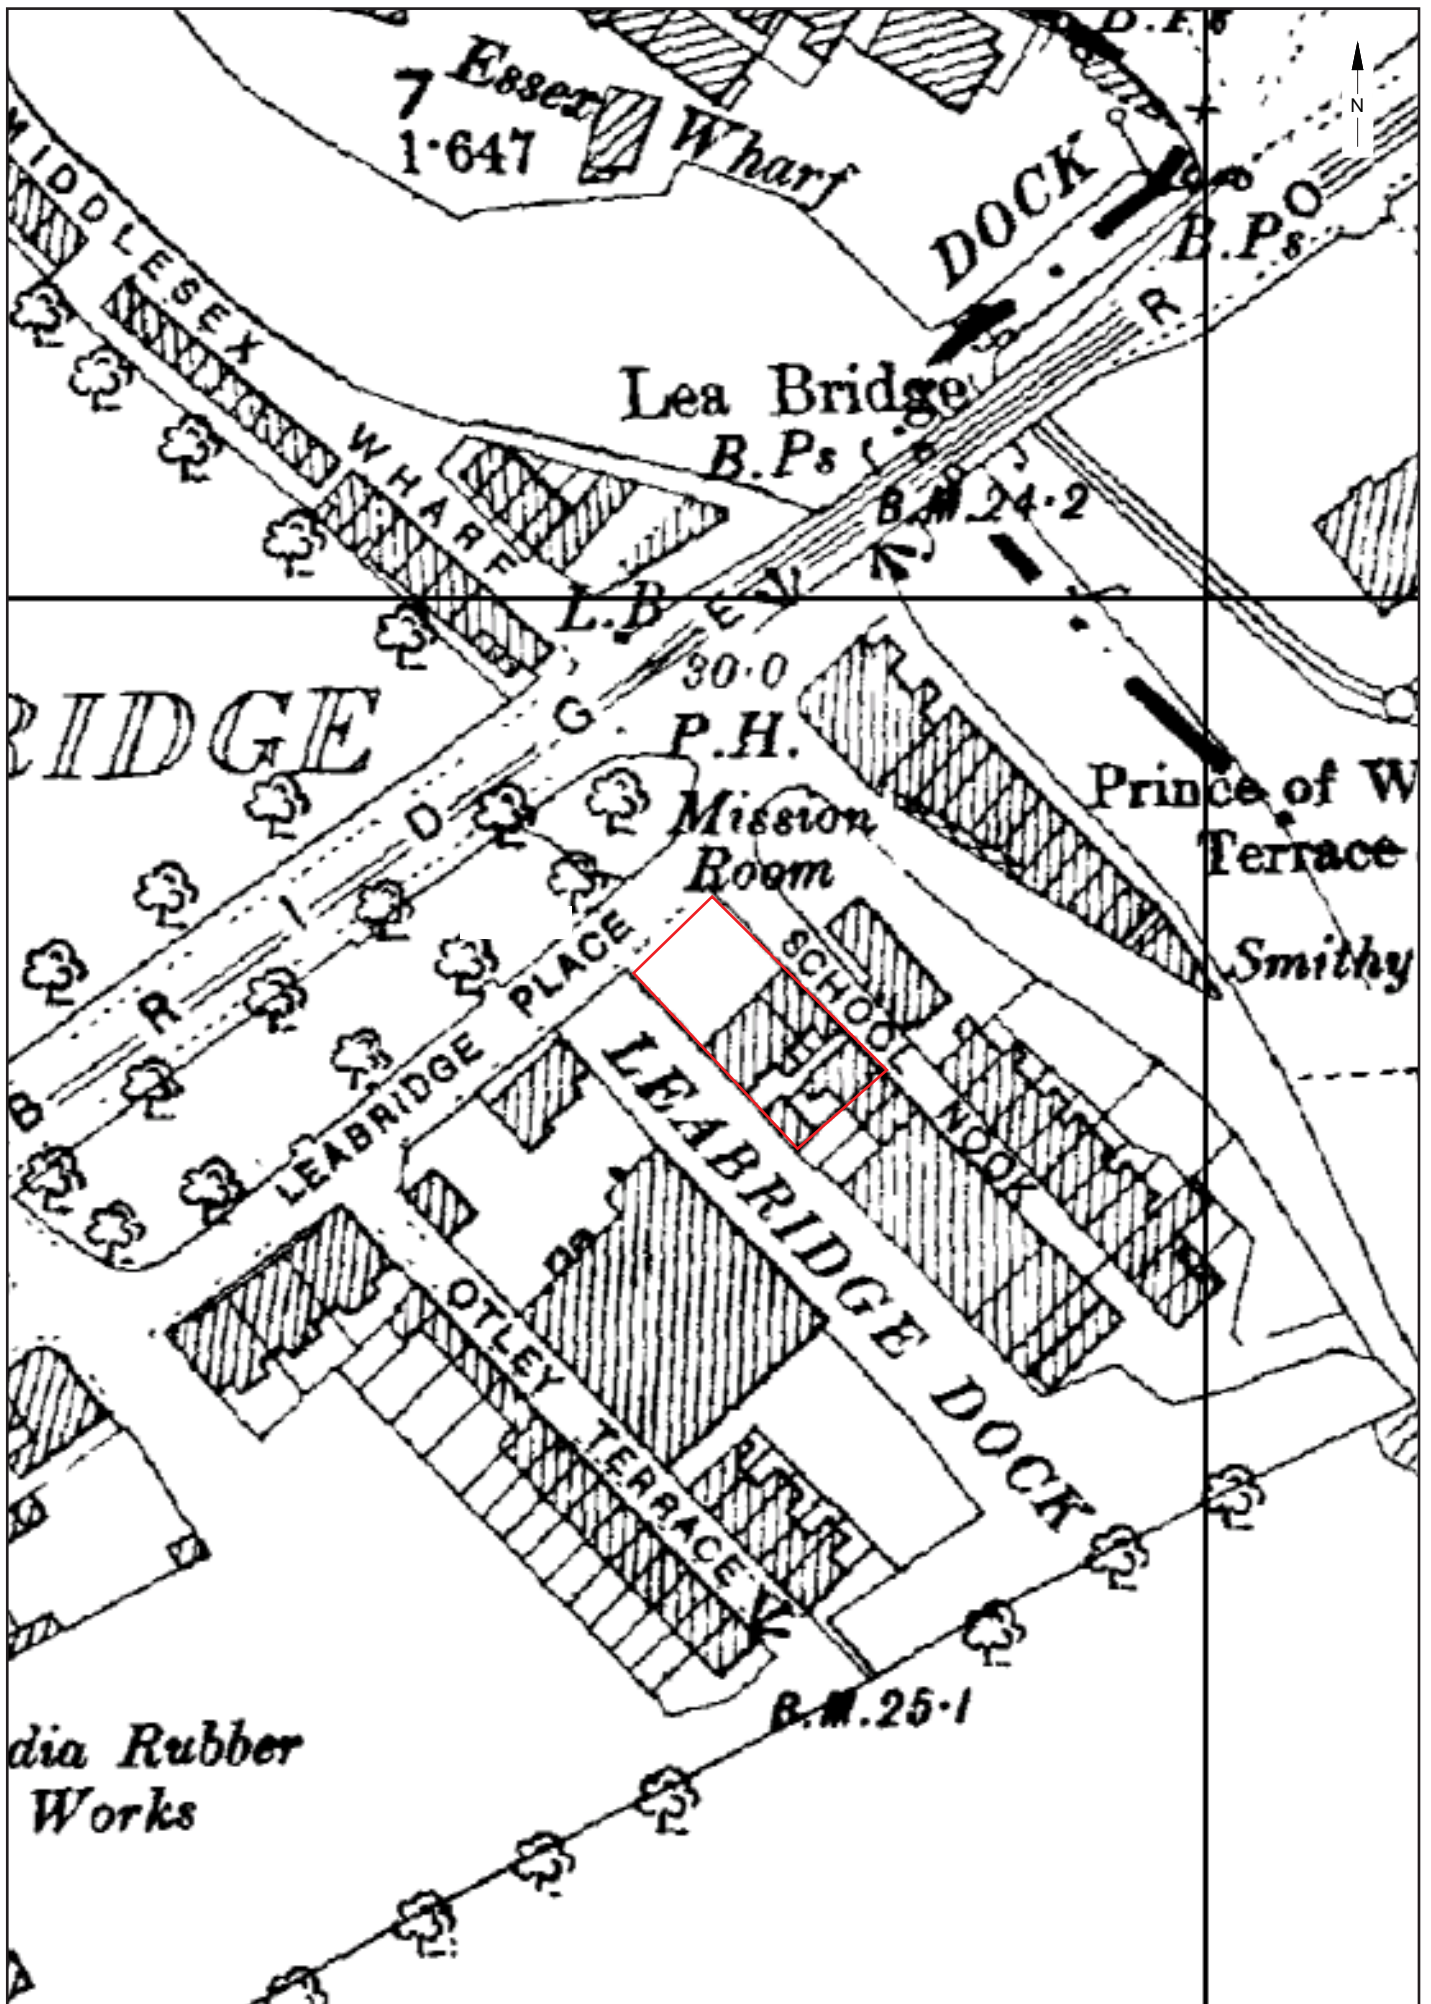
© Archaeology South-East		'Ship Aground', Lea Bridge Road, Hackney	Fig. 7
Project Ref: e2668	June 2013	1896 Ordnance Survey (1:2,500). Approximate site area in red.	
Report Ref: 2013154	Drawn by: GH

- 4.11 The 'Carbonic Acid Gas Works' first appears in Kelly's Directory of 1896-97, managed by Herman Steinem. It is first shown on the 1896 Ordnance Survey map between Lea Bridge Dock and Otley Terrace (Figure 7).

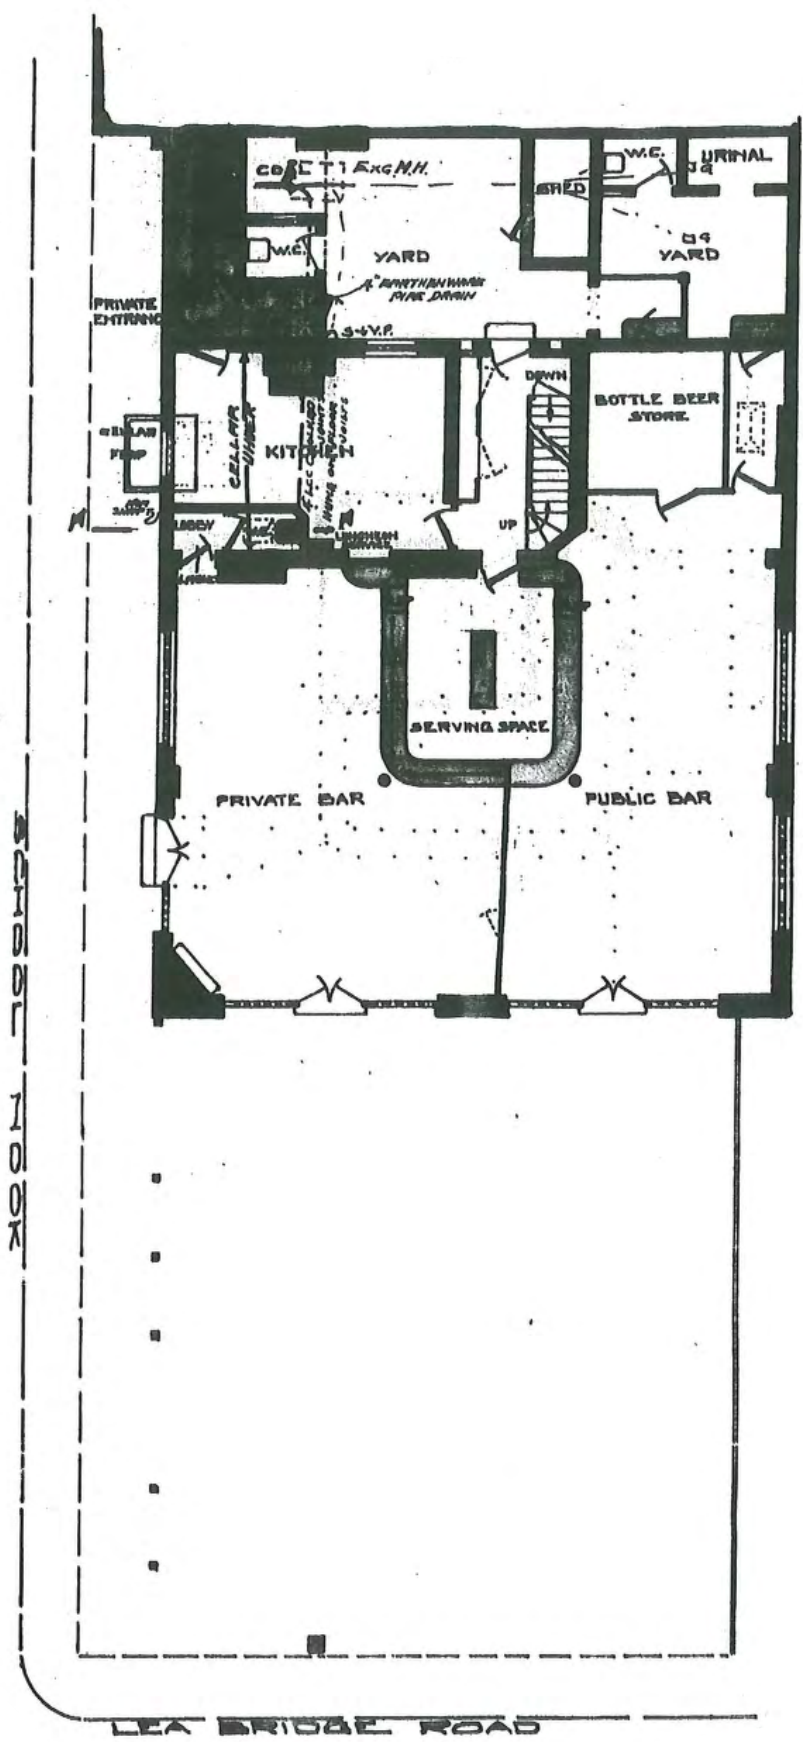
© Archaeology South-East		'Ship Aground', Lea Bridge Road, Hackney	Fig. 10
Project Ref: e2668	June 2013	Drainage Application, 1931. Ship Aground, proposed alterations.	
Report Ref: 2013154	Drawn by: GH

- 5.8.9 The southeast wall of the main outbuilding chamber holds a blocked fireplace with an iron plate acting as lintel above, the chimney breast above using queen closers at its northern edge. This is a replacement of a previous corner fireplace shown on the drainage application of 1931 (Figure 9), necessitated by the removal of the wall between the kitchen and scullery (Figure 10).

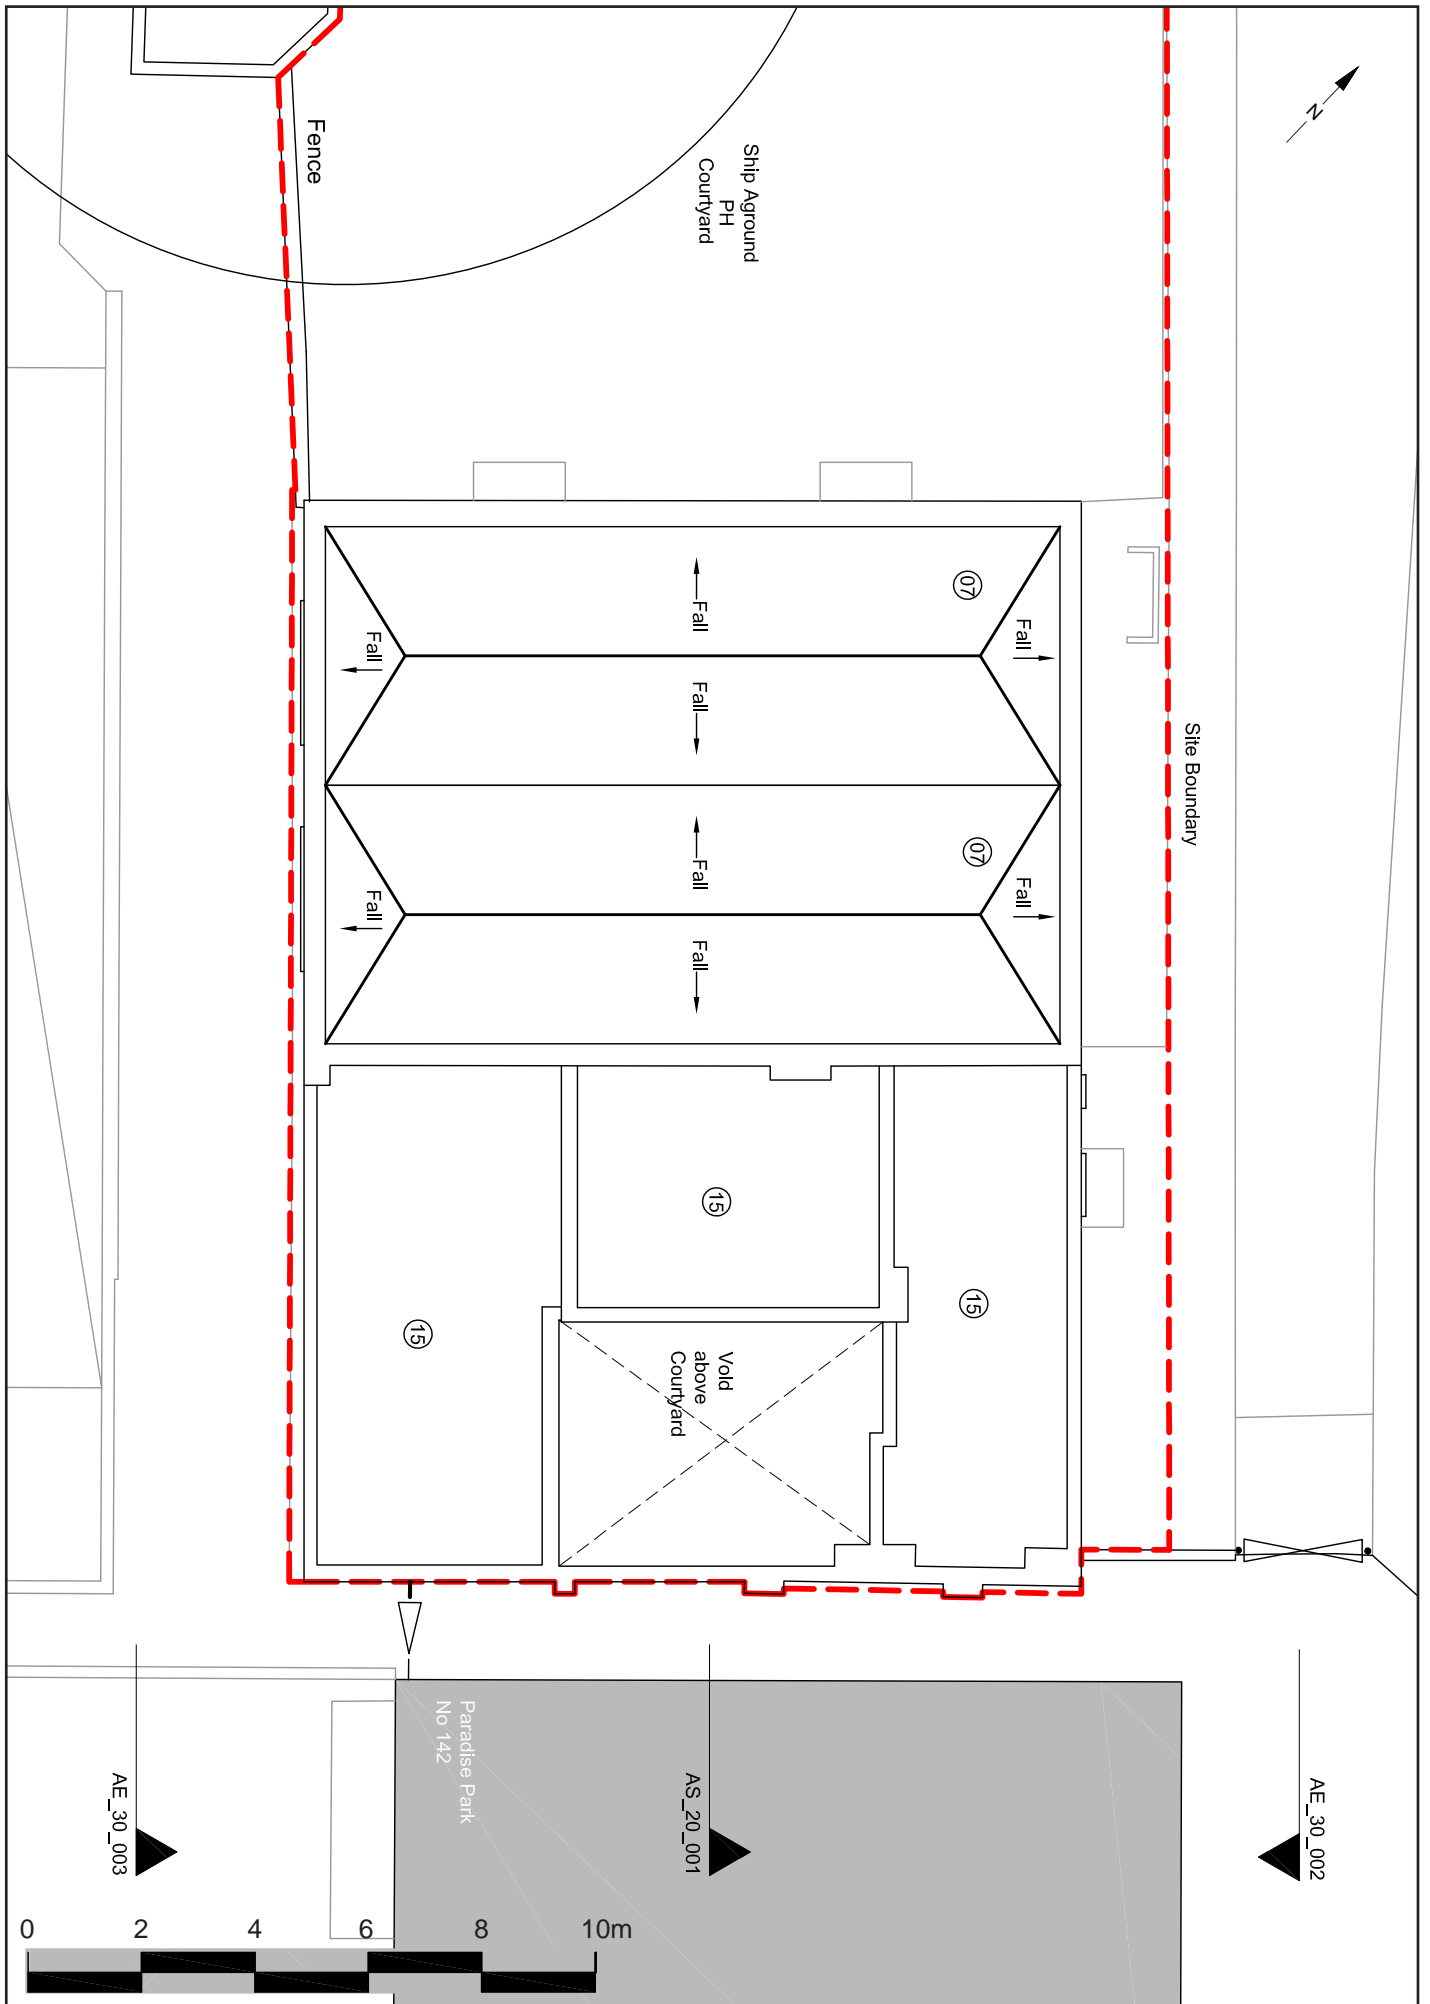
© Archaeology South-East		'Ship Aground', Lea Bridge Road, Hackney	Fig. 16
Project Ref: e2668	June 2013	Existing building, roof plan (January 2012) and photograph locations.	
Report Ref: 2013154	Drawn by: GH

5.7.1 The roof is of twin hipped construction with central valley between (Figure 16). The exterior was not visible at the time of survey, being hidden by the parapet, but records suggest that it was slate covered with red clay ridge tiles. The interior of the roof was not directly visible, but it was possible to obtain a photograph by pushing a camera through a broken window at first floor level.
