Essex Barn and Cart Lodge at Little Canfield Hall

Little Canfield, Essex

Historic Building Record and Archaeological Monitoring

Report No.: 2014236

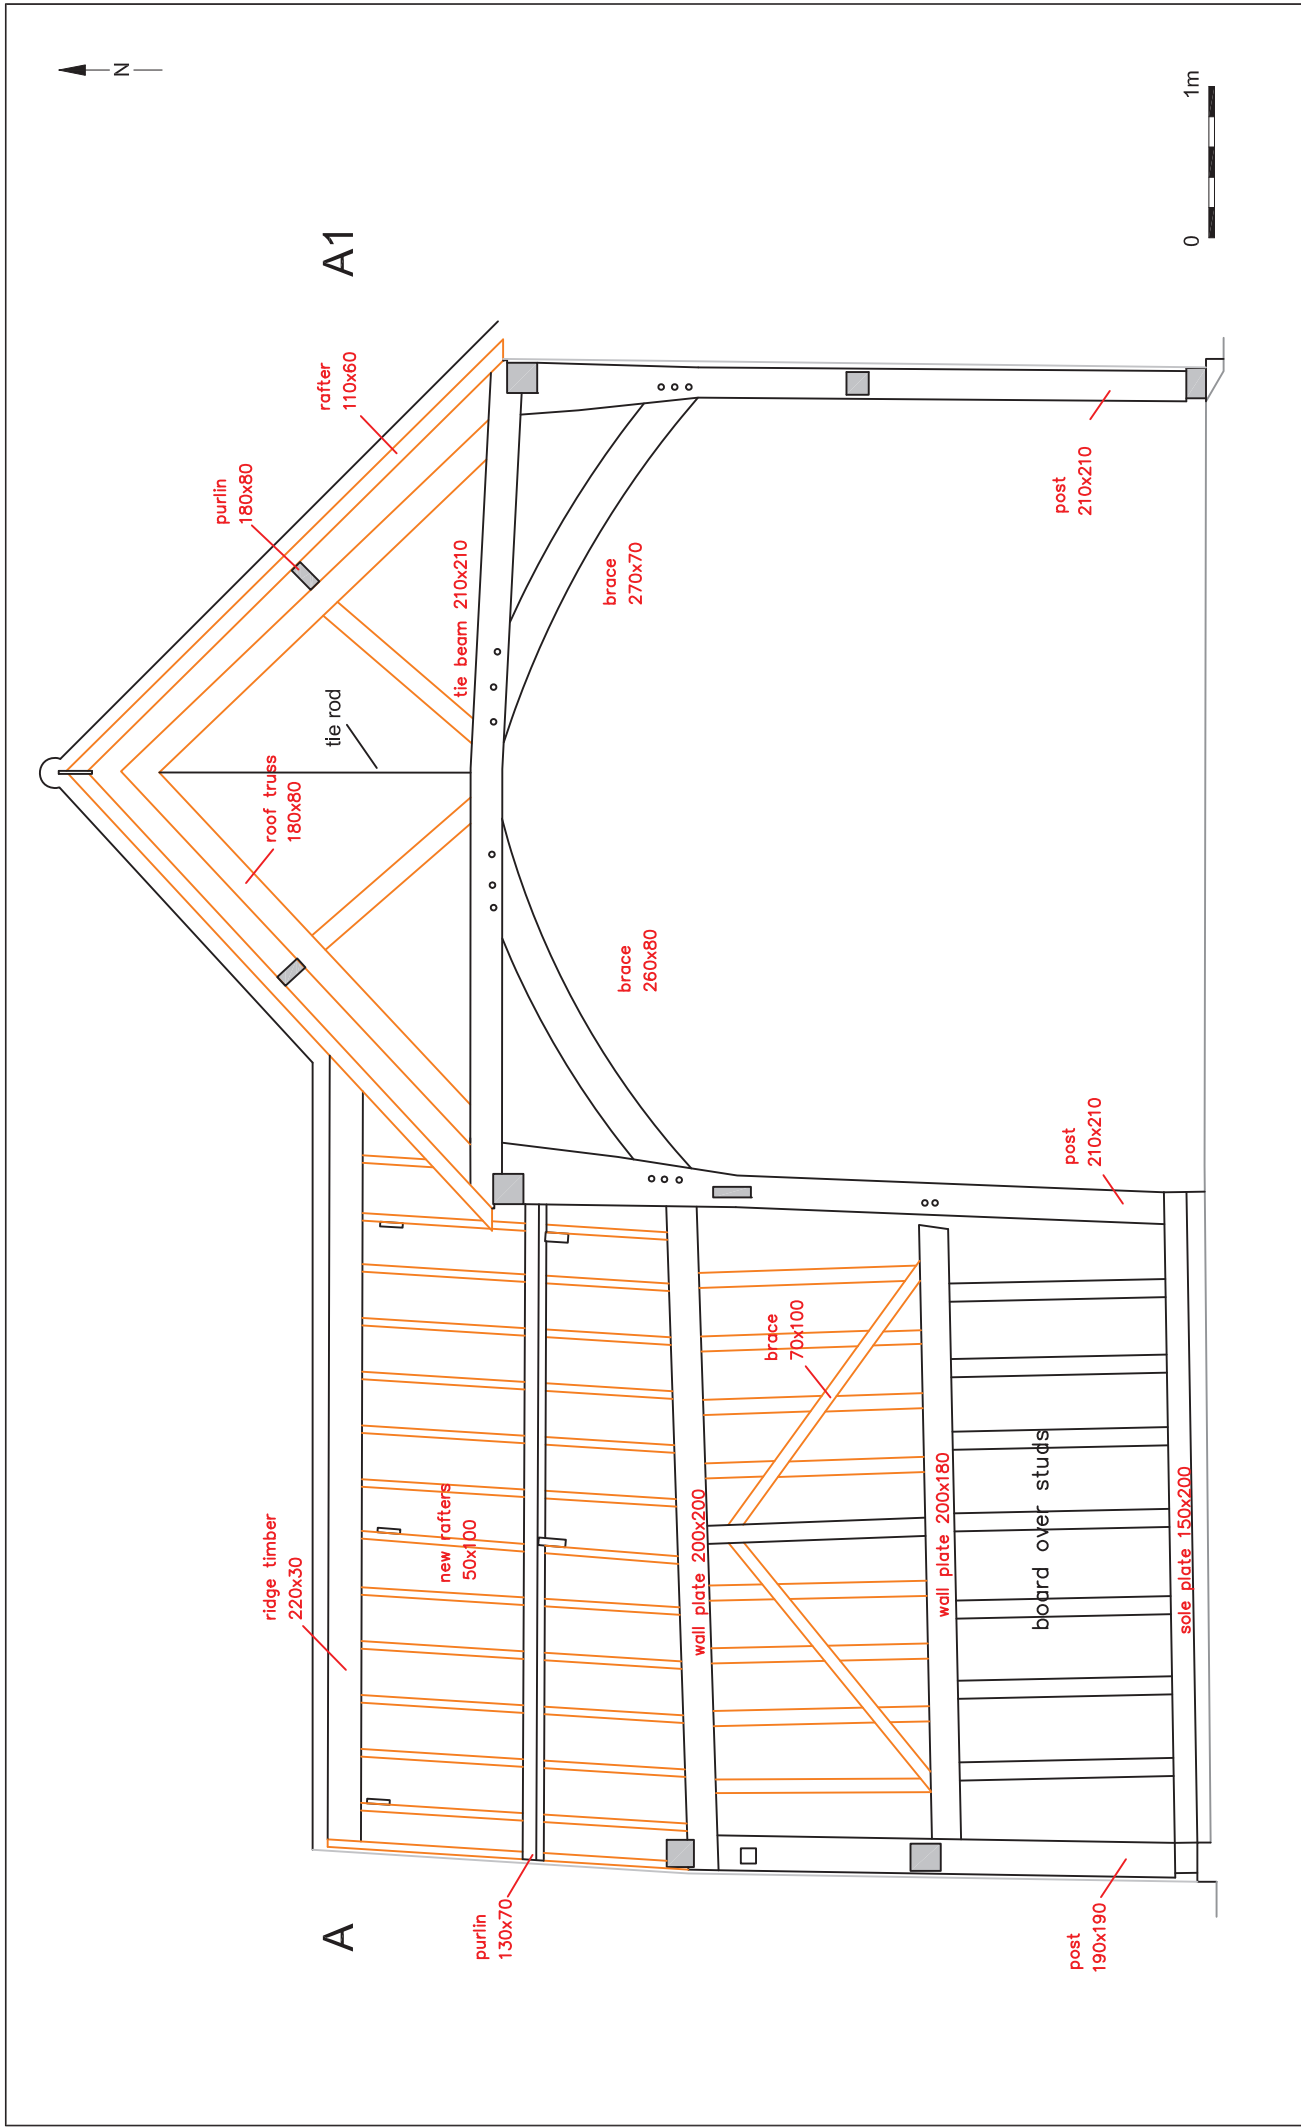
Cross-section A-A1

6.2.17 The roof was replaced in the late 19th or early 20th century with pre-fabricated machine-sawn raking strut frames fitted with bolted iron king rods and modern rafters (Fig. 8). No evidence of the earlier roof form was recorded in the survey. The roof appears to retain its original, re-laid, tiles.

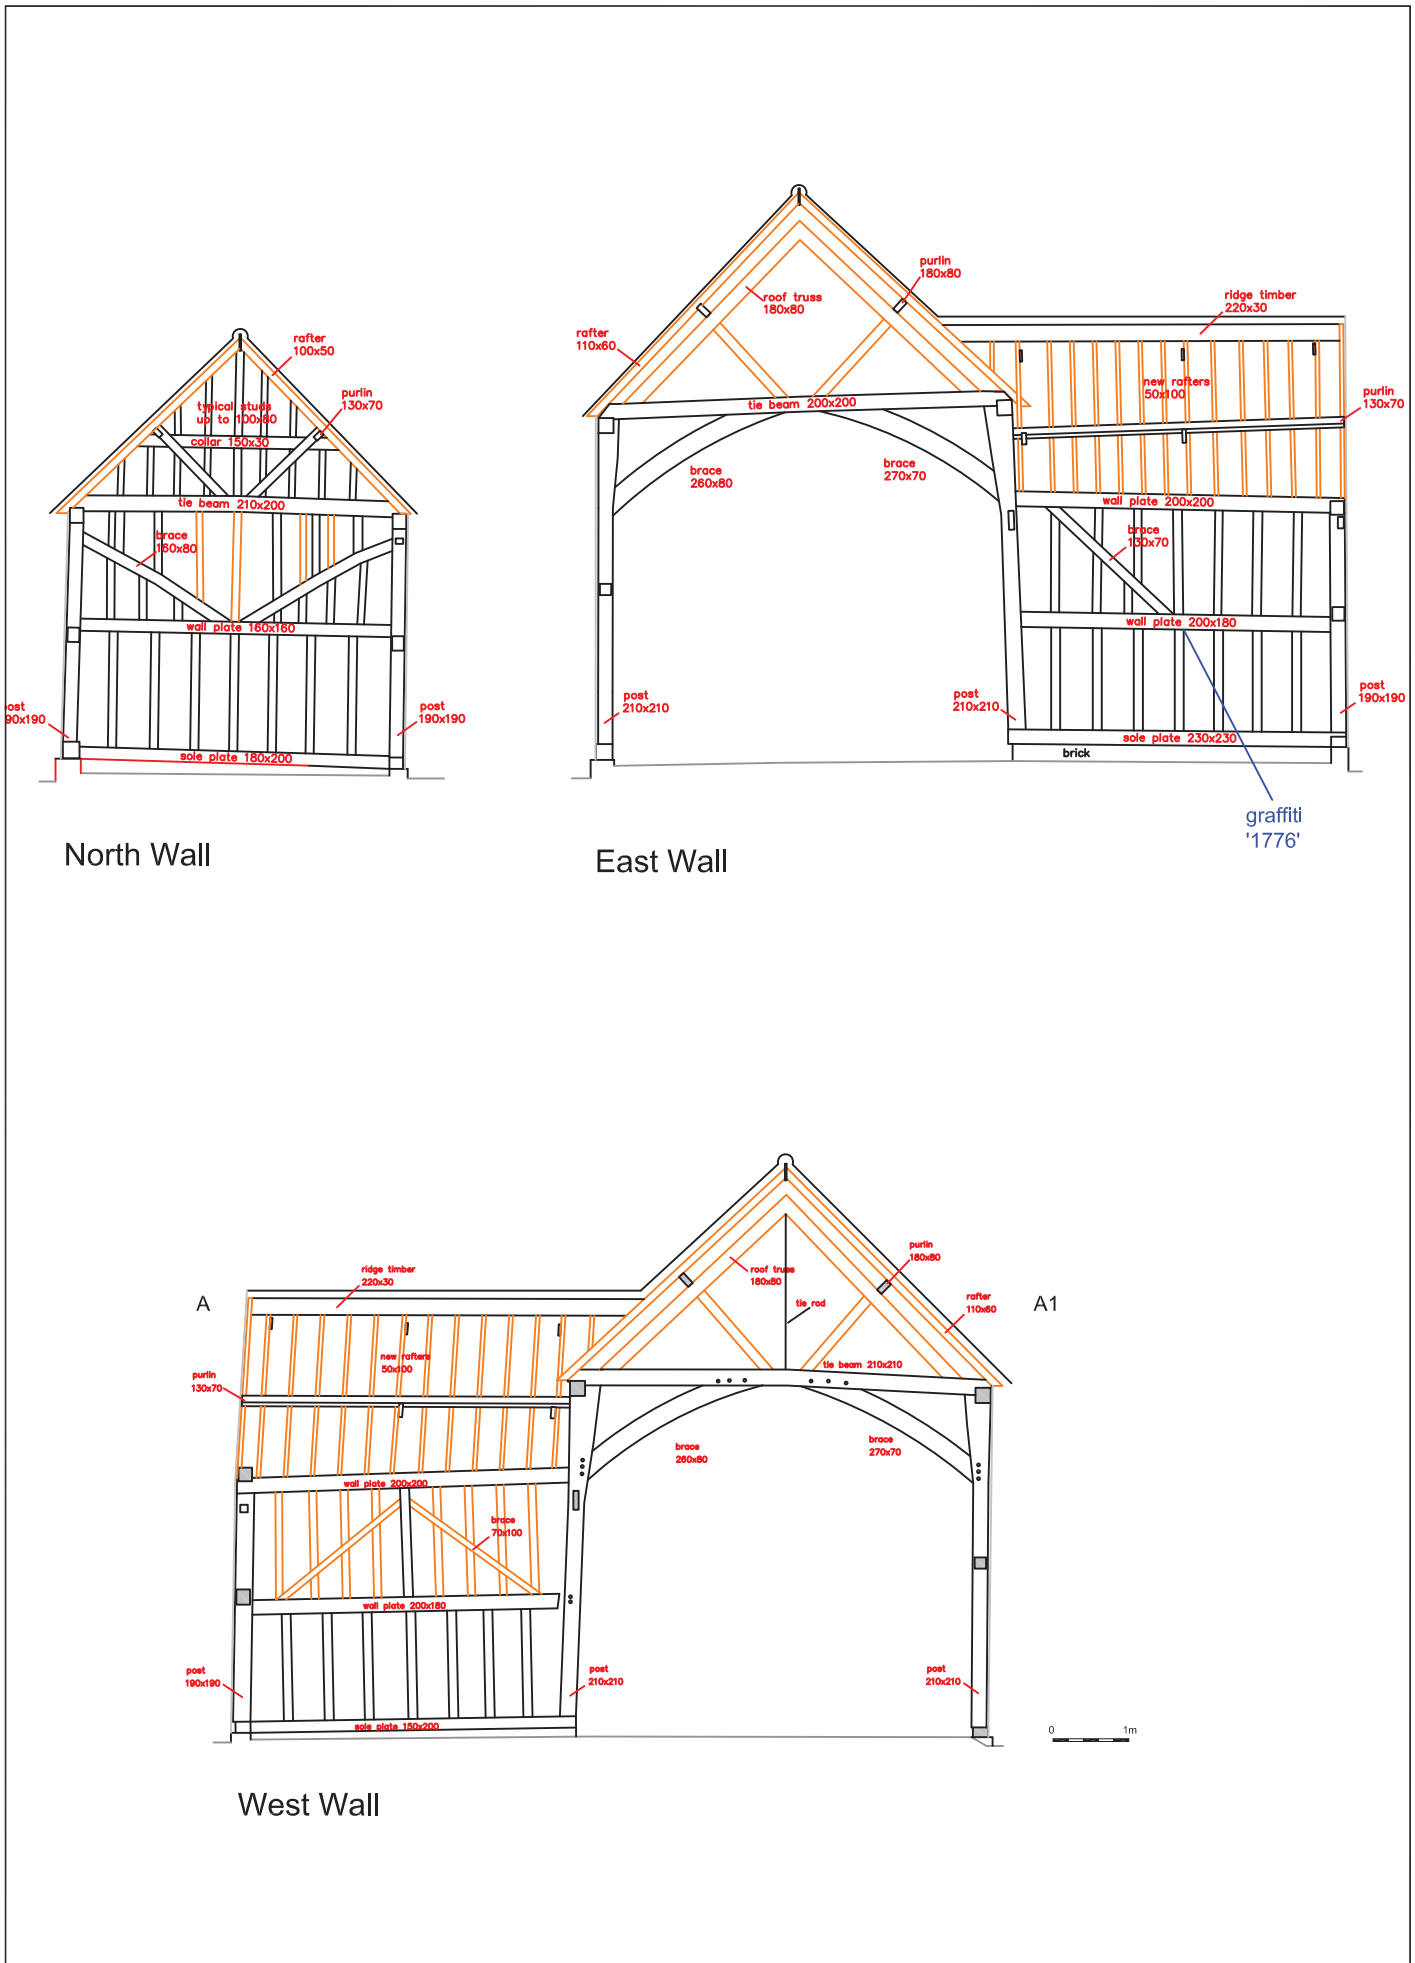
© Archaeology South-East		Essex Barn at Little Canfield Hall, Little Canfield	Fig.10
Project Ref: 8183	Aug 2014	Timber survey: Porch	
Report Ref: 2014236	Drawn by: APL

6.2.15 The porch (Plate 9) appears to be contemporary with the main part of the barn and the brick infilling between the studs on the lower register uses bricks of similar size to those of the plinth. They are laid in single width courses and rendered either side. Part of the north wall has been rebuilt since there is a higher proportion of machine-sawn timbers on this side, but this is only relative. Both lapped and bladed scarf joints were recorded in the side walls. Studwork in the upper half of the east wall appears to have been rebuilt in more regular timbers and straight primary bracing, falling from the middle post (Fig. 10).

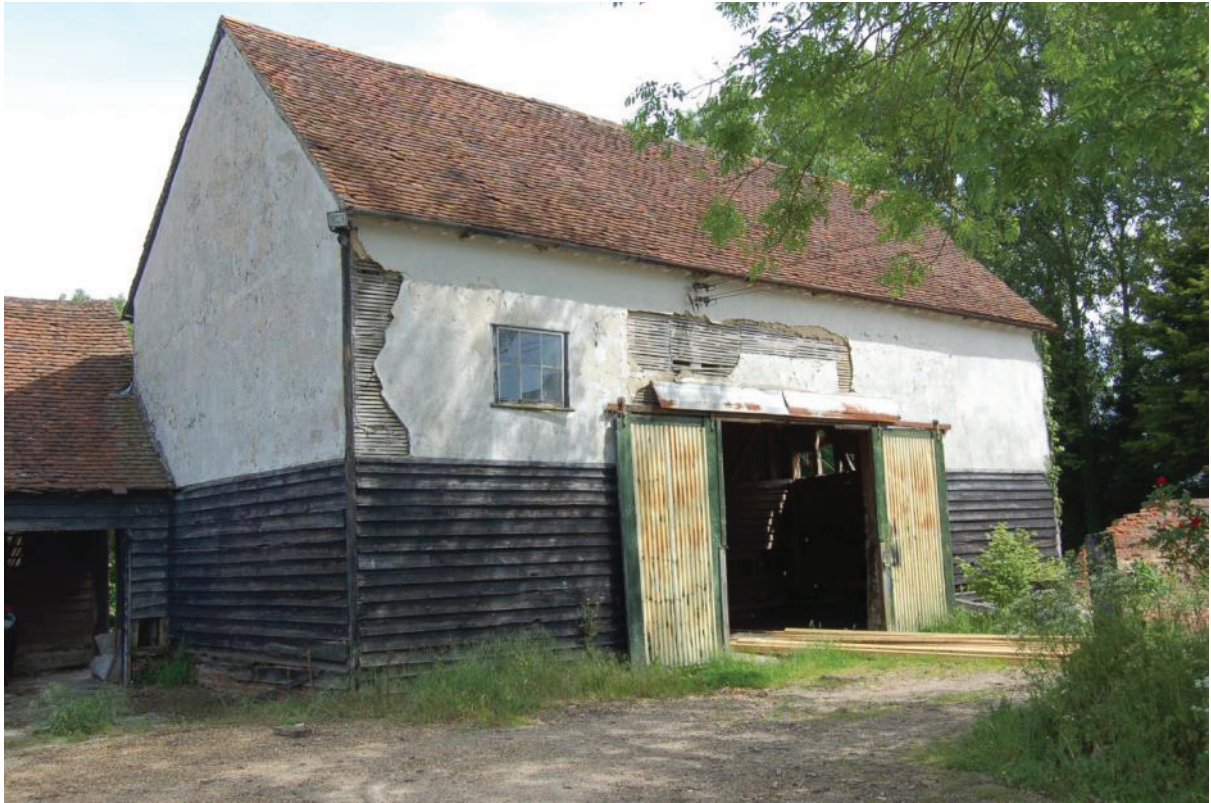
- 6.2.5 At the centre of the south elevation (Plates 3 and 4) is the doorway, which has been replaced by a pair of later (post-war 20th century) sliding doors constructed from corrugated tin sheets on a light wooden frame. Above and to the west is an inserted fixed 6-pane window that may be contemporary with the modern door, or slightly earlier. Laths are exposed above the doorway and in the southwest corner where the render has failed.

- 6.2.8 The cart lodge is partly attached to the west elevation, which is half-boarded and has suffered least from failure (Plate 3).

Plate 3 Barn viewed to north-east

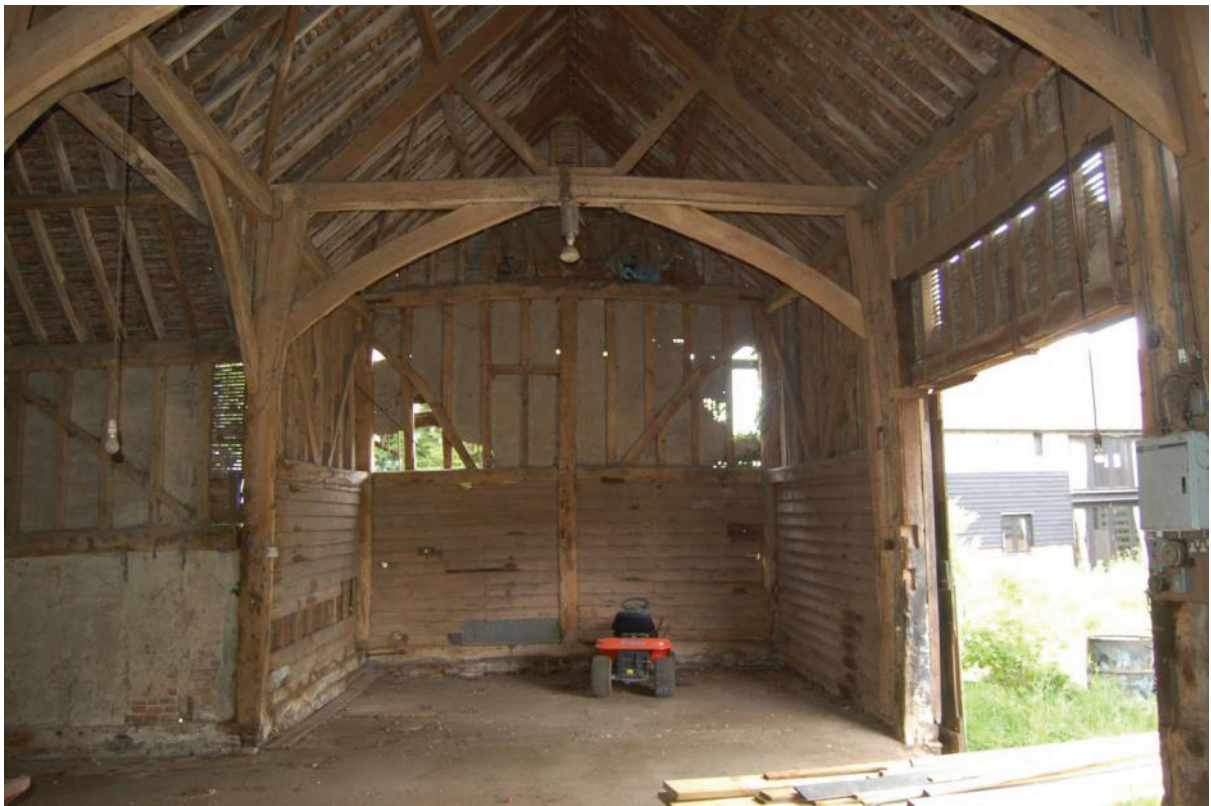
- 6.2.9 The interiors (Plates 6 & 7) were dry, clear and free to access and particularly well-preserved with good timberwork suggesting a 17th century date. Oak and elm appear to be used in the construction. In Figs. 8-10 original wall-framing is shown in black and replaced areas of framing are indicated in red.
- 6.2.10 There are three equal 4.5m-wide bays in the main part of the barn and a single bay to the north for the porch. All floors are laid to concrete. The wall timbers in the main part of the building are clad in pine boarding in the lower register but are exposed in the upper part with lath and plaster between. In the porch, the lower register is

for an early window, divided into two lights beneath the wall plate on the north side of the middle post (Plate 6), but this was blocked-in some time ago. The north wall contains some quite waney locking studs in the upper register and the west elevation continues the common build themes and is also well-preserved.

Plate 6 Interior of barn viewed to east

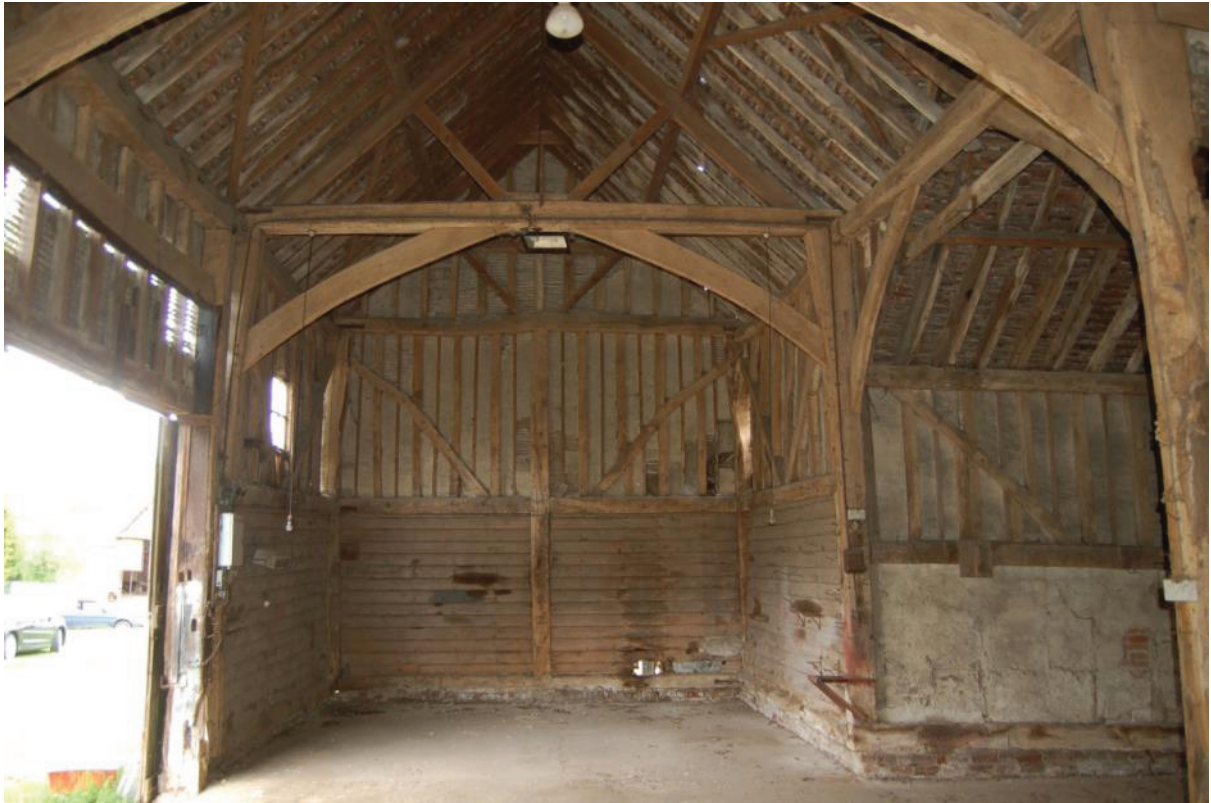
Plate 7 Interior of barn viewed to west

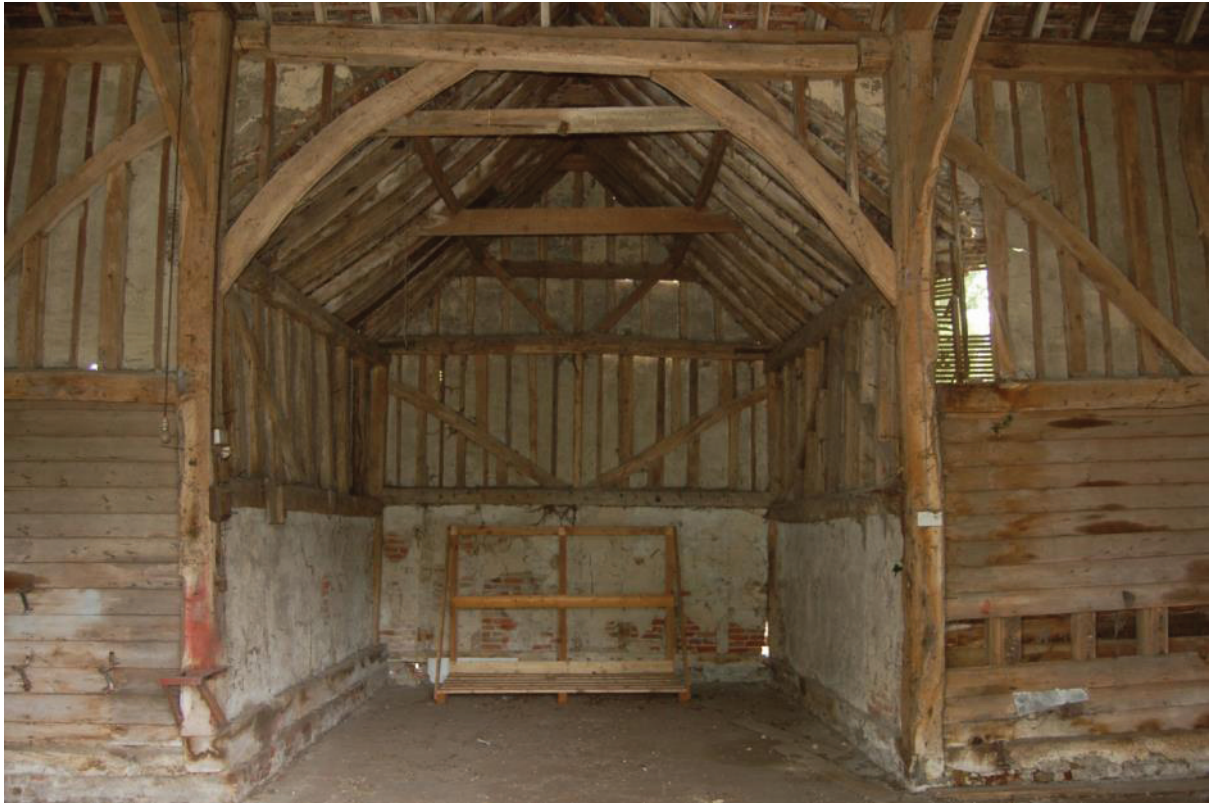
Plate 9 Porch interior

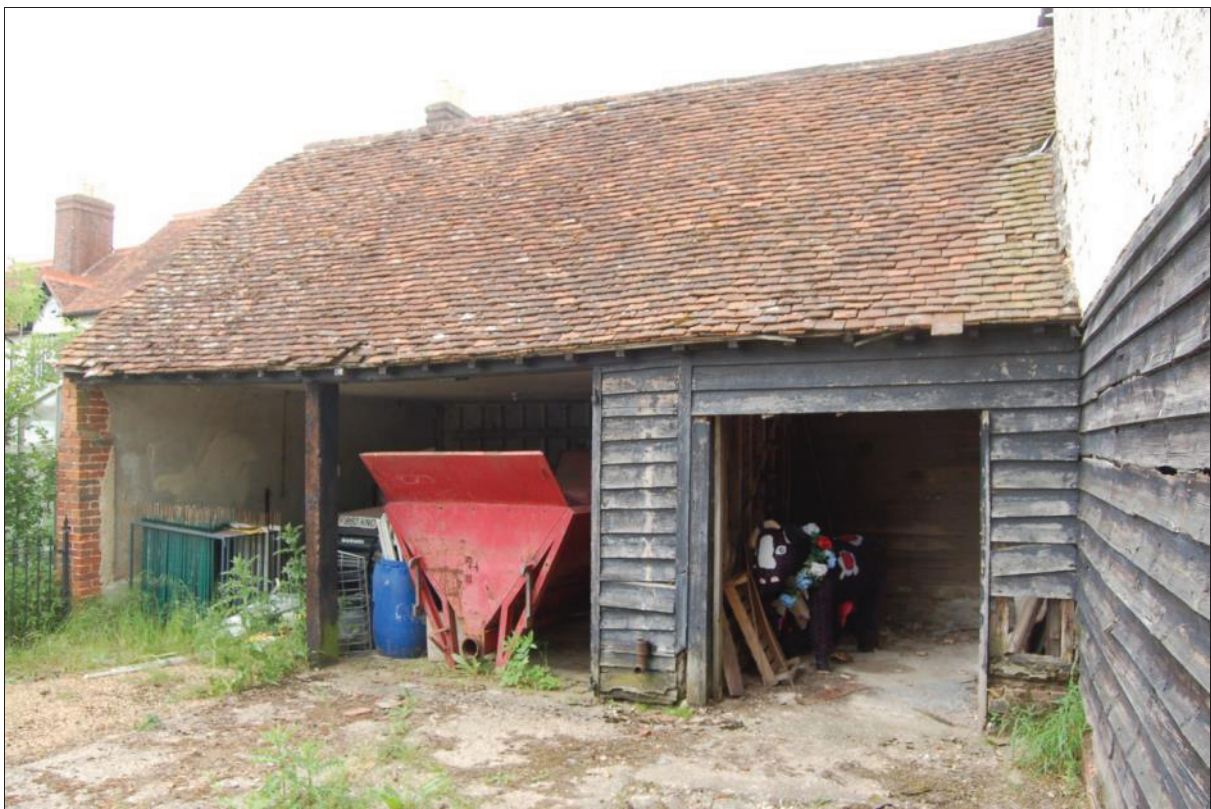
6.3.3 The two open bays on the main (south) elevation (Plate 12) are divided by a central post that appears to be a modern replacement or insertion. Pintels on the east side of the middle bay indicate there was once a door here, and there is likely to have been a door on the other side as well, for securing the carriages. The third bay at the east end was originally enclosed but has been opened up to admit a modern metal roller door.

Plate 12 South elevation of cart lodge

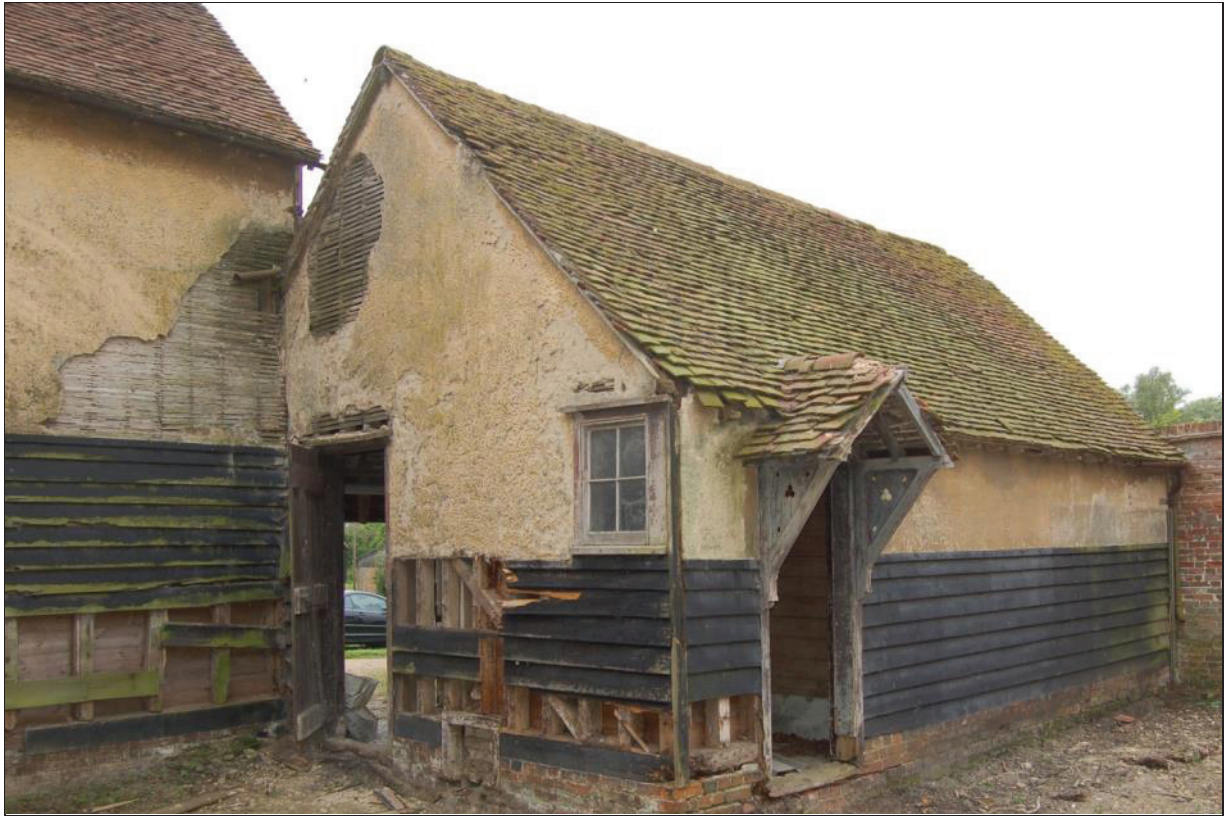
6.3.4 On the east elevation (Plate 13) the main features here are a single doorway at the south end that provided access into Room 2 and a window to the north of the elevation that lit Room 3. The doorway is fitted with a replaced ledged, braced and boarded door with T-hinges, but occupies an earlier aperture. The window is a plain fixed four pane type with narrow mullions probably contemporary with the building and perhaps with the one in the barn. At the base of the wall, between the two features where some of the boarding has been removed, is a blocked square aperture approximately 0.5m wide and 0.4m high that is neatly built into the wall plinth (Fig. 7 and Plate 13). This may be the aperture for an old power drive shaft.

Plate 13 Rear of cart lodge viewed to south-west, showing blocked aperture at base of wall

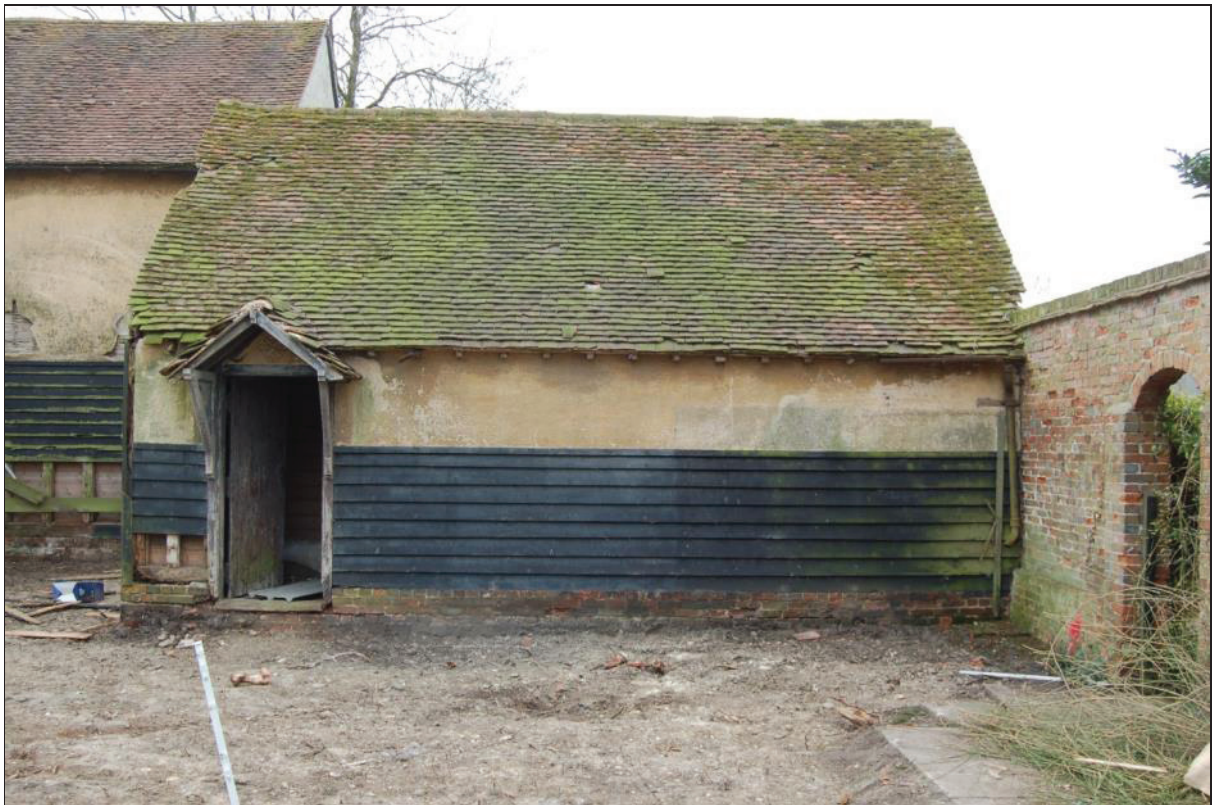
6.3.5 The north (rear) elevation has the same traditional half-boarding as the east side (Plate 14). A doorway stands to the east beneath a small canopied porch. The porch is Gothic in style with a tiled pitched canopy supported on brackets with trefoil-decorated spandrels and a naturalistic 'daisy wheel' design in the plaster above the door head (Plate 15), perhaps a later addition. The door is boarded on the outside with a round knob and connected with the garden gateway. It leads into small panelled Room 2.

Plate 14 North elevation of cart lodge

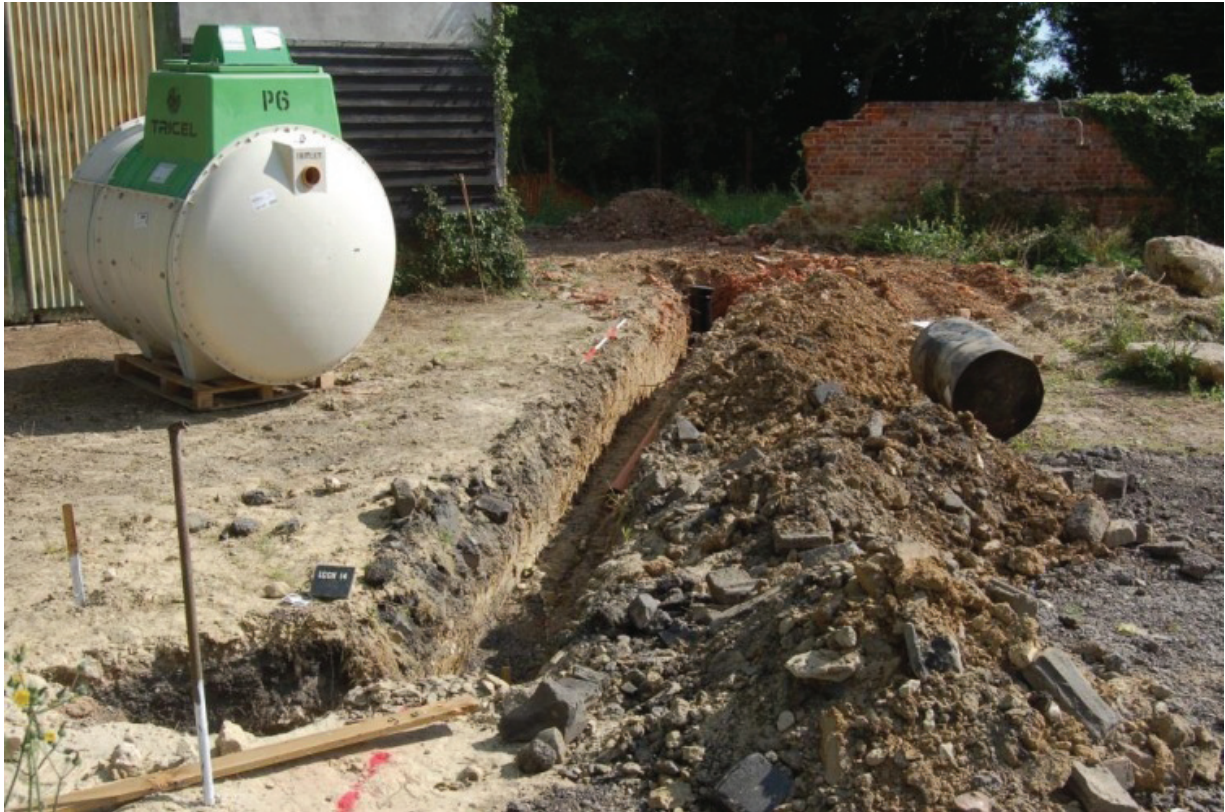
Plate 23 Pipe trench at front of barn, viewed to north-east

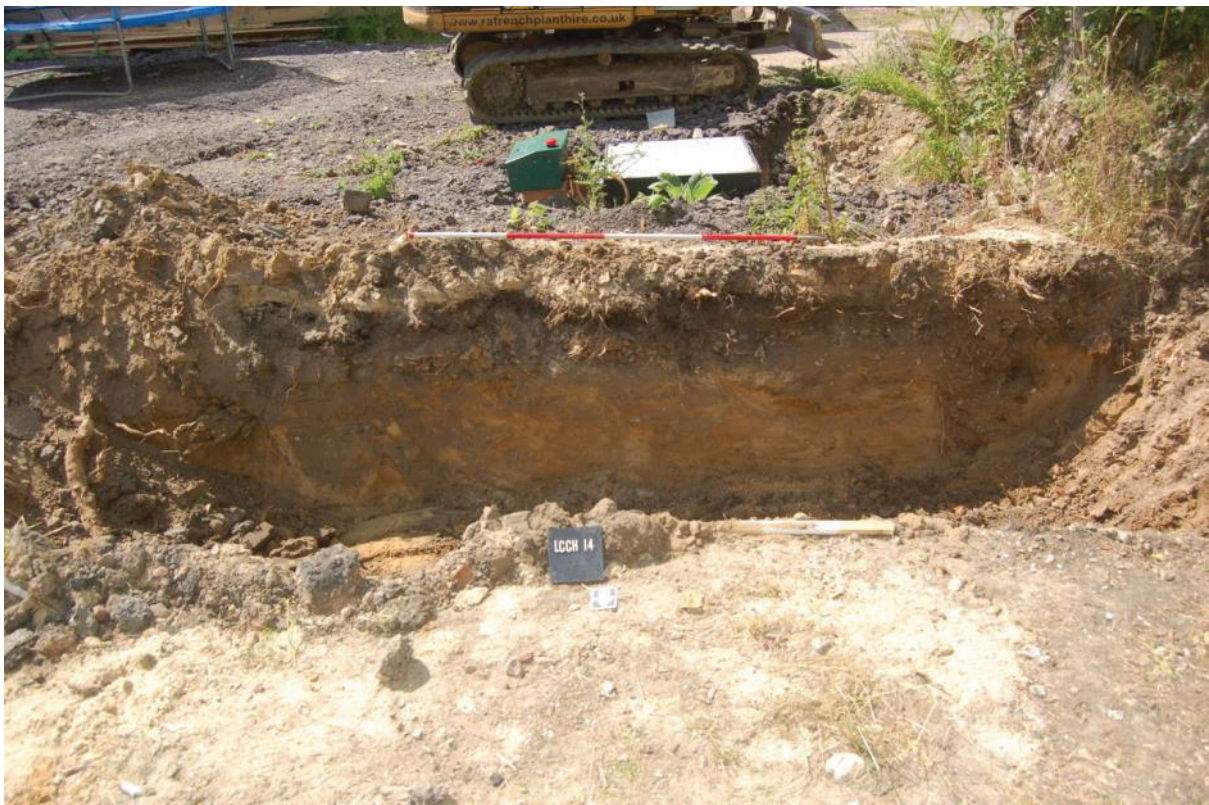
- 7.3 The tank trench was excavated 11m to the south of the barn and measured 2m x 5m and was 1.2m deep. At the top was topsoil, 0.5m thick, mixed with gravel and other modern debris and disturbed by roots from a neighbouring tree. This lay above a thick brown grey clay layer on the north side, with chalky clay at the bottom, and fine mid yellow orange sand on the south side, demonstrating the abrupt changes in natural geology on the site (Plate 24).
- 7.4 No archaeological features were observed or finds collected during the monitoring works.

Plate 24 Klargester pit viewed to south
