**SUTTON GARAGES, ALFRISTON ROAD,
SEAFORD, EAST SUSSEX
(NGR 549282 099674)**

**HISTORIC BUILDINGS RECORD
(ENGLISH HERITAGE LEVELS 1 & 2)**

ASE Project No. 6569

Report No. 2014293

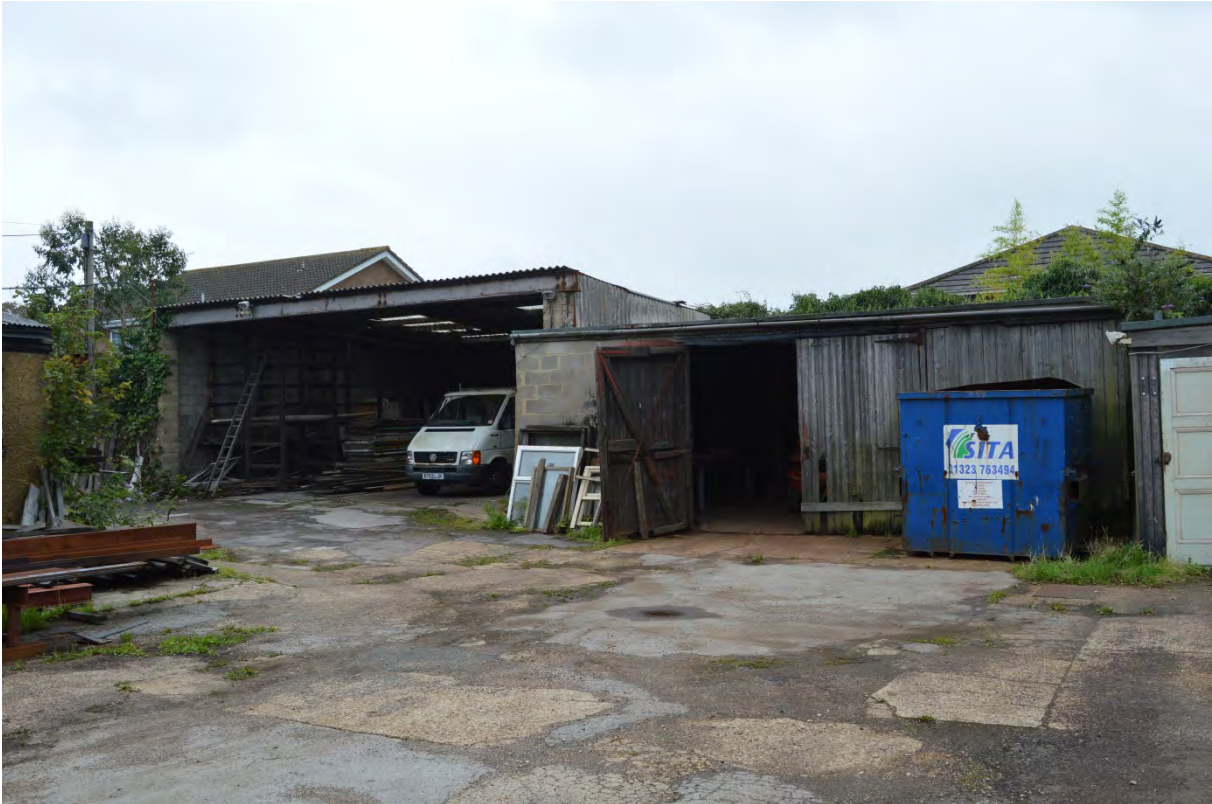
- 6.1 Building 1 is an open-fronted structure, located on the southern boundary of the site, with its open front facing north towards the yard (Plate 1). Its walls are constructed in concrete blocks clad with corrugated asbestos sheet, its floor is concrete and its shallow mono-pitched roof comprises a combination of steel I-girders and timber joists, clad with corrugated asbestos and containing occasional corrugated polycarbonate rooflights. The building appears to have functioned as a garage or workshop and is understood to date to the 1970s.

- 6.2 This building is similar in construction to Building 1, comprising concrete blockwork walls, a concrete floor and a flat roof constructed with steel I-girders and timber joists, clad with timber sarking and finished externally with roofing felt (Plate 1). Its north elevation is partially clad with vertical weatherboarding and contains a pair of full-height timber plank-and-batten doors. It has previously functioned as a workshop and is understood to have been constructed by the mid-1960s.

Plate 1: Buildings 1 & 2, looking south-east (52)

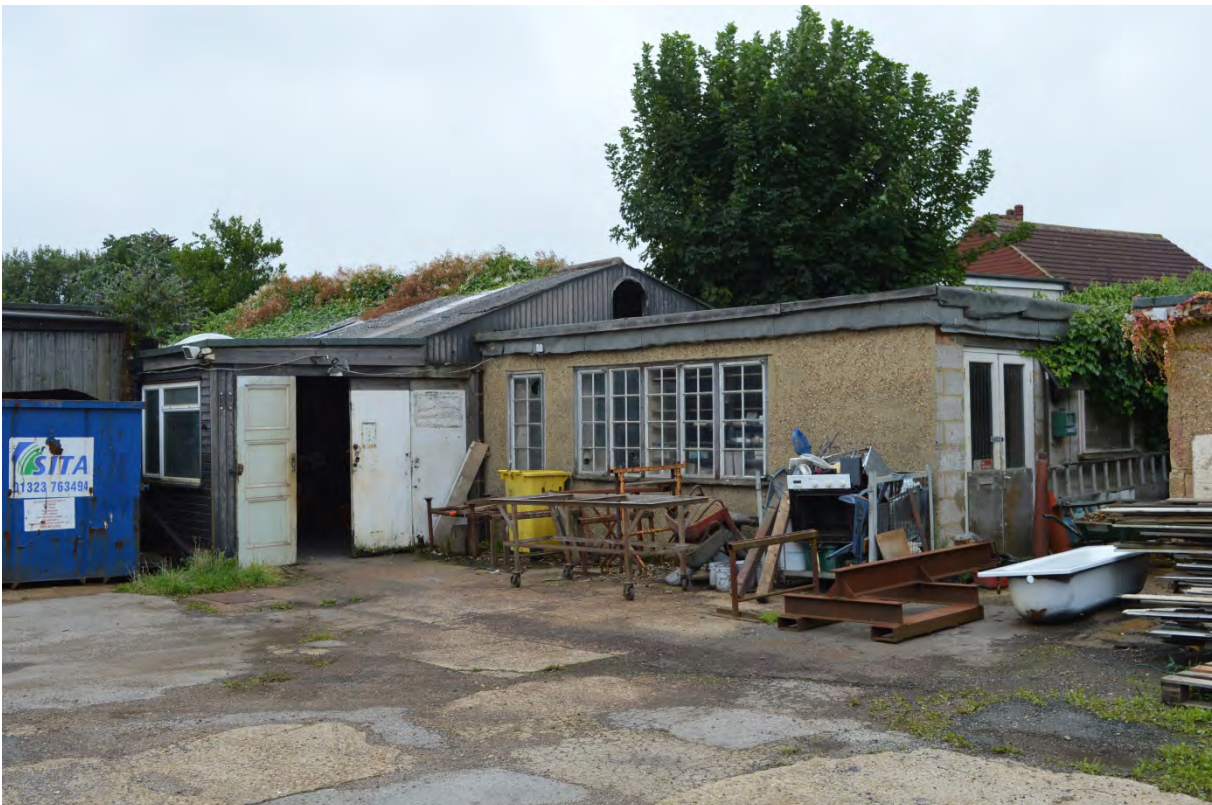
- 6.3 This building is predominantly of very late 19th/early 20th century date (constructed between 1899 and 1927), and is in use as a workshop (Plate 2).

- 6.6 Building 4 is attached to the north-west corner of Building 3 (Plate 2). It is of breeze block construction, clad on its eastern elevation with pebbledash, with a flat roof comprising timber joists clad with sarking and finished externally with roofing felt. Its west elevation contains a series of Crittall-type windows set in timber frames and its north elevation contains a pair of glazed timber doors. The interior is subdivided by timber partitions, some of which are glazed, and it appears to have functioned as a small office/staff room and store. Access to Building 3 is gained via a doorway in its southern wall.

Plate 2: Buildings 3 & 4, looking south-west (51)

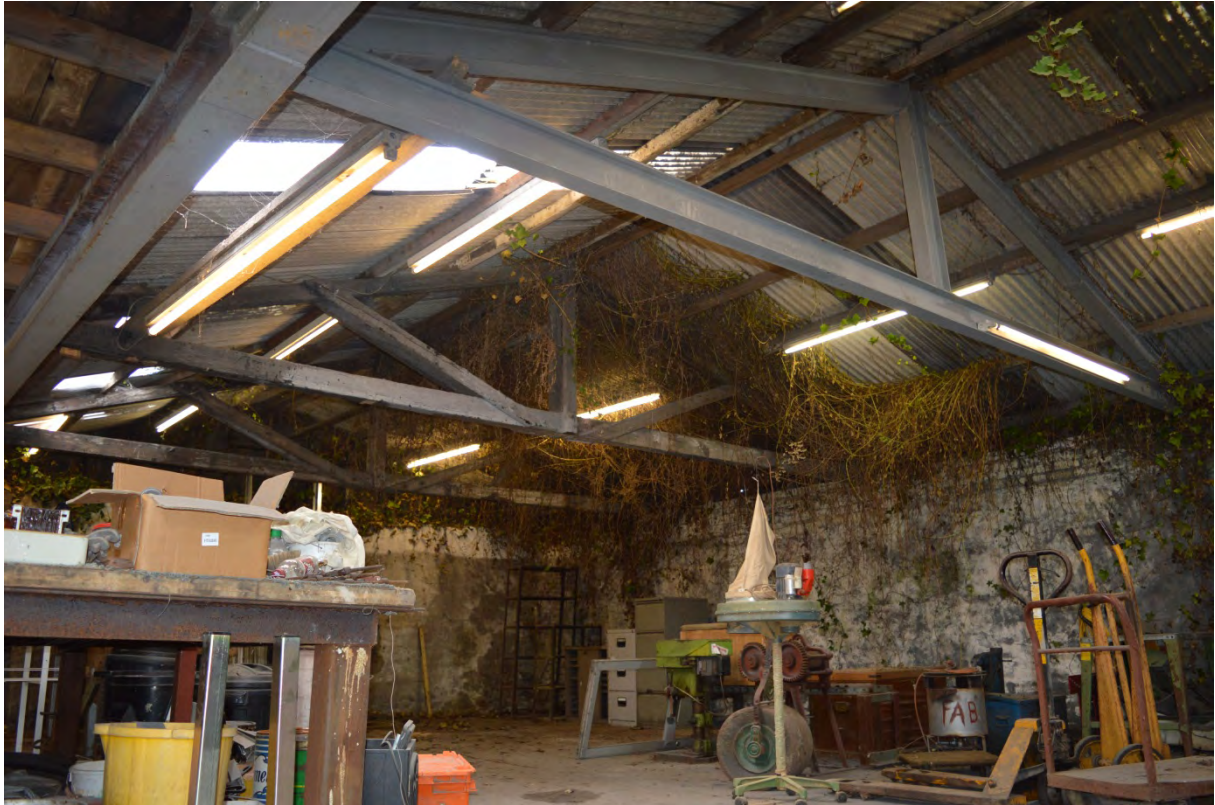
- 6.4 The interior of the building is open-plan across both the main part of the building and the addition to the eastern side. The main range is of four bays, and is open to the roof with timber roof trusses (Plate 3). The trusses comprise tie beams with pairs of timber planks bolted onto either side to form a king post and raking struts to the principal rafters. The central truss bears evidence of having been subjected to high levels of heat at its western end, and the northernmost truss has been replaced with one constructed in I-section steel. The roof covering is supported by a series of timber purlins to each roof slope and contains corrugated polycarbonate rooflights.

Plate 3: Interior of Building 3 (54)

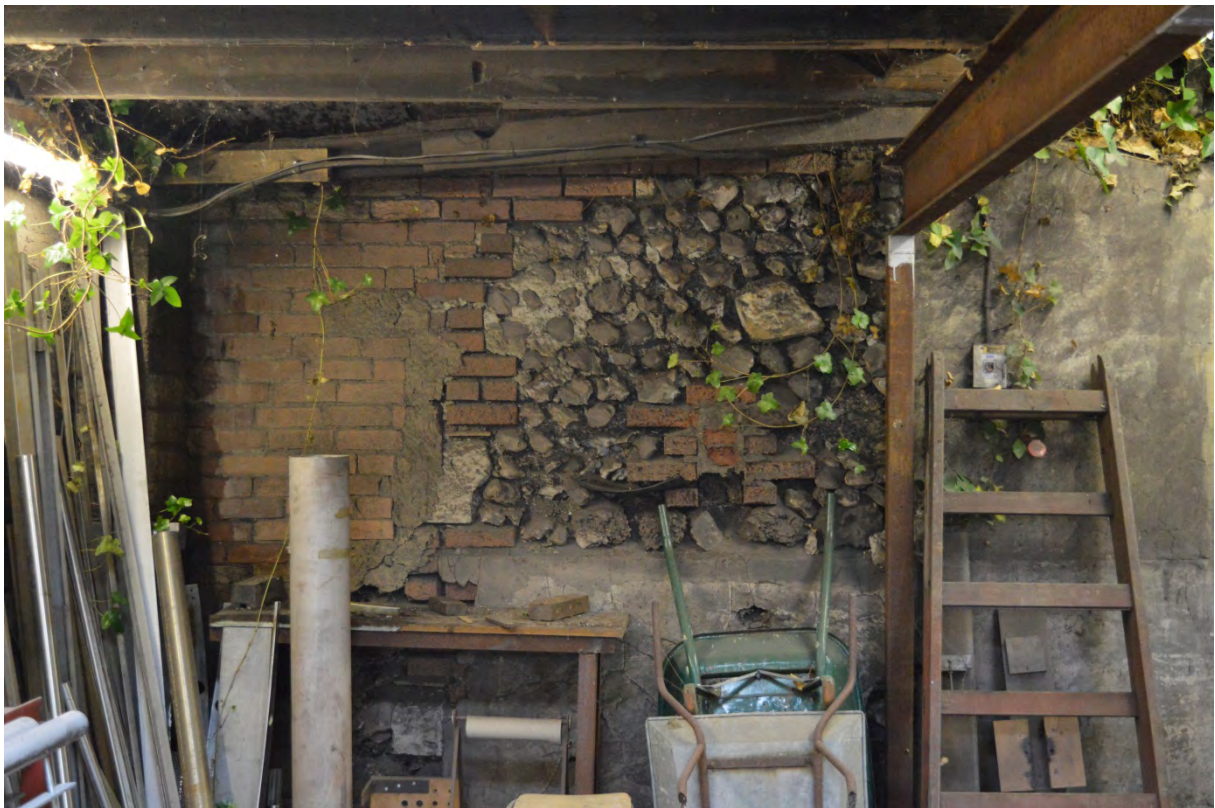
- 6.5 The eastern wall of the building is constructed in concrete blocks; the northern wall is clad internally with timber boards below the level of the gable, which is of softwood timber frame construction. The southern and western walls of the building appear to be formed by the farmyard wall. To the west the wall is constructed in coursed flint, raised by 5-6 courses of brick, all with a whitewashed finish. The southern wall is largely rendered with visible areas of modern concrete block and brick construction; however, an area of coursed flintwork is visible at the eastern end of the wall (Plate 4).

Plate 4: Flint wall on southern side of Building 3 (57)

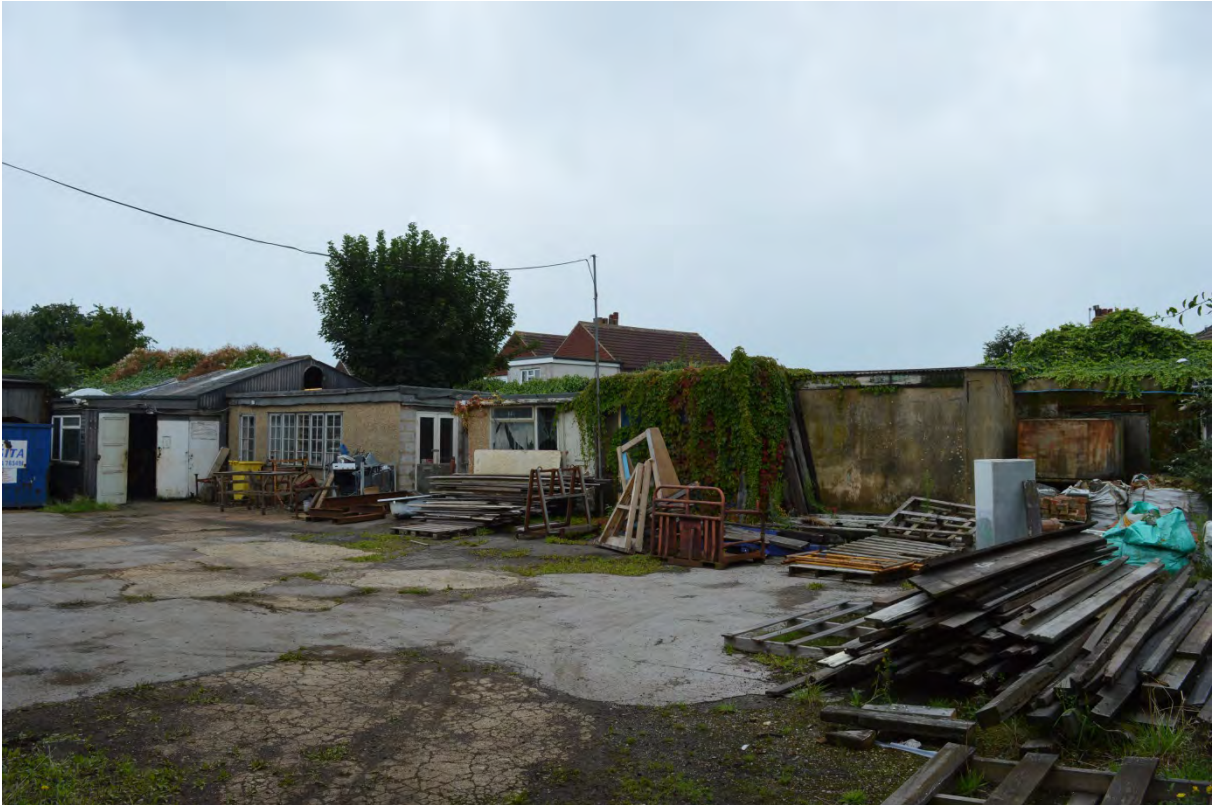
- 6.7 Building 5 is of mid-later 20th century date and is a linear structure, aligned north-south along the western boundary of the site (Plates 5 & 6). It is a single-storey structure, built in concrete block and rendered externally. It has a shallow mono-pitched roof, the main part of which is constructed in I-girders with a corrugated asbestos cladding incorporating corrugated polycarbonate rooflights. A small addition at the southern end of the building has a timber roof structure clad with sarking and felt, in the same manner as Building 2.

Plate 5: Buildings 3-6, looking south-west (49)

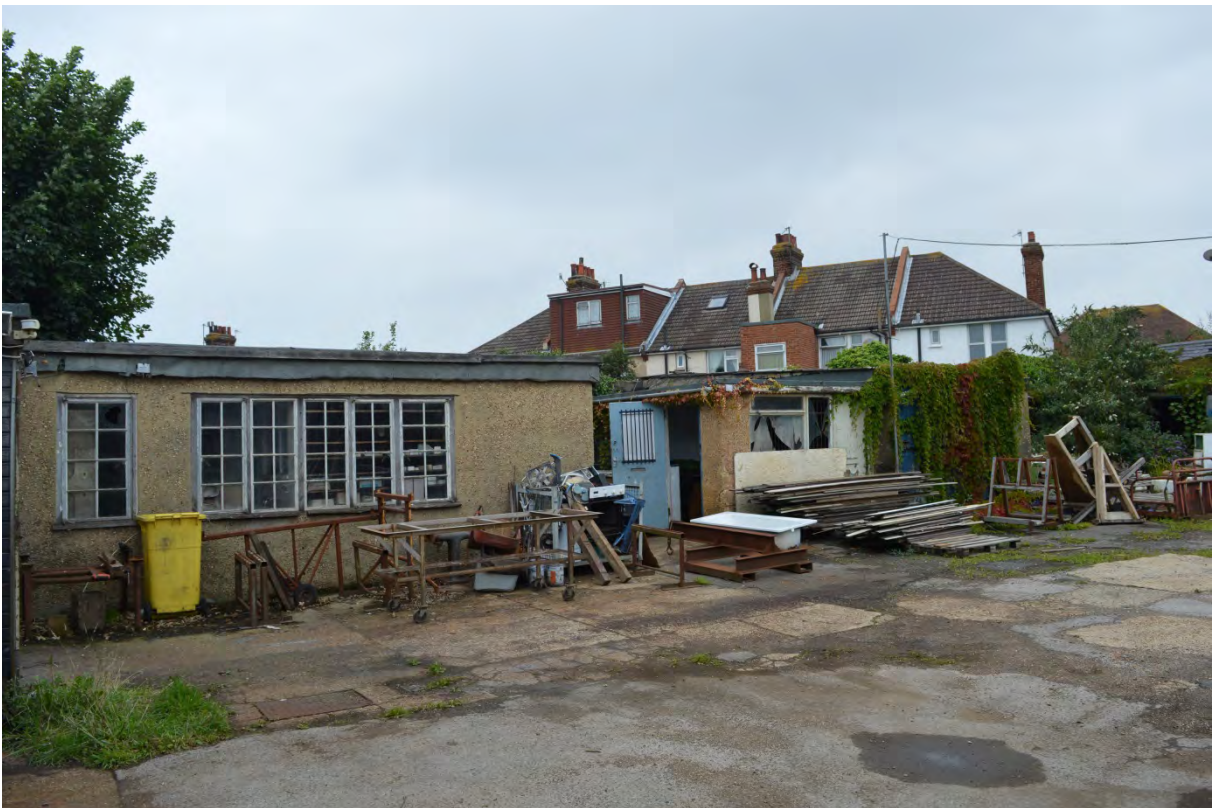
- 6.8 Building 6 is a small single-storey structure attached to the northern end of Building 5 and the south-west corner of Building 7; it is of likely mid-late 20th century date. It is rendered with a corrugated asbestos roof. The structure was overgrown at the time of the survey and could not be entered (Plate 6).

Plate 6: Buildings 4-6, looking north-west (50)

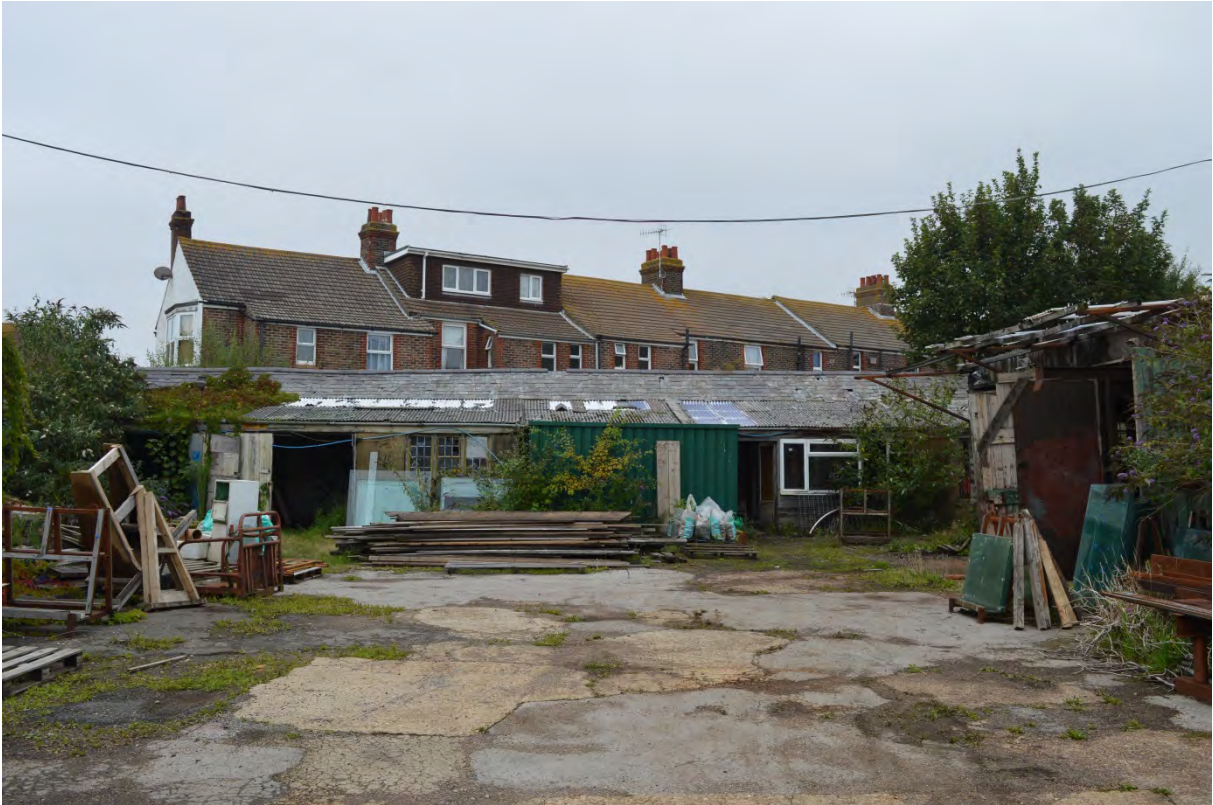
- 6.9 Buildings 7-11 form a long, linear single storey range, running along the northern boundary of the site, which has been subdivided to provide six separate units/rooms (Plate 7). The earliest part of the range is at the rear, the building having been extended with a lean-to addition to its southern side in the 1950s. The structure is of likely late-19th century date, based on its constructional details and evidence provided by historic map sources, which show a long linear range in place along the northern boundary by 1899 (Fig. 7). At this date, the western end of the structure was shown as open-fronted, facing onto an enclosed yard, suggesting it probably functioned as an animal shelter shed.

Plate 7: Buildings 7-11, looking north (31)

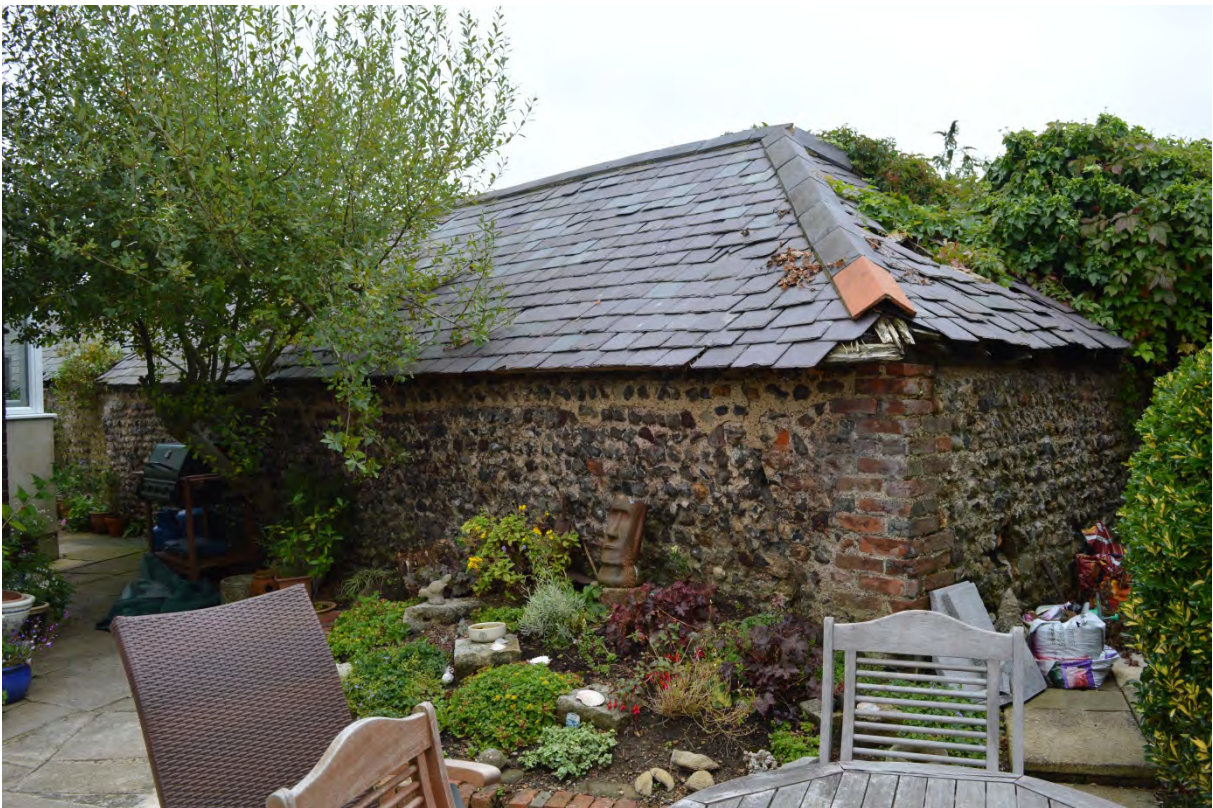
- 6.10 The west elevation and the north elevation of Buildings 7-8 were inspected from the owner's garden in Hindover Road, to the north of the site. The walls are constructed in coursed field flint with brick quoins and are largely blank (Plate 8). A change in the construction of the flintwork is noticeable midway along the visible part of the north wall of Building 8, with the eastern portion comprising coursed field flint with occasional brick inclusions, set in a yellow gravelly mortar which is penny-struck between the courses. The western portion comprises more closely-spaced flints and courses, with occasional ironstone inclusions, set in a pale gravelly mortar. The top two courses of this part of the wall have been raised; the yellow mortar and style of the work matches the eastern portion, suggesting the two are contemporaneous. The flintwork of the west elevation is closely-spaced and includes two small triangular openings, lined with clay tiles (Plate 9). These were probably vents which are now blocked internally. The brickwork quoins have an 18th/early 19th century appearance, suggesting that the wall is, at least in part, of probable earlier date than the remainder of the structure. The raising of the wall also suggests the present building incorporates remnants of an earlier structure.

Plate 8: Buildings 7-8, from the north-west (46)

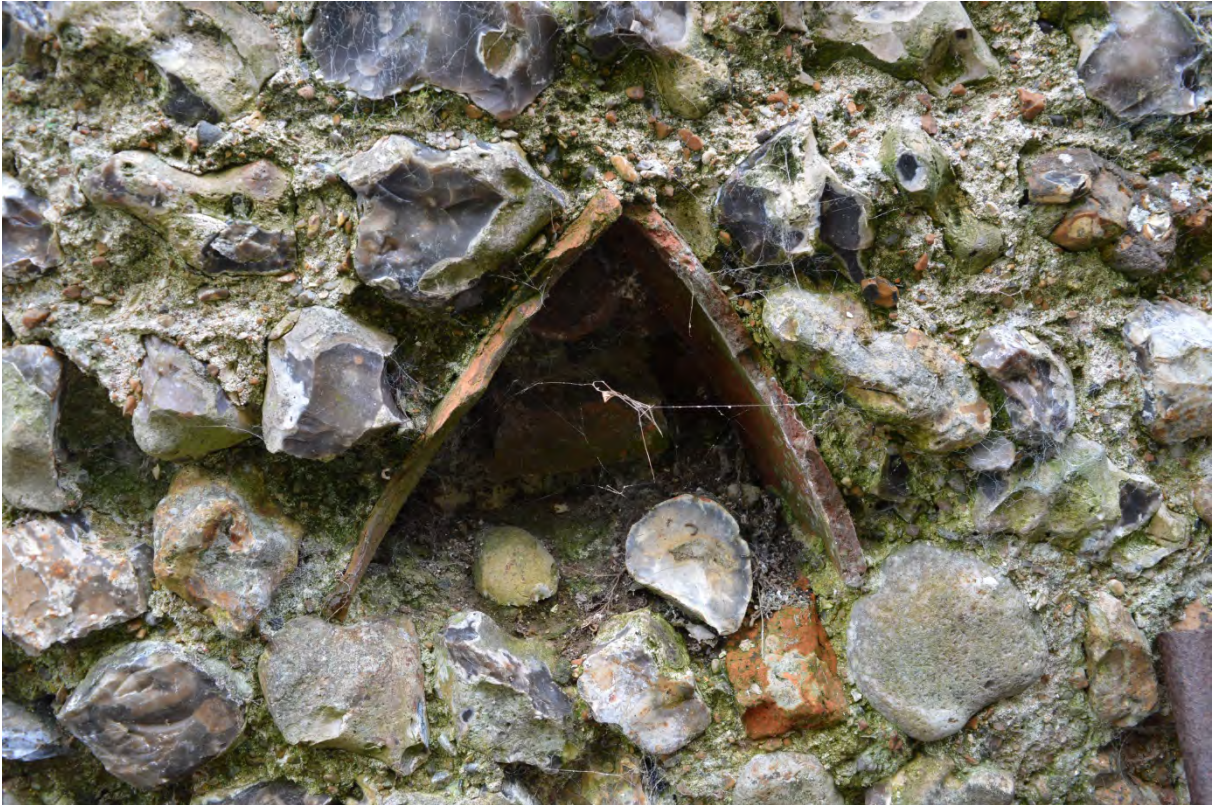
Plate 9: Probable blocked vent to Building 7 (47)

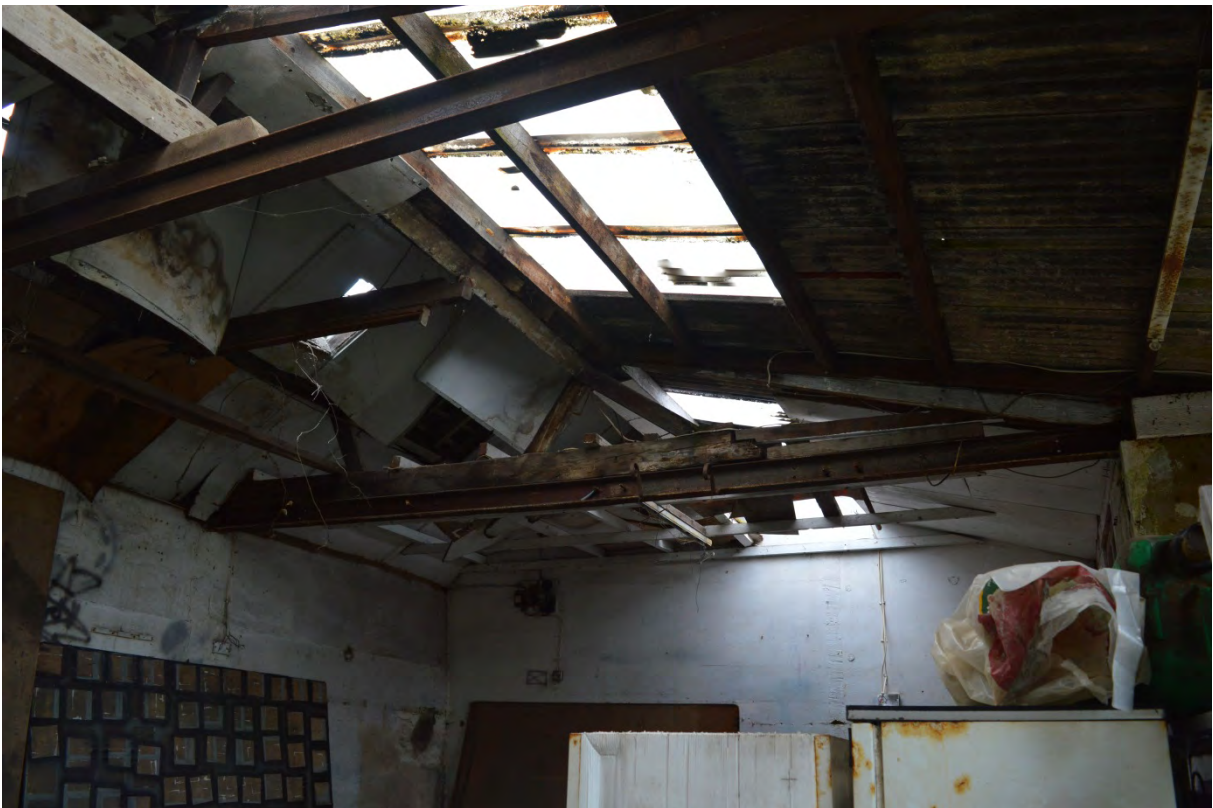
- 6.12 The main range is of ten bays, including the western end bay beneath the hip. The roof is formed by paired common rafters which meet at a ridge board, with side purlins supported by raking struts from the tie beams. The roof structure is nailed together and the trusses are strengthened with iron strapping to the tie beams. Steel girders have been inserted beneath the timber trusses, which extend beyond the original building line to carry the later roof structure to the south (Plate 10).

Plate 10: Roof structure of Buildings 7-11, viewed from Building 8 (42)

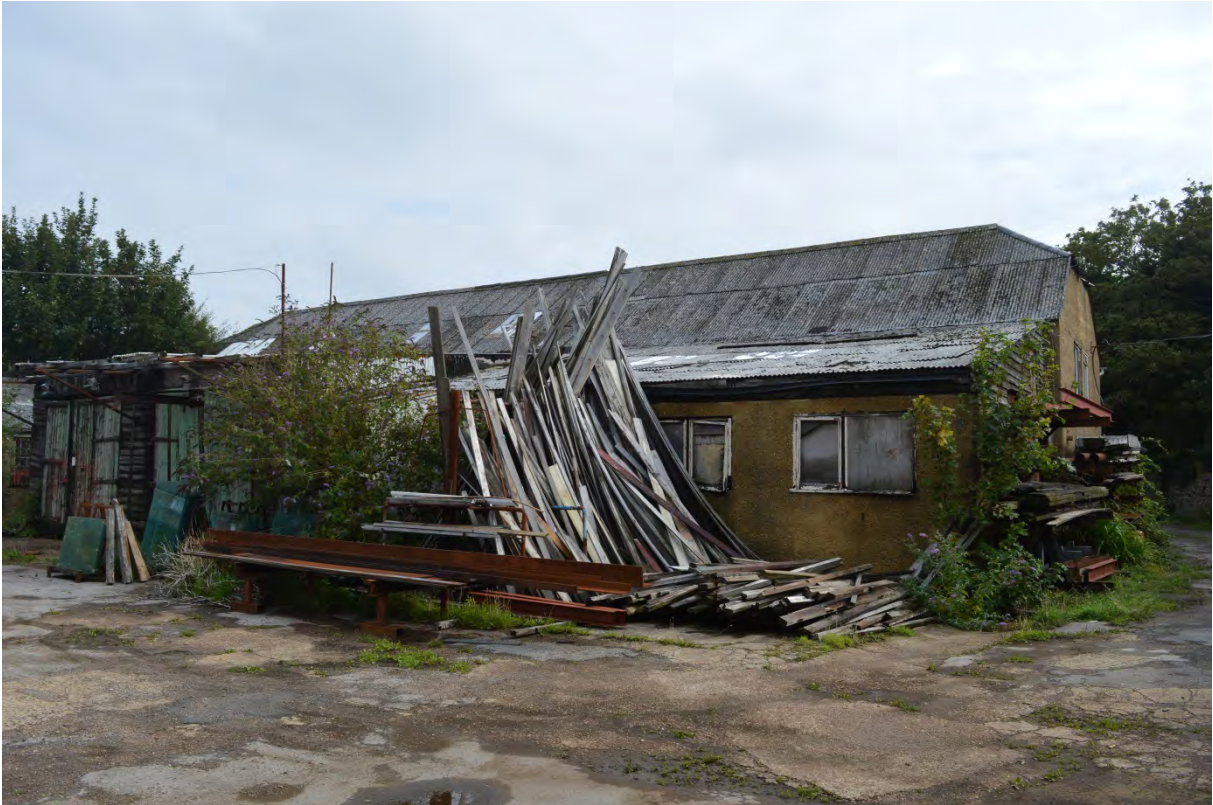
- 6.14 Buildings 12-14 occupy a former barn, which forms a linear range attached to the eastern end of Buildings 7-11 and aligned north-south (Plates 11 & 12). Its visible constructional details are indicative of a late 18th/early 19th century date. Buildings 12 and 14 are in use as a store, and Building 13 is used as a second-hand furniture shop.

- 6.21 Buildings 15-17 form a range of three buildings constructed in the 1960s against the western side of the former barn (Plate 11). Building 15 is a lean-to structure constructed in concrete blocks, covered externally with pebbledash render and weatherboarding, and a timber roof structure clad with corrugated asbestos and polycarbonate rooflights. It is accessed via Building 14 and is lit by two timber pairs of casement windows on its western elevation, now blocked. A mezzanine storage area is located at the southern end of the building. It appears to have functioned as a workshop/store. Buildings 16 and 17 again form a lean-to structure, with a slightly higher roofline than Building 15. They are of matching concrete block construction and are clad with weatherboarding externally; the roof is formed by a combination of I-girders and timber rafters clad with corrugated asbestos and polycarbonate rooflights. Access to both buildings is gained from the western elevation via full-height double timber doors; the north elevation of Building 17 contains a Crittall window and a single doorway blocked with concrete blocks. These two buildings appear to have functioned as a car repair workshop: what appears to be an inspection pit, covered with planks, is located in the floor of Building 16.

Plate 11: The barn (Buildings 12-14) with Buildings 15-17 in the foreground (1)

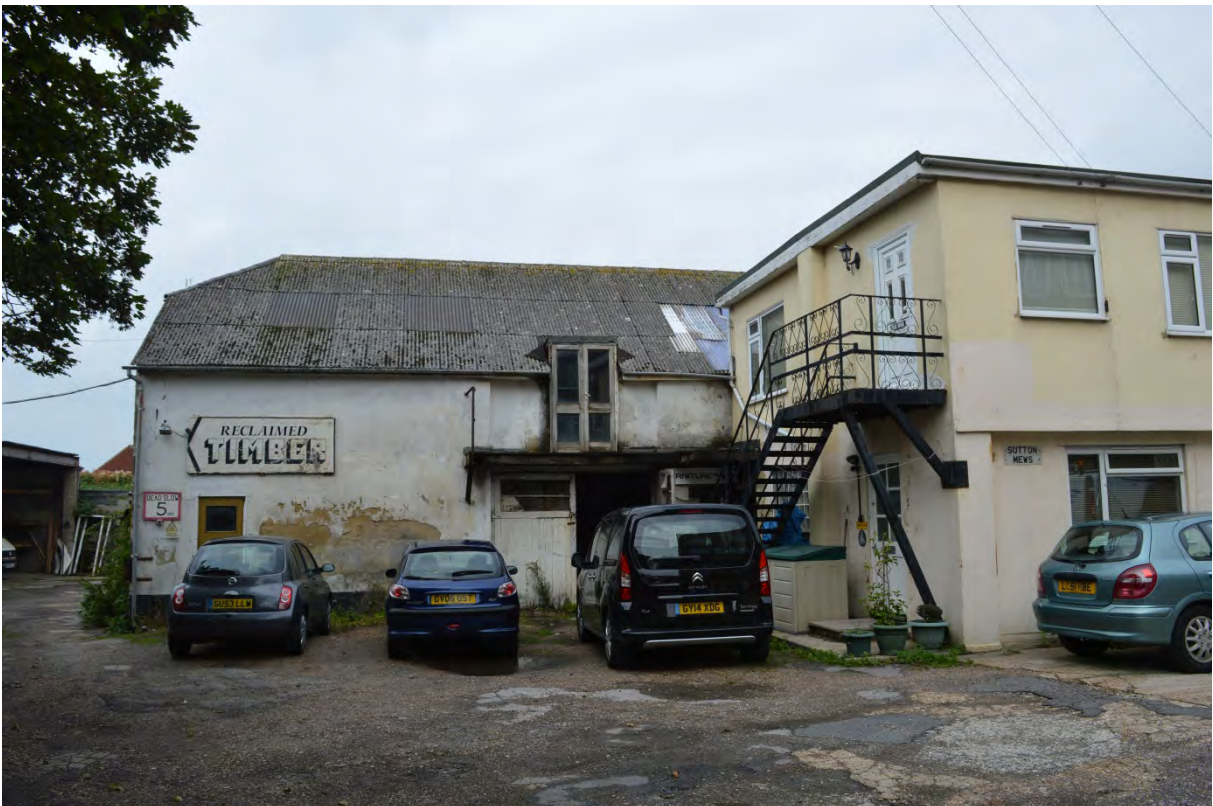
Plate 12: The barn, viewed from the east (5)

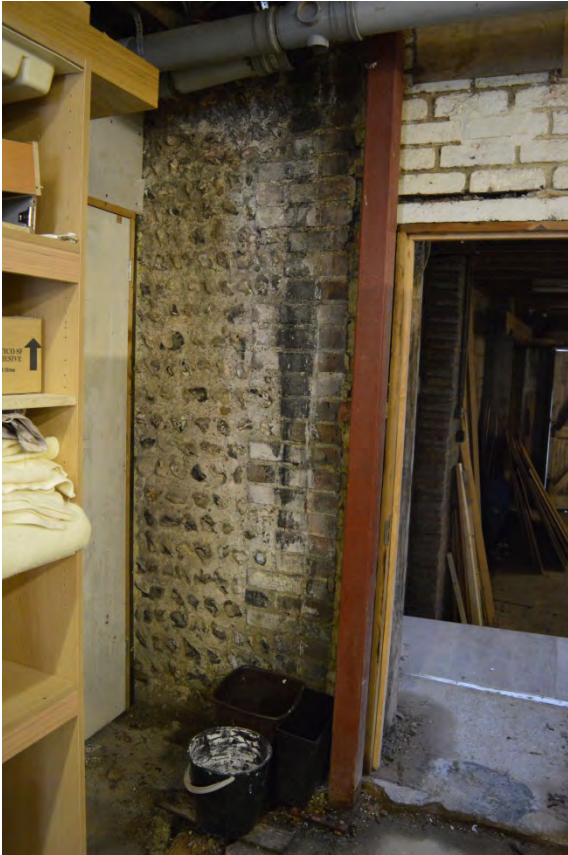
- constructed in modern Fletton brickwork and containing timber doors with timber overlights.
- 6.16 Limited areas of the underlying mass construction were visible from the interior of the building and comprise coursed field flints with dark red brick quoins set in a gravelly lime mortar (Plate 13).

Plate 13: Visible area of flint wall construction in eastern wall of barn (9)

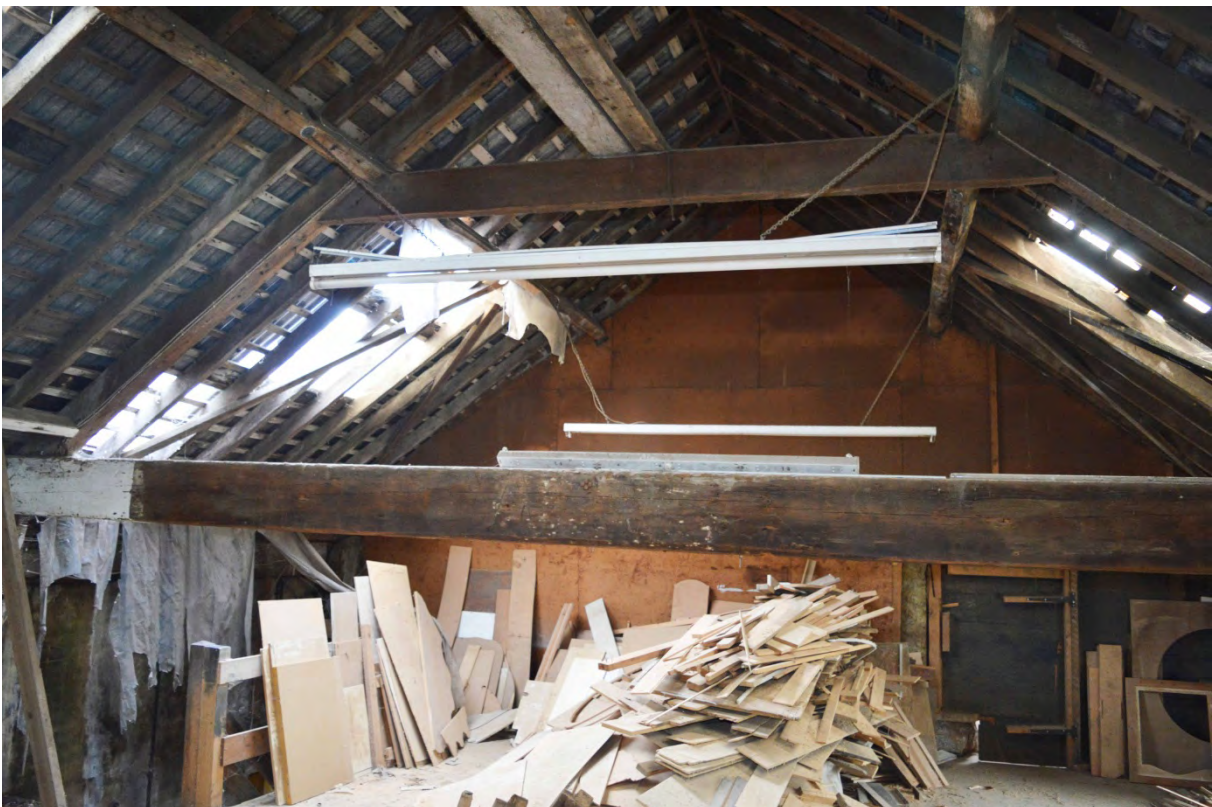
- 6.17 The barn is of seven main bays as defined by the principal roof trusses, and has a clasped-side-purlin roof with paired common rafters meeting at a ridgeboard. Long, slender braces are nailed to the underside of the rafters on both slopes. The principal trusses are collar trusses with substantial tie beams and principal rafters snugly notched around the purlins (Plate 14). The central and southern trusses (within the present Building 12) are supported on the eastern side of the barn by jowled principal posts with rounded bowls (Plate 15), which appear to have been reused from an earlier structure. The tie beams of the two southernmost open trusses (within the present Building 14) have been truncated, the roof being tied midway between the tie beam and collar by planks bolted to either side of the principal rafters (Plate 16), presumably relating to the insertion of the first floor which is understood to have occurred in the 1950s (Brooks 2012). The northernmost bay includes an intermediate collar truss, without a tie beam.

Plate 14: Roof structure over Building 12 (13)

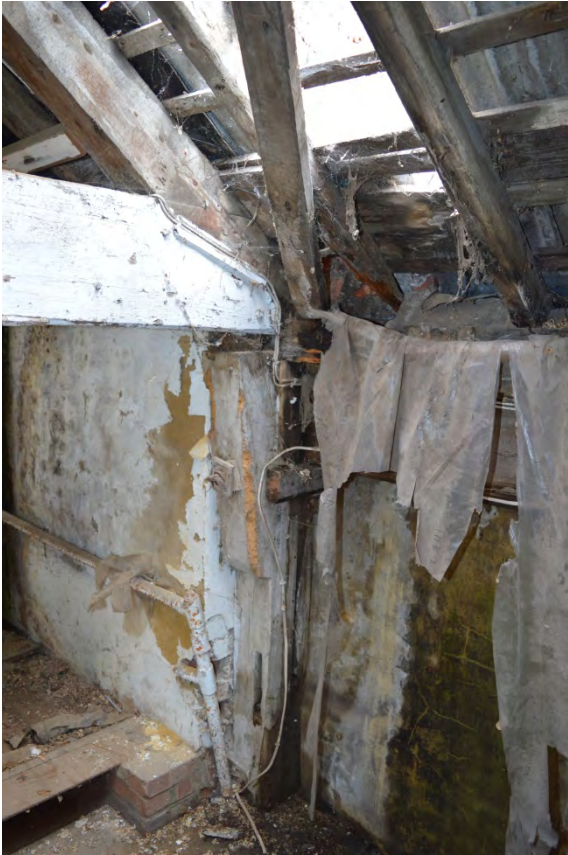
Plate 15: Jowled post on eastern side of Building 12 (15)

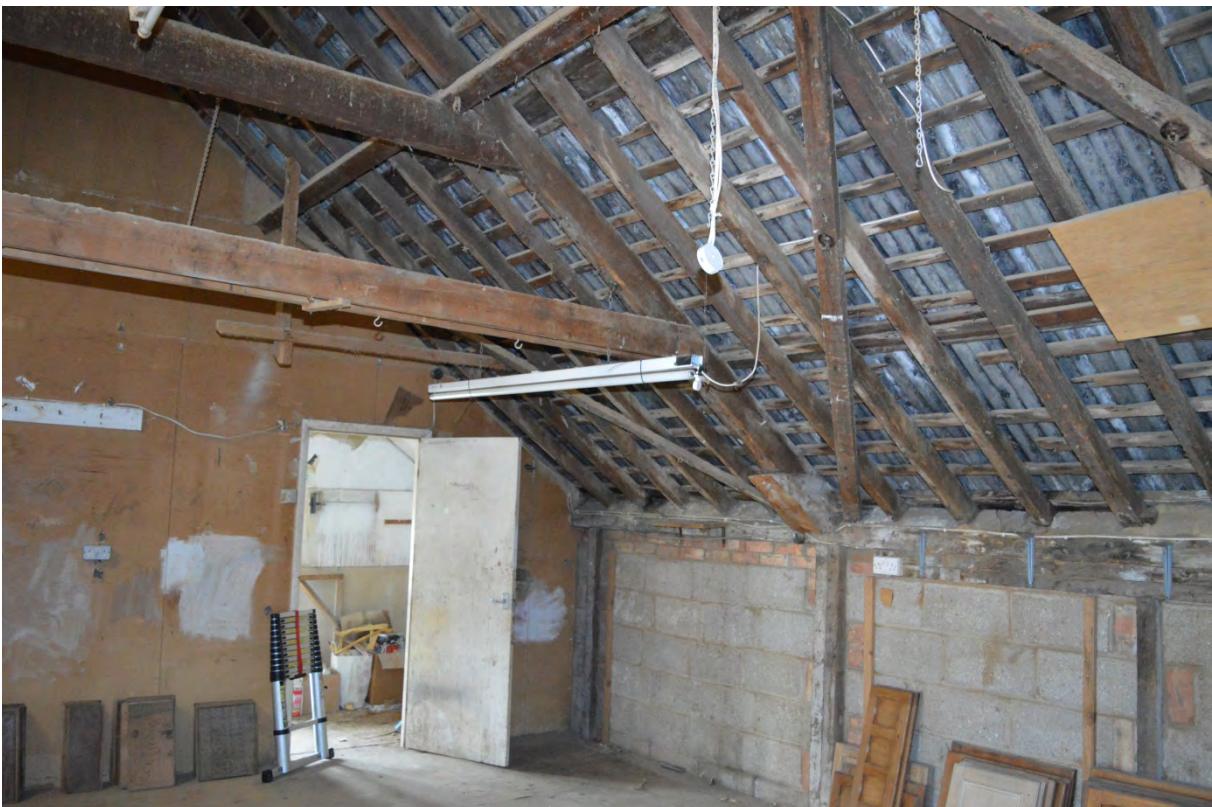
Plate 16: Truncated tie beam in Building 14 (23)

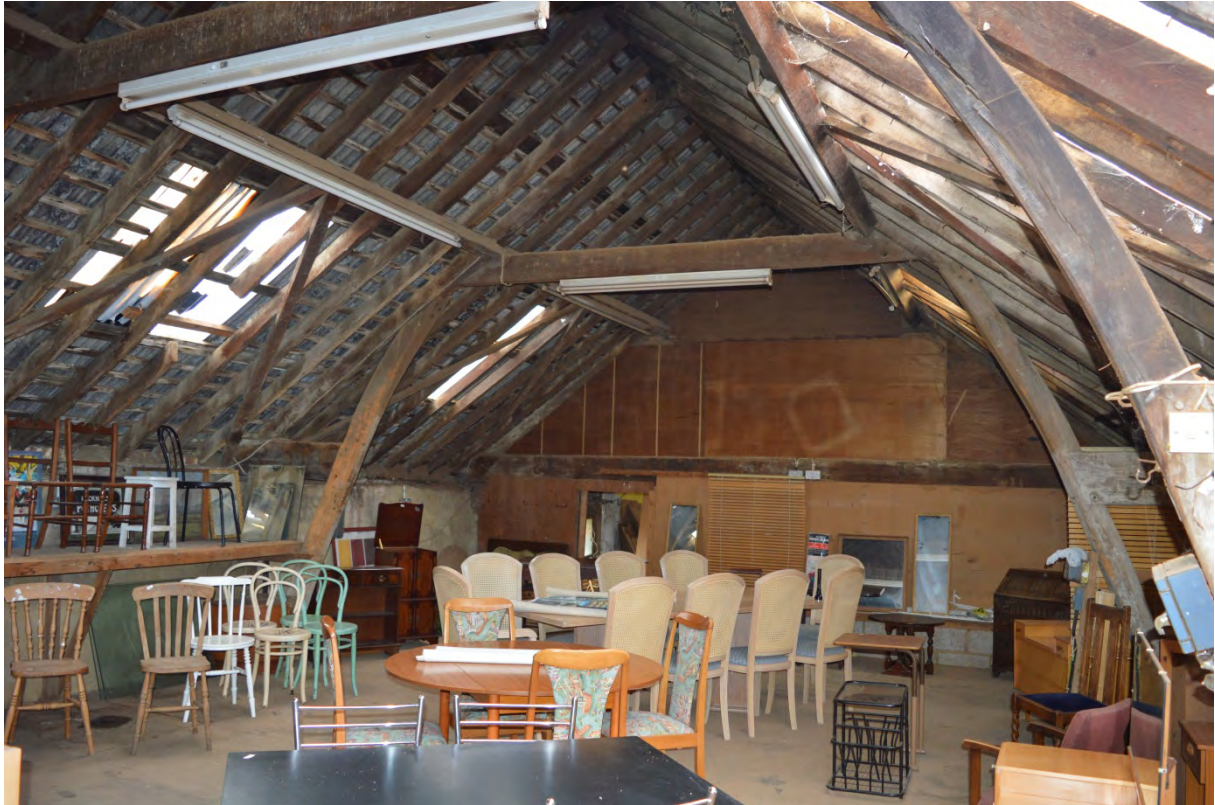
- 6.18 Two trusses to either side of the central bay (within the present Building 13) are of a notably different form, with interrupted tie-beams and long, cruck-like sling braces between the collars and principal posts on both the east and west sides (Plates 17 & 18). This appears to be an original feature of the barn's construction, as both the interrupted tie beam stubs and braces have matching carpenters' marks and are properly jointed and pegged. The posts in these trusses areunjowled.

Plate 17: Trusses with interrupted tie beams and sling braces, in Building 13 (20)

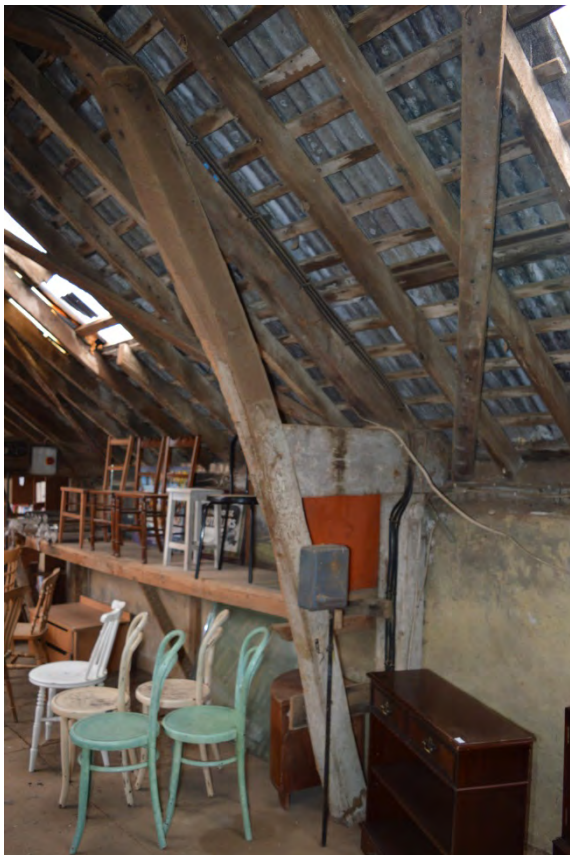
Plate 18: Detail of sling brace (19)

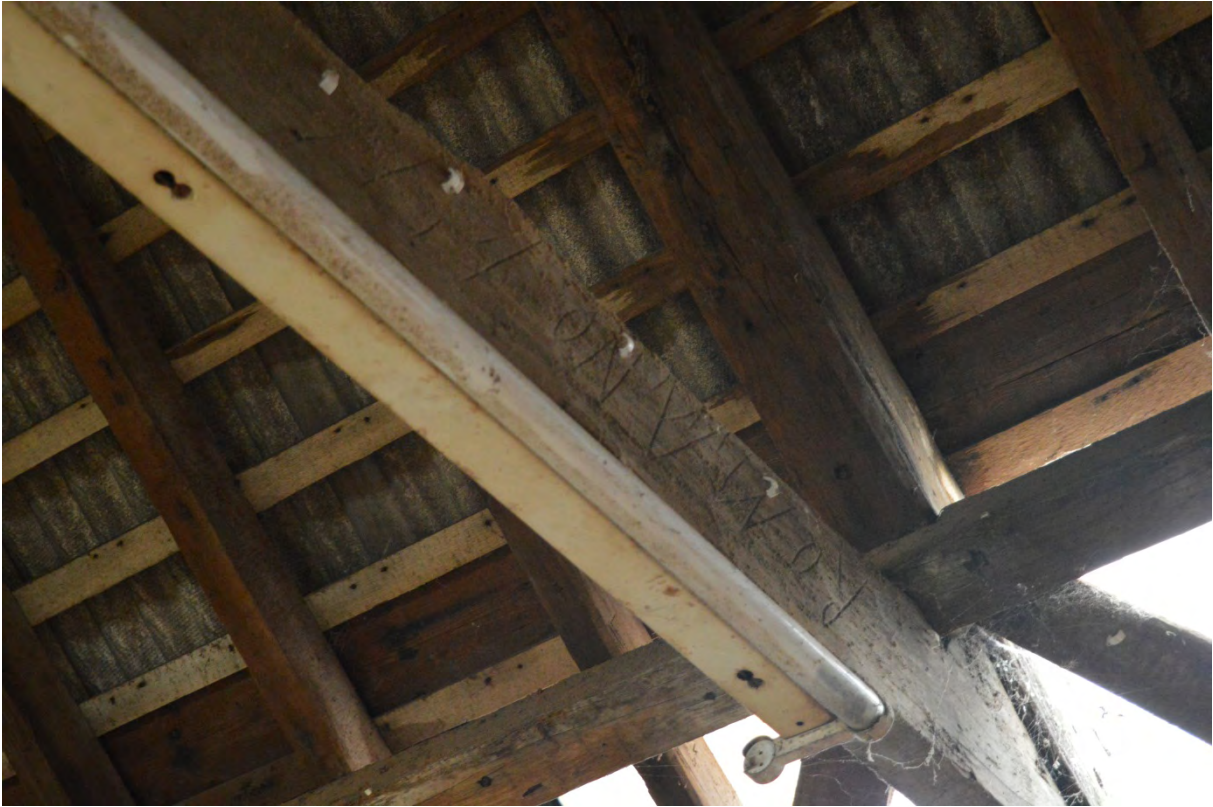
- 6.19 There is good evidence of carpenters' marks, the components of each truss being consistently numbered with both a set of neat, chiselled characters and a set of more sweeping, scribed characters. There is no clear sequence in the numbering of the trusses along the length of the building. The roof timbers display a number of prominent Baltic merchants' marks, which confirms the roof is constructed in Baltic softwood. One of these marks, located on the collar of the intermediate truss at the northern end of the barn, reads 'ROMANO' (Plate 19).

Plate 19: Collar in Building 12 with Baltic merchant's mark (22)

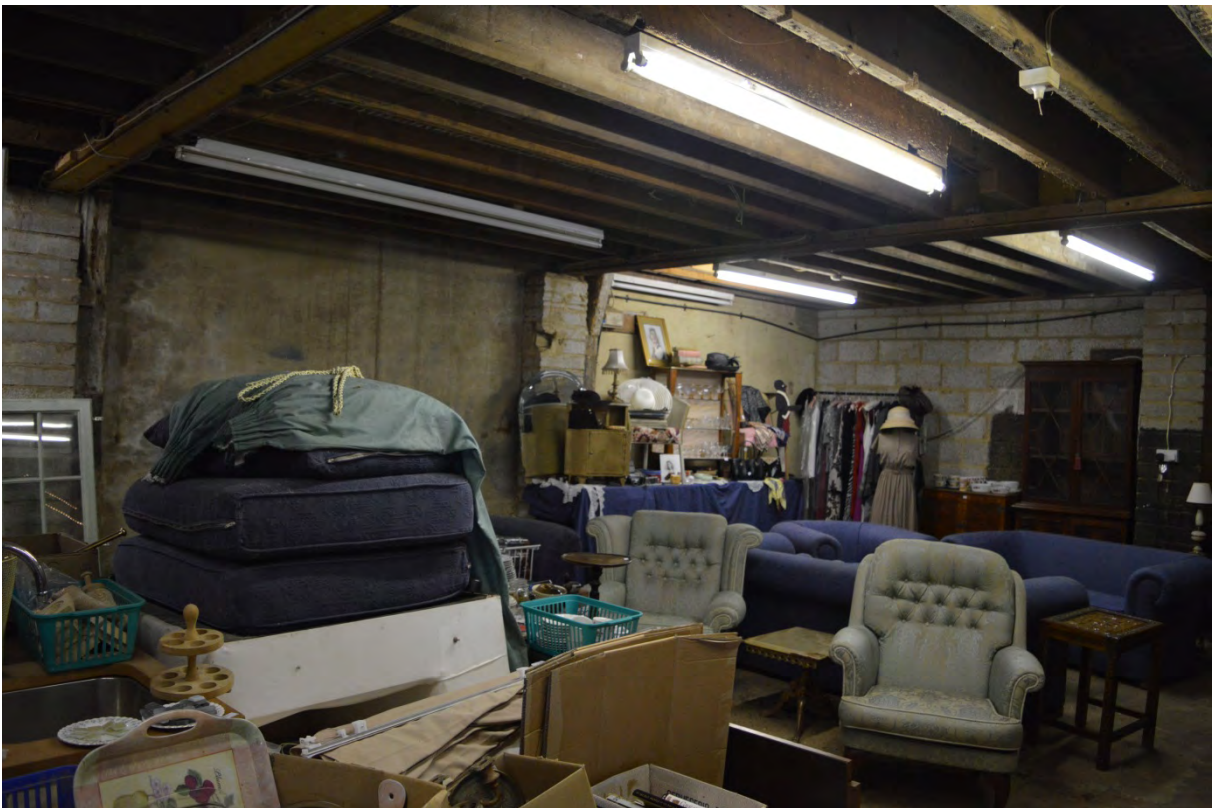
- 6.20 The barn has been modified during the 20th century to provide workshop and storage space, through the insertion of a first floor comprising I-girders and timber joists, including some reused material with stripes characteristic of a former lath and plaster finish, and the construction of breeze block partitions in the 1960s to subdivide the barn across its width into three two-storey units (Plate 20) (Brooks 2012).

Plate 20: Inserted floor and partition in Building 13. The bottom half of the principal posts of the sling-braced trusses are visible to the centre and left of the photograph (26)

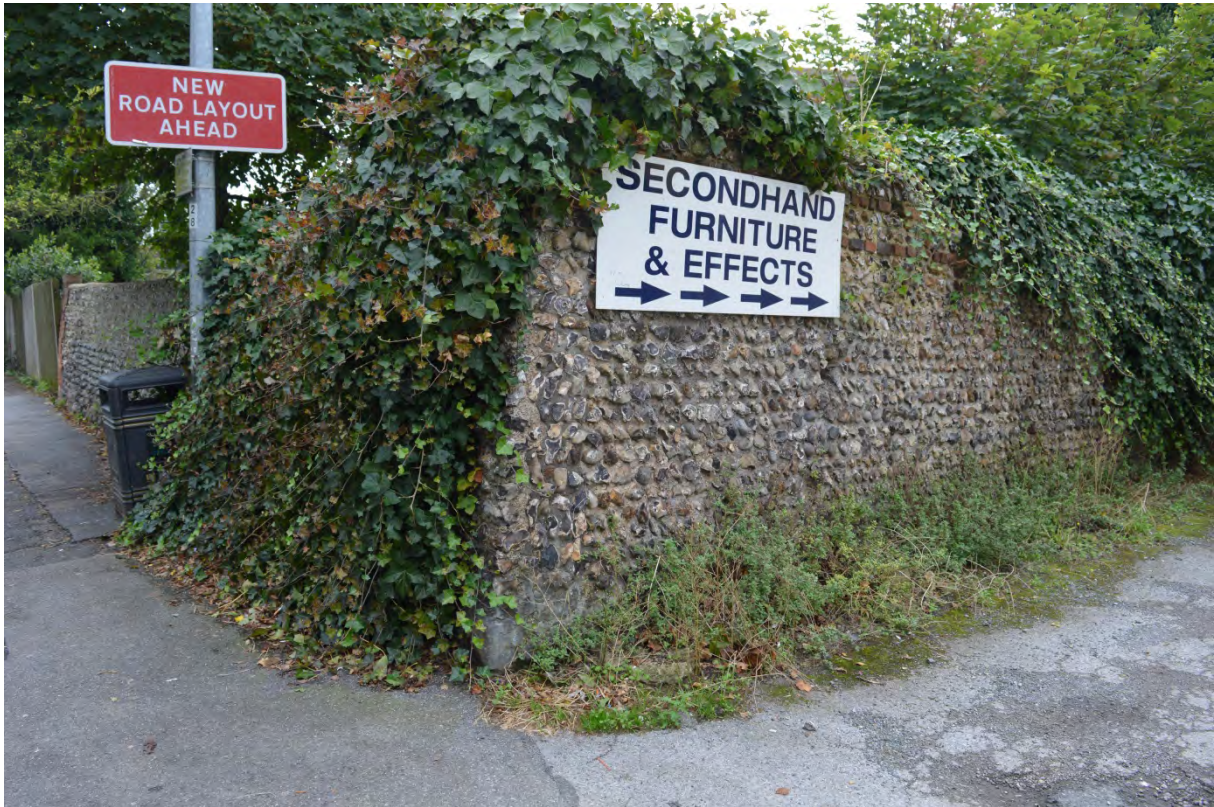
Plate 21: The eastern end of the southern boundary wall (63)
