**SUTTON GARAGES, ALFRISTON ROAD,
SEAFORD, EAST SUSSEX
(NGR 549282 099674)**

**HISTORIC BUILDINGS RECORD
(ENGLISH HERITAGE LEVELS 1 & 2)**

ASE Project No. 6569

Report No. 2014293

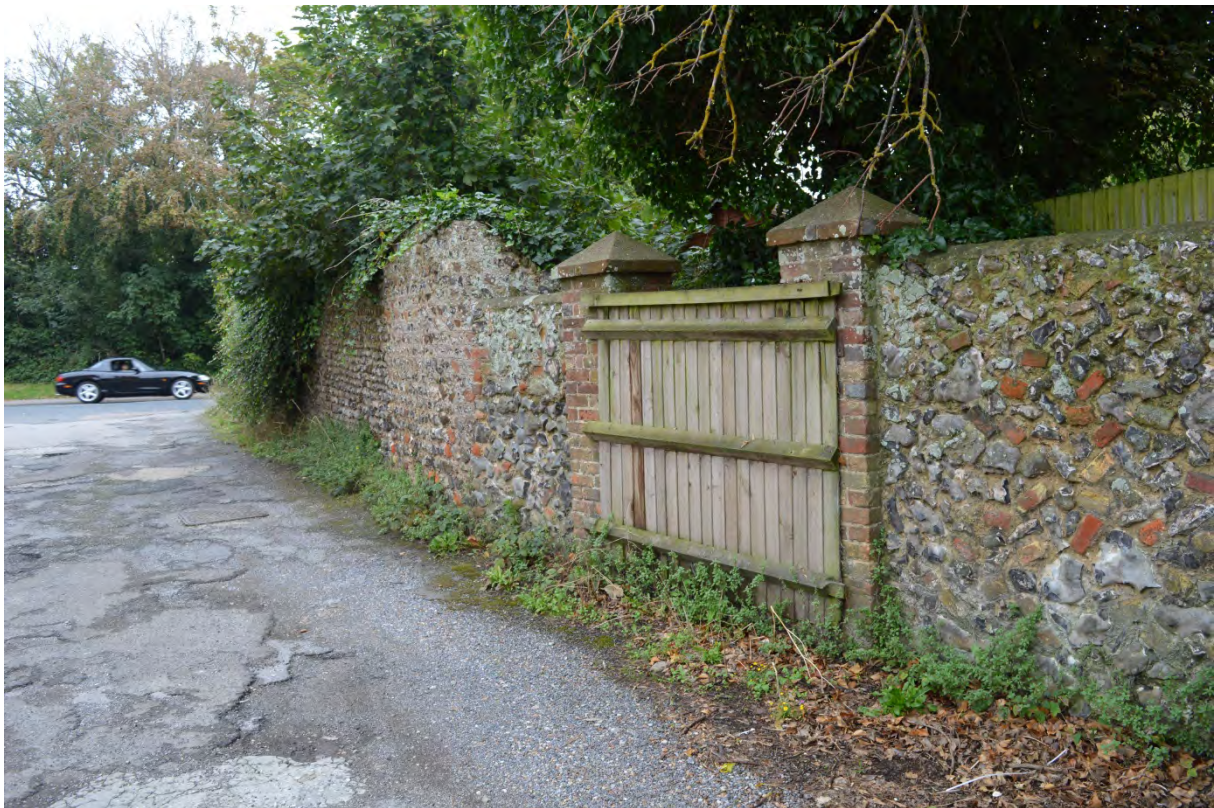
- 6.22 A long stretch of the farmstead's boundary wall runs alongside the access to the site, forming part of the site's southern boundary. It is constructed in three notably different styles. The eastern end of the wall is constructed in closely-spaced, coursed field flints, with two brick lacing courses towards the top of the wall (Plate 21). This part of the wall joins the eastern boundary wall of the garden to the south (outside the site); the corner junction is formed in flint, without the use of brick quoins: an unusual detail. At its western end, a small, curved section of wall is attached (Plate 22). This is constructed in coursed bungaroosh with penny-striking between the courses. The western section of the wall adjoins this. Its construction in randomly-laid bungaroosh with a rounded concrete coping is noticeably different (Plate 22). A blocked gateway defined by two brick piers is located towards its eastern end, and matching brick quoins form its western terminal. The different phases of wall construction concur with historic maps which confirm the western section is of early 20th century date, extending the pre-existing wall at some point between 1899 and 1927. The eastern section of wall was certainly in place by 1874 and is of possible late 18th/early 19th century date. The small curved section may be a remnant of a splayed entrance leading to the now-demolished Little Sutton House, which was located to the south; the Tithe map of 1839 appears to show a gap in a wall to the north of the house.

Plate 22: Looking east along the later section of wall, constructed in bungaroosh with brick gate piers; the curved section of wall is visible beyond (61)
