Pevensey Castle, Pevensey, East Sussex

Historic Building Watching Brief

**ASE Project No: 7284
Site Code: PEC15
ASE Report No: 2015134**

October 2015

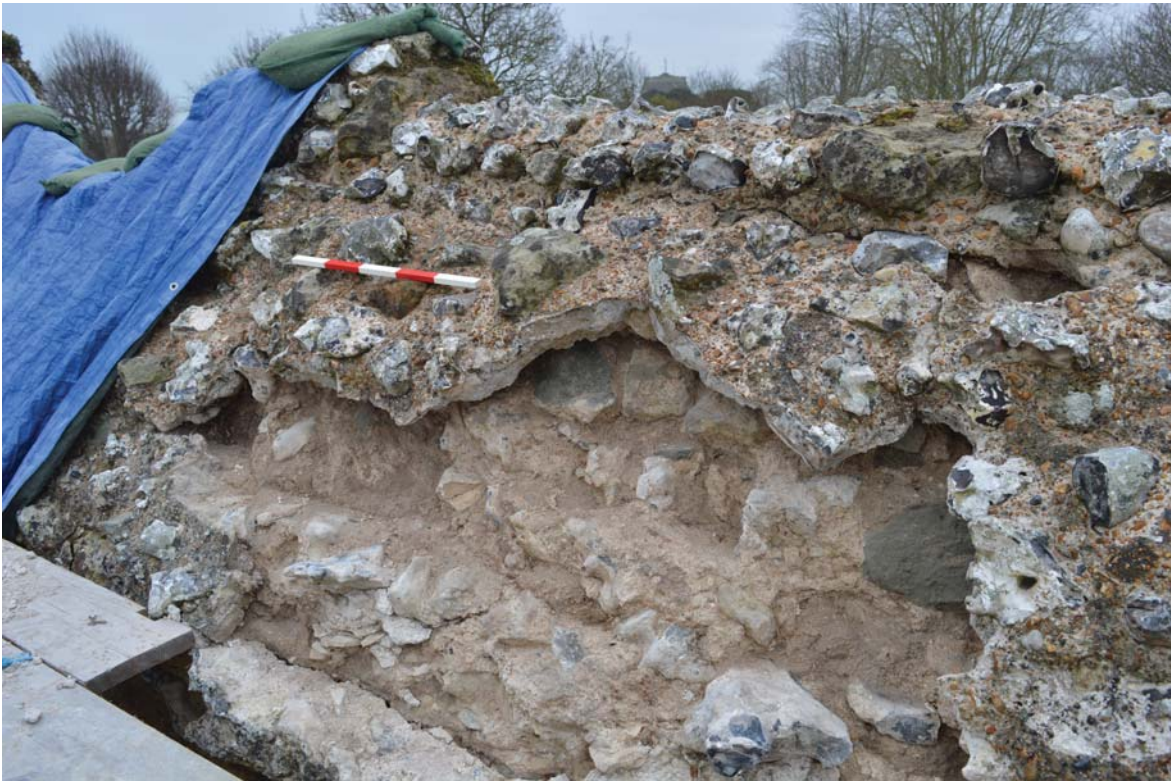
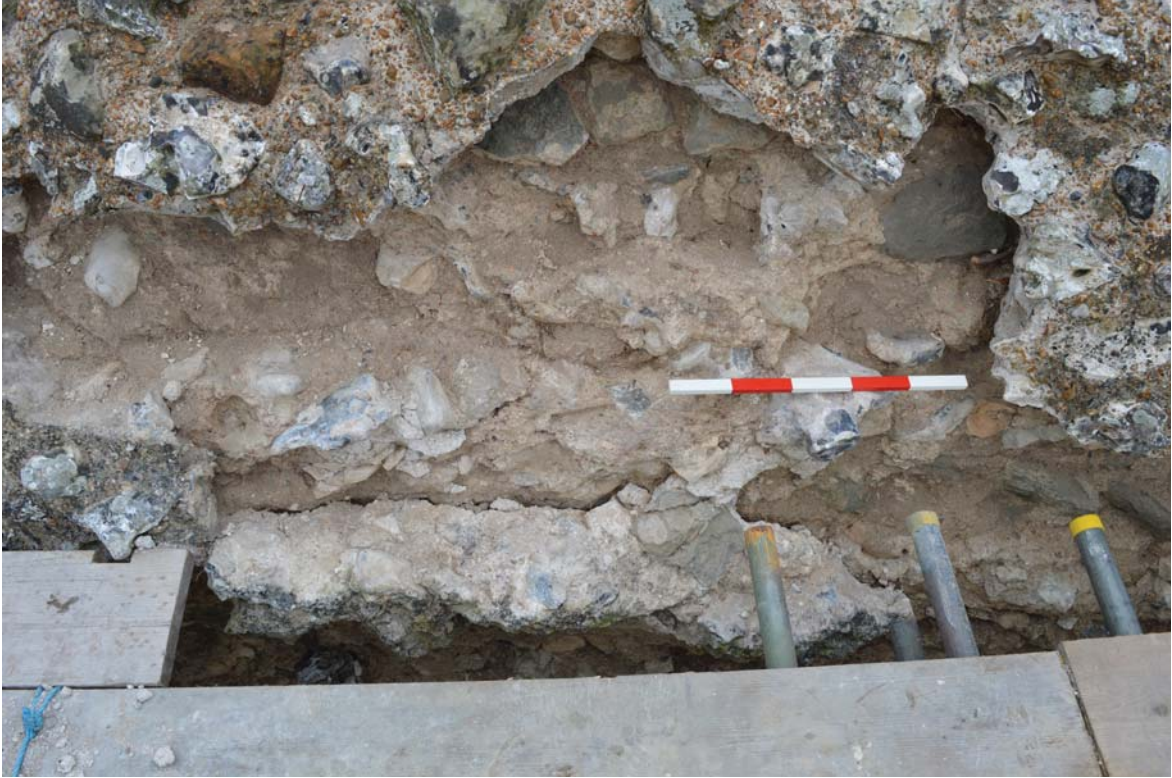
© Archaeology South-East		Pevensey Castle, Pevensey, East Sussex	Fig. 8
Project Ref: 7284	April 2015	Top lift, section 4: view of exposed wall core	
Report Ref: 2015134	Drawn by: MGS

- 4.7 Upper lift, section 4: a small tree with deep roots was removed from the wall, necessitating the removal of the outer skin of flint and concrete and the exposure of the Roman core. This consisted of flint laid in a pebbly white mortar, with occasional sandstone rubble (Figures 8 & 9).

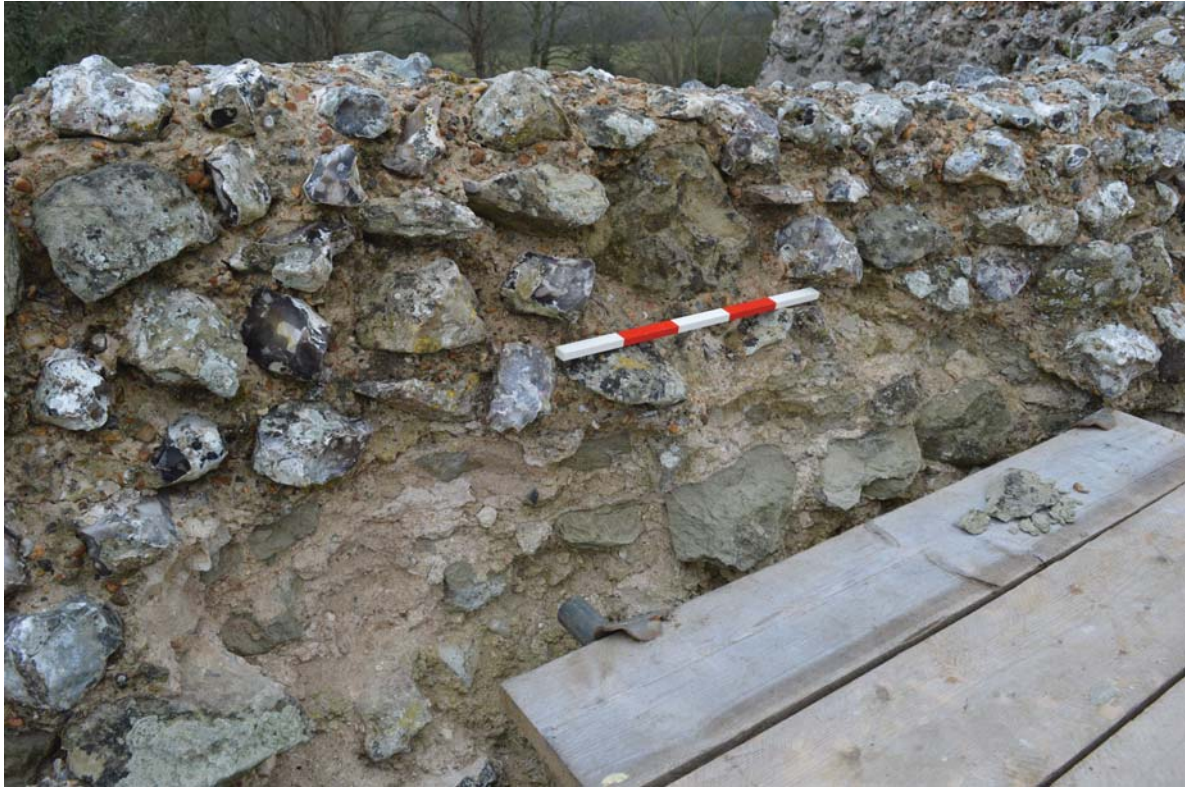
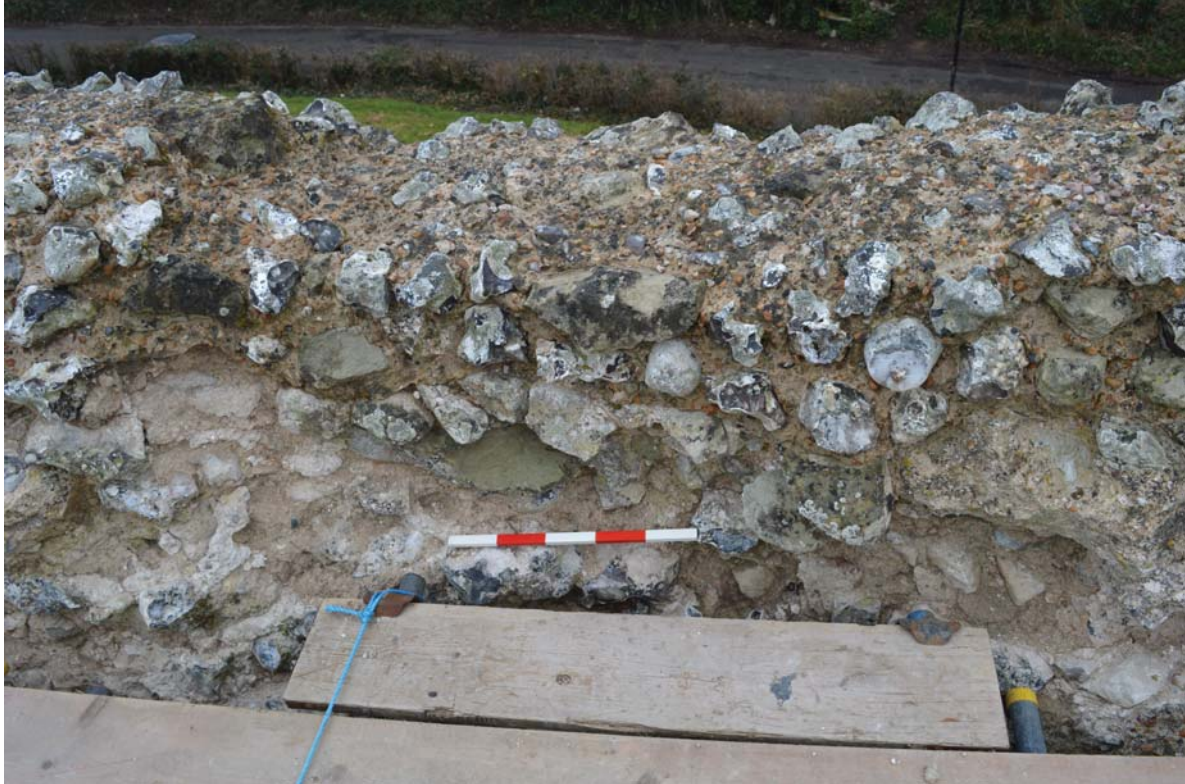
© Archaeology South-East		Pevensey Castle, Pevensey, East Sussex	Fig. 10
Project Ref: 7284	April 2015	Top lift, section 5: view of exposed wall core	
Report Ref: 2015134	Drawn by: MGS

- 4.8 Upper lift, section 5: the removal of shrubs and deep-rooted ivy exposed the Roman core, which here consisted chiefly of sandstone and ironstone rubble laid in a pebbly white mortar, with surprisingly little flint (Figure 10).

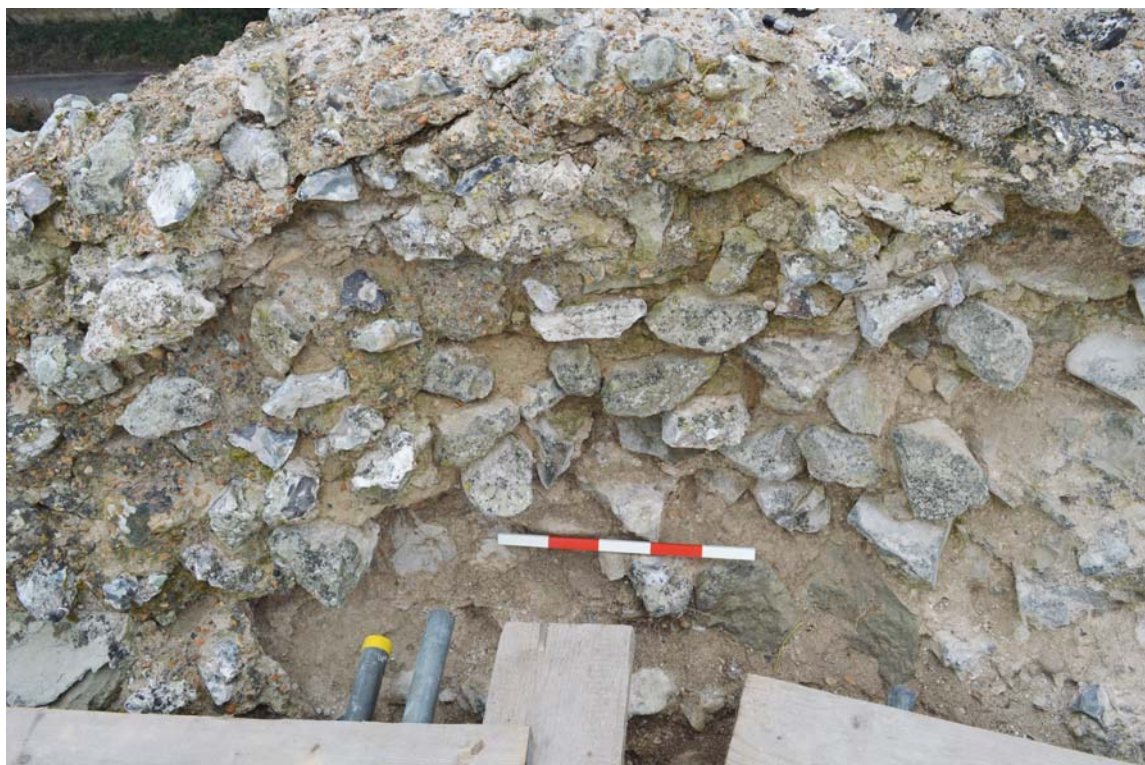
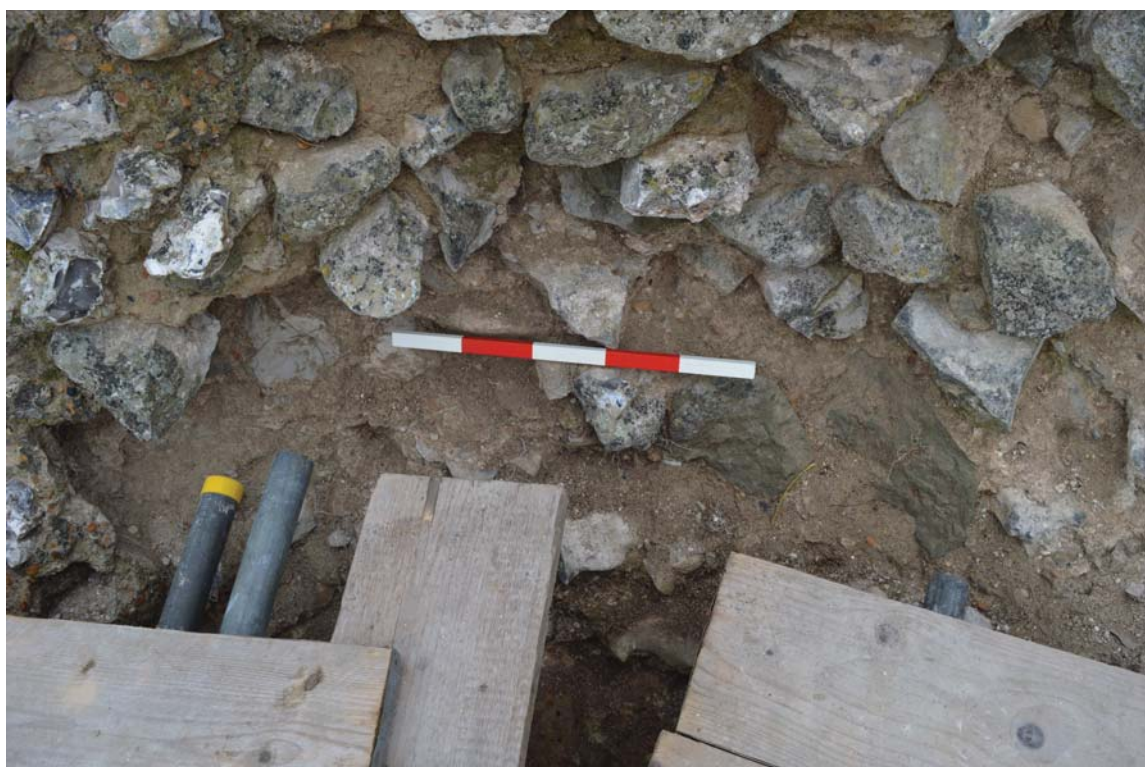
© Archaeology South-East		Pevensey Castle, Pevensey, East Sussex	Fig. 11
Project Ref: 7284	April 2015	Top lift, section 6: view of exposed wall core	
Report Ref: 2015134	Drawn by: MGS

- 4.9 Upper lift, section 6: The removal of ivy cover necessitated the dismantling of the modern outer skin of flintwork. This exposed chiefly sandstone rubble with little ironstone or flintwork. It was laid in a pinkish pebbly mortar, implying this part of the wall’s fabric is a modern repair work (Figure 11).

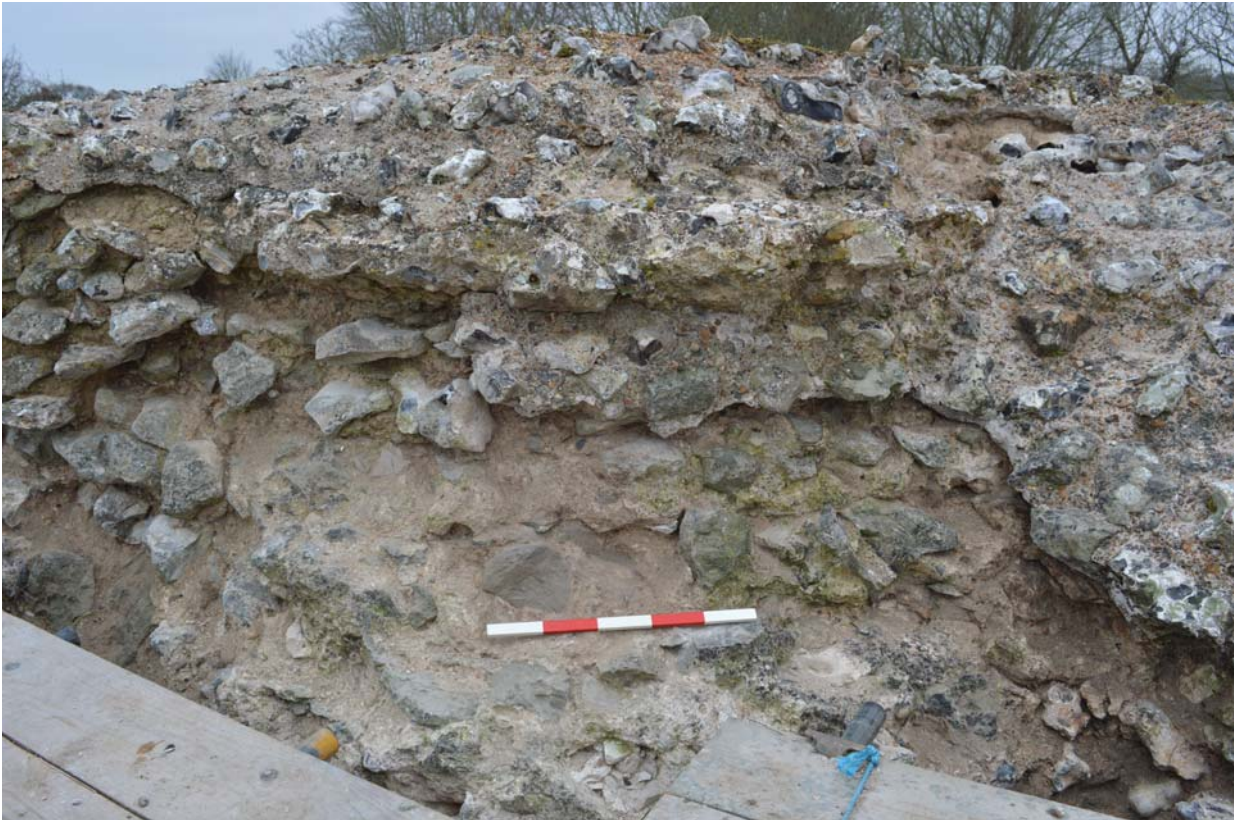
© Archaeology South-East		Pevensey Castle, Pevensey, East Sussex	Fig. 12
Project Ref: 7284	April 2015	Top lift, section 7: view of exposed wall core	
Report Ref: 2015134	Drawn by: MGS

- 4.10 Upper lift, section 7: Extensive repointing involved rebuilding the outer skin of flintwork to the wall. The Roman core consisted of sandstone and flint in a pebbly white mortar with no visible ironstone (Figure 12).

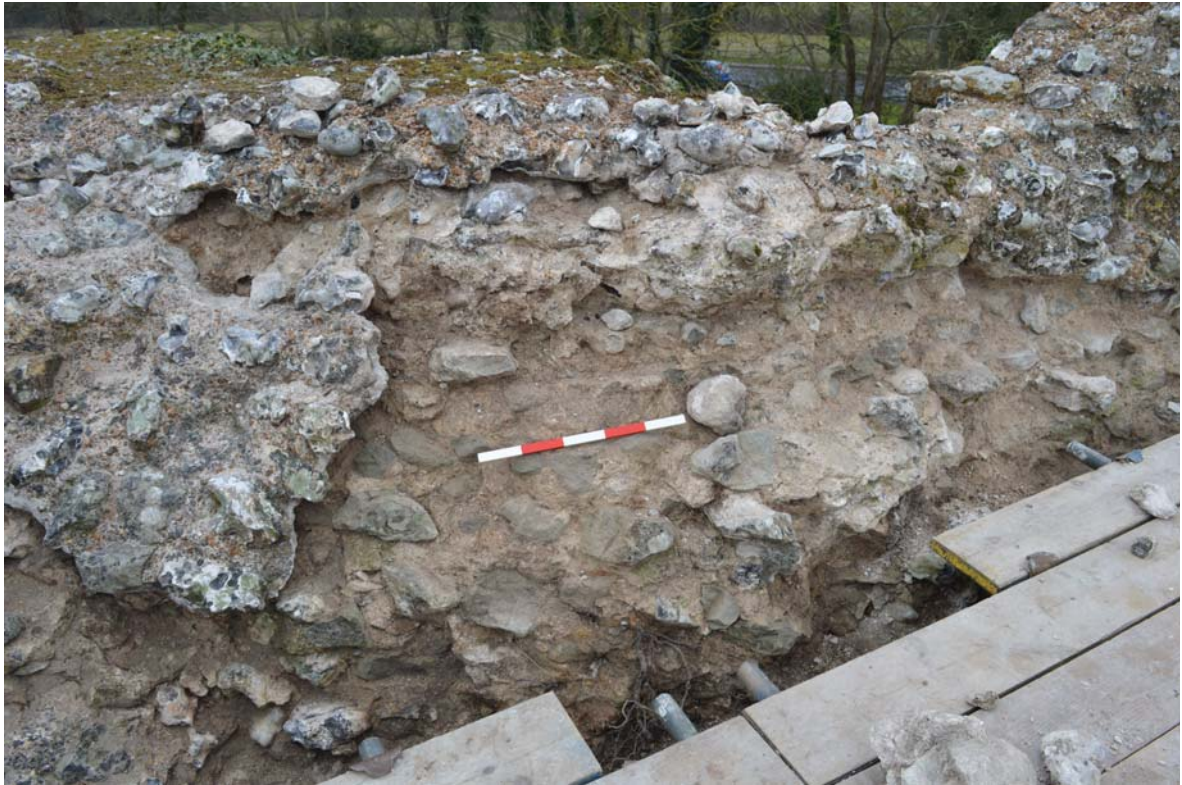
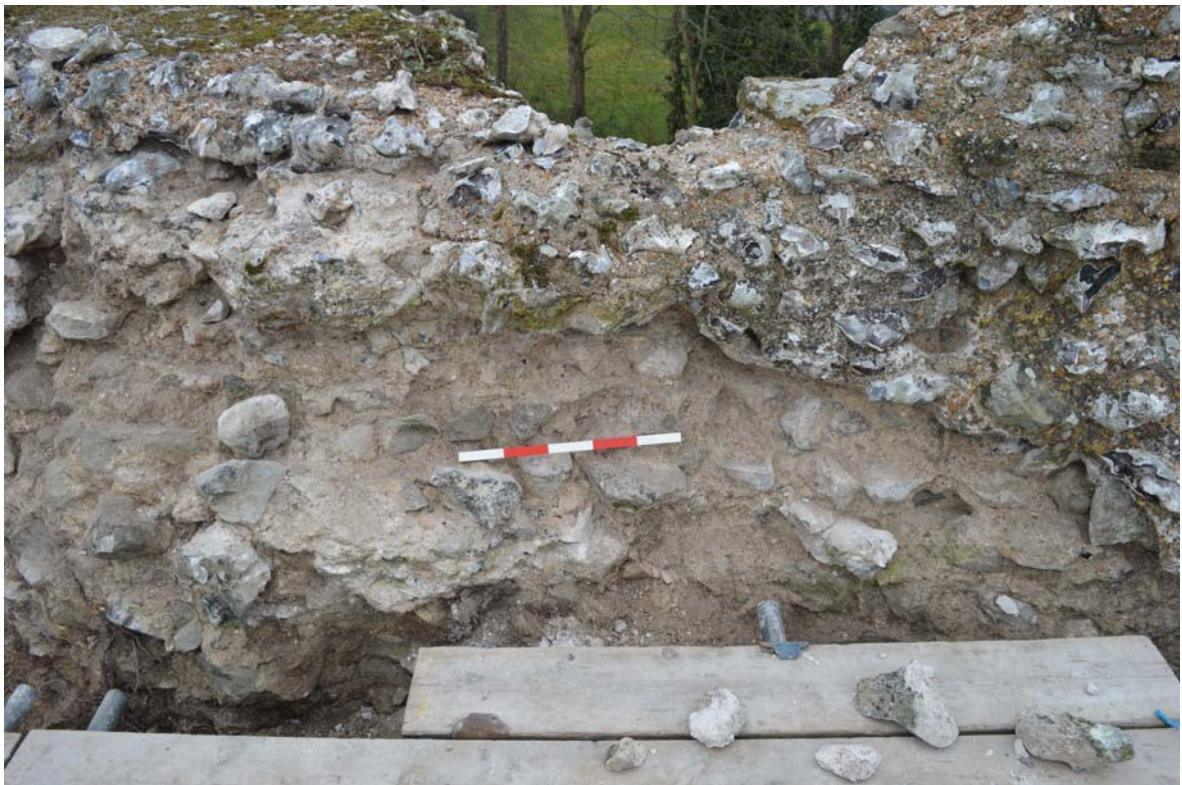
© Archaeology South-East		Pevensey Castle, Pevensey, East Sussex	Fig. 13
Project Ref: 7284	April 2015	Top lift, sections 9/10: view of exposed wall core	
Report Ref: 2015134	Drawn by: MGS

- 4.11 Upper lift, section 9/10: The removal of thick ivy and small shrubs involved the removal of the outer skin of modern flintwork. The Roman core behind

again consists of mixed sandstone rubble with very little flint or ironstone (Figure 13).

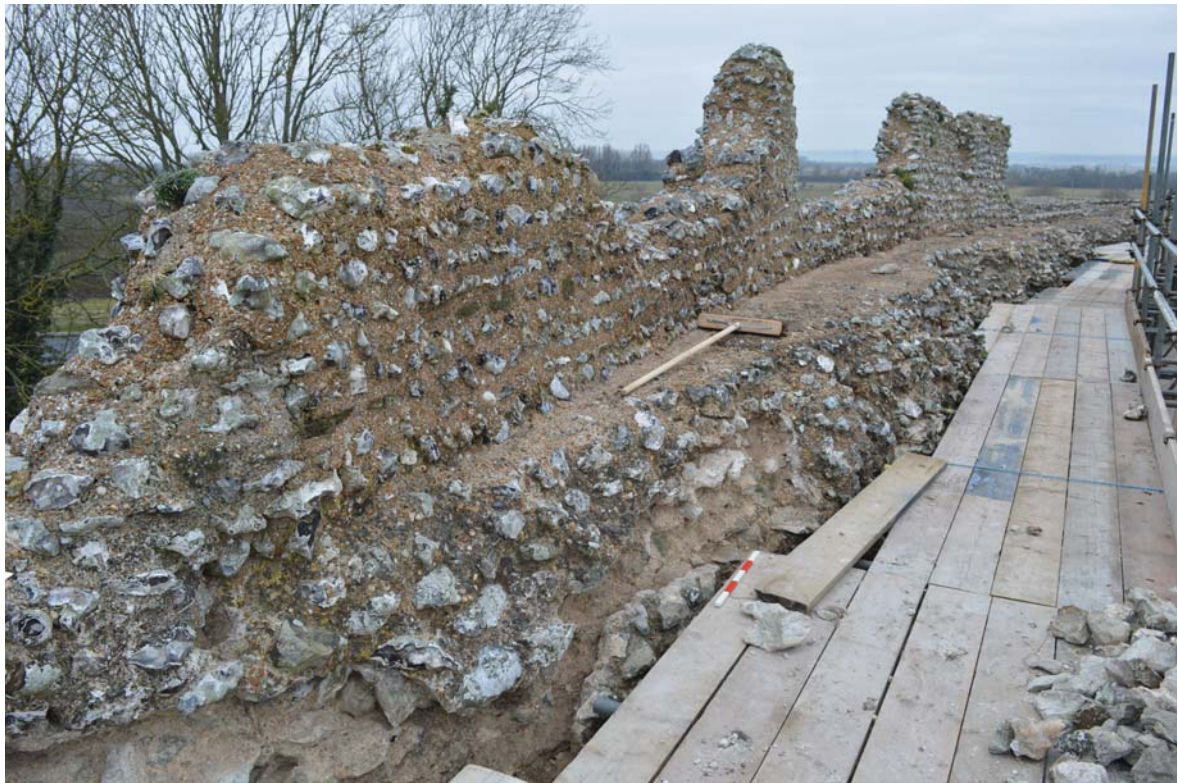
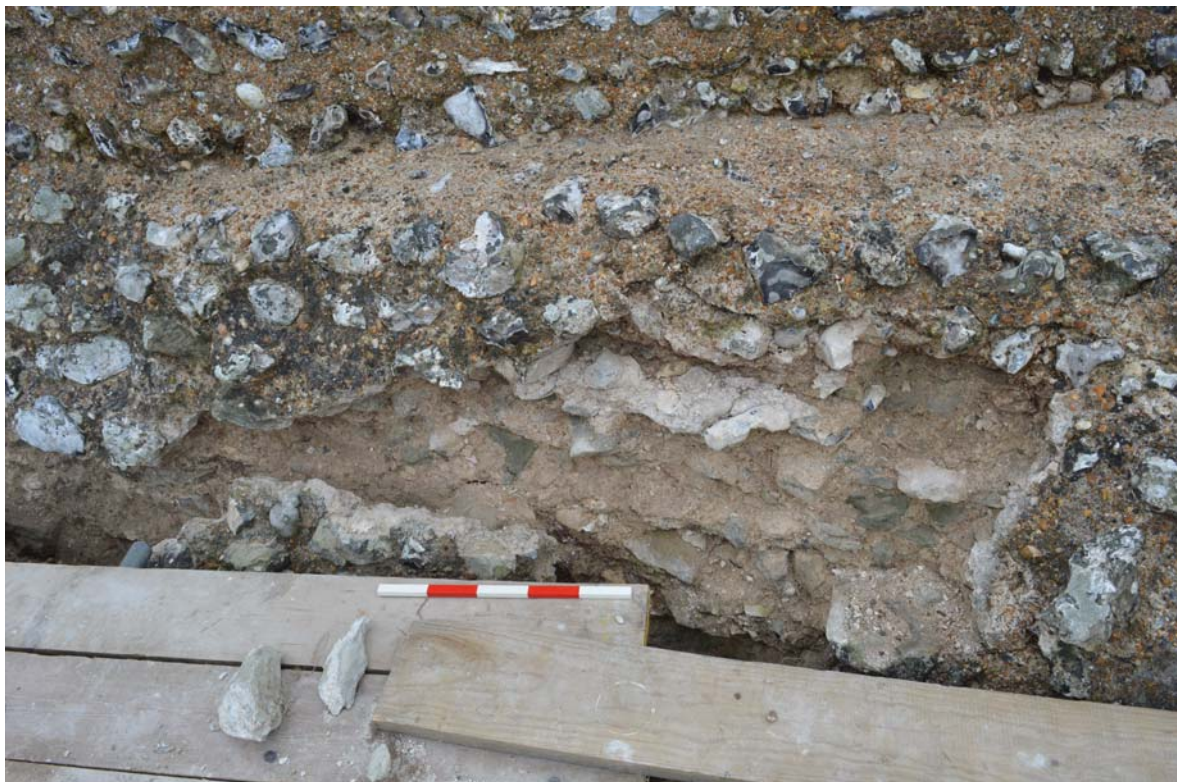
© Archaeology South-East		Pevensey Castle, Pevensey, East Sussex	Fig. 14
Project Ref: 7284	April 2015	Top lift, sections 13/14: view of exposed wall core	
Report Ref: 2015134	Drawn by: MGS

- 4.12 Upper lift, section 13/14: The removal of vegetation and loose outer flintwork revealed a long, narrow strip of the Roman core, which was revealed to be of sandstone and flint in equal measure (Figures 14 & 15).
- 4.13 Middle lift, section 4: Repair of loose outer stonework revealed mostly flint and frost-damaged sandstone. The mortar was pinkish and pebbly, suggestive of Roman work. Interestingly, the frost-damaged nature of the sandstone indicates this part of the wall had long been exposed to the elements, prior to the modern flint repair. Given the lack of maintenance work between the late medieval period and the early 20th century, this probably represents the wall's exposed inner face for much of that period, if not before (Figure 16).

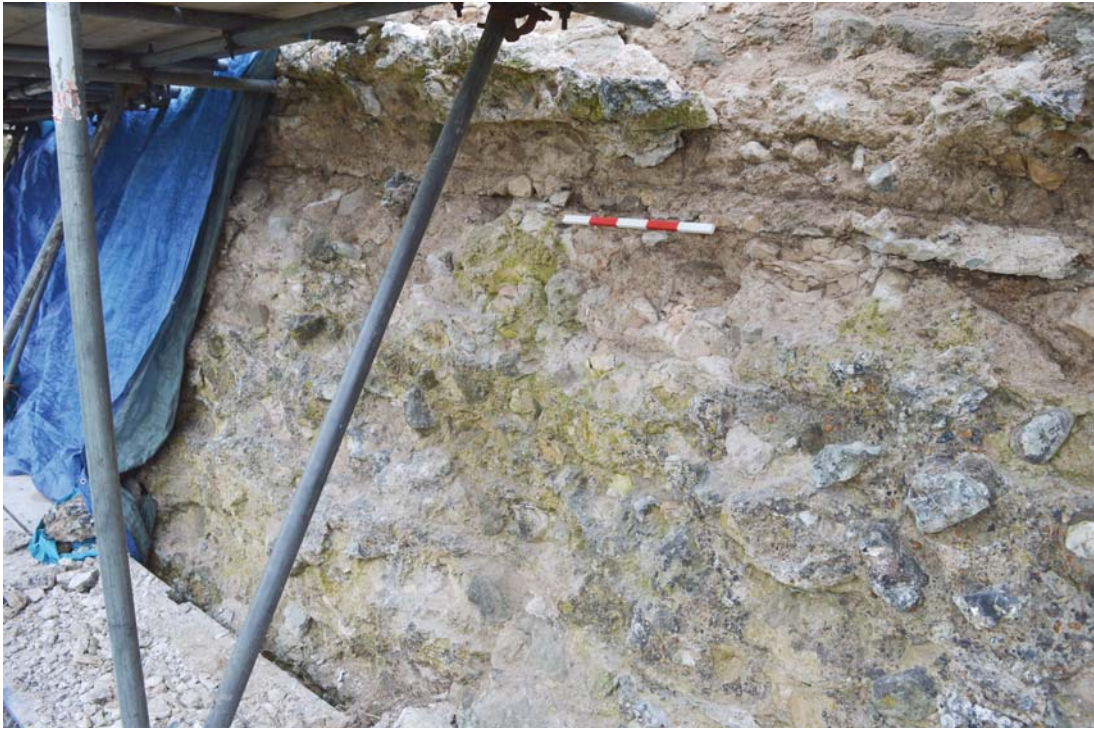
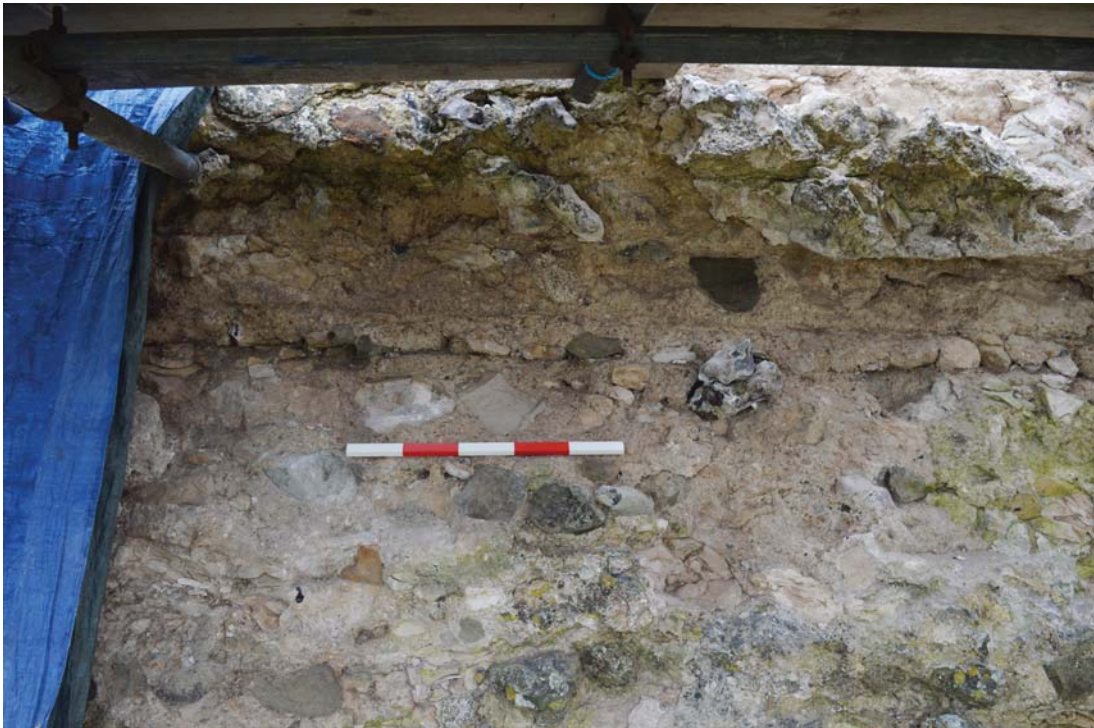
© Archaeology South-East		Pevensey Castle, Pevensey, East Sussex	Fig. 16
Project Ref: 7284	April 2015	Middle lift, section 4: record of removed modern flintwork facing	
Report Ref: 2015134	Drawn by: MGS

5.3 Frost-damaged sandstone was encountered beneath the modern flintwork in section 4 of the middle lift. This implies this part of the core was left as the wall's exposed inner face prior to the early 20th century, probably for much of the later medieval and early modern period. This is additionally useful indicating something of the conservation philosophy of (presumably) the Ministry of Works in the 1920s: not only was degraded stonework replaced, but new areas were created where the historic fabric was missing from the wall's internal face.
