COMBERS GLASSHOUSES, NYMANS, WEST SUSSEX

**HISTORIC BUILDINGS RECORD
(HISTORIC ENGLAND LEVEL 3)**

ASE Project No. 7494
Report No. 2015184

Date of Issue:	June 2015		
Revision:

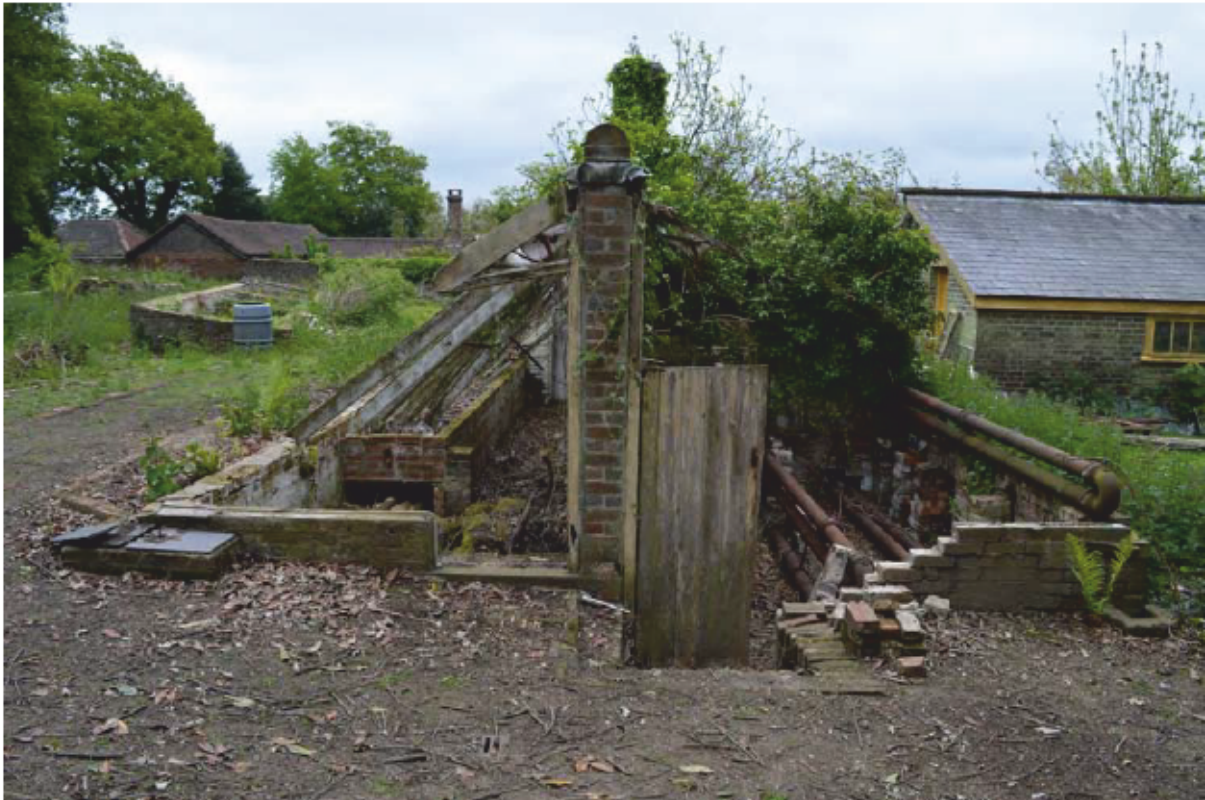
- 6.1.1 Building 1 consists of a brick spine-wall, with south- and north-facing lean-to greenhouses to either side (Plate 1). The northern half of the building extends west from Building 4. A south-facing greenhouse appears on the Ordnance Survey mapping as early as 1875, suggesting that the southern element may be the earliest extant glass structure in the complex (Figure 6).

Plate 1: West elevation of Building 1, looking east (Photo #61)

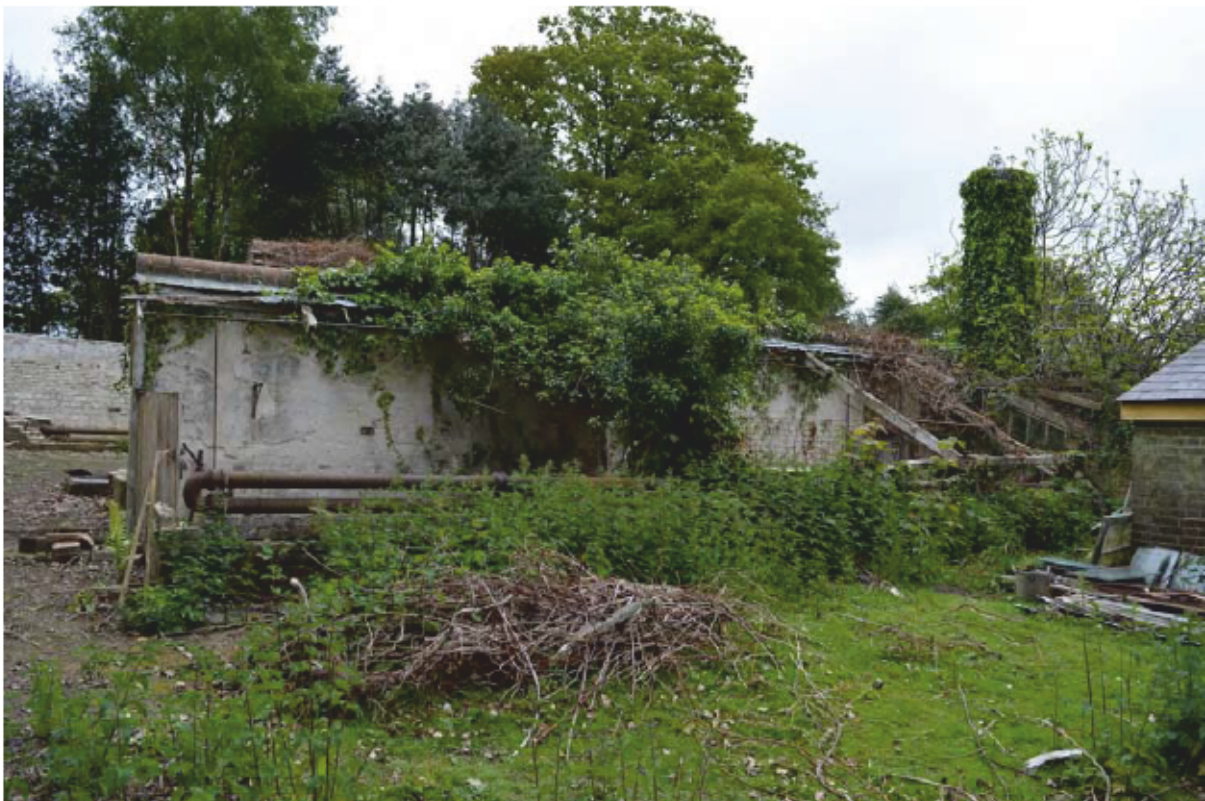
- 6.1.3 The southern lean-to is south-facing (Plate 2). The exterior walls of the building are constructed of a mid-orange brick in stretcher bond, with a wall width of 0.12m; 0.24m for the east wall. The building consists of two rooms, divided north-south by a central brick wall (0.12m thick) constructed in stretcher bond (Plates 3 and 4). It appears that the doorway within the dividing wall has been inserted, as with the heating pipes (see Figure 3), likely reflecting a later modernisation of the structure. Interior walls are, at least in part, painted white. The building is accessed via a set of three brick steps to its west down to a timber door with strap hinges and seemingly
-

Plate 2: South elevation of Building 1, southern lean-to, looking north (Photo #62)

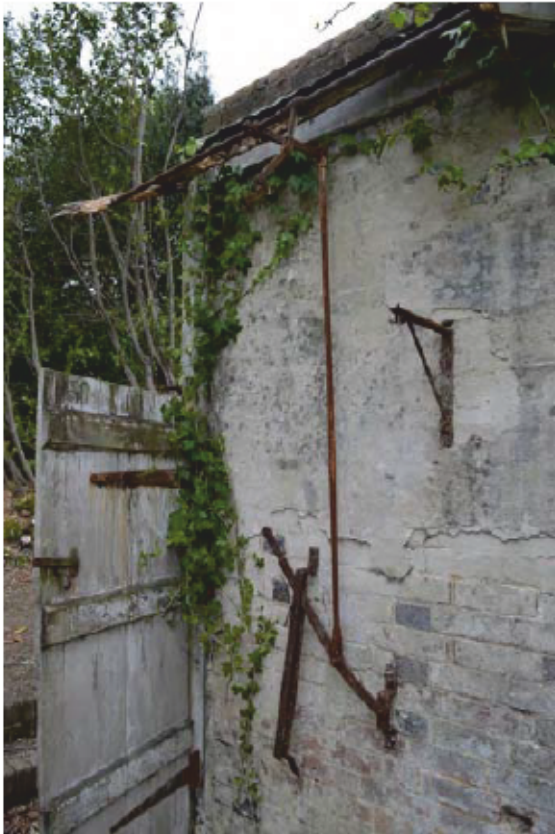
original hardware (Plate 5). A similar door leads north through the spine-wall to the northern lean-to at the east end of the building (Plate 6).

Plate 5: Southern lean-to, Building 1, door to west and lever tackle, looking west (Photo #66)

Doors: The site retains a number of surviving historic doors, particularly those in Building 1. These should be retained and repaired, as appropriate. Repairs are to be carried out by suitably qualified / experienced personnel.

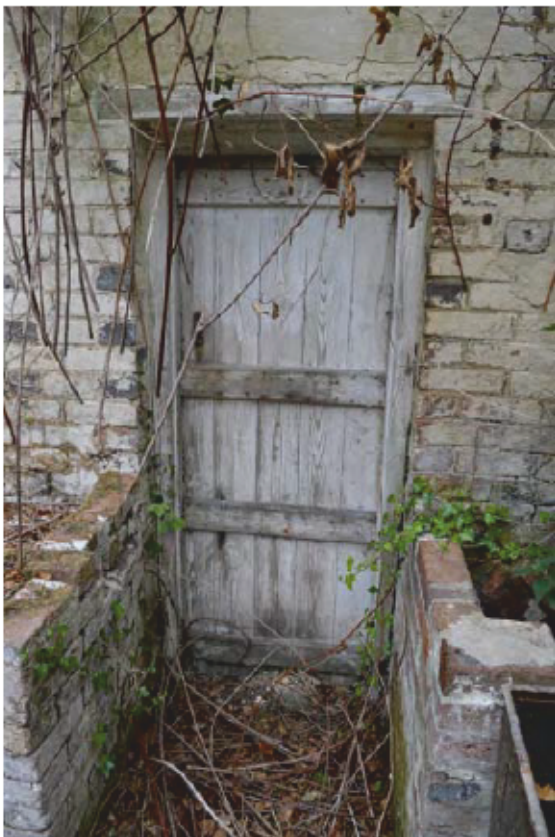
Plate 6: Southern lean-to, Building 1, door to northern lean-to, looking north (Photo #75)

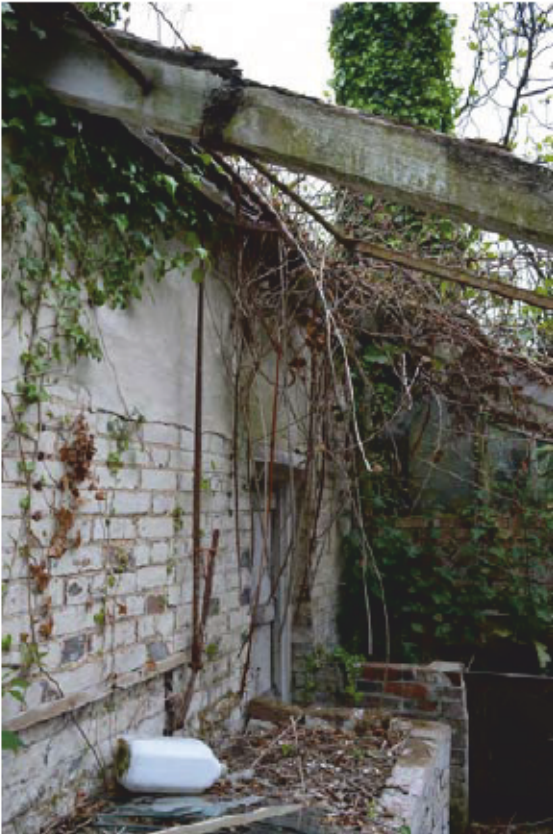
Plate 9: Southern lean-to, Building 1, lever tackle and roof construction. Note void mortise for timber purlin. Looking east (Photo #72)

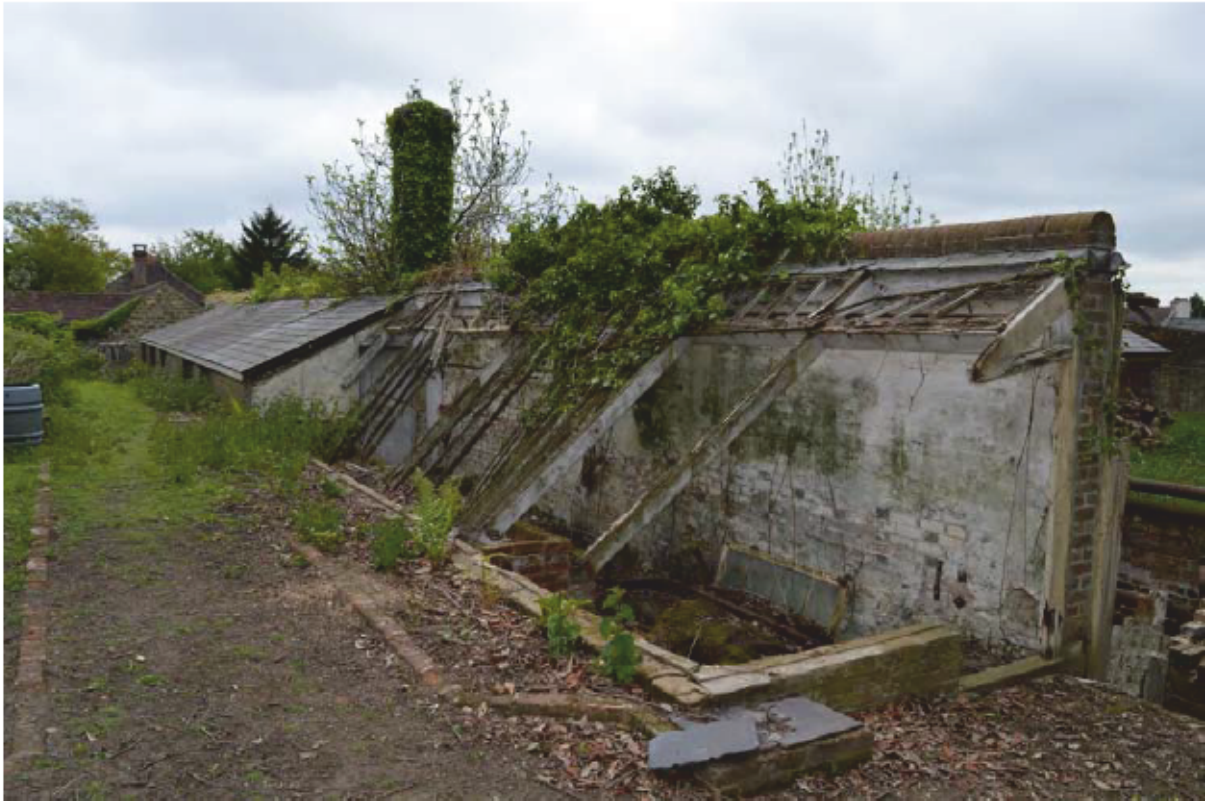
- 6.1.7 The northern lean-to (Plate 11) is similar in construction to the southern, albeit with fittings of an apparently better quality and better state of preservation, as well as a steeper pitch to the roof. Wall widths for the external walls are 0.24m. The lean-to is accessed to its west via a doorway leading to a flight of three steps down (Plate 12). The building abuts Building 4 to its east, with a timber door leading through. Additionally the roof lacks the iron tension rods on the principal rafters, and sits directly on the northern wall at its base. The principal rafters are situated every 1.50m, with glazing bars every 0.32m between. Glazing bars are mortised into a timber purlin (Plate 13). Again, it is not clear whether glazing was attached with putty, or not, to the bars.

Plate 11: Northern lean-to, Building 1, looking south-east(Photo #47)

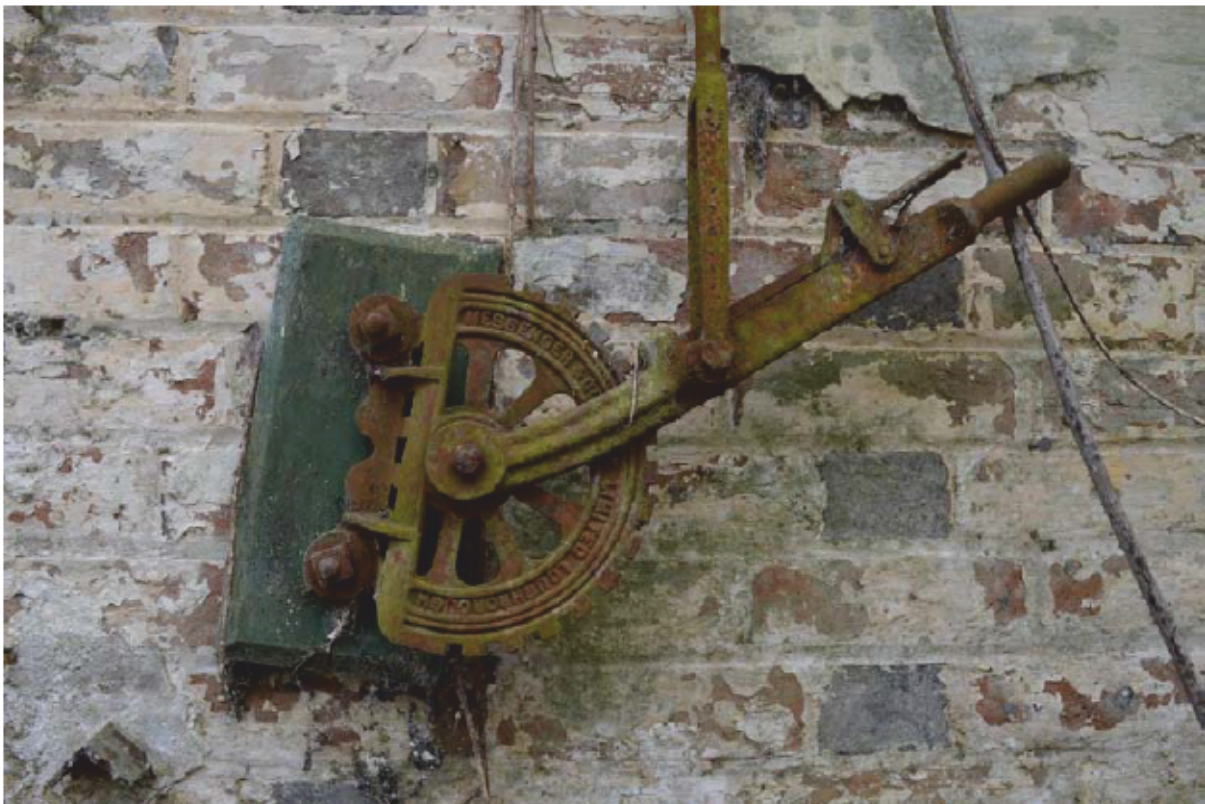
- 6.1.8 The spine-wall features a number of iron pegs and wires for trailing plants. An extant lever tackle on the wall bares the following text (Plate 14):

Plate 14: Northern lean-to, Building 1, lever tackle, looking south (Photo #53)

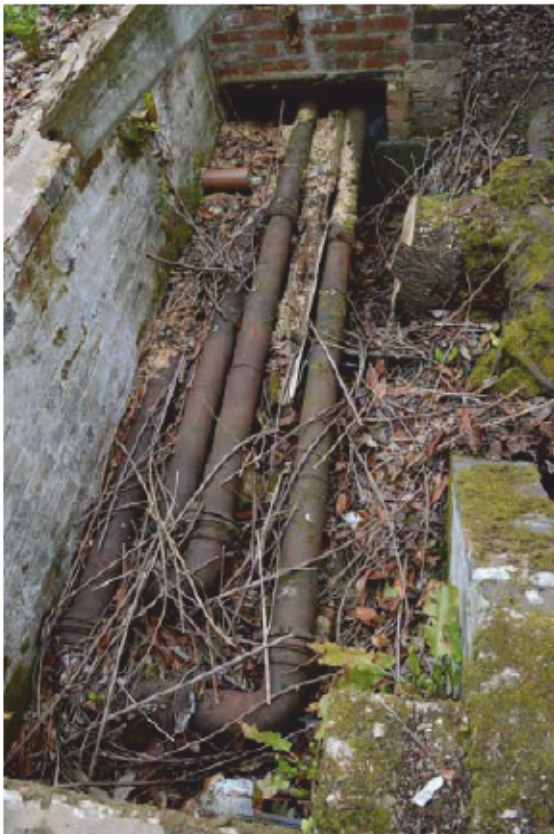
stretcher bond. The bed features a void beneath through which a set of four heating pipes run (Plate 16). The bed contains gaps in the brickwork for drainage and ventilation. Within the west of the lean-to is a slate-lined tank of unknown purpose, situated beneath the pipes.

Plate 16: Northern lean-to, Building 1, pipes running below the northern bed, looking east (Photo #59)

Pipes: The extant piping and boiler form a significant element of the extant structures. If possible they should be retained, or replaced in kind, as reflective of the technologies and historic practices at the site.

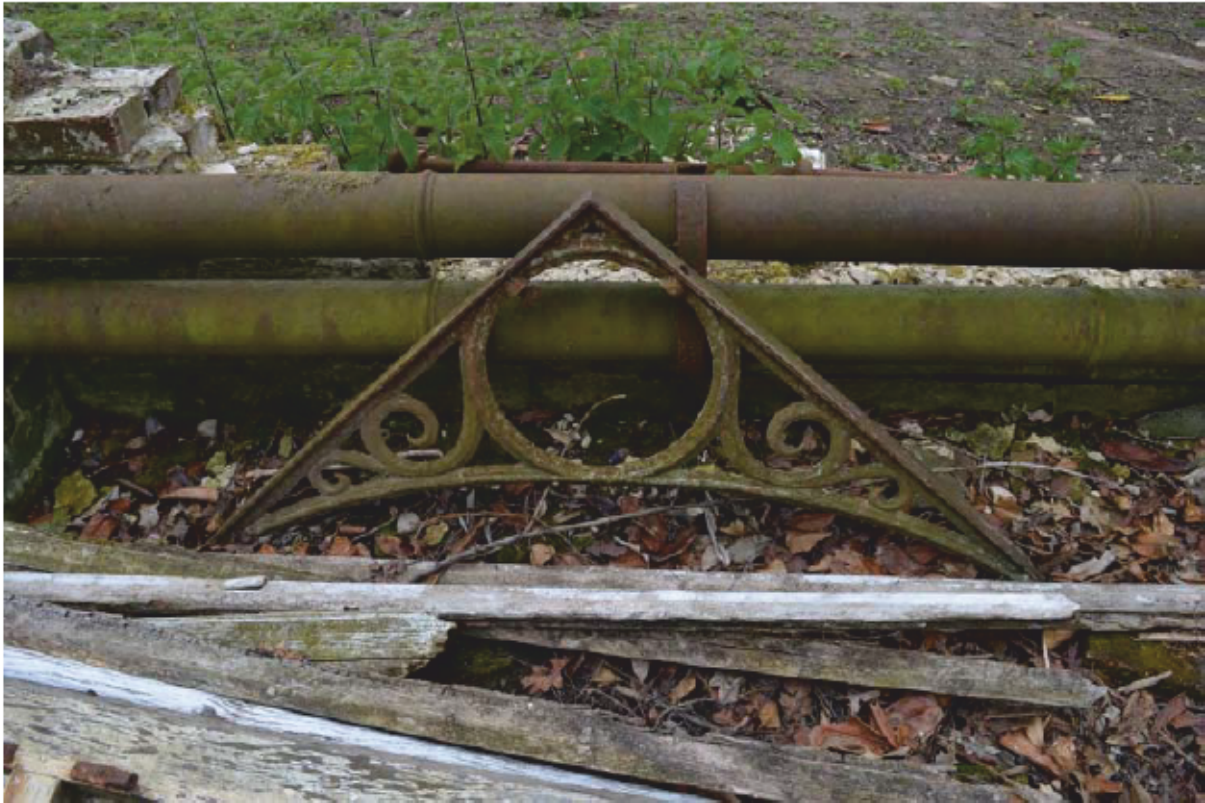
decorative motif, was found in Bay 1 pertaining to the clear-span roof (Plate 27). A number of extant window frames with intact glazing were stacked in Bay 1 (Plate 28). The window frames were of mortised timber elements set with five glass panes, each pane measuring 0.29m x 0.45m, appearing to be affixed with putty beneath the glass panes. It is likely the extant frames were from the lower walls, and do not pertain to the removed roof, considering their form and preservation. Windows were opened for ventilation using the screw operated devices previously mentioned which drove a horizontal shaft attached by arms to the window sashes.

Plate 27: Building 2, spandrel in Bay 1, looking south (Photo #9)

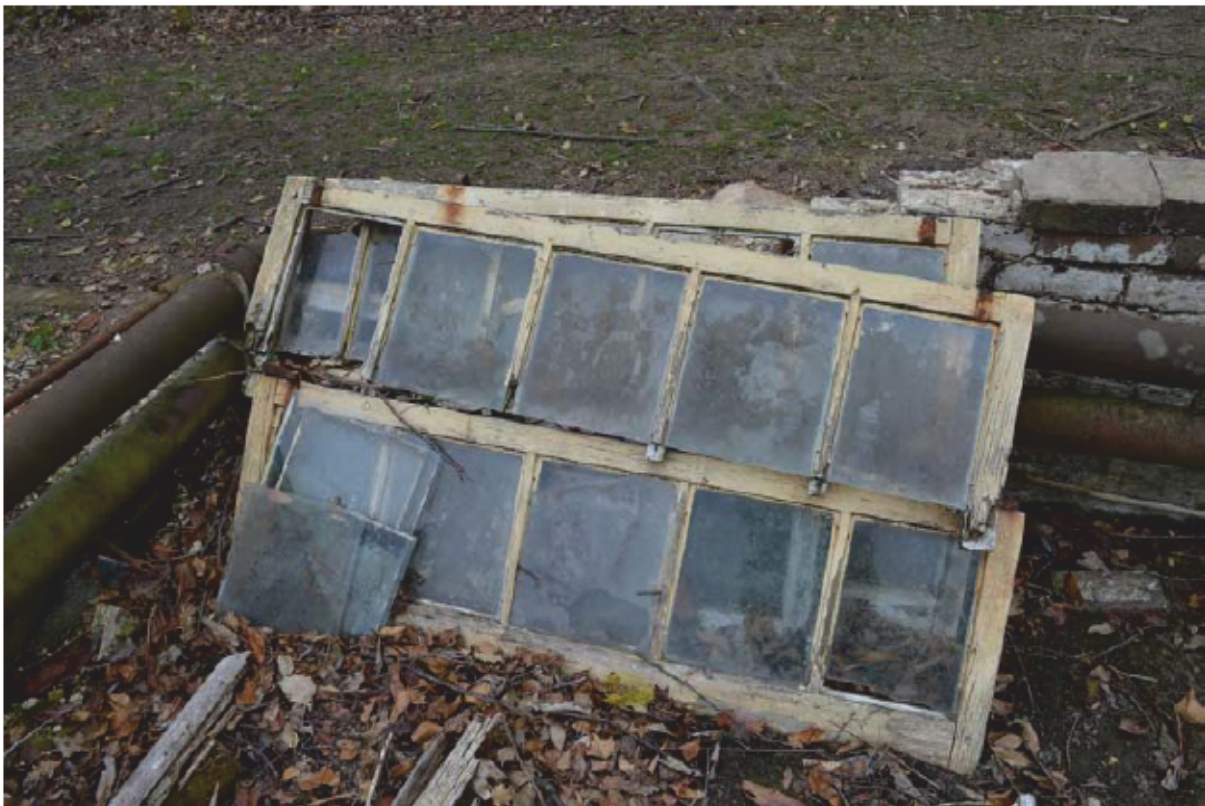
Plate 28: Building 2, window frames, looking west (Photo #8)

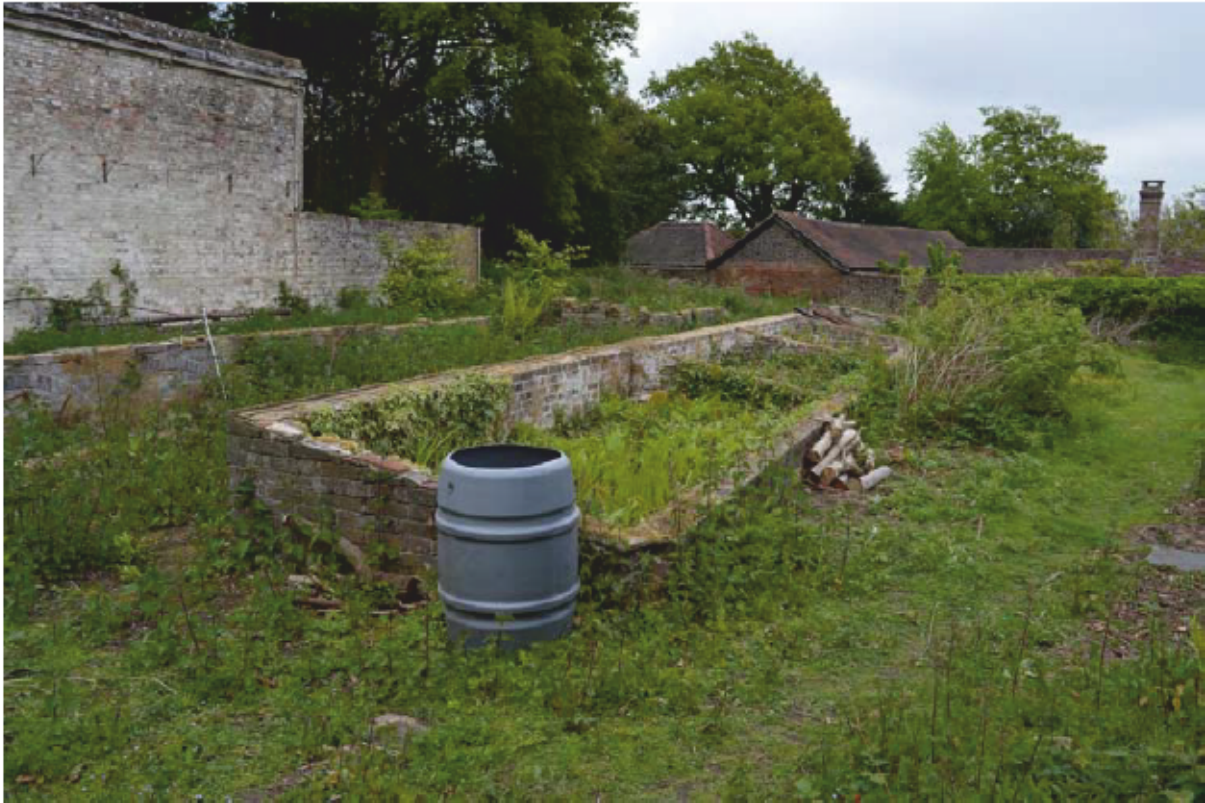
6.3.1 Building 3 is a low cold-frame structure with a south sloping profile (Plate 31). The structure was constructed between 1897 and 1910. The structure is constructed of a mid-orange stock brick with burnt inclusions in Flemish garden wall bond. Occasional clay tiles and concrete-parging create an even coping on which a timber and glass frame would have been positioned. No elements of the glass covering remain. The brickwork shows patches of white paint. The walls have a width of 0.24m, while the internal divisions are 0.12m.

Plate 31: Building 3 overview, looking north-east (Photo #29)

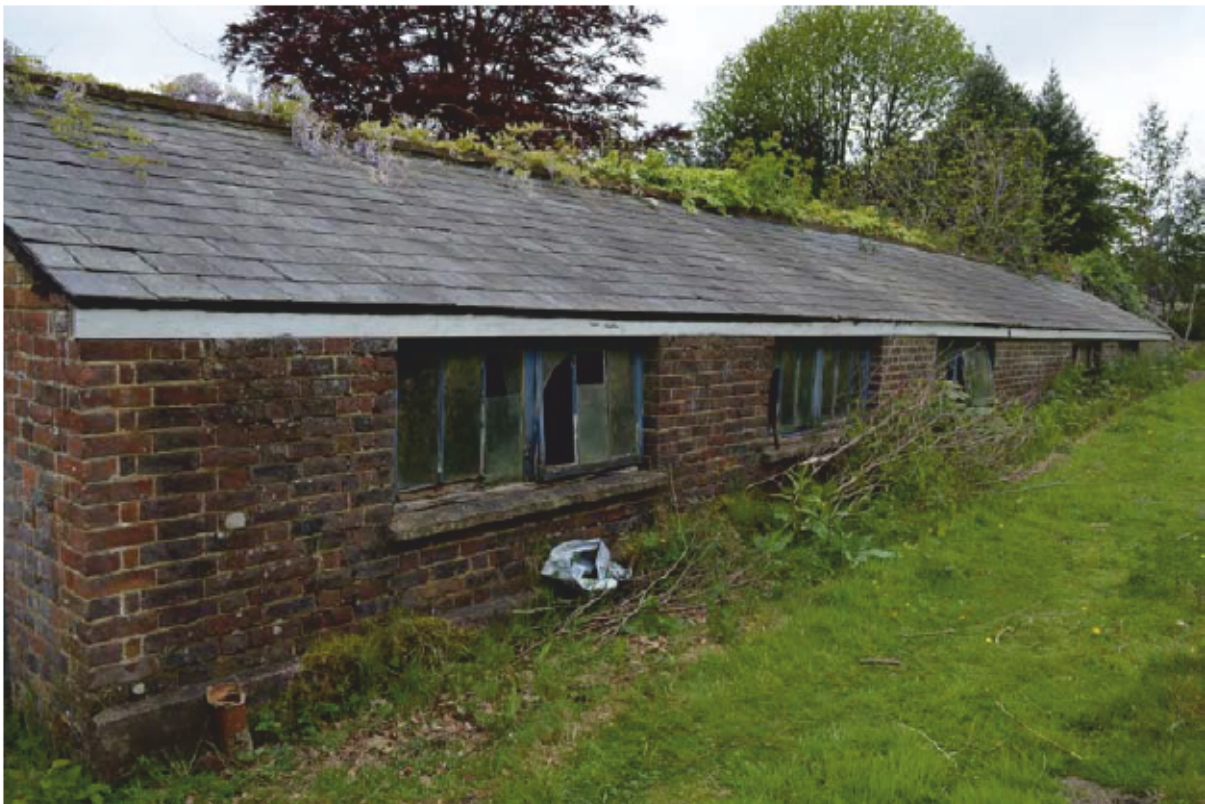
6.4.1 Building 4 consists of two keyed in lean-to structures alongside the north wall of the kitchen garden, abutting Building 1 to its west (Plate 32). The kitchen garden wall is constructed of roughly-coursed stone, with a later extension of large bricks in stretcher bond and a brick coping above. The interior of the building will not be described as it was deemed unsafe to survey after a potentially dangerous substance was identified in the area of the boiler during a safety check at the west end of the structure. The building as a whole features a lean-to tiled roof, with a timber fascia running the length of the building's front. Where the building meets the garden wall is features a straight joint, and is not keyed in.

Plate 32: Building 4 overview, looking west (Photo #39)
