WARE FARM, DUNMOW ROAD HIGH RODING, ESSEX (NGR 560146 216989)

HISTORIC BUILDINGS RECORD (HISTORIC ENGLAND LEVEL 3)

Report No. 2015075

March 2016

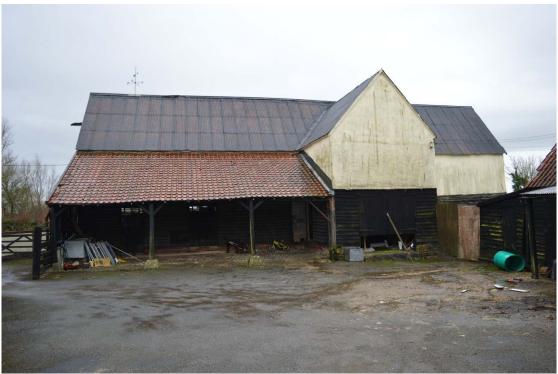
- 5.1.2 The principal elevation faces west into the yard (Plate 1). The elevation contains three openings, two stable-doors to the north of the midstrey, and a two leaf door into the midstrey. On the north side of the midstrey there is also a side door. The shelter is supported by posts on stone pads with small straight braces. The posts support a common rafter roof. Under the shelter the ground is made up of cobble stones, probably a remnant of the yard surface (Plate 2). Decorative render survives on the first floor wall of the barn where it has been protected by the shelter (Plate 3).

Plate 1: West elevation of barn showing midstrey and later shelter (HRWF_017)

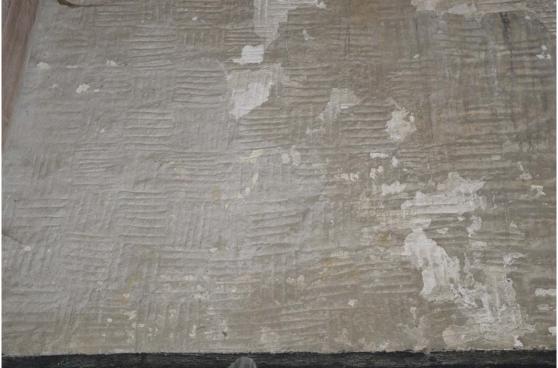
Plate 3: Decorative plaster on exterior of wagon porch wall, looking south (HRWF_020)

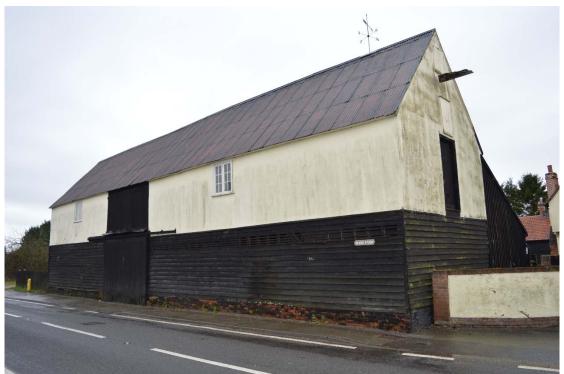
- 5.1.3 The east elevation faces the street and is punctuated by a double-width threshing doorway onto the midstrey and two small timber casement windows at first floor level (Plate 4). At the north end of the elevation the ground floor has a high level ventilation strip. The threshing doors are divided between floors, with sliding doors at ground floor level and two-leaf swinging doors at the first floor. The barn would have originally had full-height doors, and the top section may be what is left of an earlier pair.

Plate 4: North and east elevations of barn (HRWF_013)

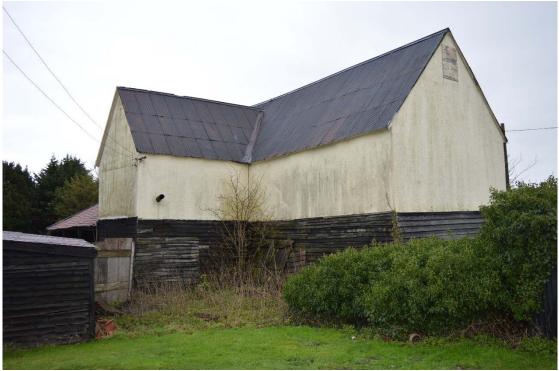
- 5.1.5 The south elevation is plain apart from a boarded window below the apex of the gable (Plate 5).

Plate 5: South elevation and part of west elevation of barn (HRWF_007)

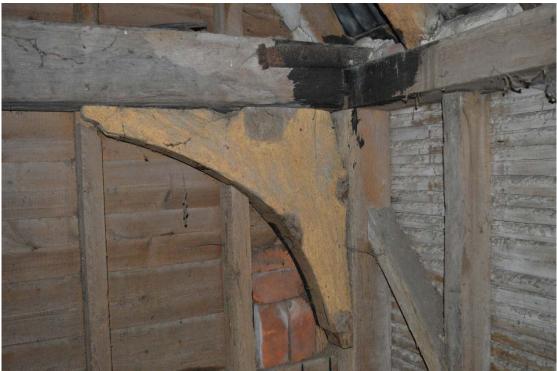
- 5.1.7 Where the posts, tie beams and wall-plates meet, the posts are not jowled but have oak brackets bolted between the tie beams and posts (Plate 7); many of the joints are also reinforced by the use of a stapled iron strap. The roof is of common rafter construction, with clasped purlins supported by collars located at or near to the bay intervals and at each

Plate 7: Junction of post, wall-plate and tie-beam with bracket (HRWF_050)

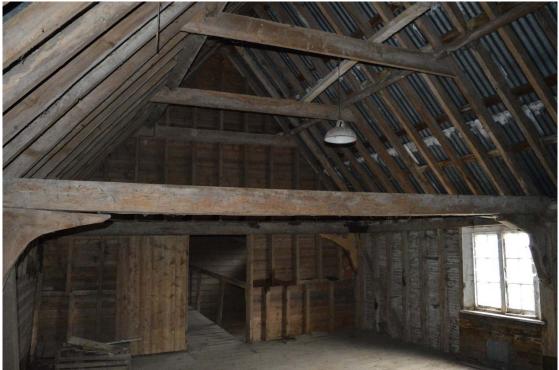
- 5.1.12 At first floor level Bays 1 and 2 form a large empty room open to the roof (Plate 8). The room is lit by a small 20th century casement window in the east wall and formerly by a high window in the gable. The room is accessed from a doorway leading onto the gangway. The door is of heavy plank construction and is tight fitting. The floor is made with tightly spaced boards and the wall is partially boarded. The junction between the floor and walls is covered in metal sheeting. The heavy construction of the floor and tight tolerances indicates that the room was used as a granary. The room would possibly have had grain bins but any evidence for this has been removed.

Plate 8: Barn roof structure, Bays 1 and 2, looking north (HRWF_047)

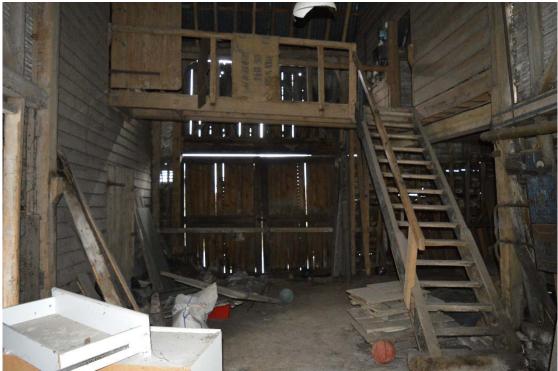
- 5.1.8 A floor has been inserted into every bay apart from the threshing bay (Bay 3), which is bridged by a gangway (Plate 9). The floor was built to carry large loads and is formed of heavy-duty deep joists, which rest on large square binding joists (Plate 10). The binding joists are squared trees and retain good quality merchant's marks, suggesting the timber is of Baltic origin (Plate 11). The binding joists are lodged over the midrails of the side walls, and on the eastern side of the barn within Bays 1 and 2 are supported by cast iron columns.

Plate 9: Barn threshing bay and gangway, looking east (HRWF_026)

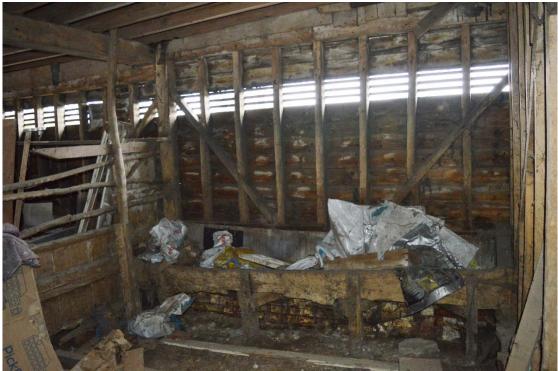
- 5.1.10 Bays 4 and 5 have been partitioned off from the rest of the barn and refitted as a cow-house. The space is accessed from the yard by a wide door and from the inside by a door to the threshing bay. The partition to the threshing bay is of stud wall construction, similar to the rest of the barn but using machine sawn timbers of larger section. The east wall has been adapted to include a high level ventilation strip and a manger below. The space is subdivided into two double stalls by a makeshift stall divider (Plate 13).

Plate 13: Ground floor of barn, Bays 4 and 5. Space converted to cow-house with manger and stall divider intact, looking east (HRWF_039)

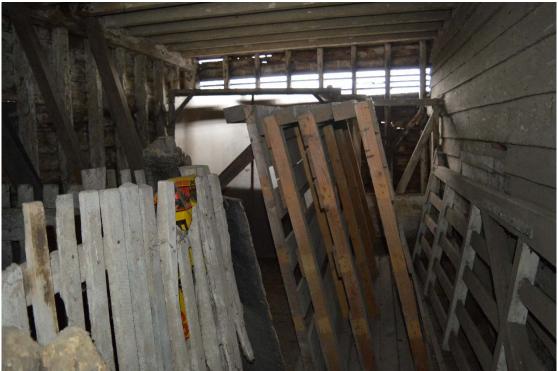
- 5.1.11 Bay 6 is partitioned into a single room, also intended to accommodate animals (Plate 14). Both the east and west walls include high level ventilation, and there is a low level manger to the east wall which is lower and wider than that of Bays 4 and 5. The north-west corner of the room is subdivided by low, insubstantial fencing, possibly for use as a calf pen.

Plate 14: Ground floor of barn, Bay 6. Converted to cow-house or animal shelter, looking east (HRWF_044)

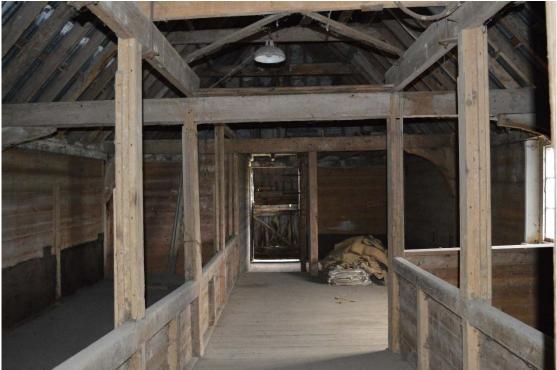
- 5.1.13 Bays 4-6 form a single room at first floor level which was used as a granary (Plate 15). The room was accessed from the gangway with a similar door to that of Bays 1 and 2. The gangway has a trap door and a

Plate 15: First floor of barn, Bays 4-6 converted to granary, looking north (HRWF_055)

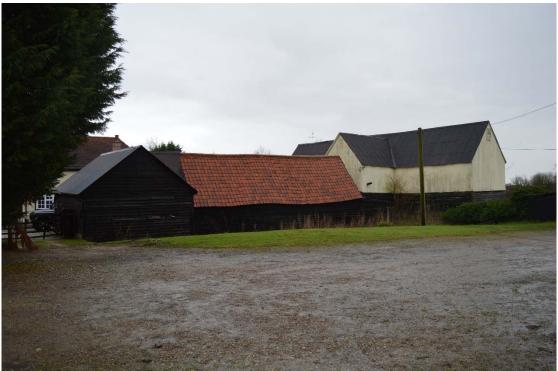
5.2.1 The stables are aligned east – west and form the southern boundary of the farmyard, backing onto the presumed moat that partially surrounds the site (Plate 18). The building is timber-framed and formed of four inline bays of stables with a lean-to to the east end and an open, perpendicular bay to the west (Plate 19). The building is clad in black weatherboarding and roofed in modern pantiles and corrugated iron. The four stables are each accessed independently from one another through its own stable door, as is the lean to at the east end. The western bay is fully open on its north side. The roof has a centrally placed dormer with no opening over Bay 3; presumably it would have provided access to a hay loft, although there is no evidence that one existed.

Plate 18: South elevation of stable, backing onto presumed moat (HRWF_004)

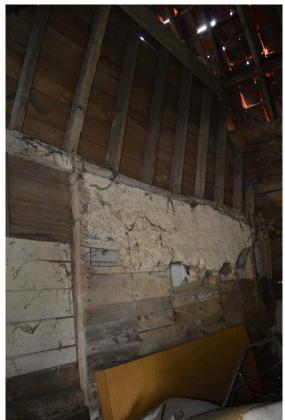
Plate 22: Interior of stable, Bay 3. Remains of daub partition, looking southeast (HRWF_065)

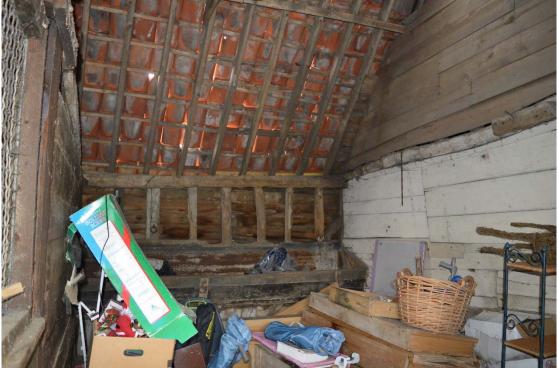
- 5.2.4 The bays are divided by stud partitions rising to collar level. Where visible, the studs used in the partitions are generally larger in section than those of the walls, although within the rear wall of Bay 2 studs of similar dimensions are visible; it is not clear whether they are of the same date. The partitions are clad with short lengths of board and in places there are substantial fragments of lath and daub, perhaps the remnants of an earlier phase of building (Plate 22). The bays retain few fixtures and fittings relating to their original function but Bays 2 and 3 have mangers complete with tethering rings on their south walls (Plate 23).

Plate 23: Manger in Bay 2 of the stable, looking south (HRWF 23_64)

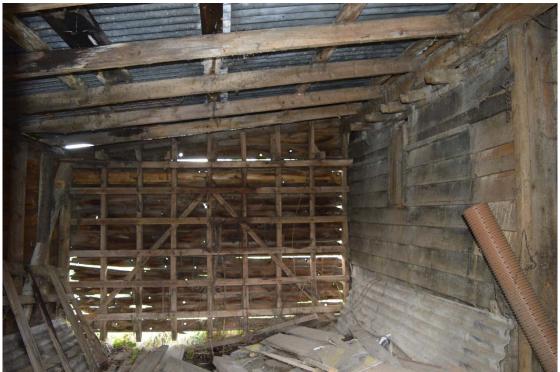
- 5.2.5 The lean-to to the east of the building is of characteristically late stud wall construction made mainly with reused timber nailed together. The wall dividing the lean-to and Bay 1 is clad in weatherboarding and contains a doorway and a blocked window, indicating the lean-to is a later addition. The roof is a shallow monopitch, with widely spaced deep rafters and purlins laid over in a grid, designed for corrugated iron (Plate 24).

Plate 24: Interior of lean-to to the east of the stable, looking south (HRWF_063)

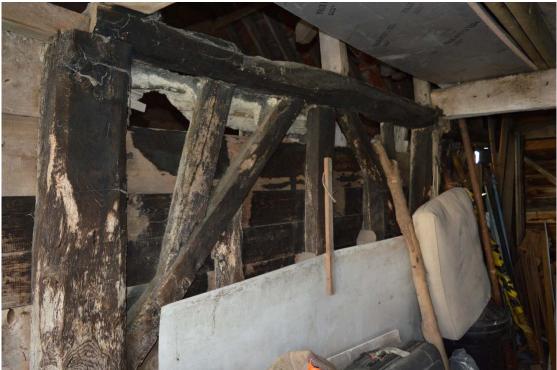
- 5.2.6 Bay 5 is built perpendicular to the main structure and is rectangular in plan. It is constructed from heavier scantling timber than the remainder of the structure (Plate 25); much of the timber is reused, but a large proportion is not, including its low tie-beams. The east wall is of simple construction and includes straight primary braces between the posts and wall plate, and rudimentary studwork. The east face is partly boarded, and partly infilled with daub. The west wall is made up of large panels with no studwork, and the posts are braced to the wall plate with short straight arch-braces (Plate 26). The posts are also connected by a series of rails tenoned half way up the posts. Other than these there is no evidence for any original infill, and the outer face of the timber – although not visible - feels weathered to the touch. This wall is now rudimentarily infilled with studs, weatherboarding and fence panels, built against the outer face of the posts. A mortice in each of the posts of the south wall might originally have accommodated rails similar to those surviving within the west wall.

Plate 25: Interior of stable, Bay 5. Stud wall built with rough, large scantling timber, looking south-east (HRWF_073)

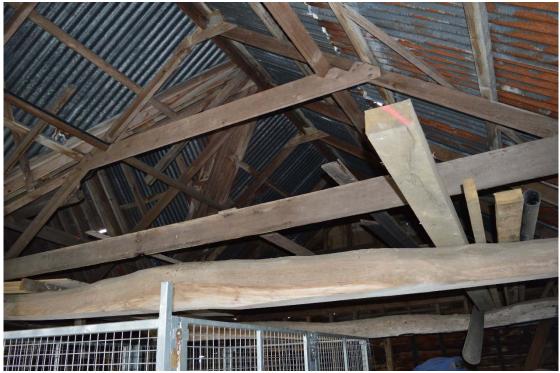
- 5.2.7 The original roof does not survive, and a later roof has been built approximately 0.4m above the original tie beams (Plate 27). Its form is consistent with the roof over the remainder of the range suggesting that the two are of the same date.

Plate 27: Interior of stable, Bay 5 roof, looking south (HRWF_072)
