HOPHOUSE BARN, HOPHOUSE FARM, CATSFIELD STREAM, EAST SUSSEX

Historic Building Record (Historic England Level 2)

ASE Project No: 160232 Site Code: HHB16

ASE Report No: 2016173 OASIS id: archaeol6-251655

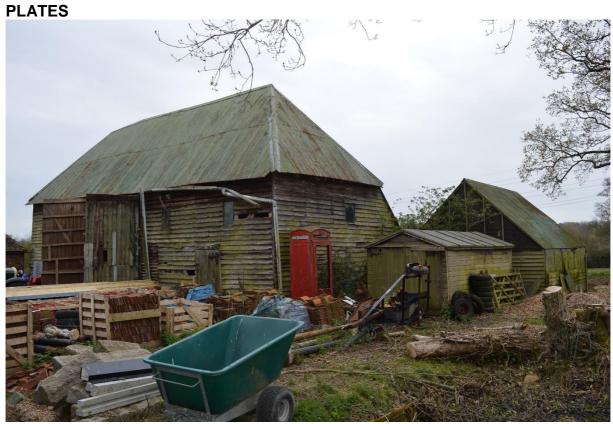
Plate 1: The barn, looking south-east (4)

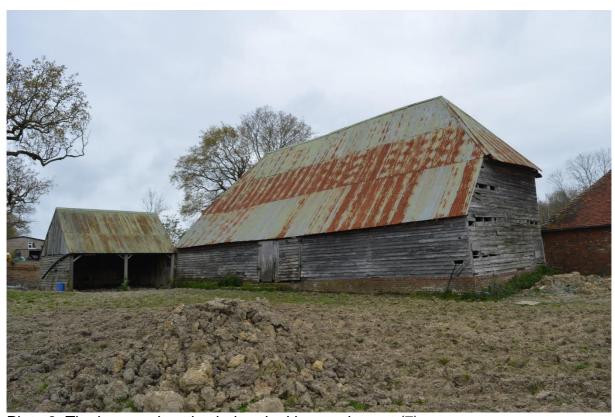
Plate 2: The barn and cattle shelter, looking north-west (7)

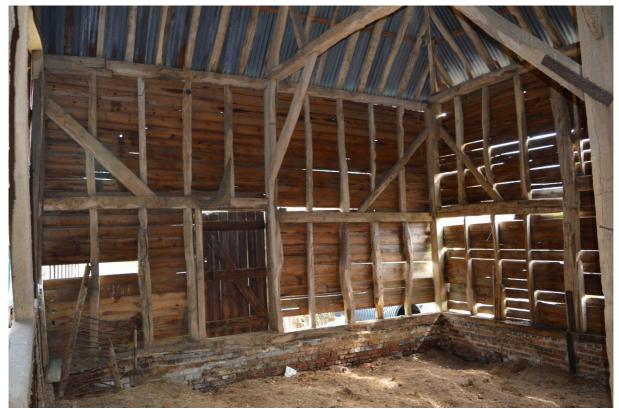
- The barn survives largely in its original form, comprising five bays, an aisle to the south side and a central midstrey. The barn is constructed with a mixture of reused and new oak. The principal trusses have rounded jowls to the posts, with slight variations (Plate 3). The arcade posts have straight braces to the arcade-plates and the principal posts to the north of Trusses 2, 3, 4 & 6 have straight primary braces to the midrails. Each post is braced to the tie beams with straight plank-like braces. The north and side walls are constructed from largely original studwork, with closely spaced, spindly studs morticed and tenoned into the midrails (Plate 4).

Plate 4: Interior of barn, looking north-east (41)

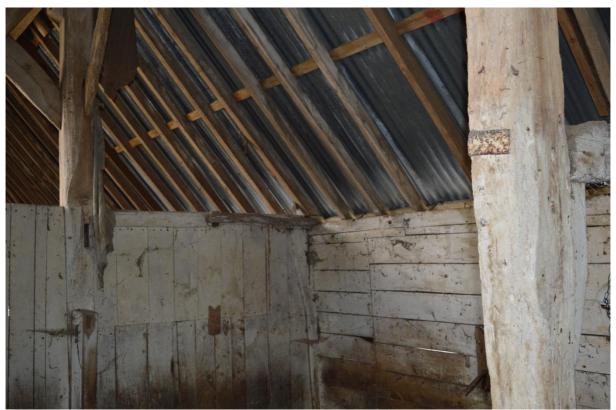
- The arcade posts of Trusses 4 and 5 have empty mortices facing each other at head height, indicating that there was originally rail spanning the two posts (Plate 7). This possibly formed a partition, effectively creating a small room for the temporary storage of grain and chaff after threshing but before winnowing (Martin & Martin 2006, p48).

Plate 7: Empty mortice on arcade post of Truss 4, looking south-east (64)

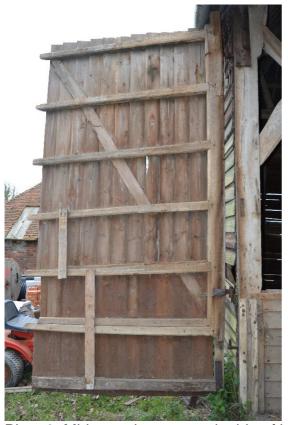
- 6.5 The doors themselves are formed of two leaves of boarded and ledged construction (Plate 8). On each leaf the chamfered ledges are tenoned into a heavy stile which in turn is held by stubby vice-like hinges. The planks and diagonal bracing are modern but it is possible that the stiles and ledges are original. A similar example of probably late 17th century date is known from a barn at Tickerage, Framfield (Martin & Martin 2006, 46). The rear doors are of similar construction, however the west leaf appears to be a more recent replacement. The main doorway to the barn has a mortice in its eastern jamb,

Plate 8: Midstrey door on north side of barn, looking east (33)

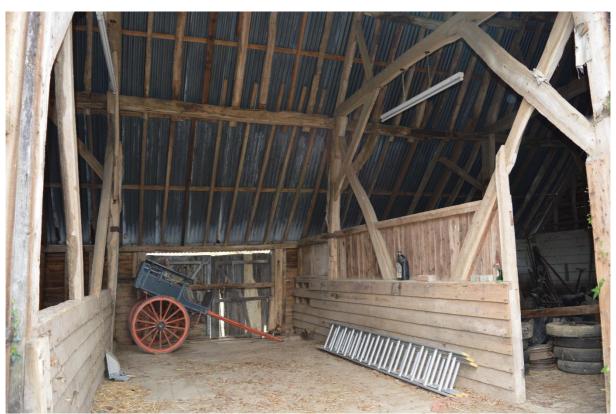
The midstrey retains its timber threshing floor, though whether this is the original floor or a later replacement is not certain (Plate 9). The floor boards are 50mm thick, and are pegged to lateral bearers measuring 220 x 110mm. The heavy duty construction was designed to cope the loads carried by the floor and its repeated bashing with a wooden flail.

- 6.7 The trusses flanking midstrey have each been reinforced by a pair of downgoing shores (Plate 9). The shores rise from sole plates resting on a brick plinth, to which they are tenoned and pegged, but are nailed to the posts, suggesting that they are a later modification. Also, the jowls of the posts have been notched to provide a better fit. There are other examples of barns in the area that were similarly adapted around this time (Martin & Martin 2006, 74).

- These trusses are also fitted with low timber partitions which separate the midstrey from the storage bays (Plate 9). The partitions stand to approximately one metre high and are formed of nailed studs with machine-sawn board fitted facing the midstrey. These would have contained the loose grain and straw within the midstrey during processing. Between the arcade post and aisle post of Truss 3 there is no permanent partition, as access would have been needed to the storage bays. Instead, timber fillets have been nailed to the posts in a similar manner to the blocks on the barn doorways which would have allowed movable boards to be slotted into place, completing the partition (Plate 10). It is not clear whether the formation of the partitions occurred at the same time as the addition of the shores, although the boards certainly seem to be later.

Plate 9: Midstrey, threshing floor and low partitions, looking south (31)

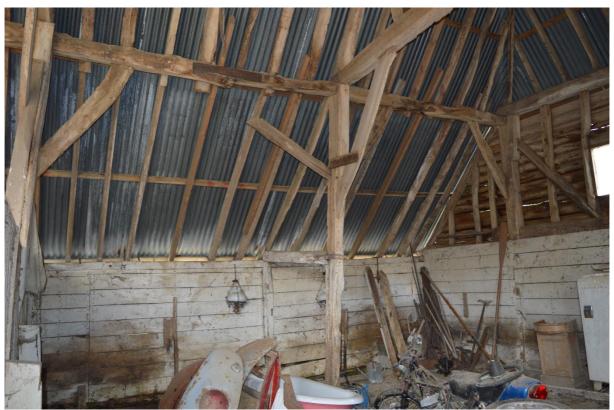
but the rafters probably represent one campaign of repair and are probably contemporary with the tin roof which is supported by battens nailed to the rafters (Plate 11).

Plate 11: Boarded walls in converted cow house, looking south (56)

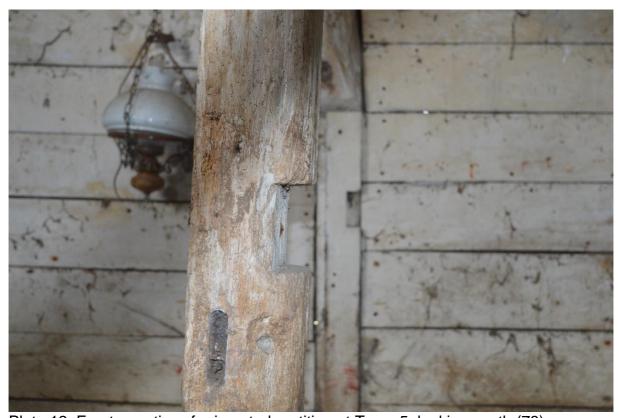
- 6.12 Empty mortices in the posts of Truss 5 suggest that a partition was inserted at this truss, forming two separate stalls (Plate 12). Two doors were inserted into the north wall which respect the former partition and would have provided independent access to the two spaces (Plate 13). The door adjacent to Truss 5 has since been blocked. It was presumably during this phase that two high-level windows were added within the north elevation to provide light for the animals and a cast iron water pump was installed adjacent to the north wall.

Plate 12: Empty mortices for inserted partition at Truss 5, looking south (73)

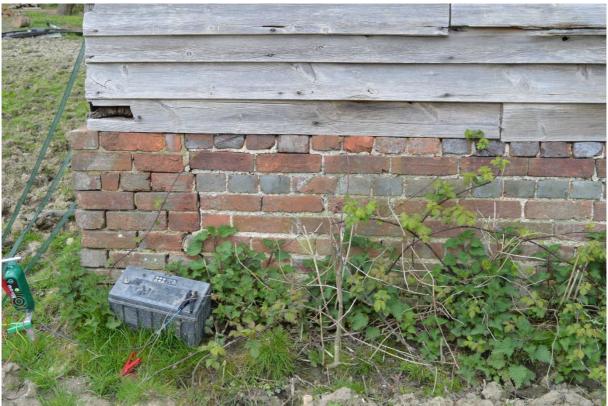
- 6.15 The brick plinth on which the barn sits is probably from this period. The bricks are laid in English garden wall bond and make use of red bricks with vitrified headers. Some of the bricks have horizontal skintles suggesting the bricks date to the early 19th century or later. A straight joint at the south-east corner of the building indicates the south and east walls were built separately or at least rebuilt in phases the brickwork is similar, so the dates are probably similar (Plate 14).

Plate 14: Brick plinth wall and straight joint at south-east corner of barn, looking west (11)

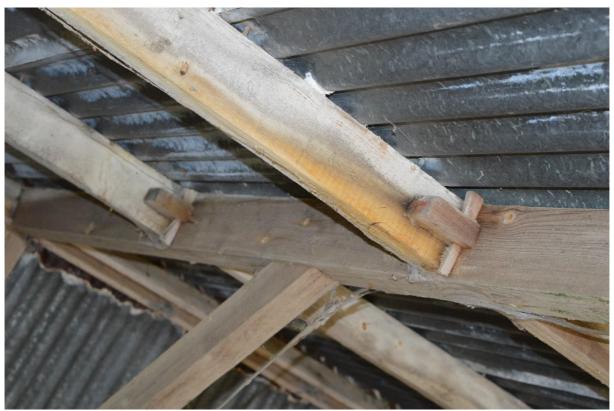
- The gabled roof is constructed with principal rafters and two flights of purlins 6.20 with keyed through-tenons and no common rafters (Plate 17). The principal rafter pairs are each linked by a pegged collar. The roof is clad with corrugated iron with a similar colour and patina to that of the barn, indicating they are probably contemporary. The lack of common rafters suggests that the roof would have been clad in this material from the outset.

Plate 17: Cattle shelter purlins jointed to rafter with through tenon and key (85)

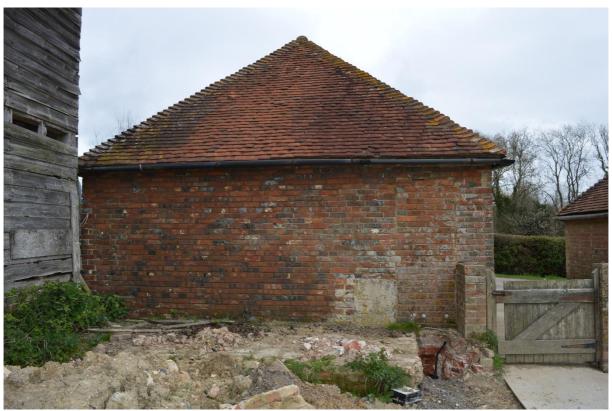
Plate 19: South elevation of stable with remains of lean-to and blocked openings (10)

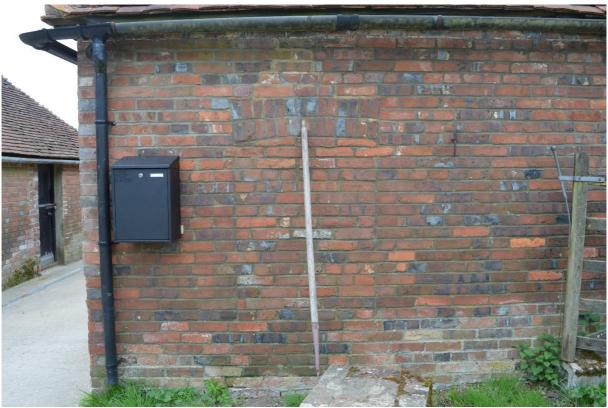
- door and a lower opening which remains unexplained. The wall also retains traces of whitewash.
- 6.23 The north wall contains a blocked opening with a plain segmental arched head (Plate 20). The opening is puzzling as it is low for a window but it is narrow and the straight joint in the brickwork does not reach the ground, suggesting it would make an odd door.

Plate 20: Blocked opening on north elevation of stable (20)

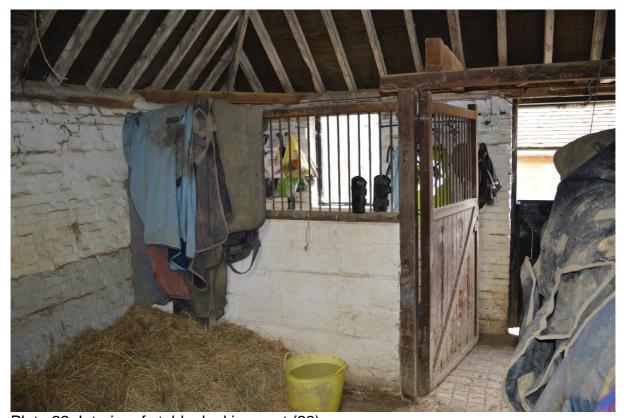
- Internally the stable is divided with concrete block and timber partitions into two stalls and a passage by the door (Plate 22). The building was probably not built with the intention of stabling horses, the tie beams have been cut to accommodate them and the blocked openings overlap with the internal partitions. The construction of the stable partitions suggests that conversion took place in the early/mid-20th century. The original function of the building and its short-lived adjoining structure remain unclear.

Plate 22: Interior of stable, looking east (22)

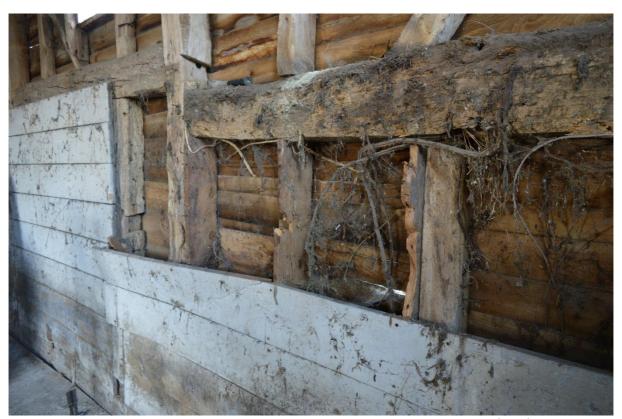
- 6.13 The two western bays were subdivided into individual stalls, this is evidenced through empty post holes in the concrete floor and corresponding marks and mortices on the walls (Plate 23).

Plate 23: Elm boarding and underlying studwork, looking south-west (100)

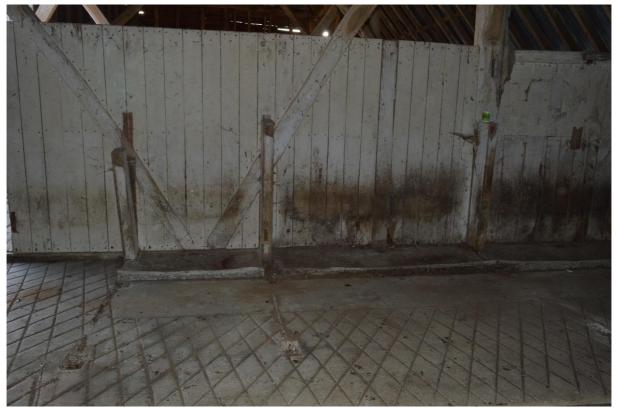
Plate 24: Evidence of cow stalls on floor and boarding of Truss 4, looking east (97)
