**RIVER LAWN,
BARCOMBE MILLS, EAST SUSSEX**

**HISTORIC BUILDING RECORD
(Historic England Level 2)**

**ASE Project No: 170180
Site Code: RLB17**

**ASE Report No: 2017107
OASIS id: archaeol6-257061**

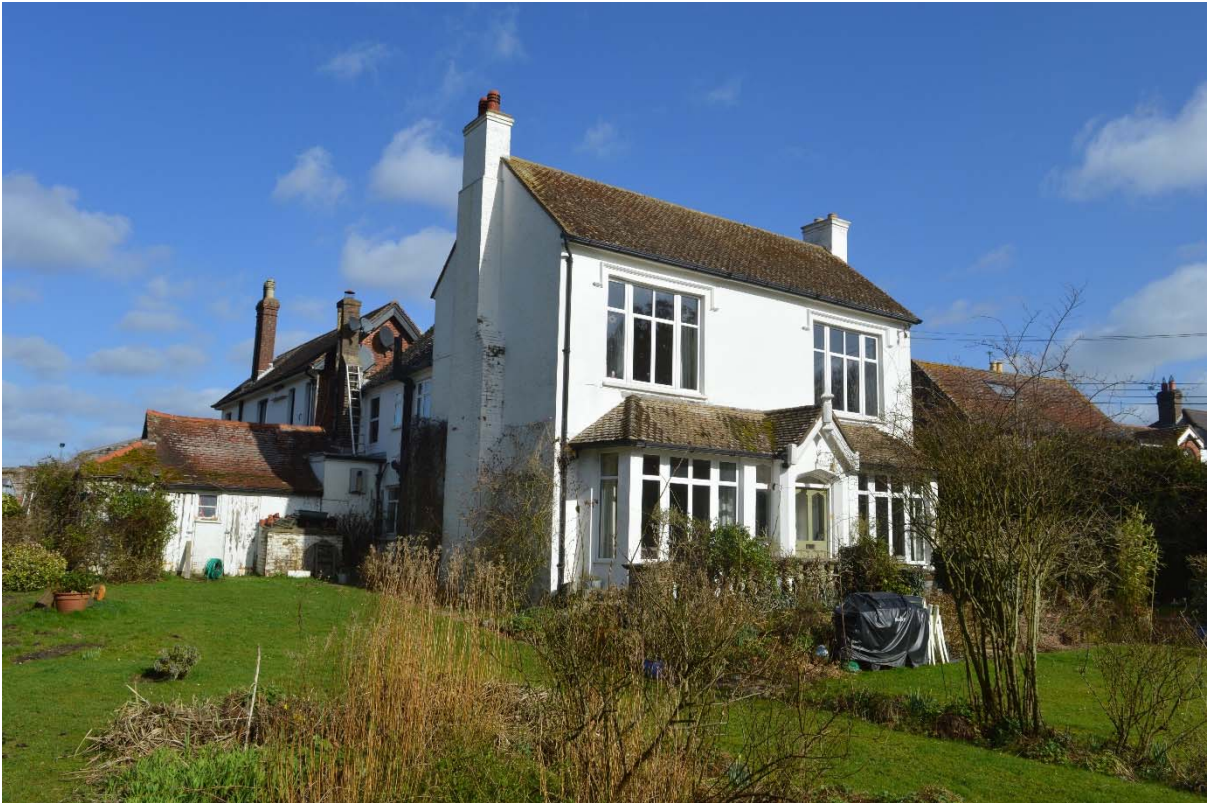
- 6.1 The house is roughly square in plan, comprising two parallel ranges aligned east – west (Plate 1). The building also includes the neighbouring house – not included in the record – known as The Lawn Cottage, which consists of two perpendicular brick ranges to the north of River Lawn.
- 6.2 The building originated as a single-range four bay timber framed house of two storeys and an attic, dating to no later than the mid-17th century (Phase 1). A perpendicular range was added to the north of the building, probably around c.1800 (Phase 2). In the mid-/late 19th century (Phase 3) the building was transformed by the addition of a range to the south of the building and the remodelling of the its interior.

Plate 1: South and west elevations, facing north-east (RLB17-0055)

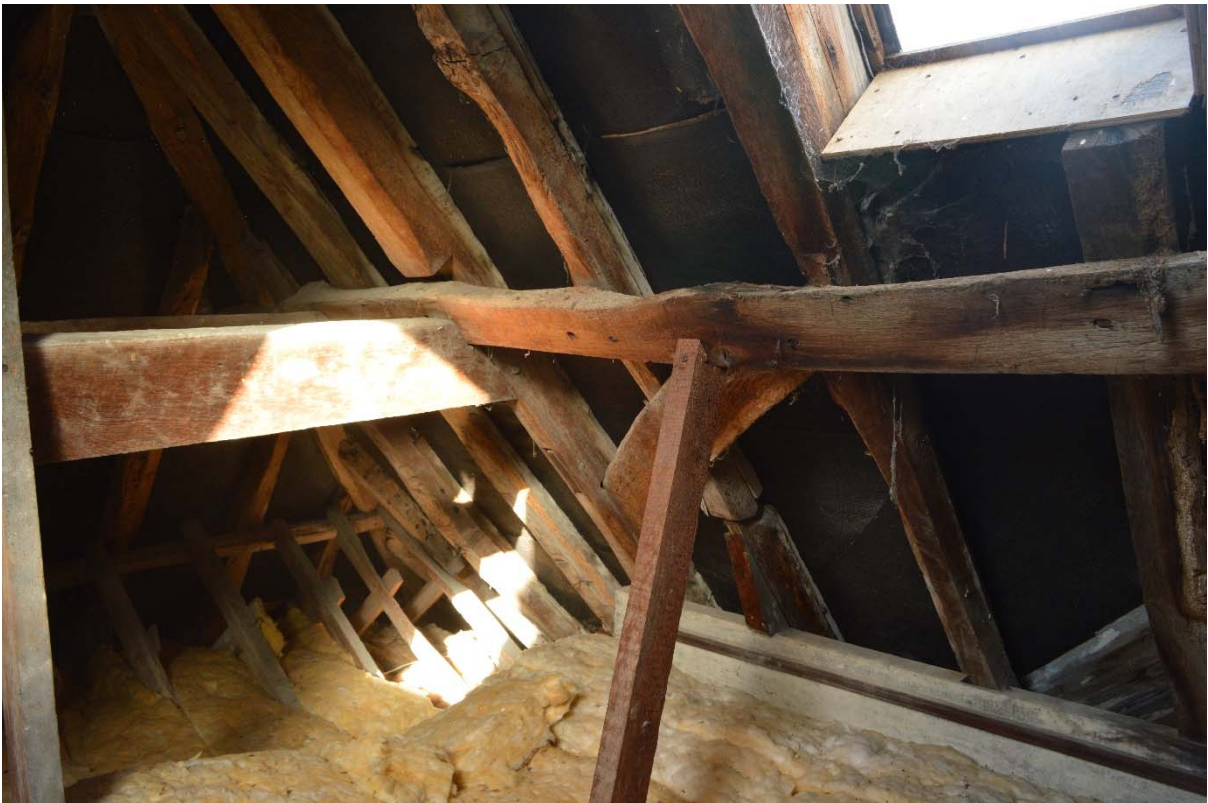
Plate 2: Junction of purlin, collar, principal rafter and windbrace of Truss 3, facing north-west (RLB17-0004)

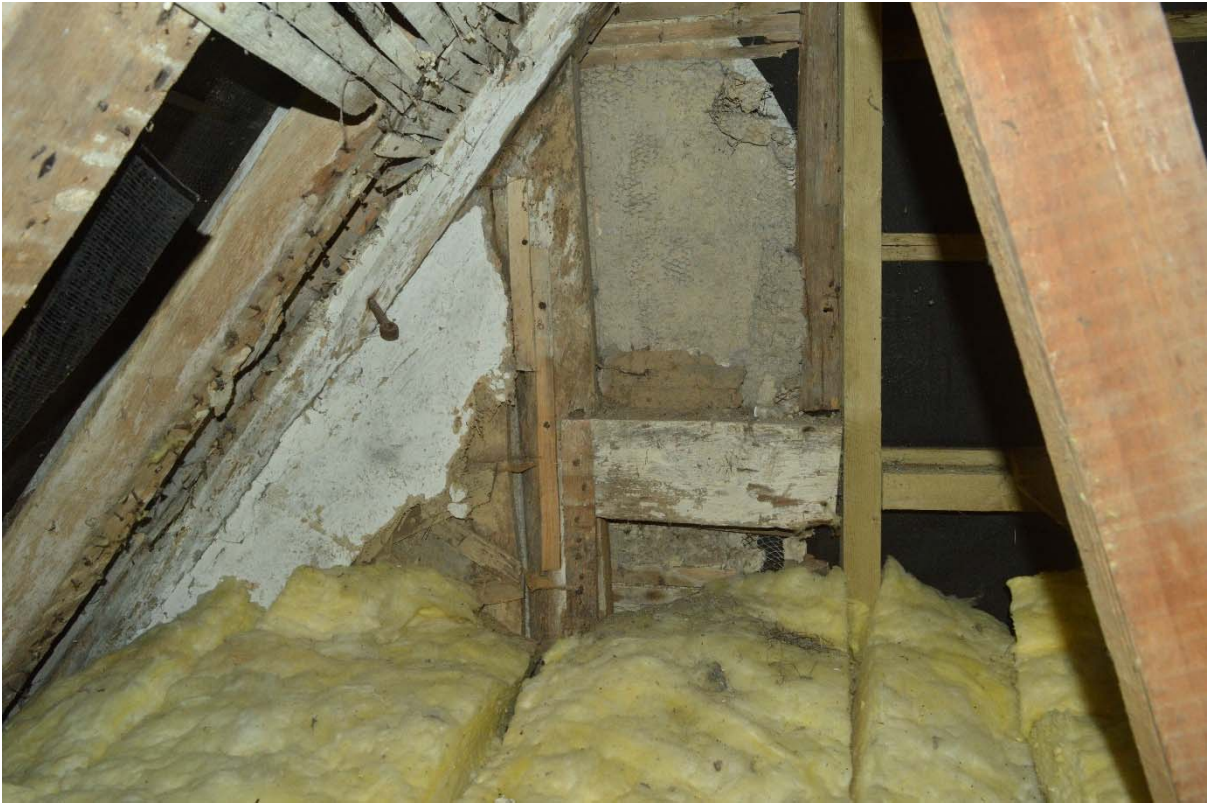
- 6.4 The roof is divided into four bays of unequal size (numbered 1 to 4 from east to west) with the third bay being the significantly narrower. The fair face of all of the timberwork faces into the third bay. Although the east wall of the roof has mostly been rebuilt in the 20th century, a fragment of framing and a daub panel survives in the corner (Plate 3).

Plate 3: Small panel of daub in east wall of roof, facing east (RLB17-0078)

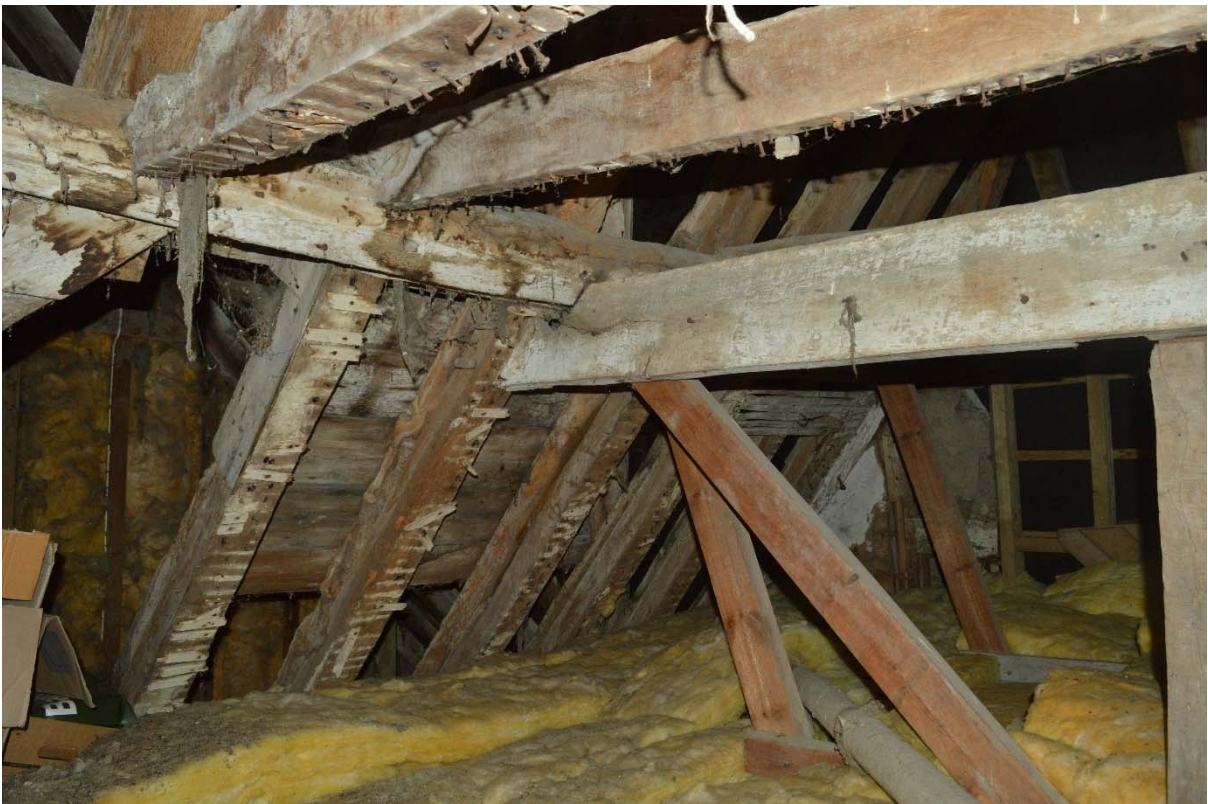
- 6.5 Bays 3 and 4 feature fairly substantial ceiling joists at collar level nailed to the purlins (Plate 4). The joists bear the remnants of lath and plaster on their soffits, as do the rafters below collar level. The collar of Truss 2 has lath and plaster facing Bay 3 indicating that half of the roof was ceiled and used as an additional storey. The collar of Truss 1 bears no lath and plaster marks, but is whitewashed. In addition the truss lacks any evidence of raking struts or partitions, indicating Bays 3 and 4 were conceived as an open room, at least at attic level. The presence of a daub panel indicates that the plastered ceiling is probably not original, although it certainly dates to an early phase. The configuration of Truss 1 indicates that even without the plastered ceiling, Bays 3 and 4 were used from the outset, but presumably open to the roof.

Plate 4: Remnants of lath and plaster in Bays 3 and 4 of roof (RLB17-0007)

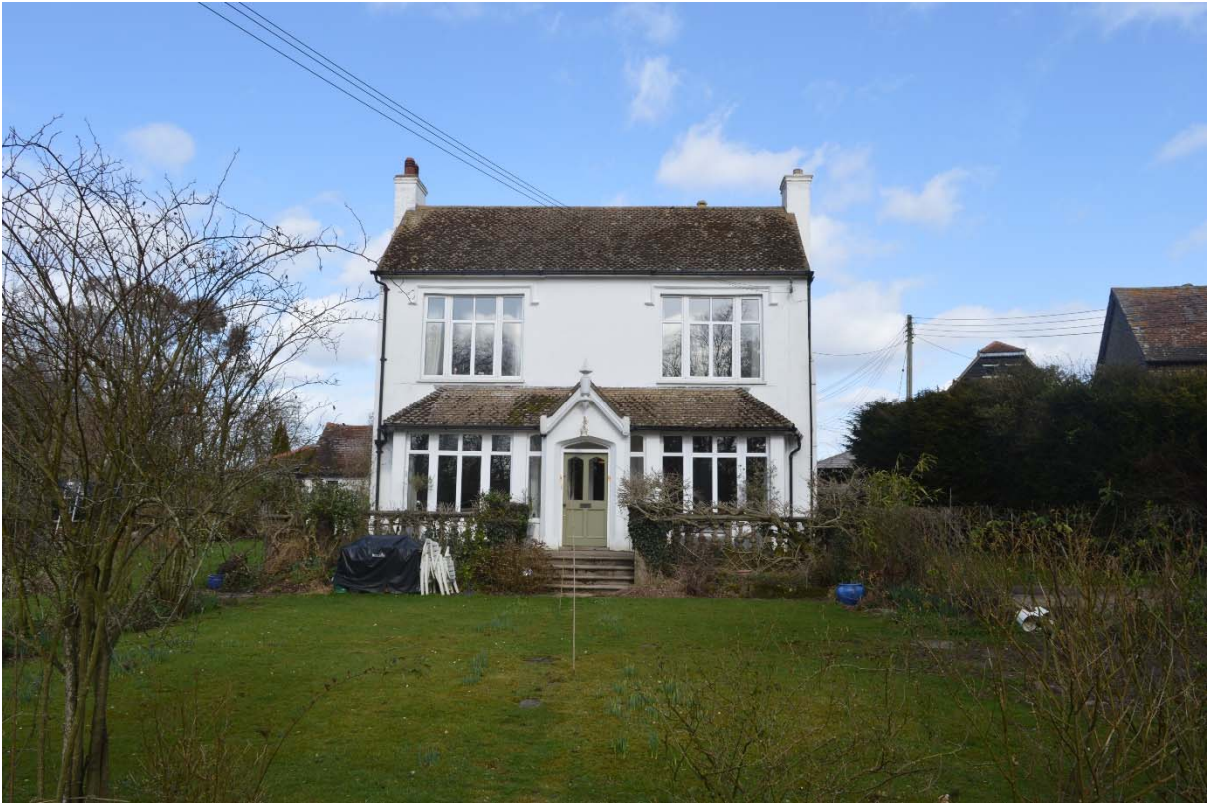
- 6.10 Externally the building was given a symmetrical appearance, with the new principal elevation facing south towards the garden (Plate 7). The principal elevation now consists of two window bays either side of a central doorway. The first floor windows are topped with a Gothic style hood-mould, while the ground floor windows break forward as bays, sitting under a lean-to roof together with the porch. The porch itself is gabled with an oversized pendant and features a four-centred arched opening with a similarly styled half-glazed four-panel door.

Plate 7: South elevation (RLB17-0054)

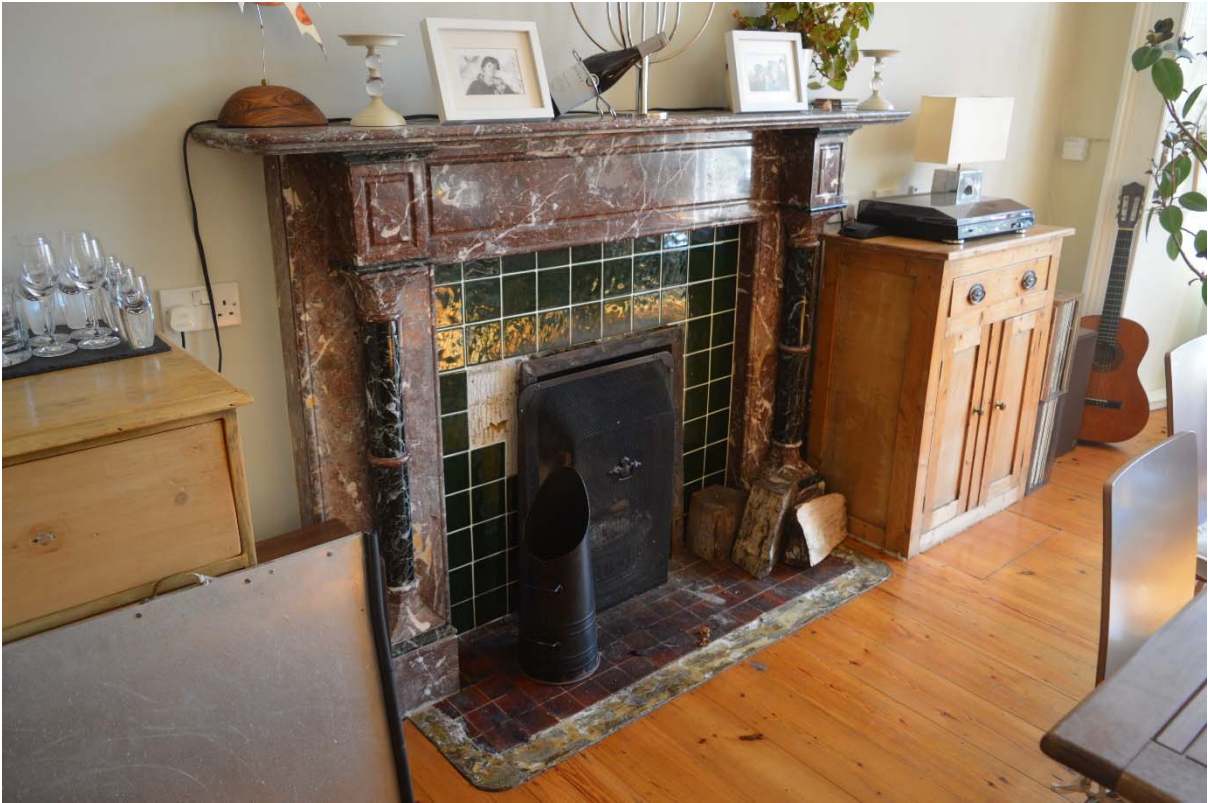
- 6.14 The south-east room is heated with an ornate marble fireplace with engaged columns to the jambs and green glazed tiles (Plate 11). The fireplace in the south-west room has been replaced with a 1930s confection.

Plate 11: Fireplace in ground floor south-east room, facing south-east (RLB17-0026)

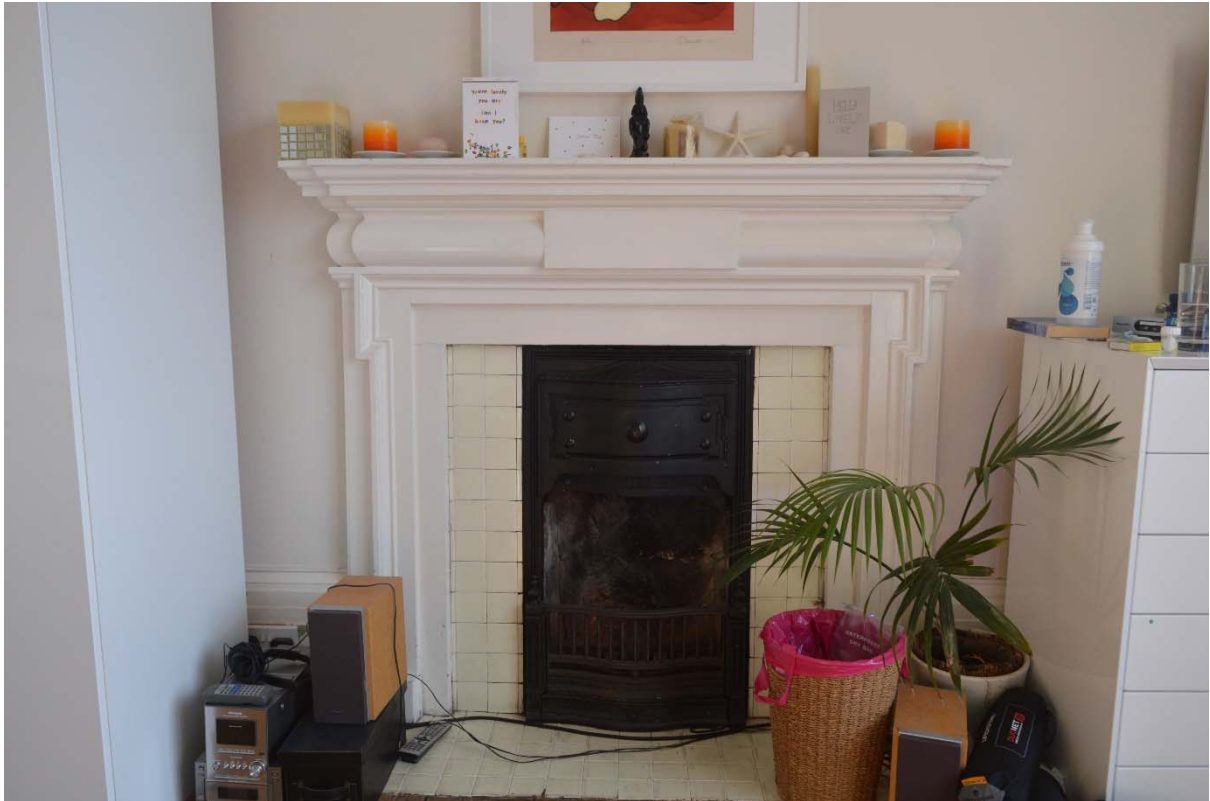
- 6.16 The south-east room retains its original fireplace, made of timber, and plainer than that of the ground floor but still relatively ornate (Plate 13). The surround features a lugged architrave and a pulvinated frieze. The fireplace in the south-west room has been lost and replaced with a modern example.

Plate 13: Fireplace in first floor south-east room, facing east (RLB17-0049)

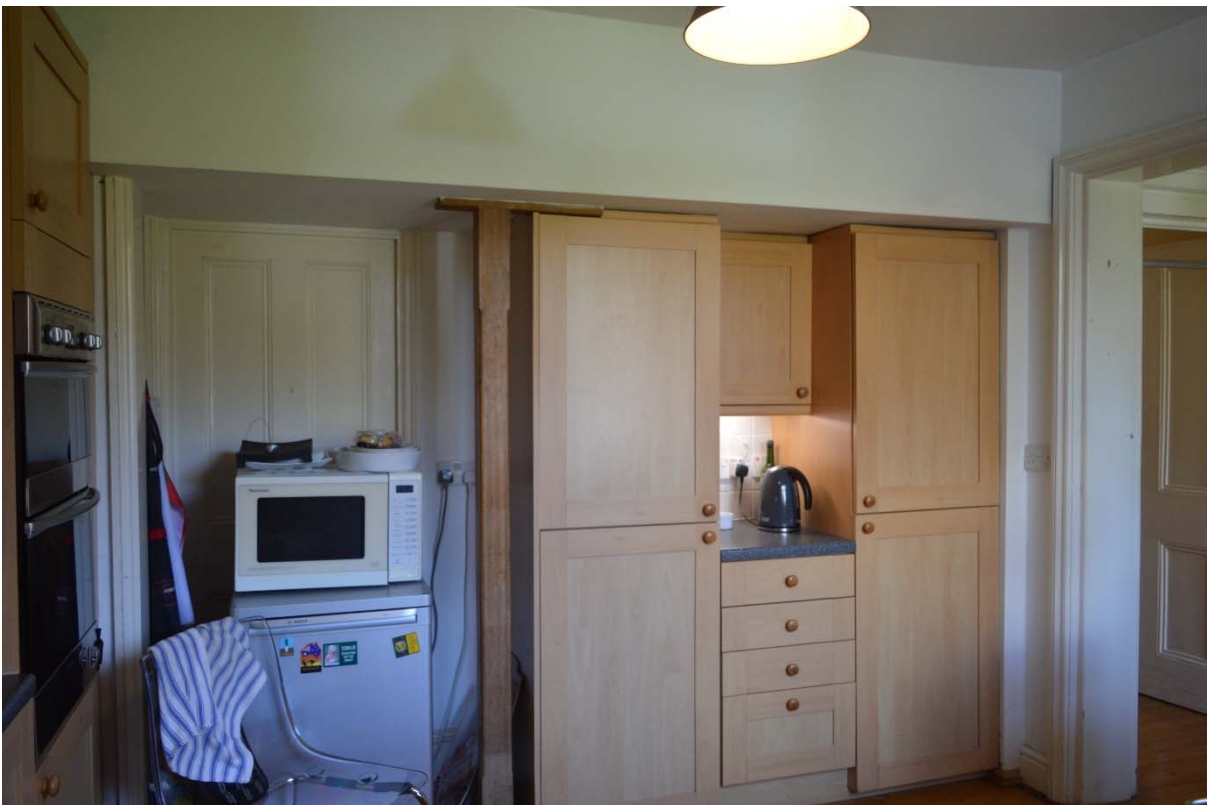
- 6.21 The kitchen also appears to have been modified significantly in recent years. It retains no historic features and its east wall has been moved further into the hallway to create more space in the kitchen (Plate 20). The kitchen is accessed from a doorway to the south leading to the side passage. It also has a doorway and four panel door, reset into the east wall but currently not in use. A doorway in the west wall leads to a small larder contained within the outbuilding range. The room is lit with a modern double glazed window in the west wall.

Plate 20: Reset wall in kitchen, facing east (RLB17-0030)

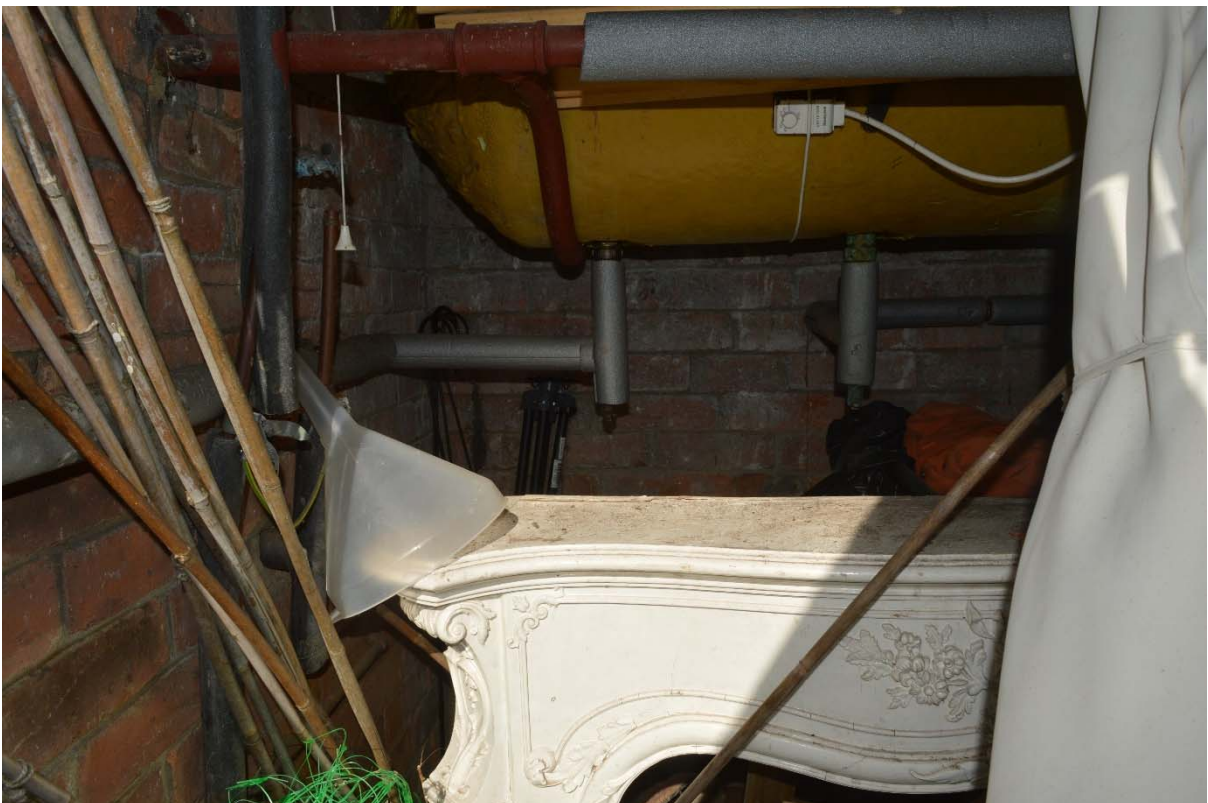
Cottage side with a mid-20th century brick partition. A contemporary brick partition also divides the River Lawn side of the structure in two (Plate 22). The interior is accessed via two modern plank and batten doors on the south face and lit with a window between the two doors.

Plate 22: Interior of outbuilding, facing north (RLB17-0063)

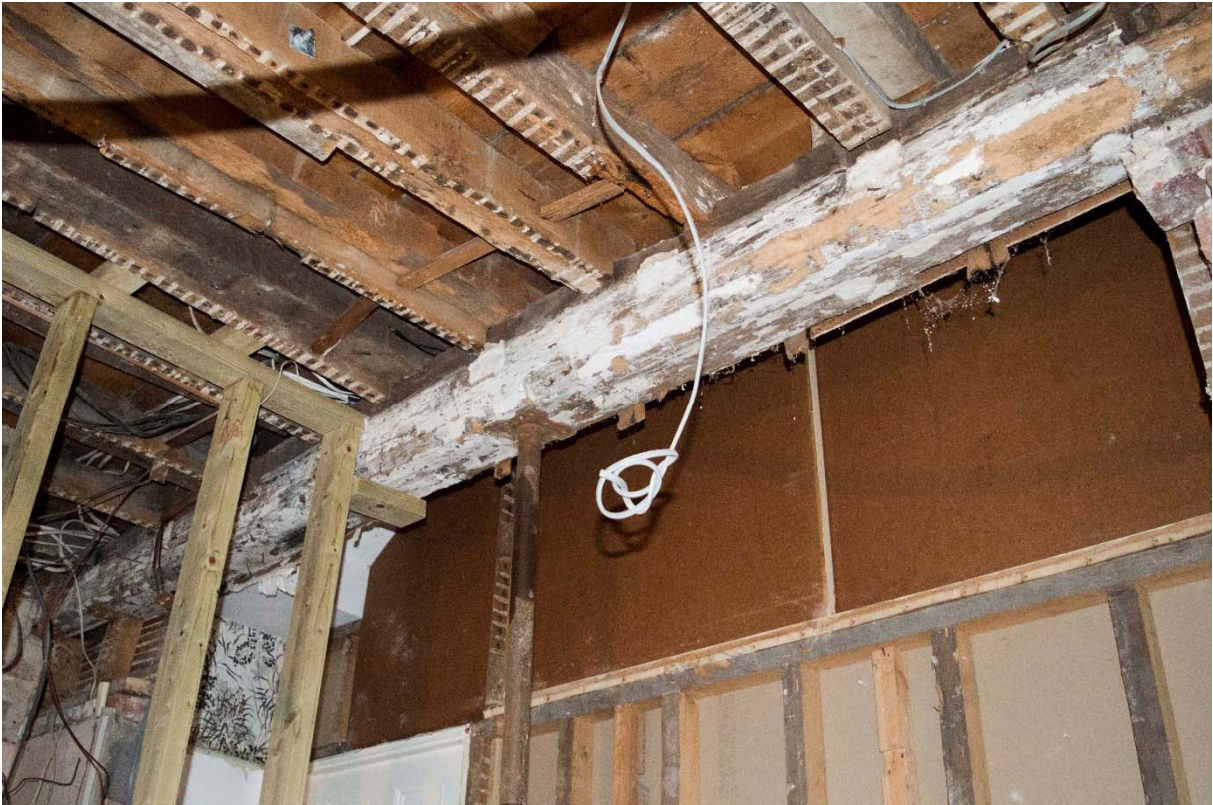
Plate A3.1: Phase-1 chamfered ceiling girder. Note the redundant joist mortises in the face of the girder where the joists have been raised. (RLB-0085)

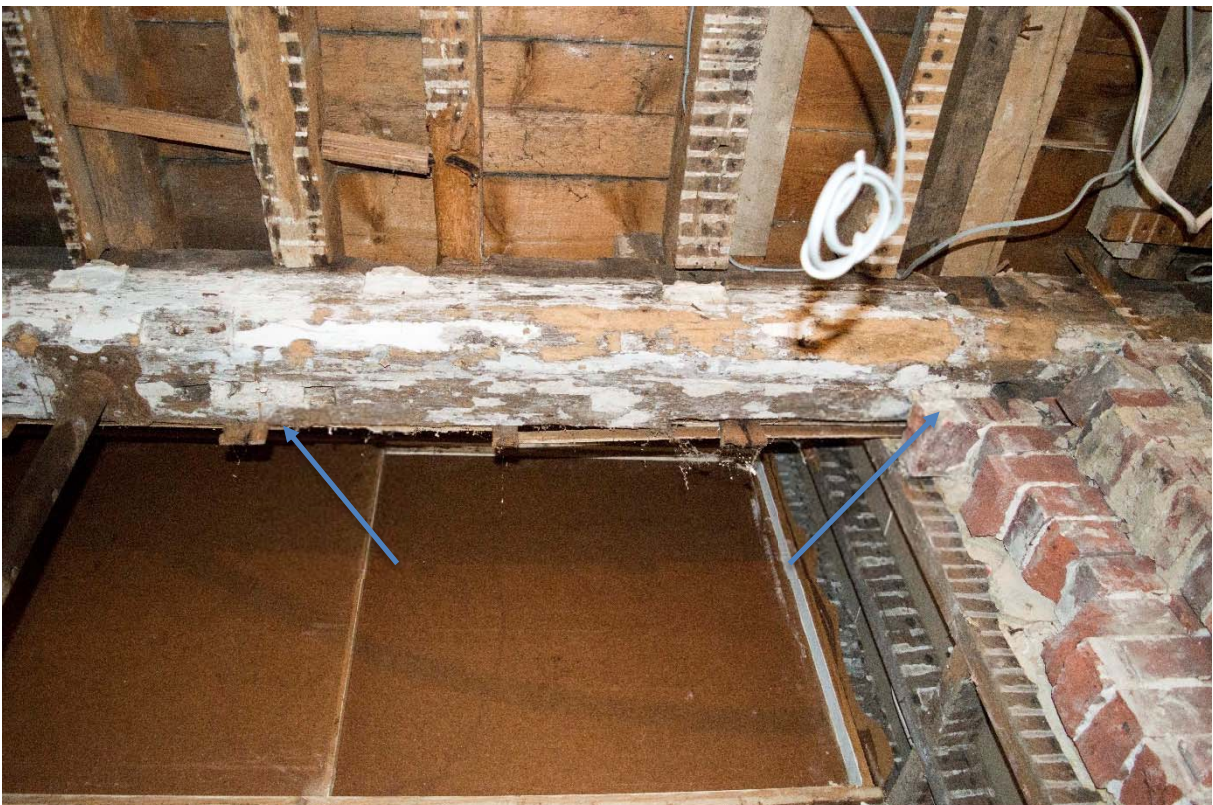
- 3.2 A series of redundant mortices are visible in the soffit of the crossbeam. These comprise stud and stave mortices for a partition. An absence of mortices between two stud mortices indicates the position of a Phase-1 doorway just south of the centre of the partition (Plate A3.2). The stud partition had latterly been replaced with brickwork, which at some stage had been demolished in order to extend the kitchen to the east; however, a stub of brickwork remains at the southern end, immediately to the north of the existing doorway to the stair hall (Plate A3.3). This comprises fairly dense, dark red brick with some vitrified/overburnt headers and 'kiss marks' from the method of stacking the bricks in a kiln. The bricks measure c.65mm thick and are characteristic of an 18th/19th century date. Attached to it is a stub of the brick wall which formerly separated the kitchen from a passageway to the south, which appears to be broadly contemporaneous, suggesting the passageway arrangement was established around this date.

Plate A3.2: Redundant mortises for studs which formed the jambs of a doorway (RLB-0087)

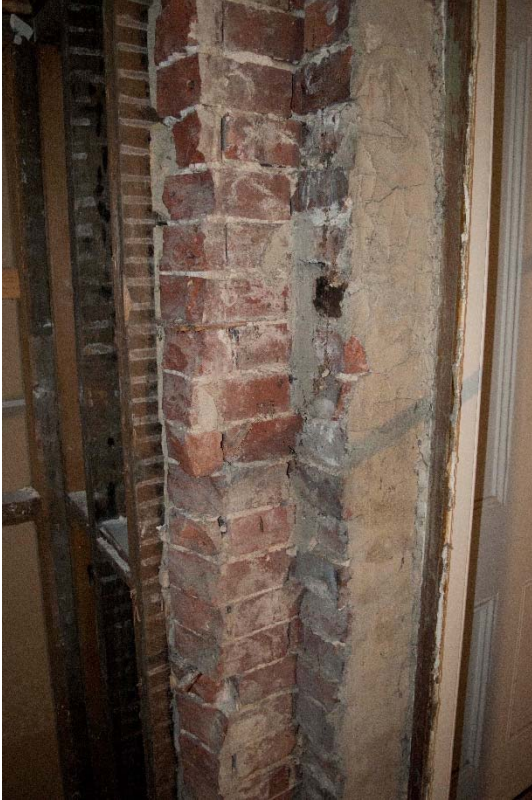
Plate A3.3: Truncated brick wall, which replaced a stud partition beneath the Phase-1 girder. Attached to the right-hand side is part of a brick wall which separated the kitchen from the passageway to the south (RLB-0096)

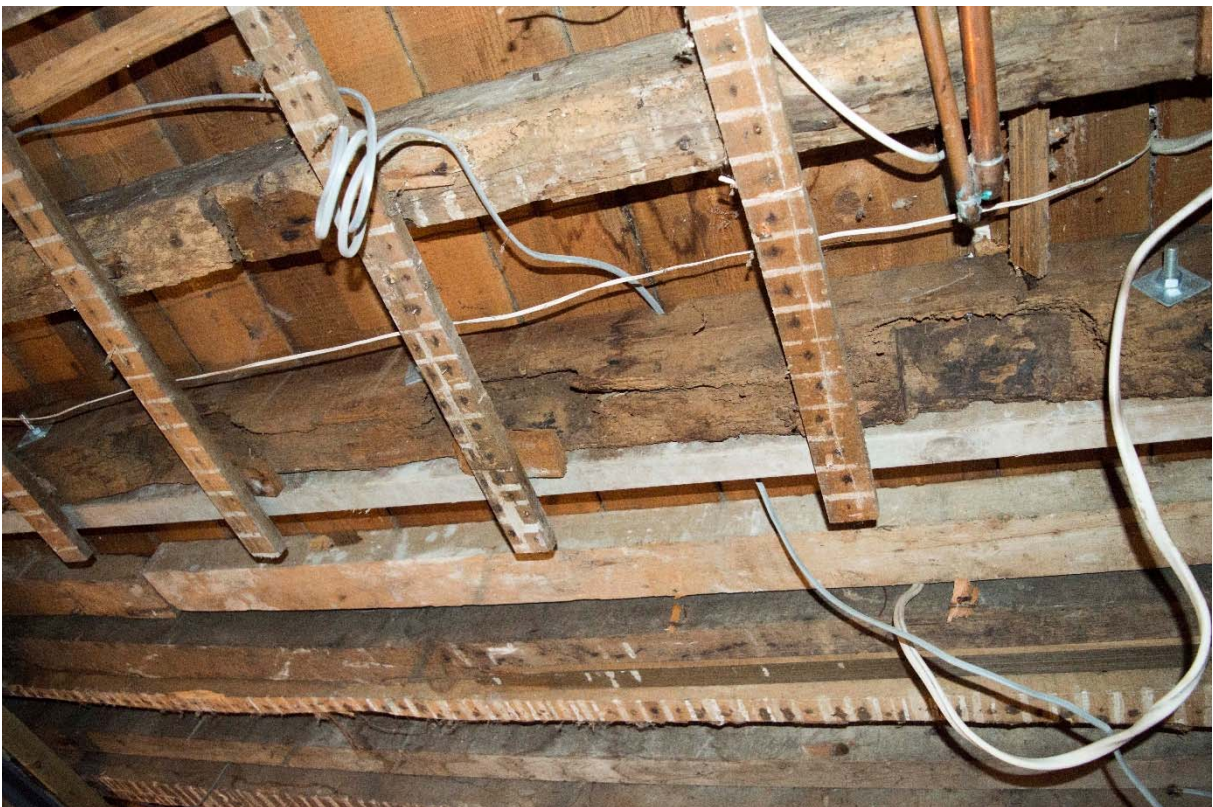
Plate A3.4: Joist formed by reused section of wallplate (RLB-0099)

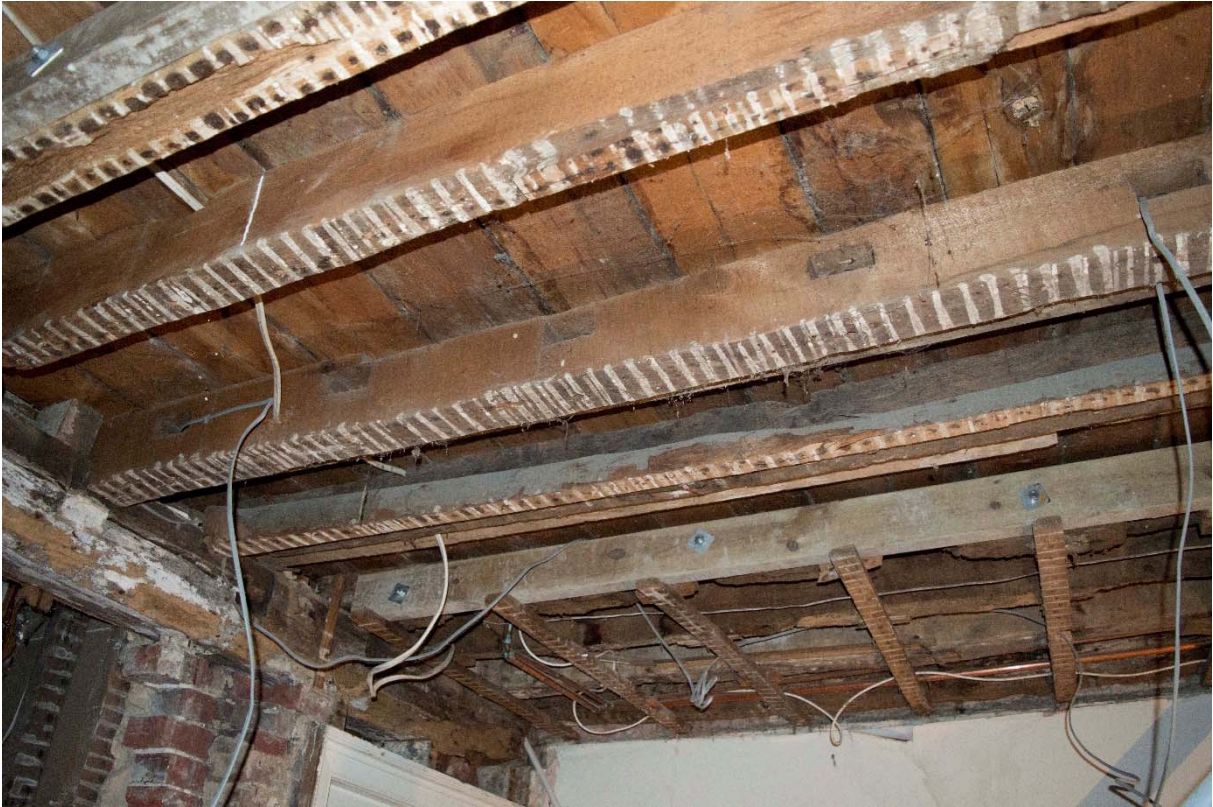
Plate A3.5: Joist with redundant stud mortices, turned through ninety degrees (RLB-0098)

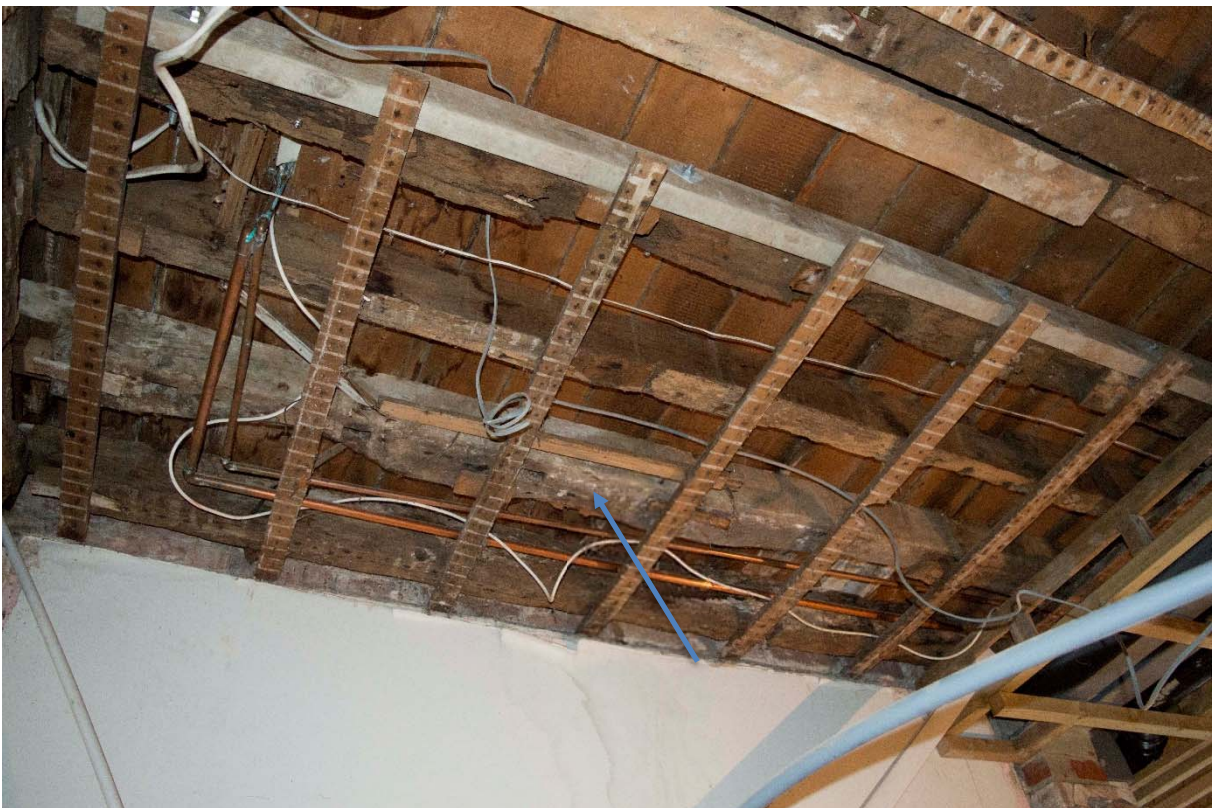
Plate A3.6: Joist with redundant stud mortices (RLB-0097)

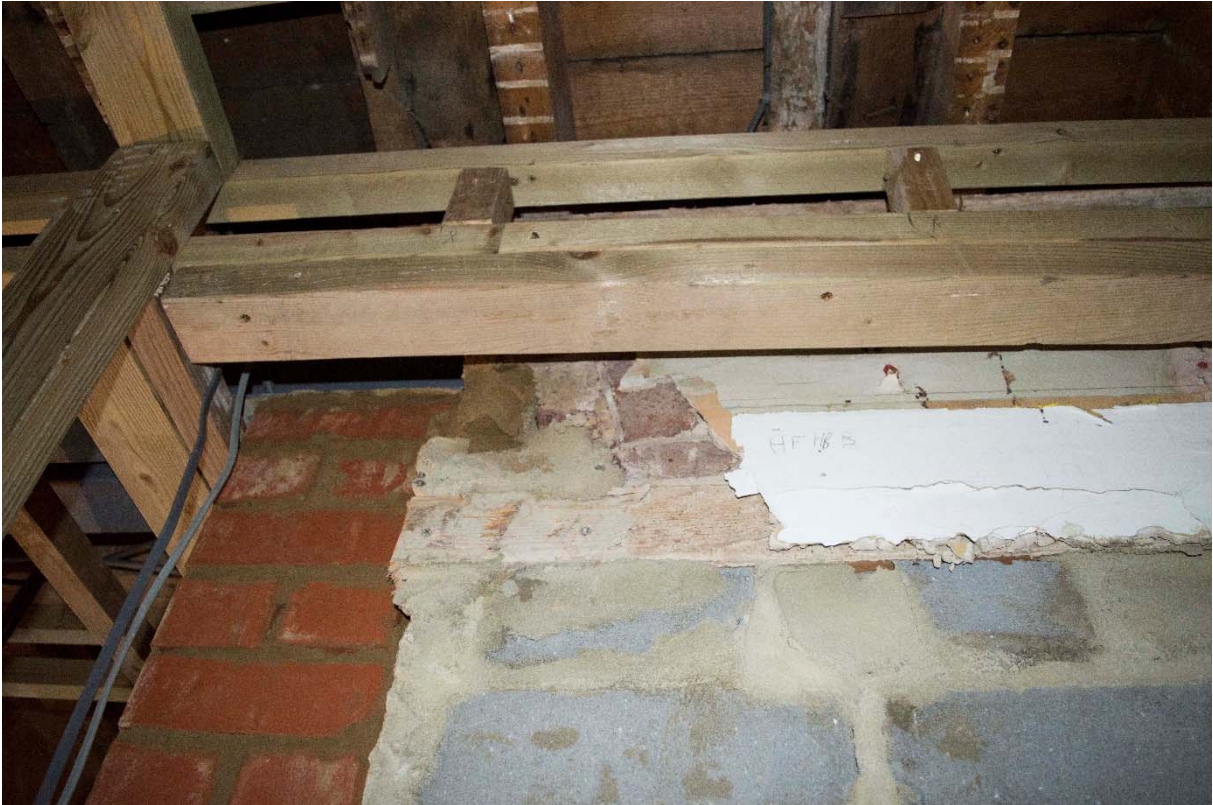
Plate A3.7: Partially visible brick arched head to former pantry doorway on western side of kitchen (RLB-0094)

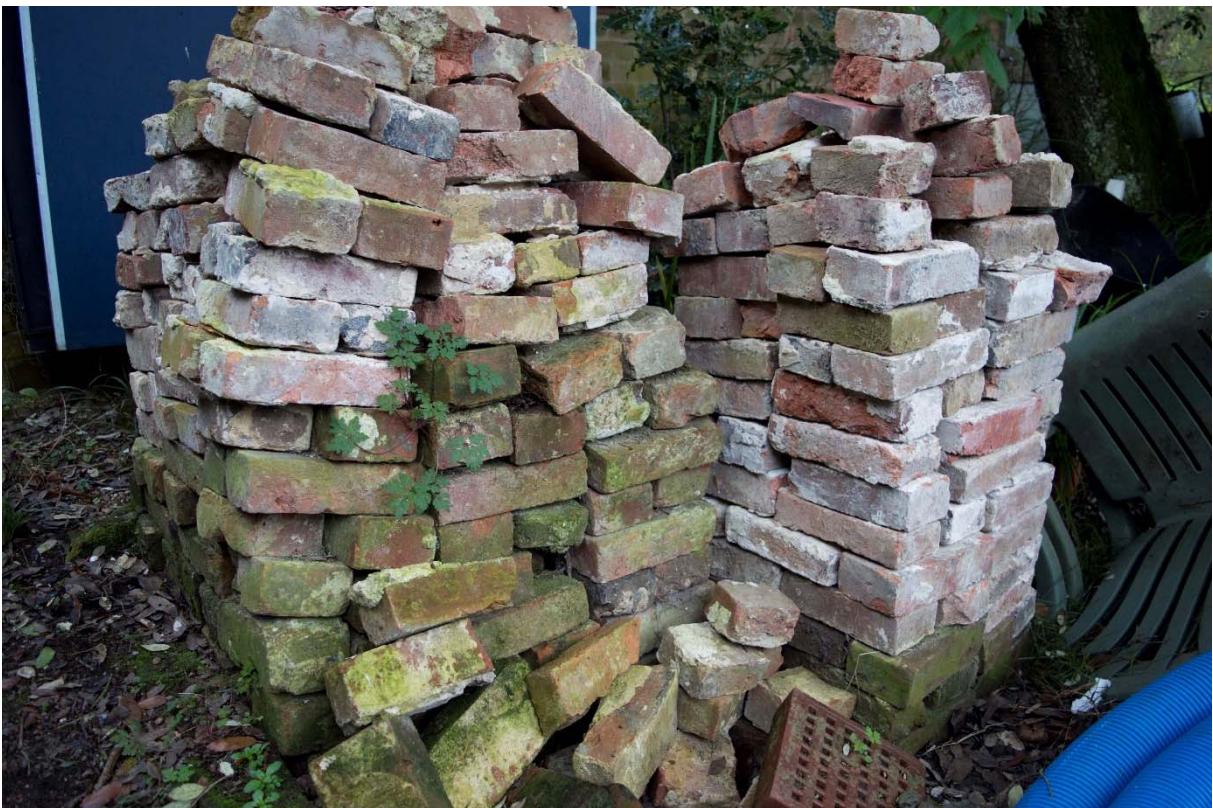
Plate A3.8: Bricks which formed the western wall (RLB-0102)
