**23 BELL STREET,
SAWBRIDGEWORTH, HERTFORDSHIRE**

HISTORIC BUILDING WATCHING BRIEF

ASE Project No: 170005

ASE Report No: 2017107

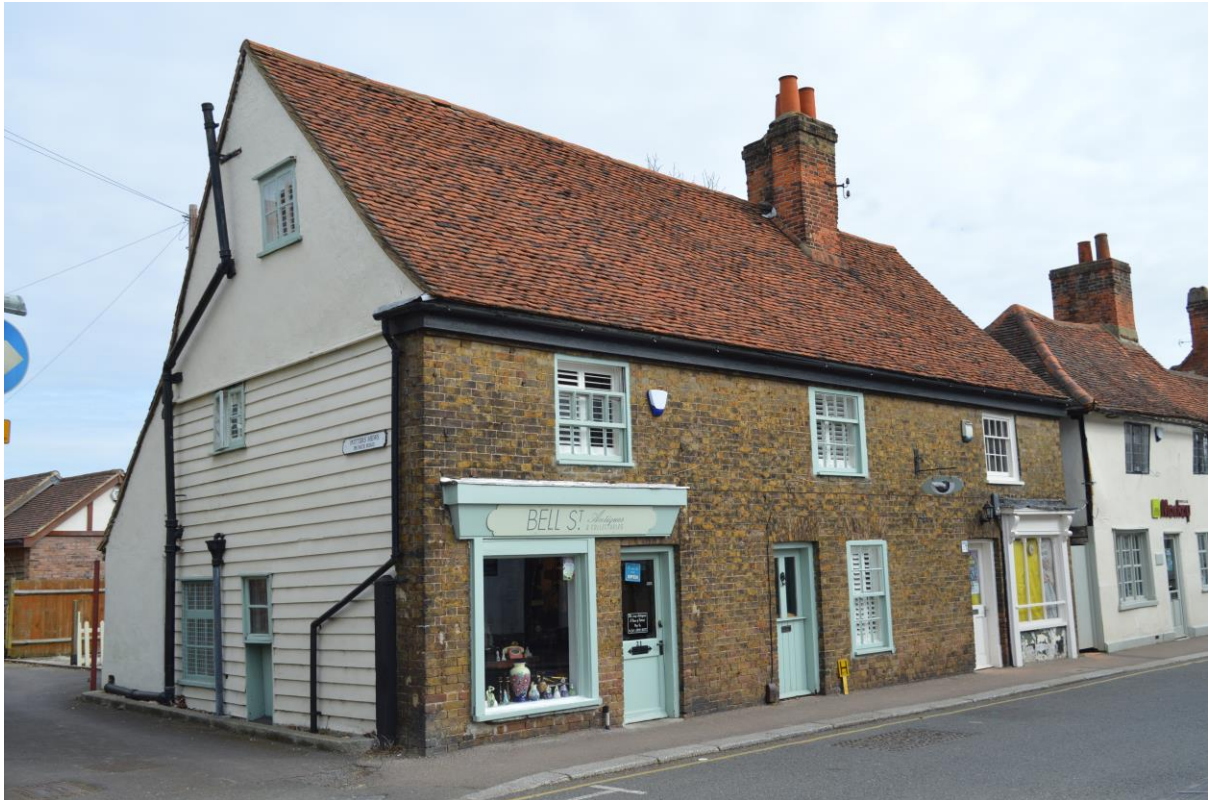
- 6.1 Together, Nos. 21 (west) and 23 (east) form a roughly L shaped plan, comprising a two storey main range running parallel to the street, with a two storey perpendicular rear wing at the east end of the building and smaller lean-to additions to the west. The building has a gabled roof clad with plain tiles and is faced with brick and weatherboarding (Plate 1).

Plate 1: South and west elevations (BES17-0055)

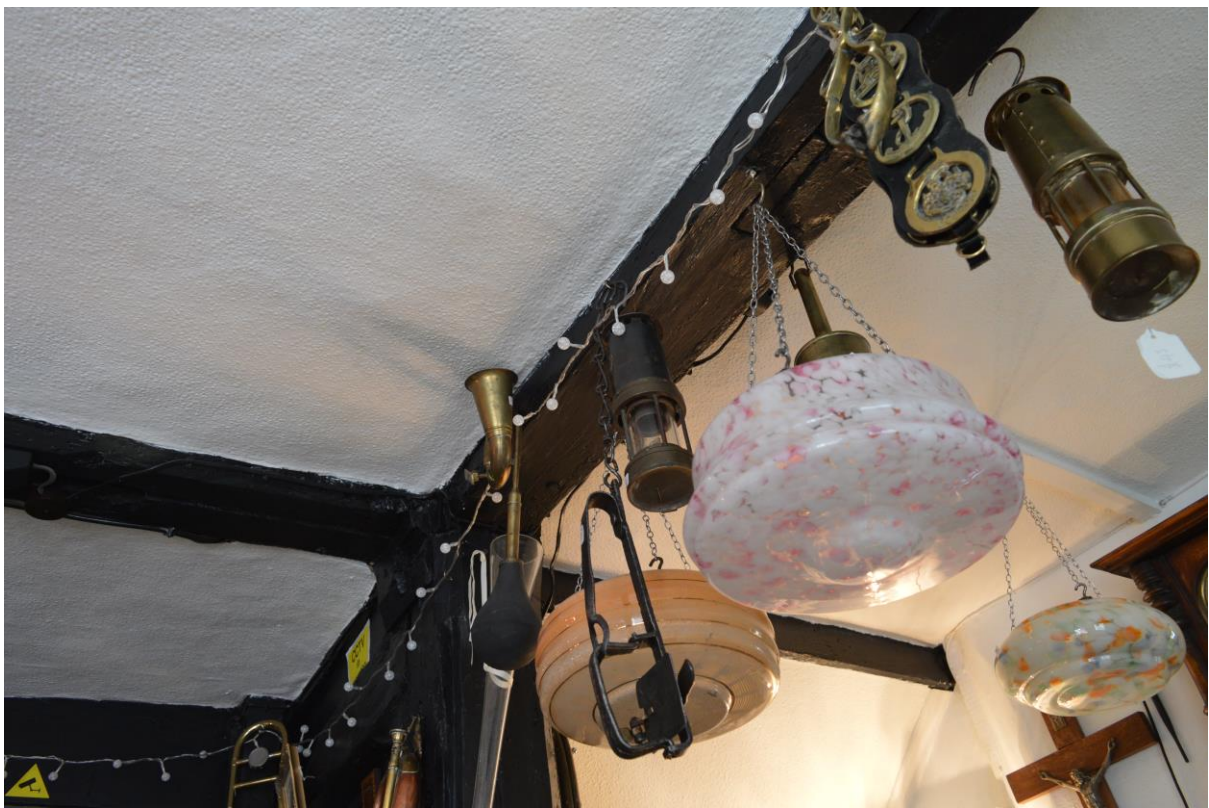
Plate 2: Redundant mortice and former doorway on low end cross beam, facing north-east (BES17-0014)

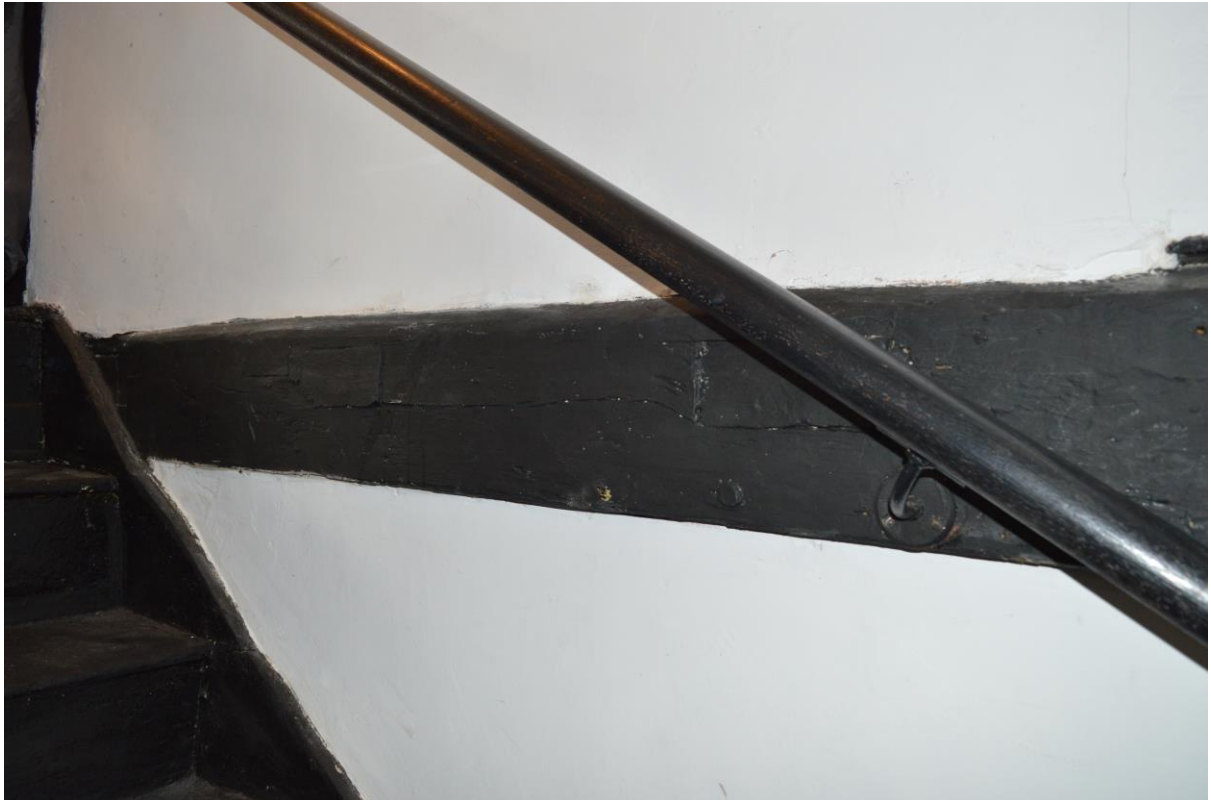
- 6.12 Much of the flooring of the Phase 1 building appears to have been replaced during later phases, however the bridging girders survive in the east and west bays and the extent to which any early joisting may survive at first floor level is unconfirmed. The majority of the hall floor structure is concealed by a later plaster finish, although within the present stair well, the low-end cross-beam exhibits redundant mortices for large flat floor joists typical of the medieval period (Plate 3).

Plate 3: Redundant mortices on hall side of low end cross-beam, facing west (BES-0008)

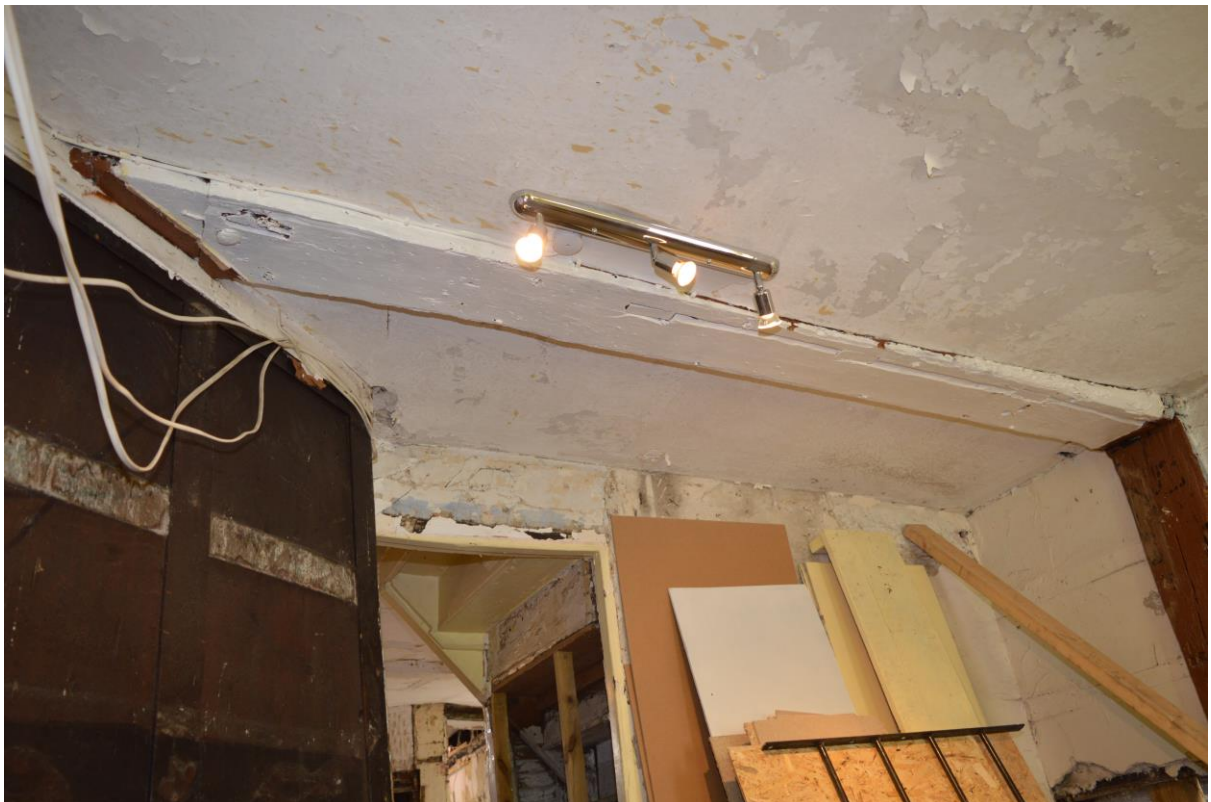
Plate 4: Bridging joist in high end bay with evidence of partition and doorway, facing north (BES-0050)

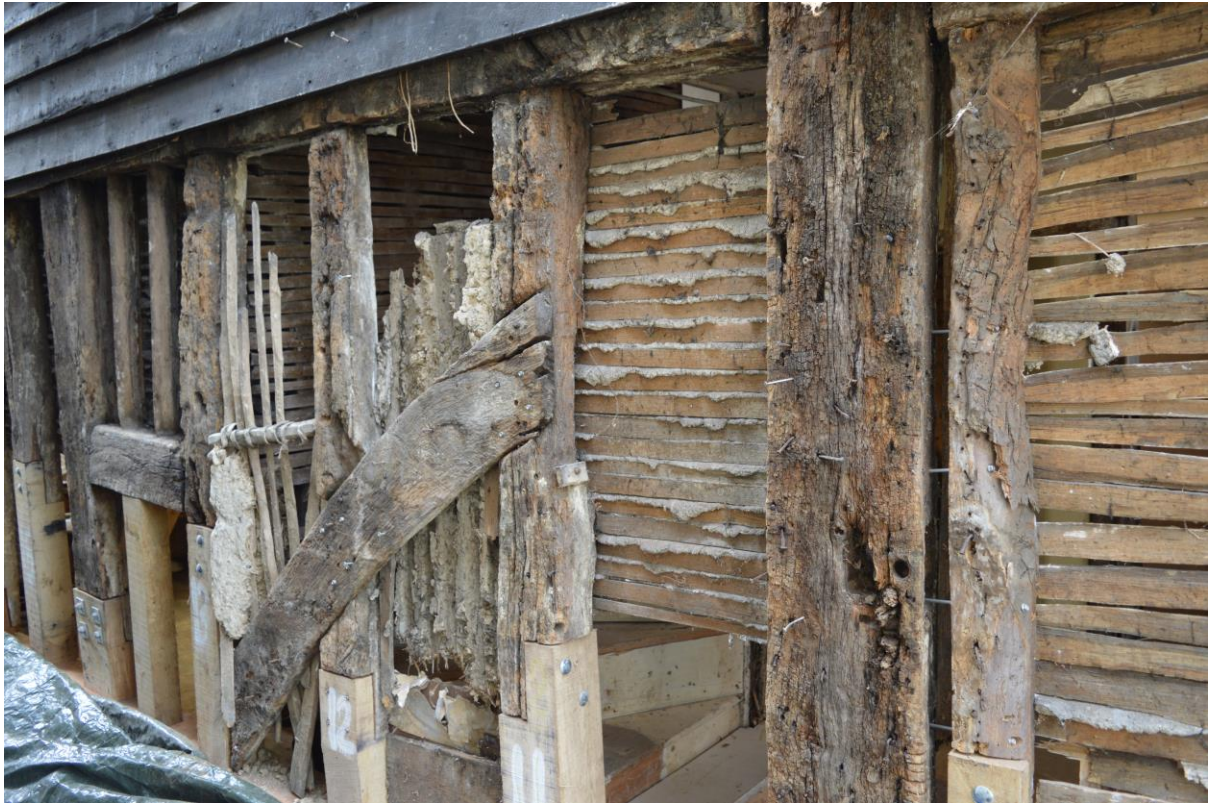
- 6.8 Externally, not much original fabric survives or is visible from the Phase 1 building, however the east wall has survived mostly intact under later weatherboarding (Plate 5). The east wall is framed traditionally with a side girt morticed and tenoned into the posts. The wall is infilled with relatively closely-spaced stout studs and braced with curved down-braces from the posts to the sole plate. The studs have been trenched to accommodate the braces, which would have remained visible externally. The panels are filled with daub on vertical staves which have been tied to horizontal bars.

Plate 5: Phase 1 wall framing and remnants of stave and daub panels on east wall (BES-0040)

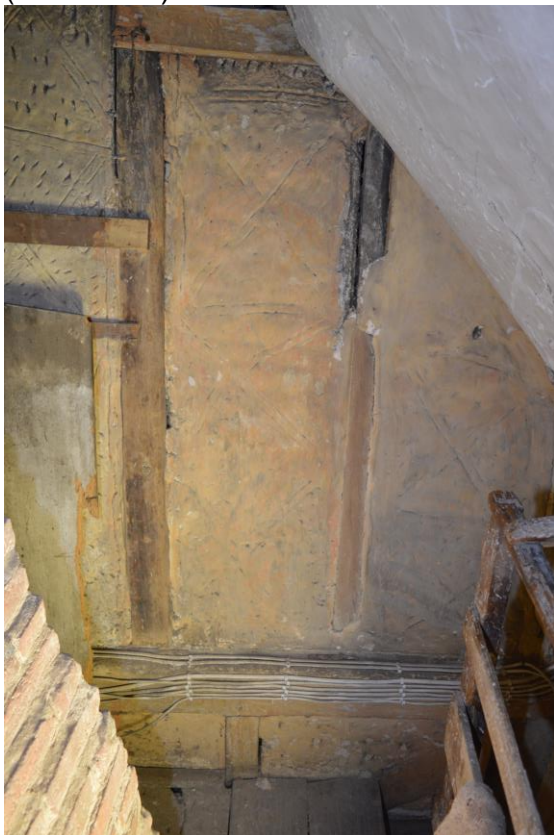
- 6.9 Internally the building has been rearranged since the original phase of construction. The original partitions would have been constructed in a similar manner to the external walls, comprising studwork infilled with staves and daub. Evidence for this can be seen in the former partitions mentioned above as well as in the partition between the eastern bay and the hall. At attic level the original partition remains visible, comprising studs infilled with daub panels. The panels are decorated with saltire patterns which would have been scratched into the daub while it was still wet (Plate 6).

Plate 6: Daub panel with saltire patterns in high end partition, facing west (BES-0101)

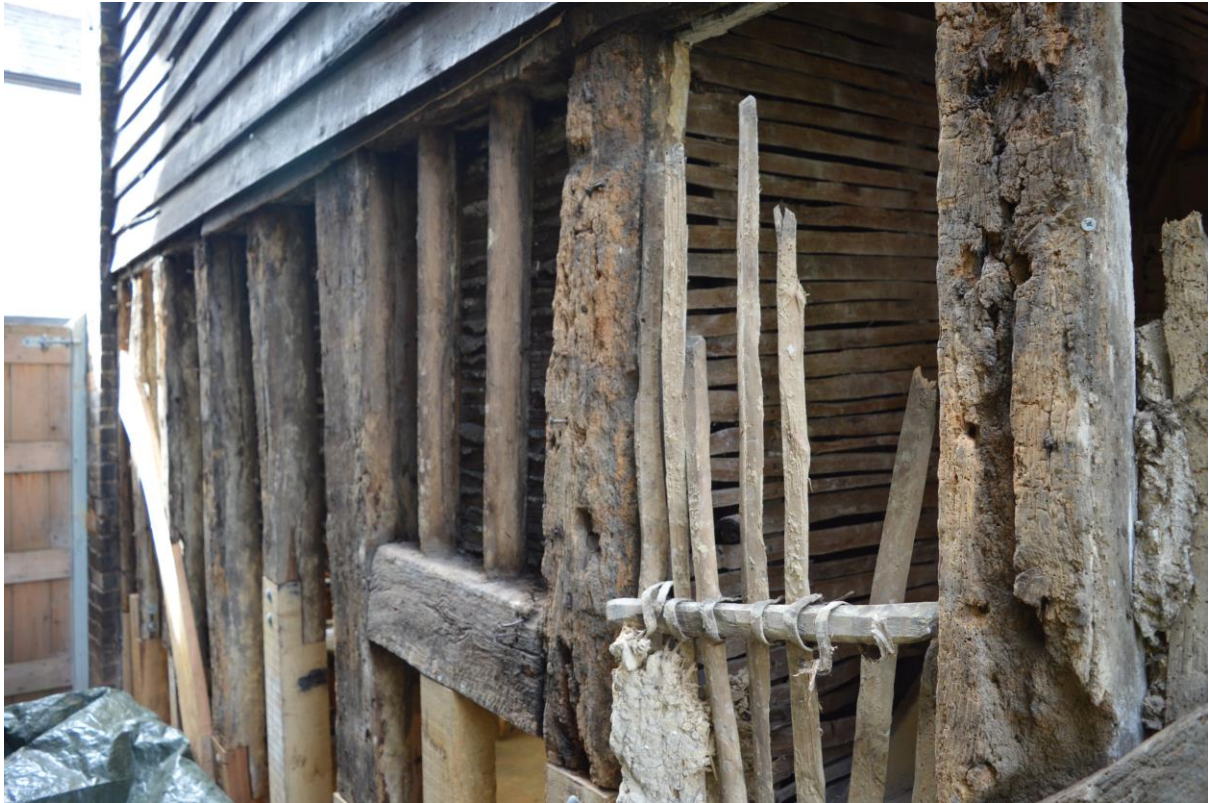
- 6.10 During the recent renovation works, an intact diamond mullion window was found within the east wall of the building, lighting the ground floor rear room (Plate 7; Figure 4). A shutter rebate can also be seen on what is left of the wall plate above it, indicating that there was also a window lighting the first floor in a similar position (Plate 8). Diamond shaped mortices were also

Plate 7: Three-light diamond mullion window on east wall (BES-0043)

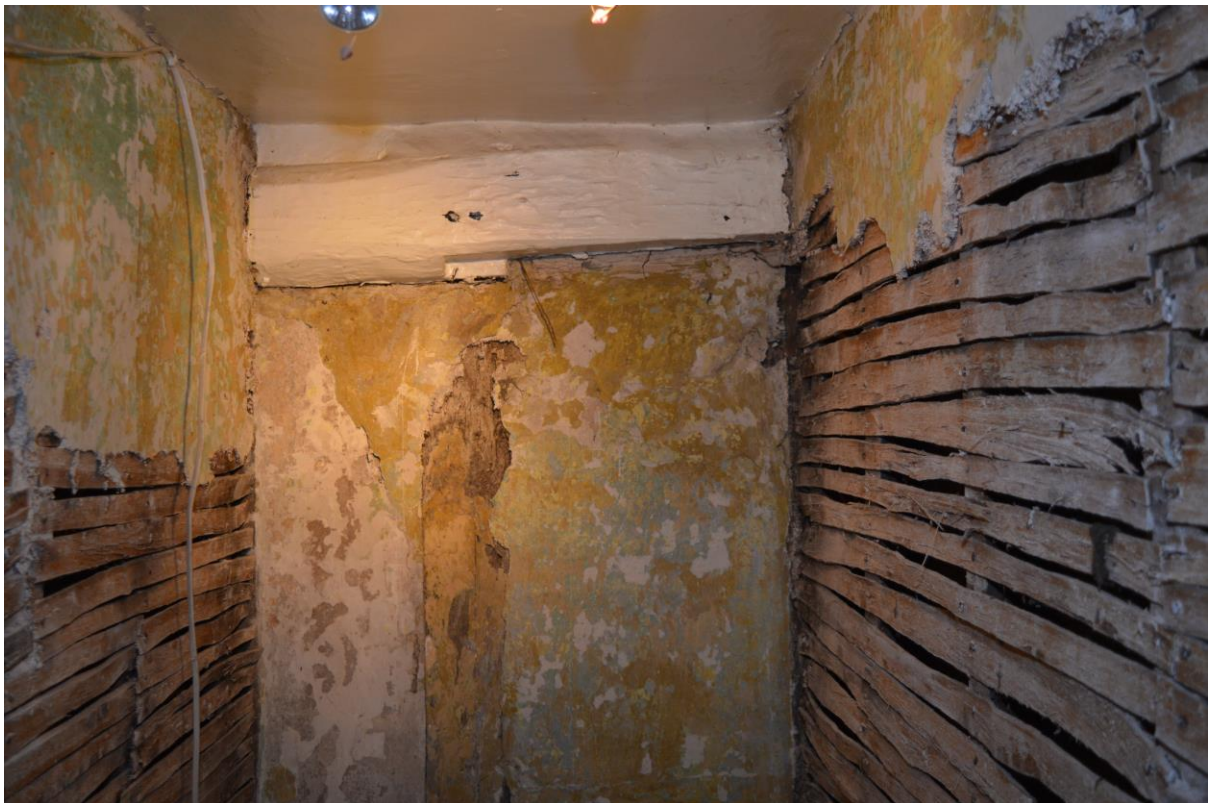
Plate 8: Shutter groove on wall plate of east wall, facing east (BES-0077)

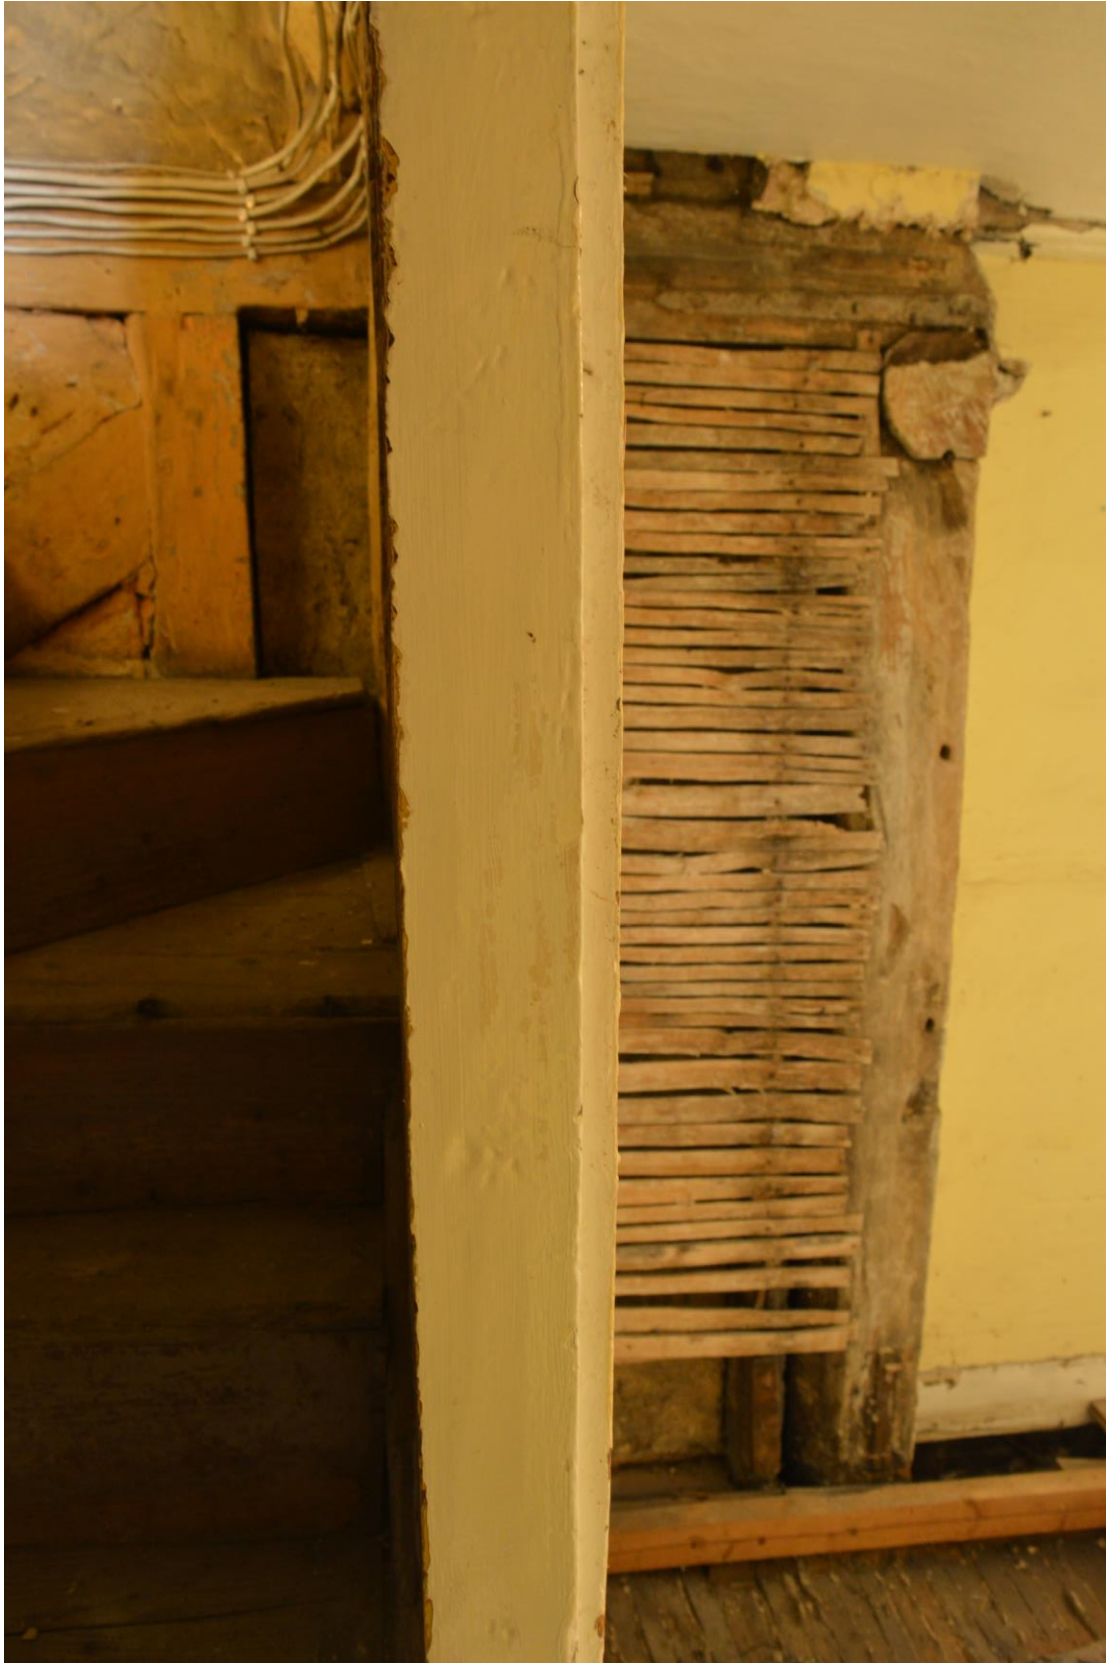
- 6.11 There are no original doors in the building and no original doorways still in use. Evidence for doorways in the high and low end partitions has already been discussed. A blocked doorway leading from the first floor of the east bay to the hall chamber has also been mentioned. The latter is evidenced by a curved brace terminating at a stud, rather than a post, as well as the lack of a stave groove on the soffit of the tie beam, indicating that the panel was originally open (Plate 9).

Plate 9: Blocked doorway between high end chamber and hall chamber, partially obscured by later partition, facing west (BES-0117)

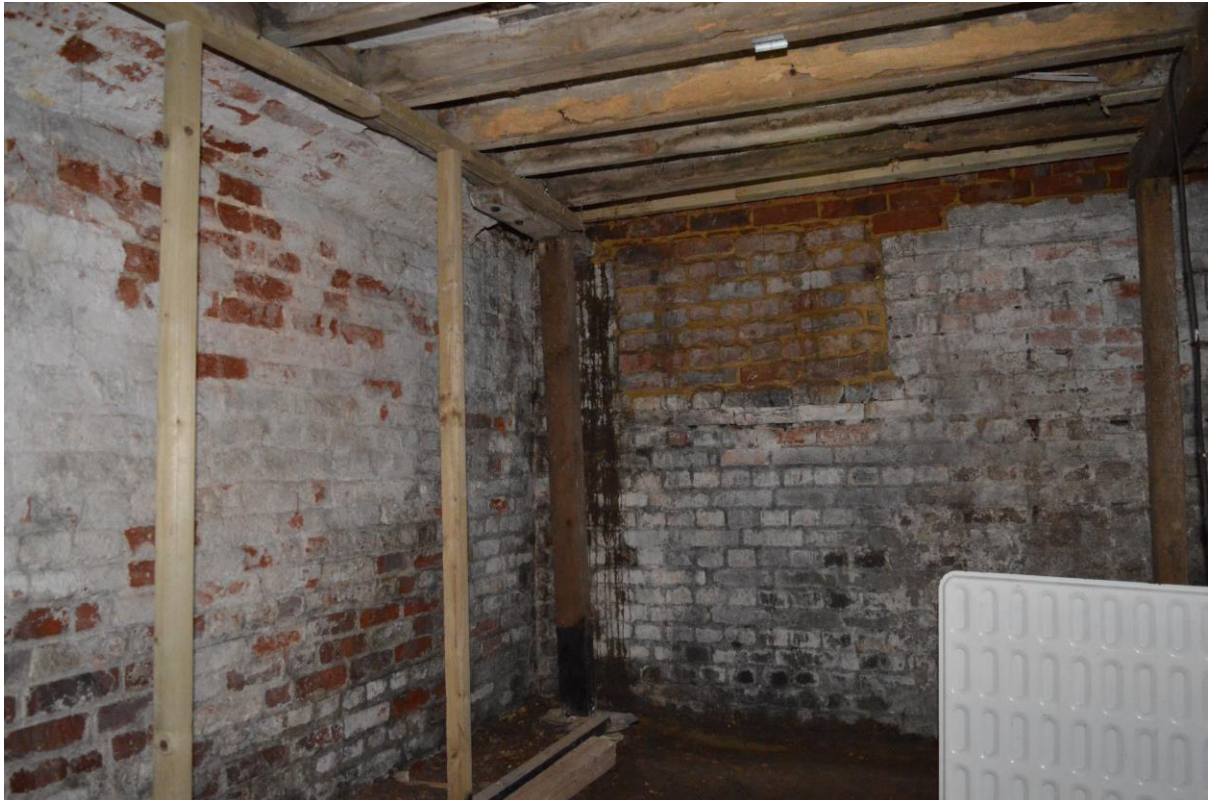
Plate 10: Basement, facing east (BES-0074)

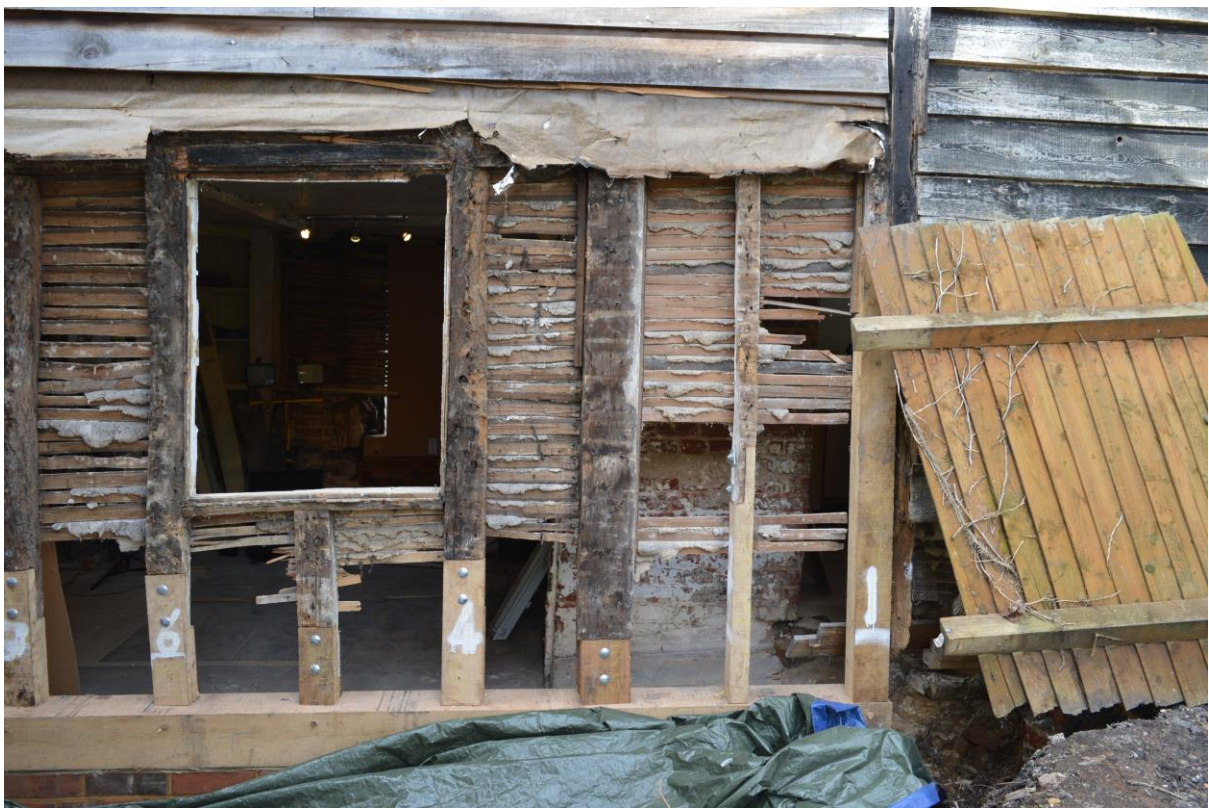
Plate 11: Phase 2 wall framing on east wall and inserted window, facing west (BES-0036)

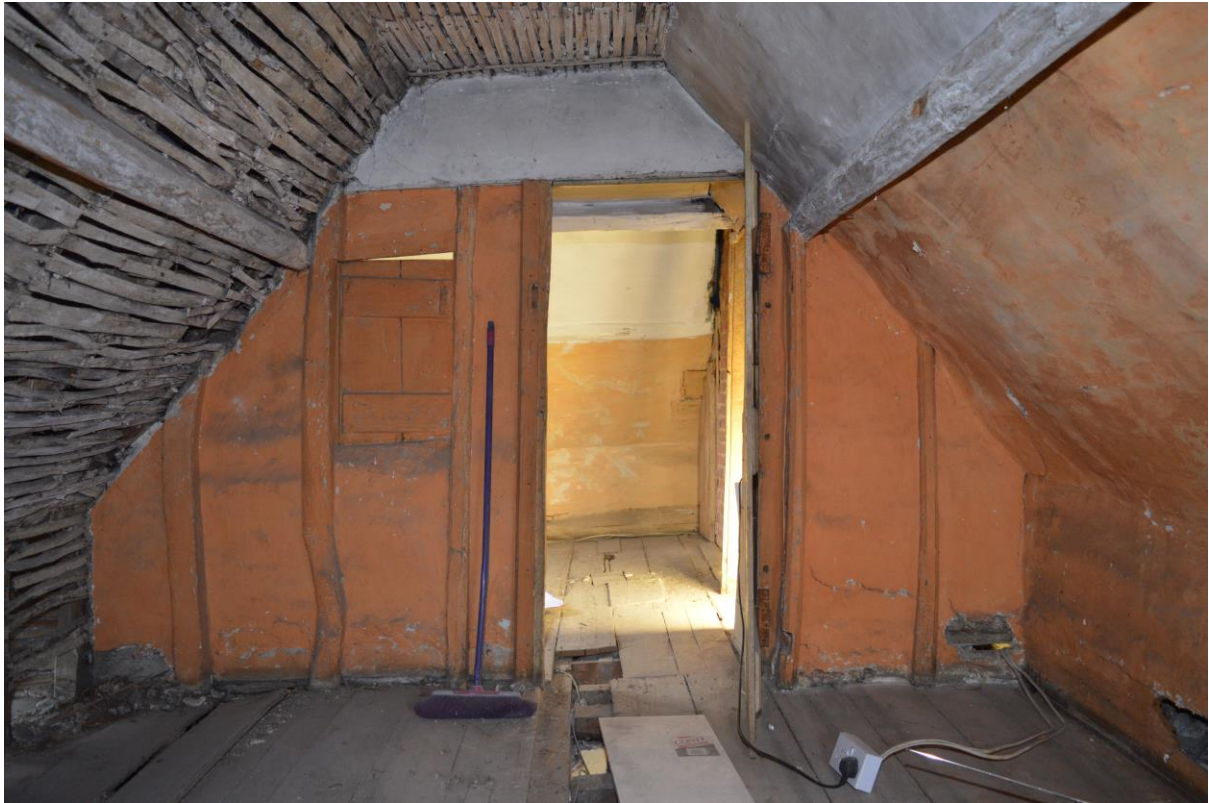
- 6.15 The new extension is constructed in a similar style to the original building but with notable differences. The basement is built from red brick, laid in English bond while the walls of the building above ground are timber framed in a traditional manner but using studs of smaller scantling and poorer quality than the earlier building (Plates 10 & 11). Two interior partitions survive from this phase of construction, including in the attic and a partition dividing the basement stairs from the ground floor. These partitions are formed of pole studs covered on one side with laths and daub (Plate 12).

Plate 12: Lath and daub partition in attic, facing south (BES-0113)

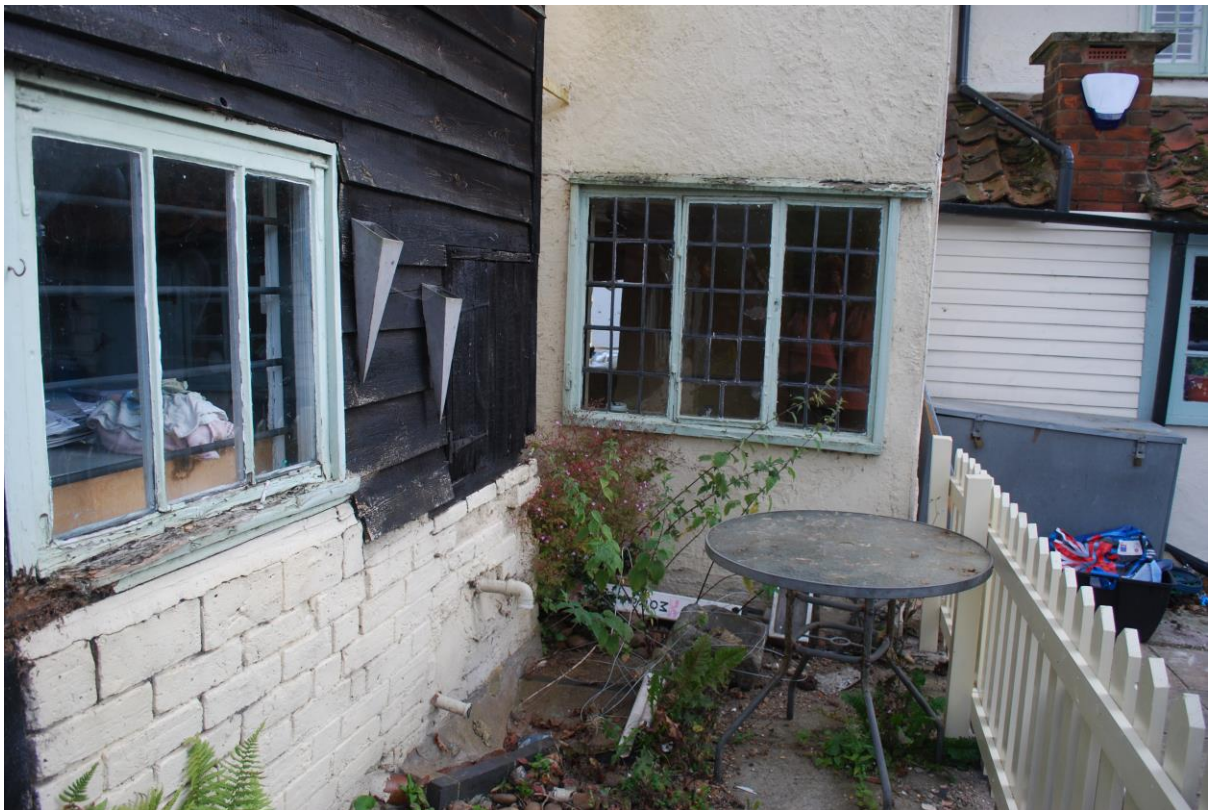
Plate 13: Three-light mullion window in north wall of rear wing, facing south (BES-120)

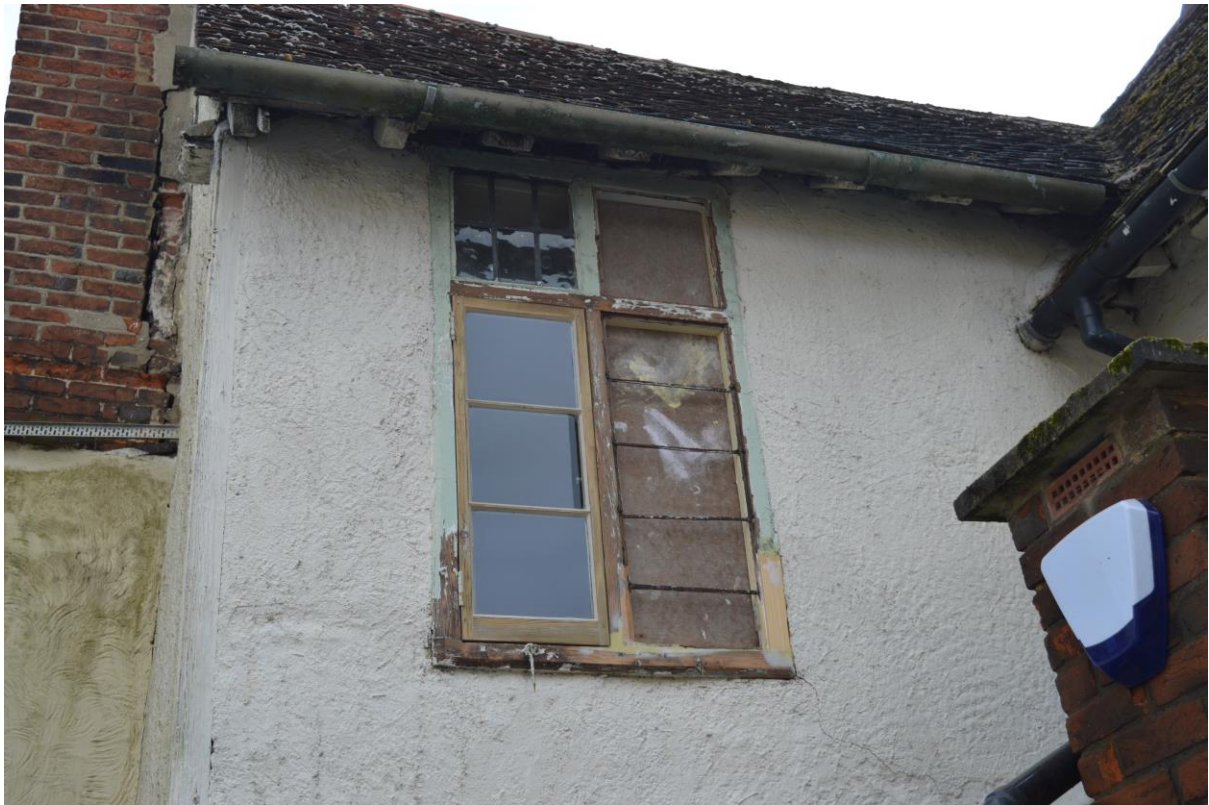
Plate 14: Cross type window on west wall of rear wing, facing east (BES-0027)

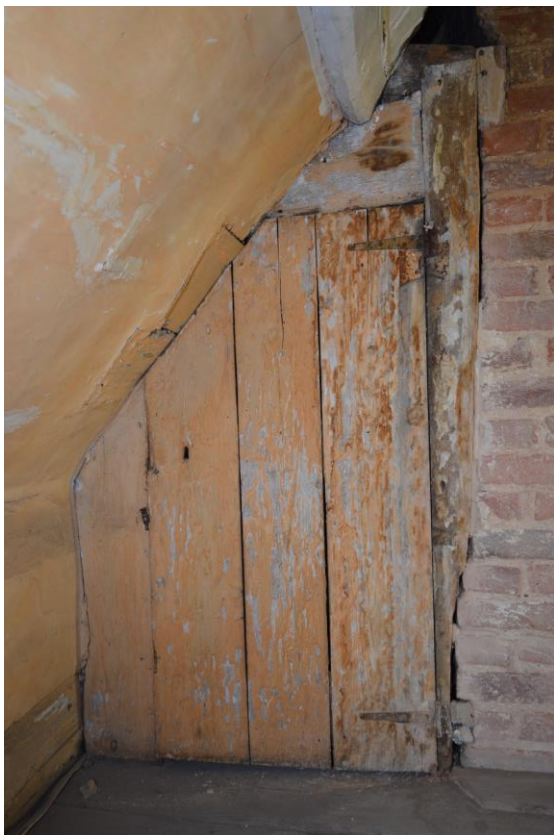
Plate 15: Plank and batten door in attic room, facing west (BES-0105)

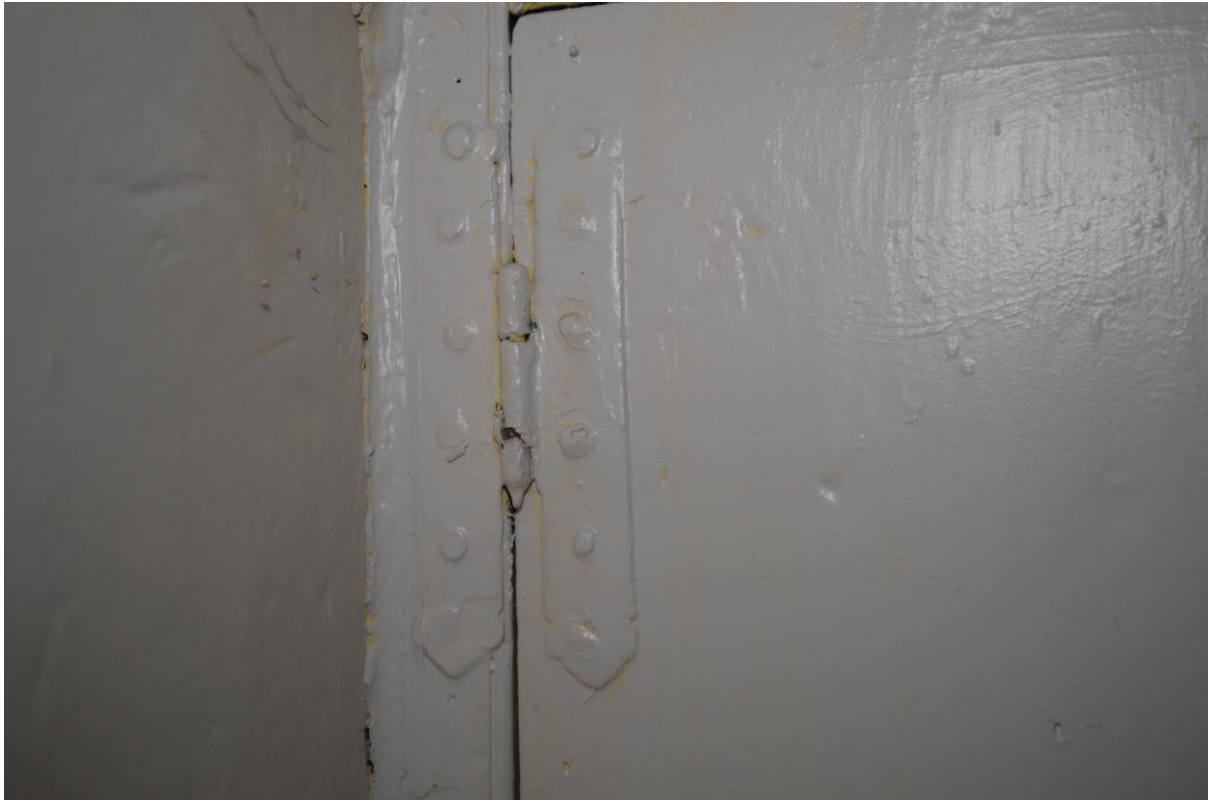
- 6.17 Few Phase 2 doors survive and there are none left in the main circulation spaces. However, a plank and batten cupboard door, which retains a butterfly hinge, survives to the south of the chimney stack at attic level (Plate 15). The attic also contains a small hatch in the attic partition with a plank door and butterfly hinges. The first floor south room also has a cupboard to the south of the chimney stack with a Phase 2 plank and batten door with H-hinges (Plate 16).

Plate 16: H-hinge on plank and batten door in first floor room, facing west (BES-0082)

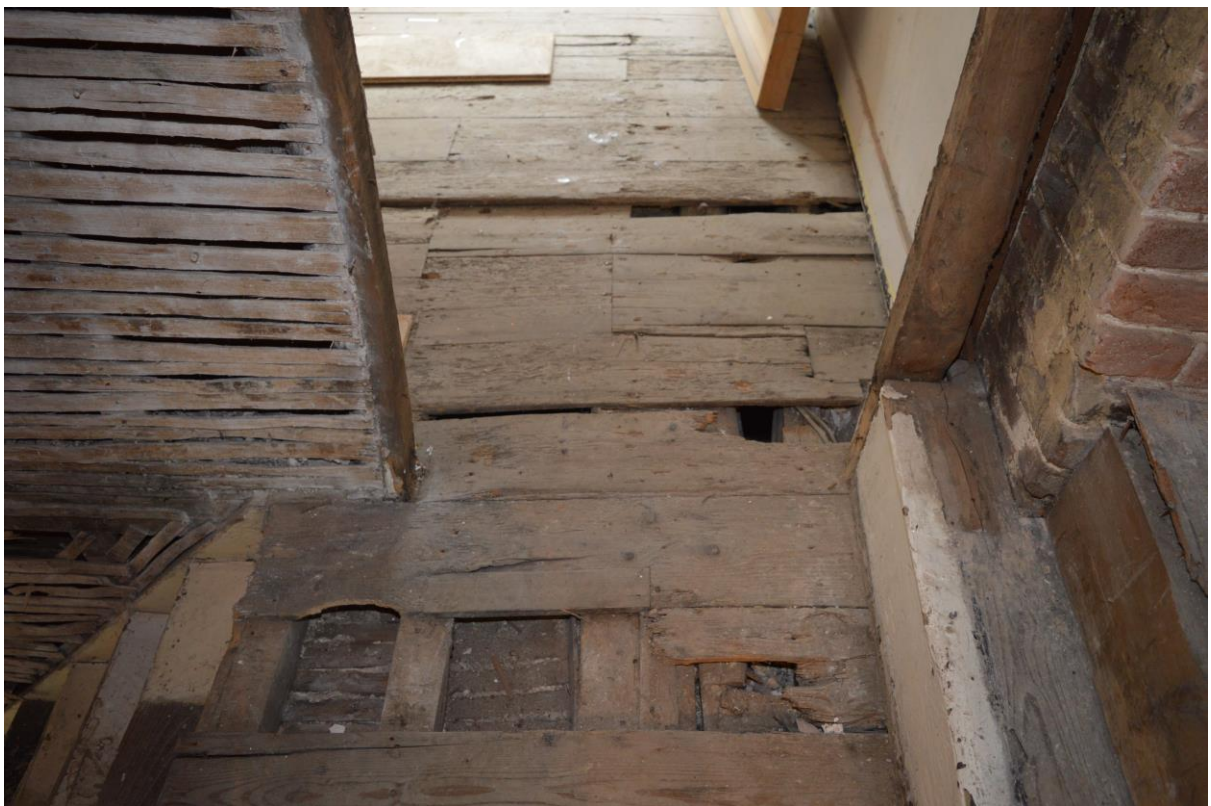
Plate 17: First floor joists and boards, facing south (BES-0086)

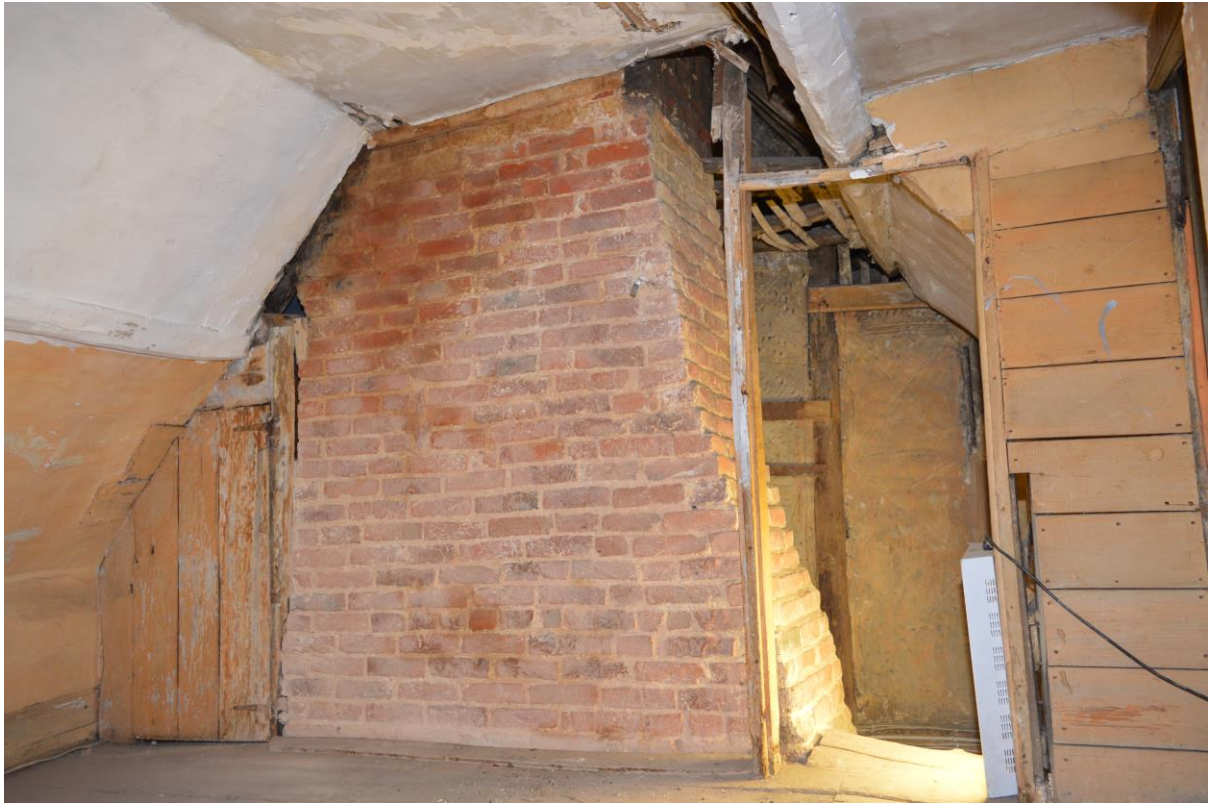
Plate 18: South chimneystack, facing west (BES-0107)

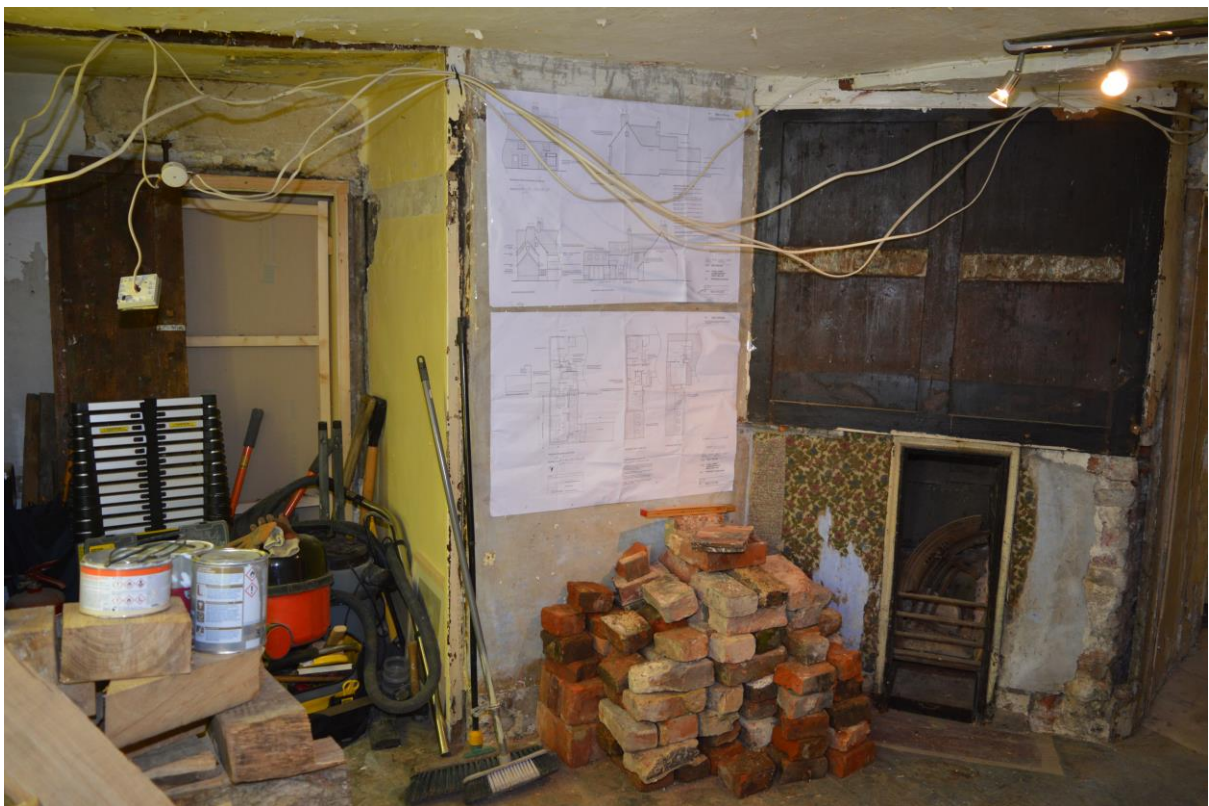
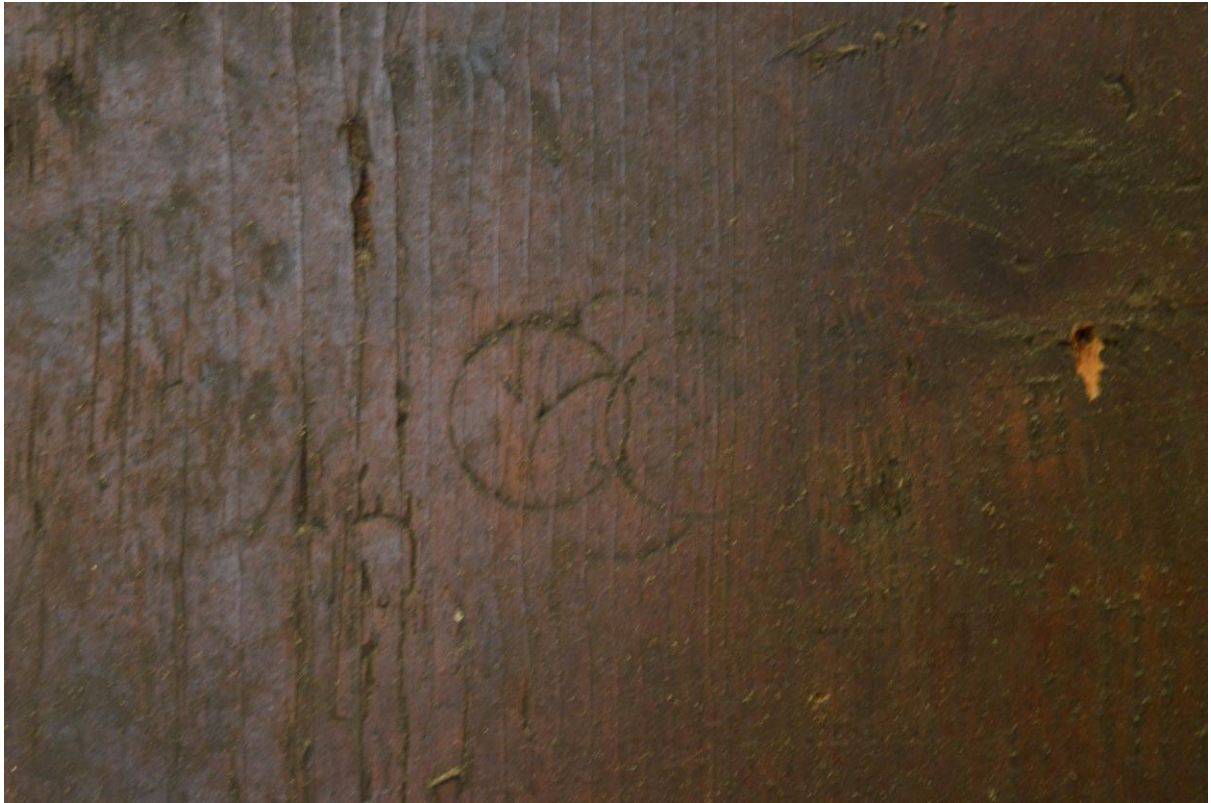
- 6.20 Little remains of the Phase 2 decorative scheme, however above the ground floor fireplace the overmantel has plain panelling and features compass circles lightly scratched into the woodwork, possibly as an apotropaic mark (Plates 19 & 20).

Plate 19: Panelling above ground floor south fireplace, facing west (BES-0046)

Plate 20: Compass circles on fireplace panelling (BES-0118)

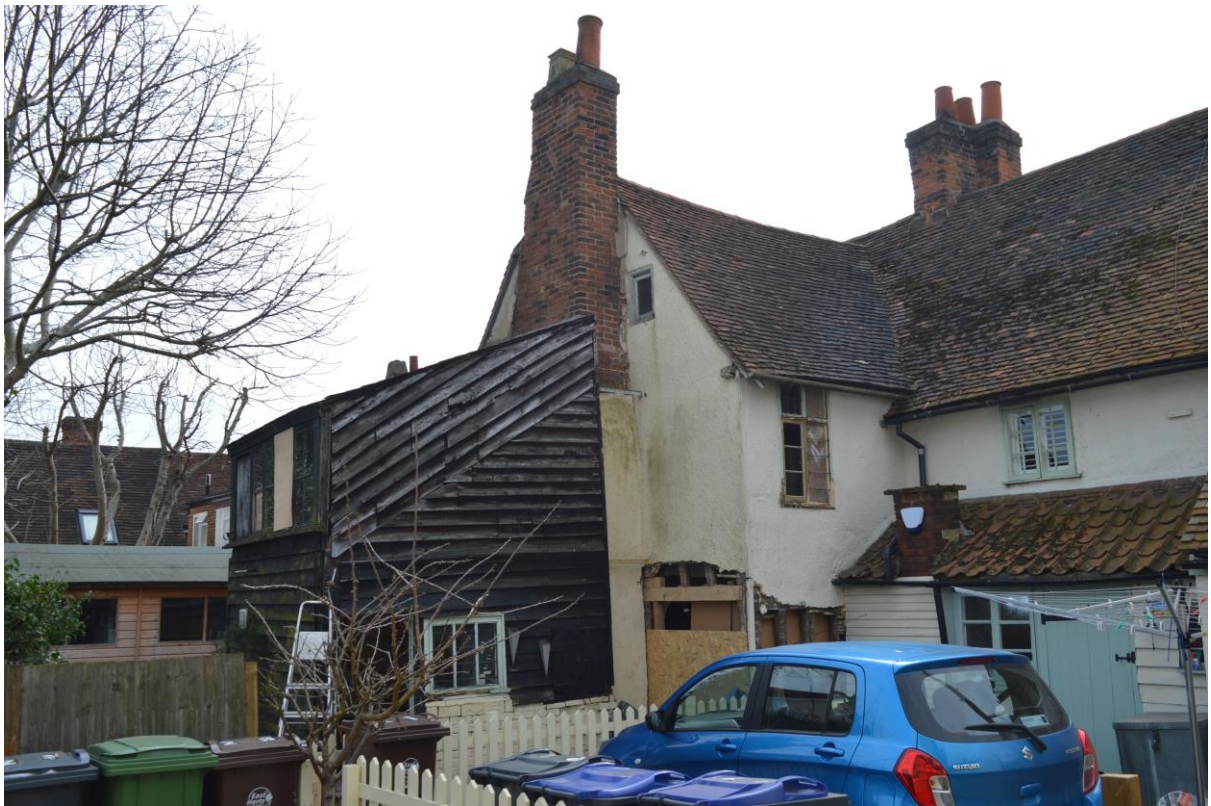
Plate 21: Phase 3 extension to the rear of the Phase 2 wing, facing south-east (BES-0025)

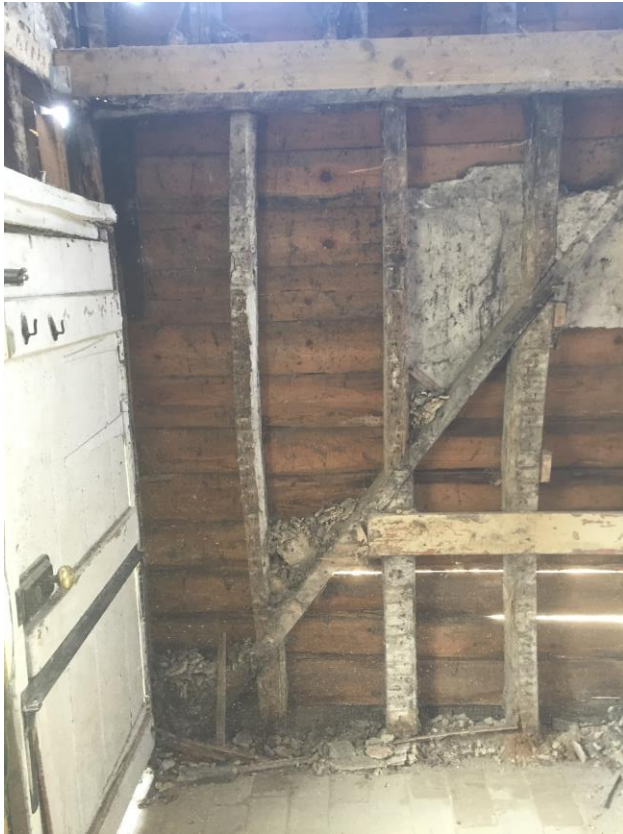
- 6.23 The extension has timber-framed walls on three sides and simply abuts the pre-existing Phase 2 building to the south (Plate 21). The lower part of the west wall is partially built from irregularly-bonded brick. Externally the walls are clad with weatherboarding, while internally the walls are clad with lath and plaster, with earlier plaster surviving in places between the studs. The walls are constructed with a lightweight timber-frame, with mostly rough cut reused timber studs and long slender braces running from the wall plates to the posts (Plate 22).

Plate 22: Wall framing of north wall of Phase 3 extension, facing north (BES-119)

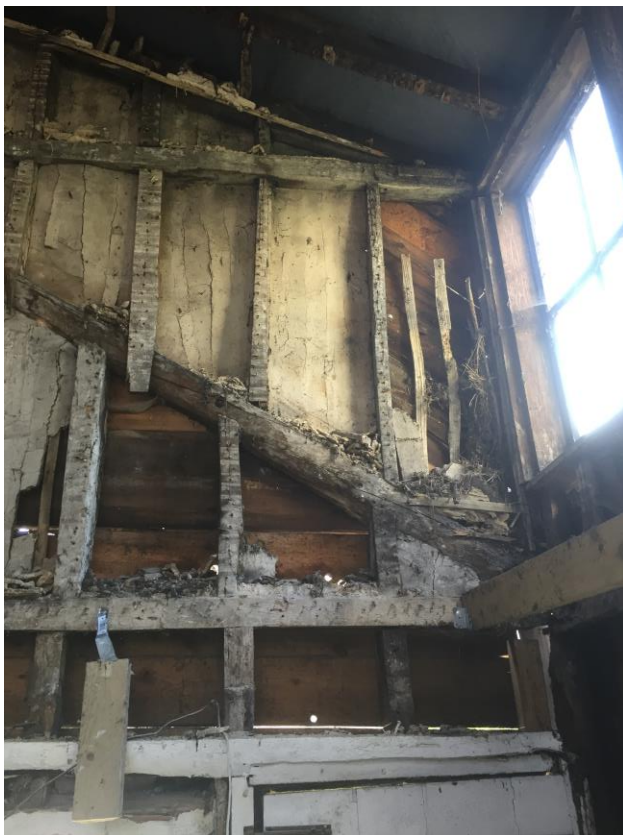
Plate 23: Phase 3 extension, original principal rafter preserved in heightened wall, facing west (BES-121)
