**23 BELL STREET,
SAWBRIDGEWORTH, HERTFORDSHIRE**

HISTORIC BUILDING WATCHING BRIEF

ASE Project No: 170005

ASE Report No: 2017107

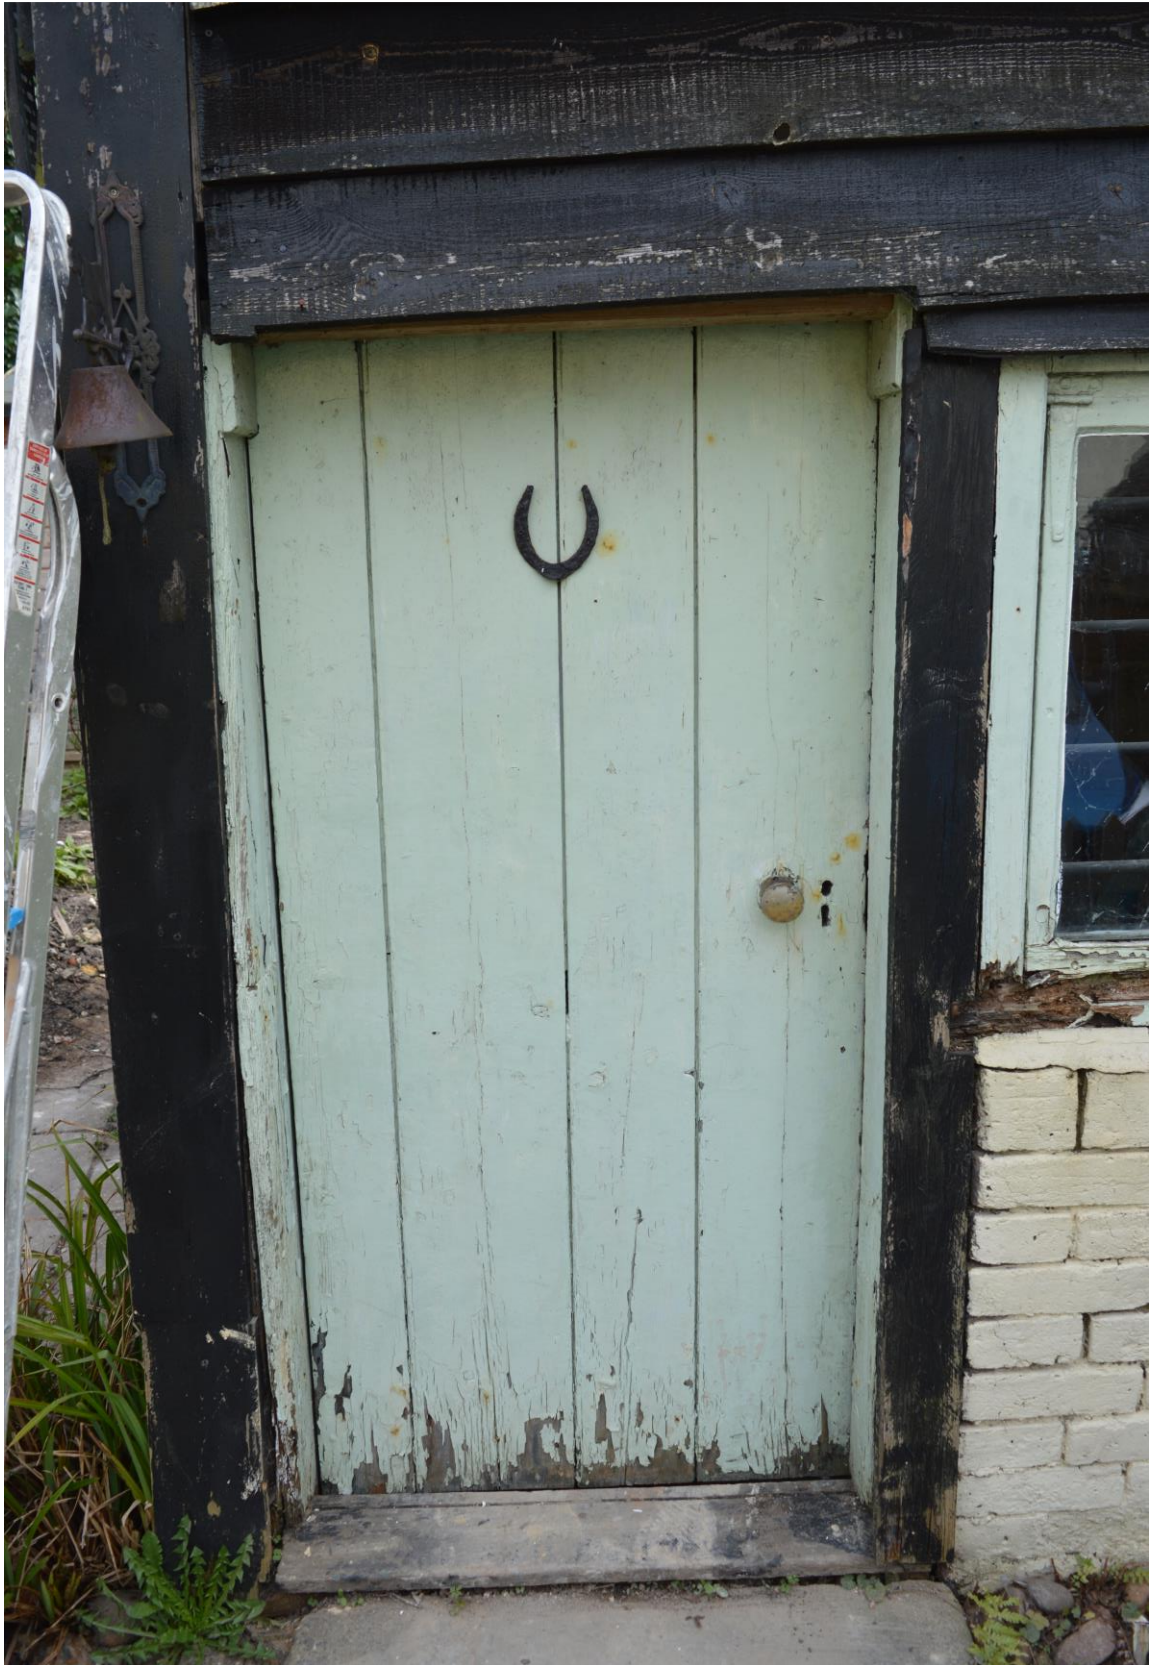
- 6.25 The extension is accessed from the main building from an opening to the east of the north chimney and also externally from a door in the west wall. The exterior doorway is probably original, as is the blank and batten door with strap hinges that it contains (Plate 24).

Plate 24: Plank and batten door leading to Phase 3 extension (BES-0029)

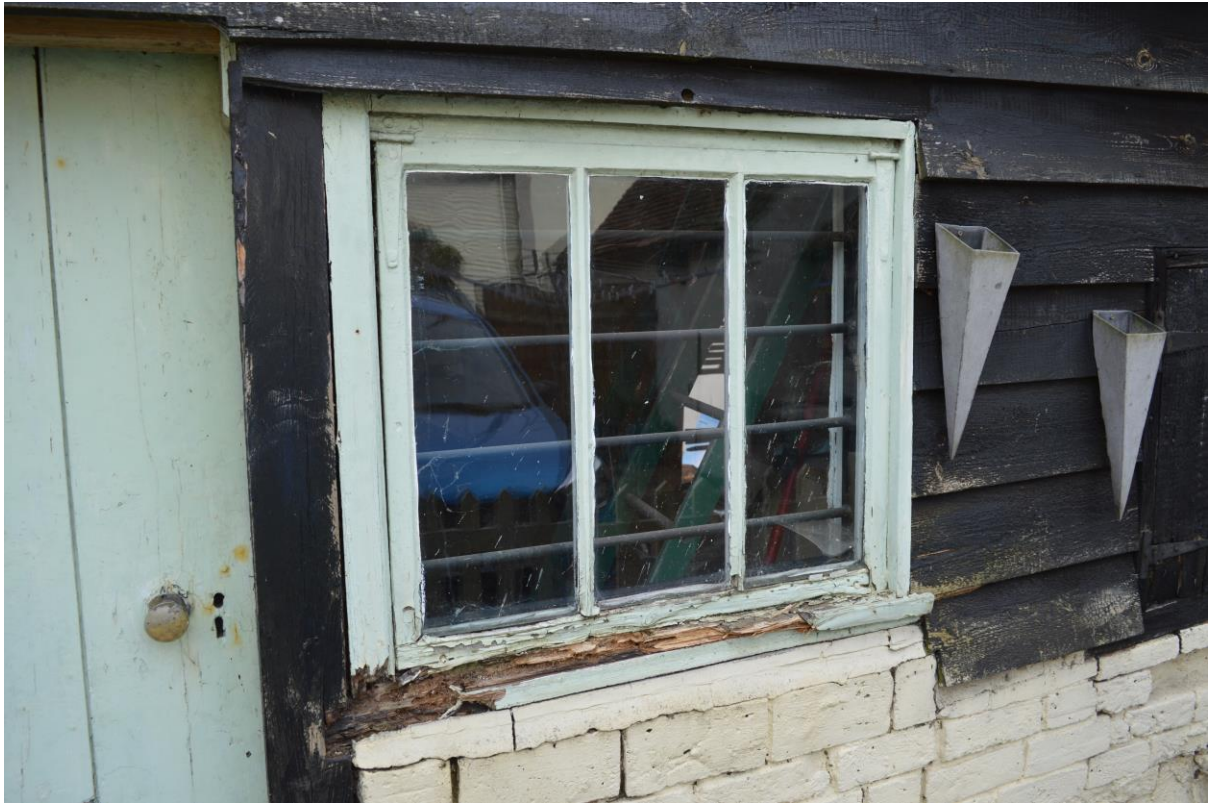
Plate 25: Casement window lighting Phase 3 extension (BES-0030)

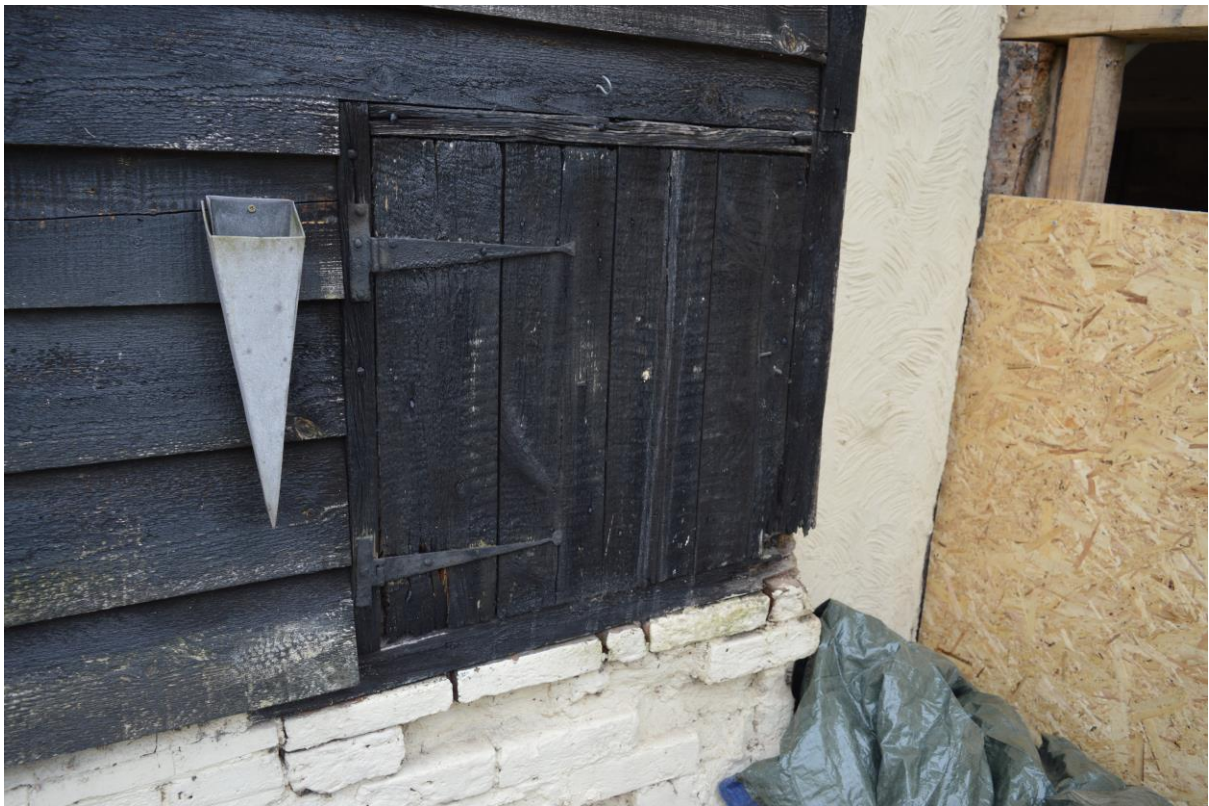
Plate 26: Plank and batten hatch in Phase 3 extension (BES-0031)

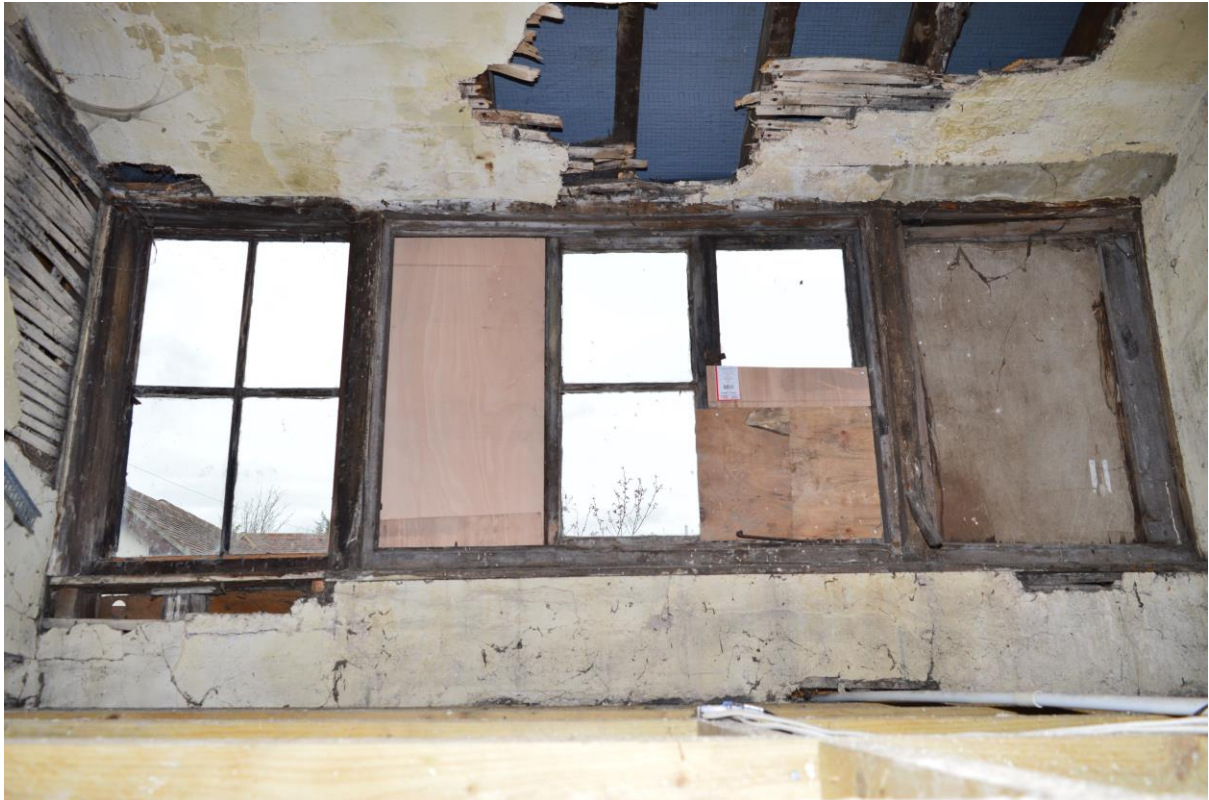
Plate 27: Clerestory windows in phase 3 extension (BES-0070)

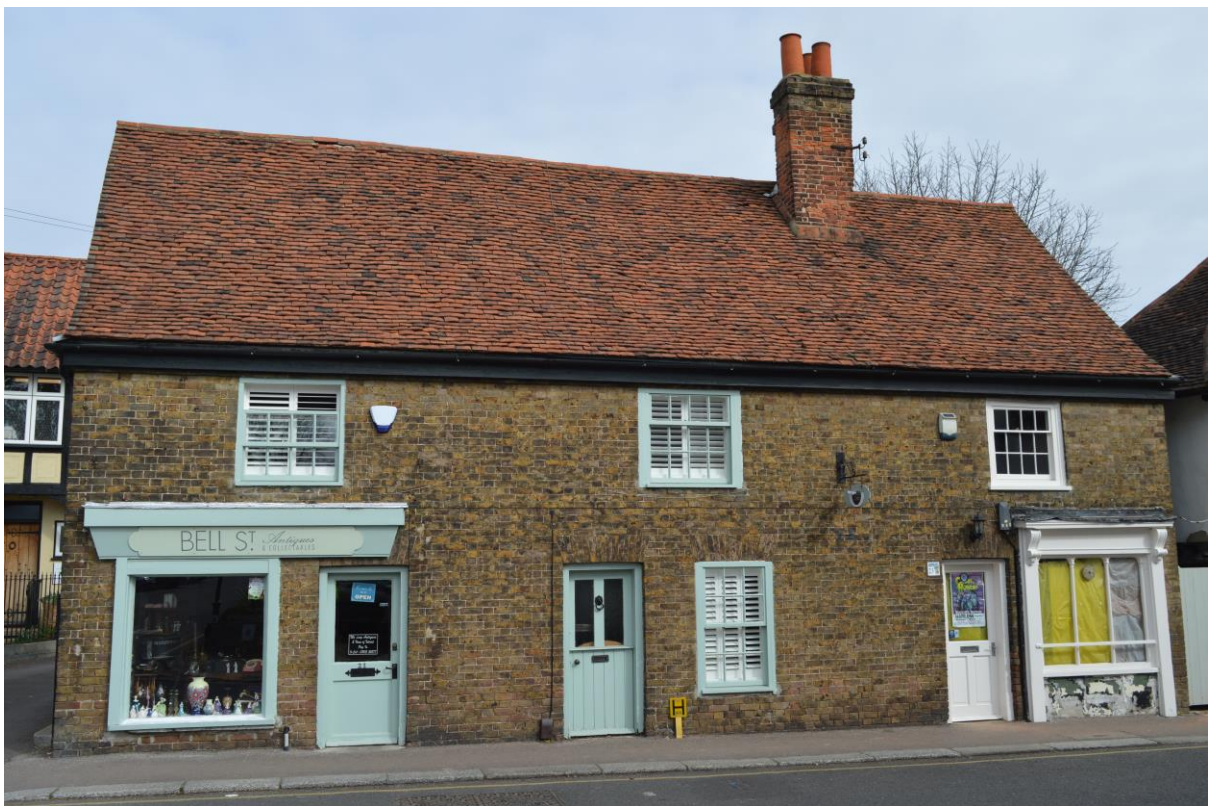
contemporary doorways, although seemingly without the original doors. Each one serves a separate division of the house (Plate 28).

Plate 28: Brick façade on street frontage, facing north (BES-0021)
