15-17 High Road, Ickenham, Hillingdon, London

Historic Building Record

**ASE Project No: 170719
Site Code: HRI17**

**ASE Report No: 2017434
OASIS id: archaeol6-298779**

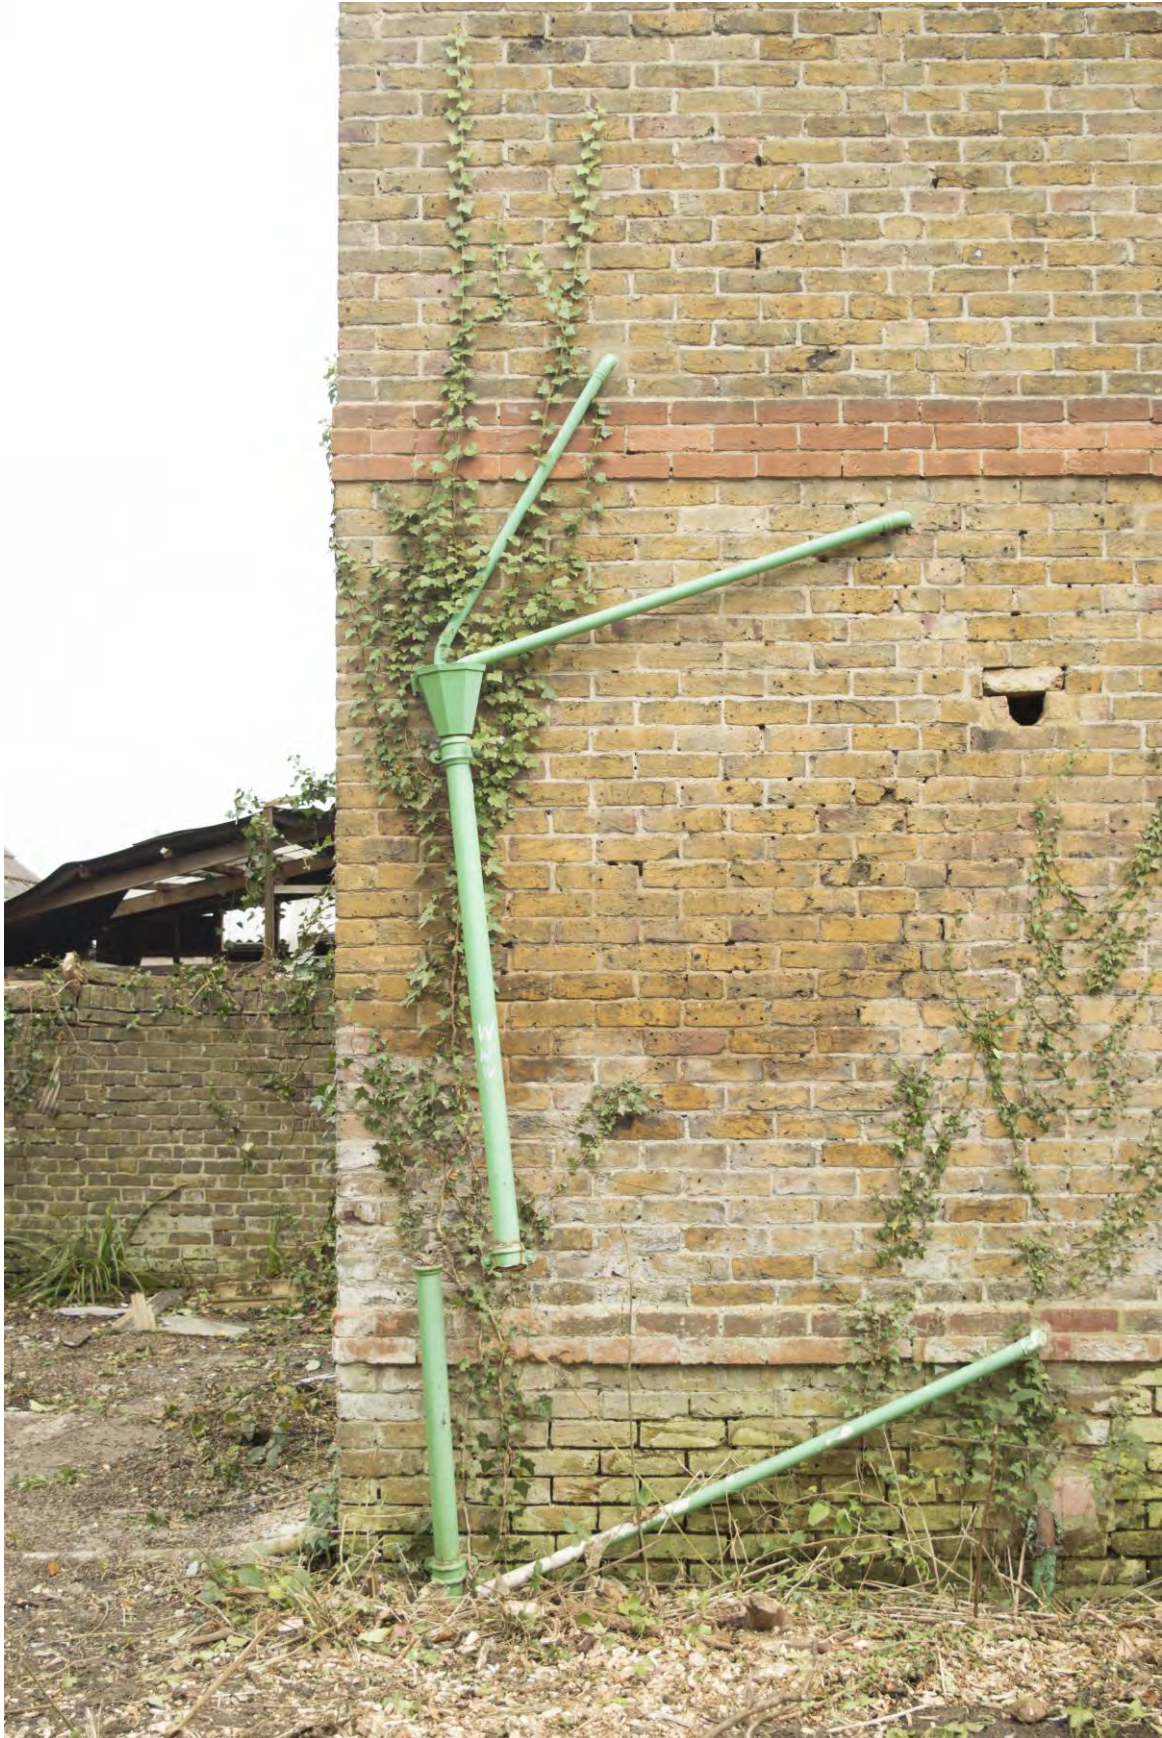
- 6.1.4 To the south west, the elevation shows the gable roof construction (plate 6). The wall here has the same construction as the south east. It features two eight-paned sash windows, smaller versions of those seen on the south east elevation. They are arranged in centrally, one on each floor. Later pipework has been added to this elevation, likely when plumbing was added to the building (plate 7).

Plate 7 – Some of the external piping added to the building (HRI17-0015)

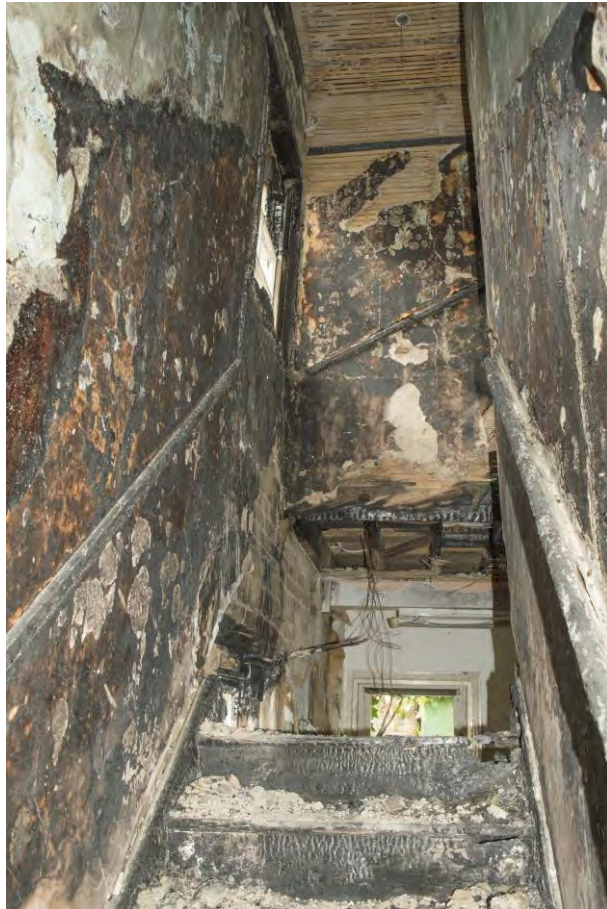
- 6.1.8 The interior of the no.15 was, at the time of recording, in a poor state of repair, having been damaged by fire and abandonment (plate 14). The layout would have comprised two rooms downstairs and three upstairs. Upon entry to the house via the front door there is a small hall area (room 1) with the stairway which leads up to the second floor to the front and a doorway with a four panelled door to the right, leading into room 2 (plate 15).

Plate 14 – Fire damaged interior of no.15 (HR117- 0104)

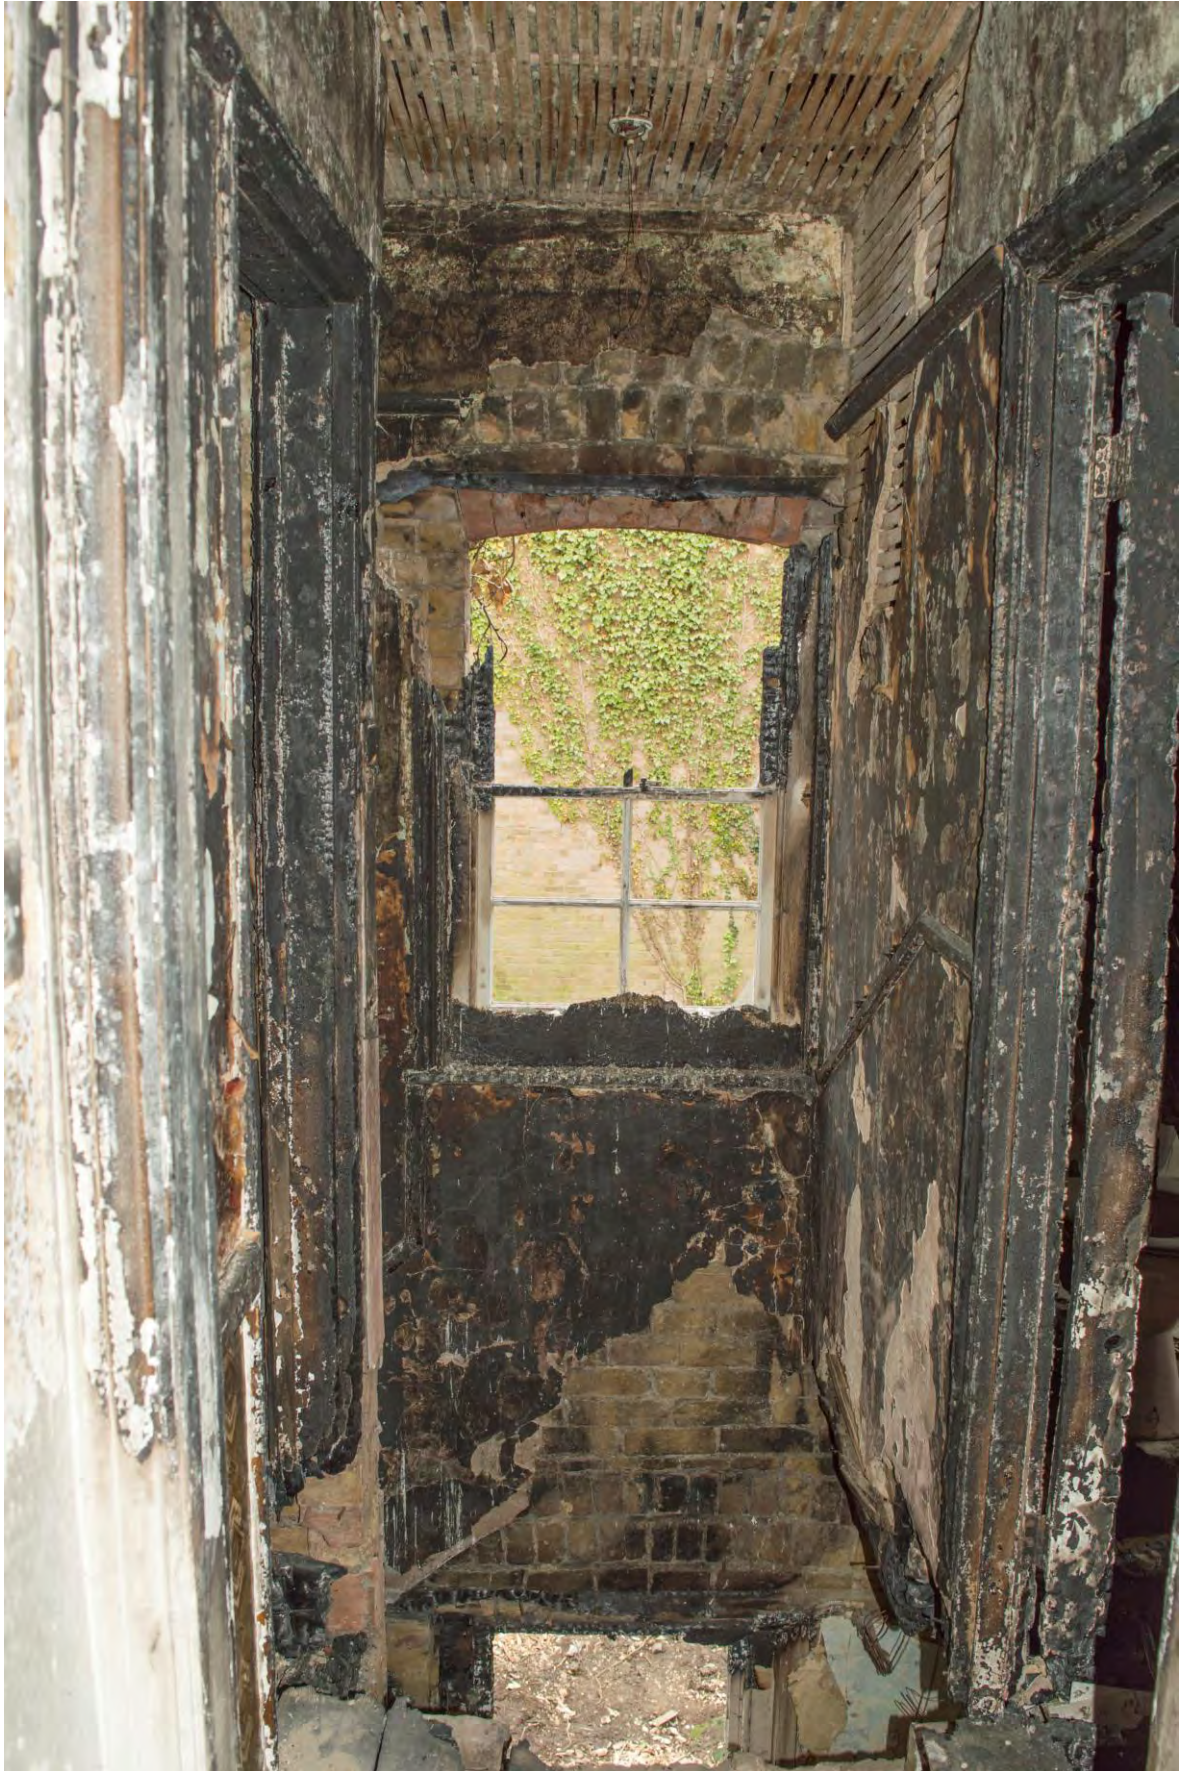
- 6.1.13 The stair is of timber construction, and heavily damaged in the fire. It consisted of a straight flight with winder to the top, with a handrail to the right and dado rail to the left. The small landing is lit by the upper of the two eight paned sash windows seen on the southwest elevation. The three doorways of the landing have architraving as seen in on the lower floor and are hung with four panelled doors, which are original, fitted with brass door handles. Fire damage in this area reveals areas of the building's construction, showing laths nailed to posts in the internal stud walling, which has then been plastered and finished with paint or wall paper. The external wall, above and below the window, has areas of visible brickwork under the plaster (plate 23). The stairwell ceiling is covered with matchboard panelling.

Plate 23 – Fire damage in no.15 revealed the construction methods used (HR117-0080)

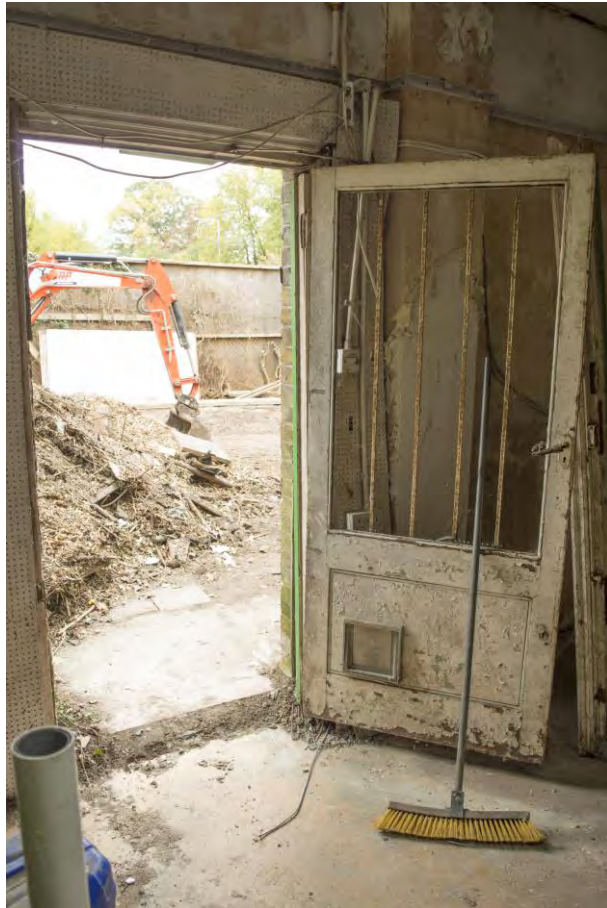
6.2.3 To the north east, the elevation is much the same as the south west. It features two eight paned sash windows and decorative red brick plat bands, and a small cast iron vent. A small casement window has been inserted to the south west end, to bring light to the small landing when the front door was removed with the addition of the shop. The shop extension has been tied into the wall, though the bonds differ. A side door sits alongside the inserted casement window, to provide a rear entrance to the shop (plate 33). This doorway has a shallow gauged head, with marks above to suggest there was a simple porch structure no longer present. The door matches that at the shop front, though it lacks a letter box, with two panels, the upper having been glazed. At some point in its past a cat flap has been inserted and the glazed panel barred for security (plate 34).

Plate 34 – The shop side door, no. 17 (HRI17- 0056)

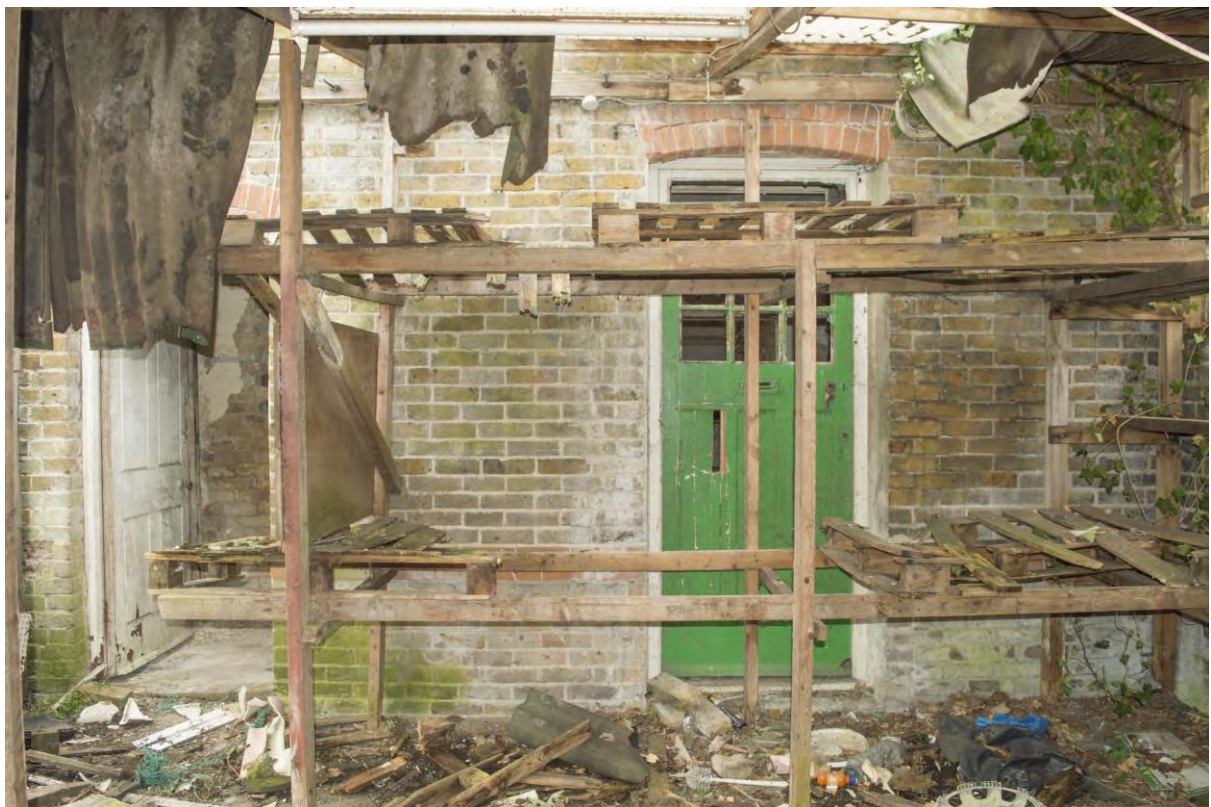
6.2.4 To the rear of the building, the north west elevation has two windows on the first floor. They are twelve paned sashes as per those seen on the south east. The third window, on the ground floor, has been converted to a doorway with a small horizontal light above the door. The doorway is hung with a part-glazed door, which has six glass panes above three panels and would have allowed access directly to the rear room of the house. The back door remains in-situ, and is unmodified in its four panelled form (plate 35).

Plate 35 – The north west elevation, no. 17 showing the inserted door (HRI17- 0040)

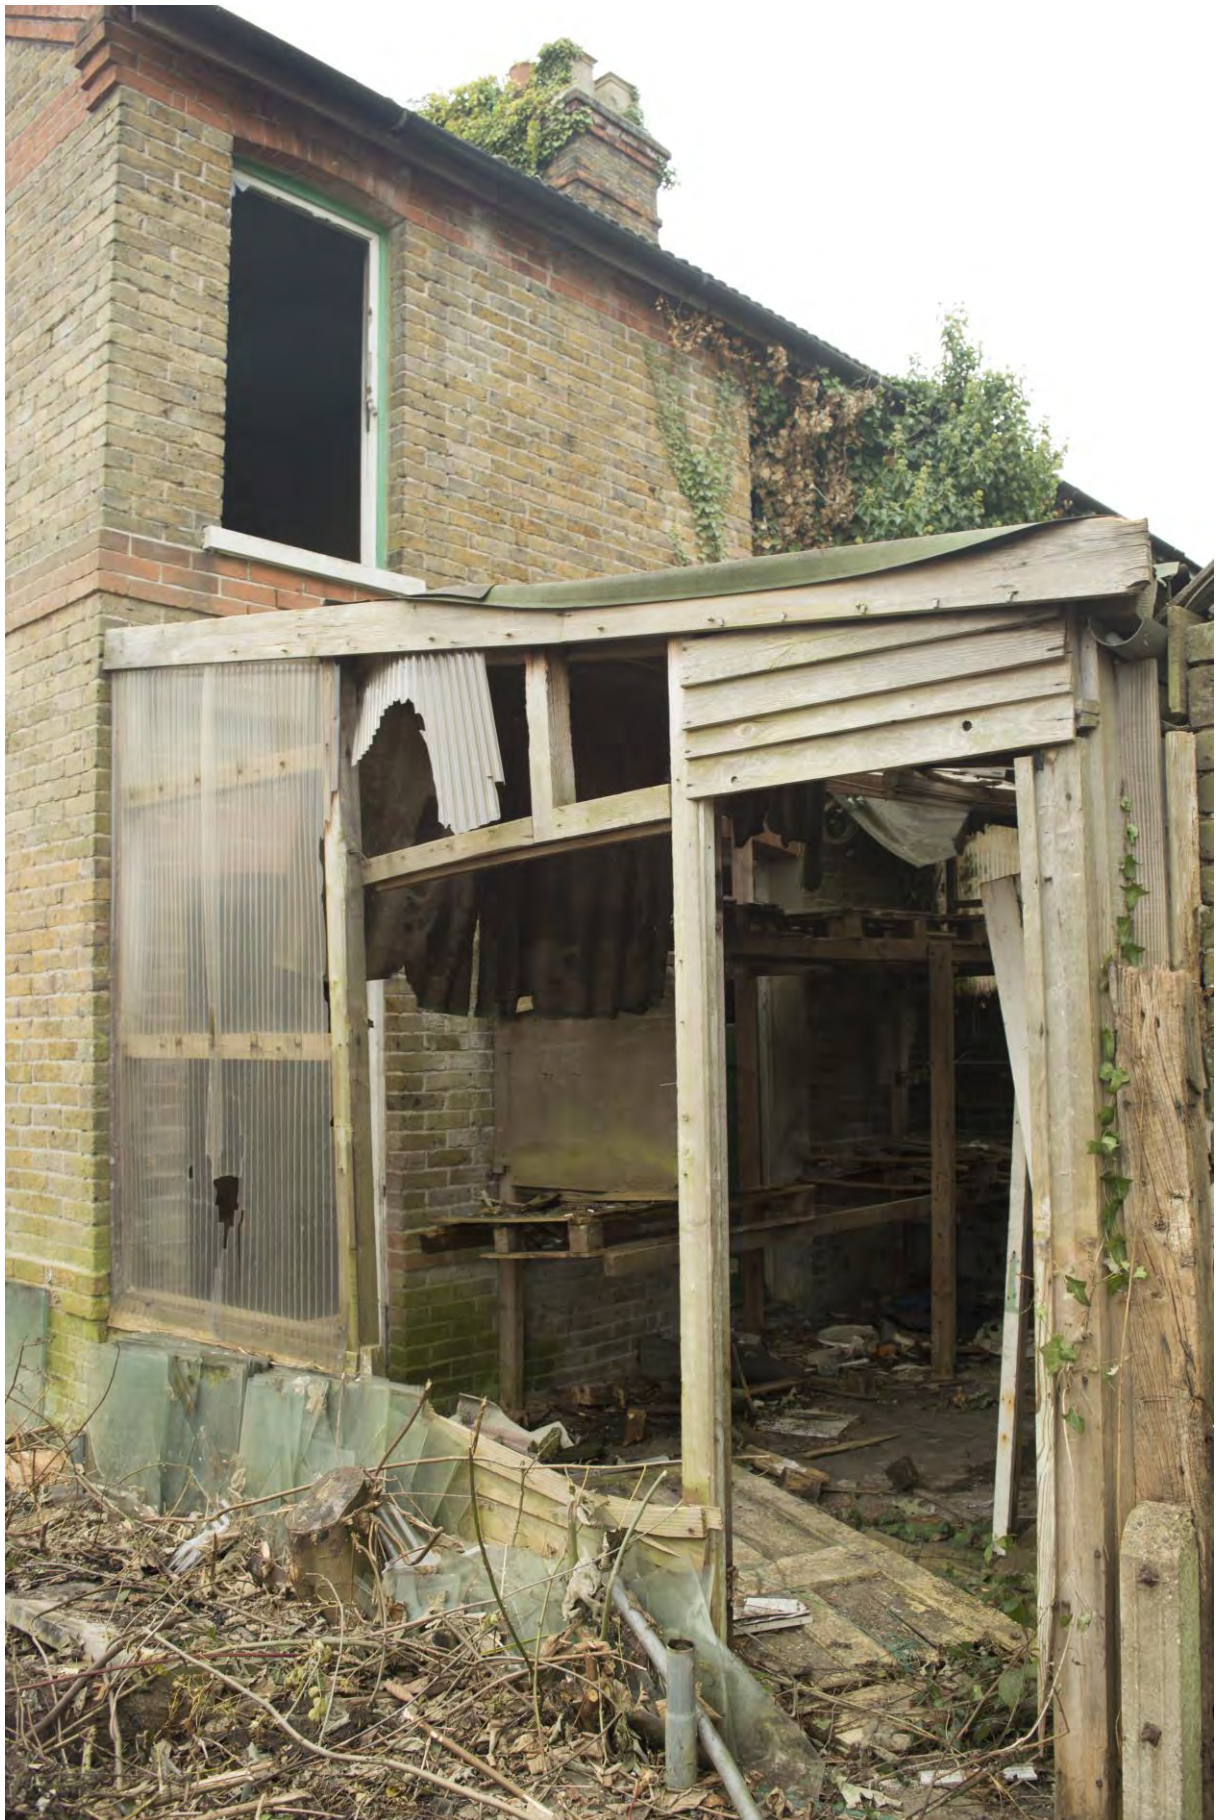
a garden centre, the yard area has been covered with an ephemeral lean-to structure built from modern materials, which has blocked the use of the inserted rear doorway (plate 36).

Plate 36 – The lean-to structure, no. 17 (HRI17- 0035)

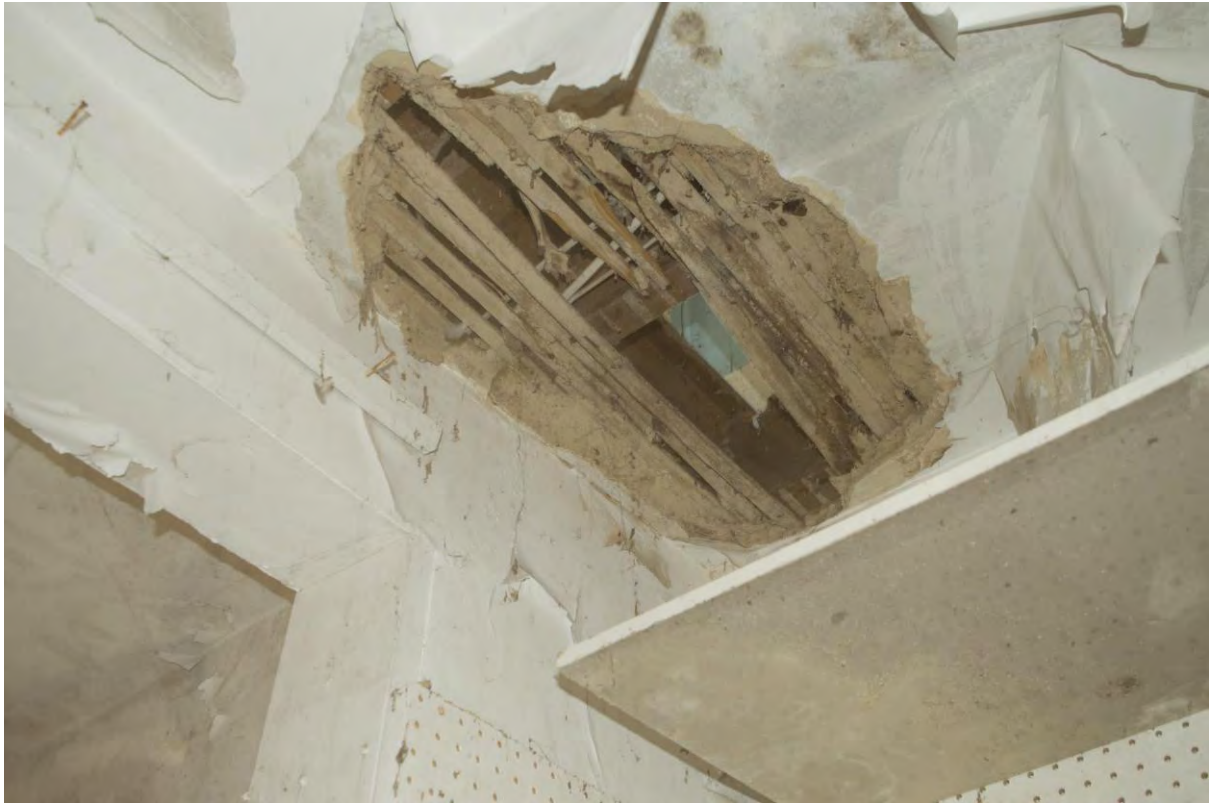
- 6.2.8 As the retail use of the building developed, the ground floor rooms were employed to expand the space available, creating the space as it currently lies (plate 39). The original front wall and internal wall of the house were removed, opening the entire ground floor space into the shop. Because of the differing floor levels, two wide steps up to the interior ground floor were added and the chimney breasts, evident by gaps in the skirting, were removed (plate 40). An L-shaped counter was added, positioned at the top of the steps to provide a clear view of the shop floor and shield the access to the stairs (room 10). The expanded shop area was fitted out with pegboard. In some areas the original fittings of the house such as skirting, architraving and picture rails have survived. Damage to the ceiling in the shows timber laths nailed to joists, over which the floorboards of the first floor are laid (plate 41).

Plate 41 – Ceiling construction revealed by damage, (room 9), no. 17 (HR117- 0054)

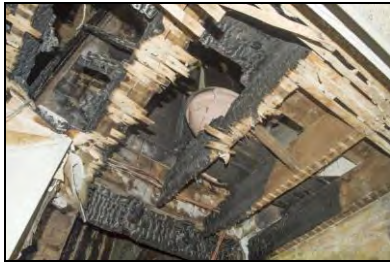
HR117-0091
Ceiling of room 3 showing fire damage
