**ST GILES FARM BARN AND DAIRY, PATTERSONS LANE,
BLENDWORTH, HAMPSHIRE, SO08 0AG**

HISTORIC BUILDINGS RECORD

**Historic Buildings Record
& Archaeological Watching-Brief**

**ASE Project No: 170925
Site Code: GIL18**

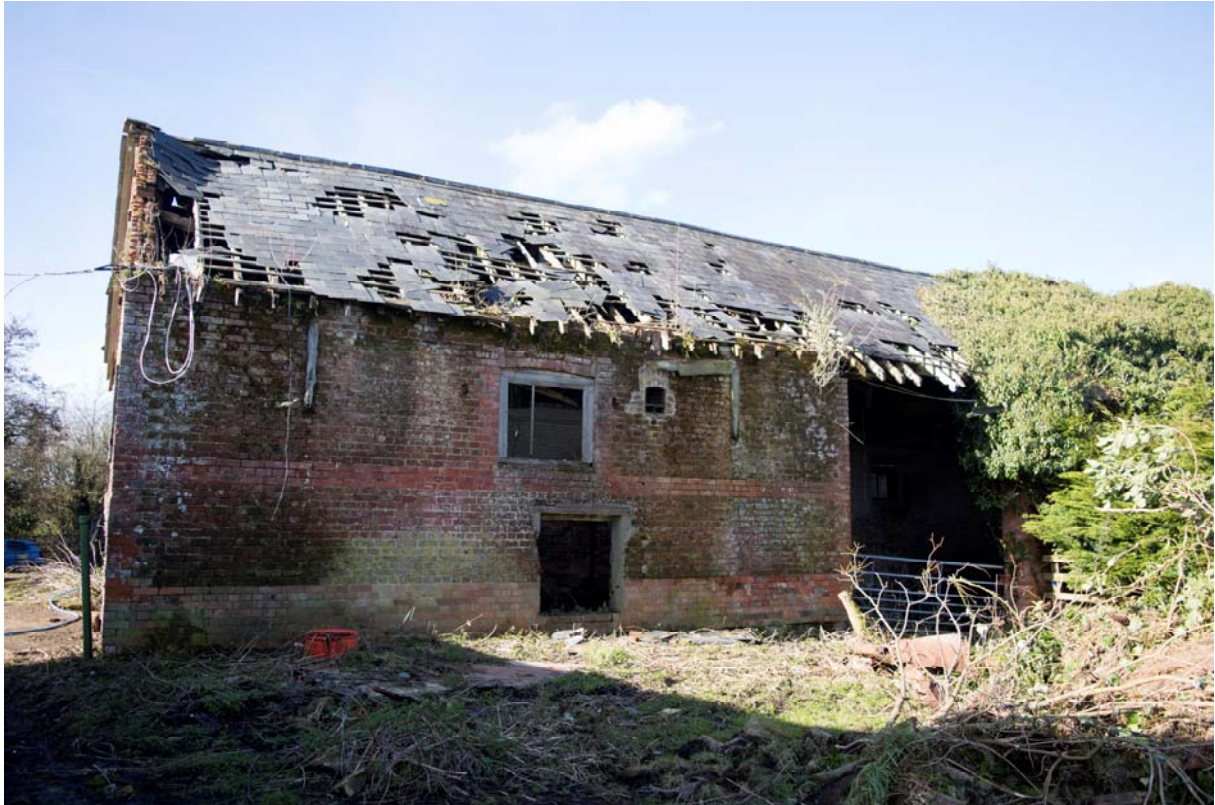
of the walls and a finer orange-red brick for the plinth and detailing such as a mid-height plat band (Plate 1). There is a slate damp-proof course near the base of the walls, above which are a series of regularly-spaced iron ventilation blocks. The roof is slated and has gabled terminals.

Plate 1 – The barn, facing north-west (GIL18-0004)

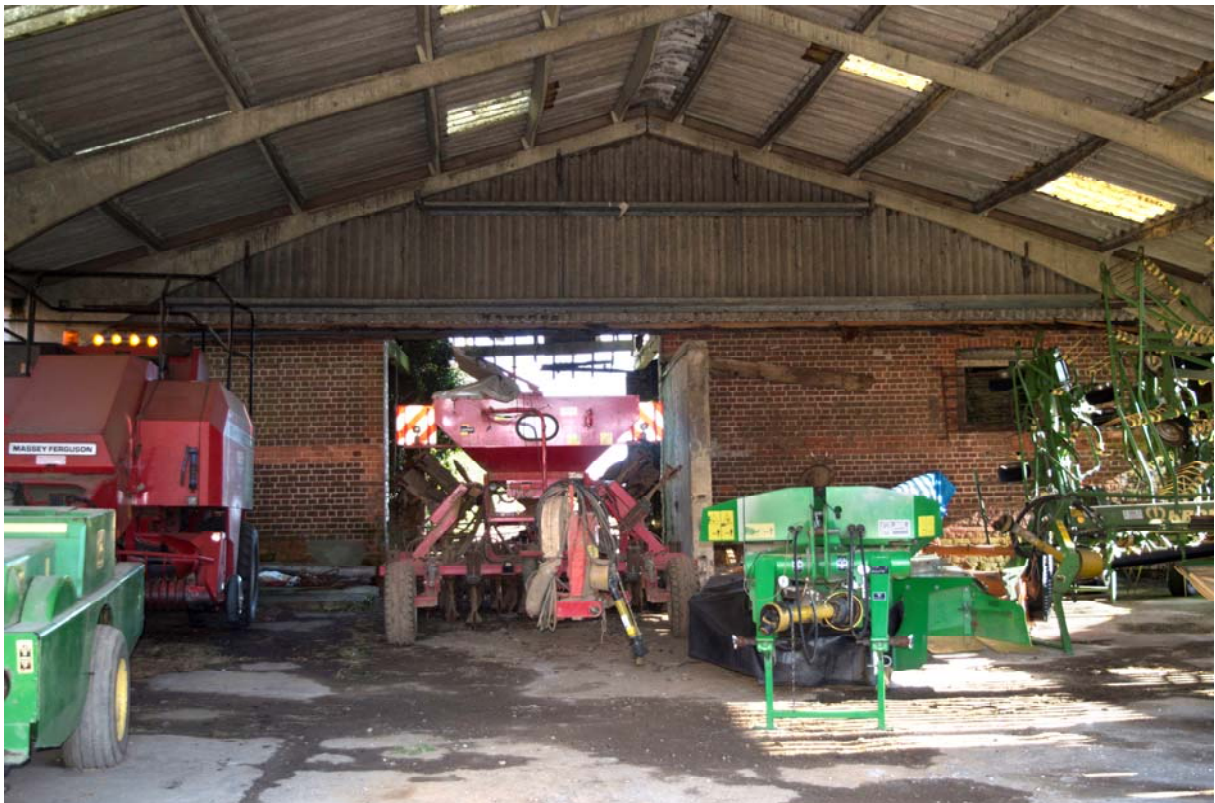
- 6.3 The principal elevation faces west into the yard, but is now largely obscured by the later barn (Plate 2). It contains a large central doorway leading onto the midstrey, either side of which a high-set window has been inserted above the plat band (Plate 3). Each window has a segmental arched arch and chamfered brick sill, which matches the style of the windows of the dairy, suggesting that they were inserted at the time of the dairy's construction. The windows of the barn are framed in wood and formerly had six panes, arranged 3x2. A projecting concrete wall has been added to the southern side of the midstrey opening.

Plate 2 – Principal elevation of the barn, facing east (GIL18-0017)

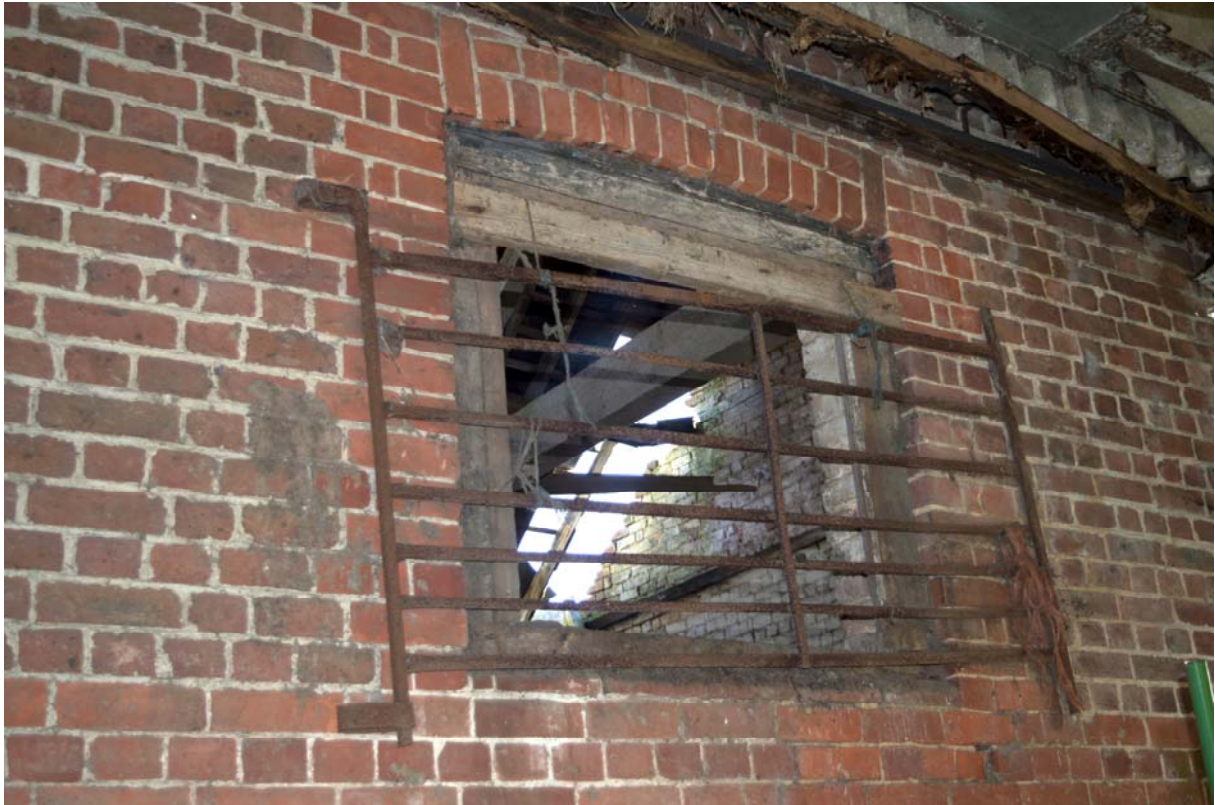
Plate 3 – Example of one of the windows inserted into the barn, facing south-east (GIL18-0022)

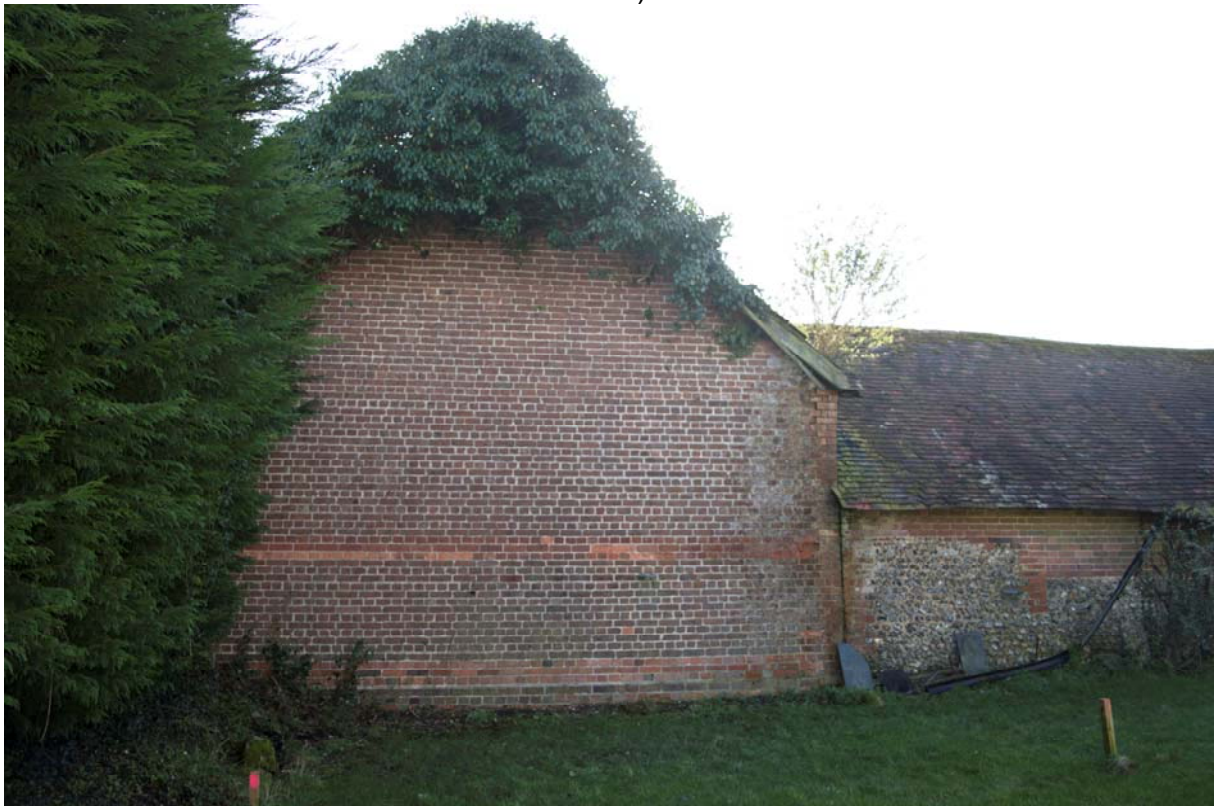
- 6.4 The gable ends are plain. The north gable is overgrown with vegetation at its upper level, although a timber barge-board remains visible (Plate 4). The south wall has some timber battening and a substantial area of the brickwork has been painted black (Plate 5). The design statement (Wheeler-Bennett, 2015) notes that this gable was clad in corrugated iron for a number of years because it faces into the prevailing weather. The yard walls meet the barn at the north-west and south-west corners but are not tied into the barn; it is probable that the yard wall predates the barn.

Plate 4 – The north gable of the barn, facing south (GIL18-0059)

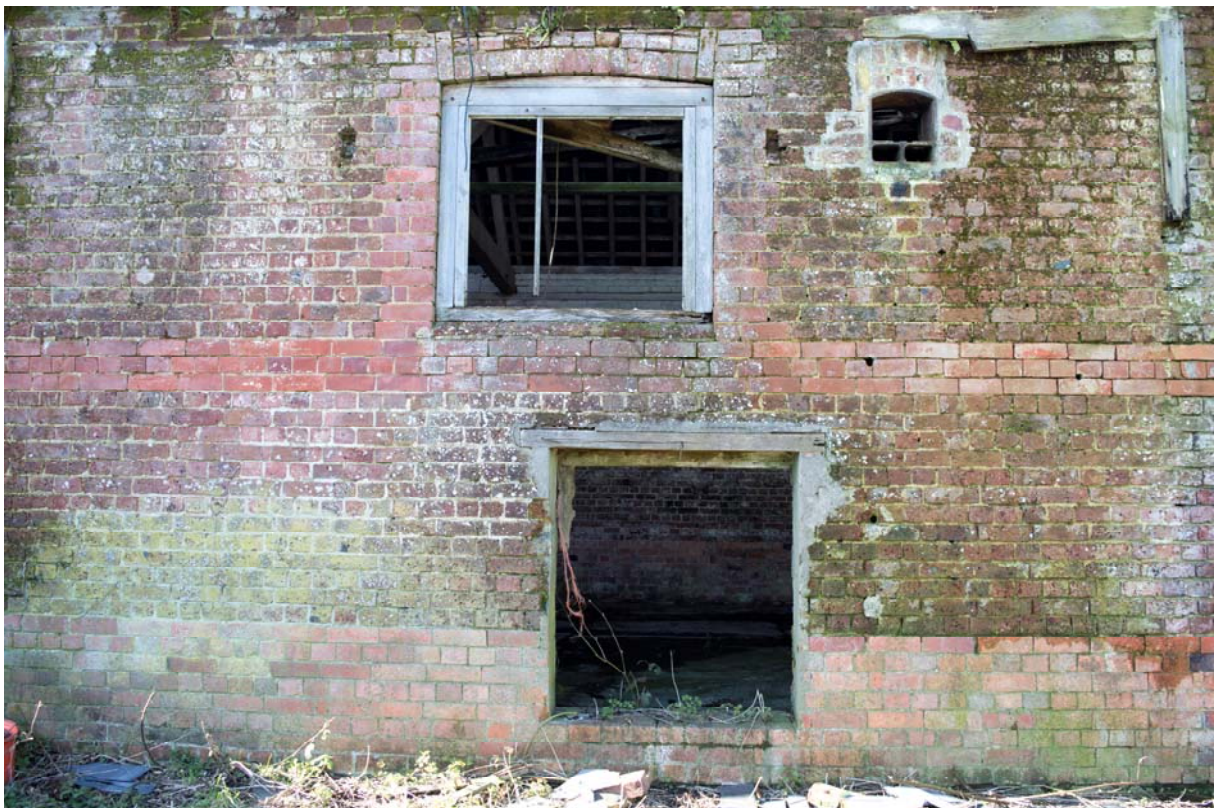
- 6.5 The east elevation matches the principal elevation in form, including the inserted windows. An additional small opening has been inserted to the side of the high-set window on the south-east side. This small opening contained a cast iron framework and likely served as a housing for agricultural machinery of some kind. Below and slightly offset from the high-set window a third opening has been inserted with less skill than the ones at the upper level. It is simple and square in form, with a timber frame. Its use was not entirely clear being rather low to the ground for a window and short for a door, though it corresponded with an area of external brick paving (Plate 6).

Plate 6 – Inserted windows and openings on the east elevation of the barn, facing west (GIL18-0006)

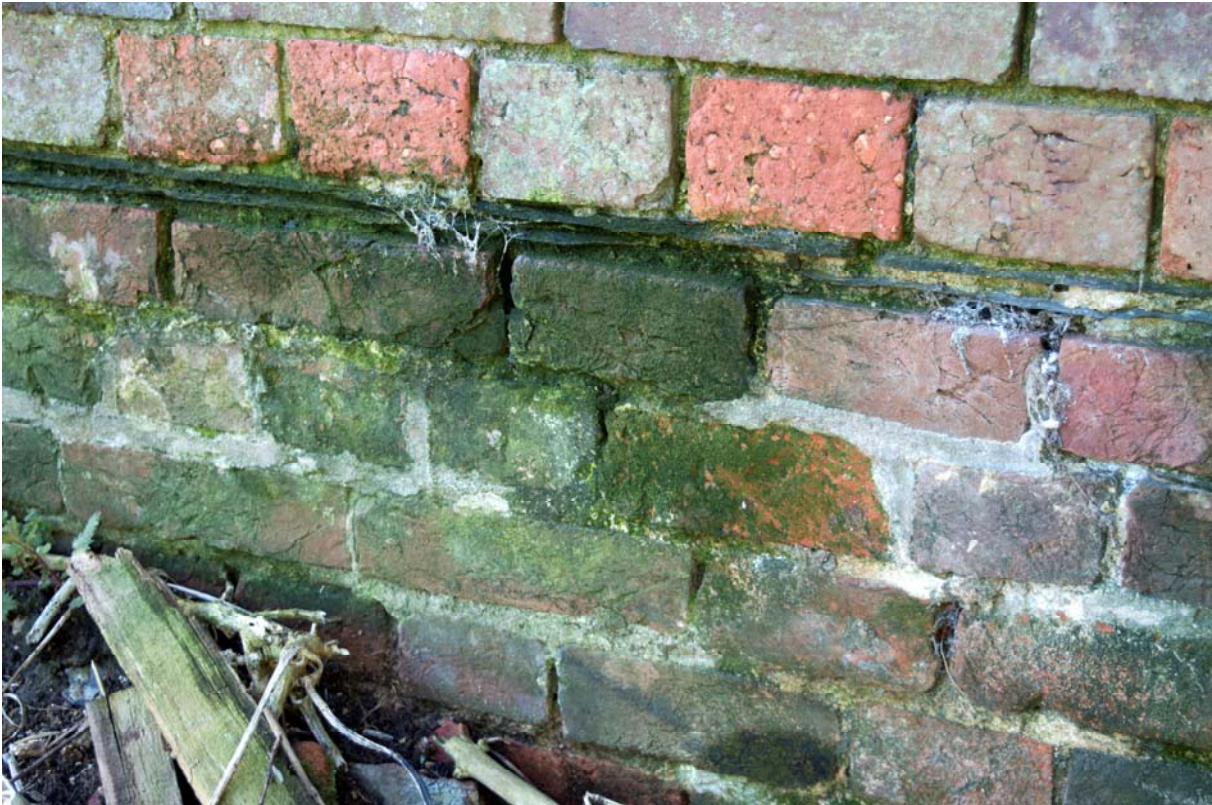
Plate 7 – Earlier brickwork below the slate damp-proof course, facing south-west (GIL18-0011)

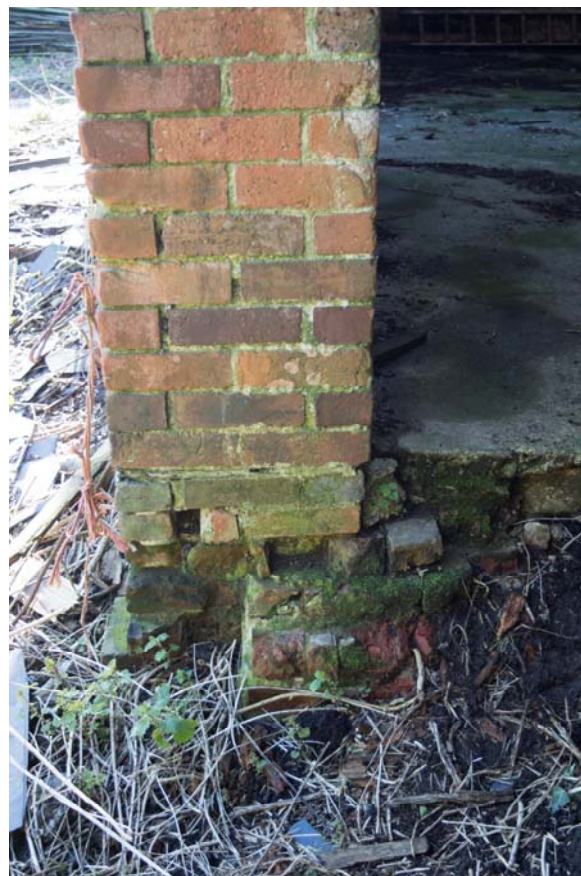
- 6.6 In several areas, particularly either side of the midstrey doorway on the east elevation, it appears the barn is constructed on earlier footings which are likely to be the remnants of an earlier barn. It is possible this could be the building depicted on the tithe map. Below the slate damp-proof course (which belong to the mid-/late 19th century construction) the brickwork is formed of smaller bricks of 50-60mm height, which are darker in colour and set in a more variable bonding pattern (Plate 7). This brickwork appears to be partially truncated at the door opening, which supports the notion that the brickwork remains *in situ* from an earlier structure rather than the bricks having just been reclaimed and reused within the later structure (Plate 8).

Plate 8 – Truncated earlier brickwork visible at the midstrey opening, facing south (GIL18-0012)

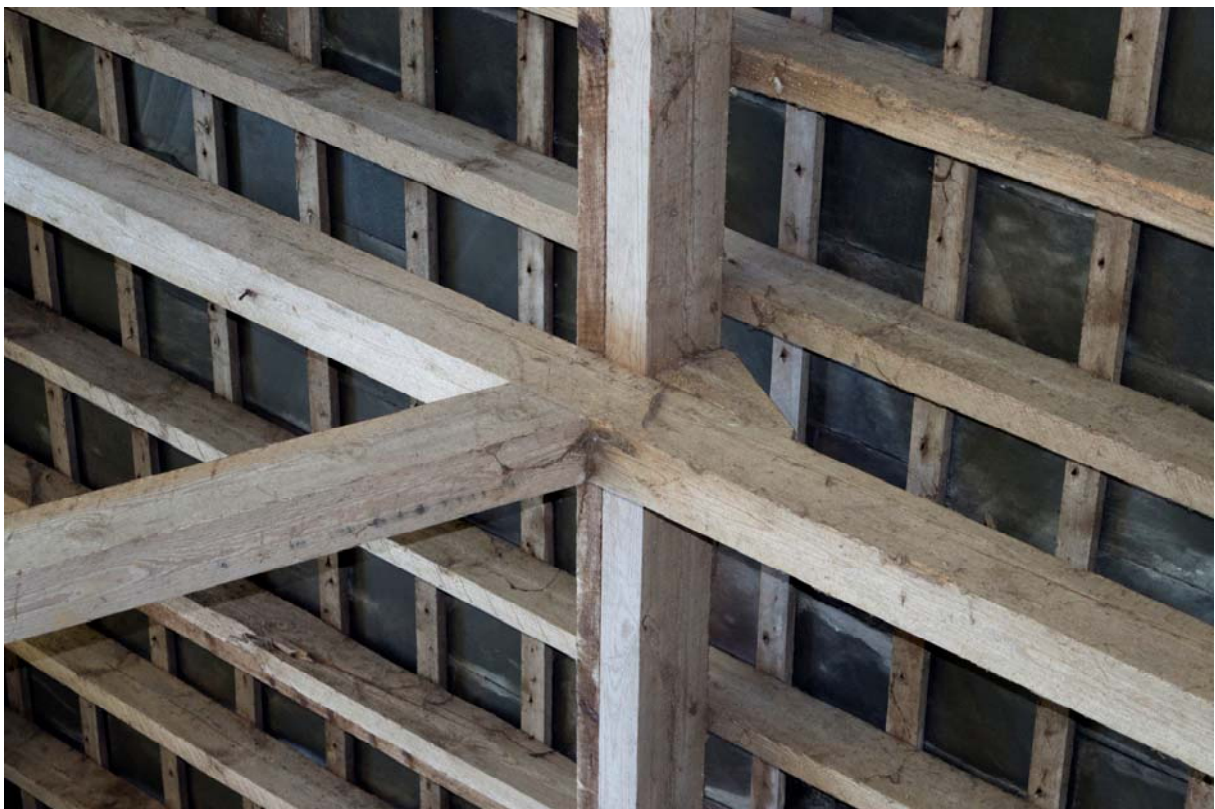
rafters by means of nailed cleats (Plate 10). The common rafters met at a ridge-board at the apex. Additional blocks have been added below the struts on some but not all of the trusses (Figure 6).

Plate 10 – Detail of roof construction, facing south (GIL18-0050)

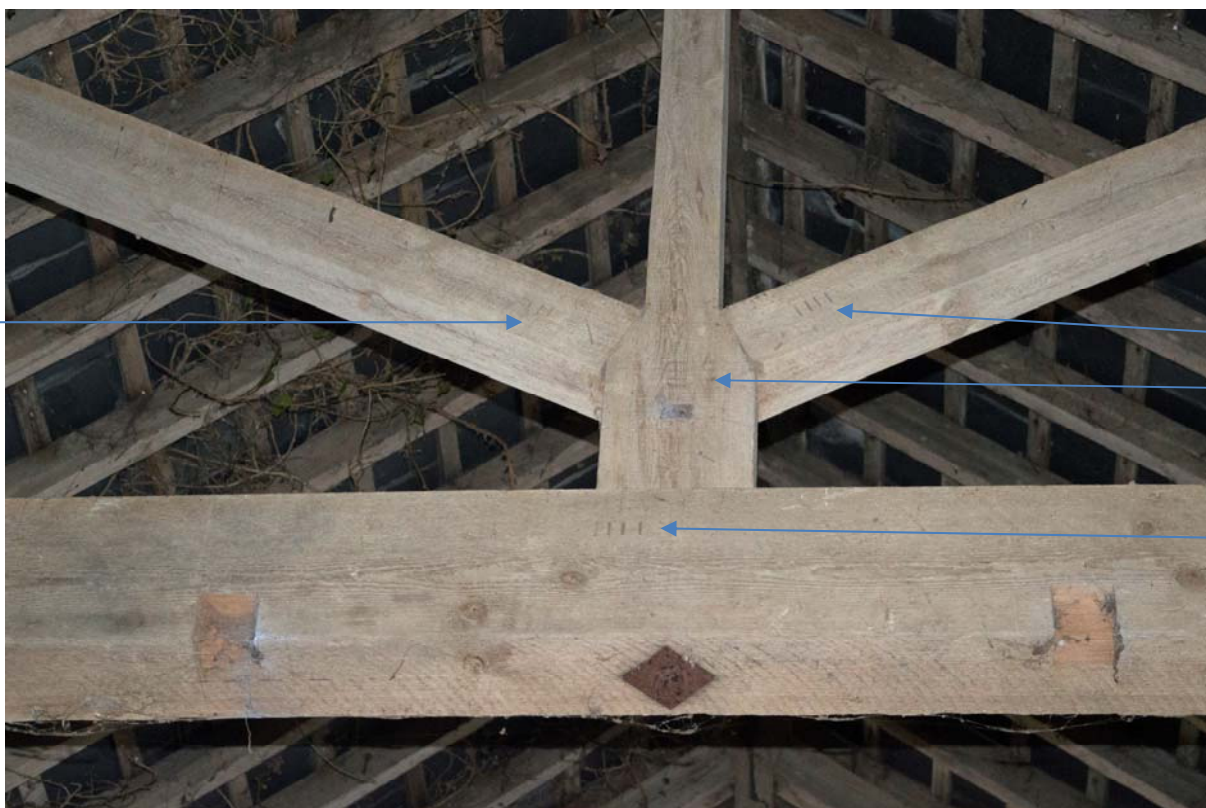
Plate 11 – Examples of carpentry marks on trusses in the barn, facing south (GIL18-0057)

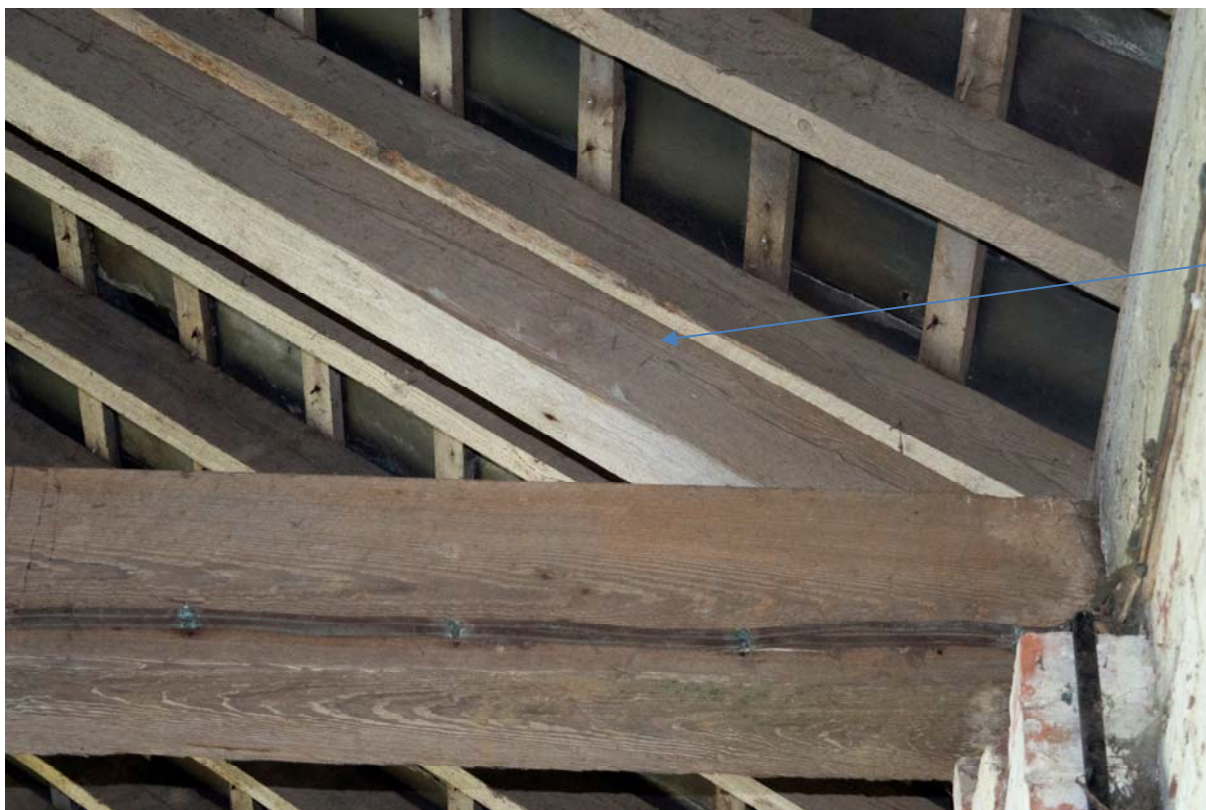
Plate 12 – Examples of carpentry marks on trusses in the barn, facing south (GIL18-0055)

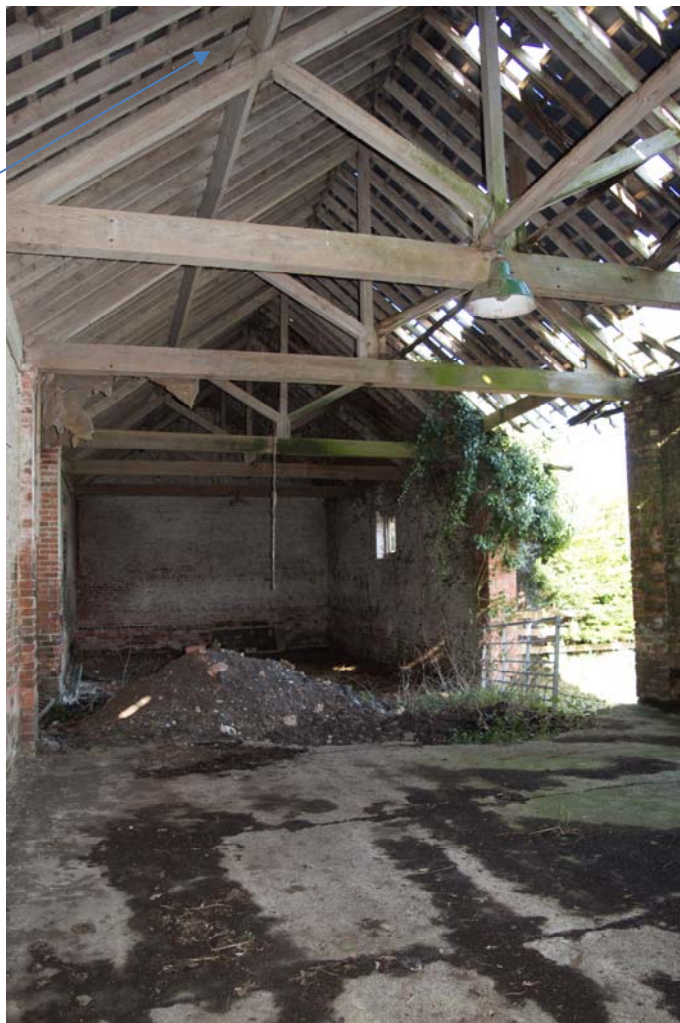
Plate 13 – Interior of the barn looking north-east. Location of E carved into the rafter is indicated by the arrow (GIL18-0043)

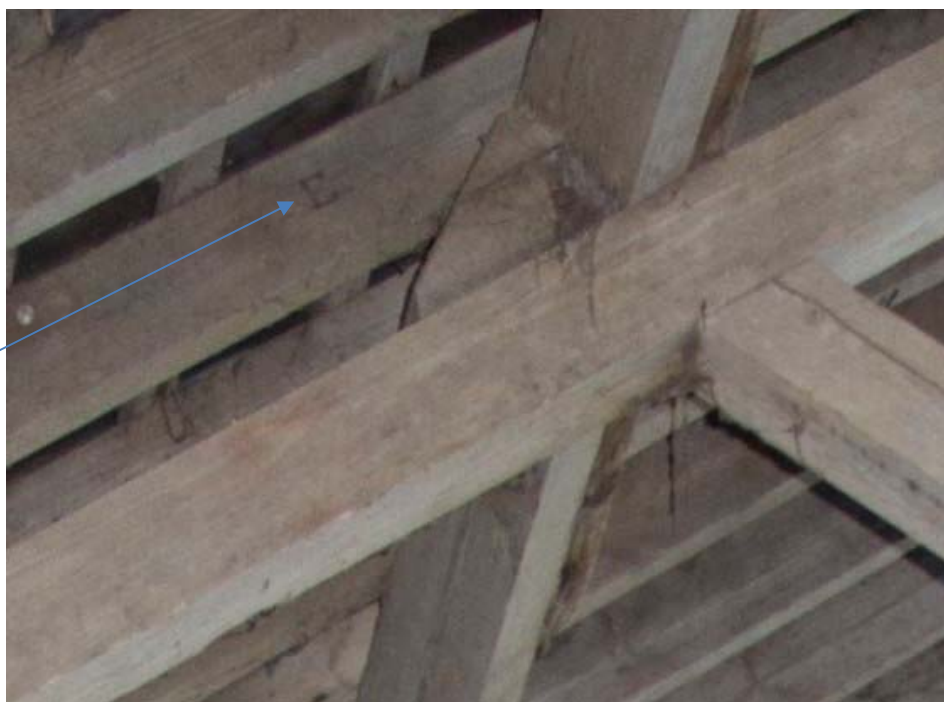
Plate 14 – Detail of the carved E (extracted from GIL18-0043)

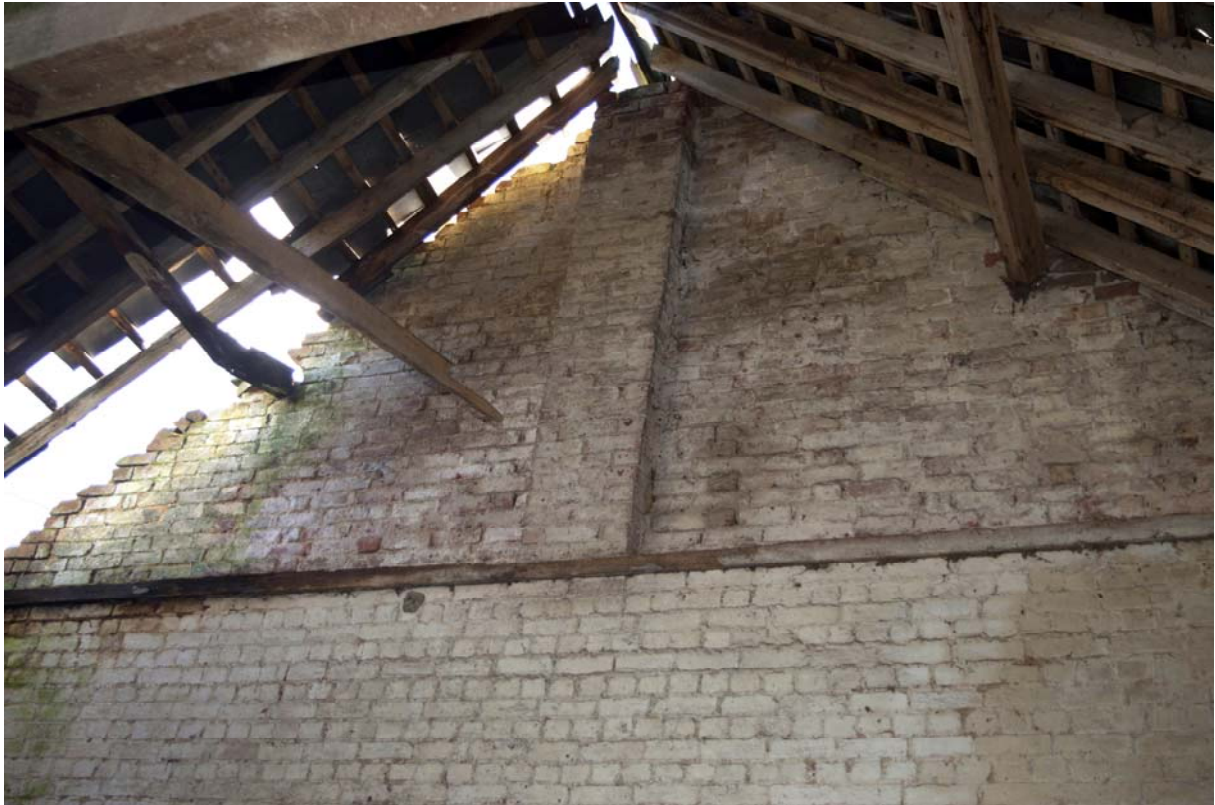
Plate 15 – Internal view of the southern gable end of the barn, facing south-east (GIL18-0051)

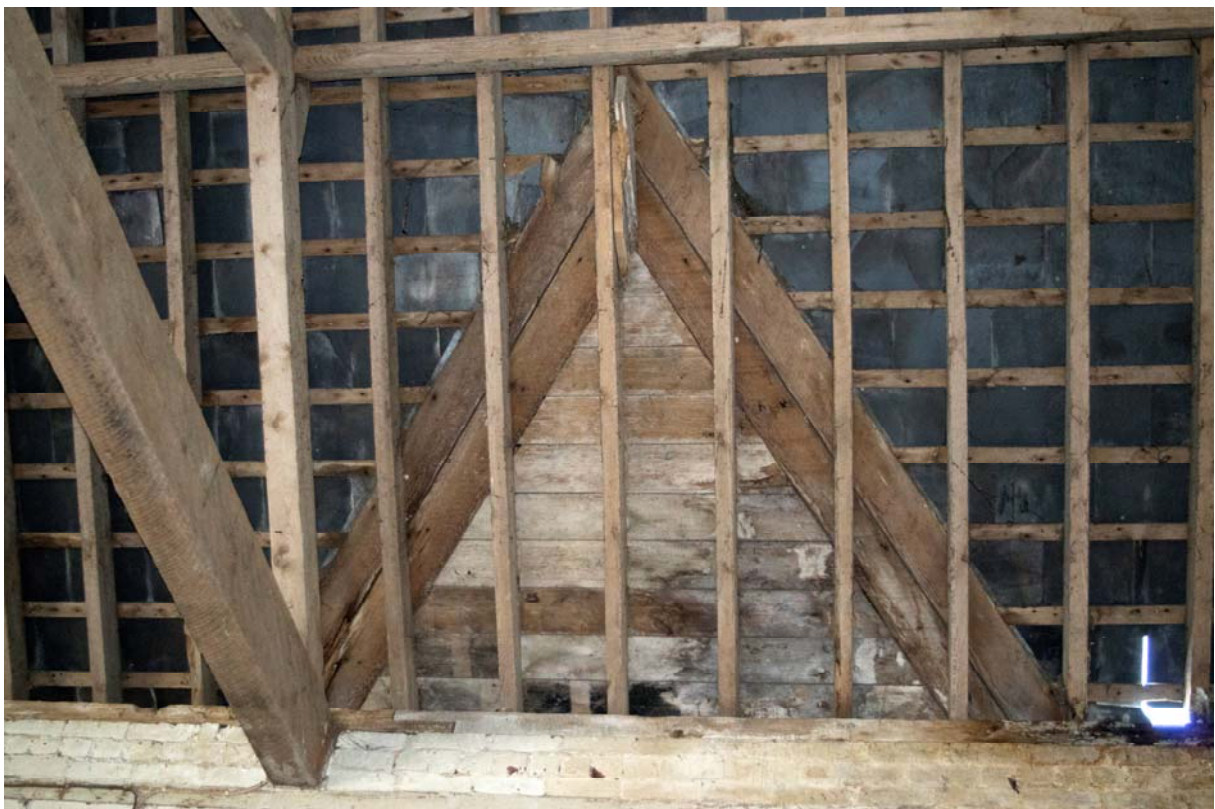
- 6.10 The width of the brickwork walls is reduced above the level of the wall-plates, although each is reinforced by a central full-width engaged pier which also provides support to the ridge board (Plate 15). Where the dairy roof meets that of the barn, the slates of the barn roof have been removed and replaced with boarding (Plate 16).

Plate 16 – Boarding replacing the barn's roofing slates where the dairy was added, facing west (GIL18-0034)

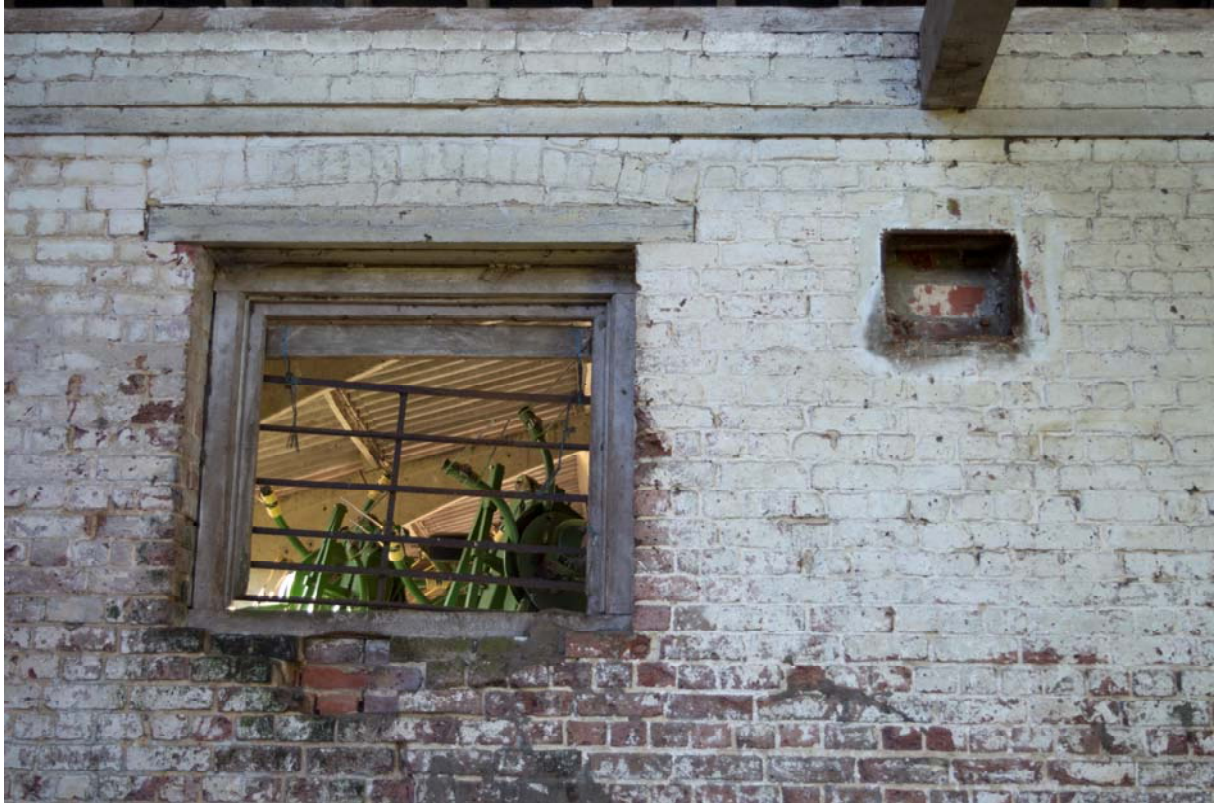
- 6.11 The inserted openings observed on the exterior are positioned centrally within the long walls of the barn to either side of the midstrey (i.e. Bays 2 and 6). A recess within the west wall corresponds with the opening observed within the east wall, and no doubt served as housing for agricultural machinery (Plate 17).

Plate 17 – Inserted window and machinery housing in the barn wall, facing west (GIL18-0040)

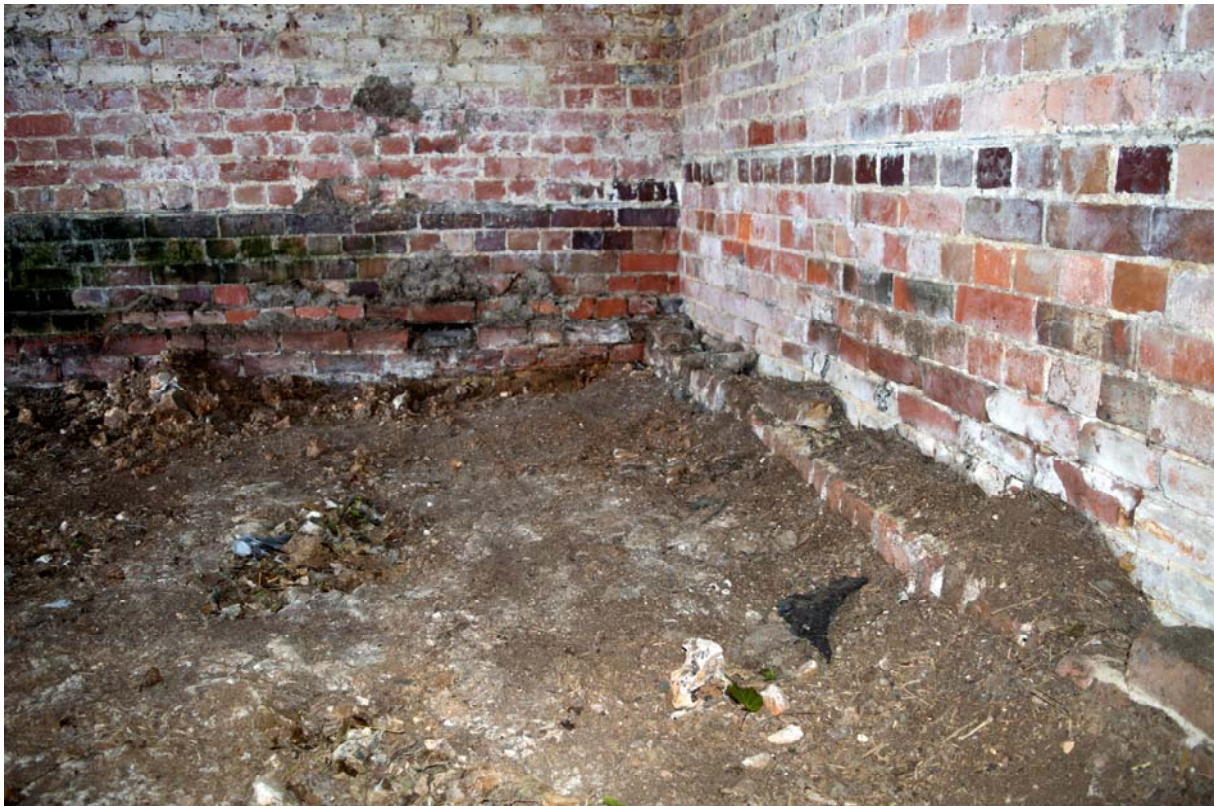
- 6.12 The floor of the southern three bays comprises a concrete screed. The floor within the remainder of the barn is of earth and is set at a lower level than the rest, affording a view of the slate damp-proof course and the earlier brickwork beneath (Plate 18). No evidence was observed for a threshing floor within the midstrey.

Plate 18 – Earlier brickwork visible below the damp-proof course, facing north-west (GIL18-0032)

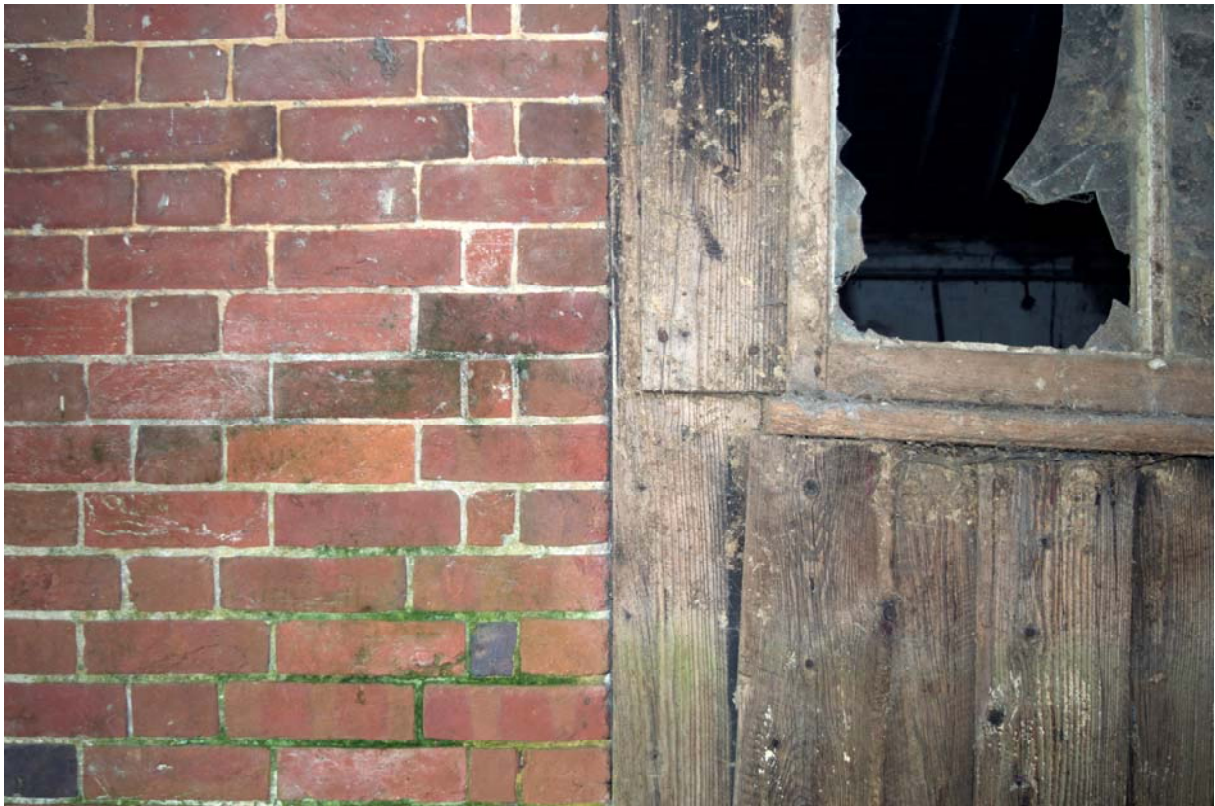
Plate 22 – Junction of the brickwork and weatherboarding showing queen closer bricks, facing north (GIL18-0077)

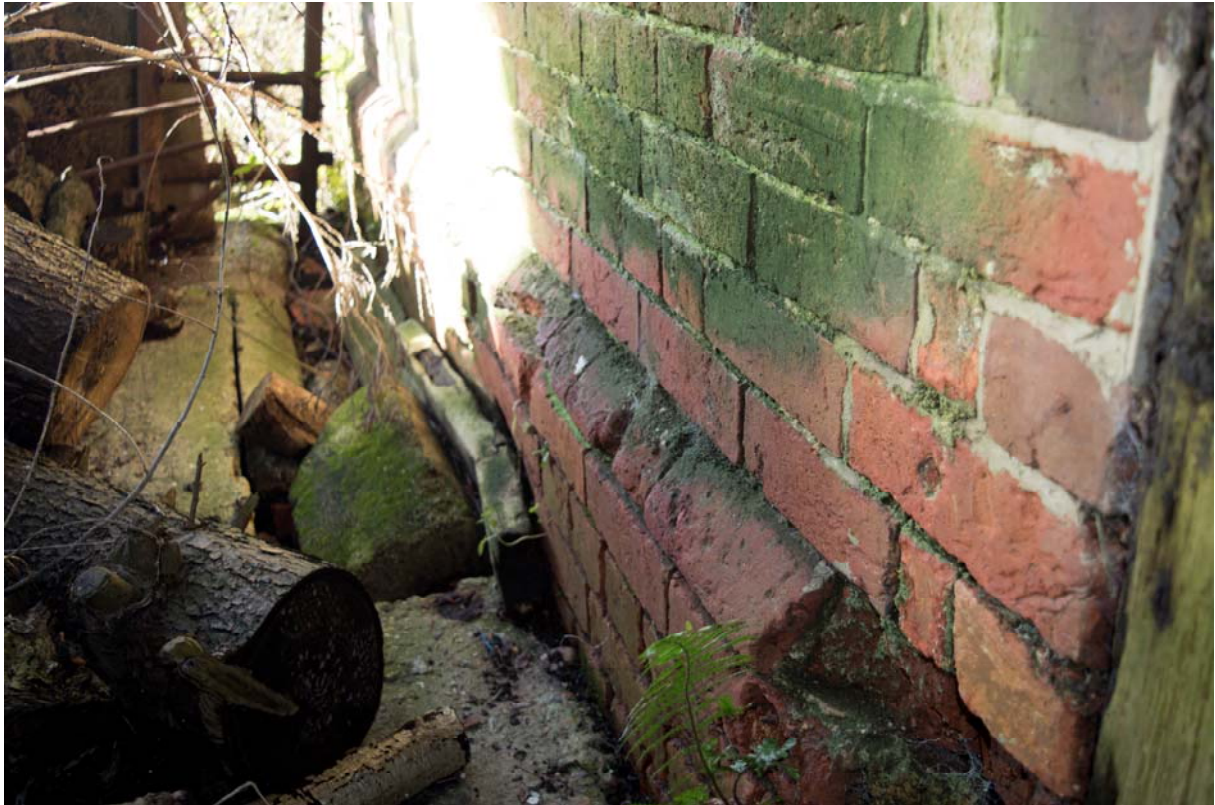
- 6.15 Towards the base of the brick wall there is a chamfered brick offset (Plate 23). The same chamfered bricks are used for the sills of the original windows sills, of which there are three. The windows have segmental arched heads and wooden frames. There are two doorways with timber lintels and timber half-doors.

Plate 23 – Brick offset at the base of the dairy walls, facing north-west (GIL18-0082)

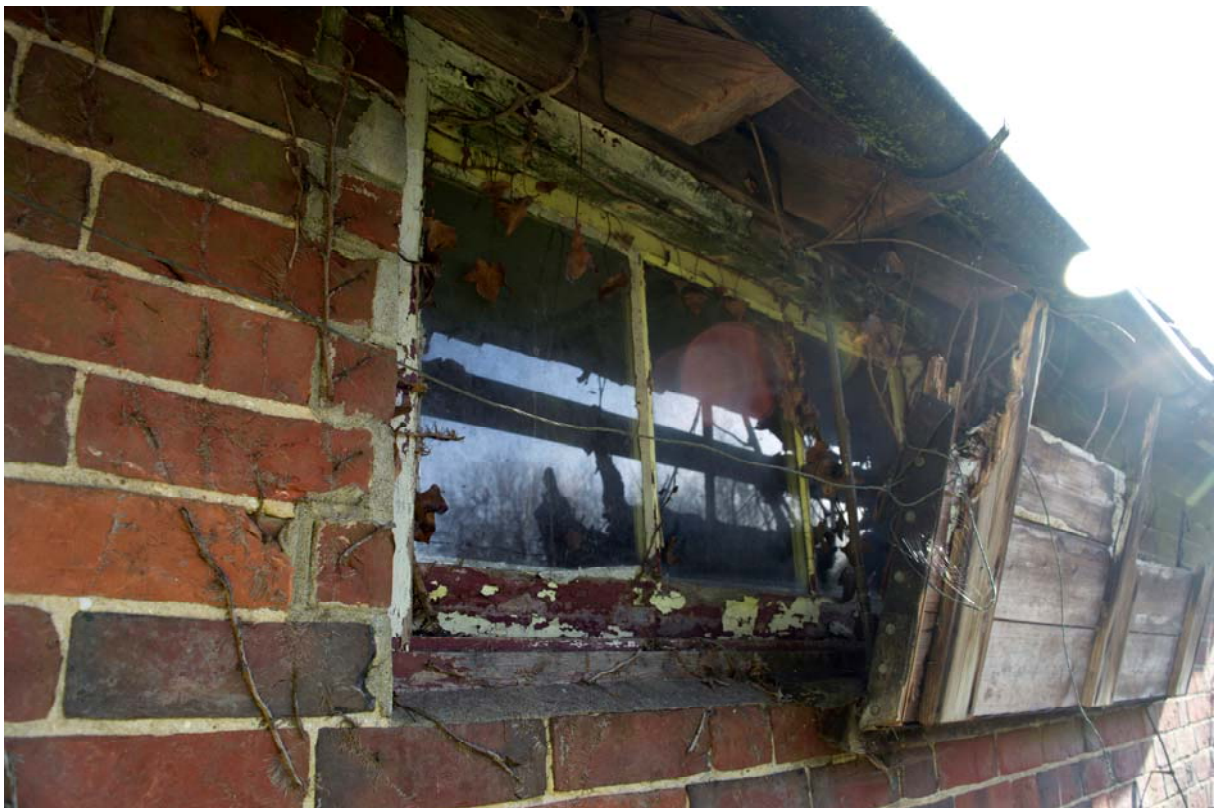
- 6.16 The west elevation is plain, barring a continuation of the offset and an inserted window (Plate 24). It abuts the original yard wall but is not toothed-in.
- 6.17 The north elevation utilises the original flint and brick yard wall which has been extended upwards in brickwork (Plate 25). A small window has been inserted into the brickwork towards the western end of the building (Plate 26).

Plate 24 – Window inserted into the west elevation of the dairy, facing south-east (GIL18-0068)

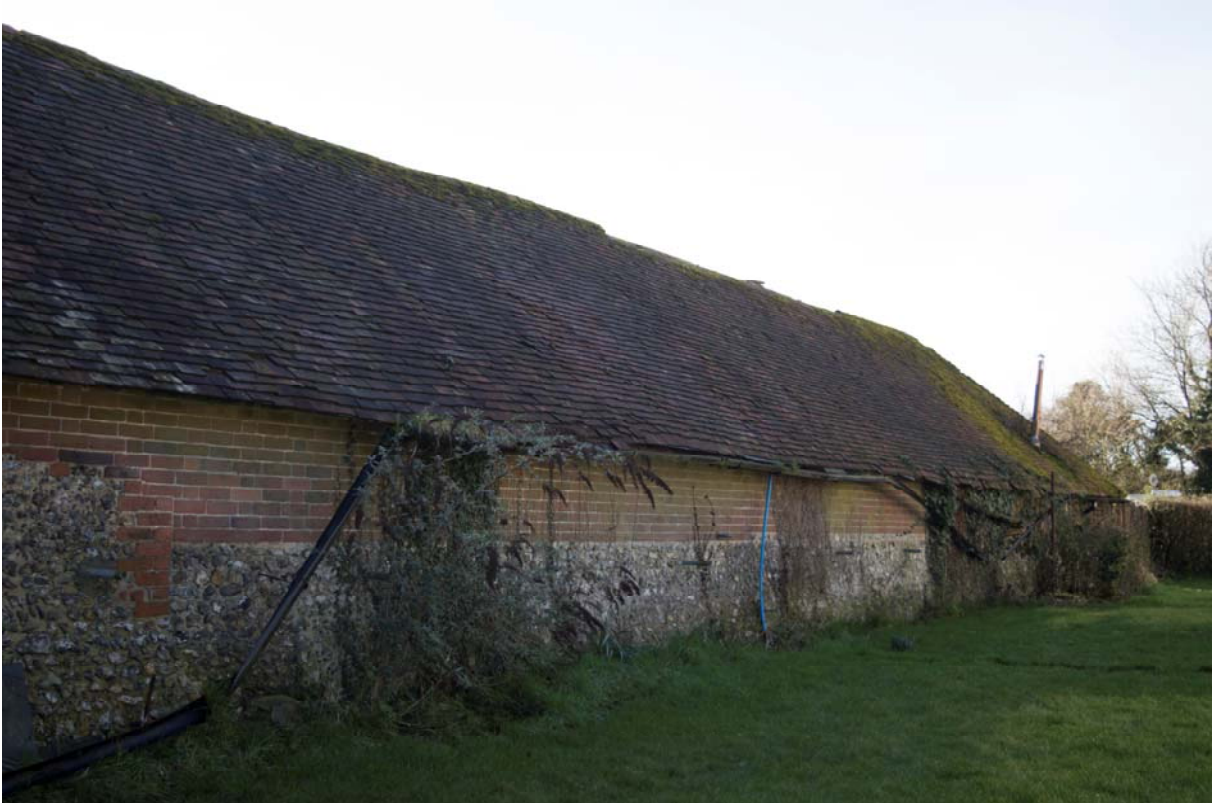
Plate 25 – North elevation of the dairy showing the incorporated flint yard wall, facing south-east (GIL18-0062)

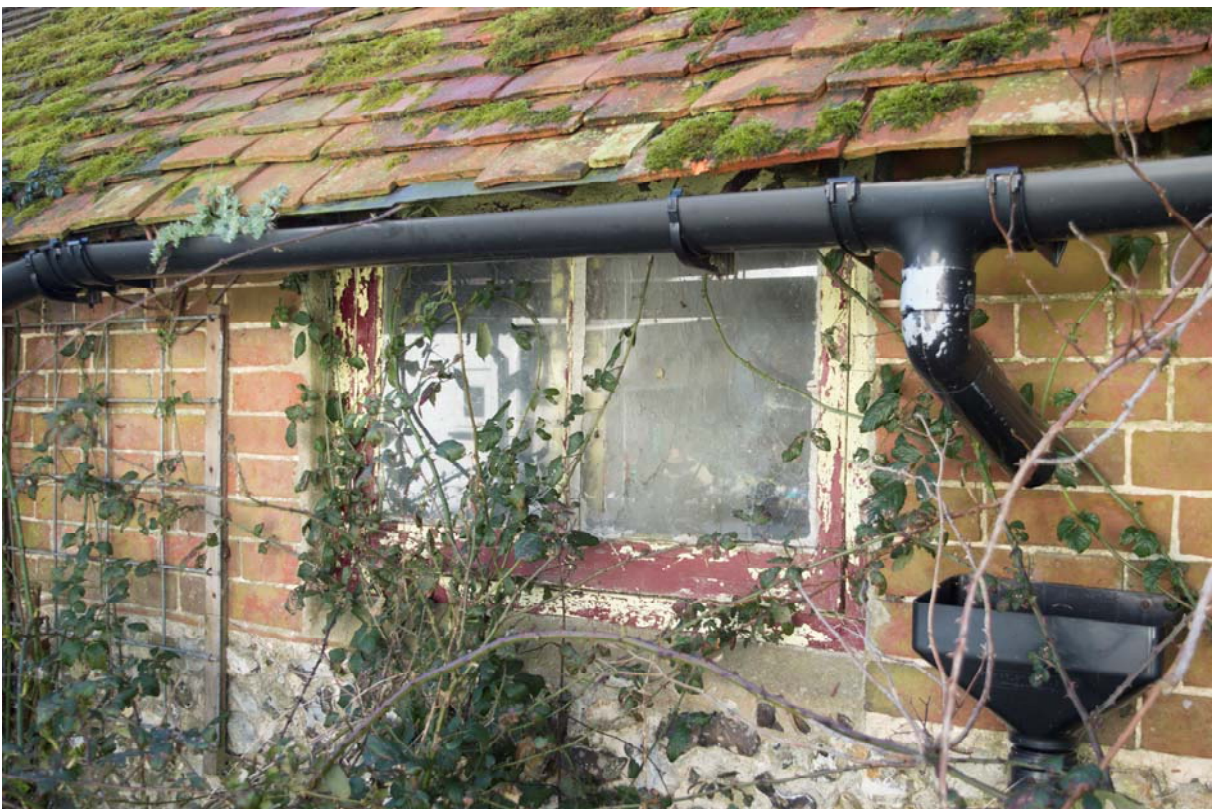
Plate 26 – Window inserted into the north elevation of the dairy, facing south-east (GIL18-0065)

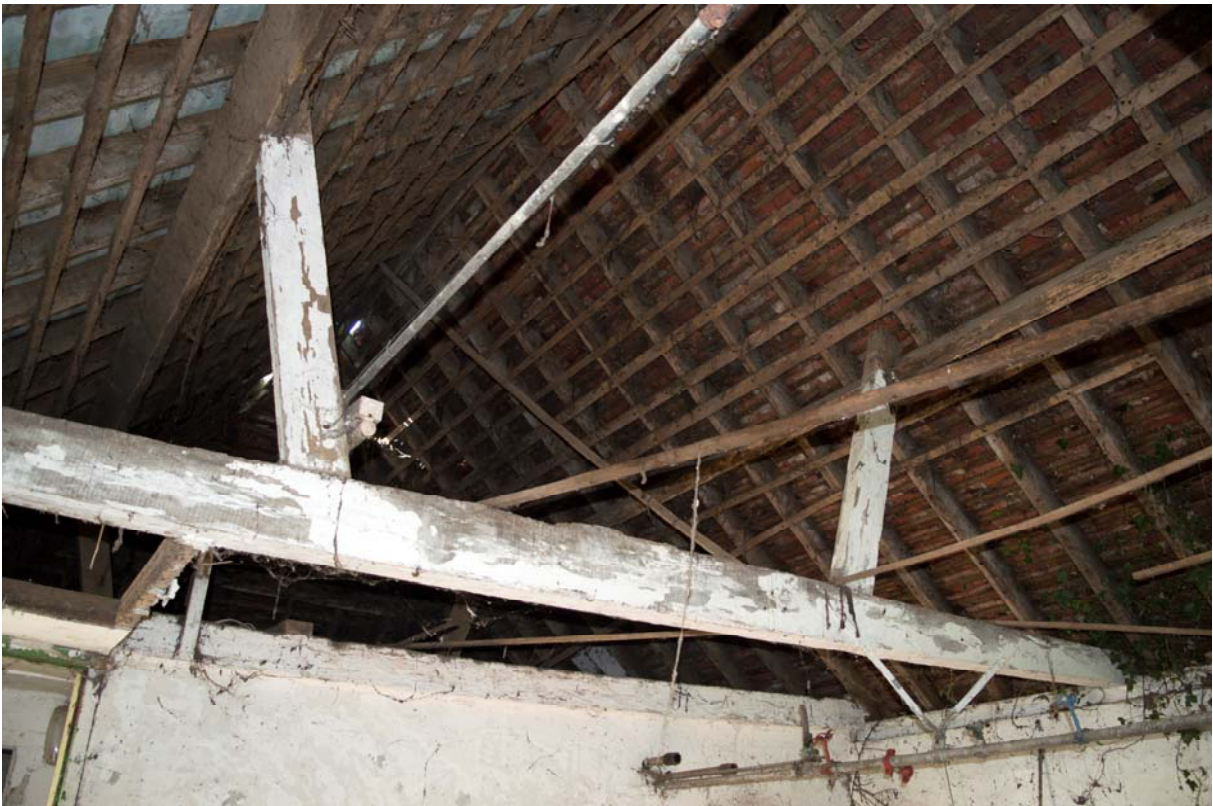
Plate 28 – Representative truss in the dairy (foreground) and that with the struts removed, facing north-west (GIL18-0093)

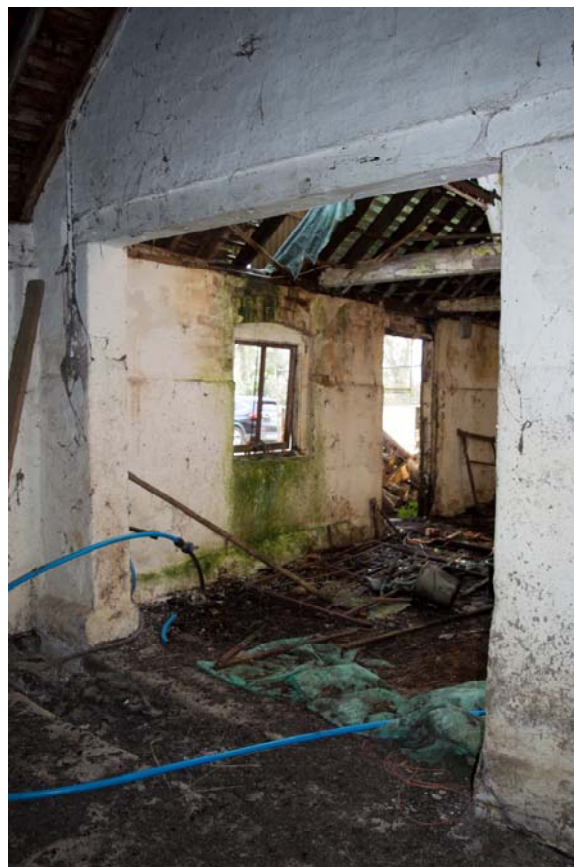
Plate 36 – Inserted opening in the brick wall between Rooms 3 and 4 of the dairy, facing south-west (GIL18-0102)
