**ST GILES FARM BARN AND DAIRY, PATTERSONS LANE,
BLENDWORTH, HAMPSHIRE, SO08 0AG**

HISTORIC BUILDINGS RECORD

**Historic Buildings Record
& Archaeological Watching-Brief**

**ASE Project No: 170925
Site Code: GIL18**

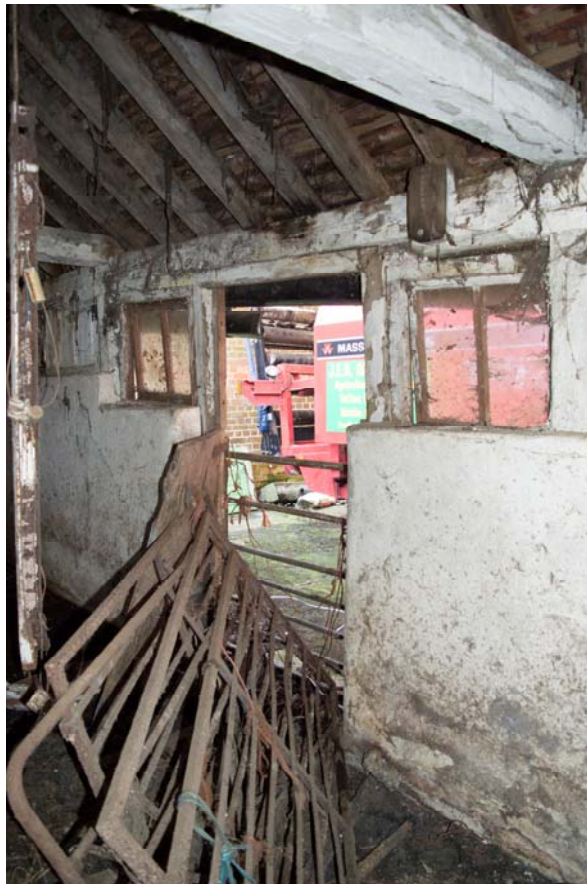
Plate 38 – Infilled original open front of the eastern part of the dairy, facing south-east
(GIL18-0103)
