**Archaeological Watching Brief Report
Hatchlands Sewer Update, Hatchlands Park
East Clandon, Guildford, Surrey**

**ASE Project No: 210250
Site Code: HLS 21
ASE Report No: 2022258
OASIS ID: archaeol6-509246**

Prepared by:	Simon Stevens	Senior Archaeologist

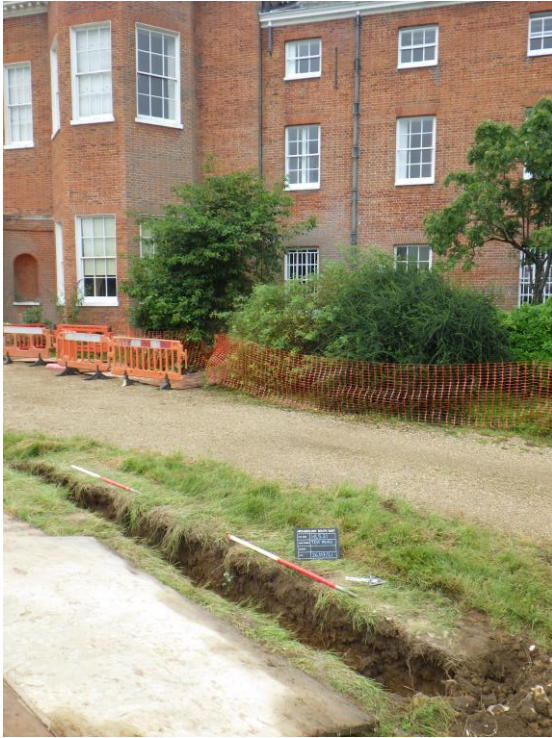
4.2.1 During visits to the site in July and August 2021, a range of deposits were encountered and recorded adjacent to the main mansion complex. Monitoring of the mechanical excavation of new service trenches and associated manholes showed extensive truncation from existing service trenches, and revealed a straightforward sequence of a dark brown clayey silt topsoil, context [001], which overlay a light brown silty clay subsoil, context [002] to the depth of the trench (usually a maximum of c.1.3m).

Service trench excavation adjacent to house

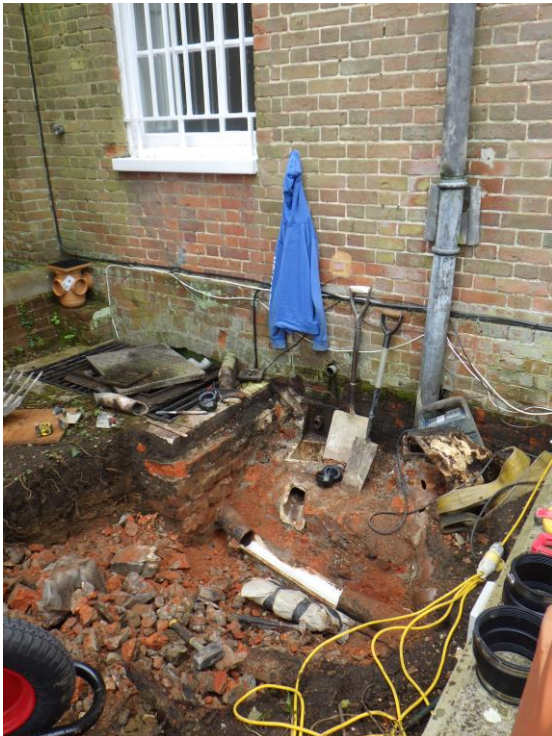
Service trench excavation next to house

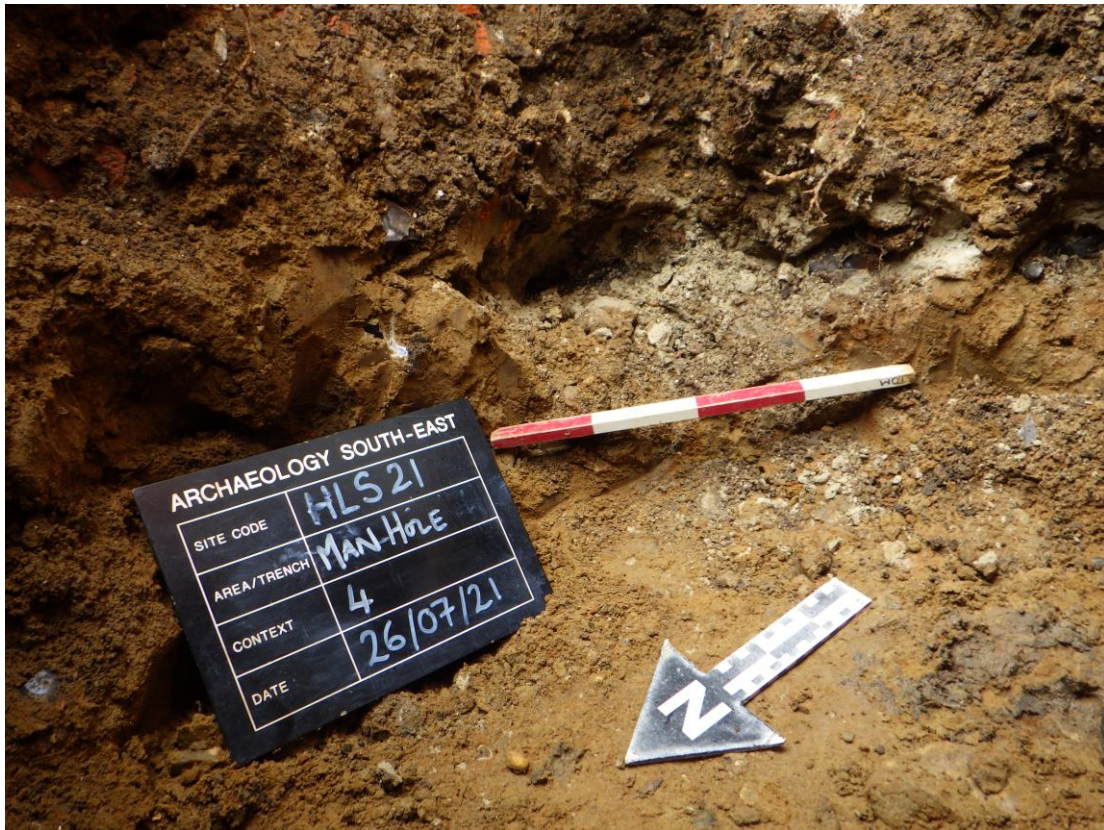
4.2.2 An area of made ground was recorded at the location of a man hole (context [003], and flint masonry (context [004]) was encountered at a depth of 1.05m but could not be fully investigated in the tight confines of the excavation. It was presumed to be an element of a wall foundation running at a right angle to the

main house, but this remains far from certain. A sample of flint from the features was retained.

Flint masonry [004]

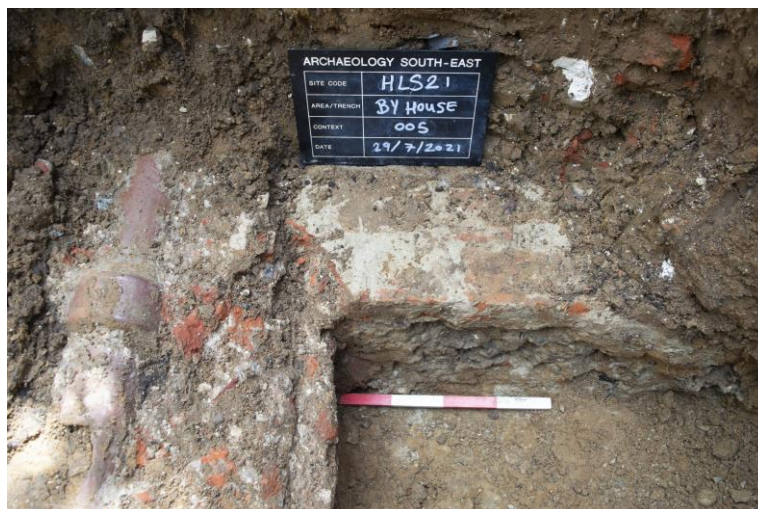
4.2.3 Further masonry was recorded in a service trench closer to the mansion complex. The form of the masonry was uncertain but it brick built (context 005) and the trench was realigned to avoid it.

Brick masonry [005] close to mansion complex

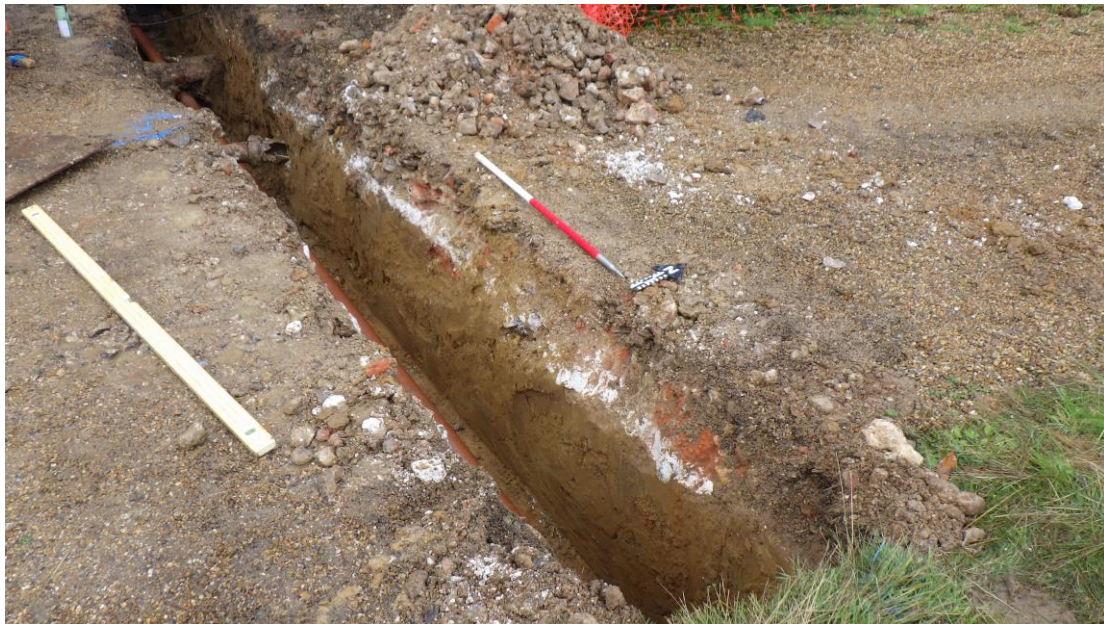
4.2.4 A short stretch of service trench was cut across the driveway to the east of the main house. The gravel driveway (context [009]) overlay a layer of brick and

flint rubble (context [008]), which in turn overlay a chalky made ground (context [007]). This overlay a deposit of apparently laid bricks (context [006]) of uncertain form and extent, encountered at the base of the trench.

Surfaces [009, 008, 007 and 006]

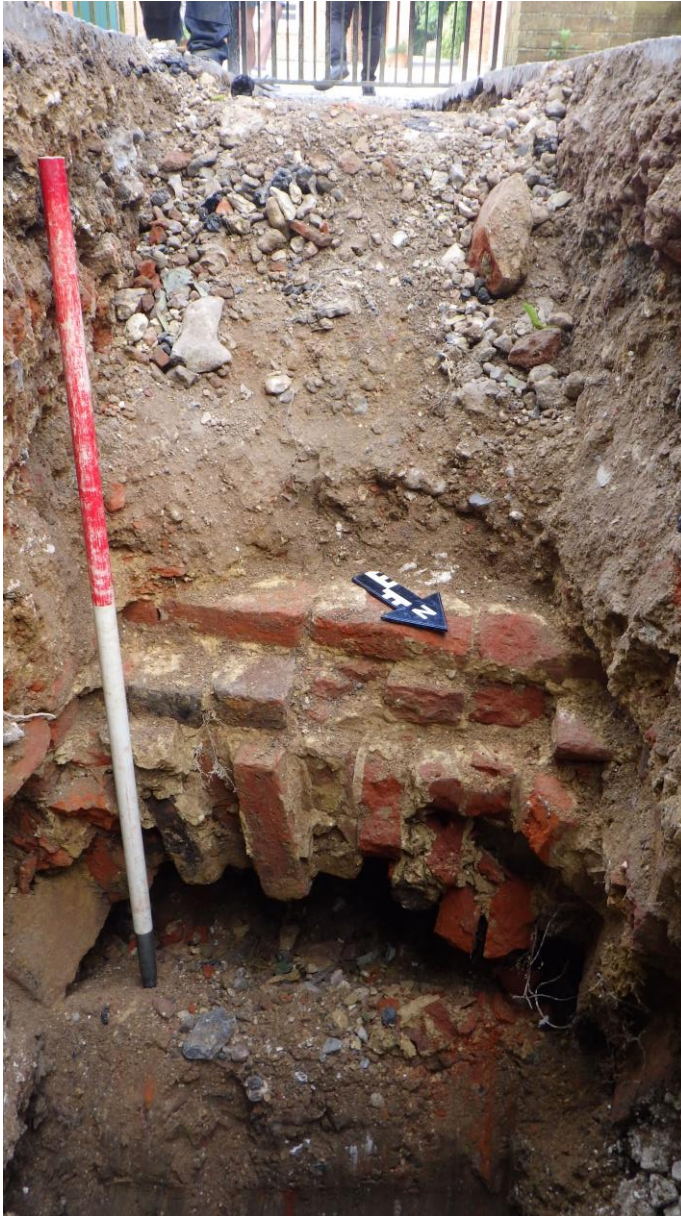
- 4.2.6 More buried masonry were encountered closer to the main mansion complex. Again detailed recording was not possible in the narrow confines of the service trench, but the surviving elements of a brick-built culvert, consisting of two side walls (recorded as context [014]), each 0.45m wide running broadly north to south across the trench, located in construction cut [017] apparently excavated into a layer of made ground (context [016]) and the local 'natural' clay (context [018]). There was with surviving cover, and the masonry extended to a depth of 1.8m, the maximum depth of the trench. It was clearly not in use and had been backfilled with brick and chalk rubble (context [015]). A brick sample taken from context [014] could not be closely dated.

Brick built culvert [014]

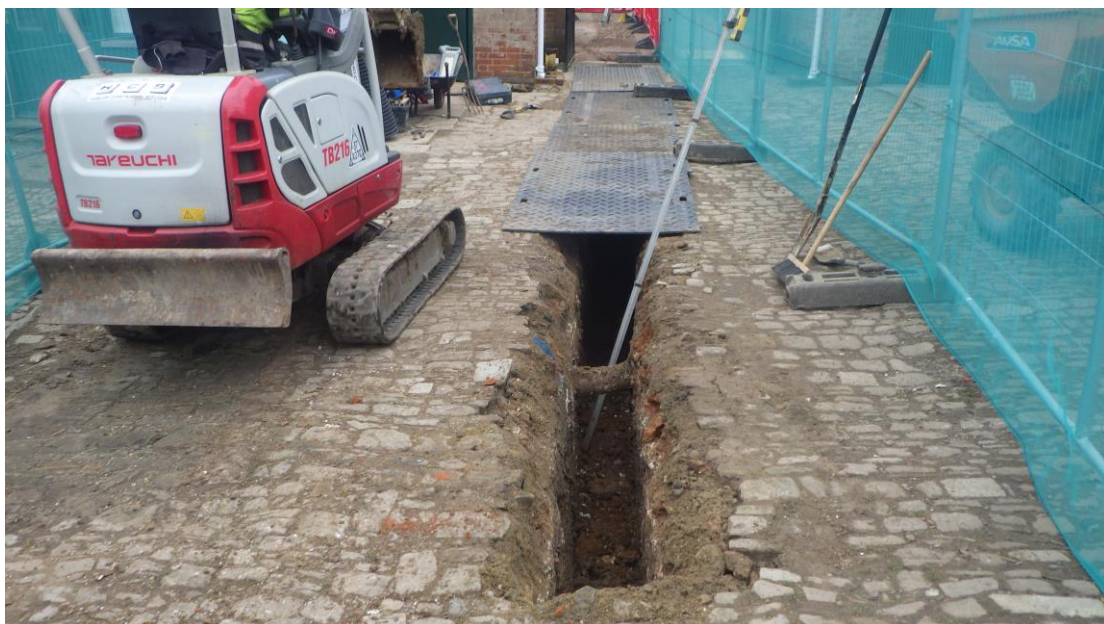
- 4.4.1 The mechanical excavation of the service trench in the courtyard of the main mansion complex was monitored. The trench was a 0.70m wide and a maximum of 1.50m deep.
- 4.4.2 The courtyard surface consisted of a limestone cobbles (context [022]), laid onto a brick and stone rubble levelling deposit (Contexts [023] and [034]), which overlay a thick deposit of made ground (context [024]), which extended to the base of the excavated trench.

Courtyard excavations showing cobble surface [022]

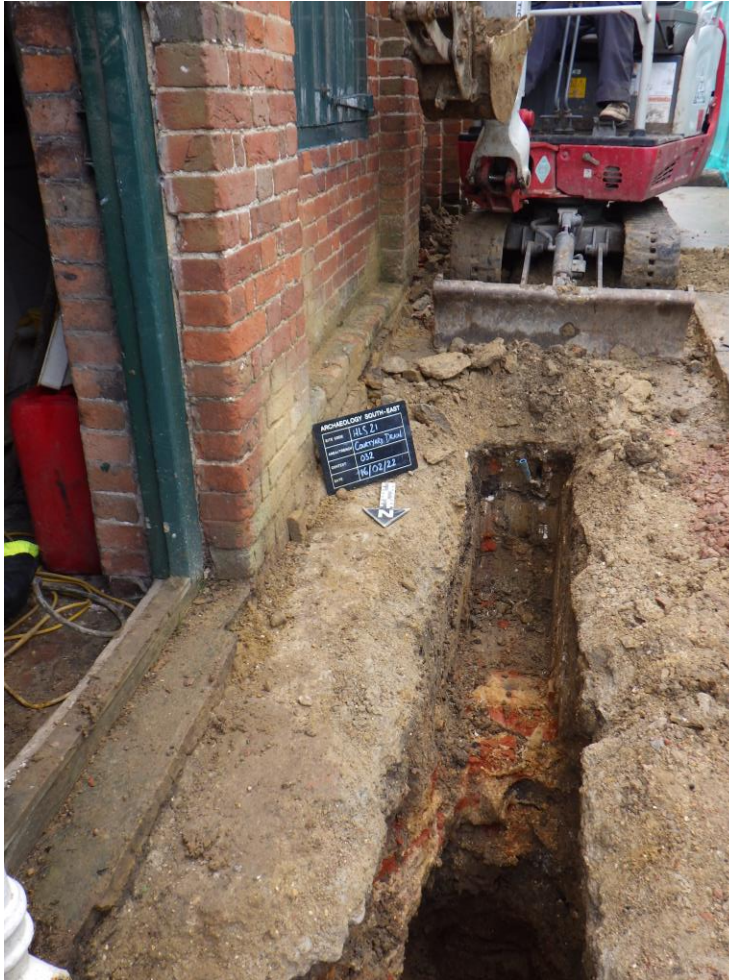
- 4.4.3 A brick-built culvert (recorded as masonry [025]) was encountered just inside the gates to the courtyard. It proved impossible to investigate in detail given the narrow confines of the trench, the depth at which the masonry was found (1.01m below the current surface) and the presence of adjacent buried services. It continued to the north-east where it was recorded as masonry [033].

Culvert [022]

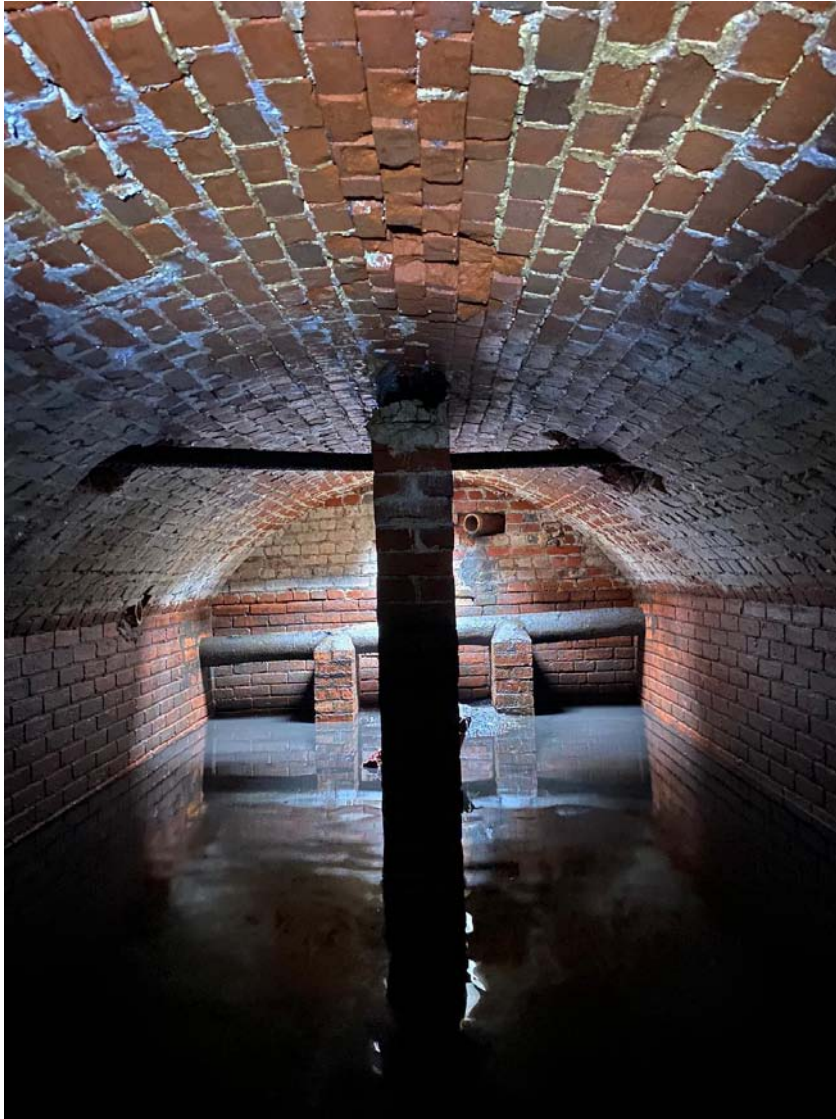
- 4.4.4 Further monitoring of service trench excavation in the courtyard area revealed part of the brick foundation of the existing structure (context [031]) exposed at a depth of 0.95m below the current surface, which extending c.0.30m out from the face of the wall. Again, the masonry could not be fully investigated in the narrow confines of the trench.
- 4.4.5 Another fragment of masonry (recorded as context [032]) was encountered at a depth of 0.75m, in this case extending c.0.70m from the base of the wall, but possibly on a slightly different orientation to the standing structure, although again this could not be confirmed in the circumstances.
- 4.4.6 Away from the standing structures, a brick-built chamber (masonry [035]) with external dimensions of 7.50m by 2.75m and a depth of 1.65m was

encountered. Again detailed recording was hampered by the conditions, but the feature was clearly still in use, with water entering and leaving the feature.

Brick vaulted chamber

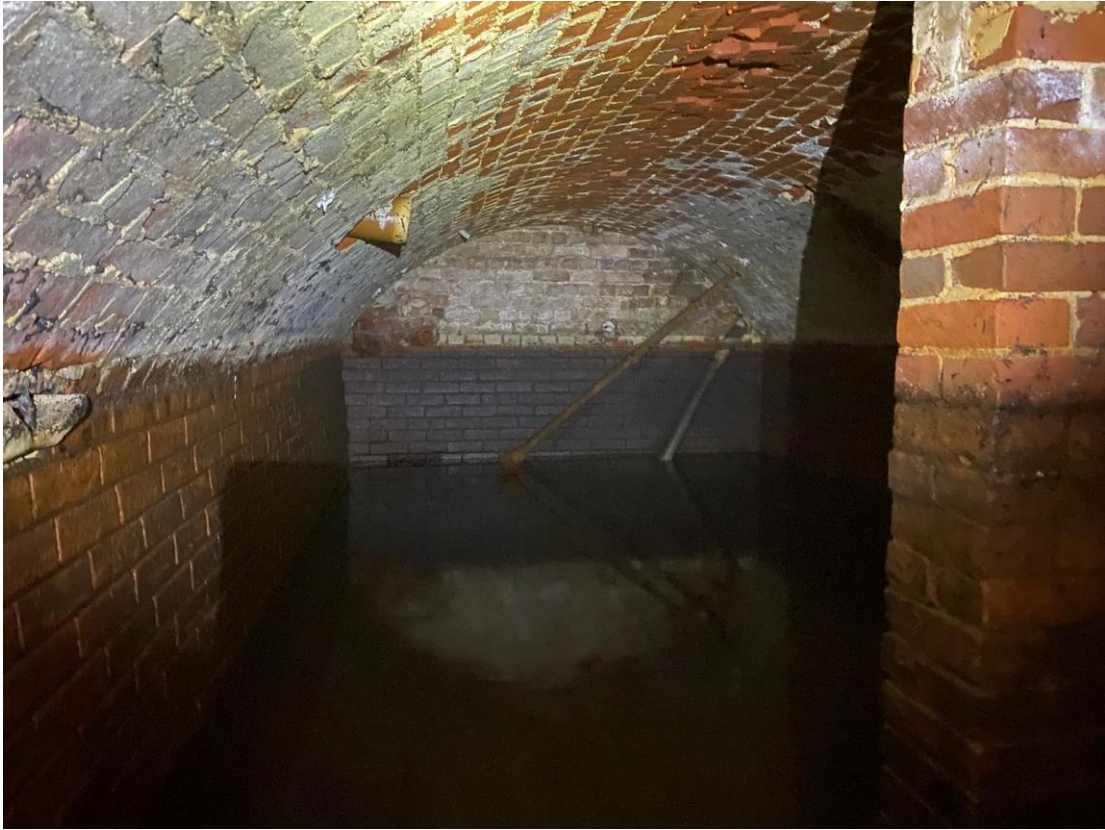
- 4.4.7 One of the pipes leading into chamber [035] came from a second, adjacent brick-built chamber recorded as masonry [036]. It had external dimensions of 1.53m by 1.53m, with a depth of 1.10m. This feature was fed by two drains and discharged into chamber [035] when full.

Brick vaulted chamber

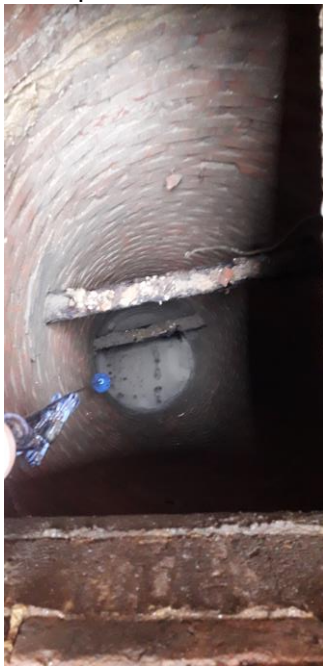
4.4.8 The only other feature recorded during the monitoring in the courtyard was a brick-built well (masonry [037]). The brickwork extended to a depth of 7.50m until a layer of silt was encountered. No further investigation or recording was attempted.

Well [037]
