**AN ARCHAEOLOGICAL WATCHING BRIEF AT 45 PARK LANE WITH A
SUPPLEMENTARY HISTORIC BUILDING RECORD DURING REPAIR AND
REFURBISHMENT WORK AT 45 AND 47 PARK LANE, SLINDON, WEST SUSSEX**

Project No: 3492
Site Code: PLS08

ASE Report No. 2008198
OASIS id: archaeol6-55483

COMMISSIONED BY
THE NATIONAL TRUST

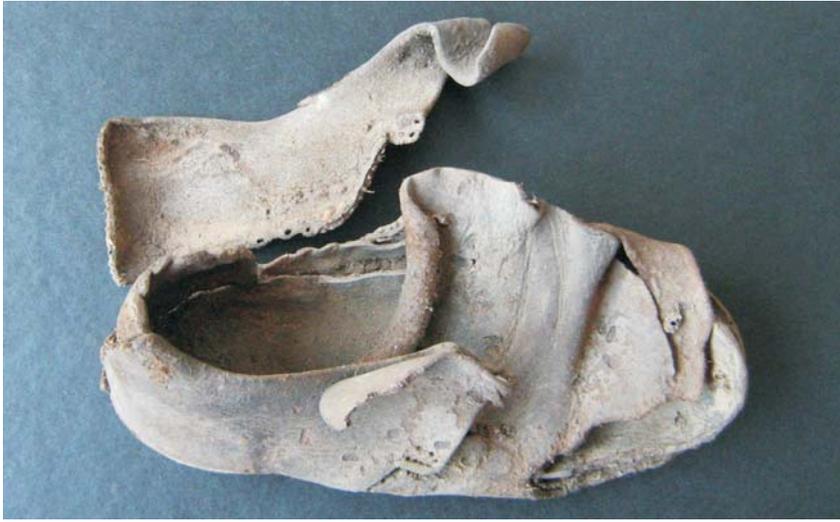
Child's Shoe

- 5.8.5 The shoe is virtually complete, but in poor and deteriorating condition. There is active infestation of some kind of parasite, evidenced by pupa cases and 'nibbled' areas at the instep. Preventative conservation is highly recommended.

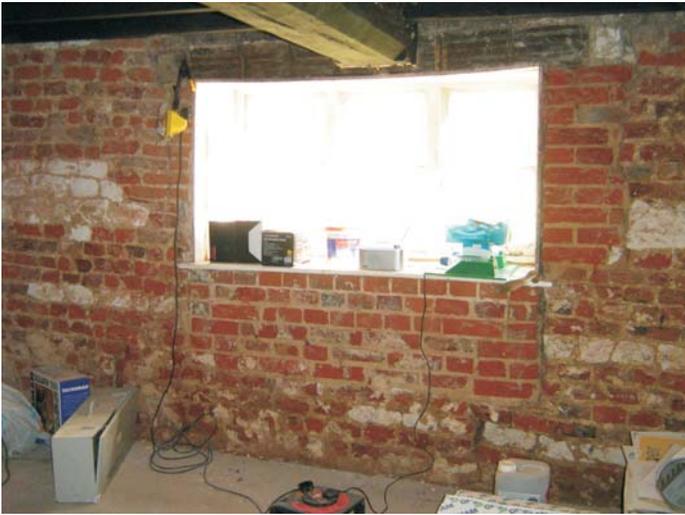
Plate 1: The east wall of the living room with the late phase of brick in-fill to a former, much larger opening

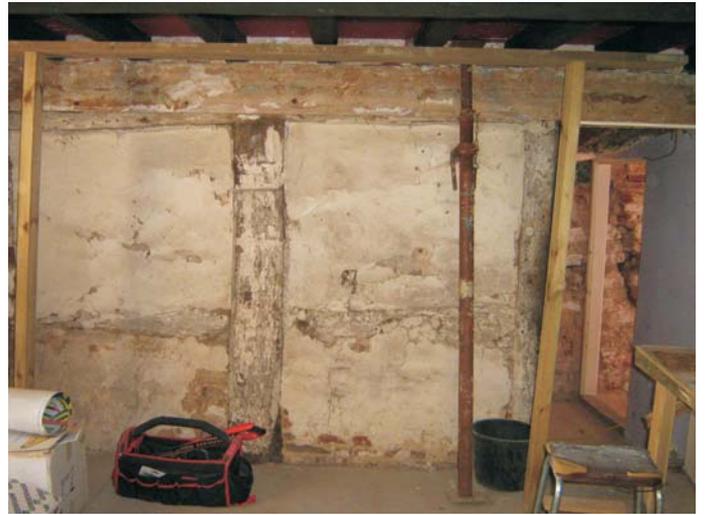
- 8.5.6 The south wall is timber framed and had suffered much from later phases of modification to the house and structurally from the slumping of the southern side of the building. The framing is small panel type (Plate 2) as described in the 2005 report. The infill (Plates 3 to 7) of the two lower panels has been replaced with brickwork; the upper two panels differed in their infill in that the eastern had horizontal rods while the western had the more usual staves.

Plate 2: The small-panel framing in the south partition wall of the living room

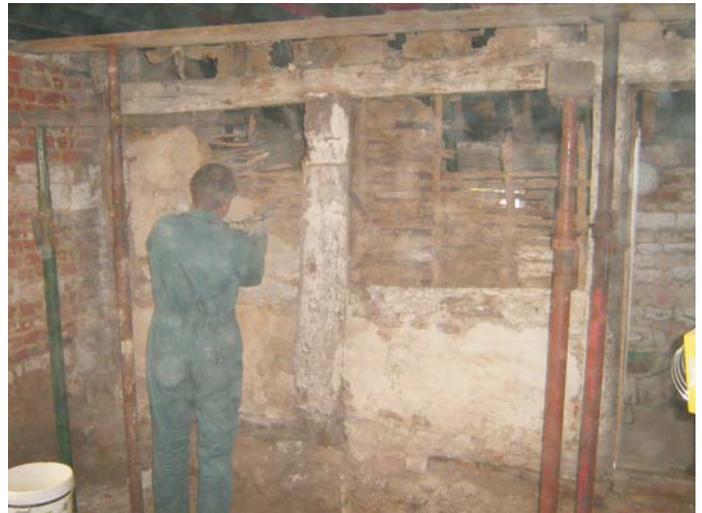
Plate 4: Stripping out of the south partition wall in progress - October 2008

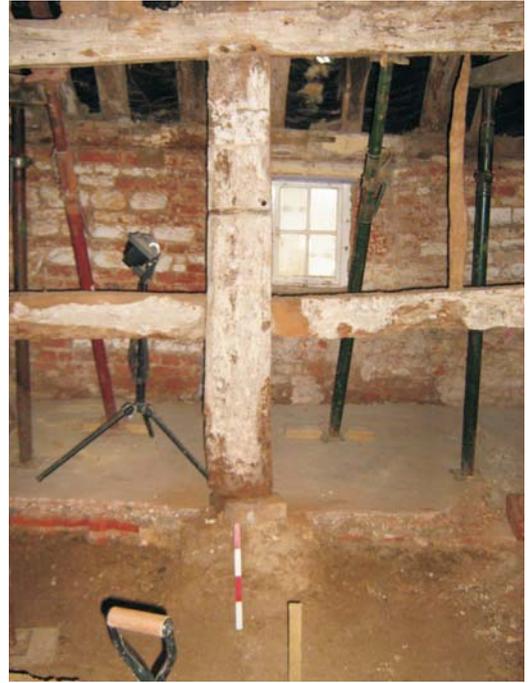
Plate 6: The full stripped wall with brick floor below the concrete in the former bathroom beyond

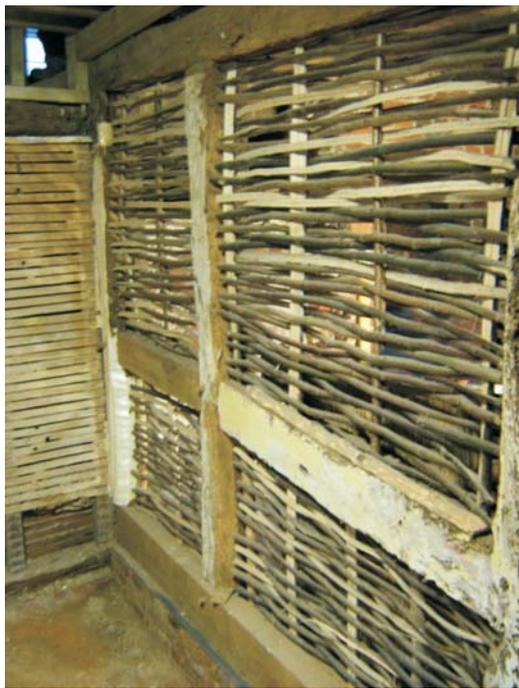
Plate 7: The south wall with replacement in-fill *in situ* - January 2009

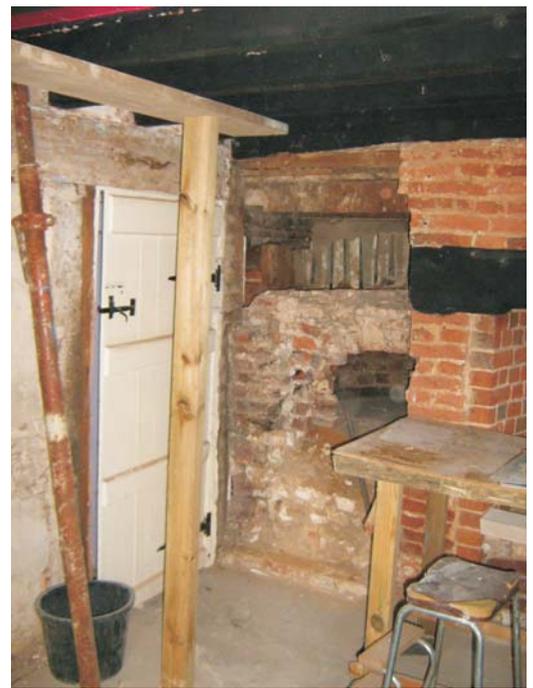
Plate 8: The exposed bread oven from the living room

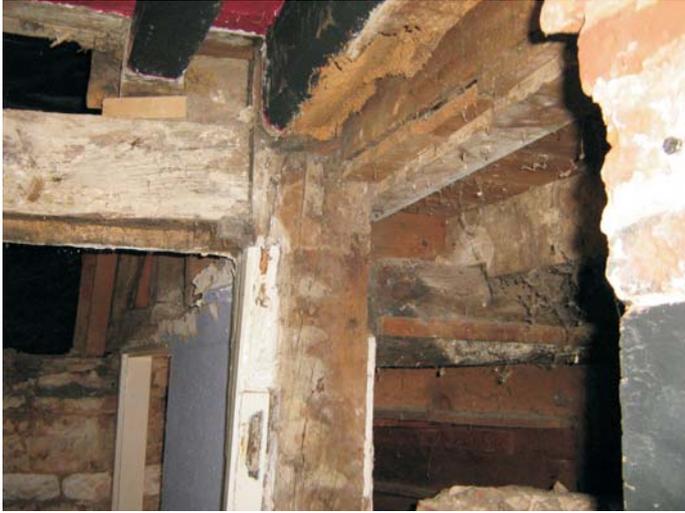
Plate 9: The timber beam across the front of the living room fireplace, jointed into the post of the original frame

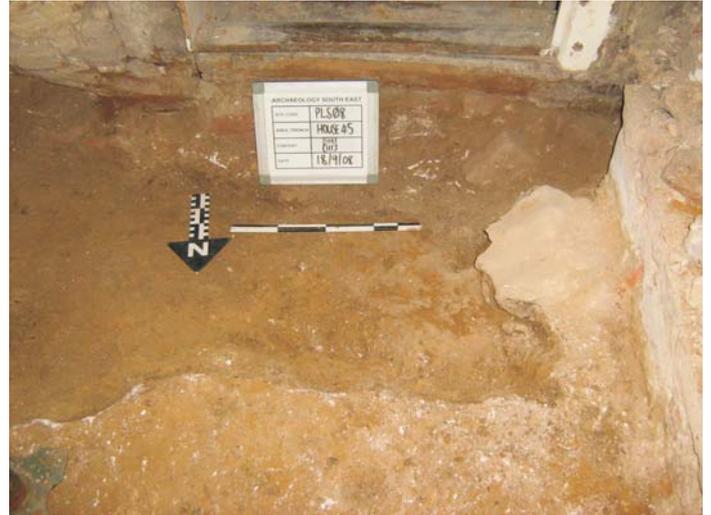
Plate 10: The remains of the sill-beam at the base of the south partition wall between living room and bathroom

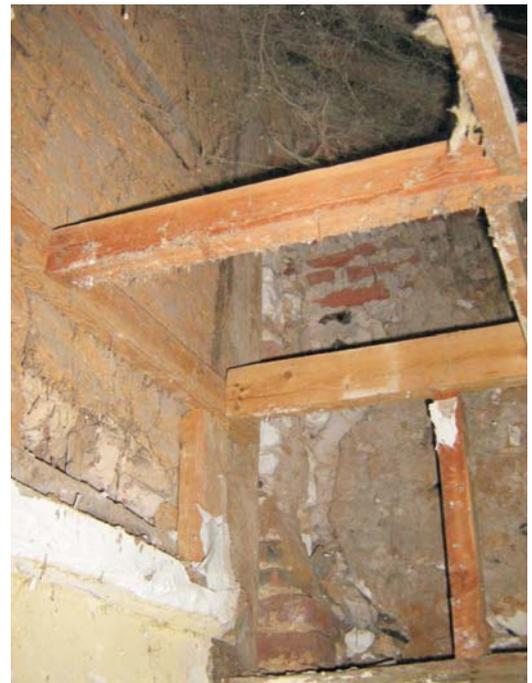
Plate 12: The east end wall of the outshot shows much modification and patching to the construction

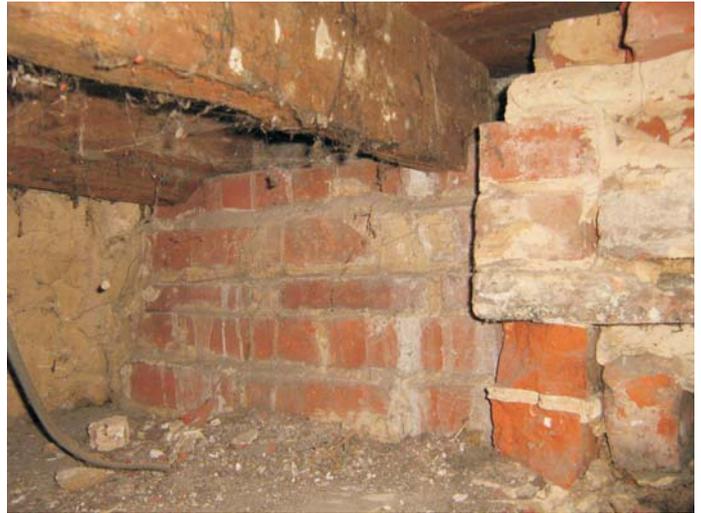
Plate 14: The modern brick inserted over the oven to support the stair construction - viewed from the living room side

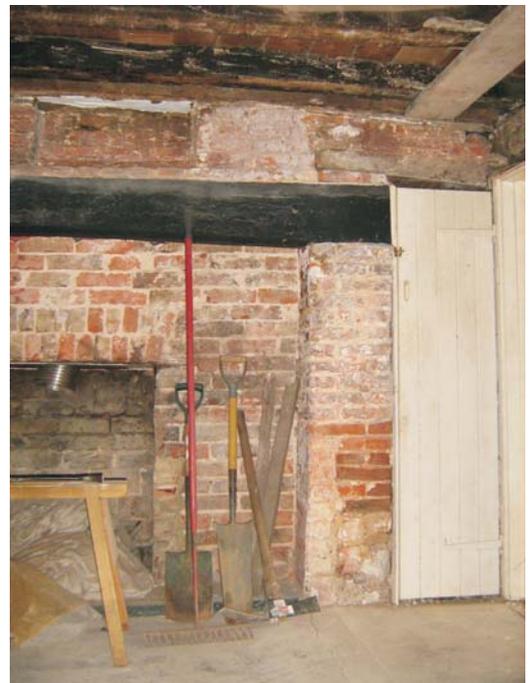
Plate 20: The south side of the inglenook with inserted cupboard under additional lintel

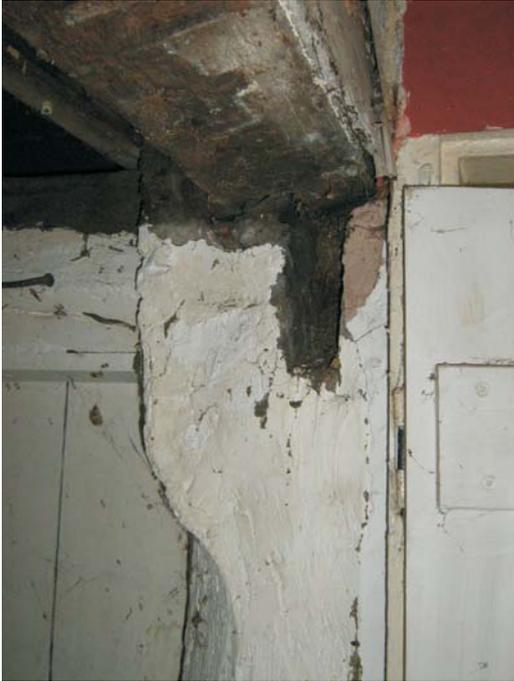
Plate 21: The post of the timber frame, within the cupboard to the south of the kitchen inglenook. There is a redundant mortise where the bressumer would have terminated prior to truncation caused by the insertion of the cupboard

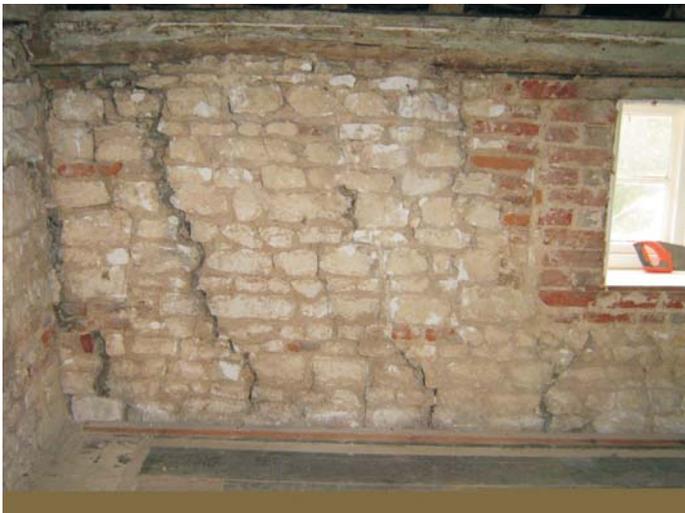
Plate 27: The west end of the north wall shows the substantial cracking of the chalk block masonry

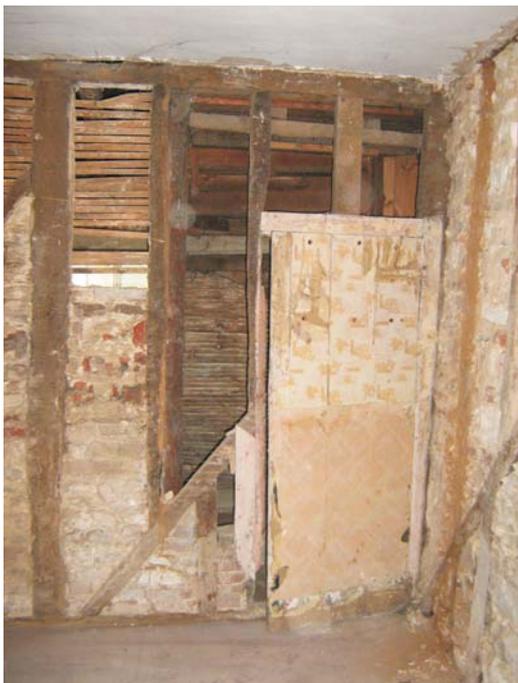
Plate 44: The south wall of the sitting room with inserted doorway overlain by successive layers of mid to late 20th century wallpaper when the door was no longer in use

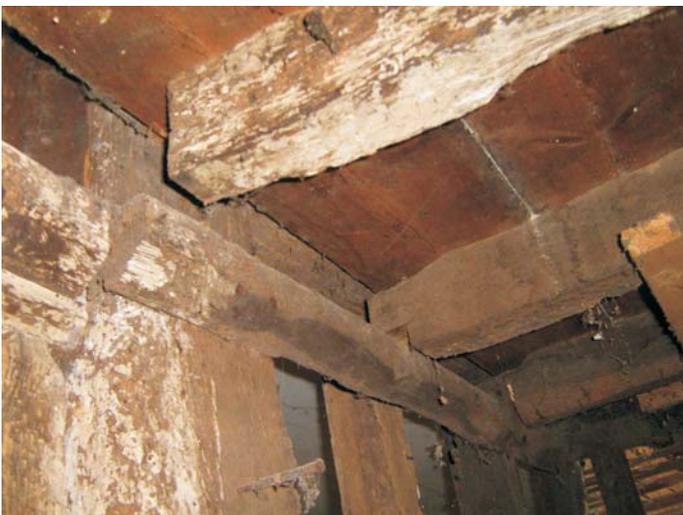
Plate 54: Added timber member attached to south side of the timber partition wall between sitting room and bathroom, to support the stair construction

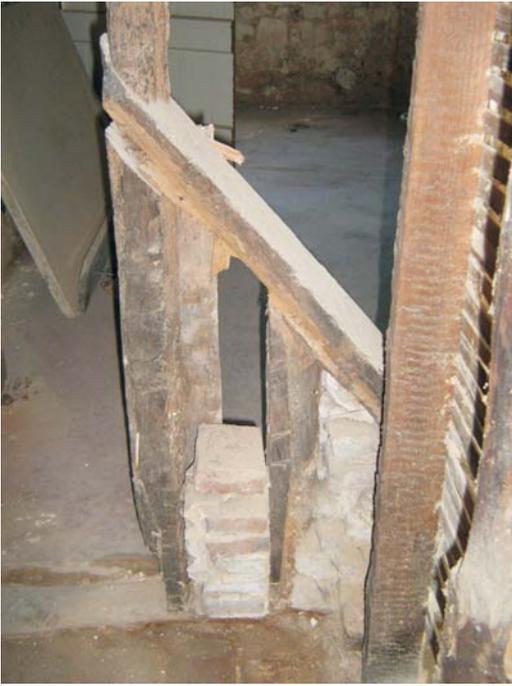
Plate 56: Truncated strut at the base of the doorway in the south partition wall of the sitting room
